**REPORT NUMBER: TWG-MGA-2008-002**

**NEW CAR ASSESSMENT PROGRAM  
SIDE AIRBAG OUT-OF-POSITION INJURY TESTING**

**DAIMLERCHRYSLER CORPORATION  
2008 CHRYSLER SEBRING CONVERTIBLE  
NHTSA NUMBER: M80301TWG2**

**PREPARED BY:  
MGA RESEARCH CORPORATION  
5000 WARREN ROAD  
BURLINGTON, WI 53105**

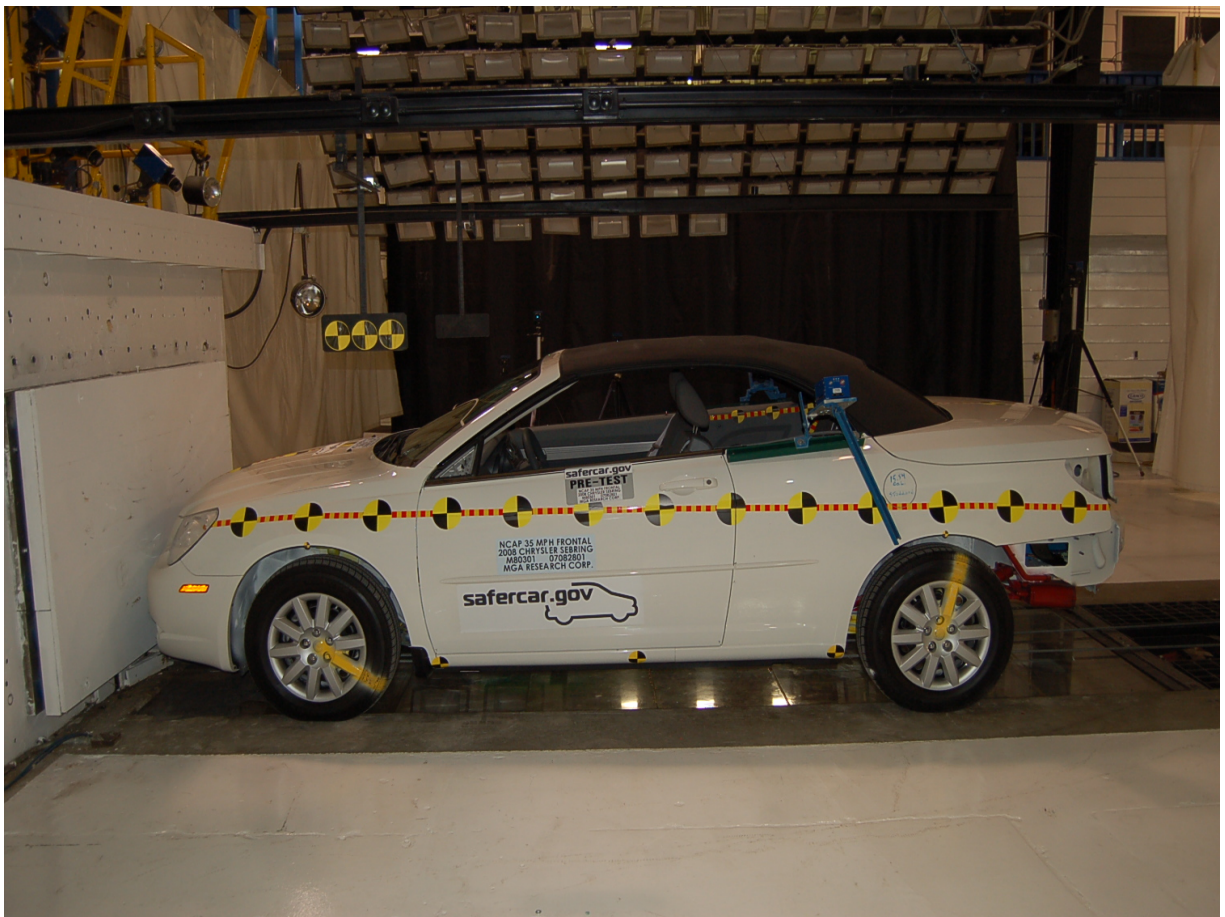
| | | <u>Page No.</u> |
|---|---|---|
| Photo No. 1. | Pre-Test Vehicle Left Side View | A-2 |

Pre-Test Vehicle Left Side View

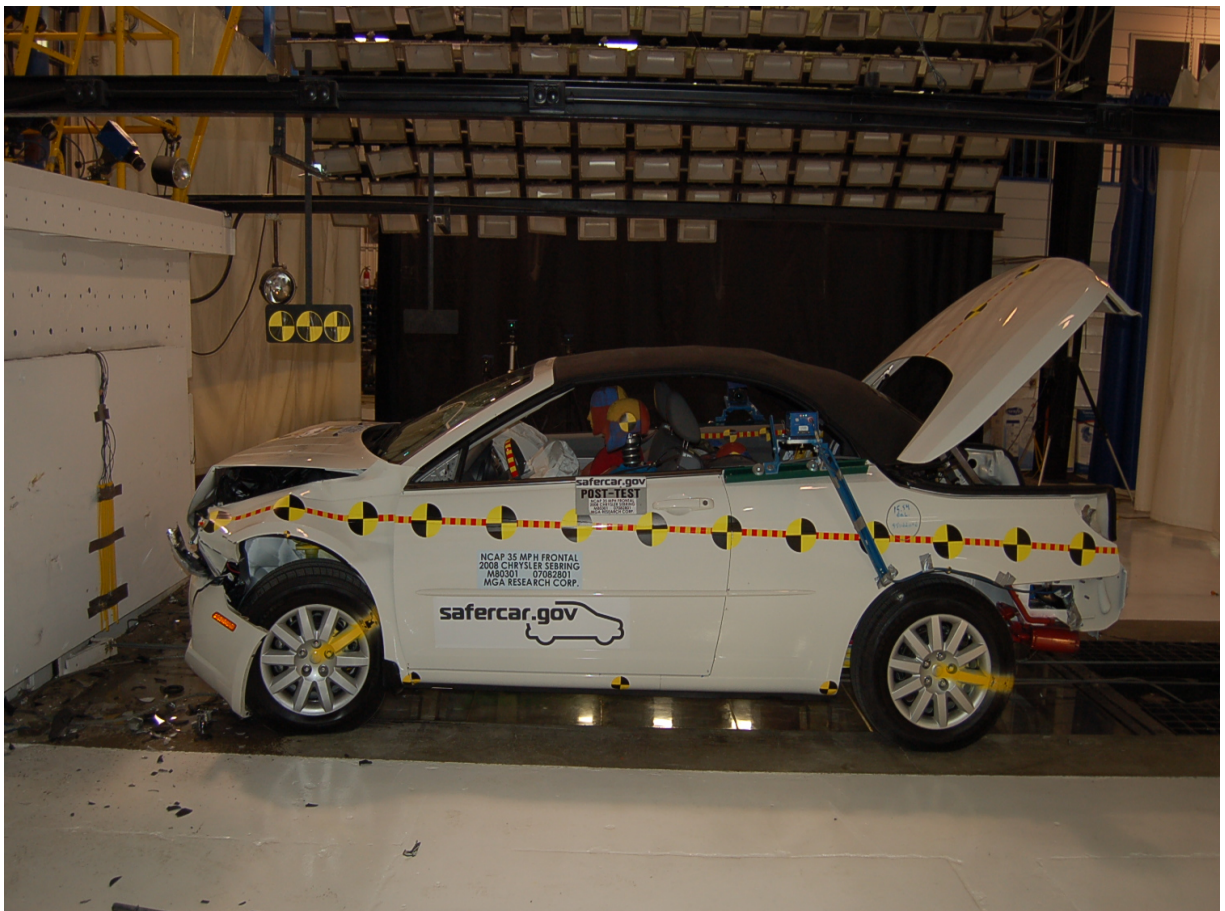
| | | <u>Page No.</u> |
|---|---|---|
| Photo No. 2. | Post-Test Vehicle Left Side View | A-2 |

Post-Test Vehicle Left Side View

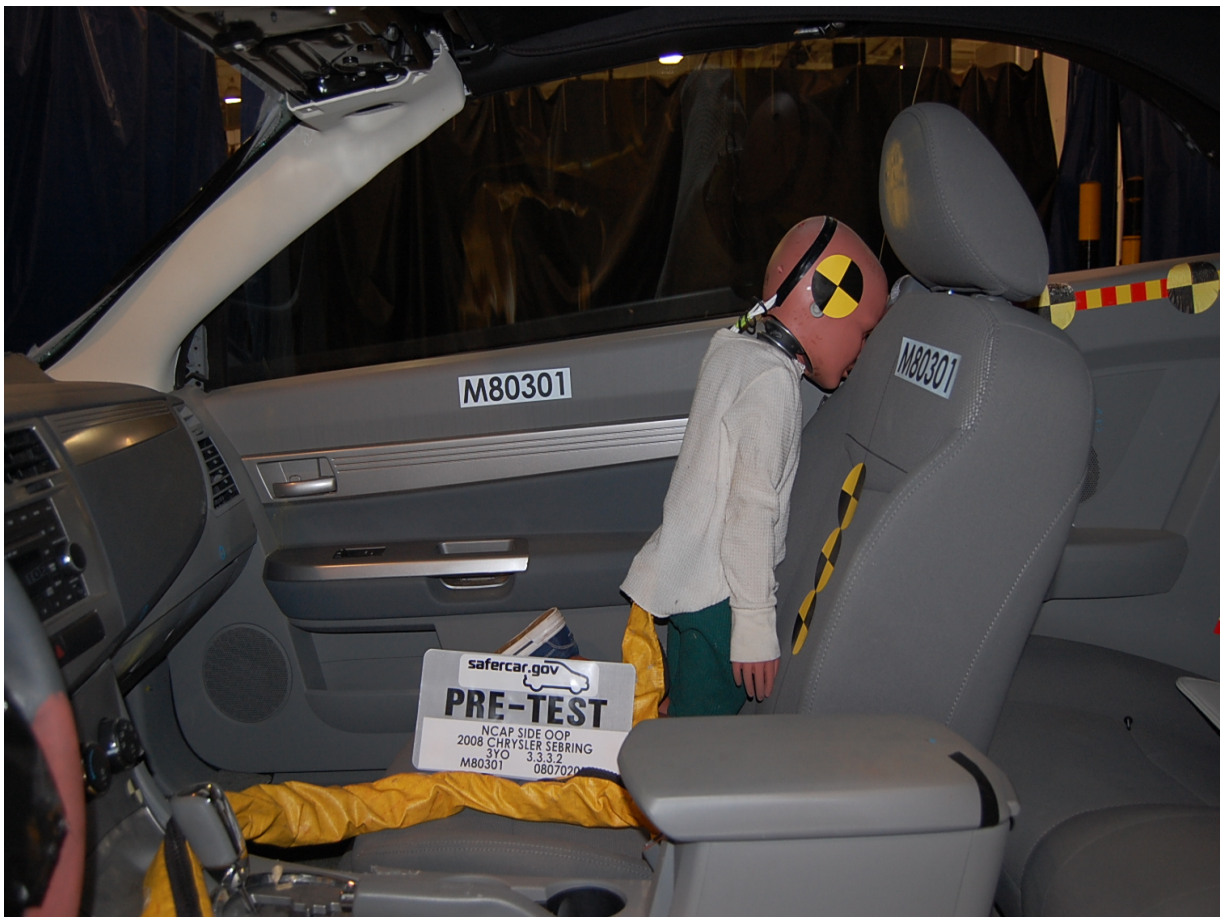
| | | <u>Page No.</u> |
|---|---|---|
| Photo No. 5. | Pre-Test 3-Year-Old Dummy Left Side View | A-4 |

The Hybrid III 3-Year-Old child dummy was placed in the right front passenger seat along the outboard edge of the seat cushion, kneeling and facing rearward. The dummy's sternum centerline was aligned vertically with the leading edge of the seat back bolster. The sternum was contacting the seat. The dummy's head was placed in between the seat bolster and the pillar/side trim. The outboard leg was positioned at the outboard edge of the seat cushion and parallel to the seat centerline. The outboard knee and lower leg was slid toward the junction of the seat back/seat cushion until the top edge of the upper rib was aligned horizontally with the top edge of the airbag module. The inboard leg was aligned parallel to the centerline of the seat cushion. The inboard knee and lower leg was skid towards the junction of the seat back/seat cushion until, a line drawn through both shoulder bolts is perpendicular to the vehicle centerline. The inboard arm was rotated towards the seat back until the thumb contacted the seat back. The outboard arm and hand was rotated to hang down as close to vertical as possible.

Pre-Test 3-Year-Old Dummy Left Side View

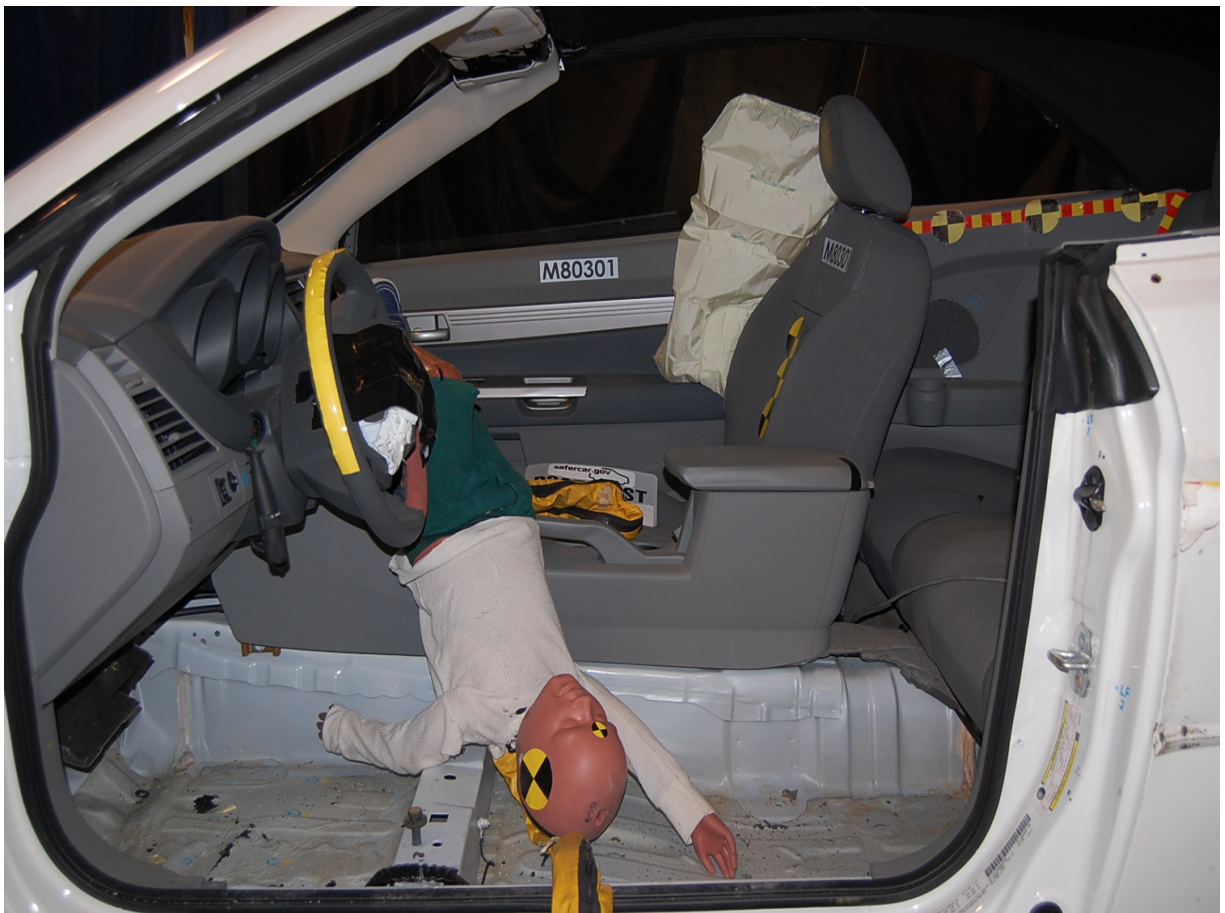
| | | <u>Page No.</u> |
|---|---|---|
| Photo No. 6. | Post-Test 3-Year-Old Dummy Left Side View | A-4 |

The Hybrid III 3-Year-Old child dummy's visible contact points were as follows: The torso airbag to the left shoulder and torso of the dummy.

Post-Test 3-Year-Old Dummy Left Side View

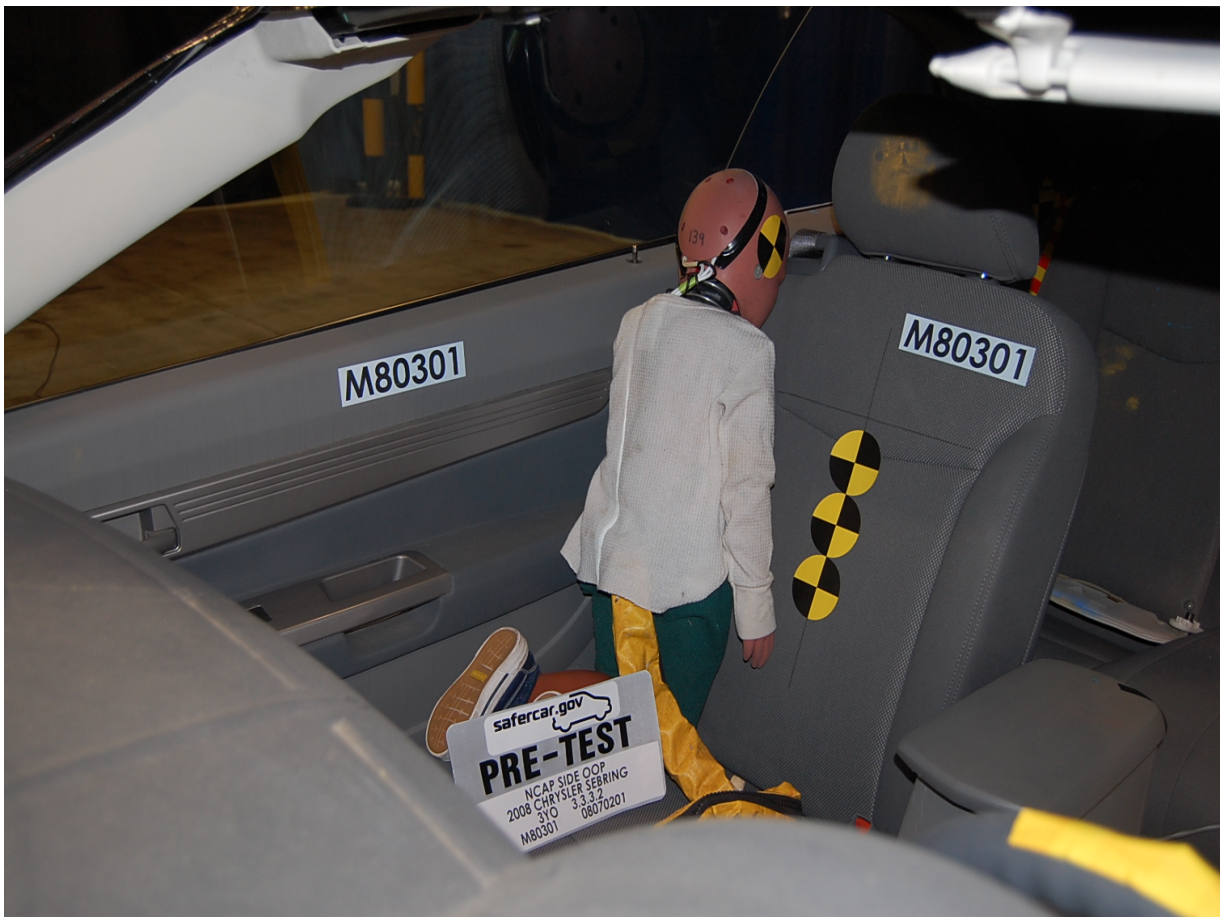
| | | <u>Page No.</u> |
|---|---|---|
| Photo No. 7. | Pre-Test 3-Year-Old Dummy Left $\frac{3}{4}$ Front View | A-5 |

Pre-Test 3-Year-Old Dummy Left  $\frac{3}{4}$  Front View

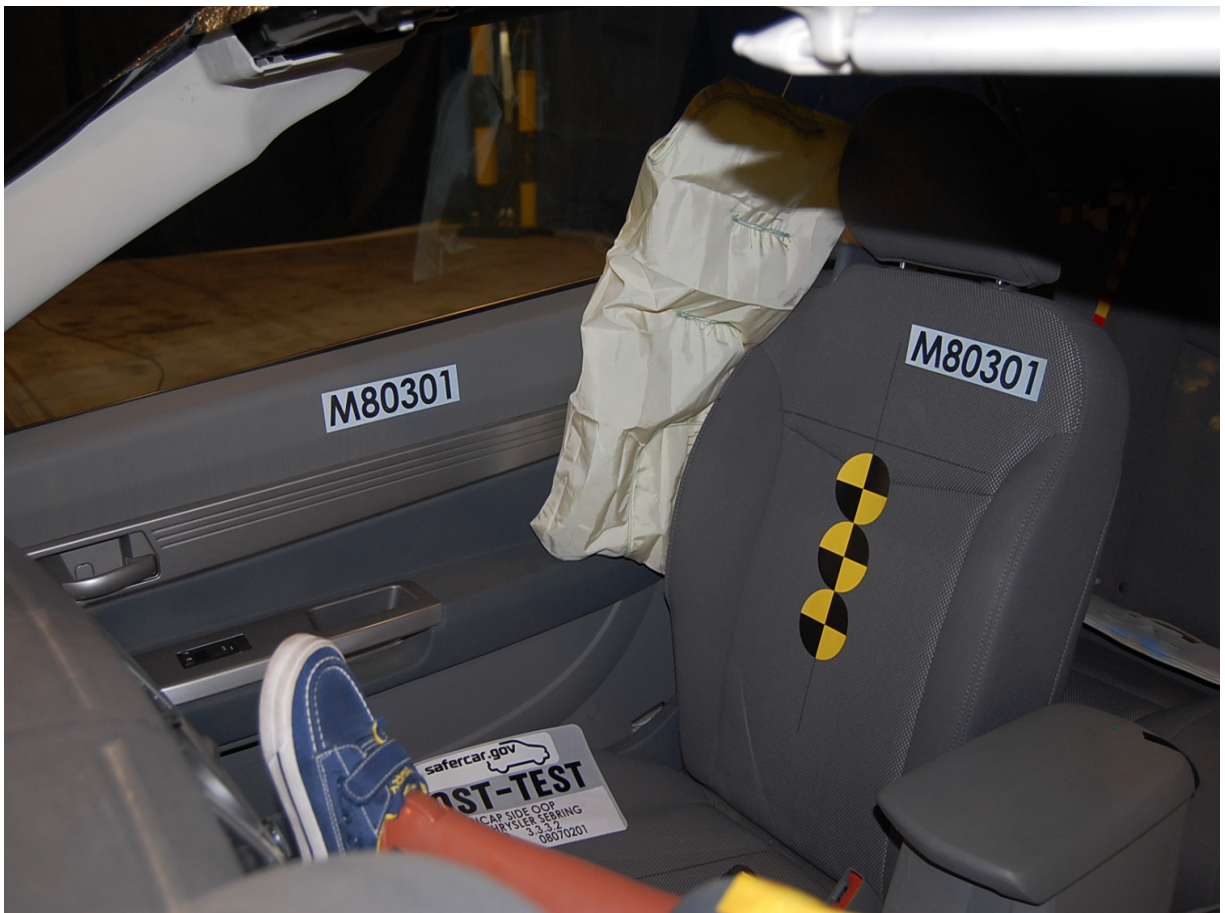
| | | <u>Page No.</u> |
|---|---|---|
| Photo No. 8. | Post-Test 3-Year-Old Dummy Left $\frac{3}{4}$ Front View | A-5 |

Post-Test 3-Year-Old Dummy Left  $\frac{3}{4}$  Front View

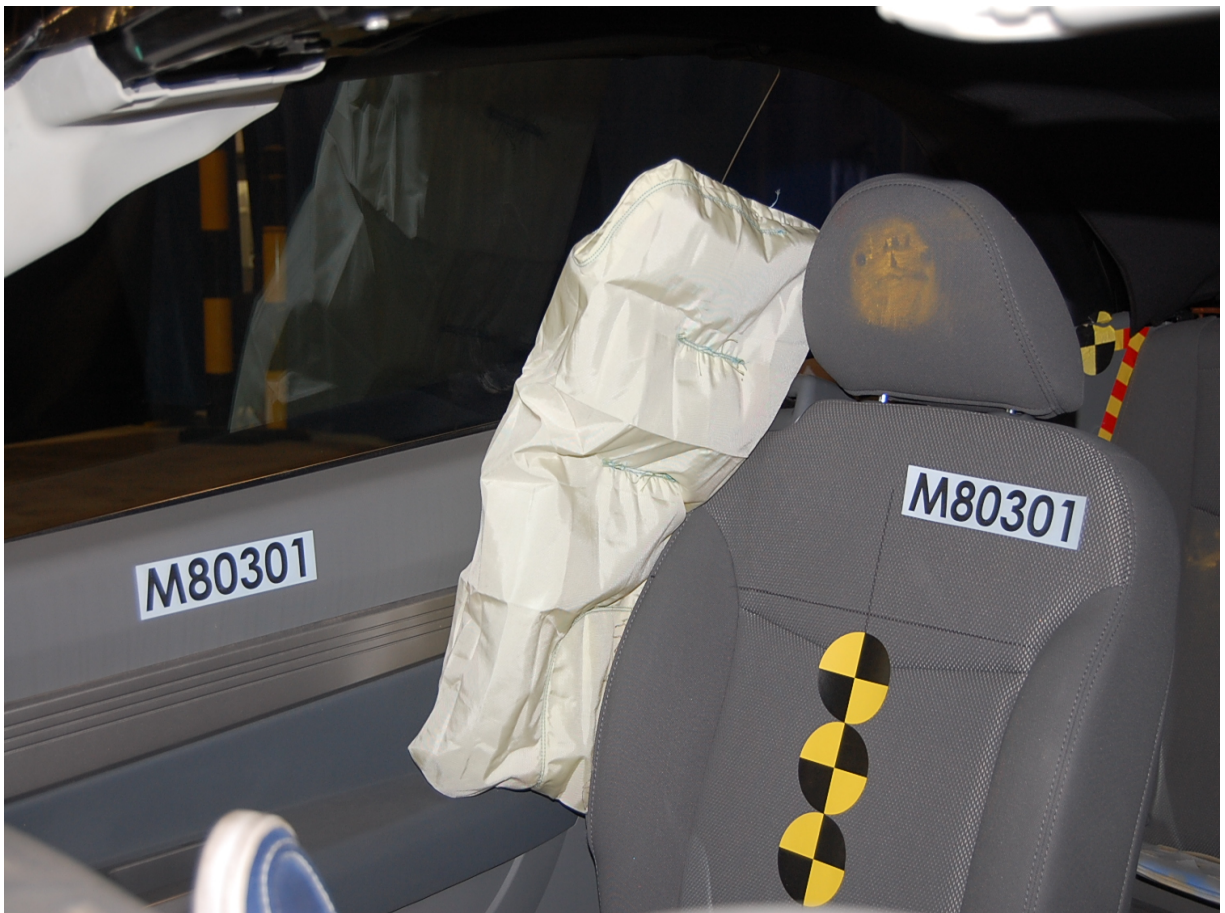
| | | <u>Page No.</u> |
|---|---|---|
| Photo No. 10. | Post-Test 3-Year-Old Dummy Left $\frac{3}{4}$ Front Closeup View | A-6 |

Post-Test 3-Year-Old Dummy Left  $\frac{3}{4}$  Front Closeup View

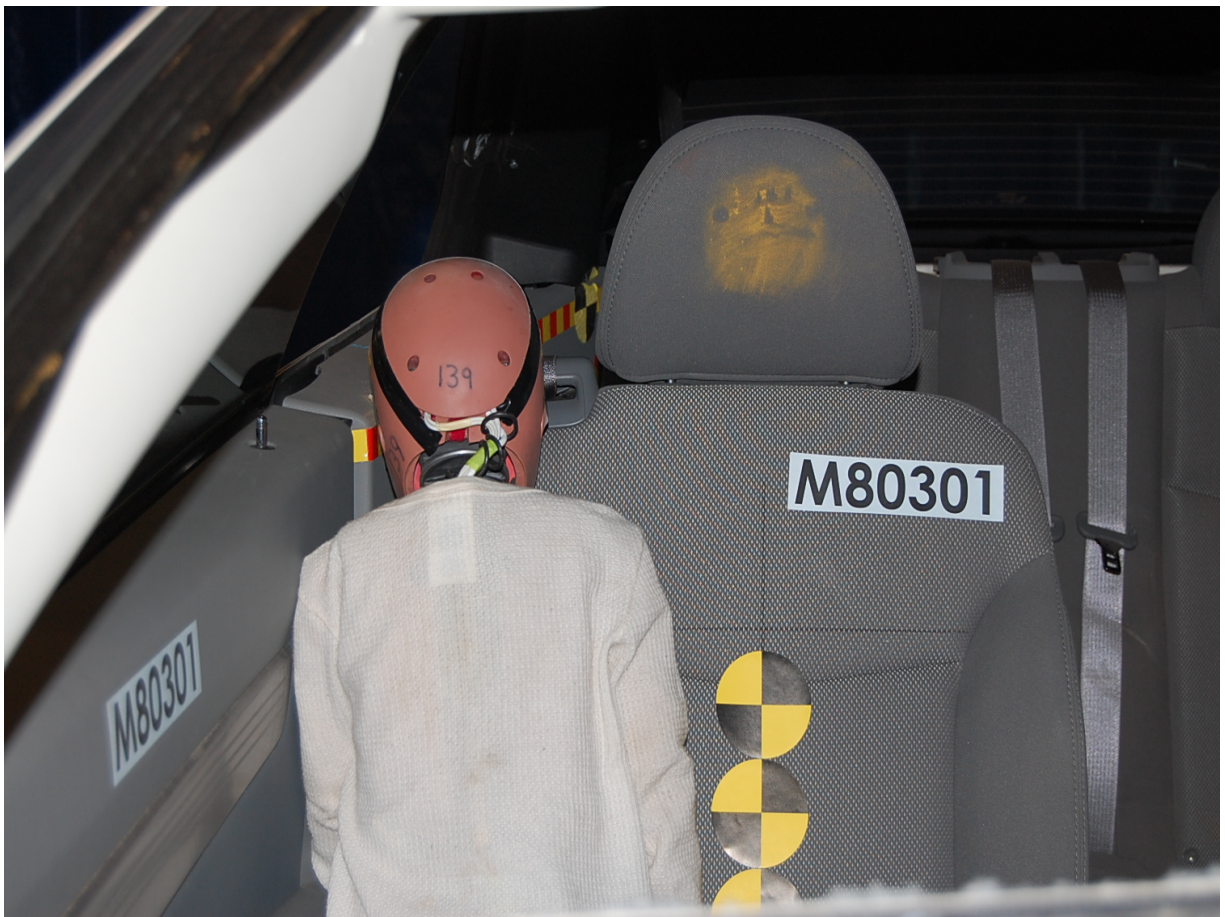
| | | <u>Page No.</u> |
|---|---|---|
| Photo No. 11. | Pre-Test 3-Year-Old Dummy Front View | A-7 |

Pre-Test 3-Year-Old Dummy Front View

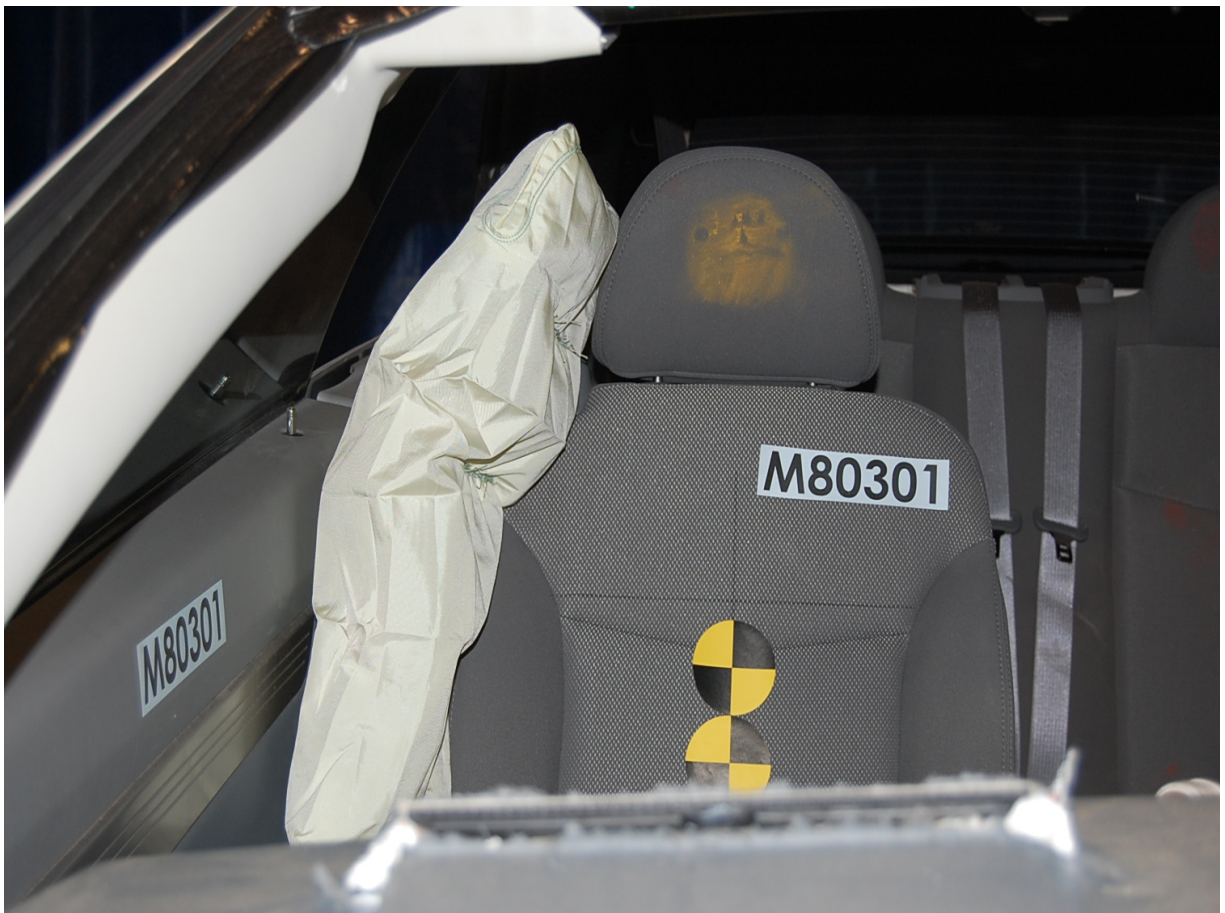
| | | <u>Page No.</u> |
|---|---|---|
| Photo No. 12. | Post-Test 3-Year-Old Dummy Front View | A-7 |

Post-Test 3-Year-Old Dummy Front View

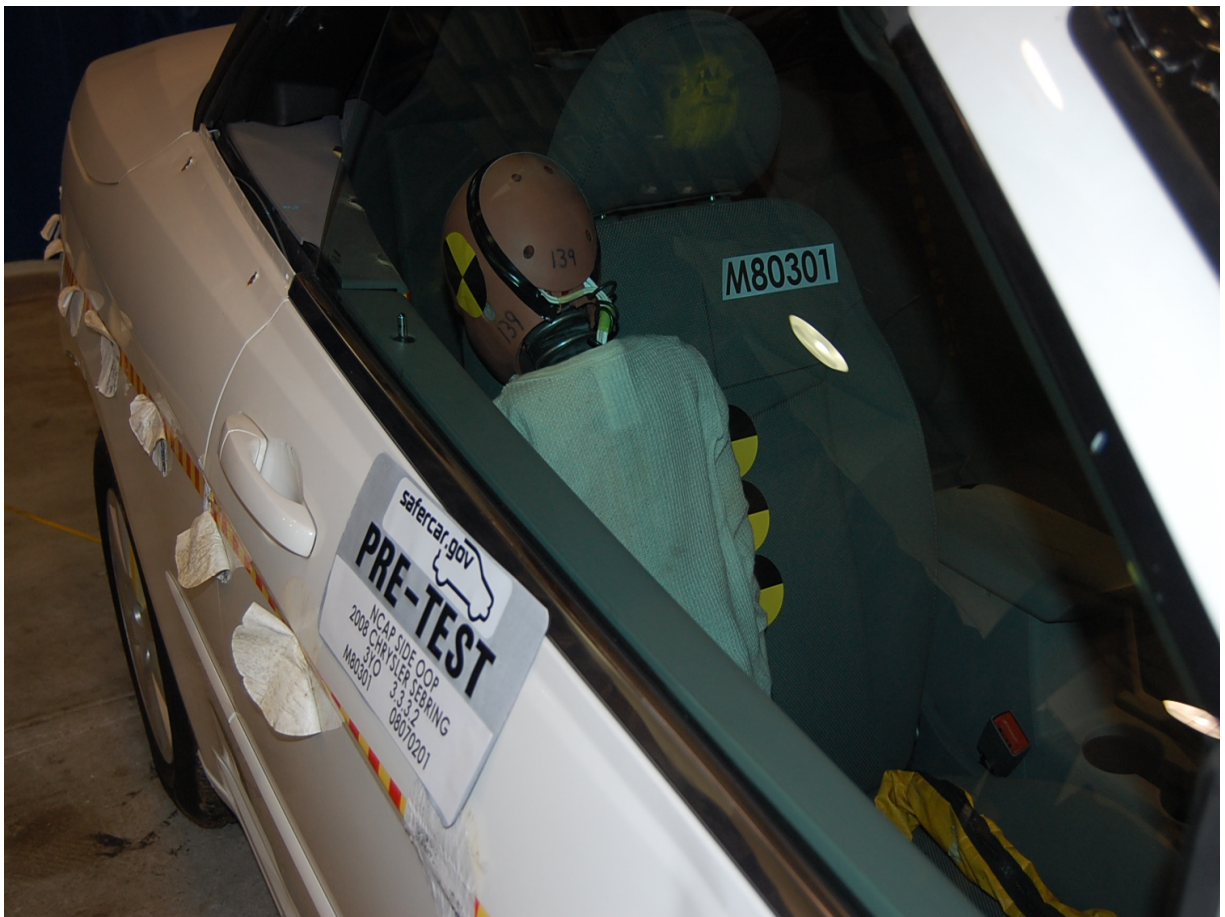
| | | <u>Page No.</u> |
|---|---|---|
| Photo No. 13. | Pre-Test 3-Year-Old Dummy Right $\frac{3}{4}$ Front View | A-8 |

Pre-Test 3-Year-Old Dummy Right ¾ Front View

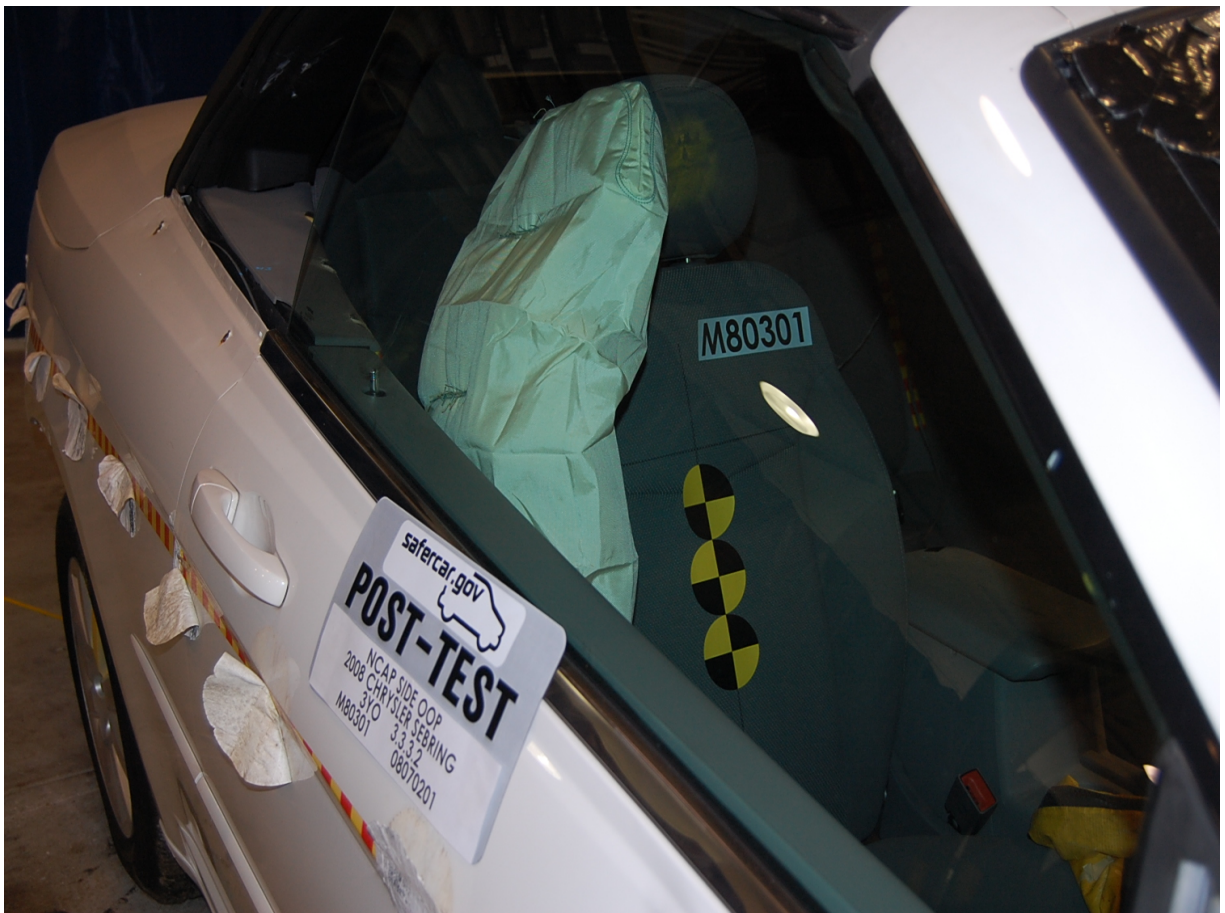
| | | <u>Page No.</u> |
|---|---|---|
| Photo No. 14. | Post-Test 3-Year-Old Dummy Right $\frac{3}{4}$ Front View | A-8 |

Post-Test 3-Year-Old Dummy Right ¾ Front View

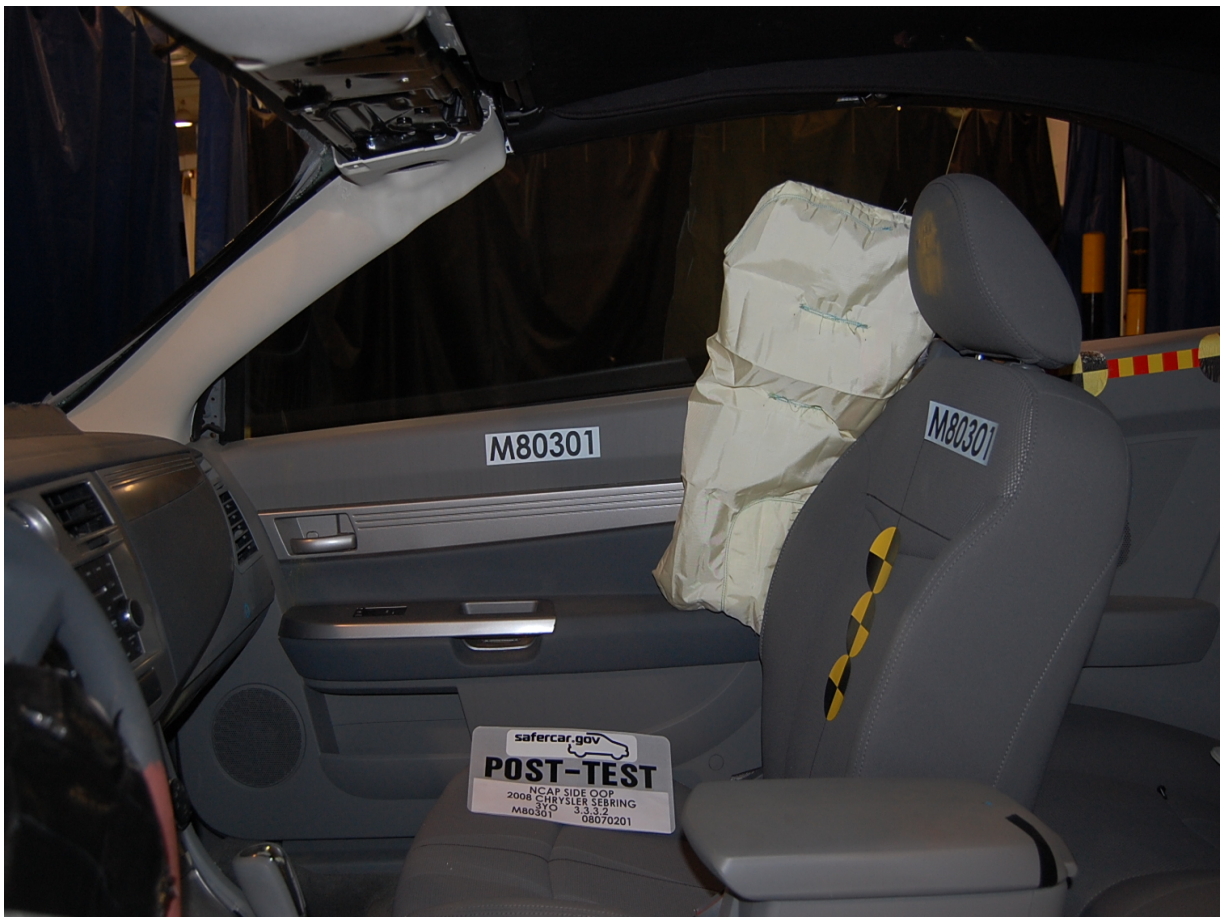
| | | <u>Page No.</u> |
|---|---|---|
| Photo No. 15. | Post-Test Right Front Passenger Compartment View | A-9 |

Post-Test Right Front Passenger Compartment View

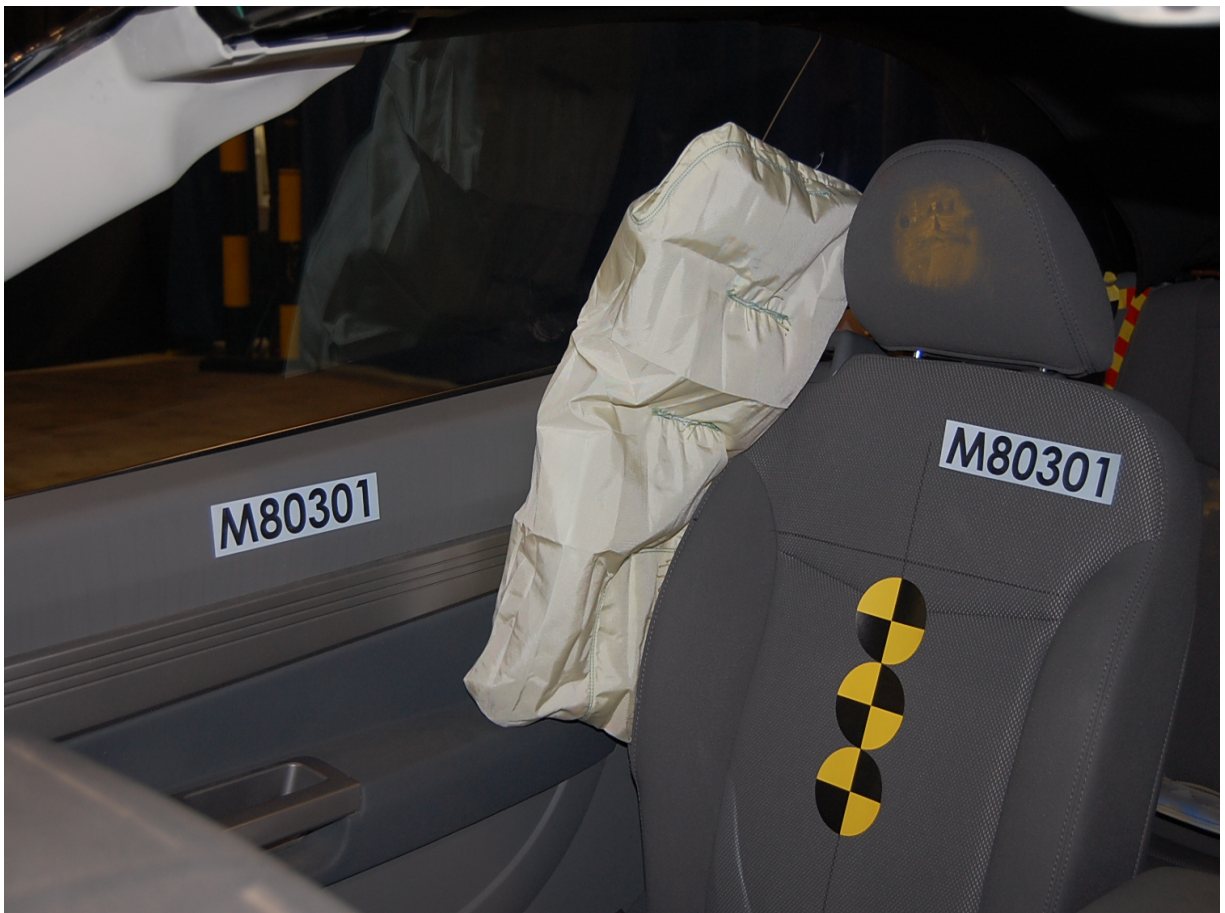
| | | <u>Page No.</u> |
|---|---|---|
| Photo No. 16. | Post-Test Torso Airbag View | A-9 |

Post-Test Torso Airbag View
