**REPORT NUMBER: TWG-MGA-2008-005**

**NEW CAR ASSESSMENT PROGRAM  
SIDE AIRBAG OUT-OF-POSITION INJURY TESTING**

**TOYOTA MOTOR CORPORATION  
2008 TOYOTA 4RUNNER 4X4  
NHTSA NUMBER: M85106TWG2**

**PREPARED BY:  
MGA RESEARCH CORPORATION  
5000 WARREN ROAD  
BURLINGTON, WI 53105**

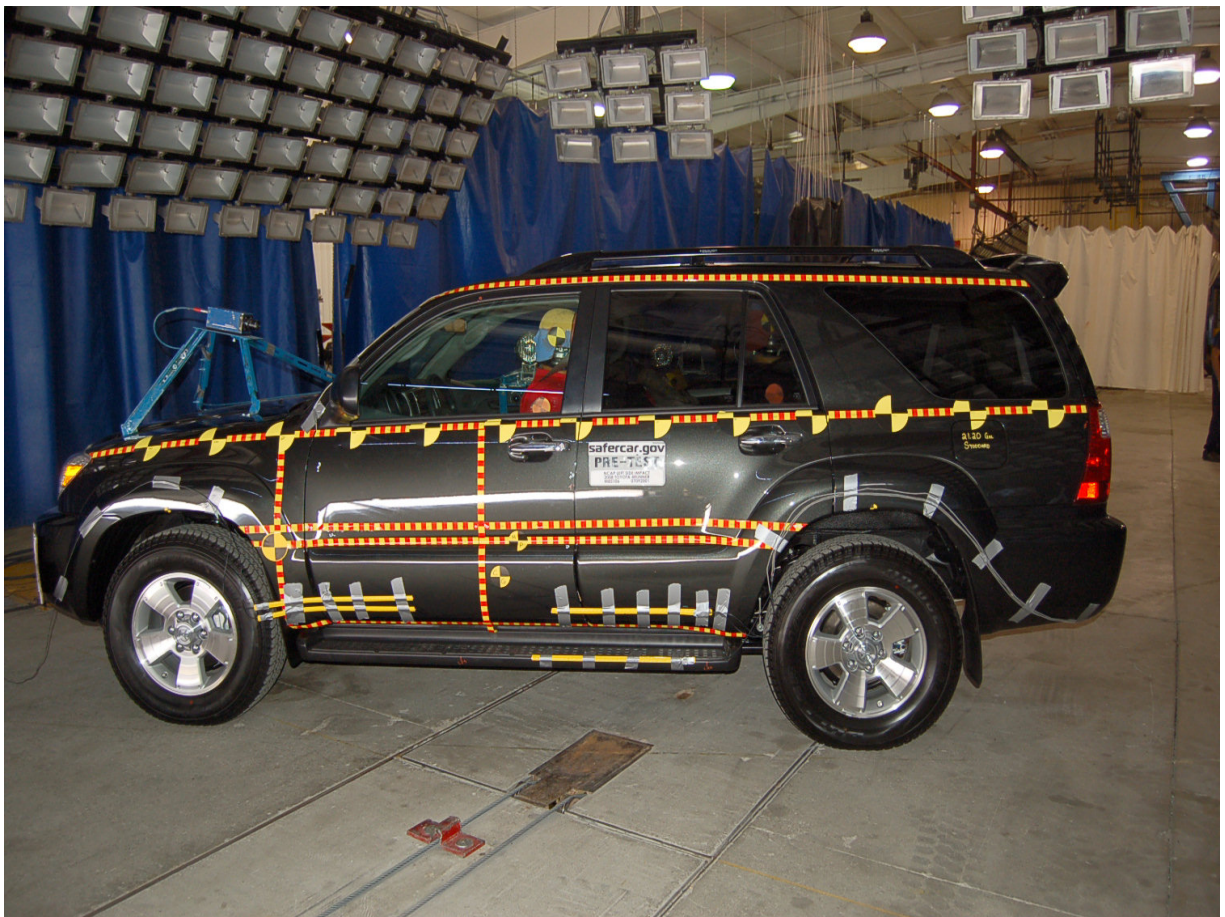
| | | <u>Page No.</u> |
|---|---|---|
| Photo No. 1. | Pre-Test Vehicle Left Side View | A-2 |

Pre-Test Vehicle Left Side View

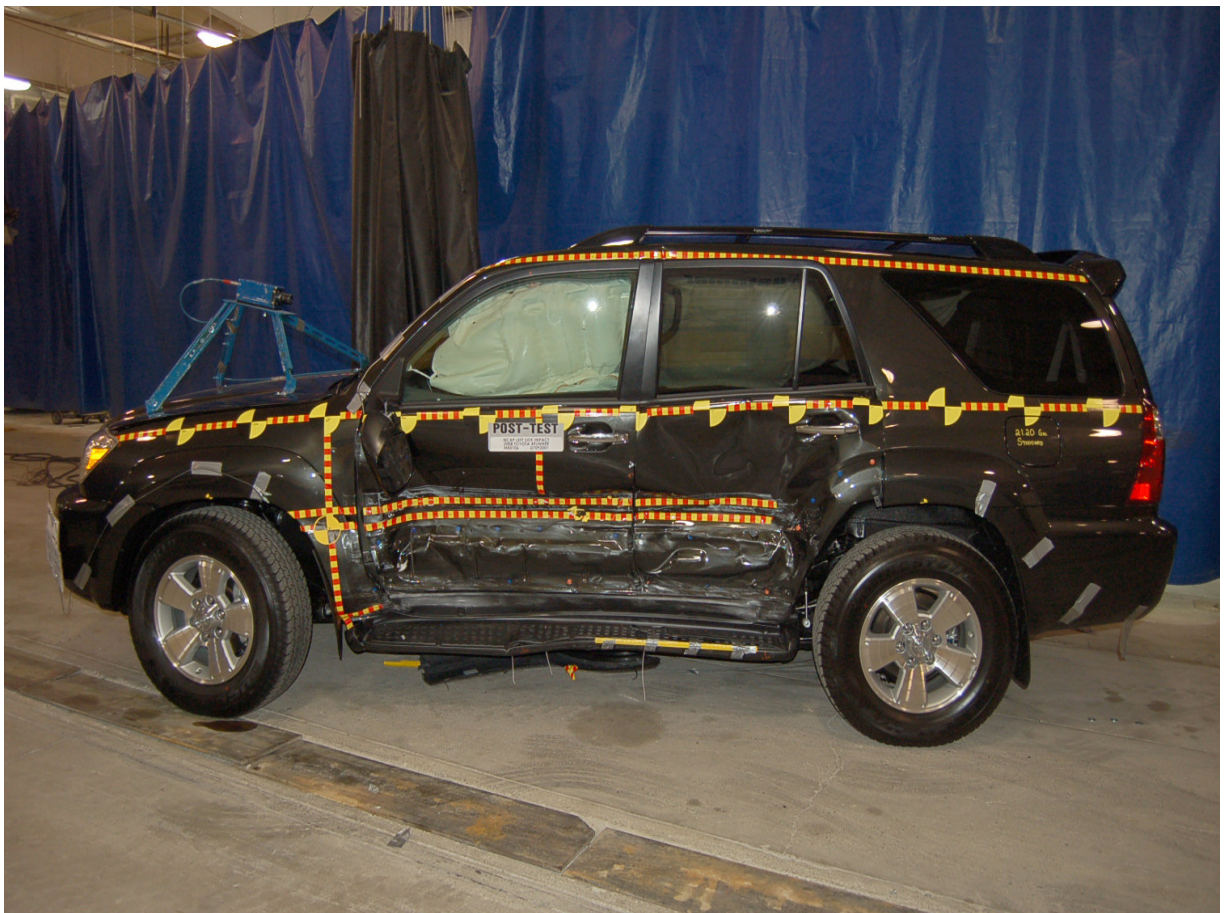
| | | <u>Page No.</u> |
|---|---|---|
| Photo No. 2. | Post-Test Vehicle Left Side View | A-2 |

Post-Test Vehicle Left Side View

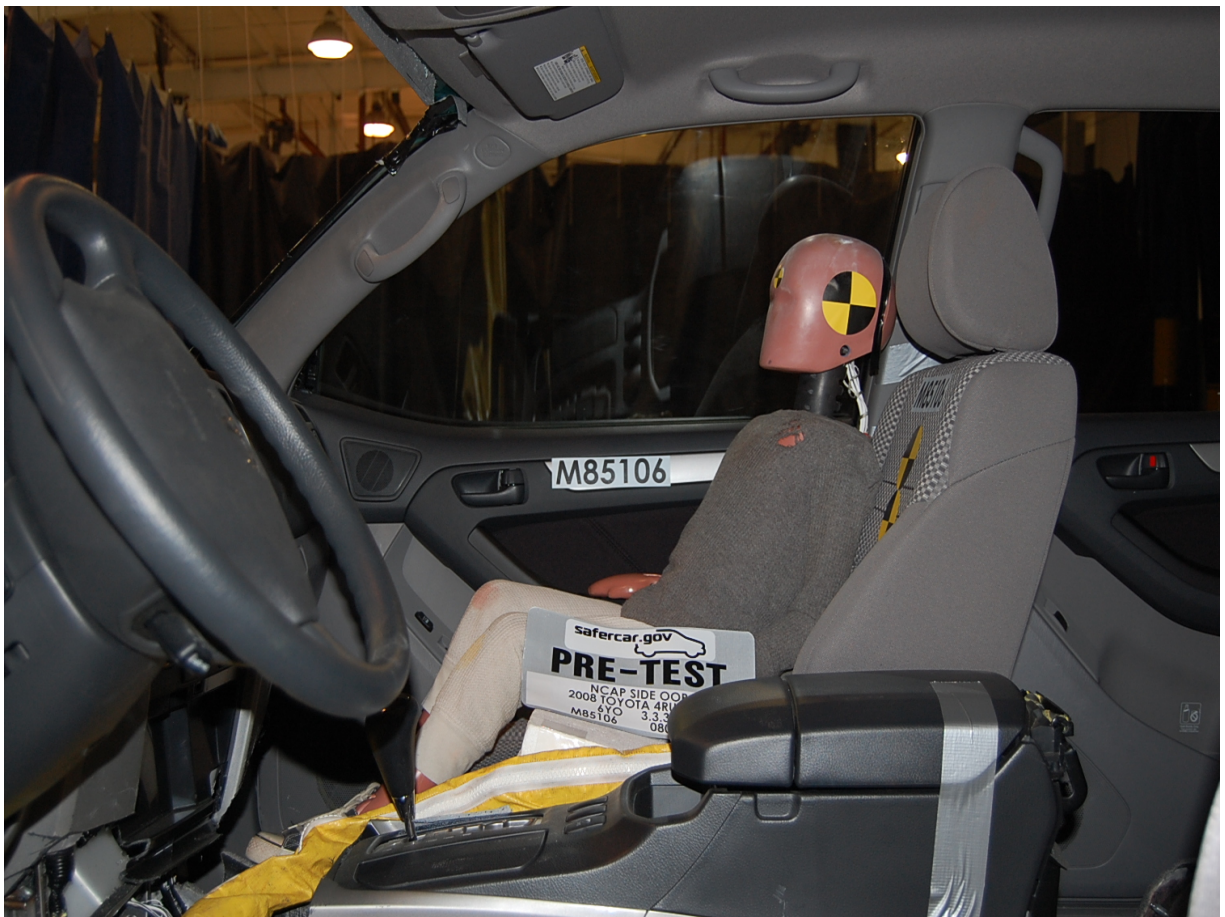
| | | <u>Page No.</u> |
|---|---|---|
| Photo No. 5. | Pre-Test 6-Year-Old Dummy Left Side View | A-4 |

Pre-Test 6-Year-Old Dummy Left Side View

The Hybrid III 6-Year-Old child dummy was placed in the right front passenger seat along the outboard edge of the foam block, aligning the upper spine with the deployment trajectory of the airbag. The dummy's head was placed in between the seat bolster and pillar/side trim. The head remained in its neutral orientation. The legs were aligned so that they cross the heel placement points that were previously marked on the seat cushion. The feet were held in place and the pelvis slid forward and parallel to the centerline of the vehicle until the dummy's head/neck junction was aligned vertically with the top edge of the airbag module. The legs were then repositioned so that they cross the heel placement points. With the vehicle door closed, the dummy's outboard arm was raised to clear the armrest and the pelvis and upper torso was slid outboard until the pelvis or torso contacted the door. The outboard arm was placed on the armrest. The inboard arm was flexed so that the upper arm contacted the seat back and the fingertips contacted the foam block.

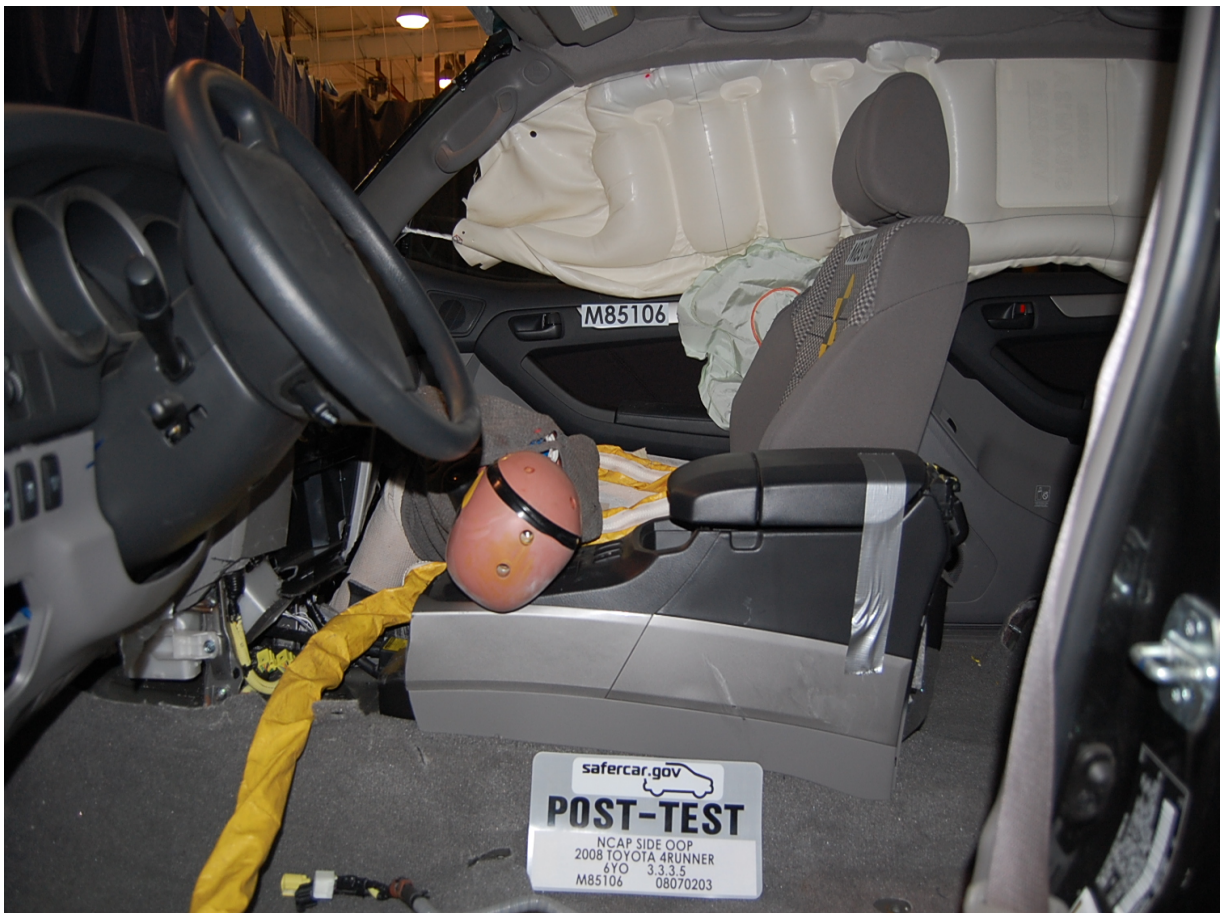
| | | <u>Page No.</u> |
|---|---|---|
| Photo No. 6. | Post-Test 6-Year-Old Dummy Left Side View | A-4 |

Post-Test 6-Year-Old Dummy Left Side View

The Hybrid III 6-Year-Old child dummy's visible contact points were as follows: The torso airbag to the left shoulder and torso of the dummy.

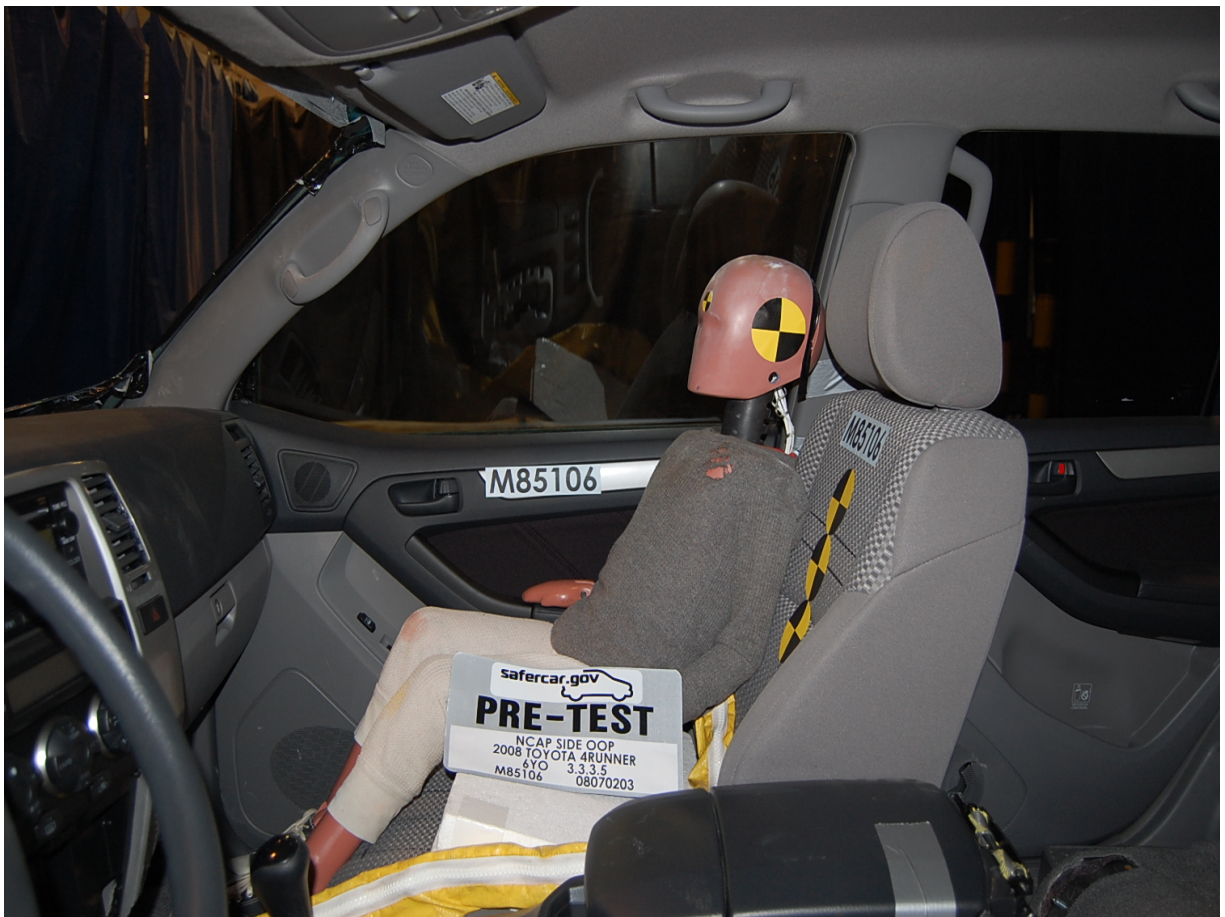
| | | <u>Page No.</u> |
|---|---|---|
| Photo No. 7. | Pre-Test 6-Year-Old Dummy Left Side Closeup View | A-5 |

Pre-Test 6-Year-Old Dummy Left Side Closeup View

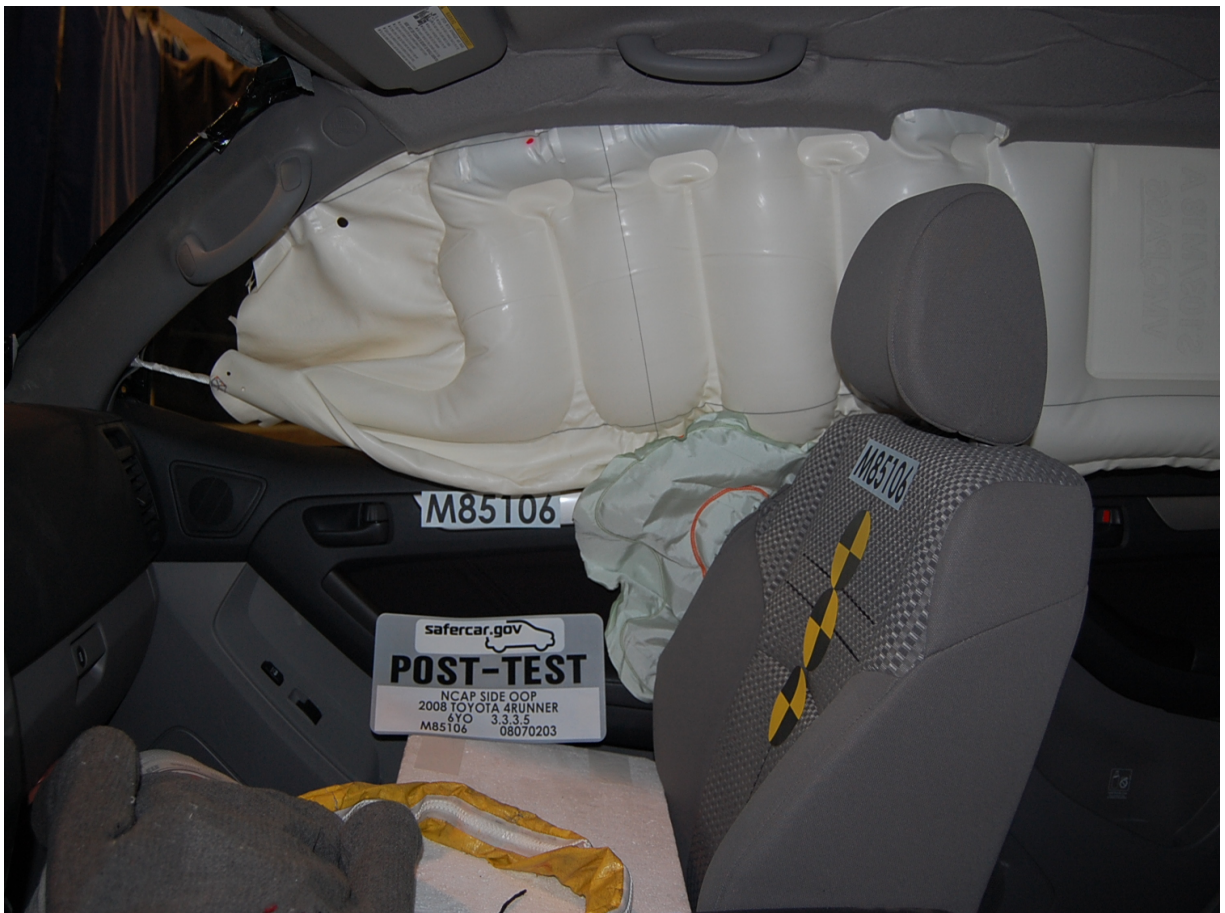
| | | <u>Page No.</u> |
|---|---|---|
| Photo No. 8. | Post-Test 6-Year-Old Dummy Left Side Closeup View | A-5 |

Post-Test 6-Year-Old Dummy Left Side Closeup View

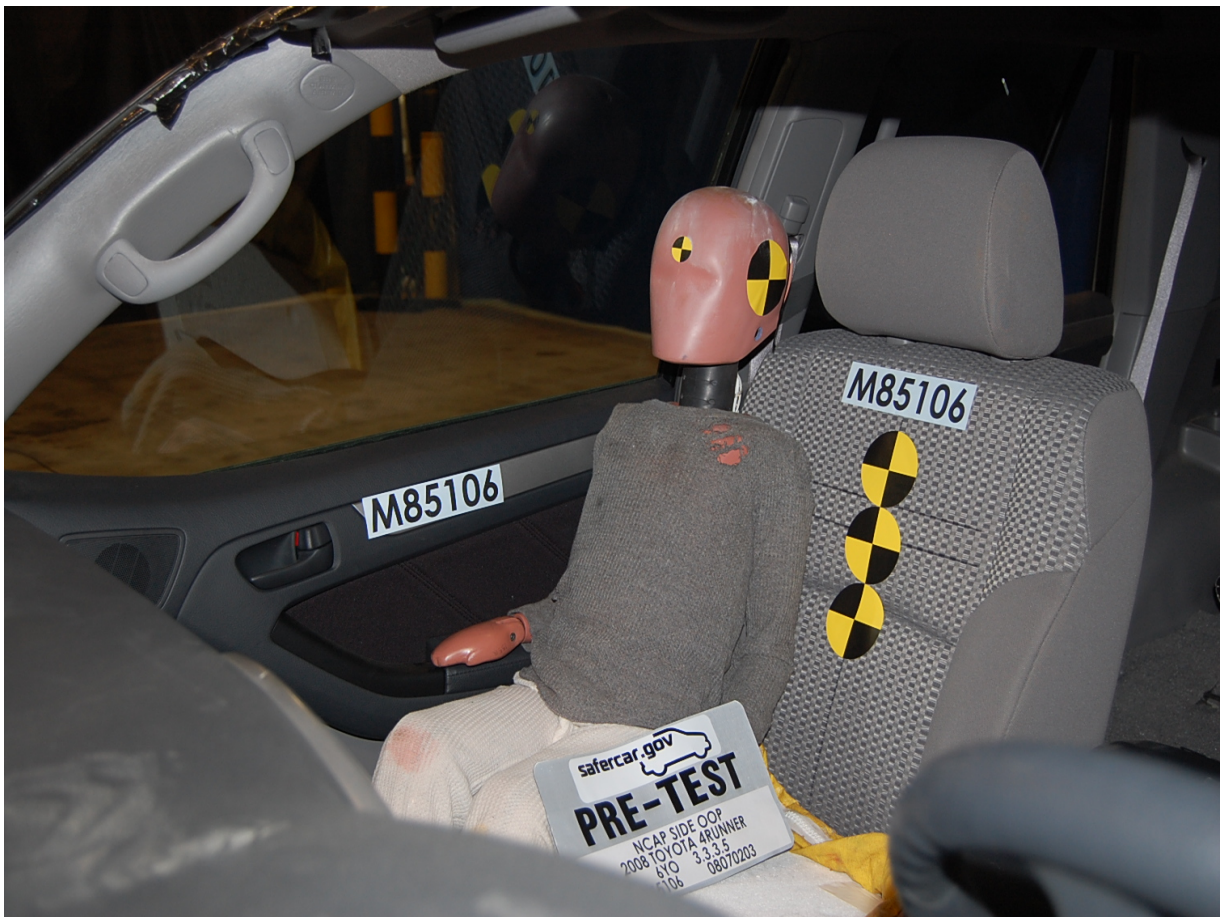
| | | <u>Page No.</u> |
|---|---|---|
| Photo No. 9. | Pre-Test 6-Year-Old Dummy Left $\frac{3}{4}$ Front View | A-6 |

Pre-Test 6-Year-Old Dummy Left  $\frac{3}{4}$  Front View

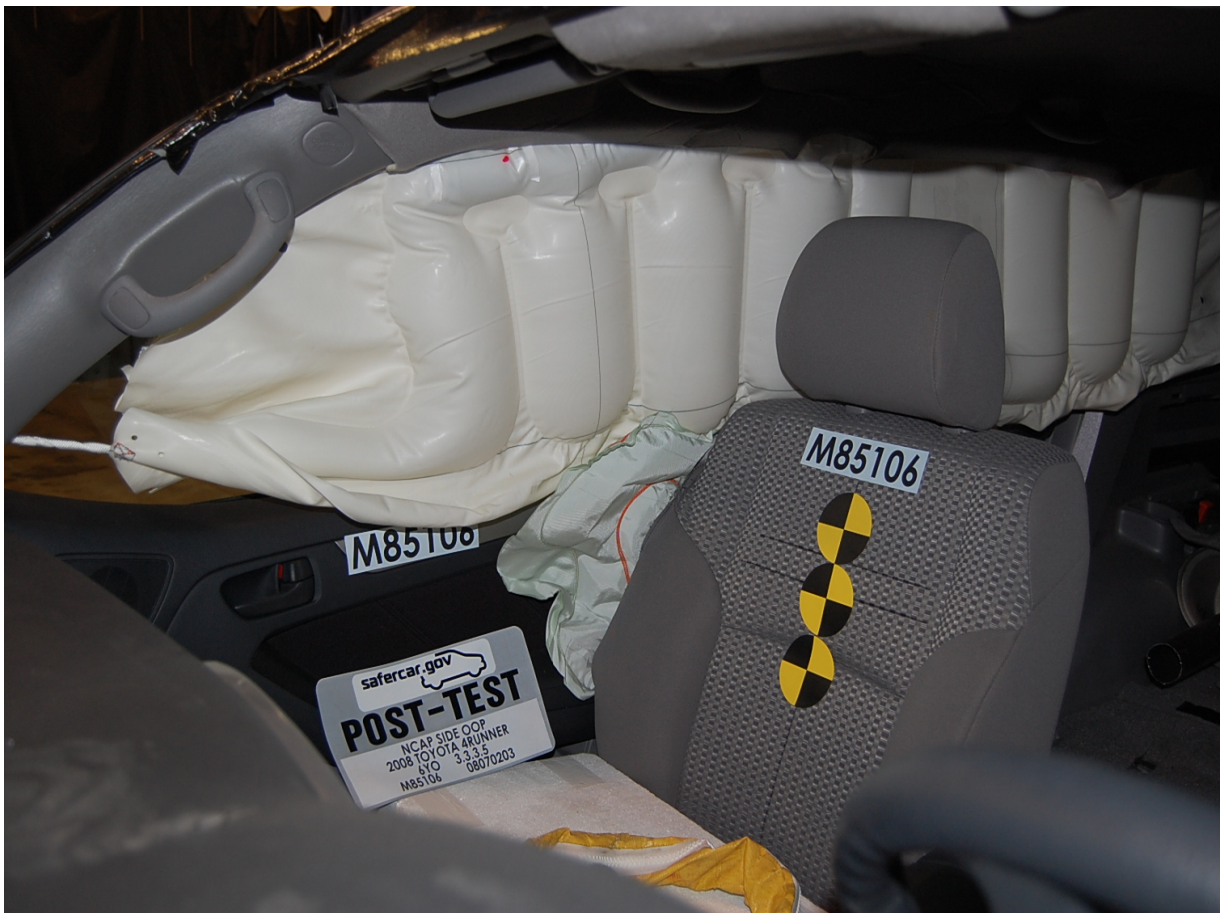
| | | <u>Page No.</u> |
|---|---|---|
| Photo No. 10. | Post-Test 6-Year-Old Dummy Left $\frac{3}{4}$ Front View | A-6 |

Post-Test 6-Year-Old Dummy Left  $\frac{3}{4}$  Front View

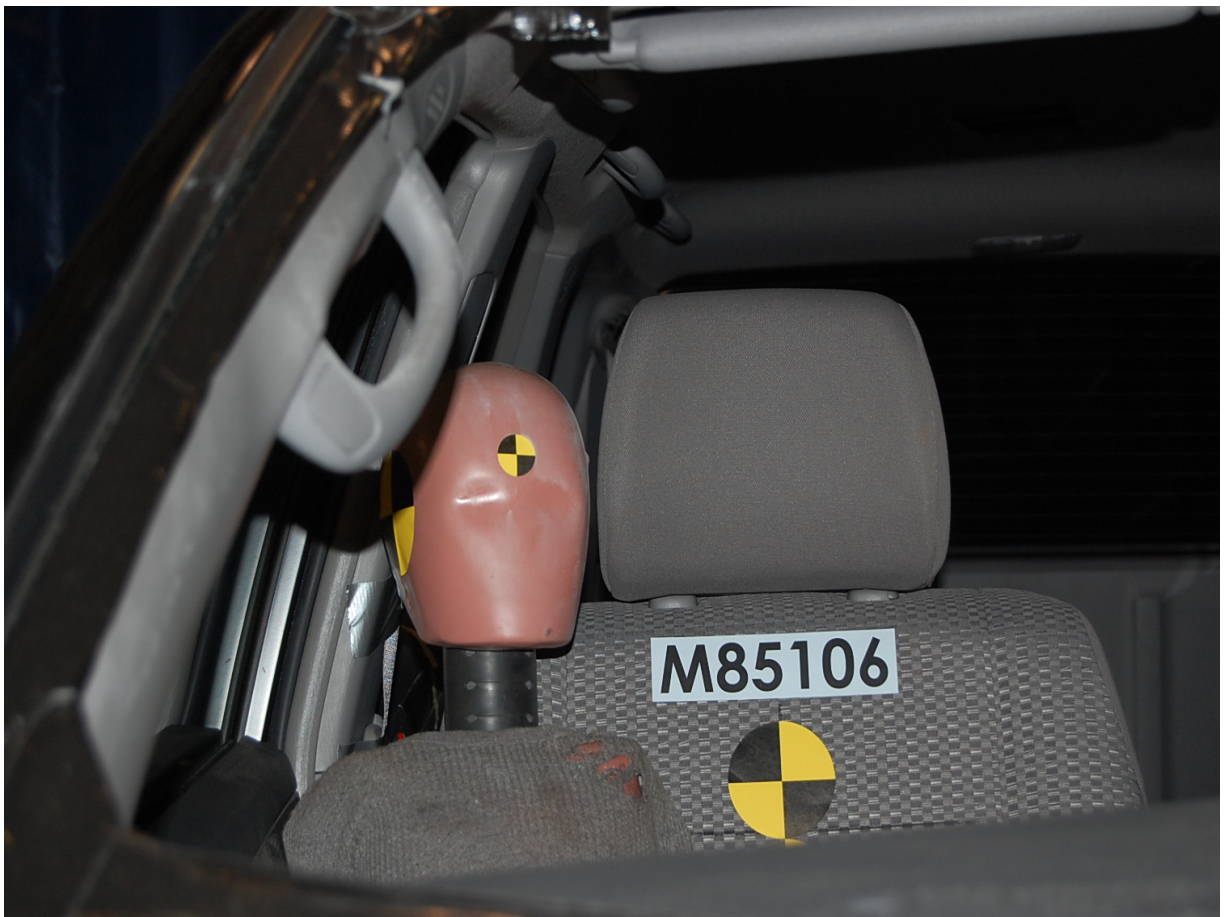
| | | <u>Page No.</u> |
|---|---|---|
| Photo No. 11. | Pre-Test 6-Year-Old Dummy Front View | A-7 |

Pre-Test 6-Year-Old Dummy Front View

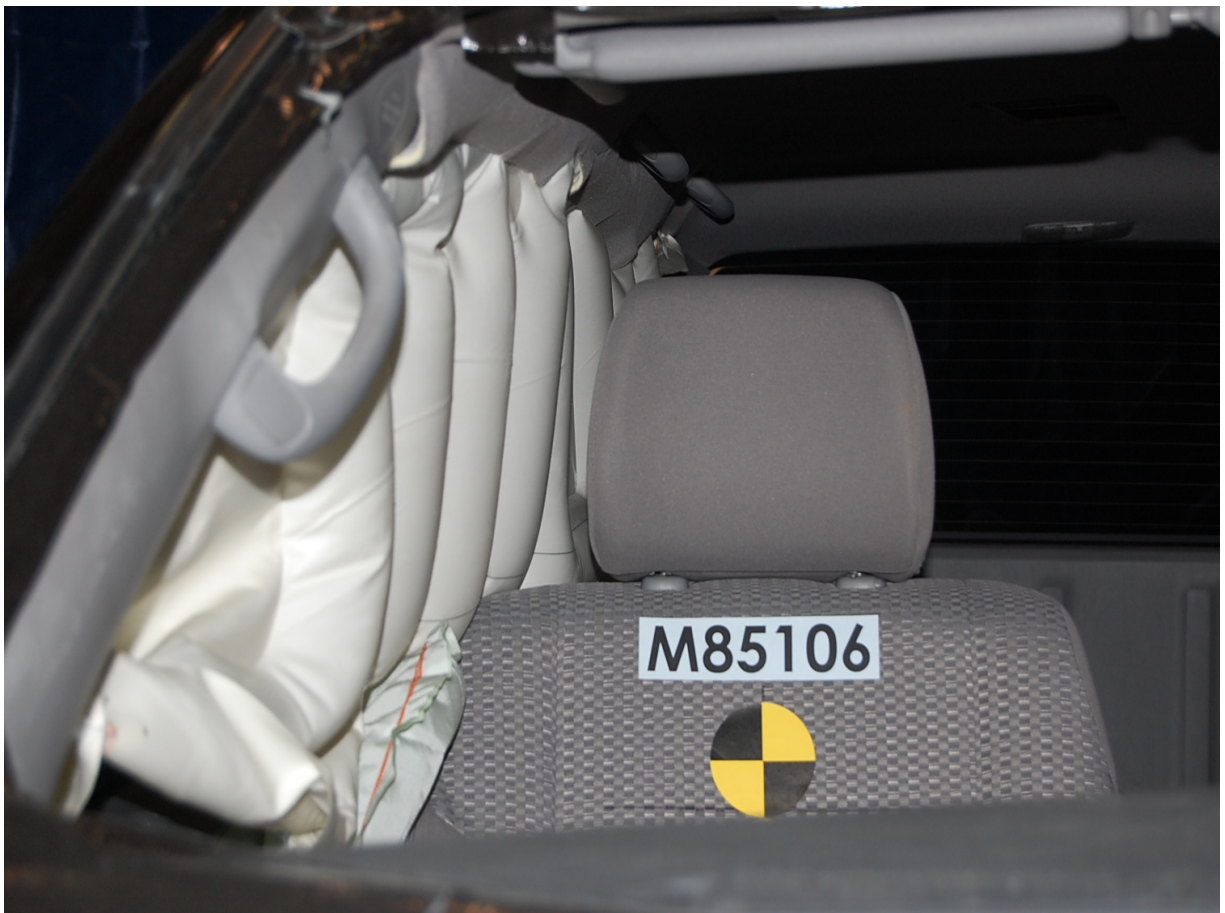
| | | <u>Page No.</u> |
|---|---|---|
| Photo No. 12. | Post-Test 6-Year-Old Dummy Front View | A-7 |

Post-Test 6-Year-Old Dummy Front View

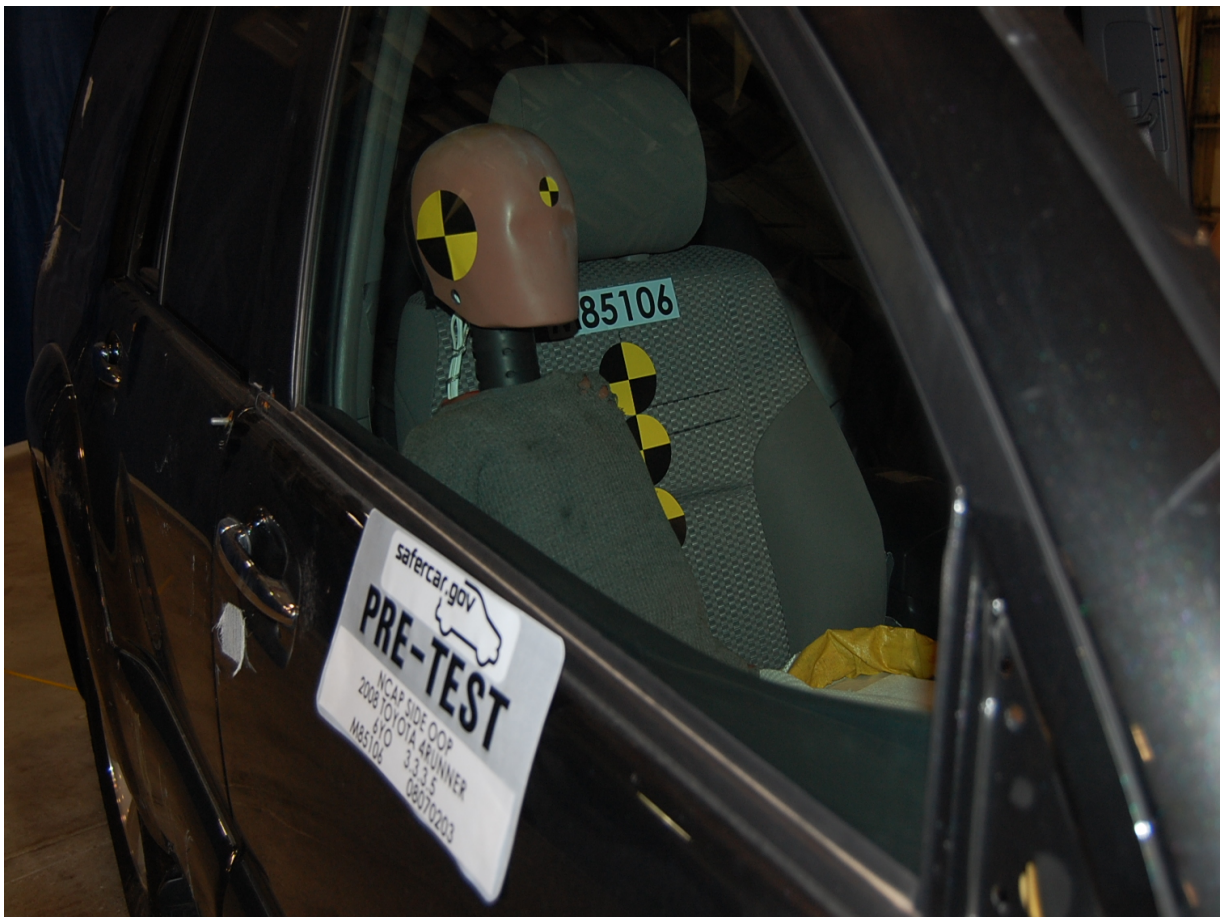
| | | <u>Page No.</u> |
|---|---|---|
| Photo No. 13. | Pre-Test 6-Year-Old Dummy Right $\frac{3}{4}$ Front View | A-8 |

Pre-Test 6-Year-Old Dummy Right  $\frac{3}{4}$  Front View

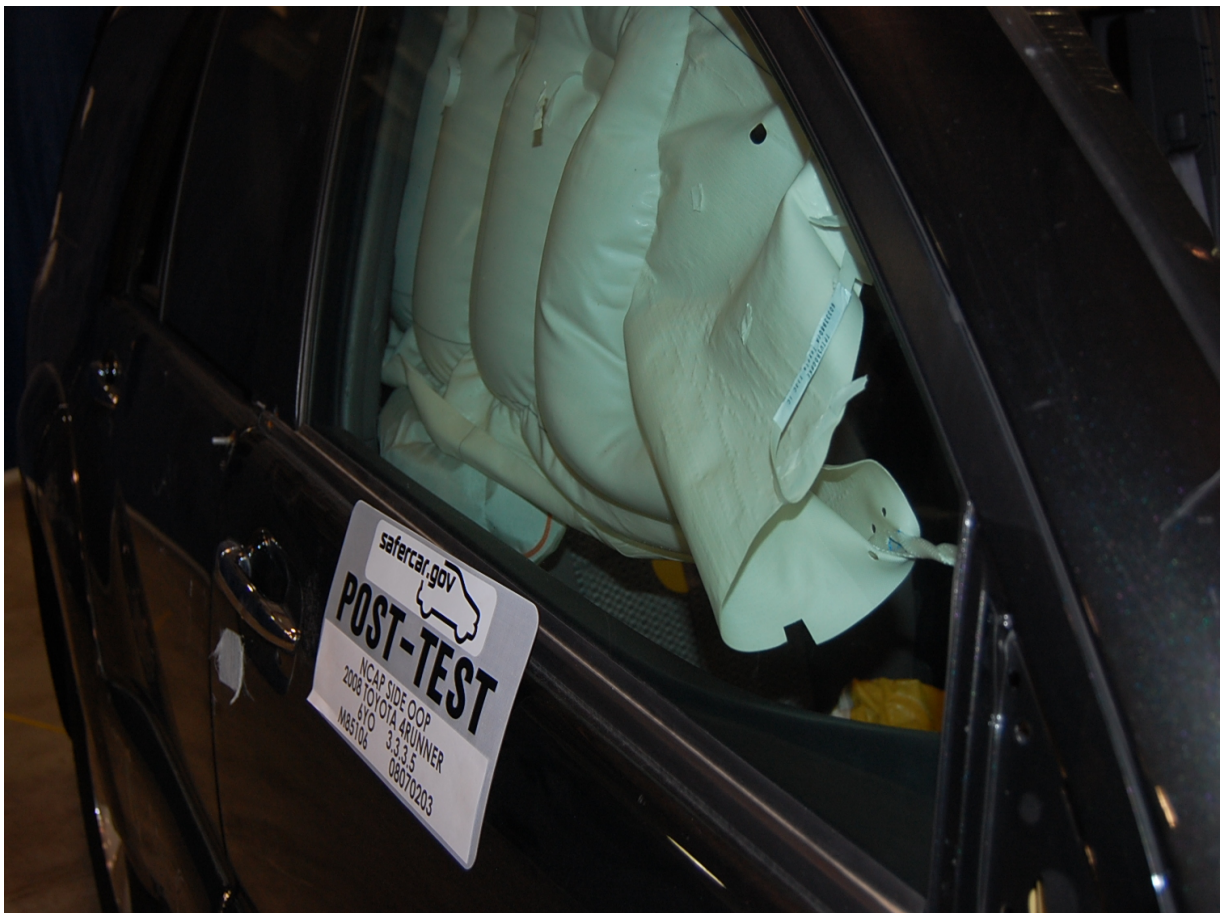
| | | <u>Page No.</u> |
|---|---|---|
| Photo No. 14. | Post-Test 6-Year-Old Dummy Right $\frac{3}{4}$ Front View | A-8 |

Post-Test 6-Year-Old Dummy Right  $\frac{3}{4}$  Front View

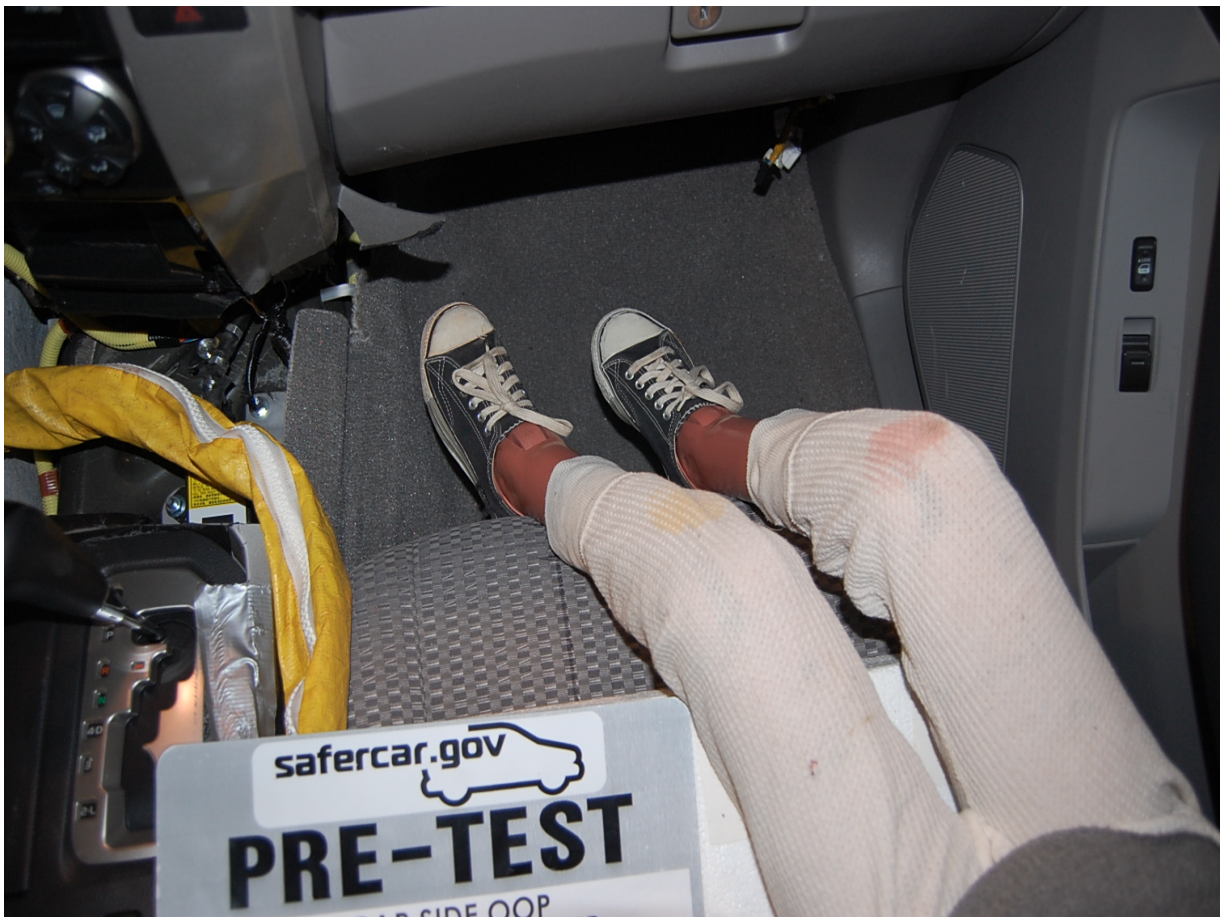
| | | <u>Page No.</u> |
|---|---|---|
| Photo No. 15. | Pre-Test 6-Year-Old Dummy Feet Position View | A-9 |

Pre-Test 6-Year-Old Dummy Feet Position View

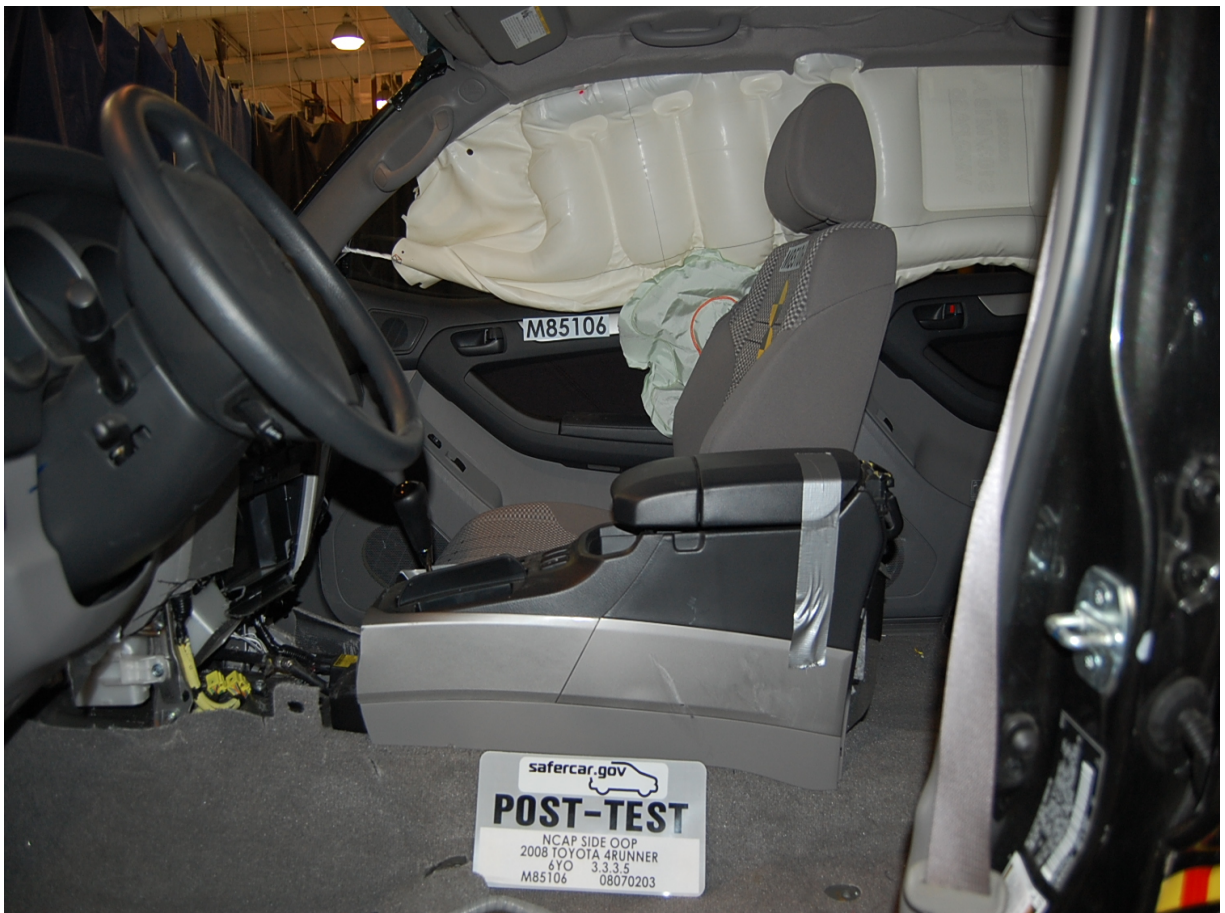
| | | <u>Page No.</u> |
|---|---|---|
| Photo No. 16. | Post-Test Right Front Passenger Compartment View | A-9 |

Post-Test Right Front Passenger Compartment View
