**REPORT NUMBER: TWG-MGA-2008-003**

**NEW CAR ASSESSMENT PROGRAM  
SIDE AIRBAG OUT-OF-POSITION INJURY TESTING**

**DAIMLERCHRYSLER CORPORATION  
2008 DODGE GRAND CARAVAN SE  
NHTSA NUMBER: M80307TWG2**

**PREPARED BY:  
MGA RESEARCH CORPORATION  
5000 WARREN ROAD  
BURLINGTON, WI 53105**

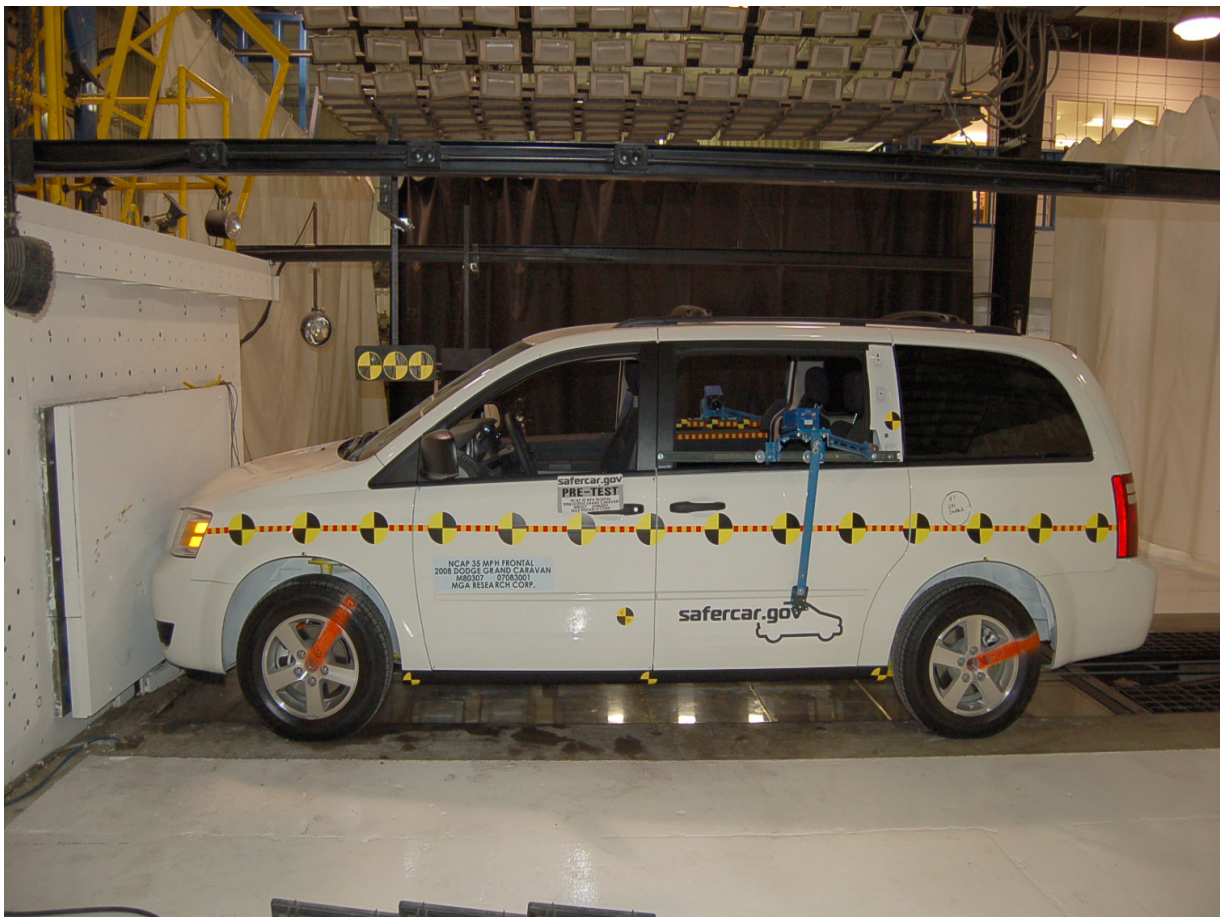
Pre-Test Vehicle Left Side View

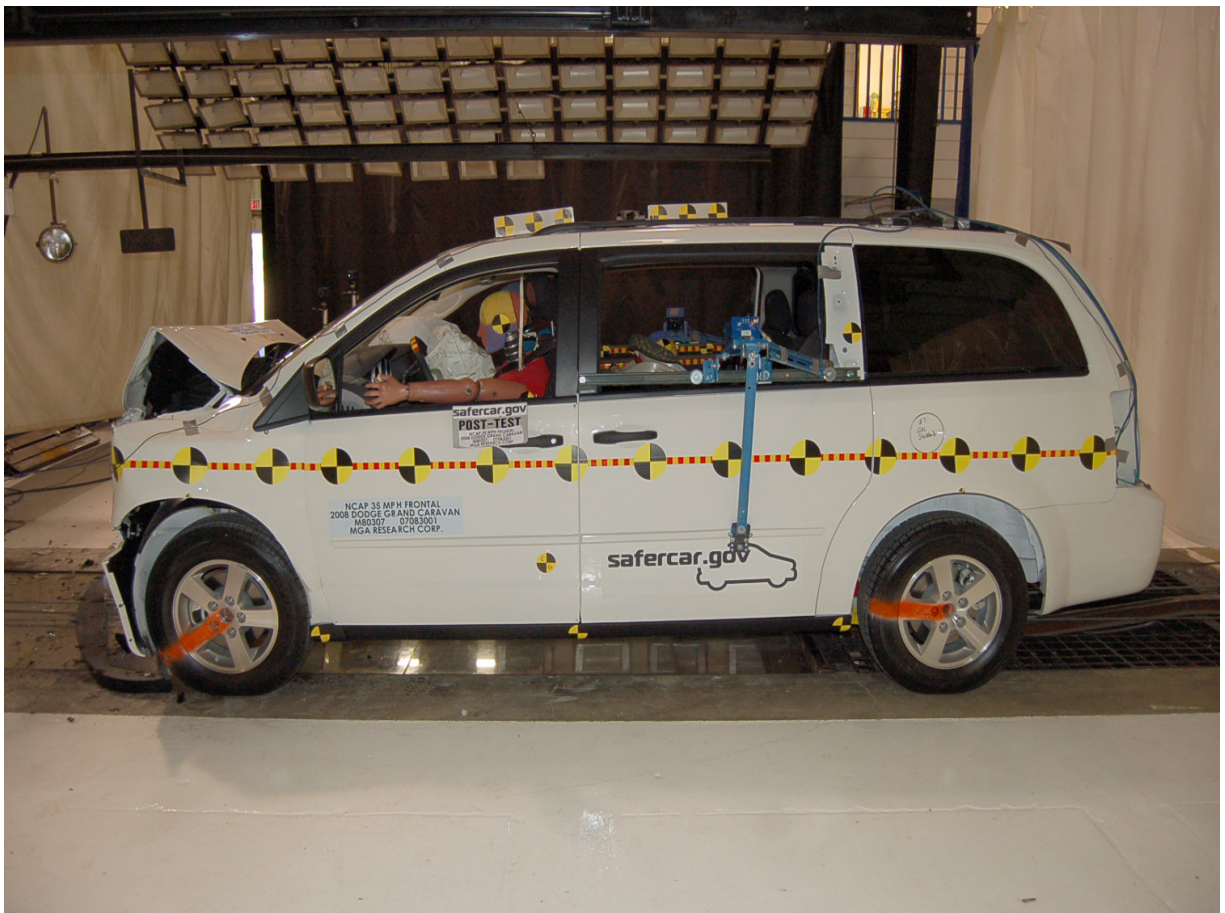
Post-Test Vehicle Left Side View

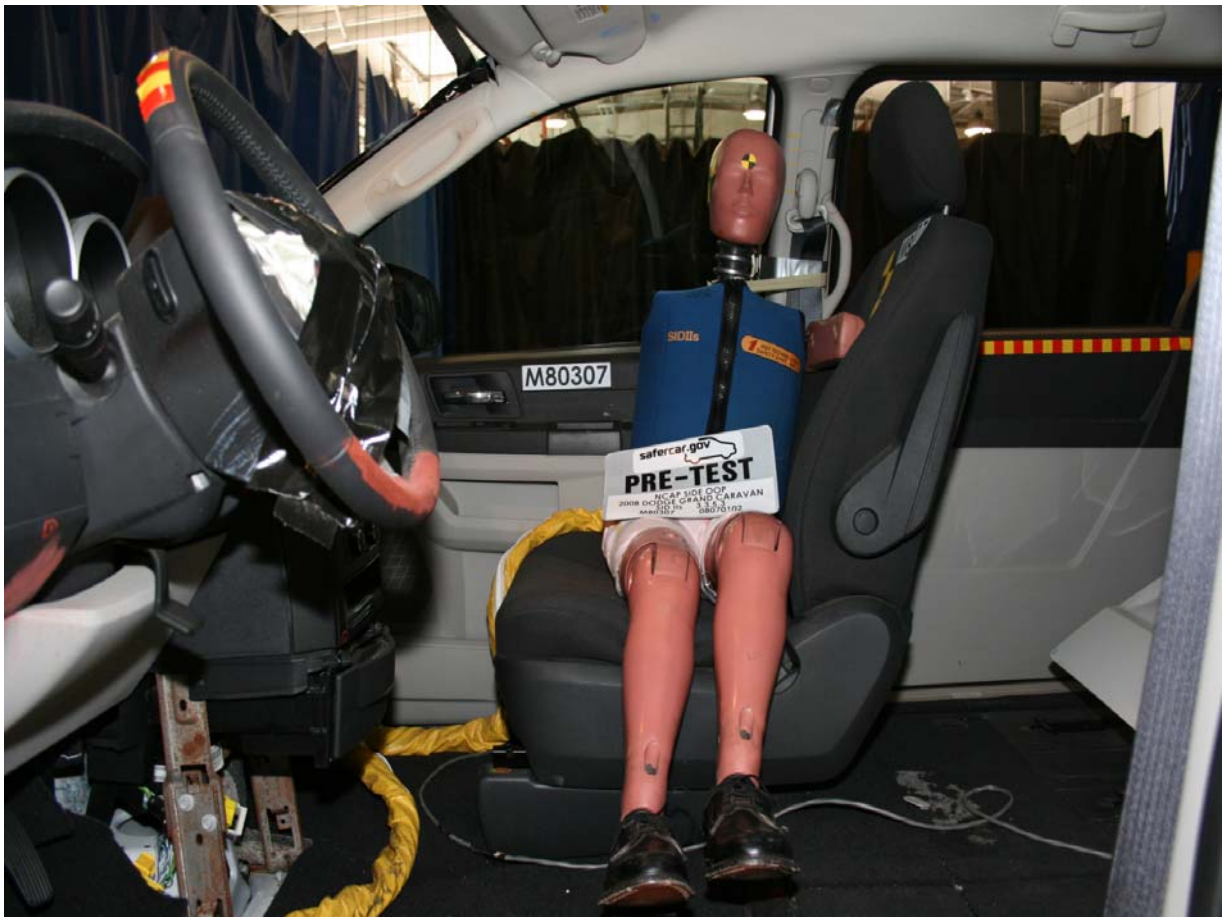
Pre-Test SID-IIs Dummy Left Side View

The SID-IIs dummy was placed in the right front passenger seat facing toward the center of the vehicle with its arm against the seatback. The arm was rotated horizontally in the forward direction with respect to the dummy. The seat track was adjusted forward. The dummy's pelvis was slid outboard until the dummy's back contacted the door trim panel or armrest and the CG of the head was centered in the deployment trajectory of the airbag. The vertical plane through the centerline of the dummy's rib-stiffener and shoulder bolt was parallel to the centerline of the vehicle. Masking tape was wrapped around the dummy's neck bracket to hold the dummy in place.

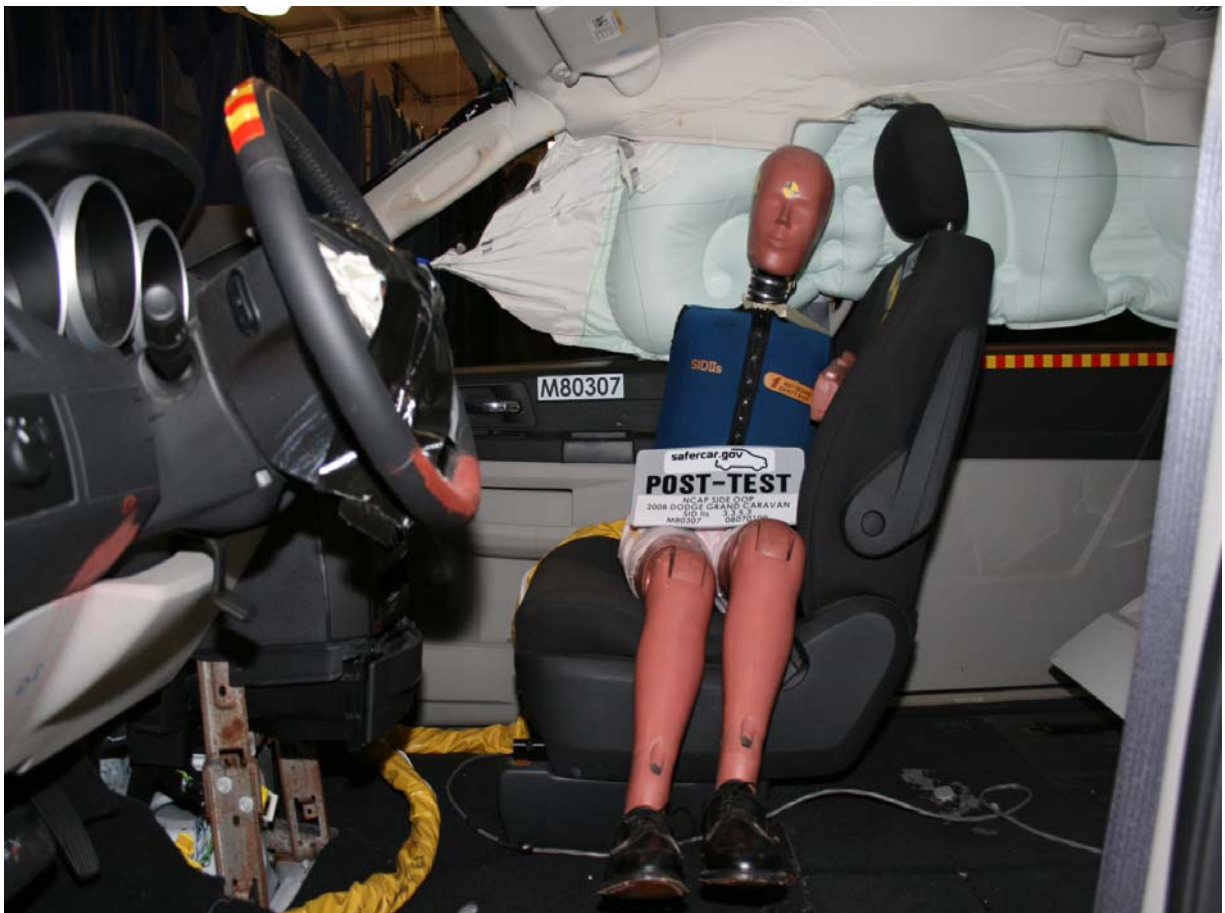
Post-Test SID-IIs Dummy Left Side View

The SID-IIs dummy's visible contact points were as follows: The curtain airbag to the top and back of the head.

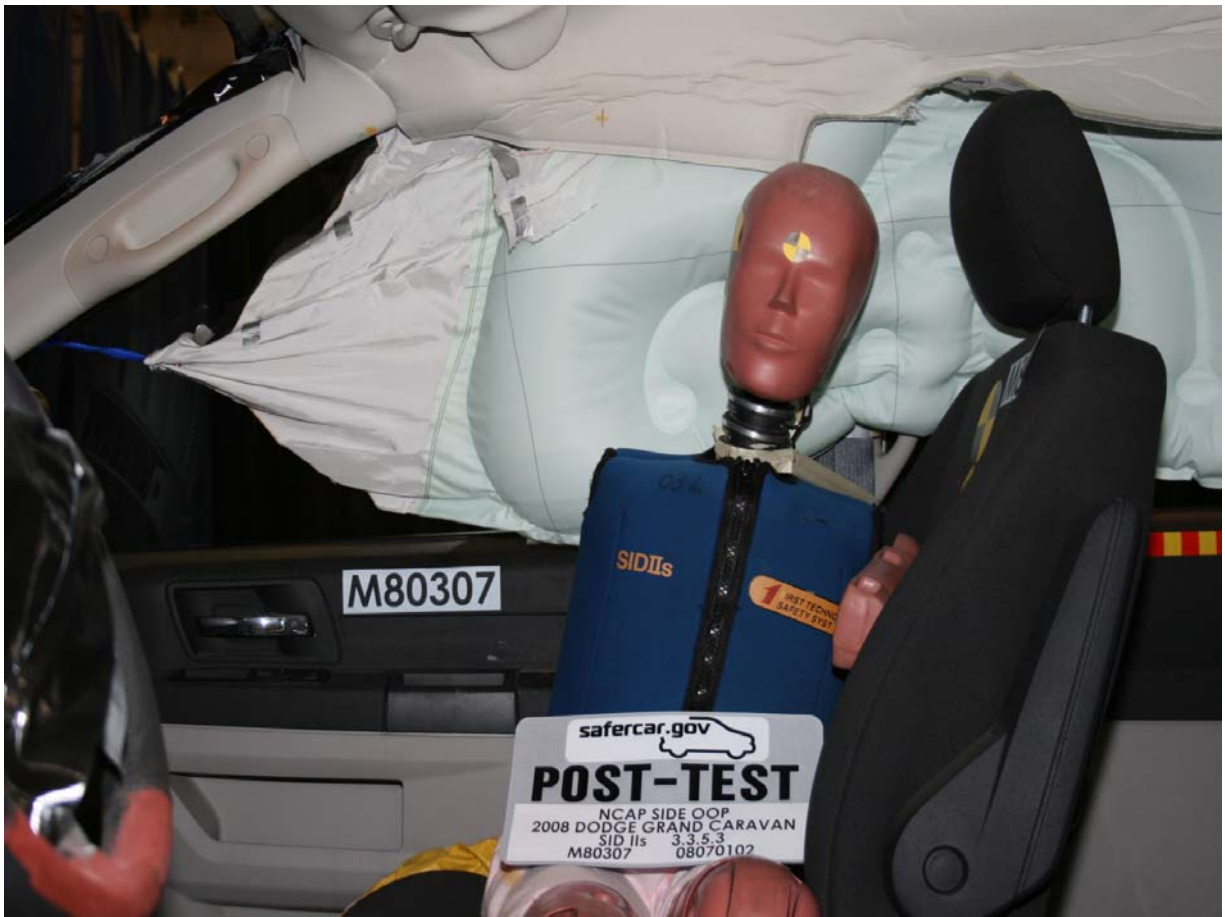
Post-Test SID-IIs Dummy Left Side Closeup View

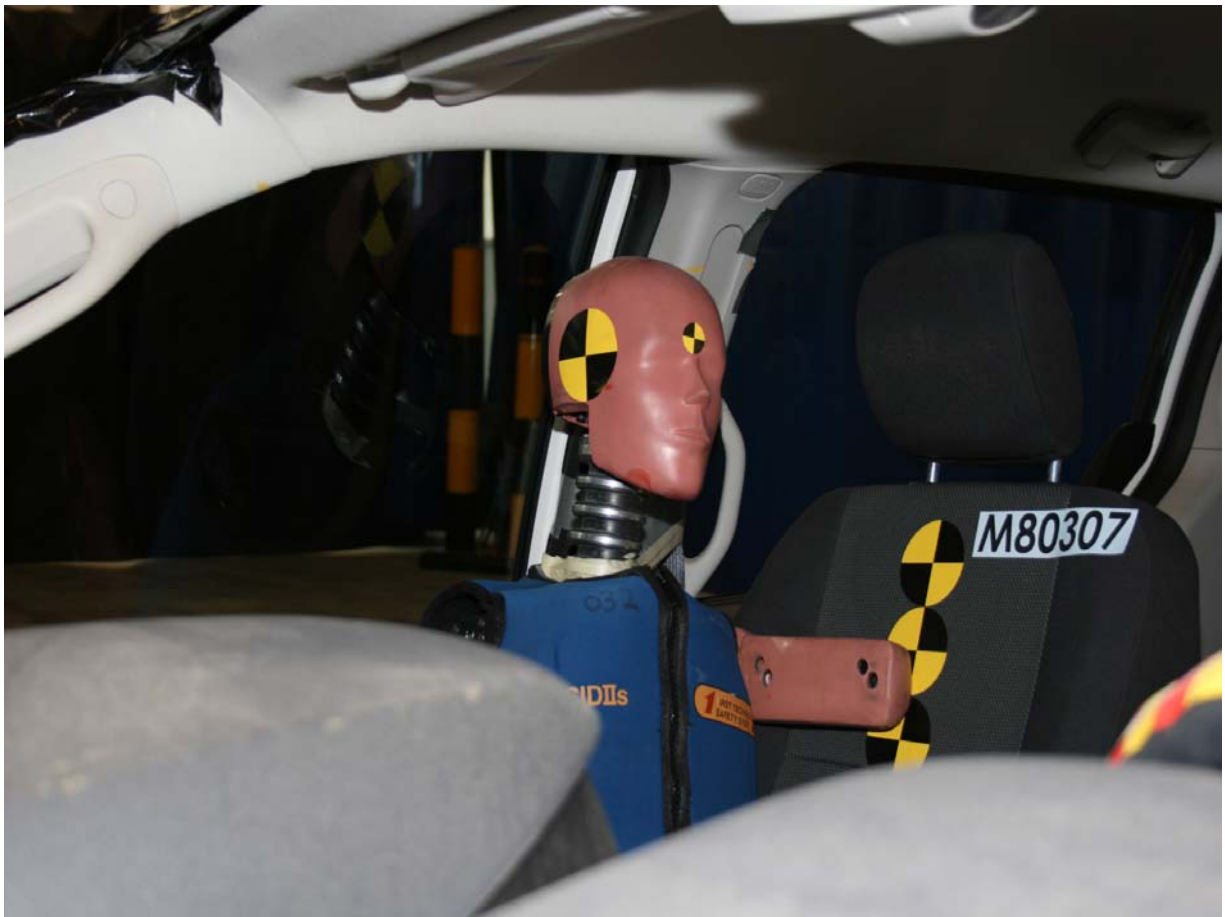
Pre-Test SID-IIs Dummy Left  $\frac{3}{4}$  Front View

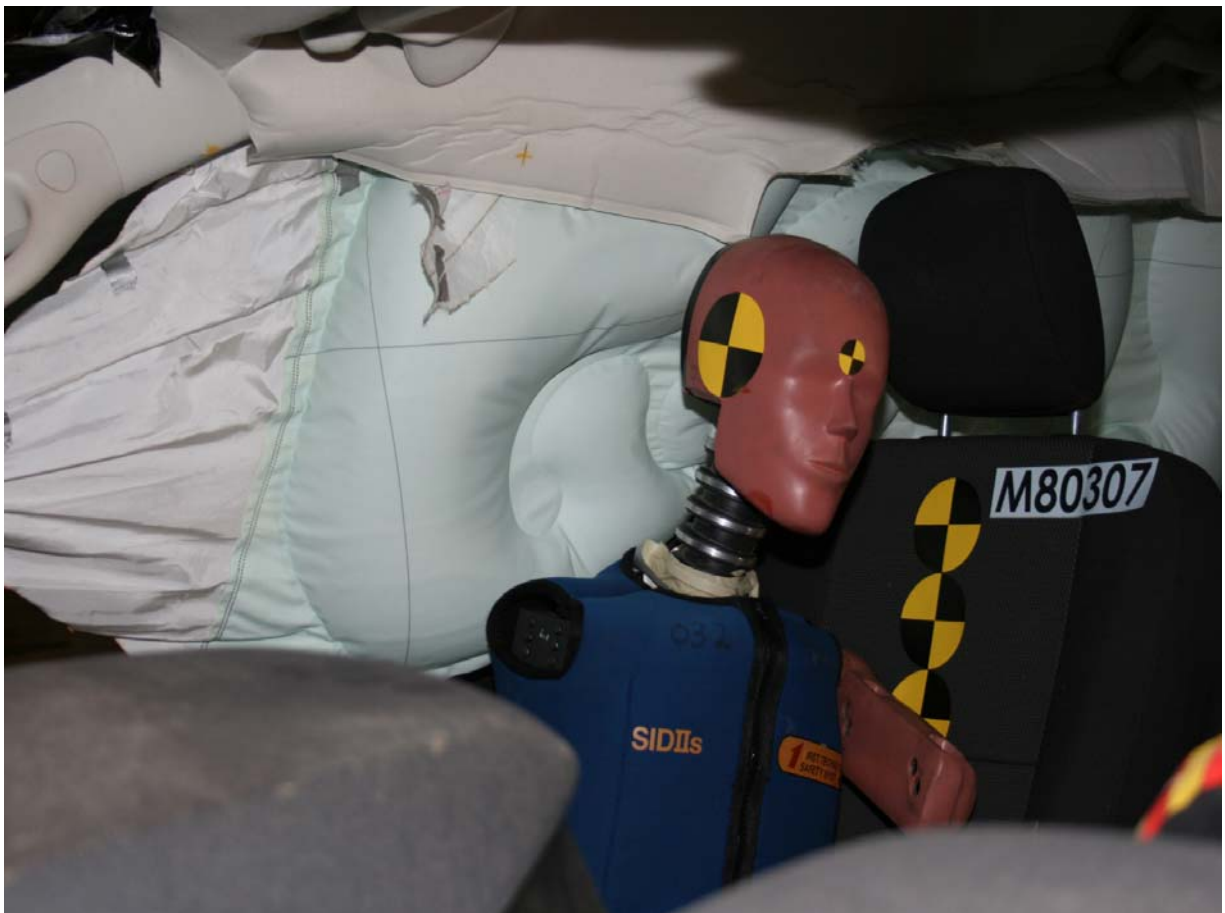
Post-Test SID-IIs Dummy Left  $\frac{3}{4}$  Front View

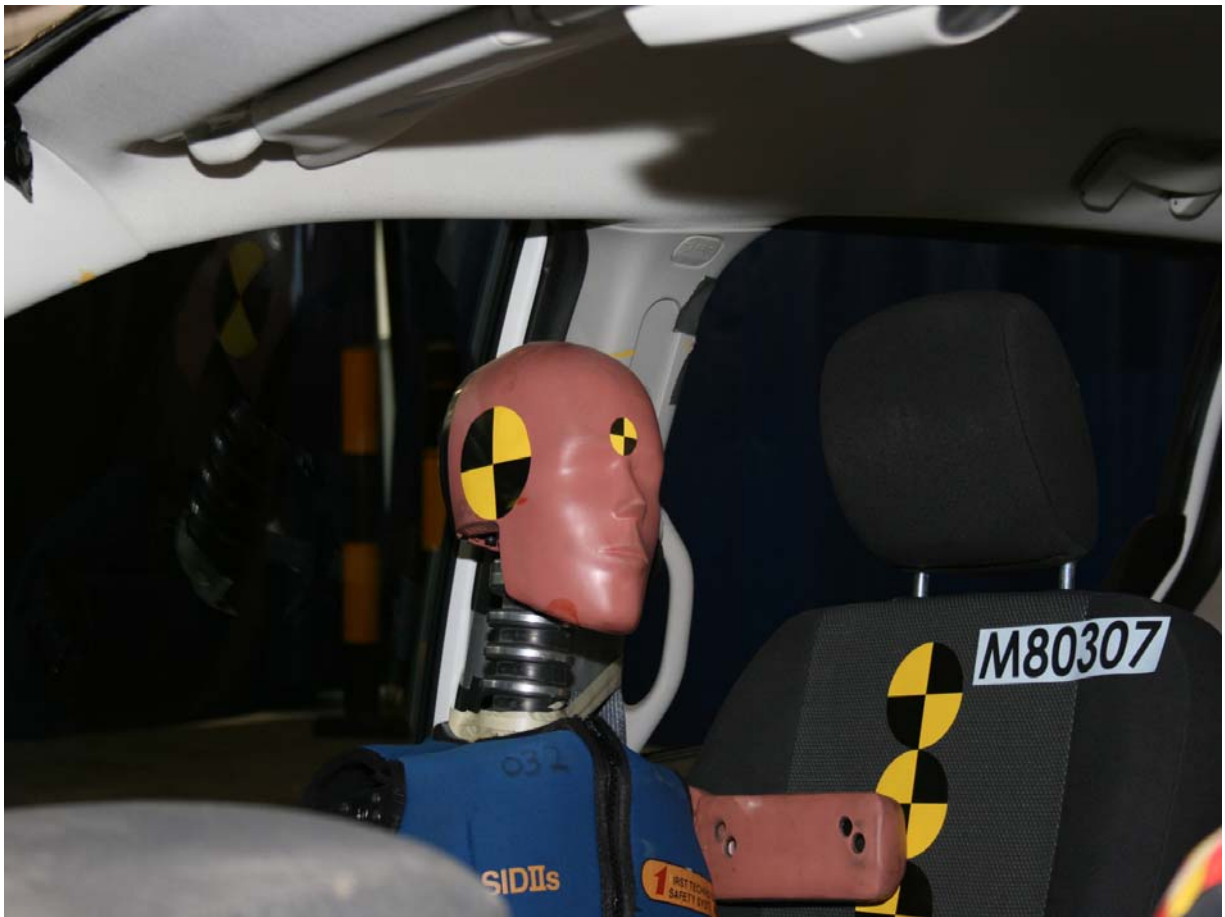
Pre-Test SID-IIs Dummy Left  $\frac{3}{4}$  Front Closeup View

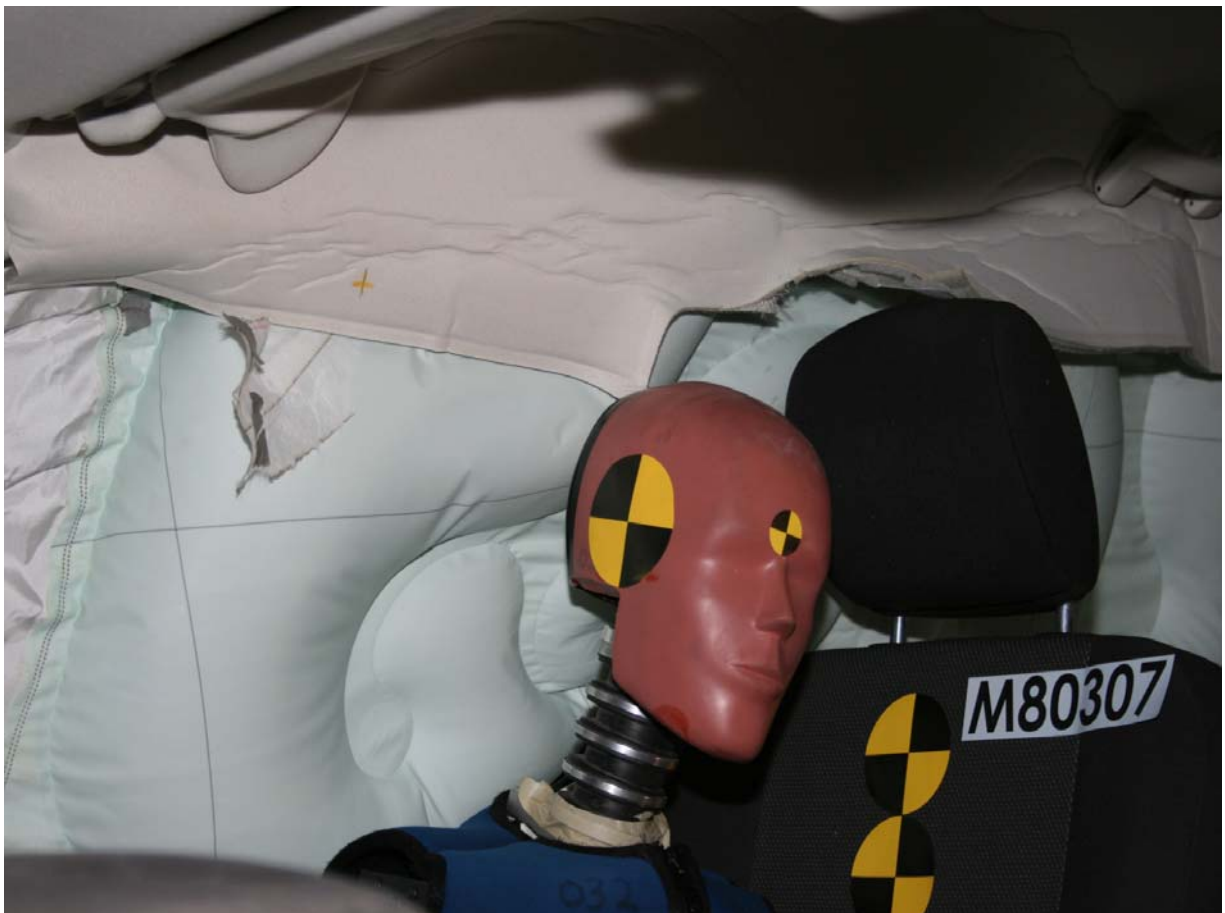
Post-Test SID-IIs Dummy Left  $\frac{3}{4}$  Front Closeup View

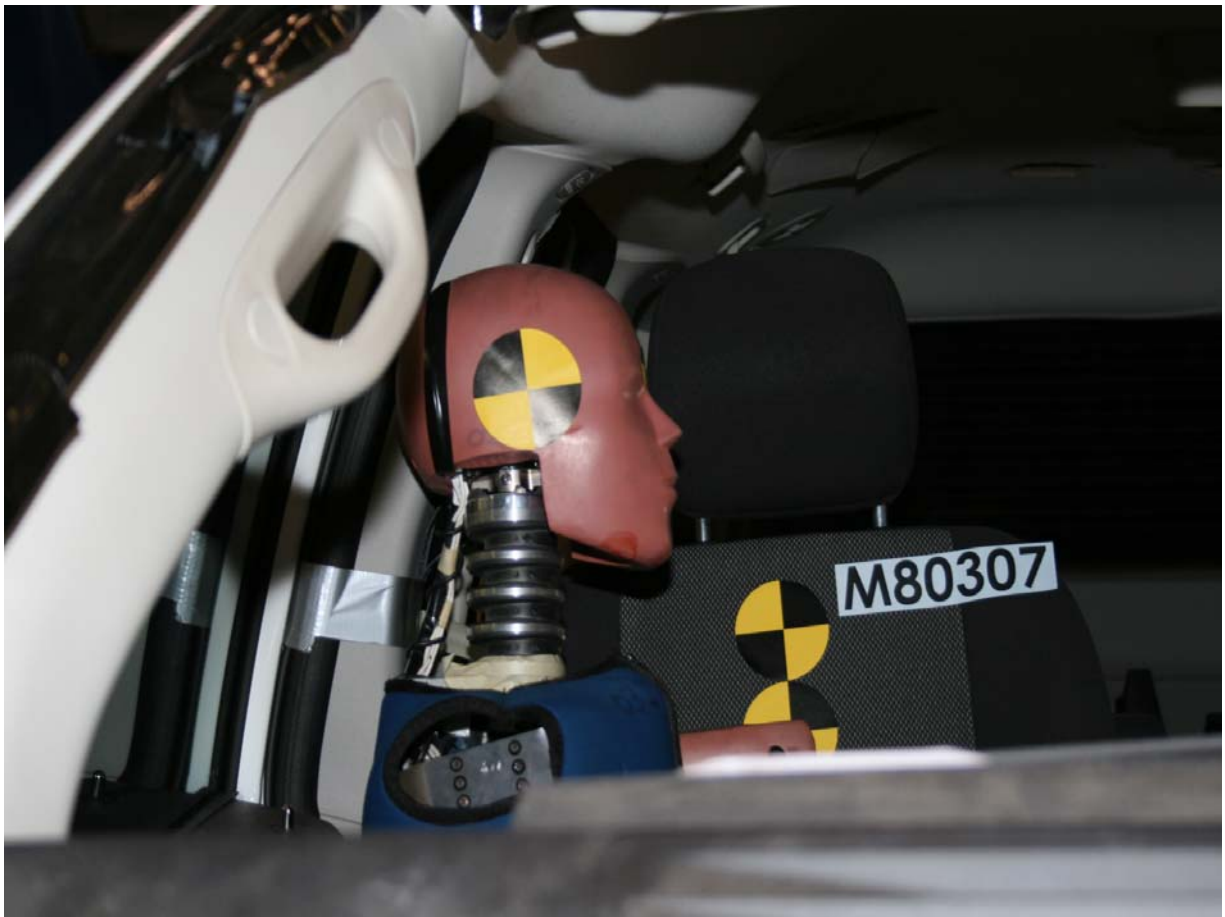
Pre-Test SID-IIs Dummy Front Closeup View

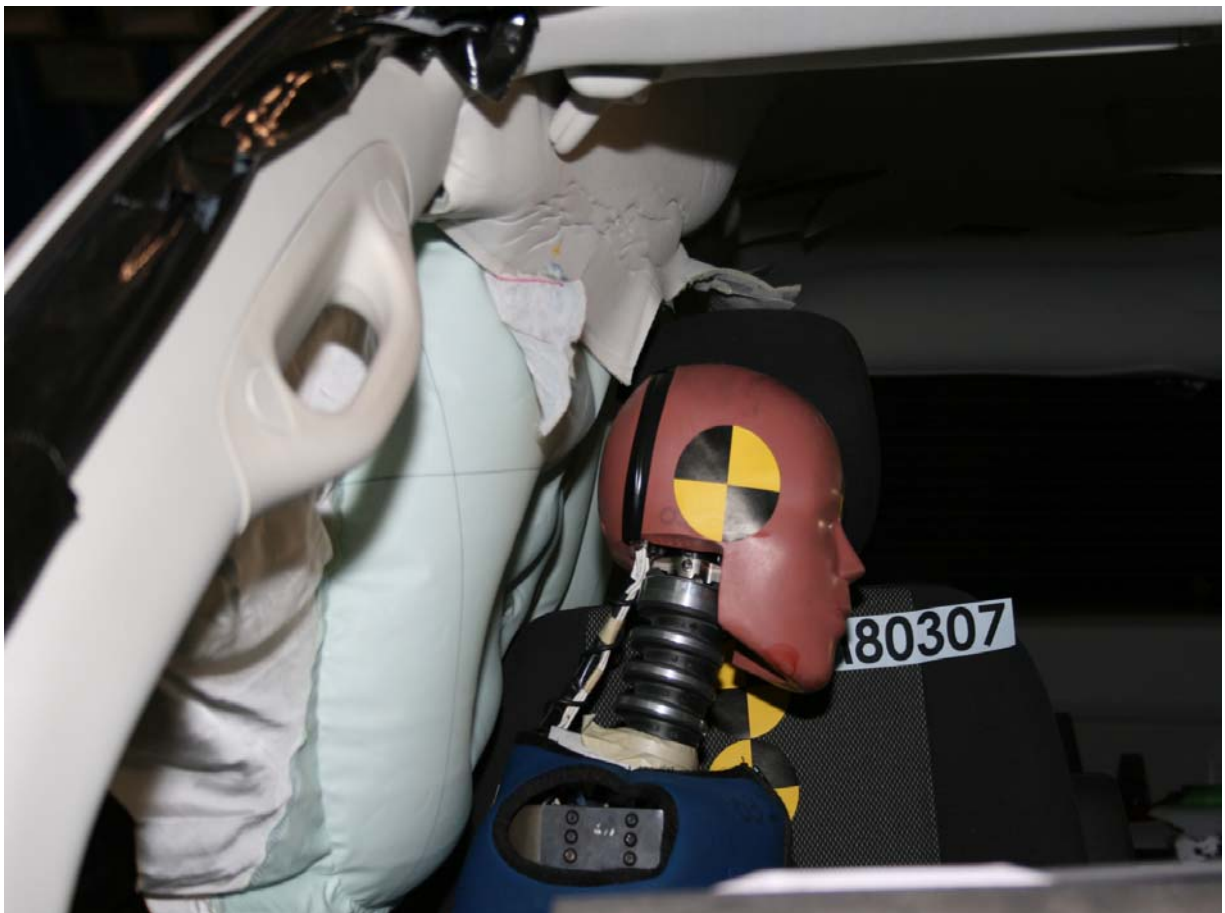
Post-Test SID-IIs Dummy Front Closeup View

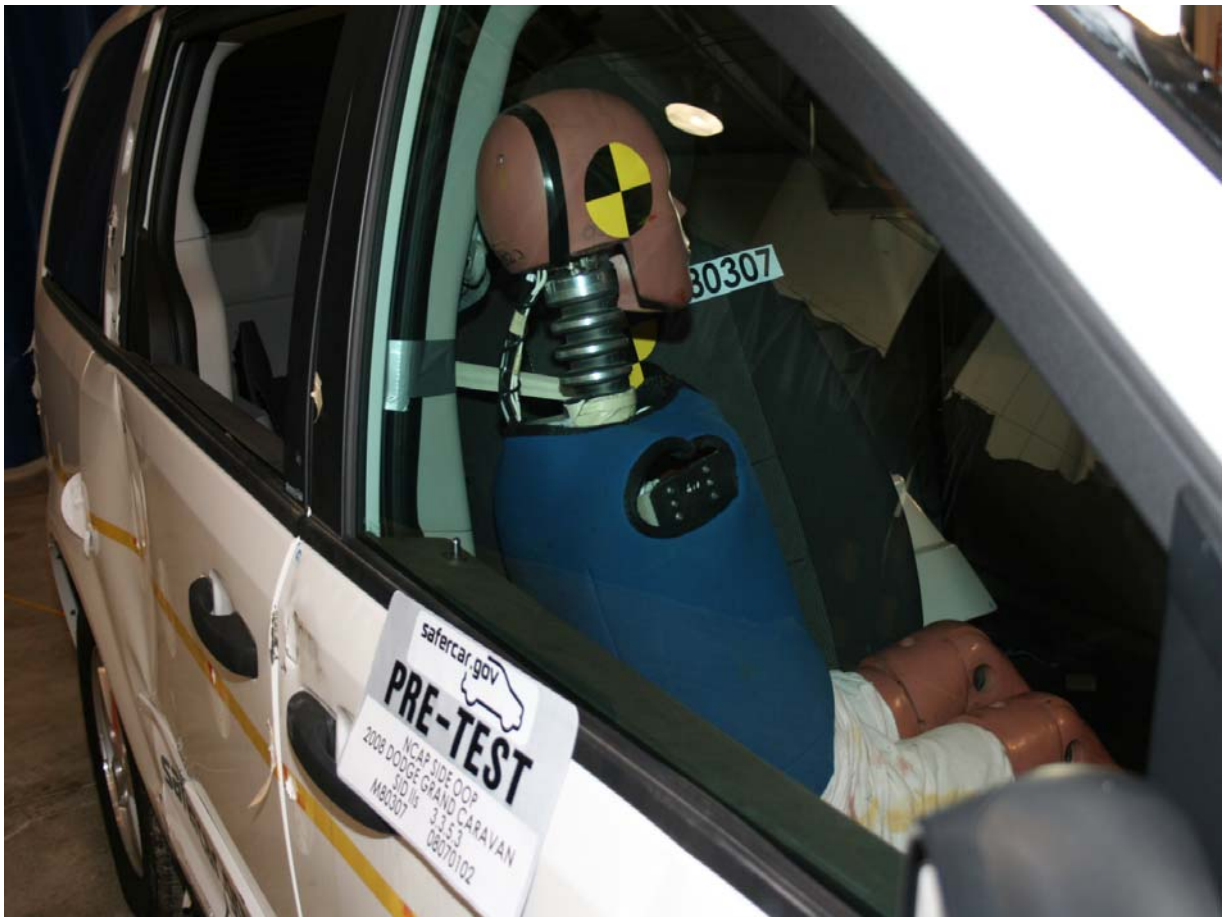
Pre-Test SID-IIs Dummy Right  $\frac{3}{4}$  Front View

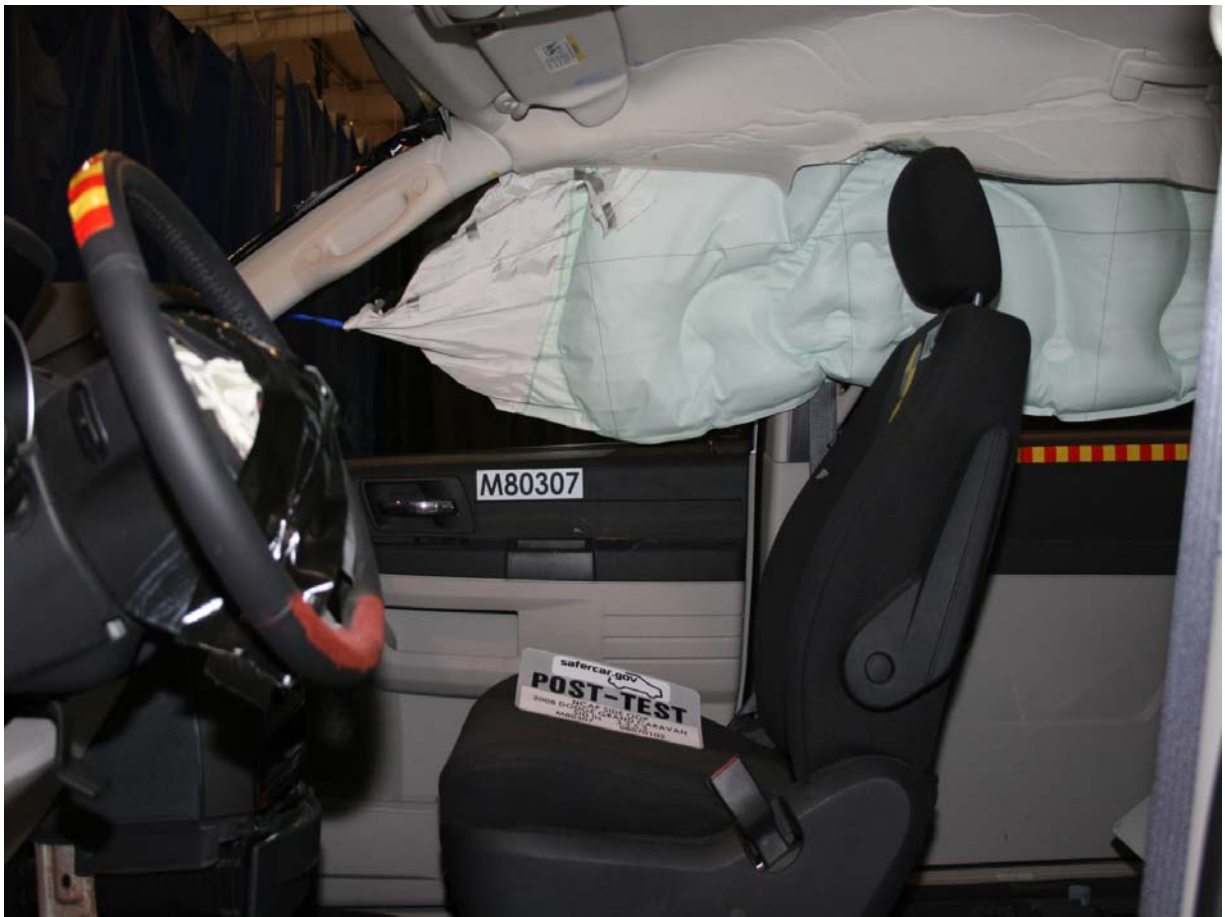
Post-Test Right Front Passenger Compartment View

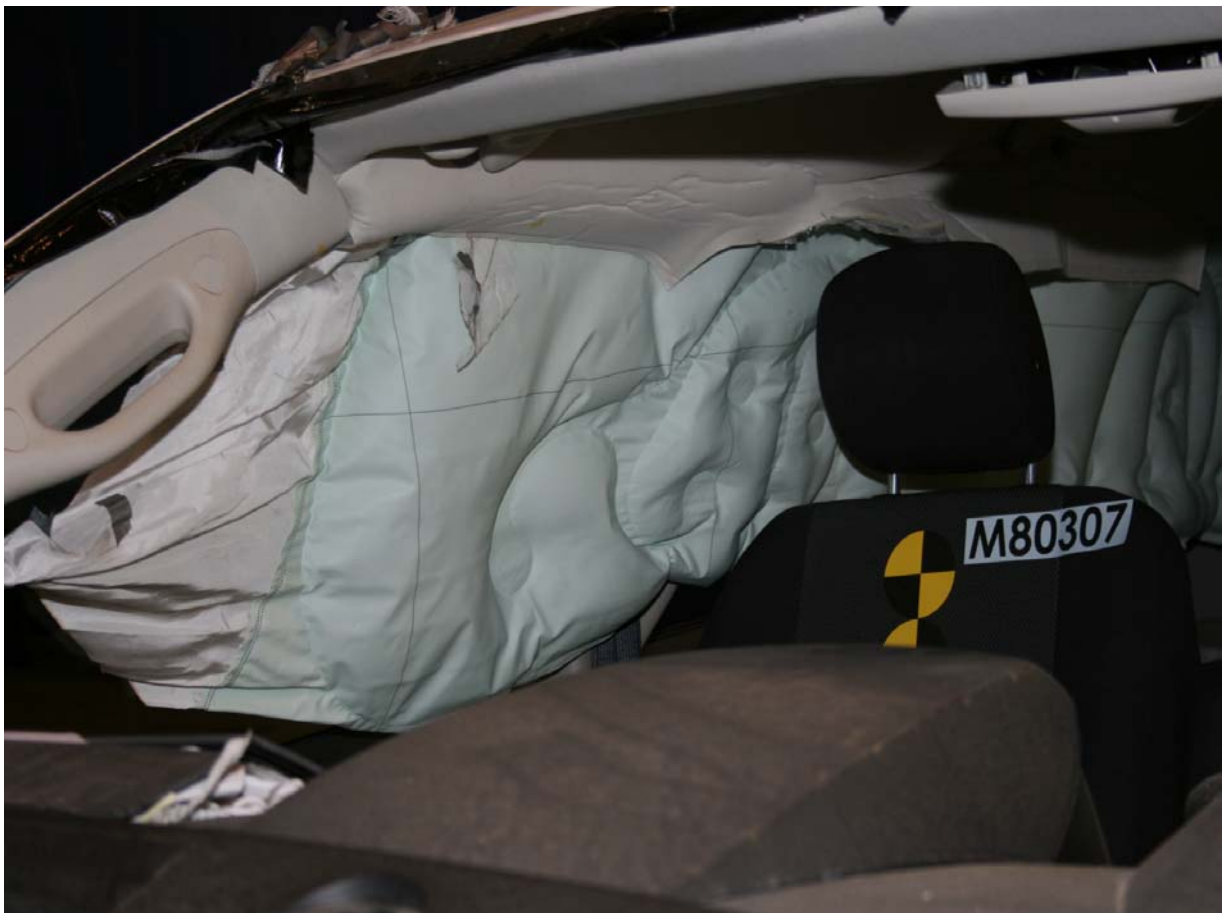
Post-Test Curtain Airbag View
