**REPORT NUMBER TR-P28059-04-NC**

**SIDE AIRBAG OCCUPANT RISK PROGRAM  
OCCUPANT OUT-OF-POSITION TESTS**

**DAIMLER CHRYSLER CORPORATION  
2008 DODGE AVENGER  
4-DOOR SEDAN**

**NHTSA NUMBER: M80303TWG2**

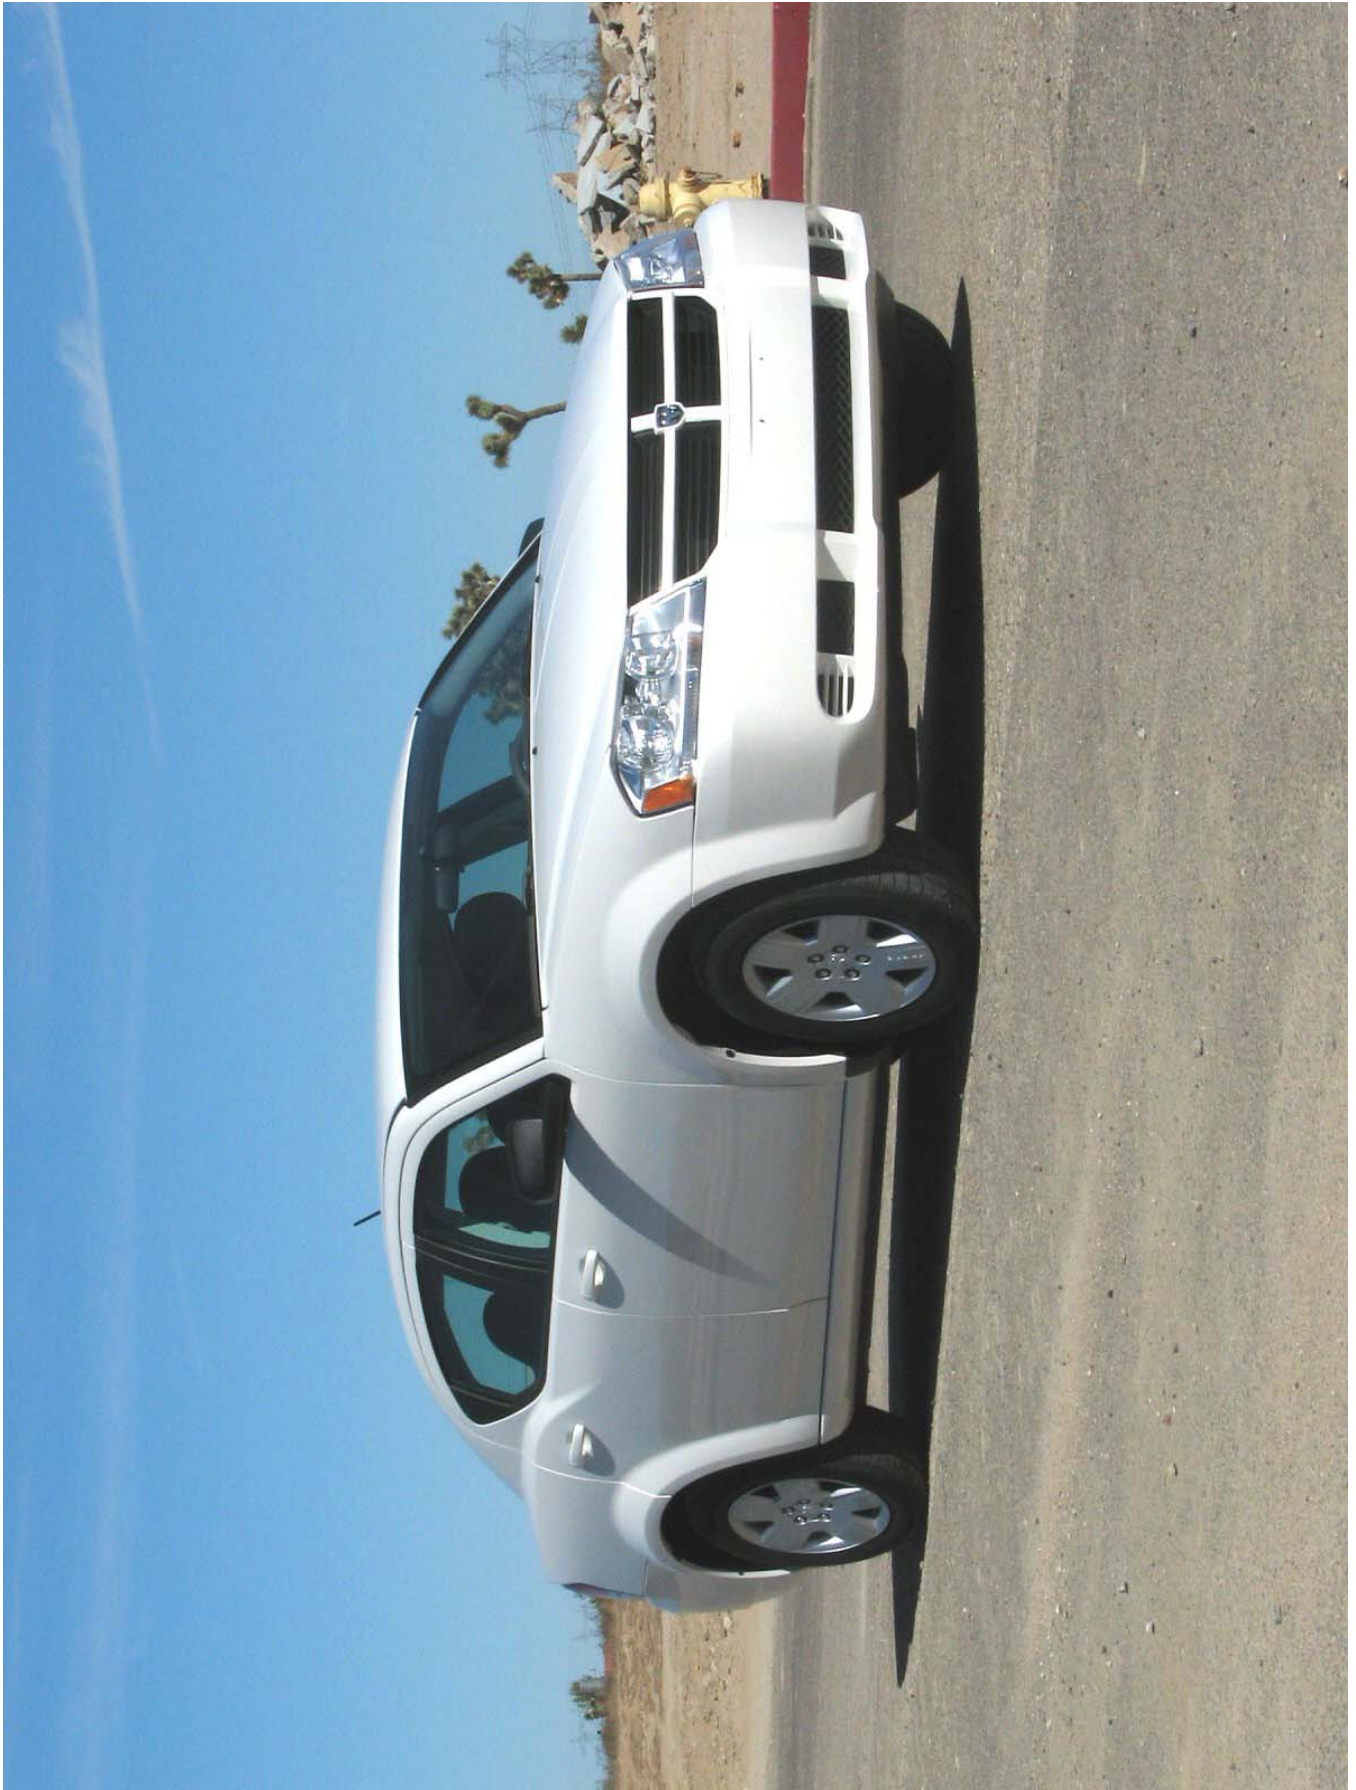
Figure A-1: Right Front  $\frac{3}{4}$  View, As Received

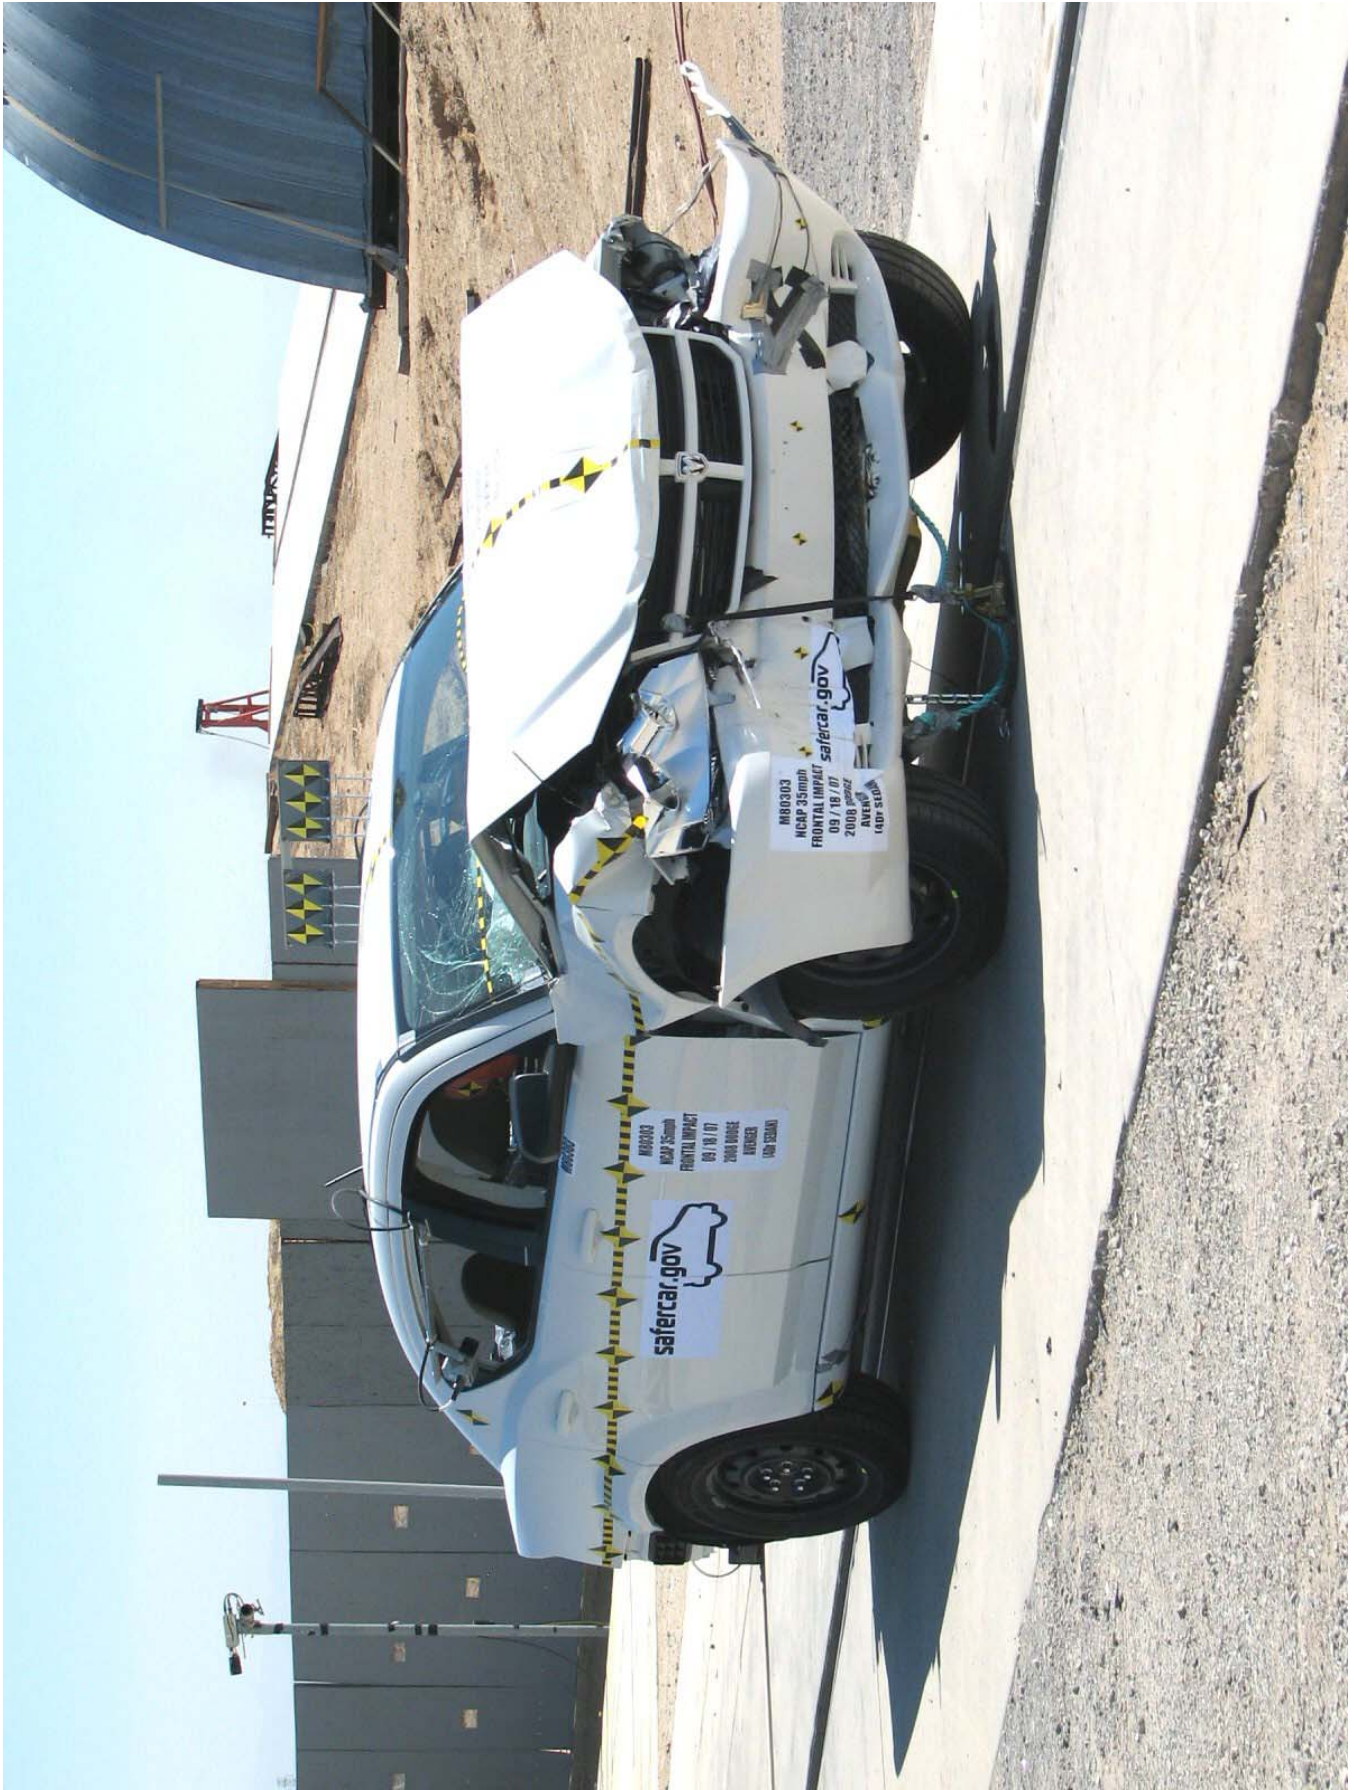
Figure A-3: Post-Test Right Front  $\frac{3}{4}$  View of Frontal NCAP Test

\* Vehicle had undergone New Car Assessment Program Frontal Impact Testing on September 18, 2007

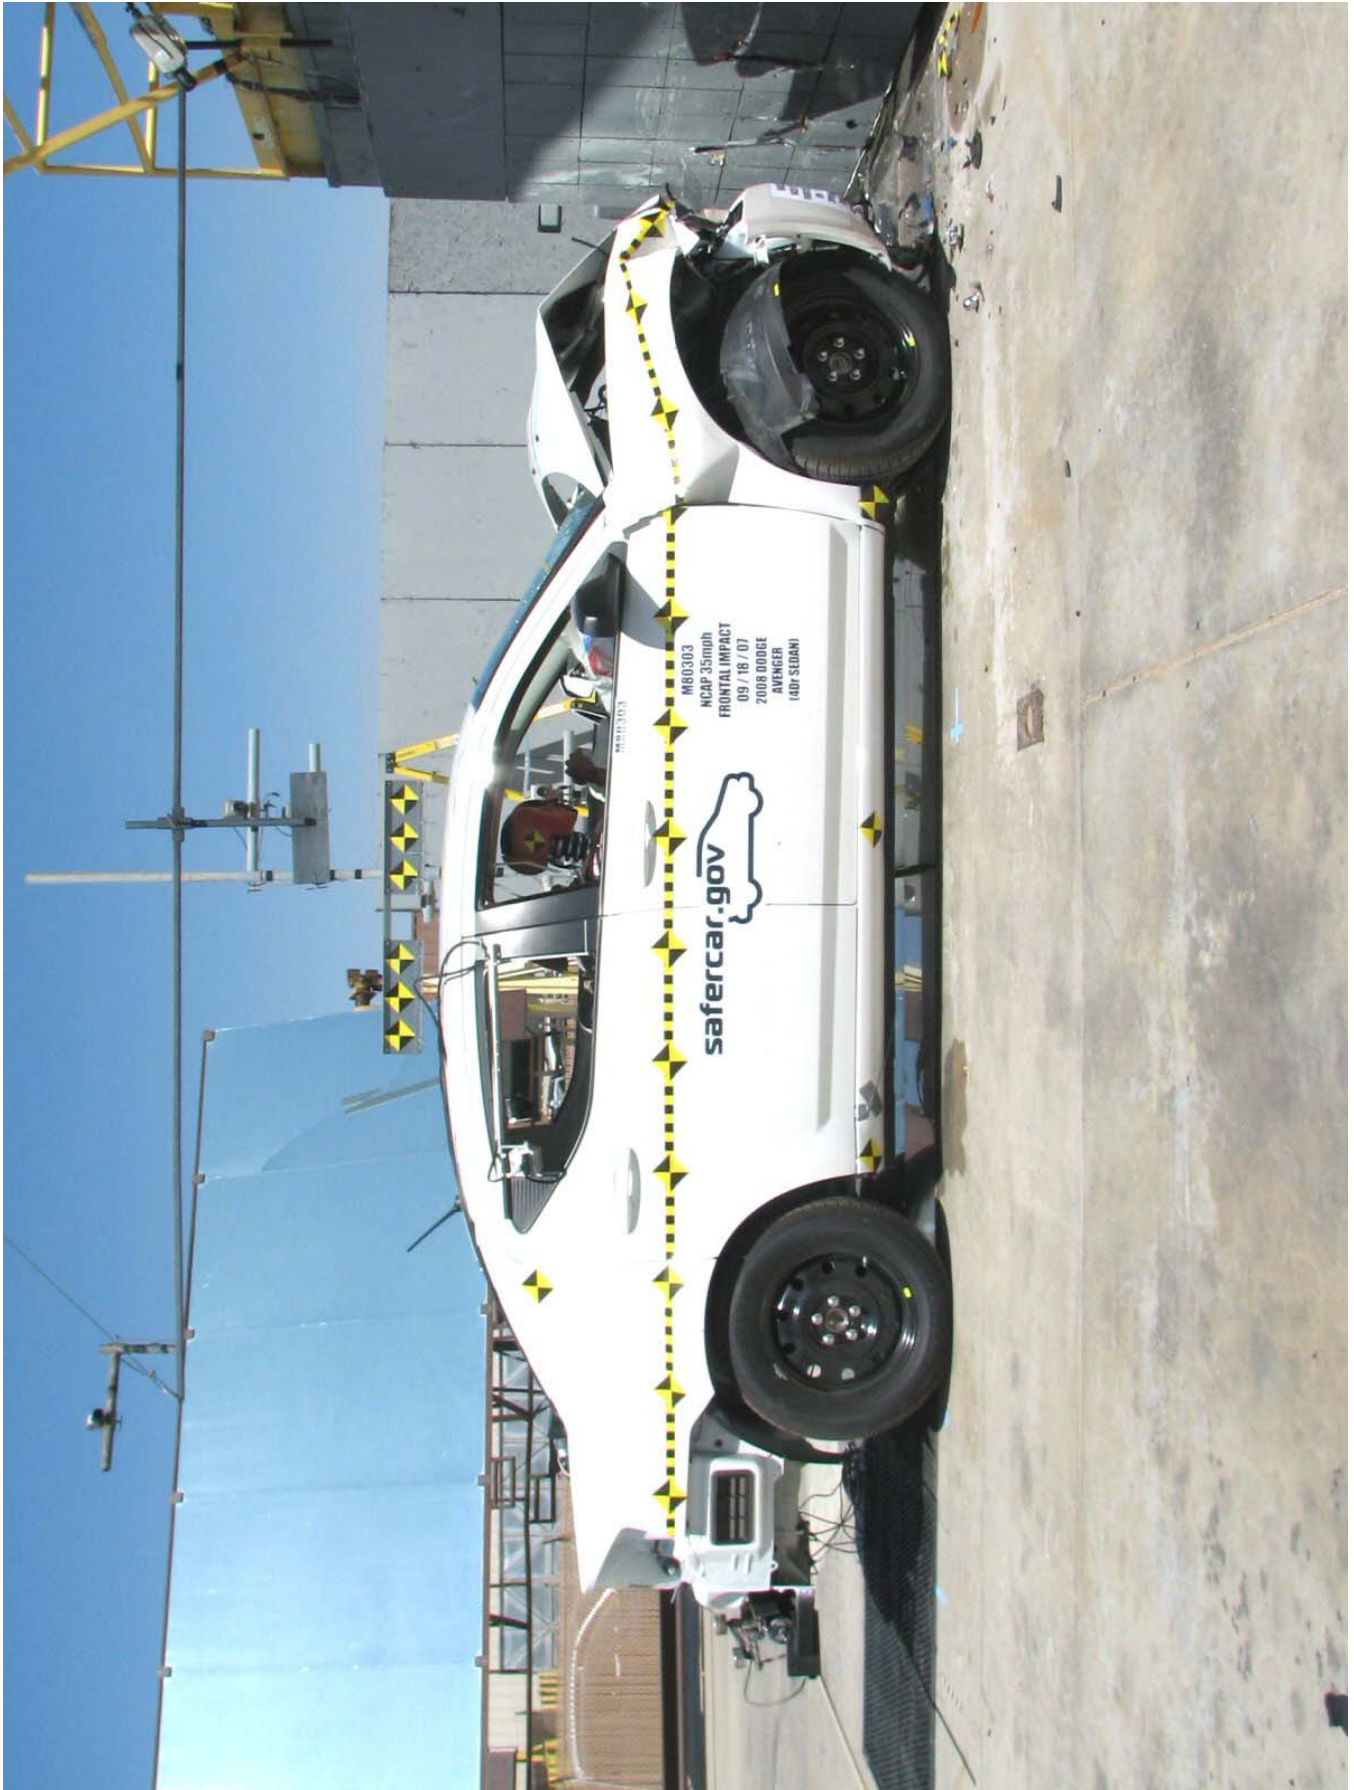
Figure A-4: Post-Test Right Side View of Frontal NCAP Test

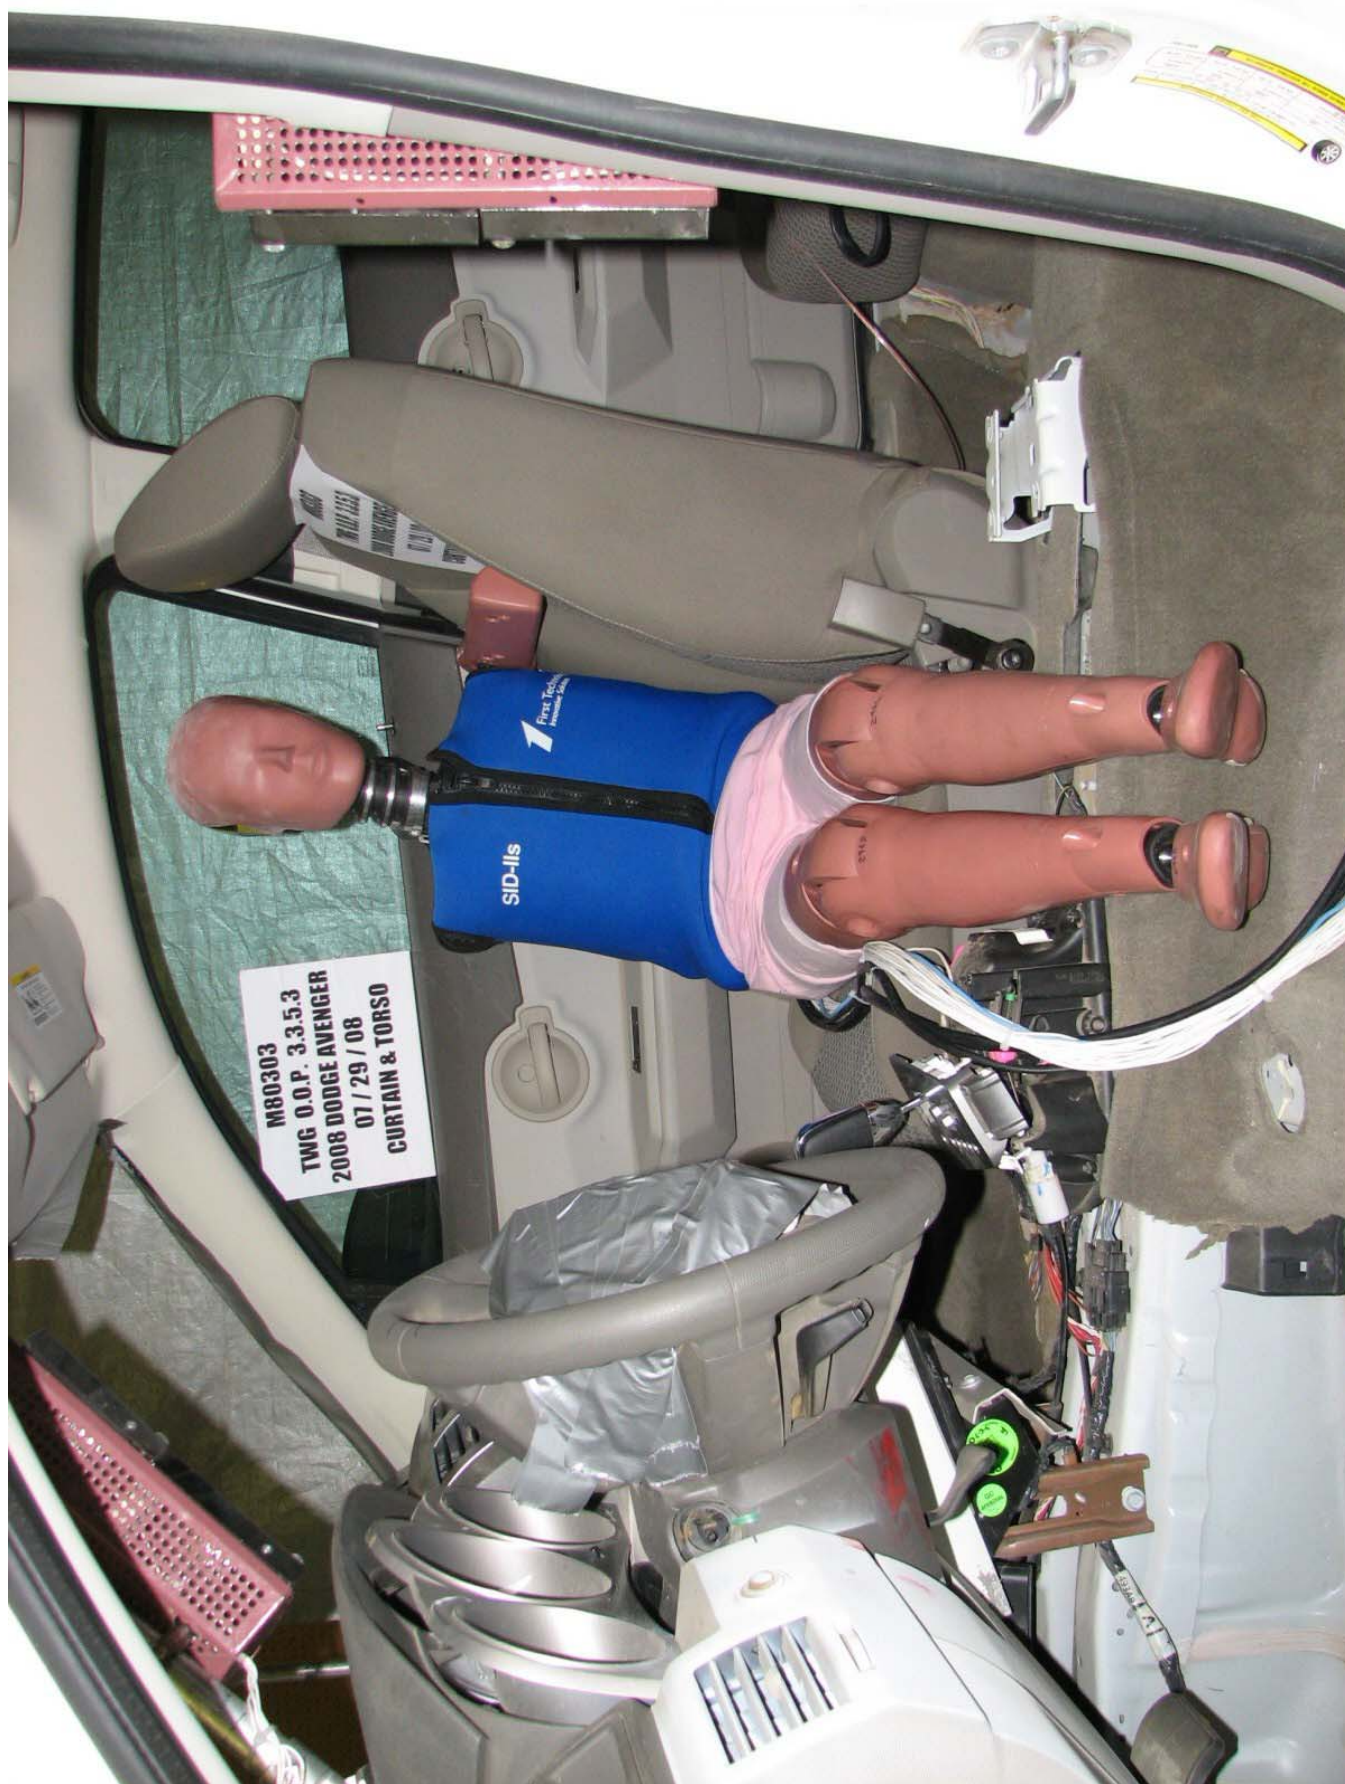
Figure A-5: Pre-Test Dummy Position, Left Side View

Orientation of the SID IIs 5<sup>th</sup> percentile adult female dummy was in the inboard facing position leaning against the front passenger door. The dummy's spine was aligned with the deploying trajectory of the curtain airbag. The lower legs were extended. This orientation complies with section 3.3.5.3 of the Technical Working Group (TWG) recommendation in the Recommended Procedures for Evaluating Occupant Injury Risk from Deploying Side Airbags.

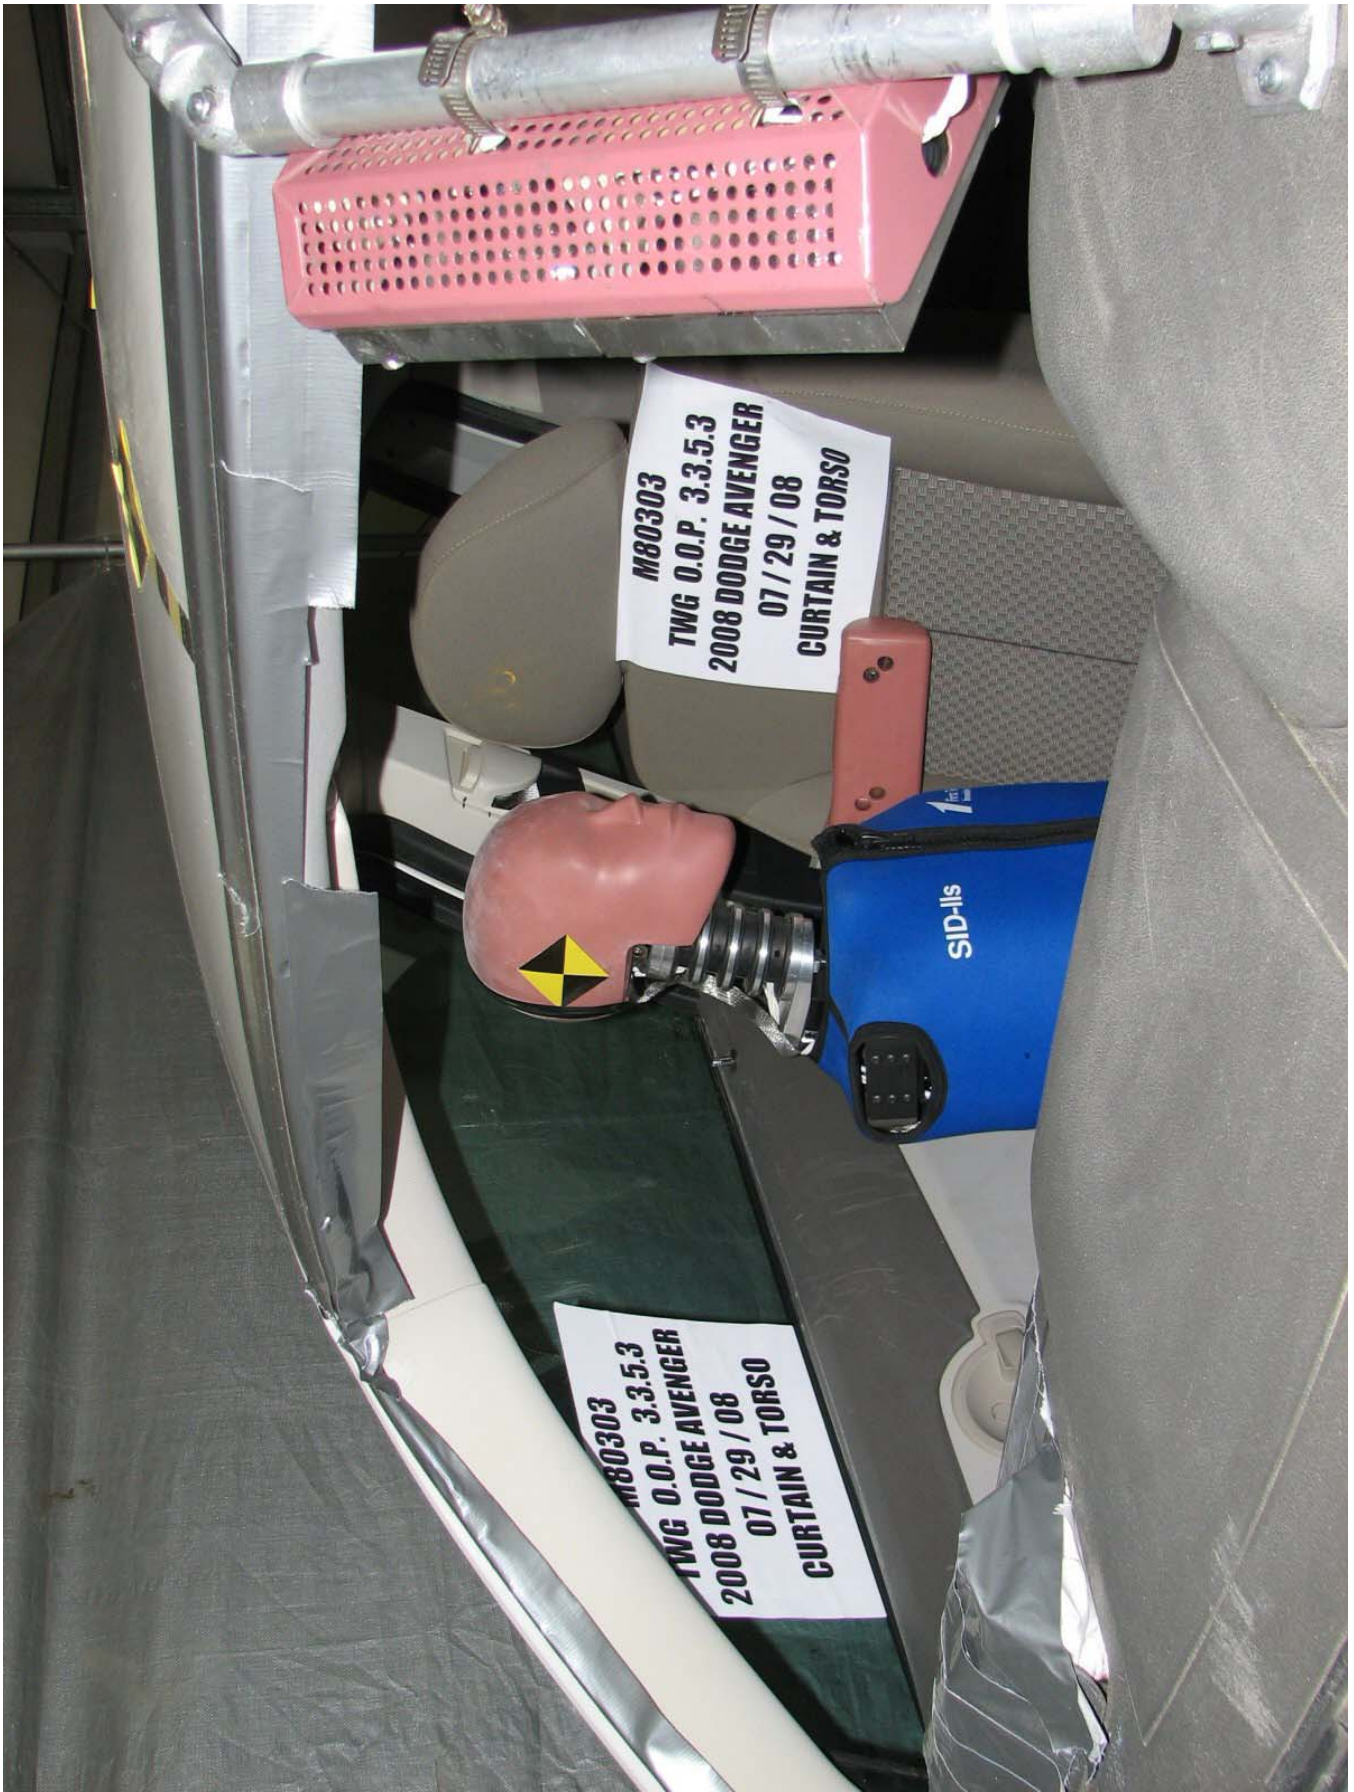
Figure A-6: Pre-Test Dummy Position,  $\frac{3}{4}$  View

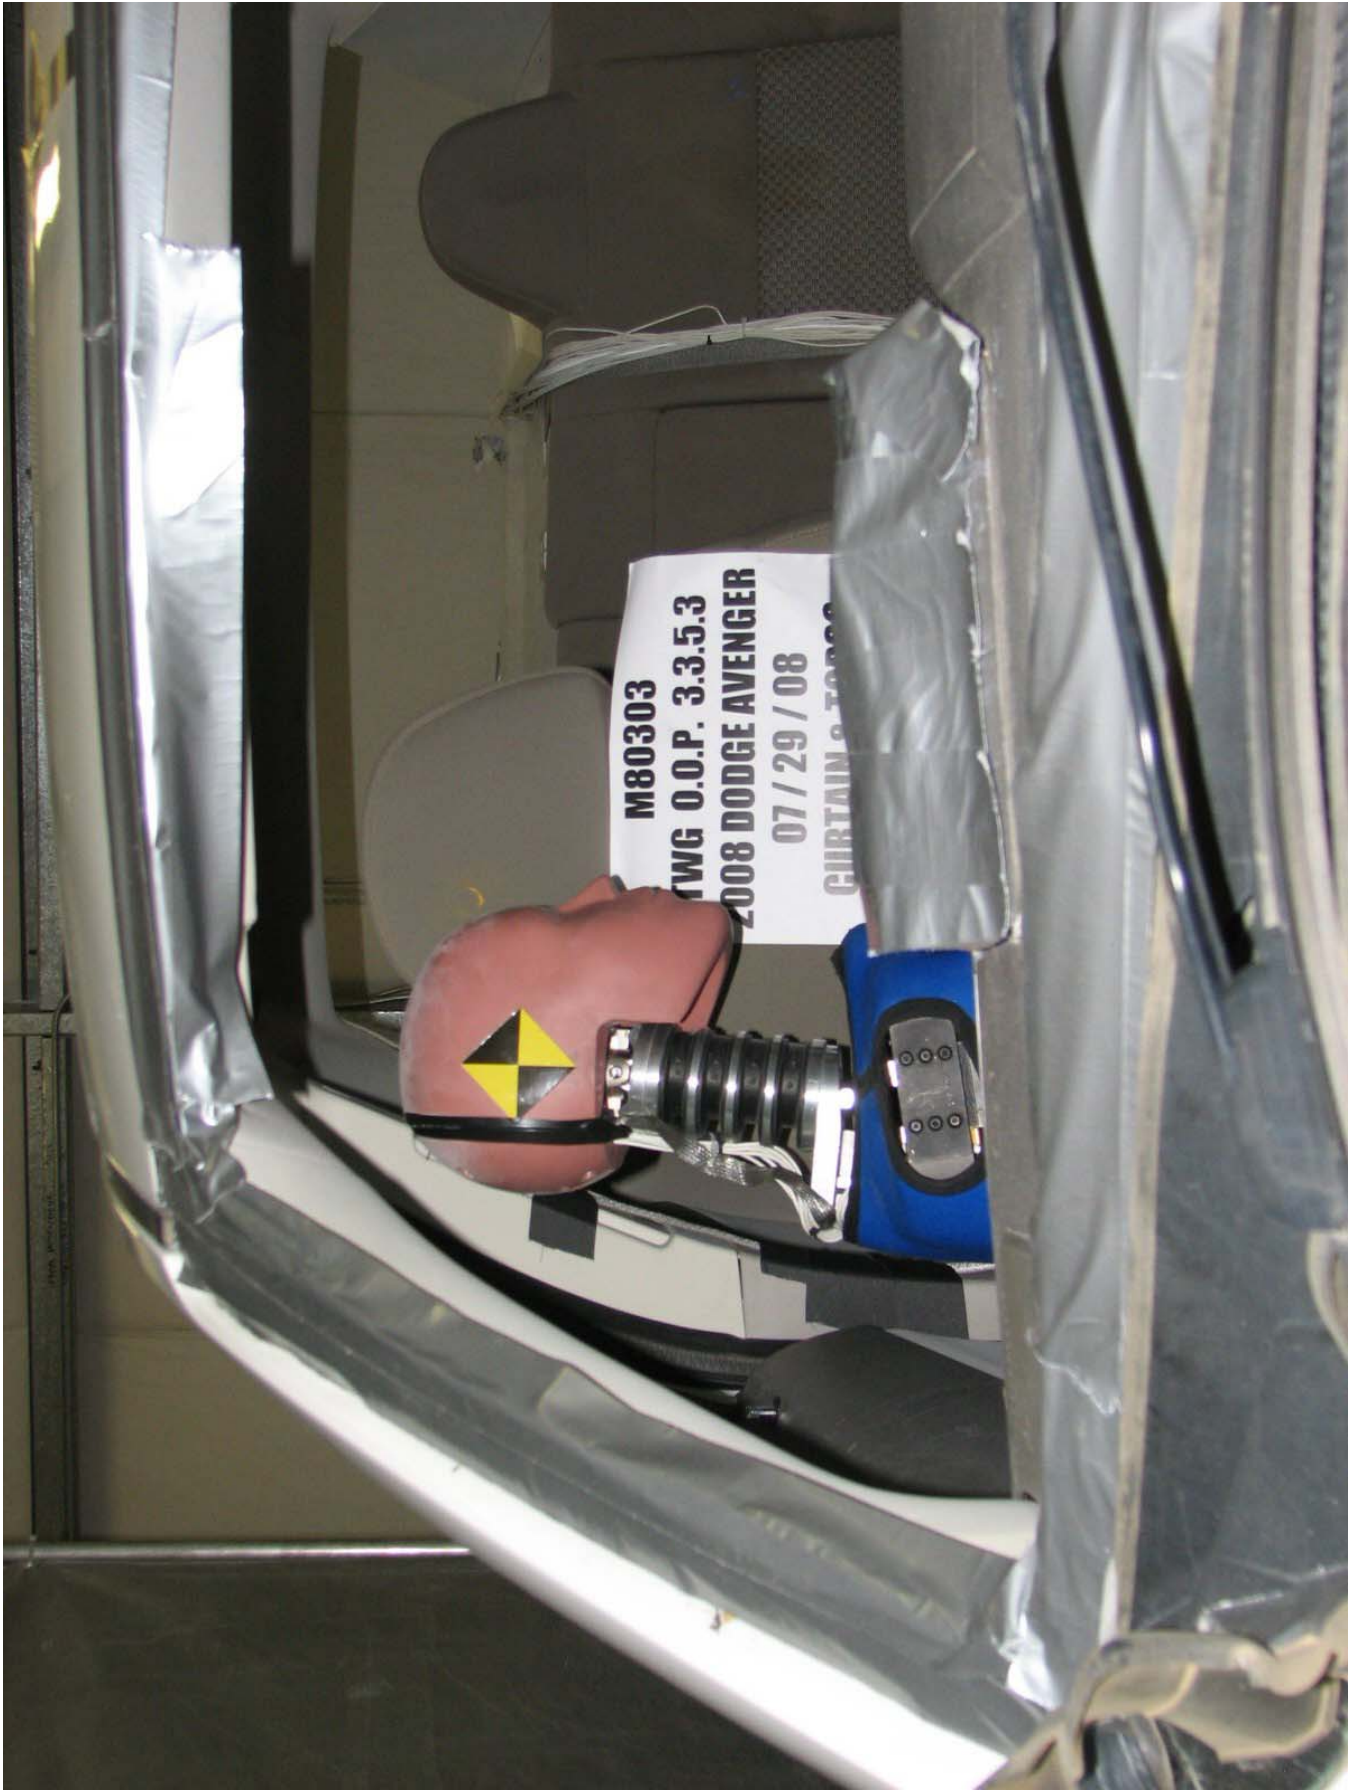
Figure A-7: Pre-Test Dummy Position, Front View

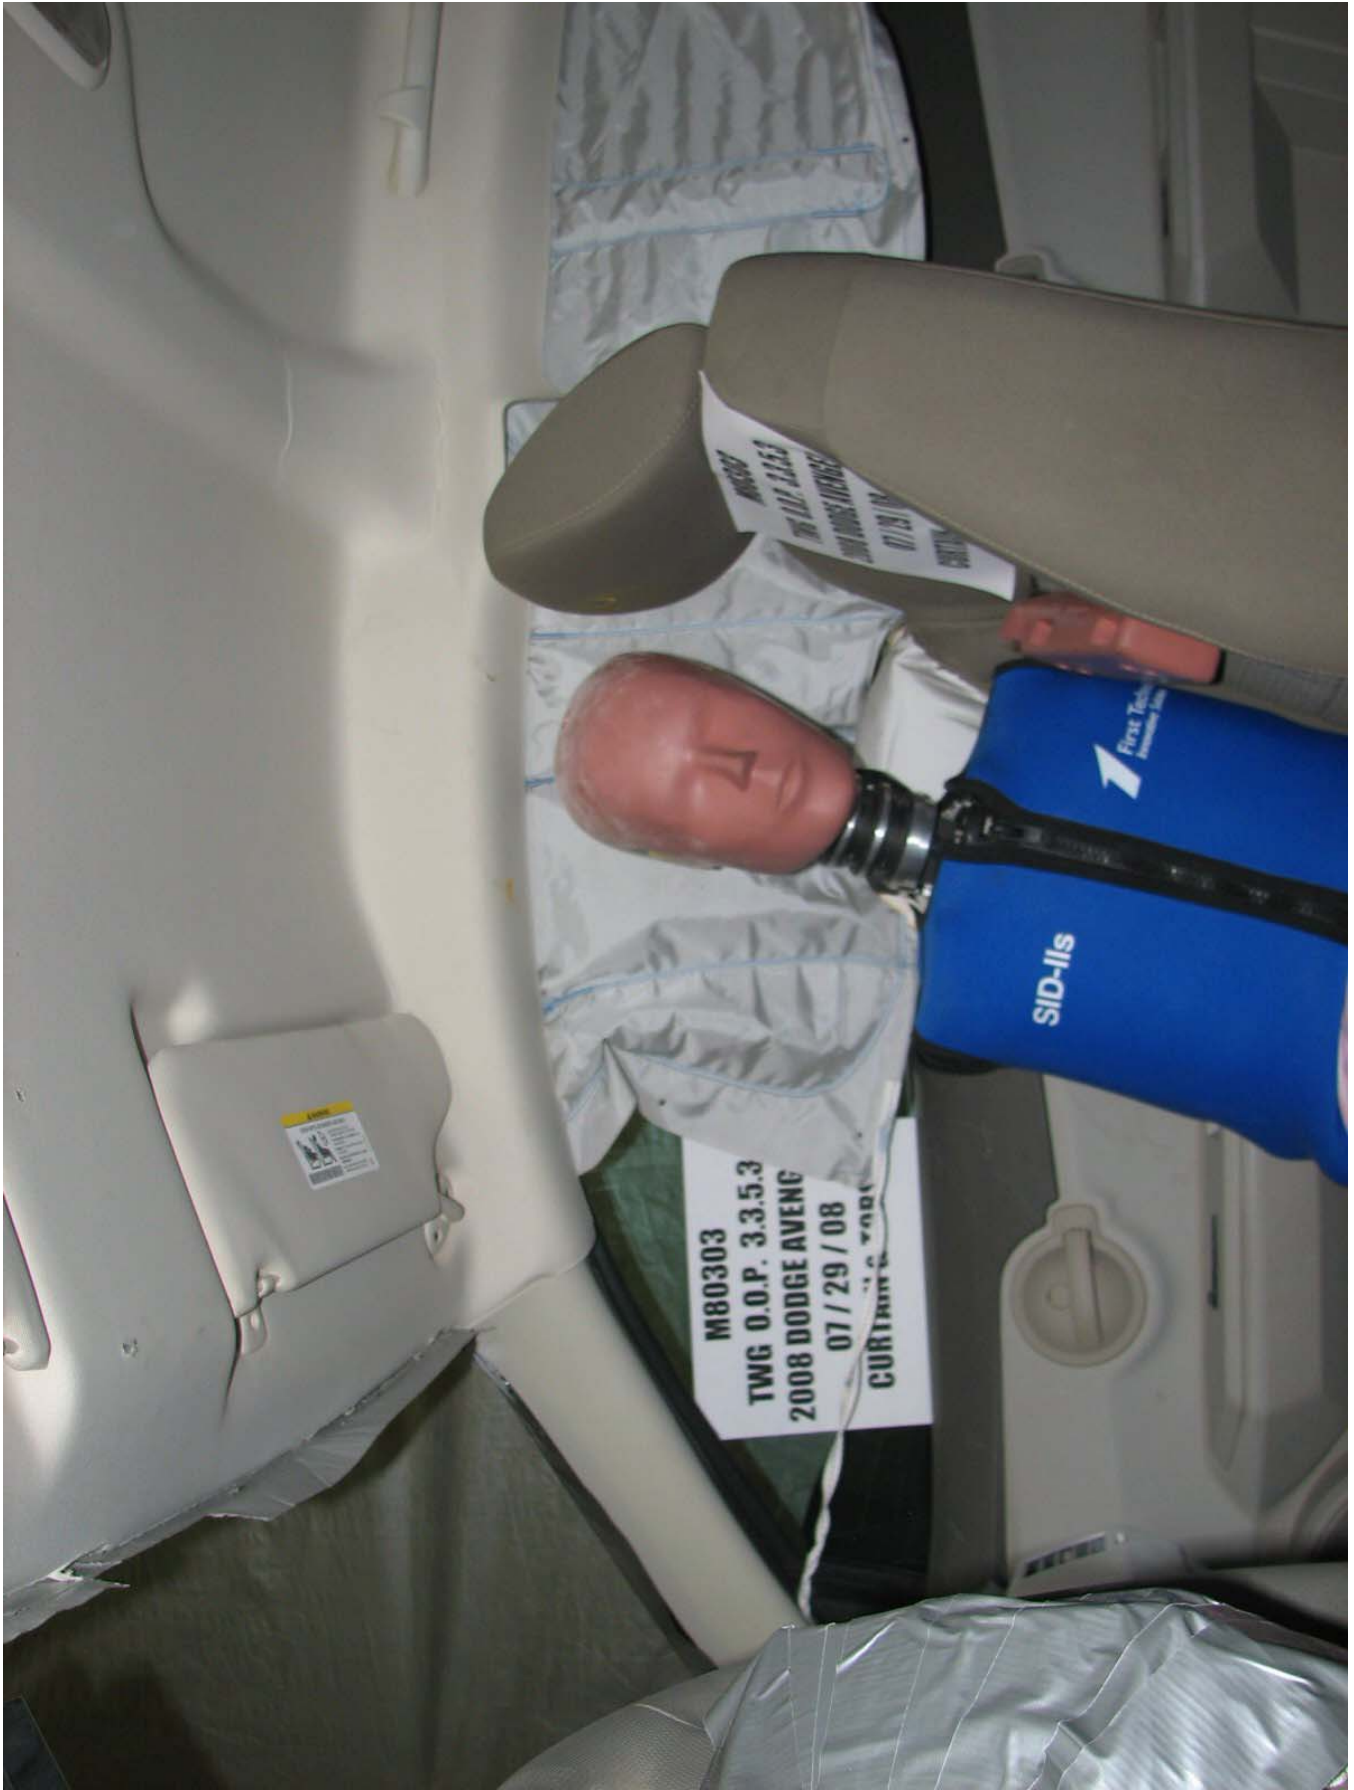
Figure A-8: Post-Test Dummy Position and Airbags, Left Side View

The SID IIs 5<sup>th</sup> percentile adult female dummy's visible contact points were as follows: The curtain airbag contacted the ATD's head and the torso airbag contacted the ATD's back.

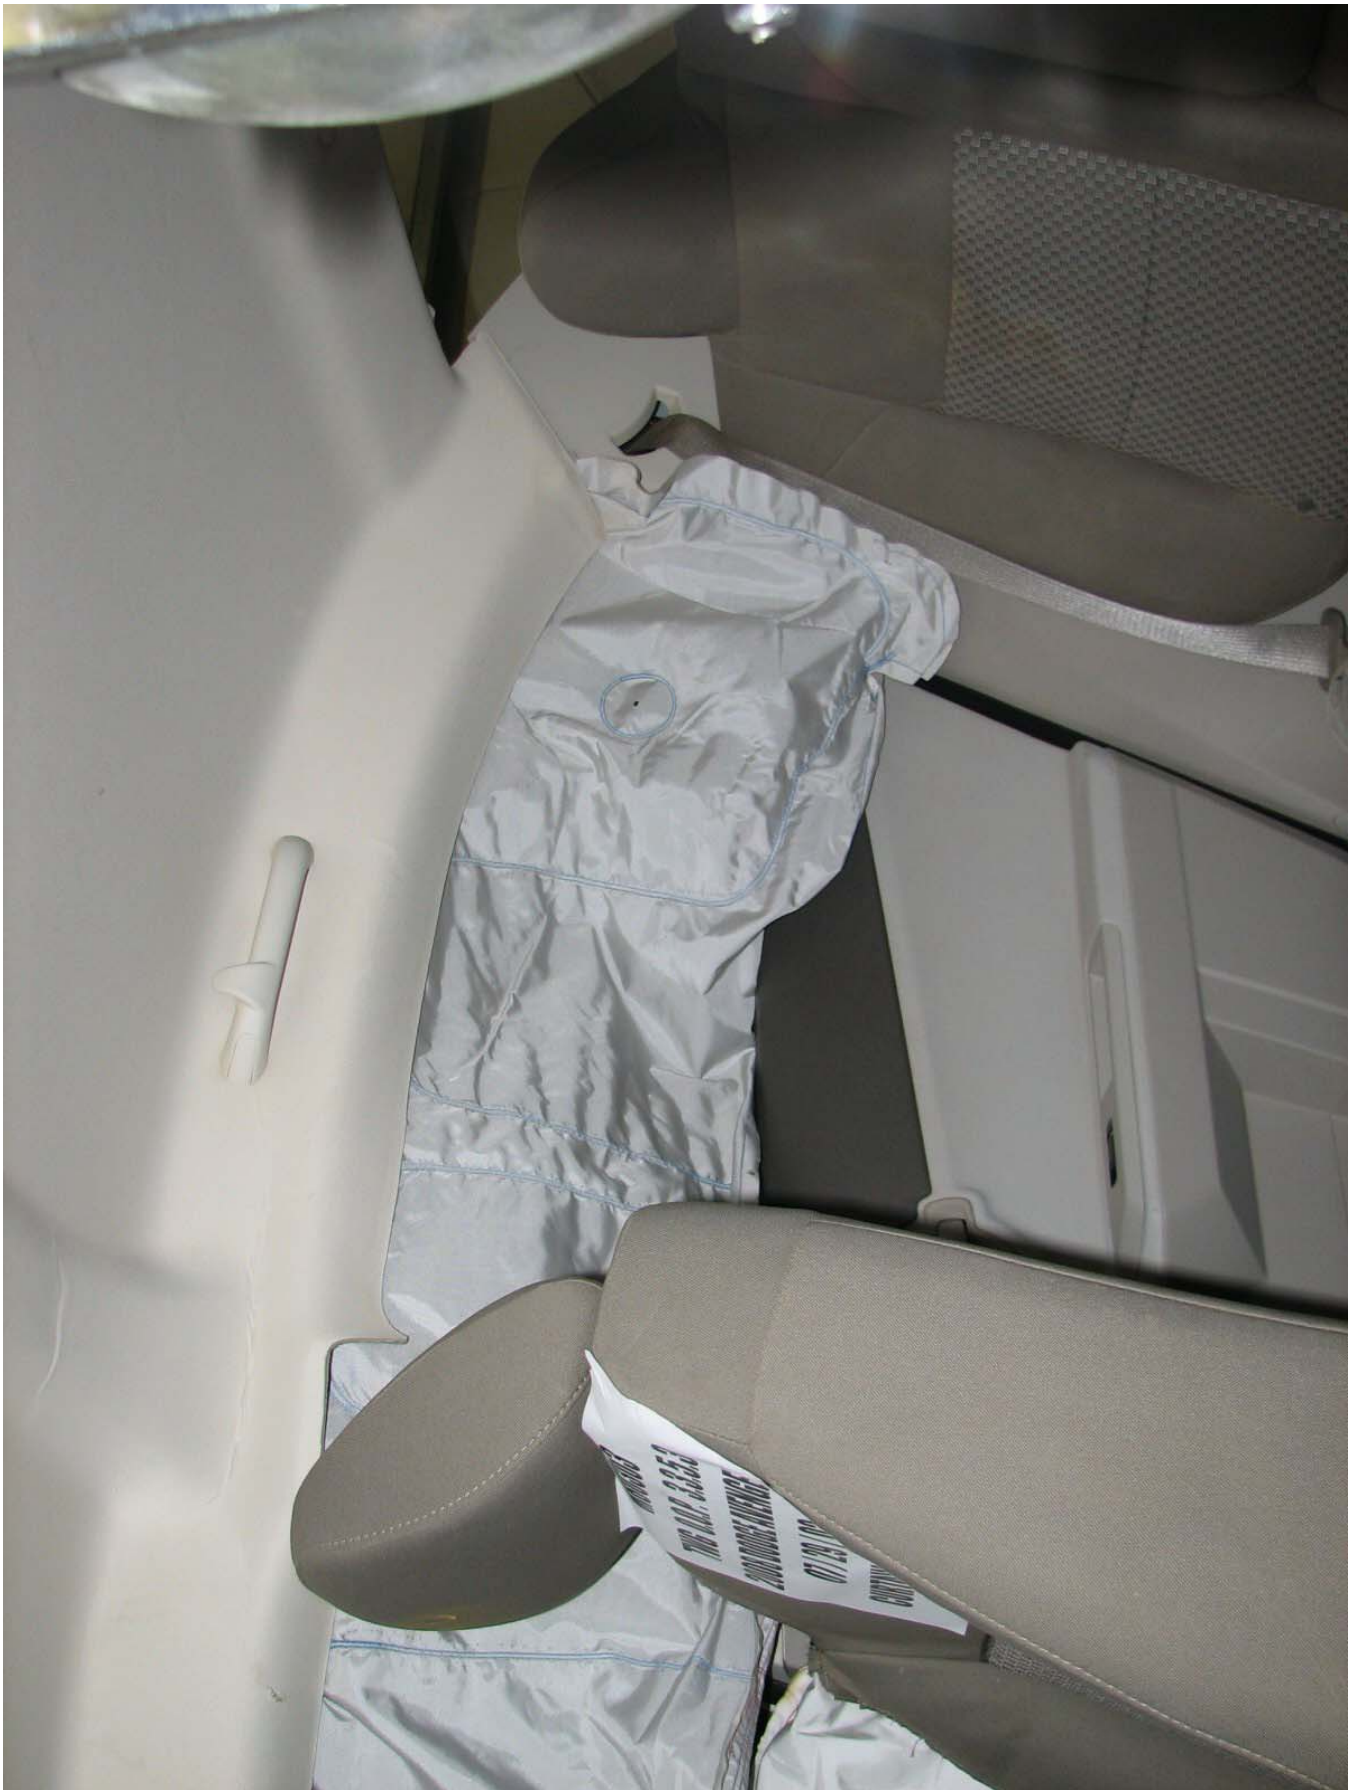
Figure A-9: Post-Test Airbags, Left Side View

The front passenger side door remained closed during the deployment and was operable after the deployment.

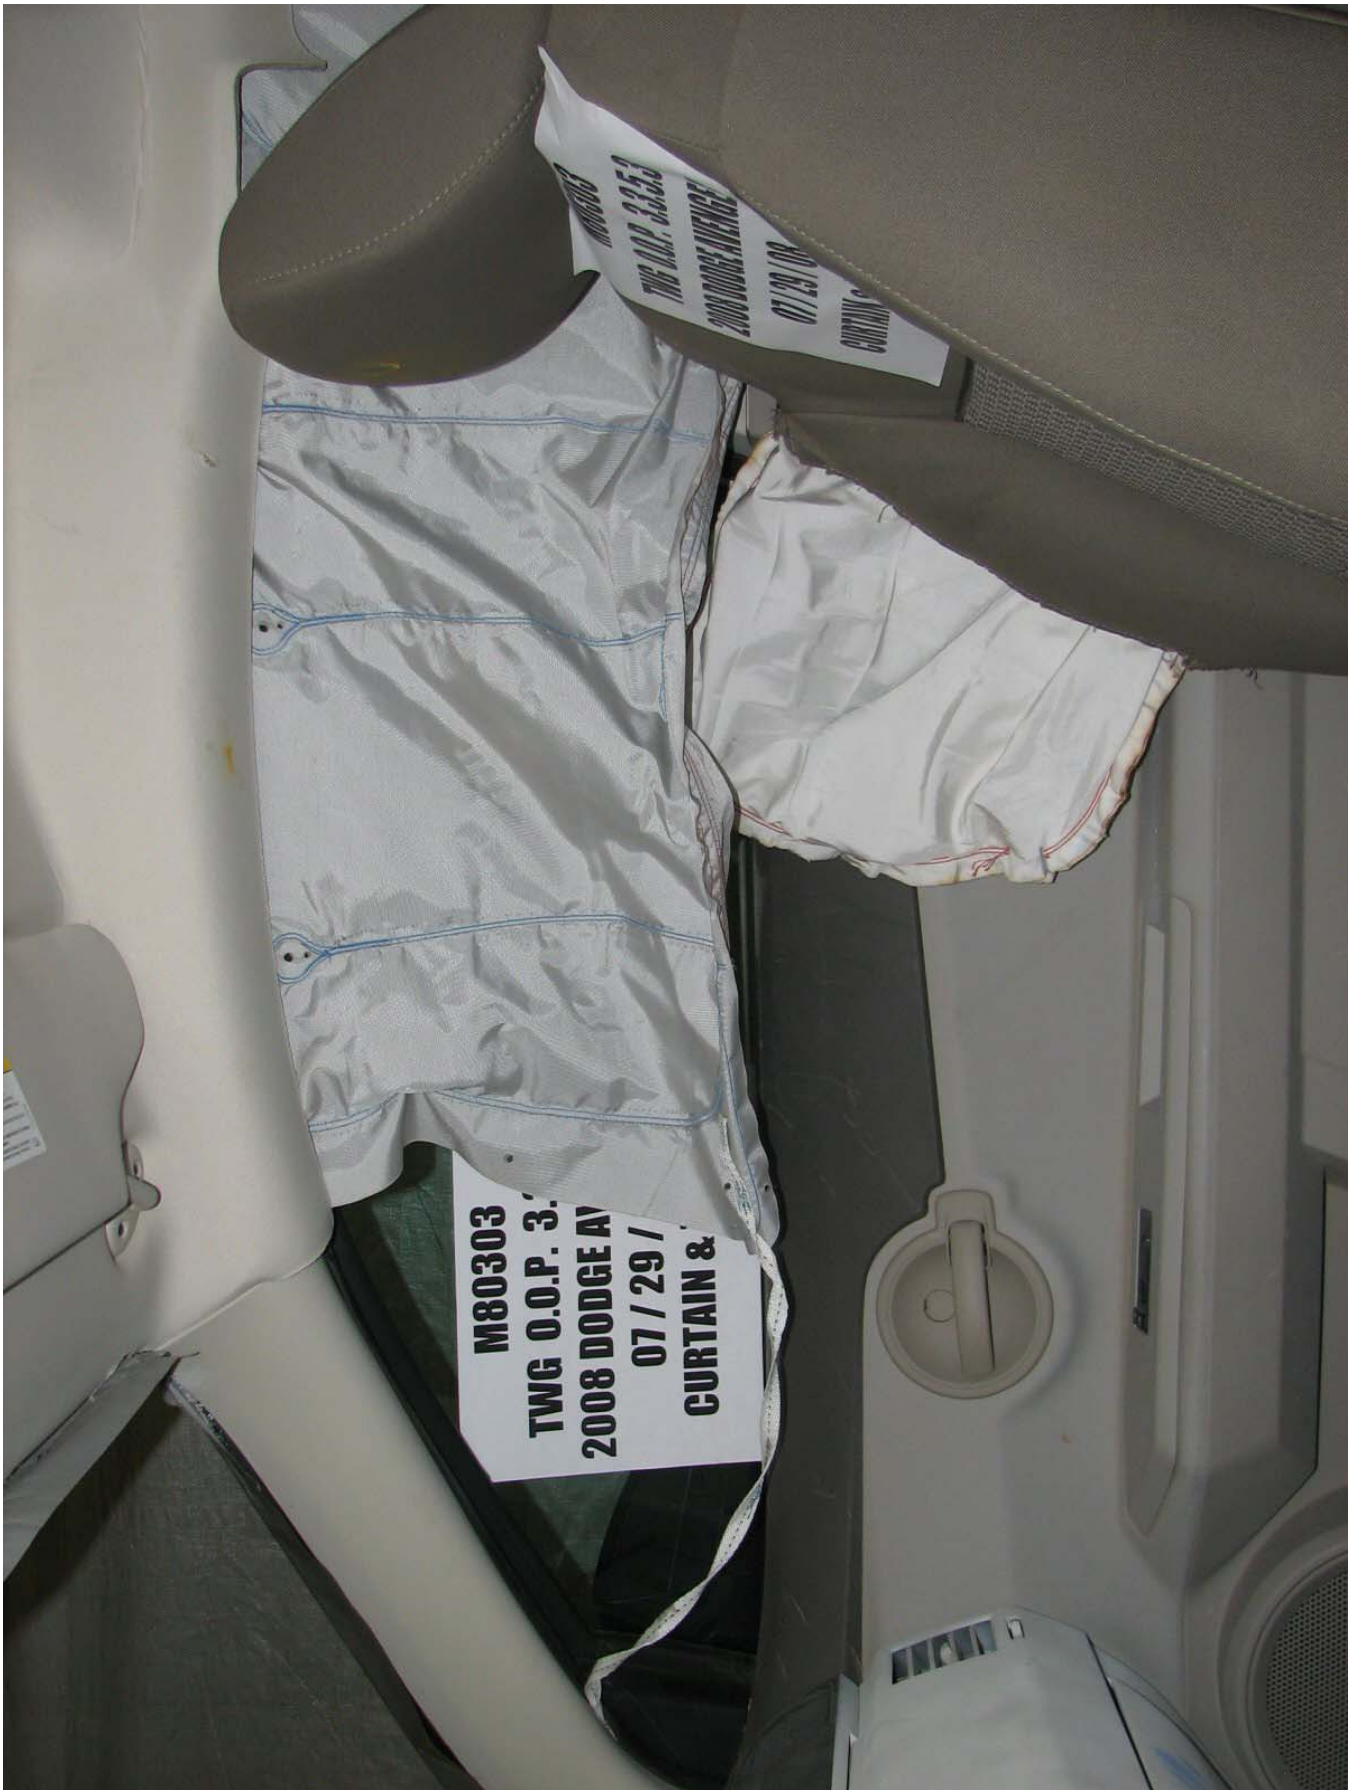
Figure A-10: Post-Test Airbags, Close-up View
