**NEW CAR ASSESSMENT PROGRAM  
SIDE IMPACT TEST**

**HYUNDAI MOTOR COMPANY  
2010 HYUNDAI GENESIS 2-DR COUPE  
NHTSA NUMBER: MA0502**

**PREPARED BY:  
MGA RESEARCH CORPORATION  
5000 WARREN ROAD  
BURLINGTON, WI 53105**

**FINAL REPORT**

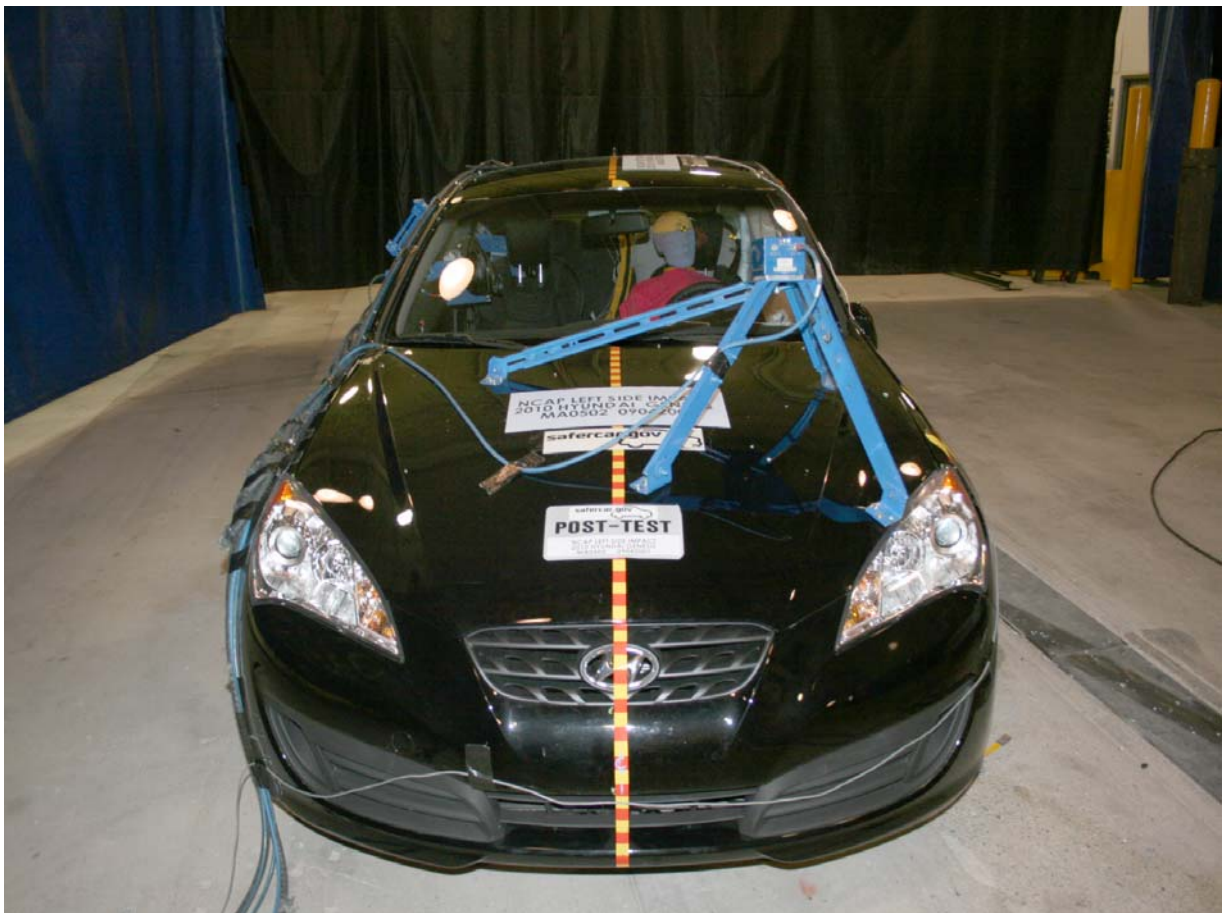
Post-Test Front View

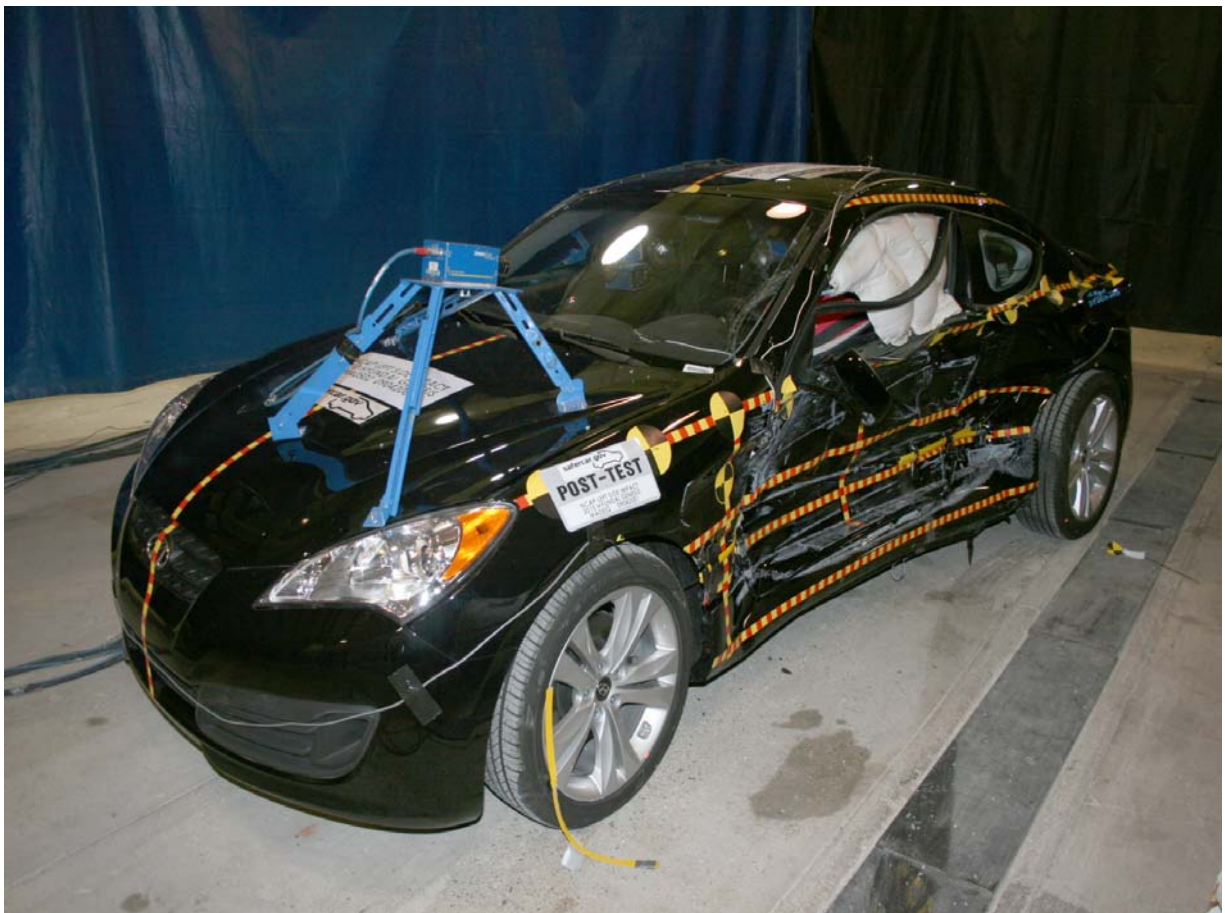
Post-Test Left Front  $\frac{3}{4}$  View

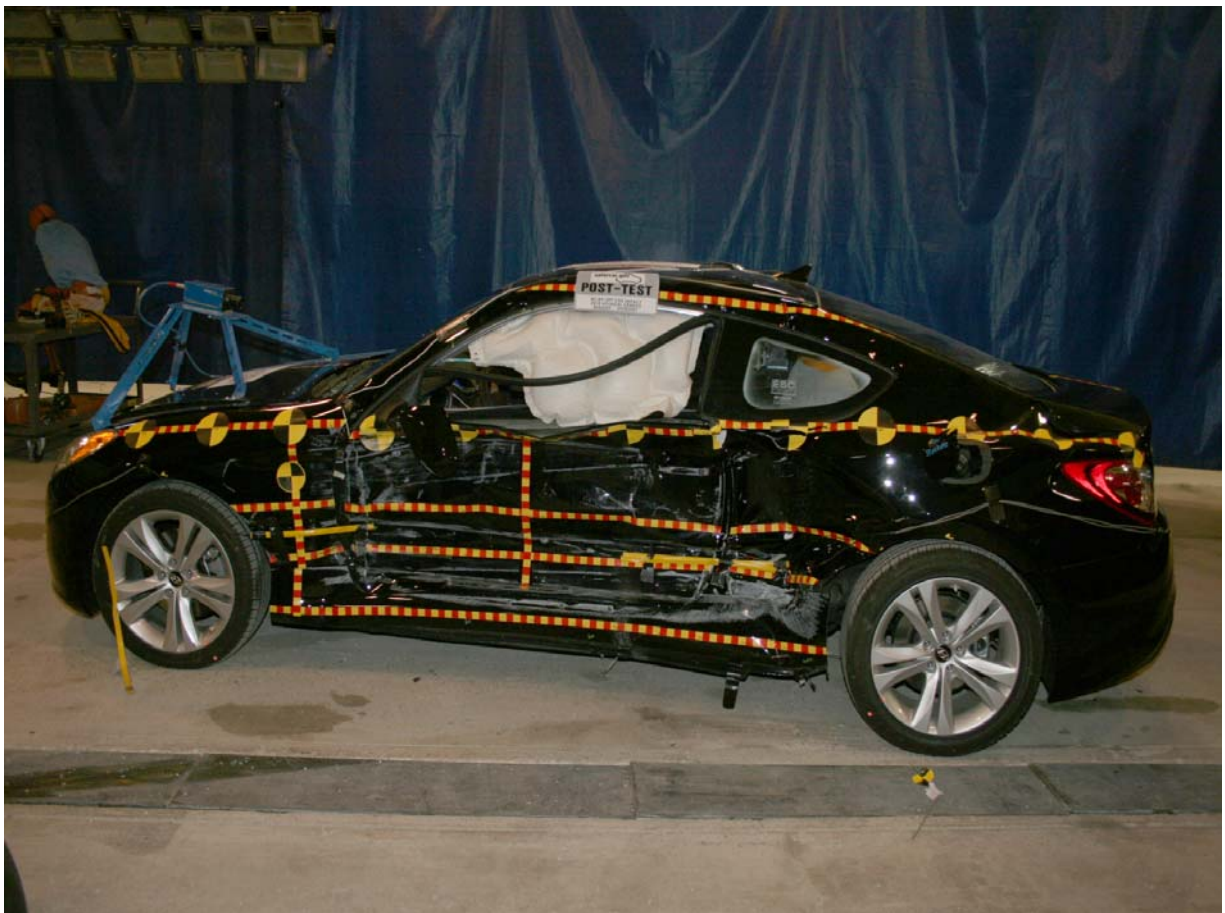
Post-Test Left Side View

The test vehicle sustained a maximum static crush of 297 mm at level 2, 1650 mm rearward of the vertical impact point. The driver SID/HII, Serial Nos. 271 was calibrated just prior to this test.

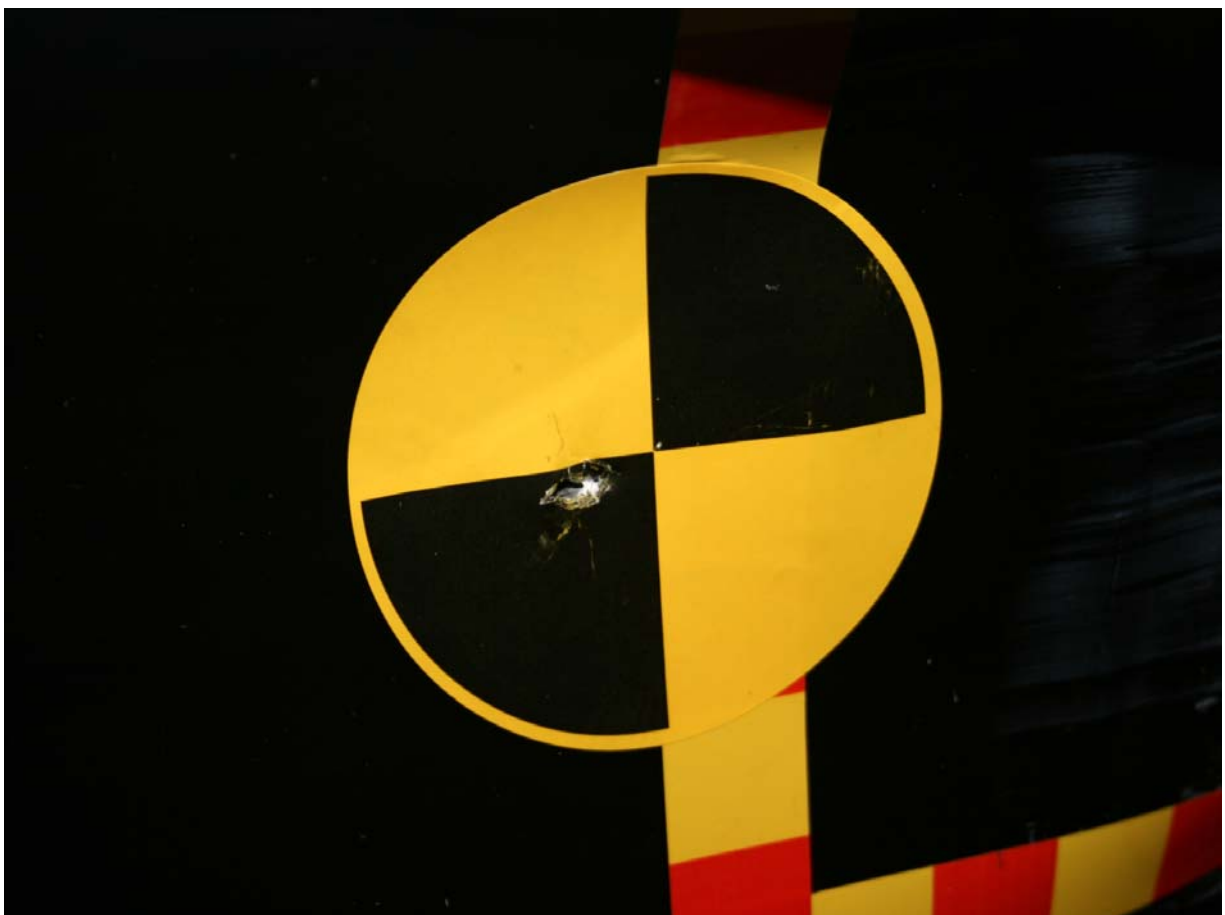
Post-Test Left Impact Point

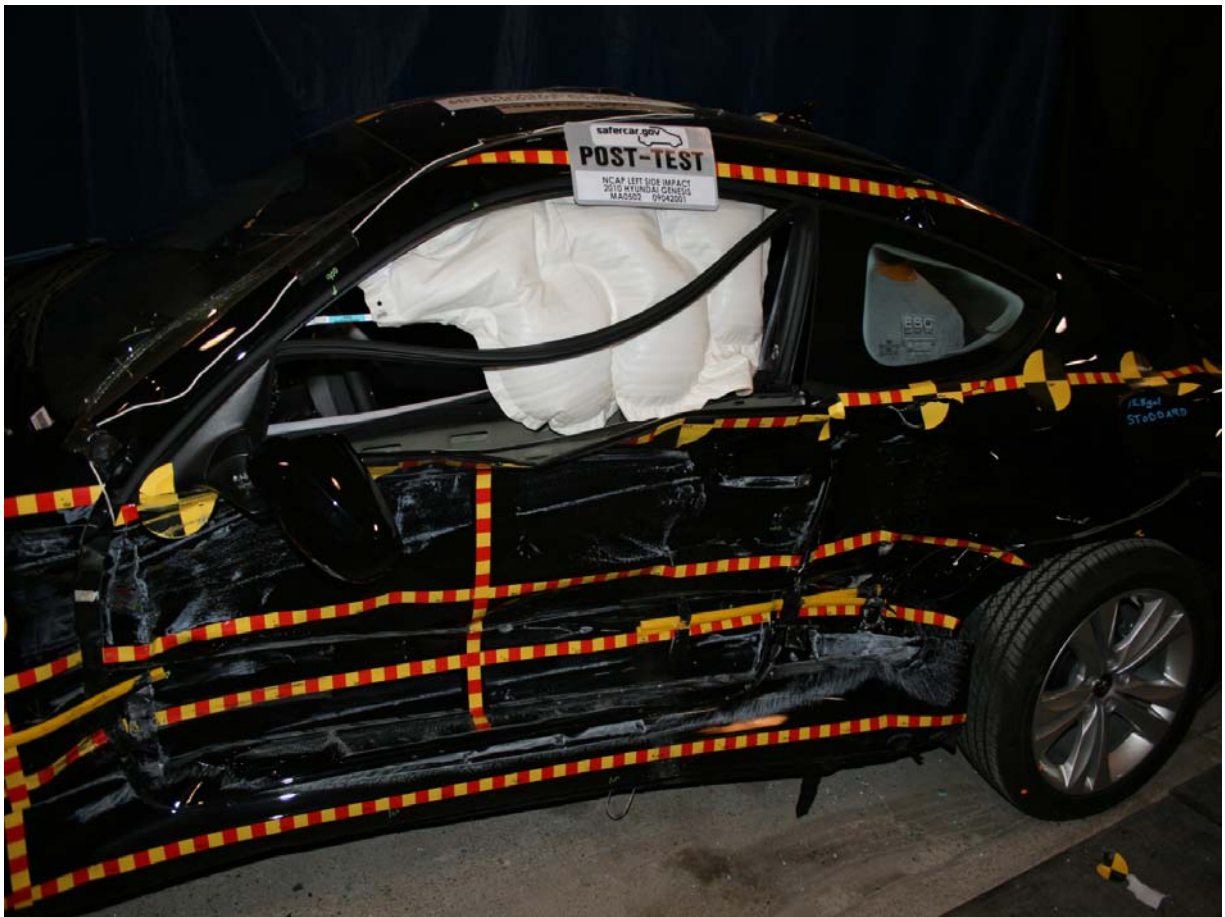
Post-Test Front  $\frac{3}{4}$  View of Left Side Door

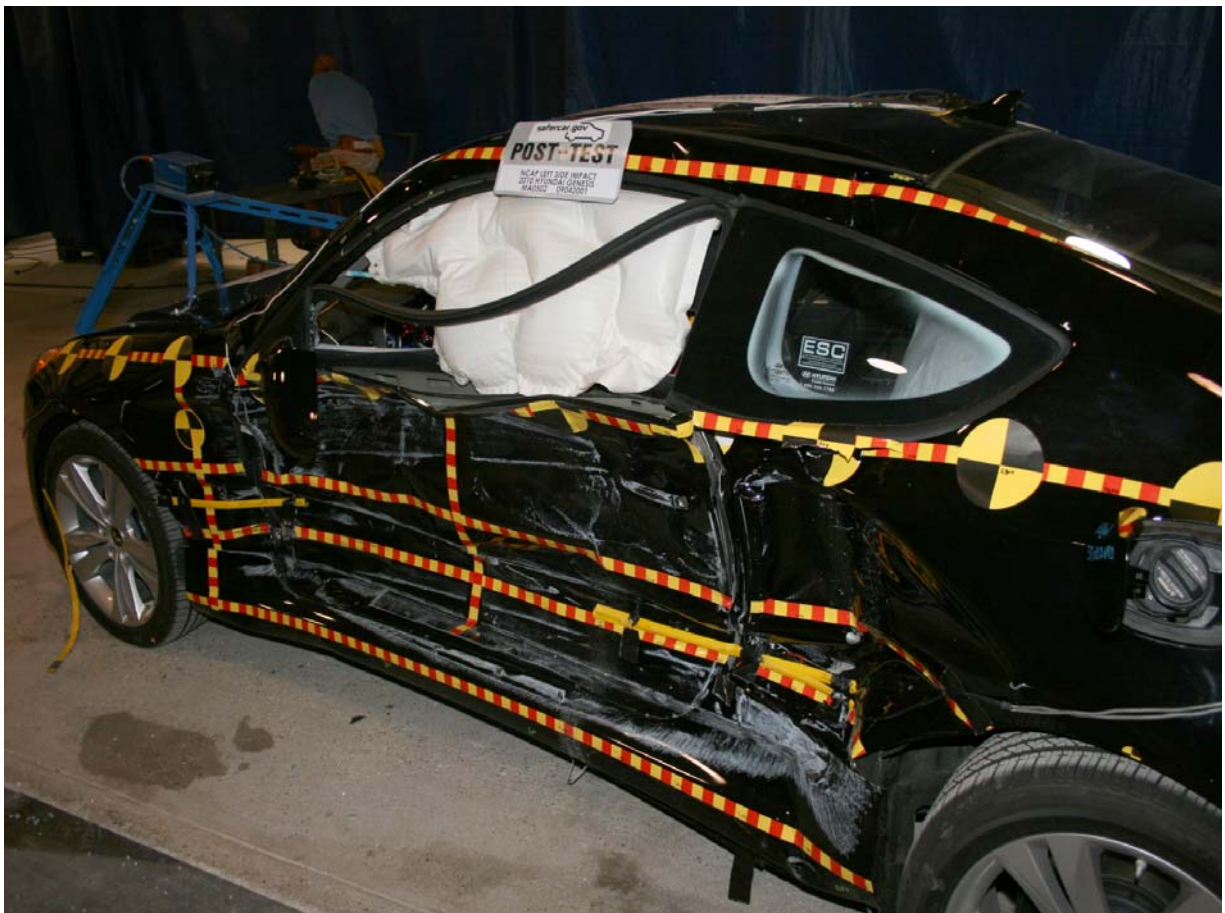
Post-Test Rear  $\frac{3}{4}$  View of Left Side Door

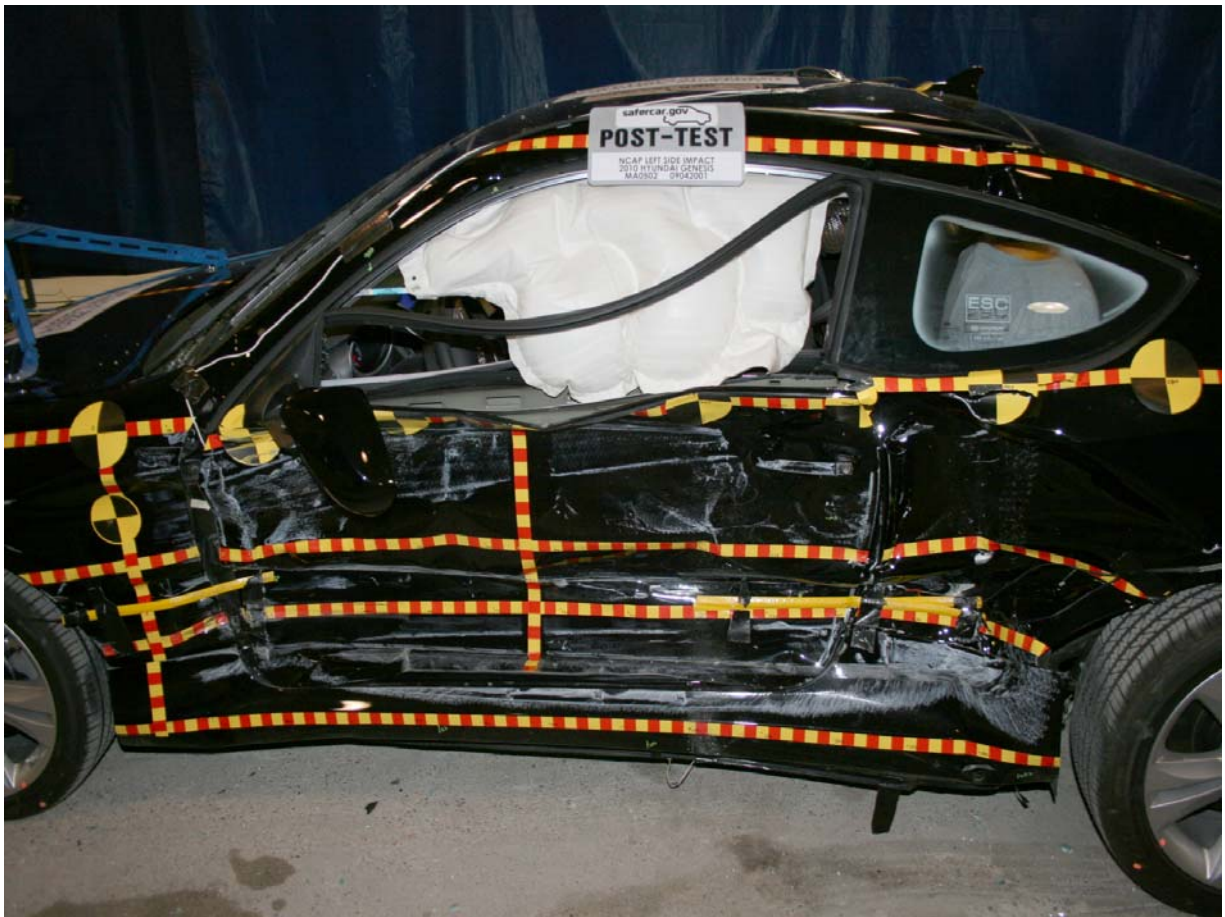
Post-Test Left Side Impact Close-up

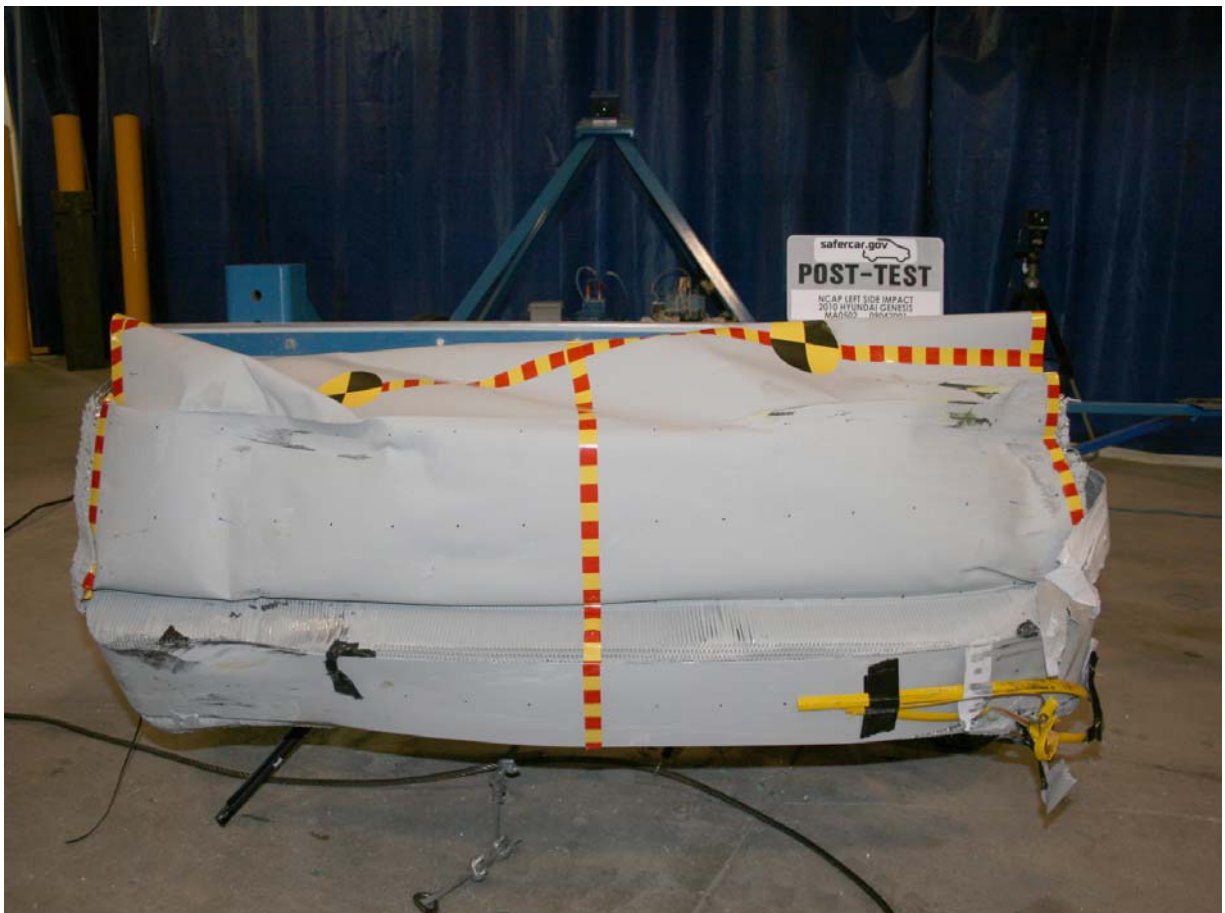
Post-Test Front View of Deformable Barrier

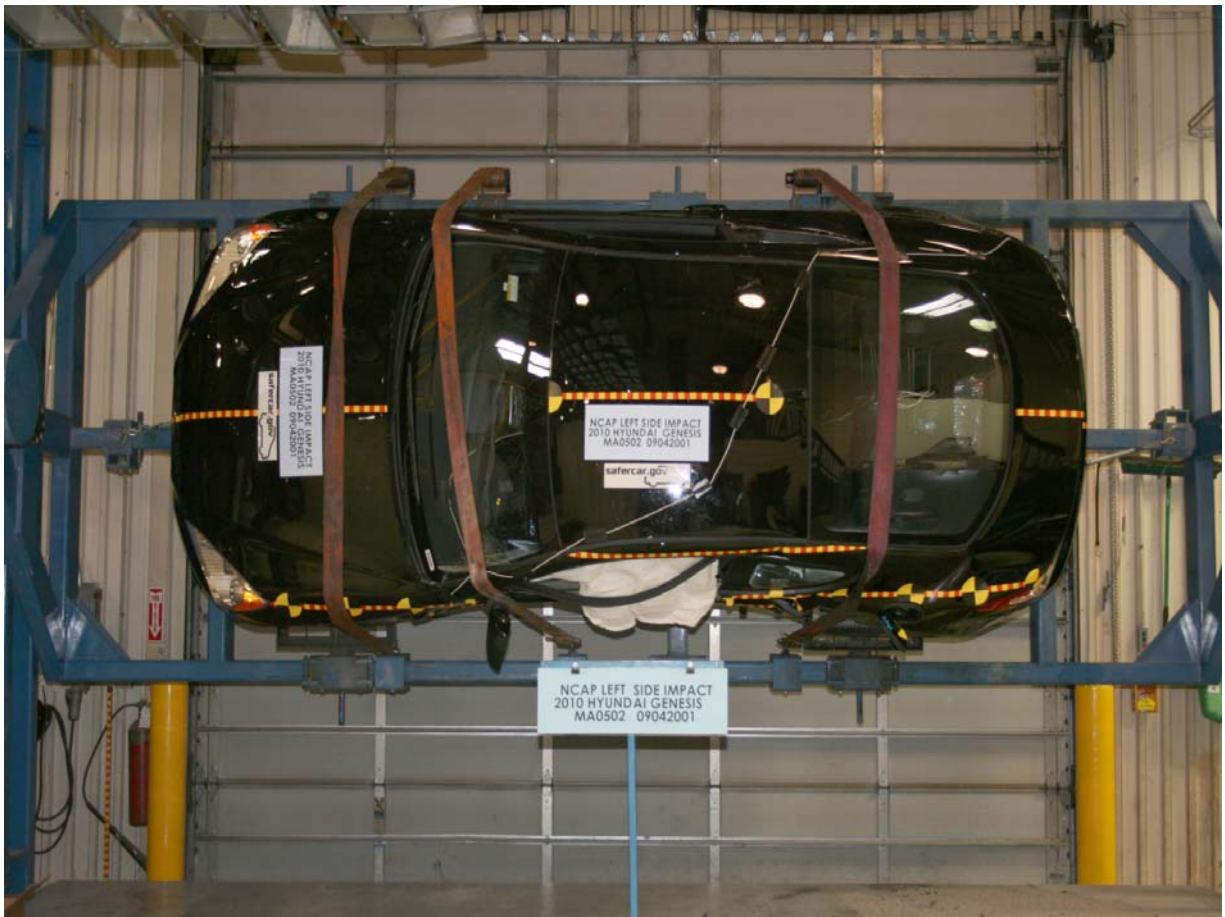
Vehicle on Rollover Device (90 Degrees)

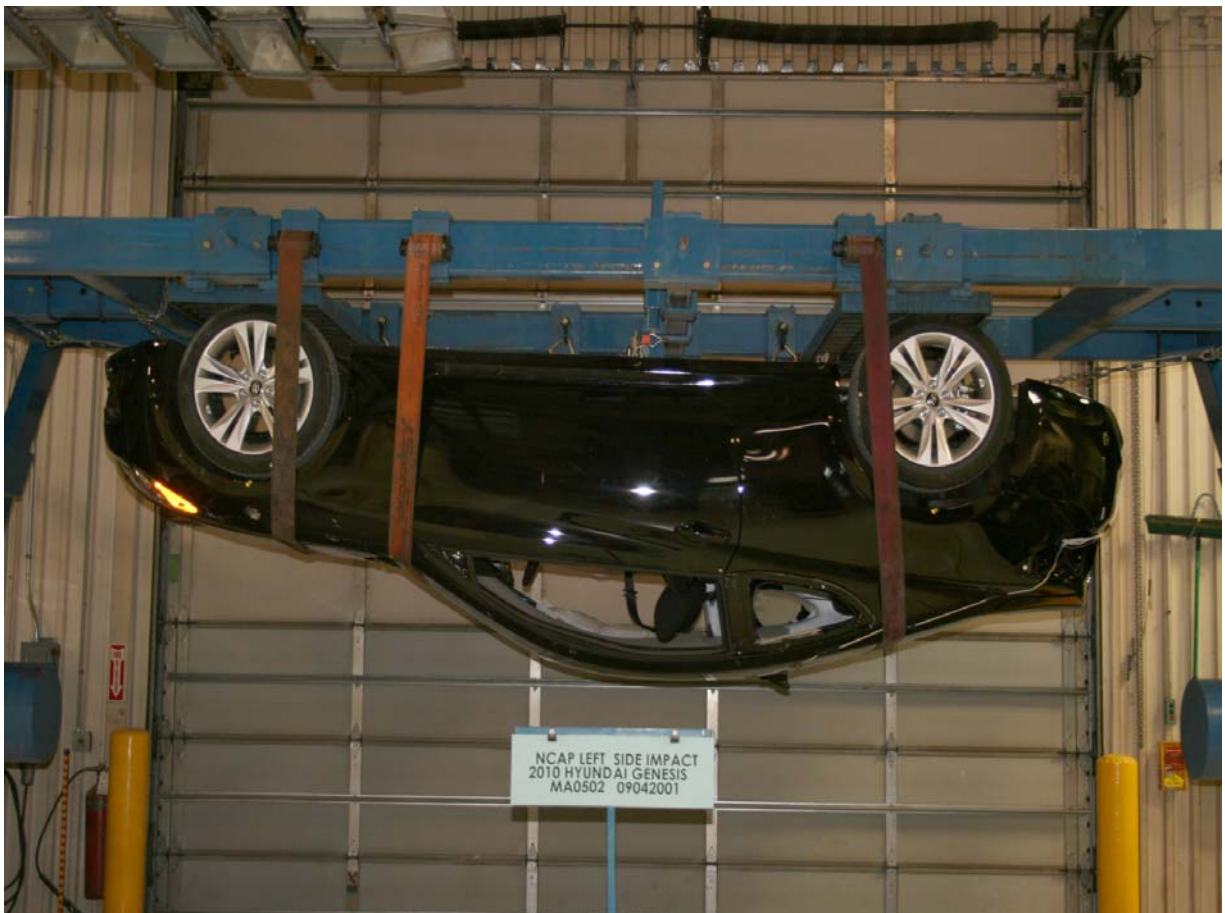
Vehicle on Rollover Device (180 Degrees)

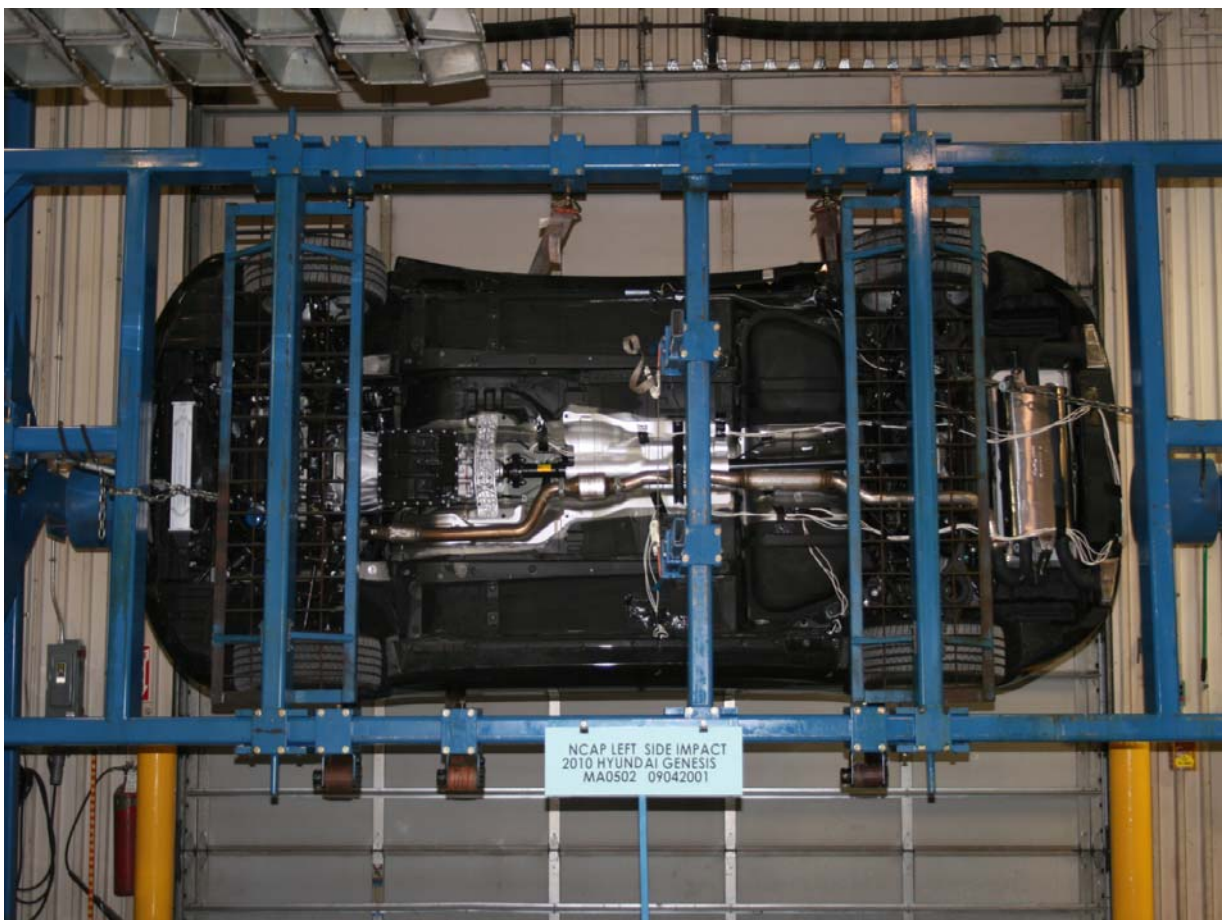
Vehicle on Rollover Device (270 Degrees)

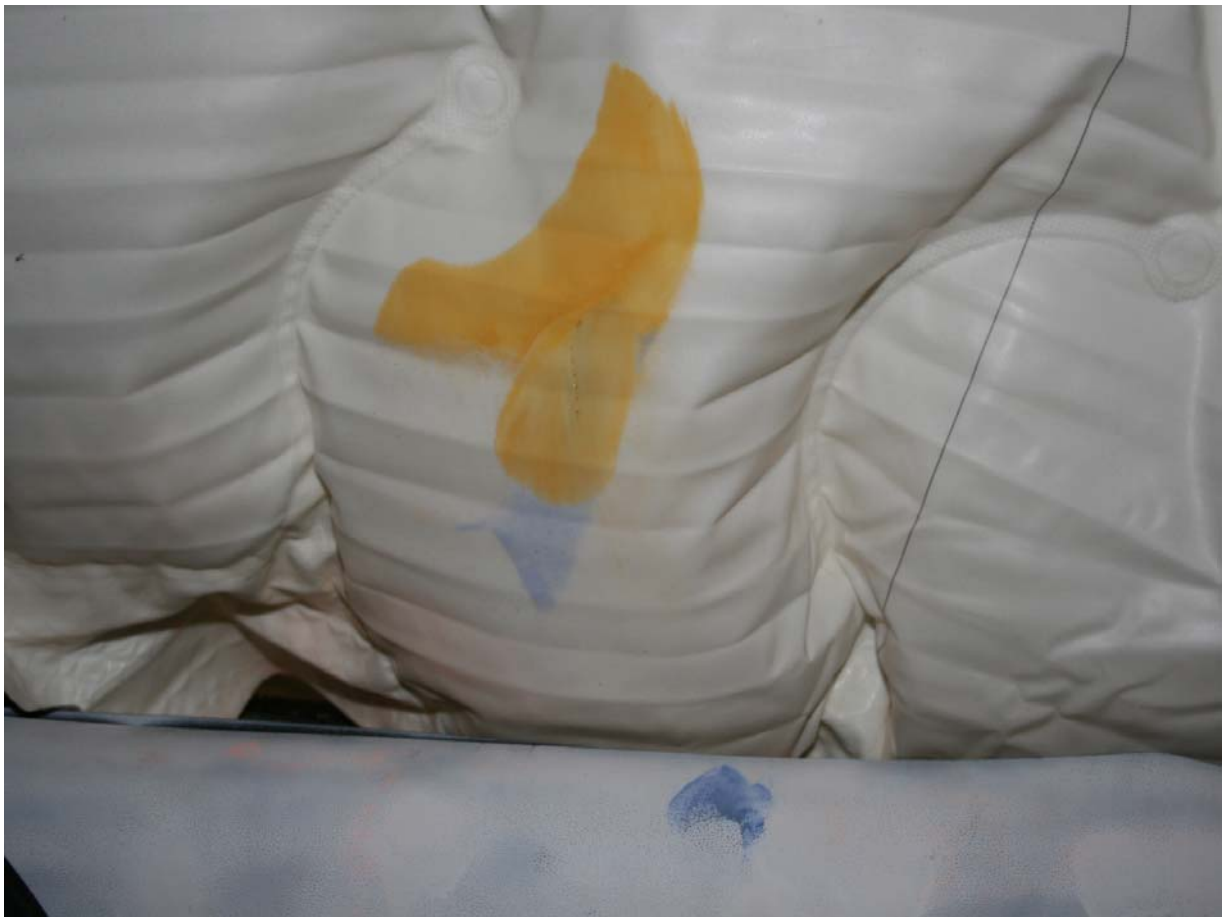
Post-Test Driver Dummy Head Contact

| Description | Front Seat SID/HIII | Rear Seat SID/HIII |
|---|---|---|
| Head Contact | Curtain Airbag, Headrest,<br>Door Panel | |

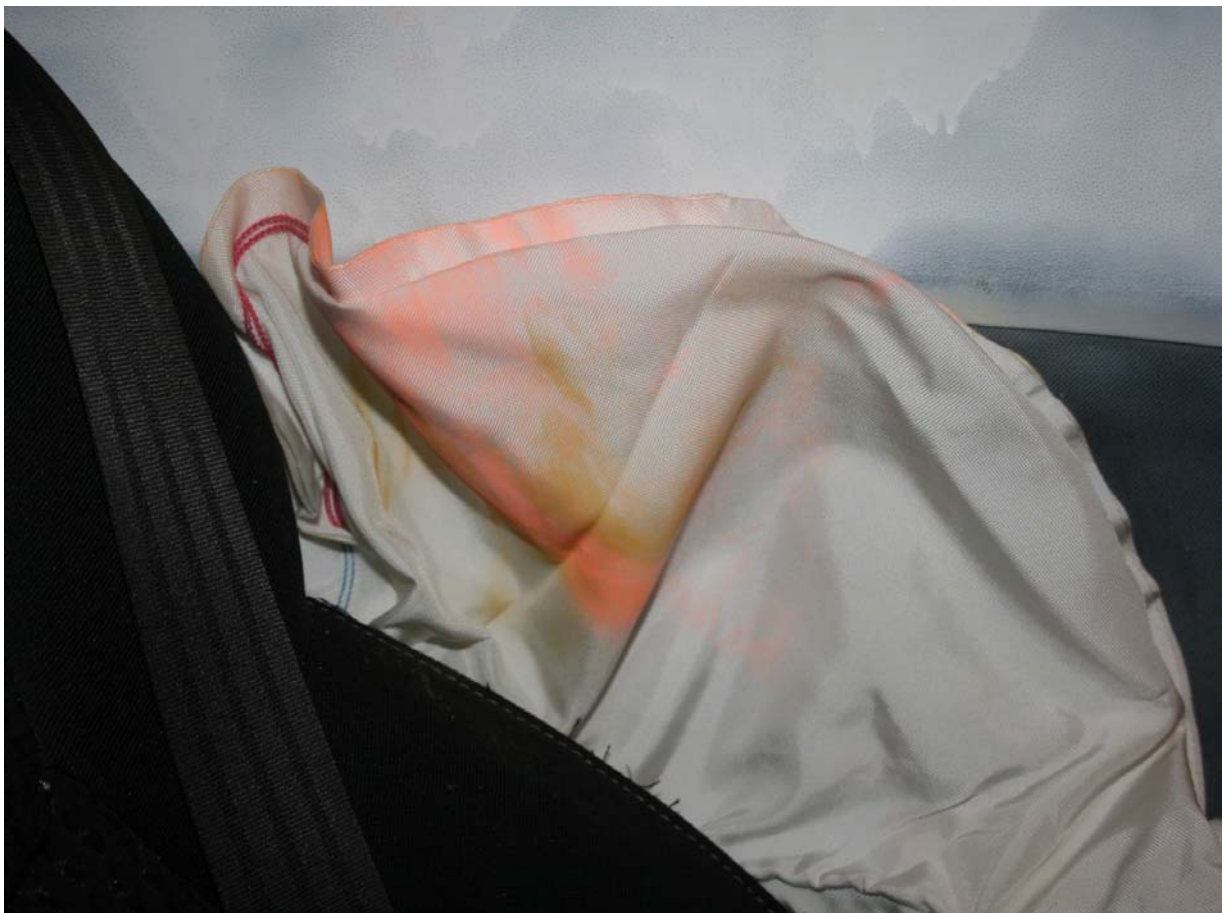
Post-Test Driver Dummy Upper Torso Contact

| Description | Front Seat SID/HIII | Rear Seat SID/HIII |
|---|---|---|
| Upper Torso Contact | Side Airbag | |

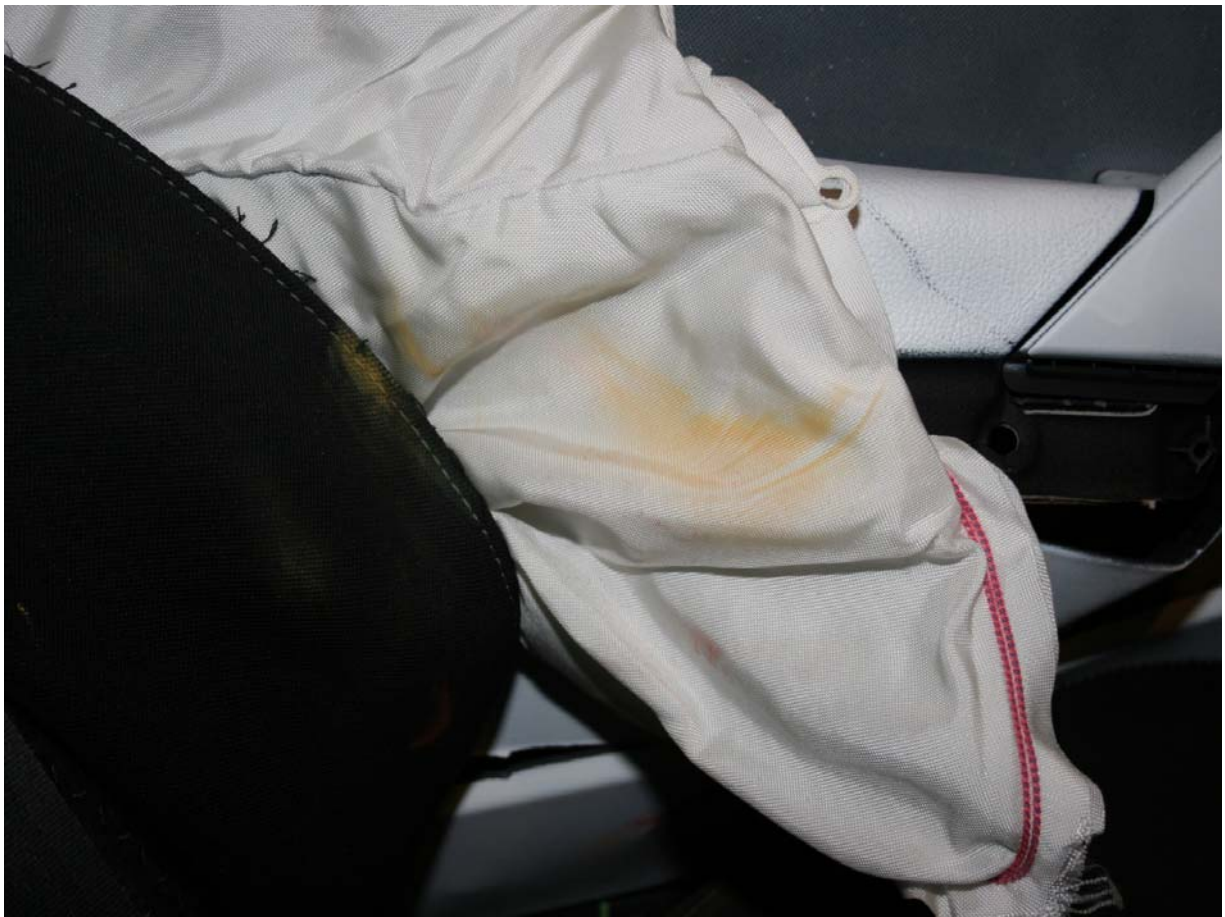
Post-Test Driver Dummy Lower Torso Contact

| Description | Front Seat SID/HIII | Rear Seat SID/HIII |
|---|---|---|
| Lower Torso Contact | Side Airbag | |
