REPORT NUMBER: CAL-10-01

**NEW CAR ASSESSMENT PROGRAM (NCAP)
FRONTAL BARRIER IMPACT TEST**

KIA MOTORS CORPORATION
2010 Kia Soul
5-Door MPV

NHTSA NUMBER: MA0505

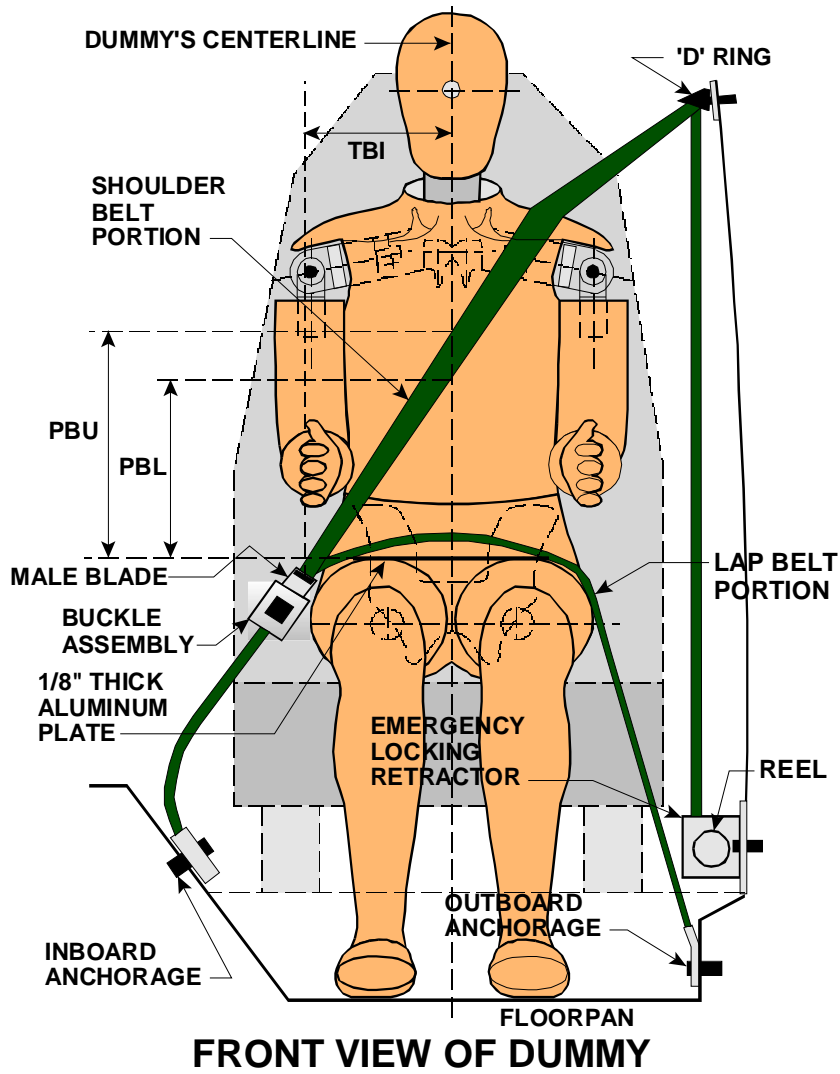
DATA SHEET NO. 6
SEAT BELT POSITIONING DATA

DRIVER DUMMY (mm)	PASSENGER DUMMY (mm)
PBU -- Top surface of alum. plate to upper edge	350	320
PBL-- Top surface of alum. plate to belt lower edge	240	240
LAP BELT TENSION	10 N	10 N
SHOULDER BELT TENSION	Retractor	Retractor

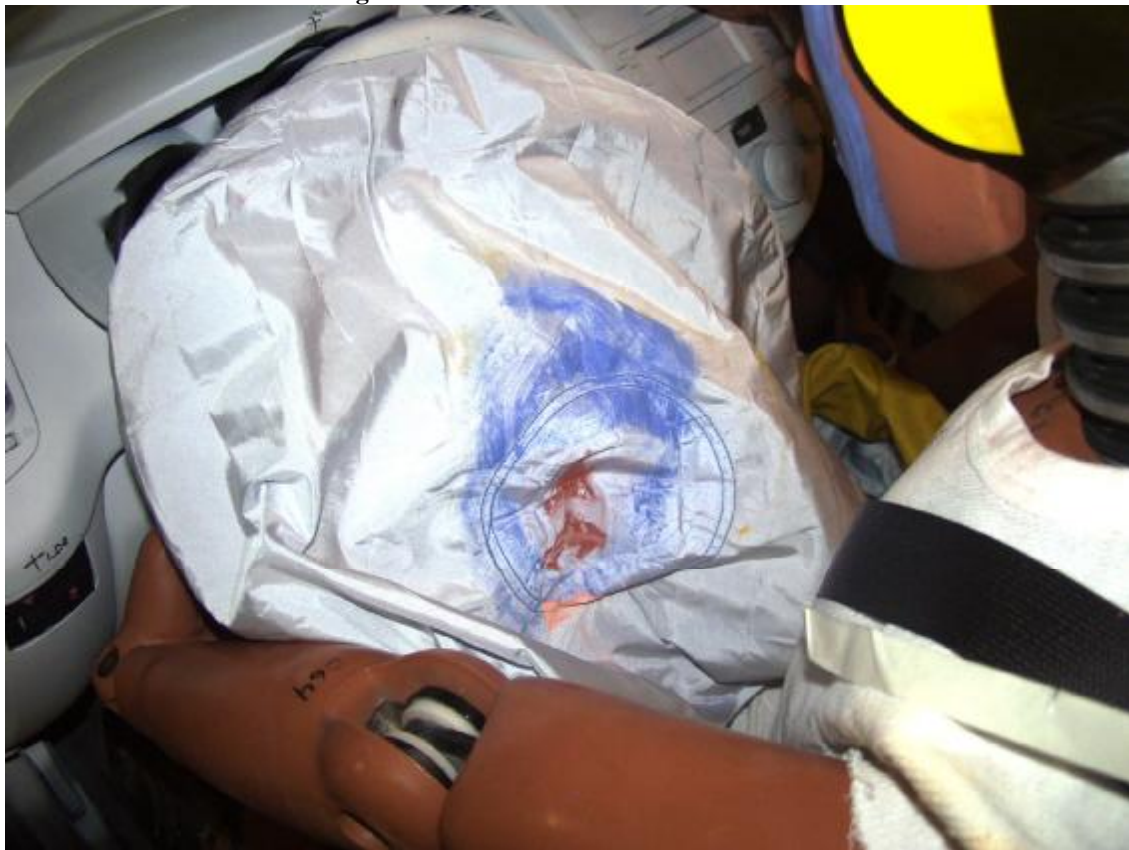
Figure A-43: Post-Test Driver Contact to Airbag

DRIVER	PASSENGER
ATD Type:	Part 572E	Part 572E
Restraint System:	Seatbelt, Frontal Airbag, Knee Bolster	Seatbelt, Frontal Airbag, Knee Bolster
Head Contact:	Face – Frontal Airbag Back of head – Head restraint	Face – Frontal Airbag Back of head – Head restraint
Abdomen Contact:	None	None
Chest Contact:	Frontal Airbag	Frontal Airbag
Left Knee Contact:	Knee Bolster	Glove Box Door
Right Knee Contact:	Knee Bolster	Glove Box Door

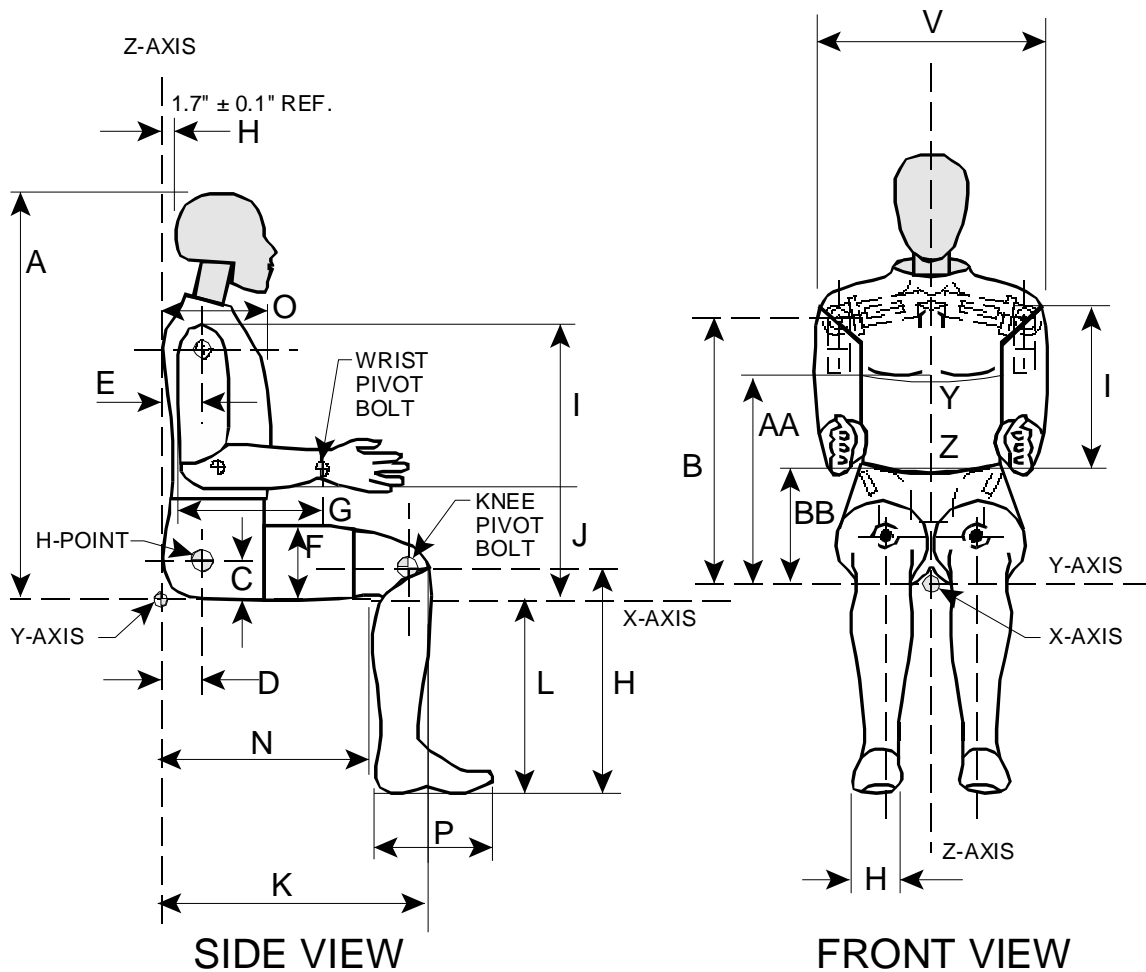
EXTERNAL DIMENSIONS SPECIFICATIONS

NOTE: Figure is referenced to the erect seated position. The curved lumbar does not allow the Hybrid III to be positioned in a perfect erect attitude. (REF: S572.31(A)(6))
