**REPORT NUMBER: NCAP-MGA-2009-004**

**VALIDATION  
FRONTAL BARRIER IMPACT TEST**

**TOYOTA MOTOR MANUFACTURING CANADA INC.  
2010 LEXUS RX 350 5-DR SUV  
NHTSA NUMBER: MA5101**

**PREPARED BY:  
MGA RESEARCH CORPORATION  
5000 WARREN ROAD  
BURLINGTON, WI 53105**

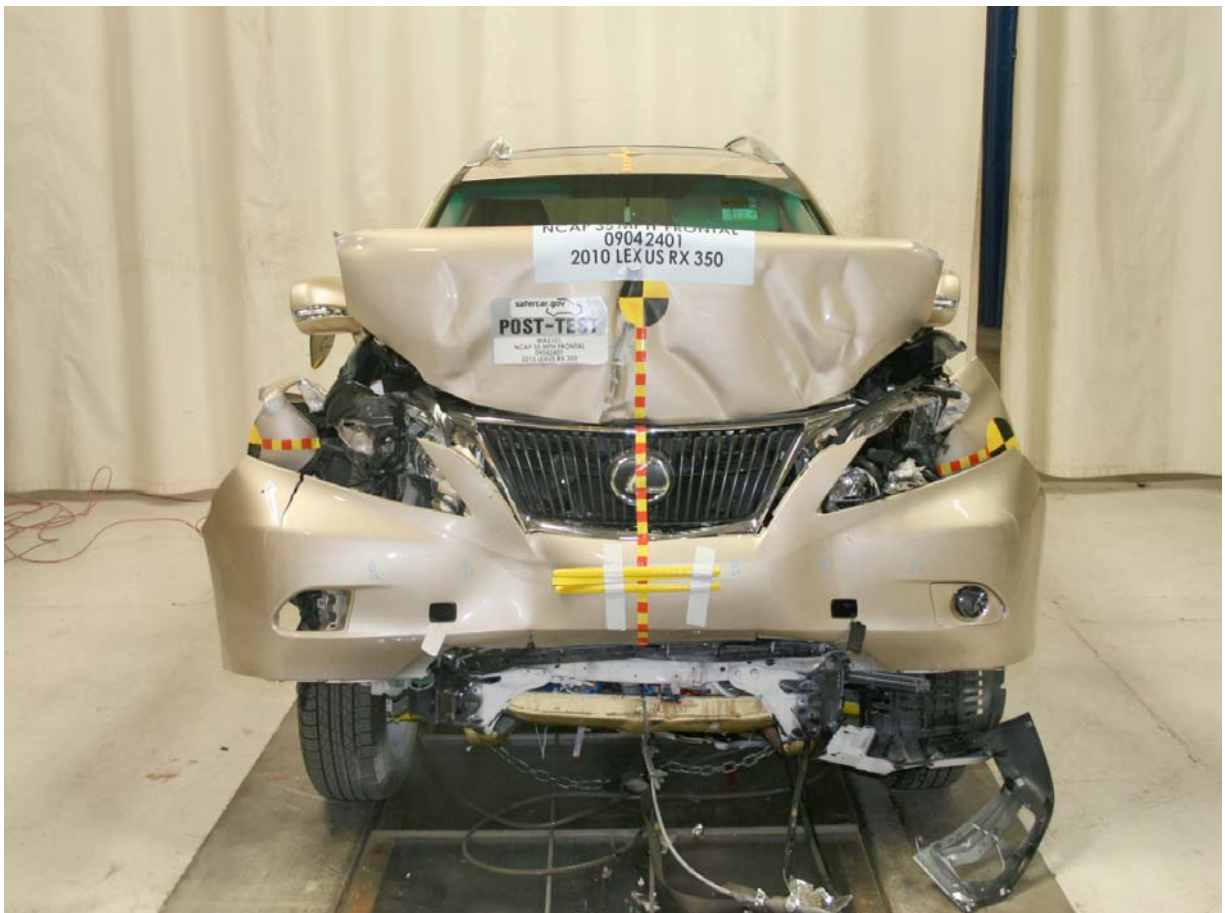
Post-Test Front View

The maximum static crush of the vehicle was 581 mm and both the driver and passenger side doors remained closed during the impact event and were operable after the impact.

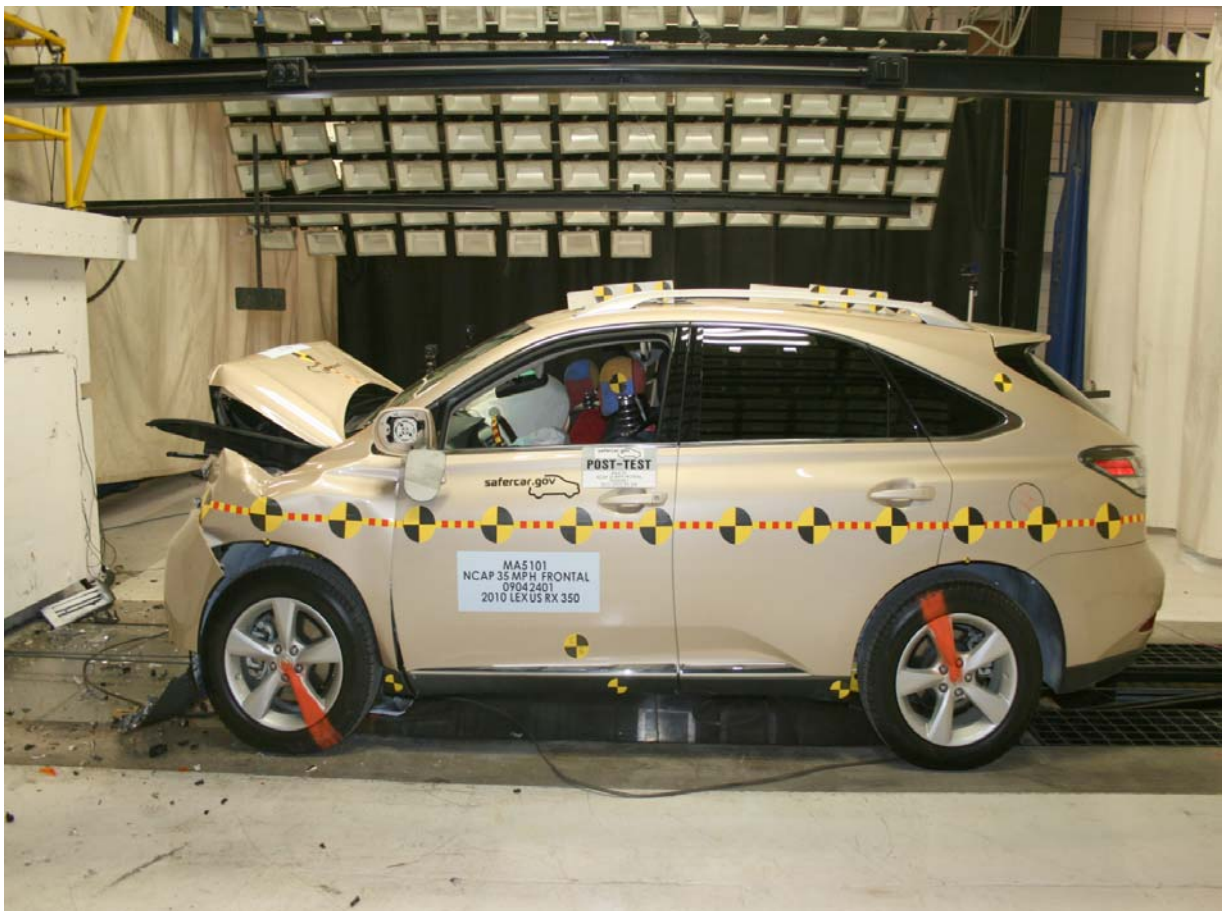
Post-Test Left Side View

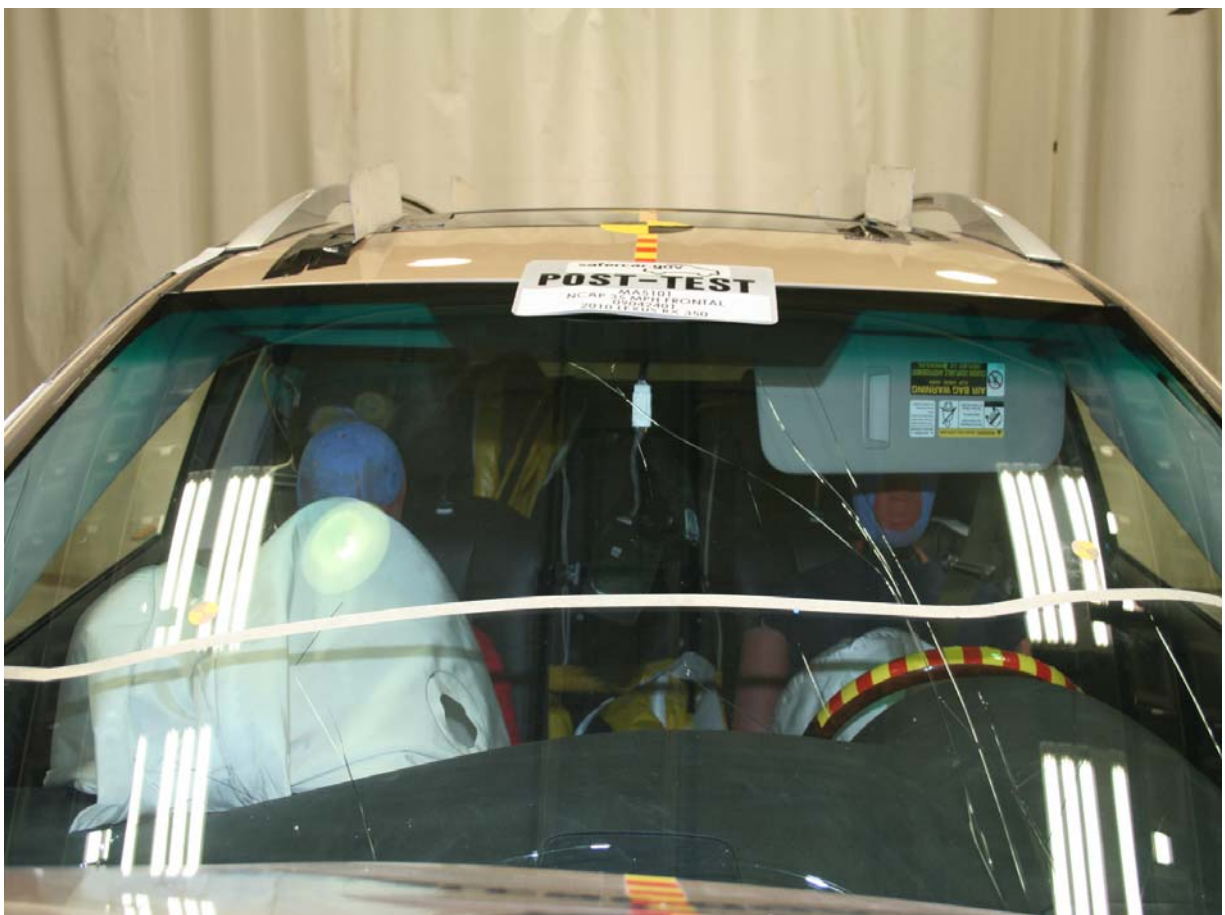
Post-Test Windshield View

There was 100 percent windshield retention and no intrusion into the protected zone of the windshield during the event. There was no Stoddard Solvent leakage after the event or during any phase of the static rollover.

| Critical Areas of Performance | Observations and Conclusions |
|---|---|
| Windshield Damage | Cracked |

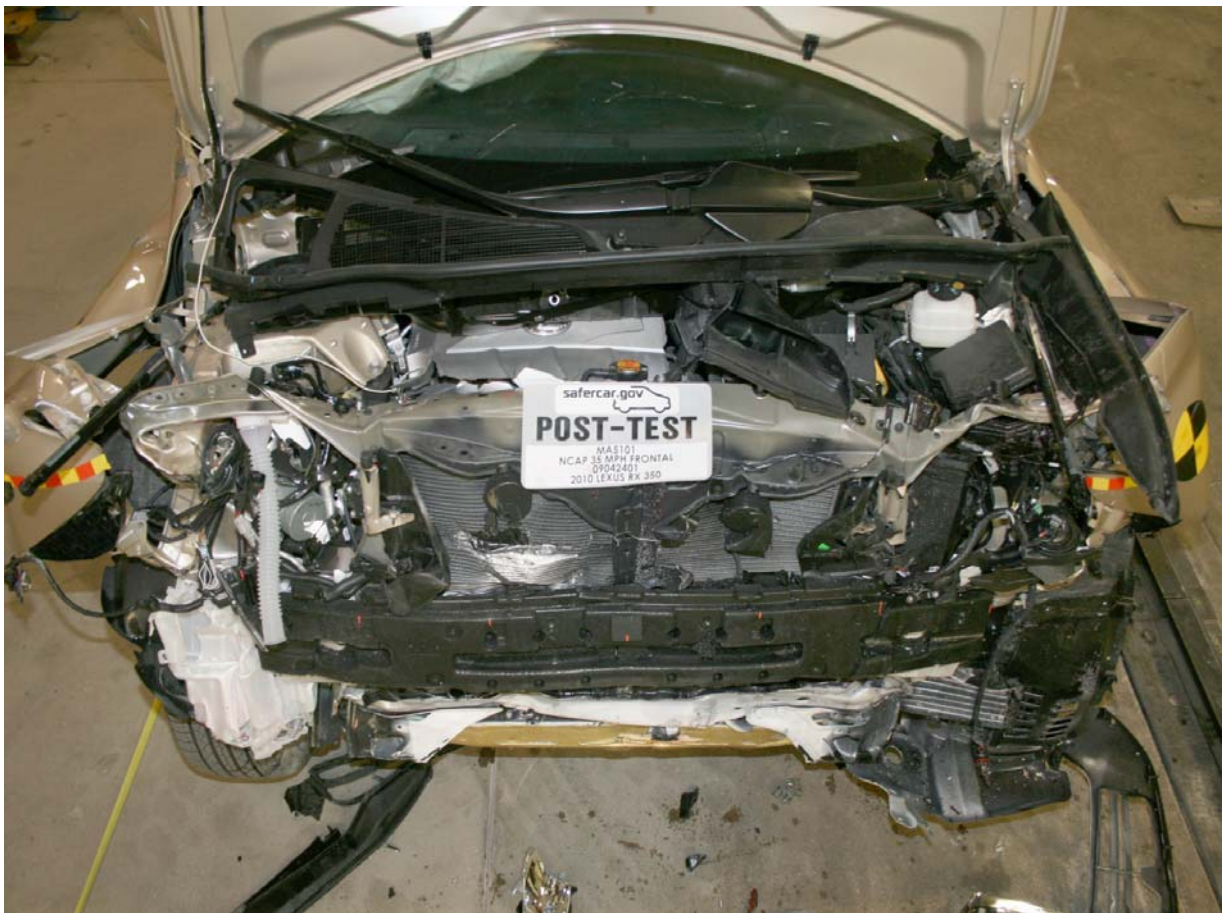
Post-Test Engine Compartment View

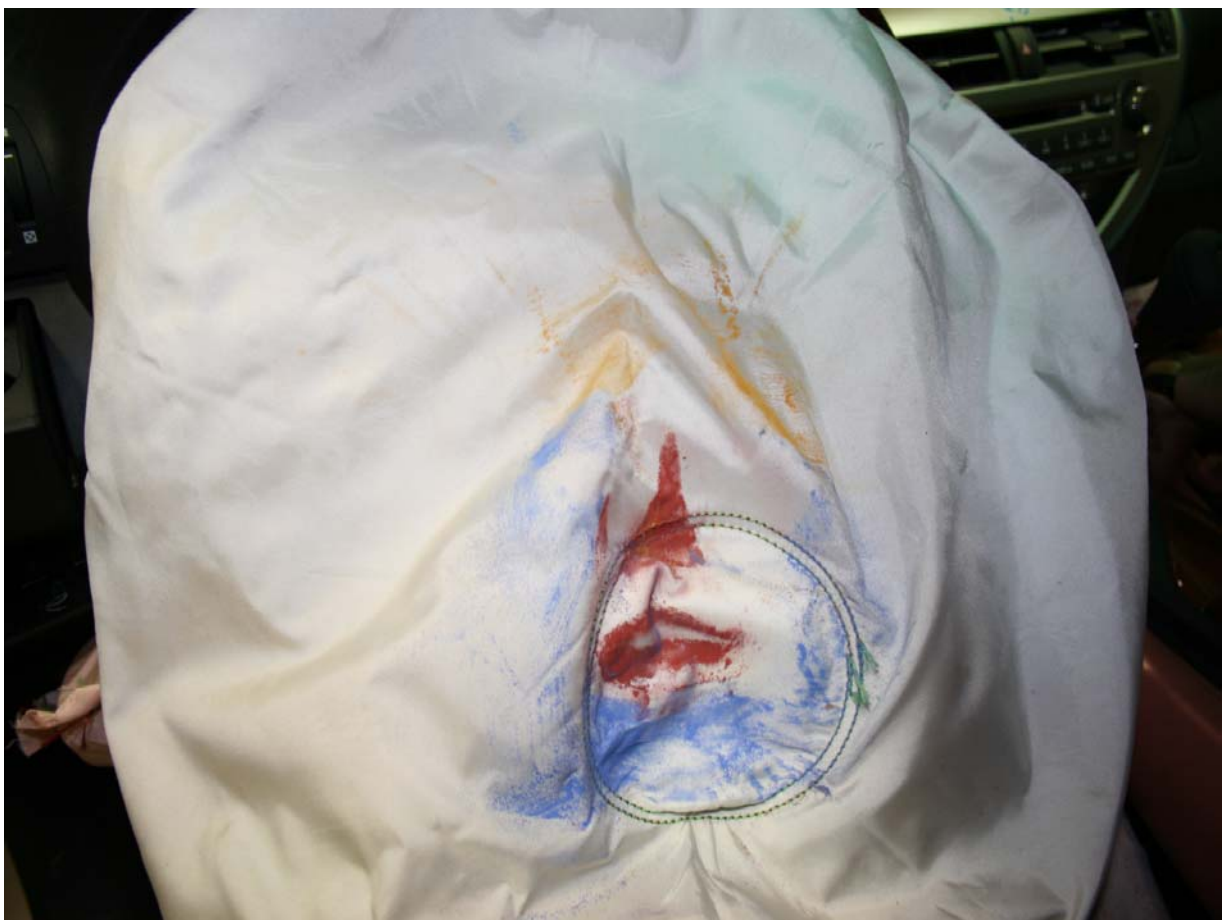
Post-Test Driver Dummy Airbag Contact

The driver's head and chest contacted the airbag. The driver's head also contacted the headrest. The driver's knees contacted the knee bag. The passenger's head and chest contacted the airbag. The passenger's head also contacted the headrest. The passenger's knees contacted the knee bag.

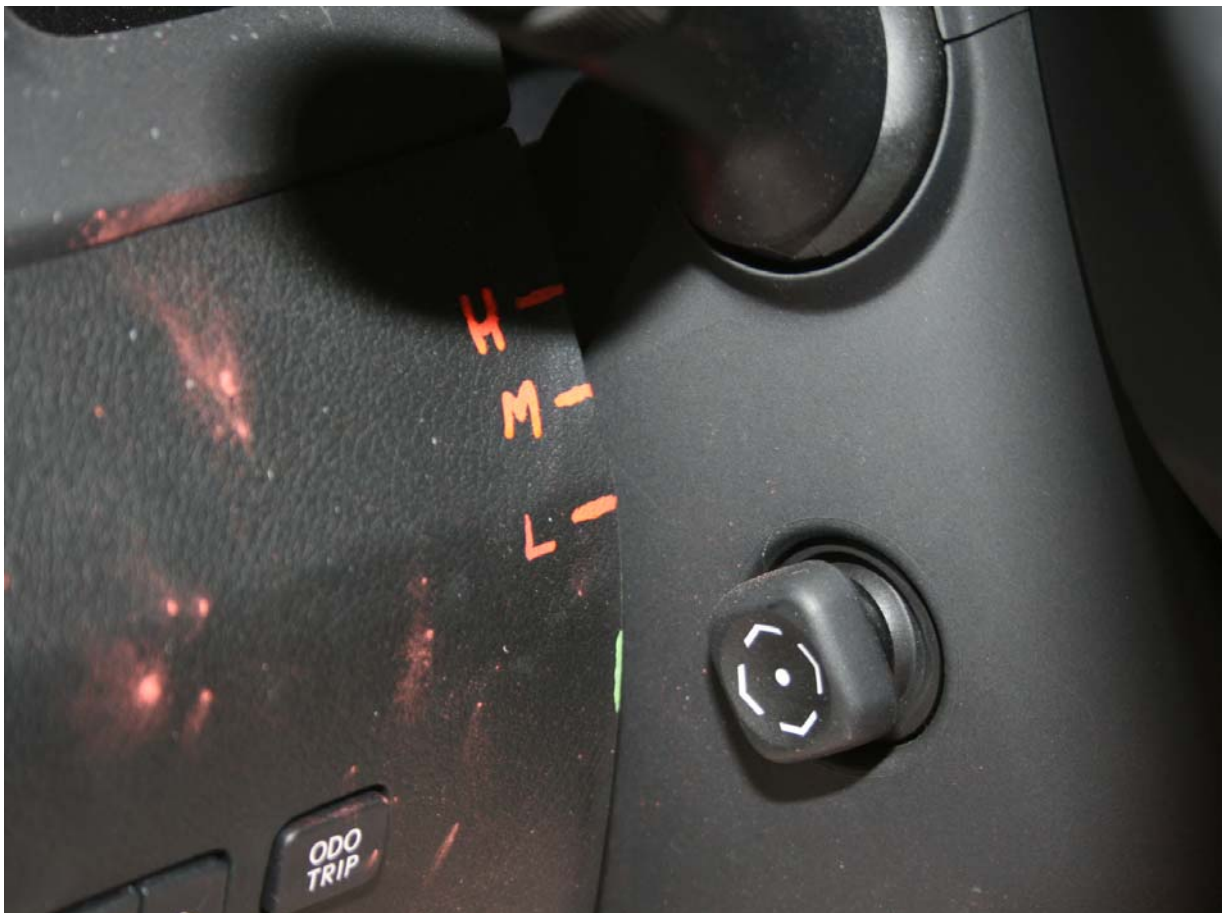
Post-Test View of Steering Column Shear Capsule

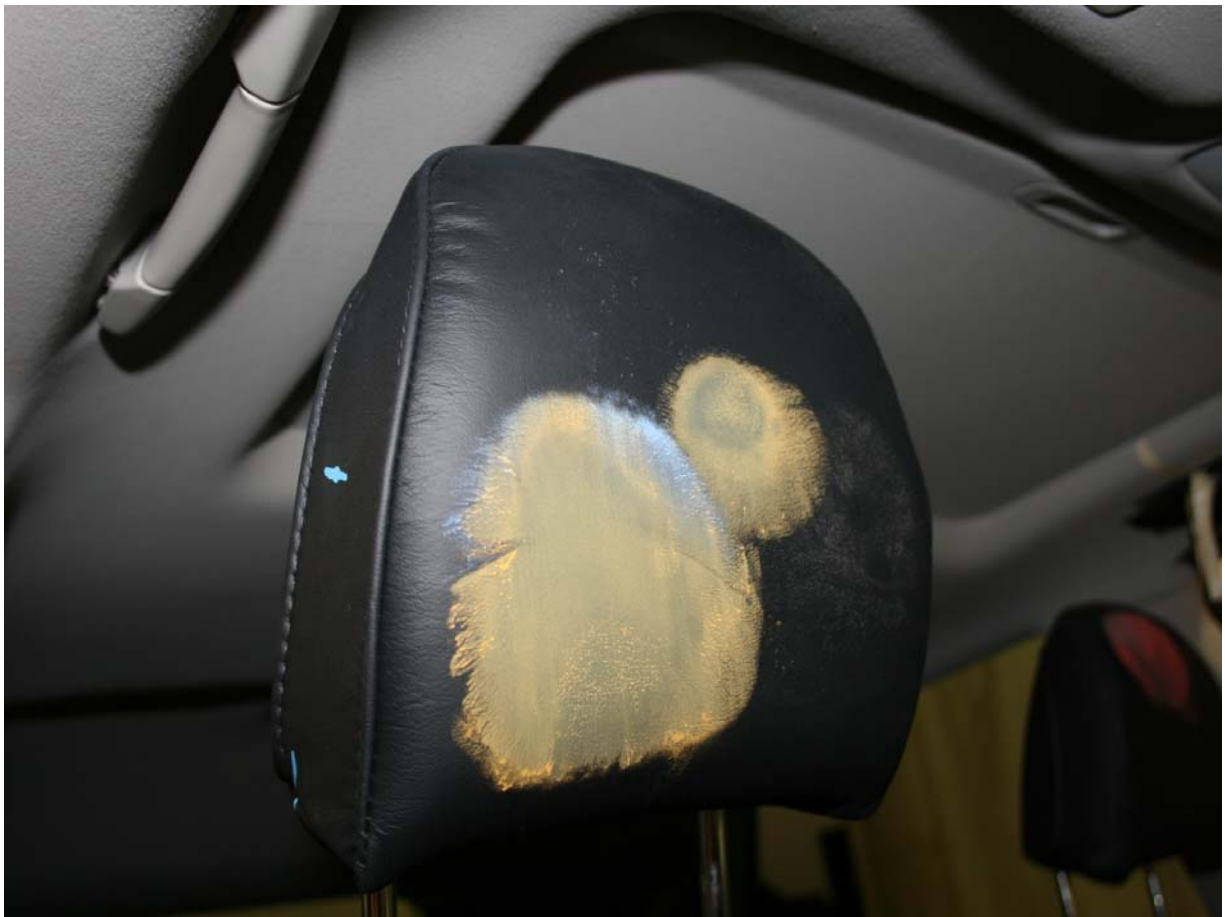
Post-Test Passenger Dummy Head Contact

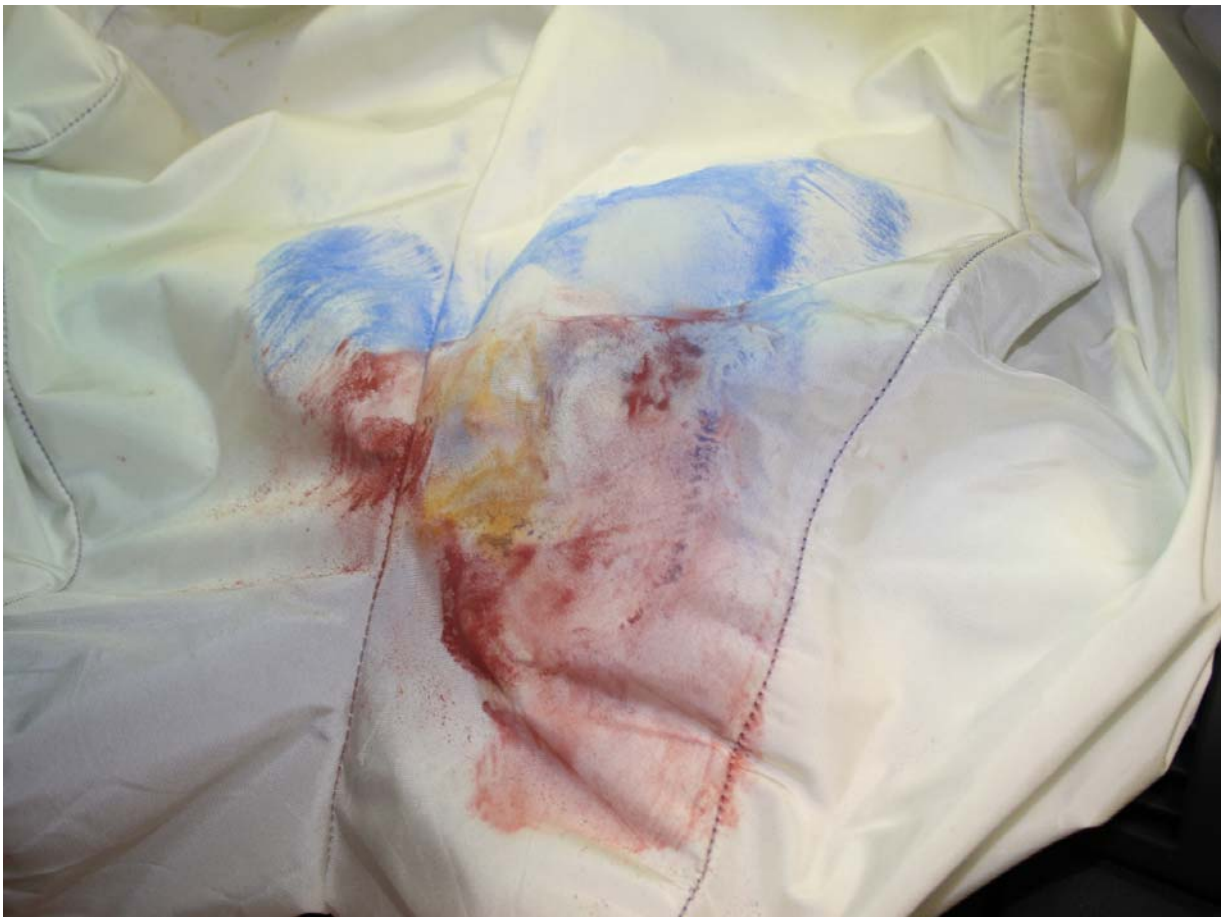
Post-Test Passenger Dummy Airbag Contact
