**REPORT NUMBER: NCAP-MGA-2009-005**

**NEW CAR ASSESSMENT PROGRAM  
FRONTAL BARRIER IMPACT TEST**

**FORD MOTOR COMPANY  
2010 FORD MUSTANG 2-DR COUPE  
NHTSA NUMBER: MA0201**

**PREPARED BY:  
MGA RESEARCH CORPORATION  
5000 WARREN ROAD  
BURLINGTON, WI 53105**

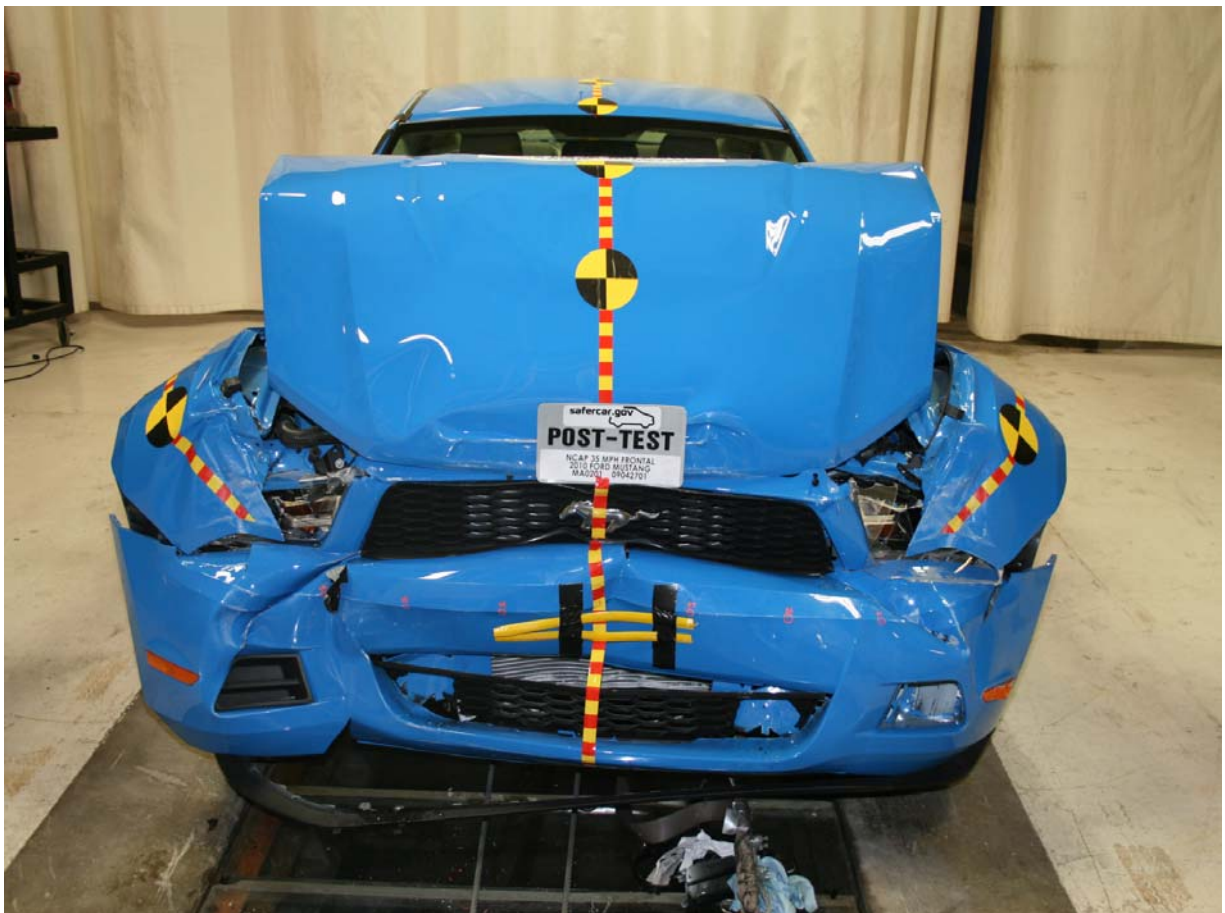
Post-Test Front View

The maximum static crush of the vehicle was 567 mm and both the driver and passenger side door remained closed and latched during the impact event and were operable after the impact.

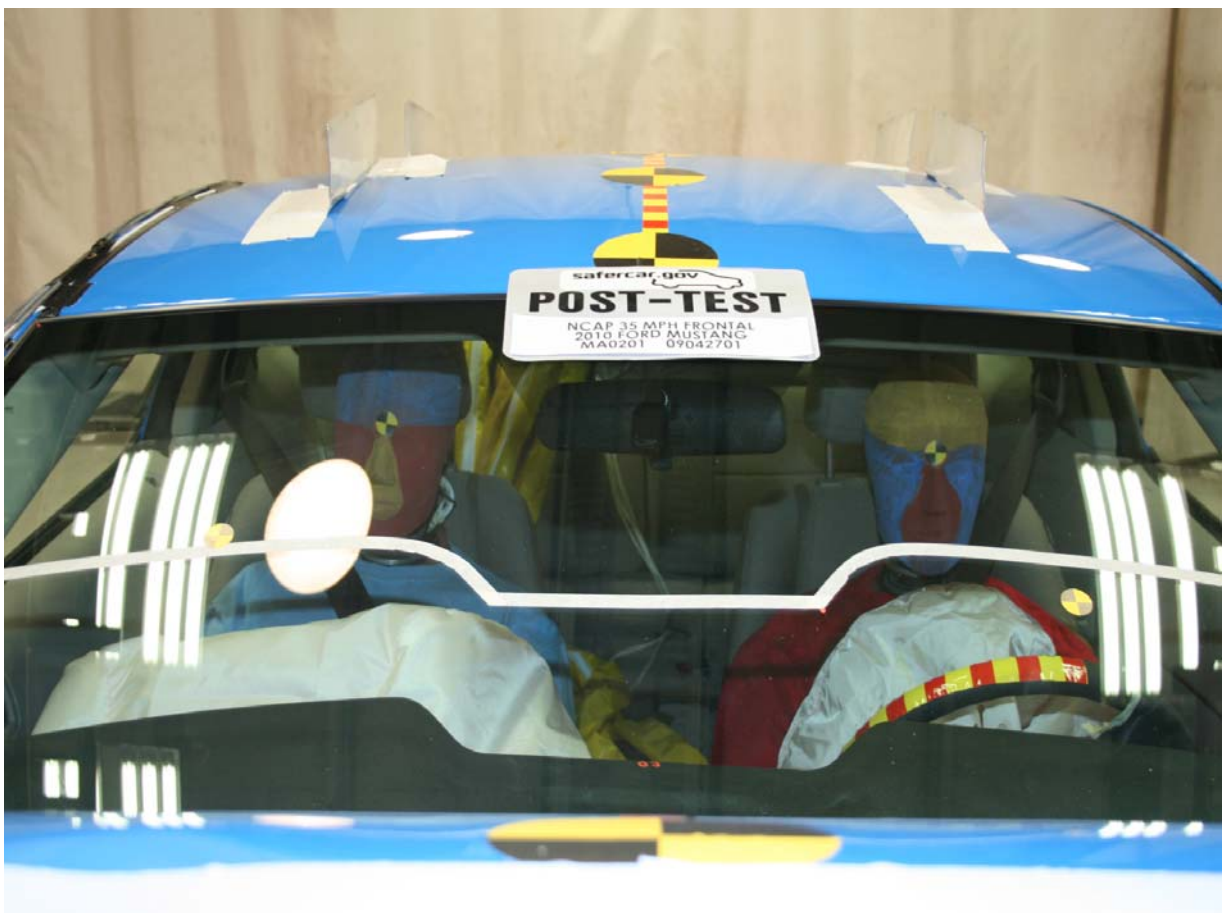
Post-Test Windshield View

There was 100 percent windshield retention and no intrusion into the protected zone of the windshield during the event. There was no Stoddard Solvent leakage after the event or during any phase of the static rollover.

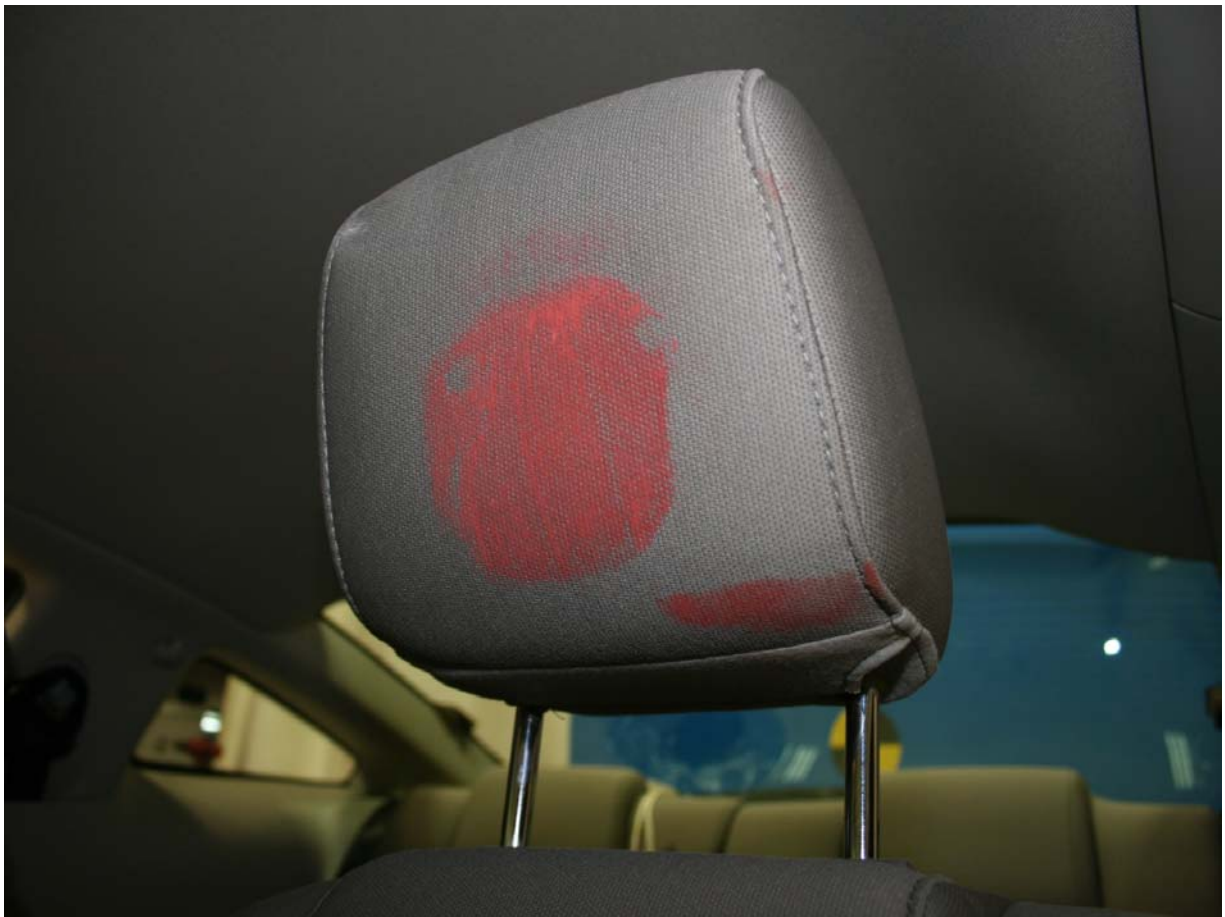
Post-Test Driver Dummy Head Contact

The driver's head and chest contacted the airbag. The driver's head also contacted the headrest. The driver's knees contacted the knee bolster. The passenger's head and chest contacted the airbag. The passenger's head also contacted the headrest. The passenger's knees contacted the glove box.

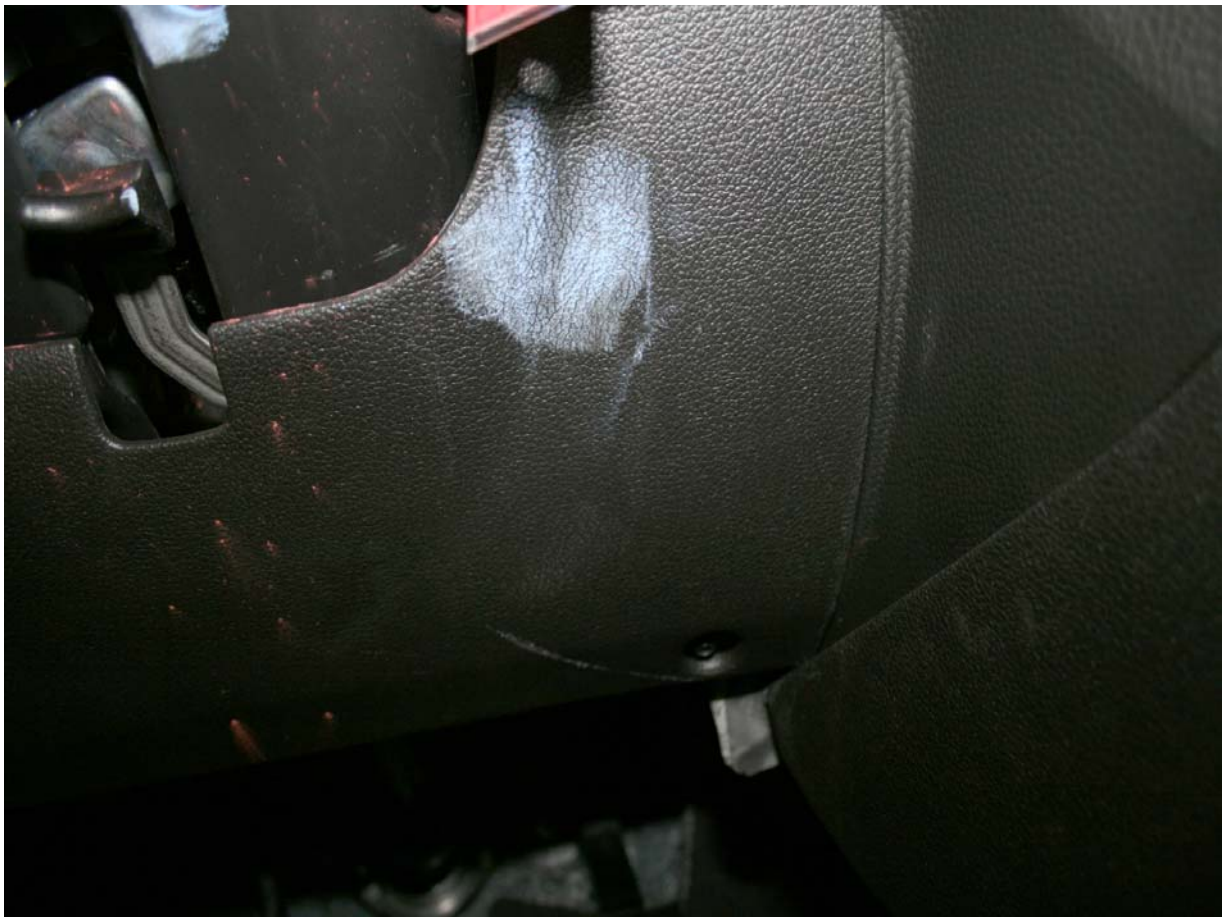
Post-Test Driver Dummy Right Knee Contact

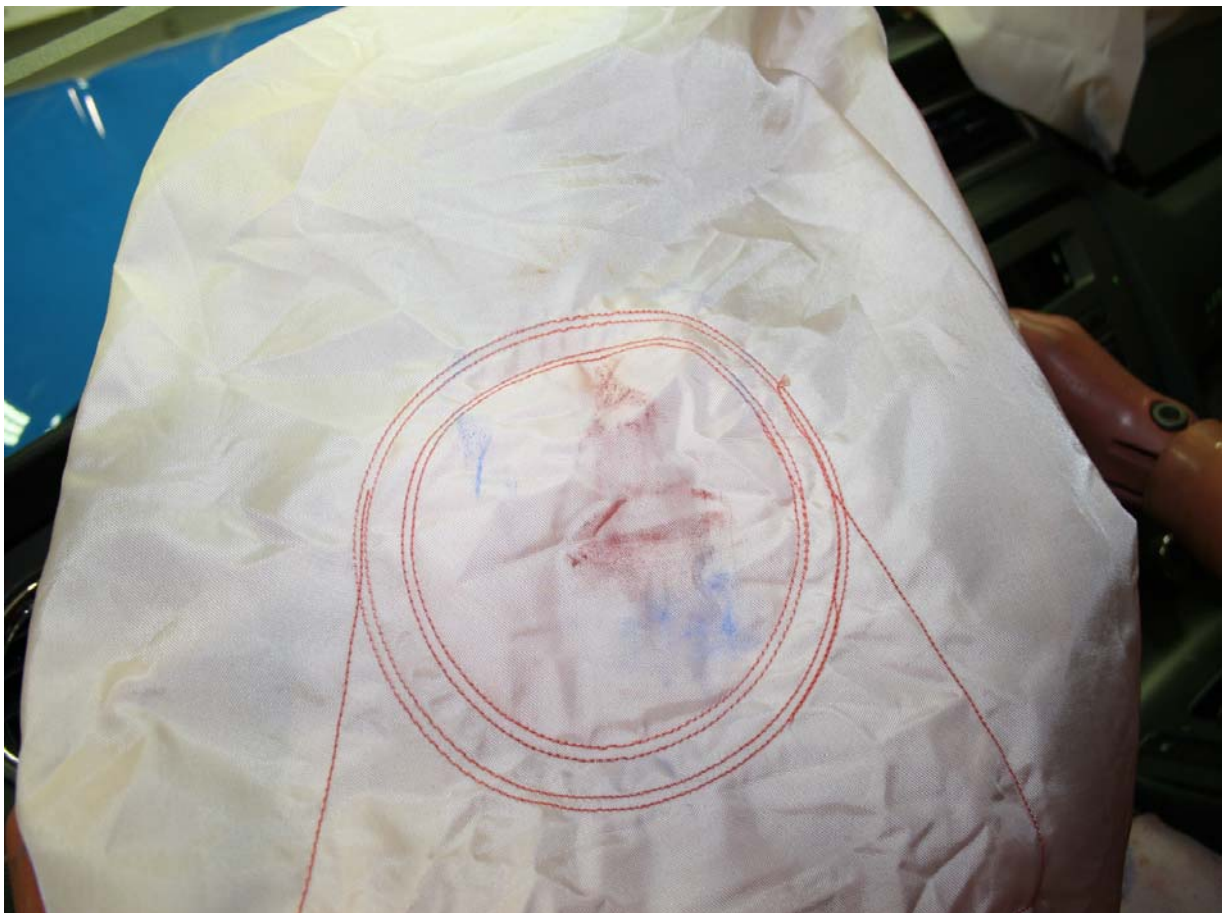
Post-Test Driver Dummy Airbag Contact

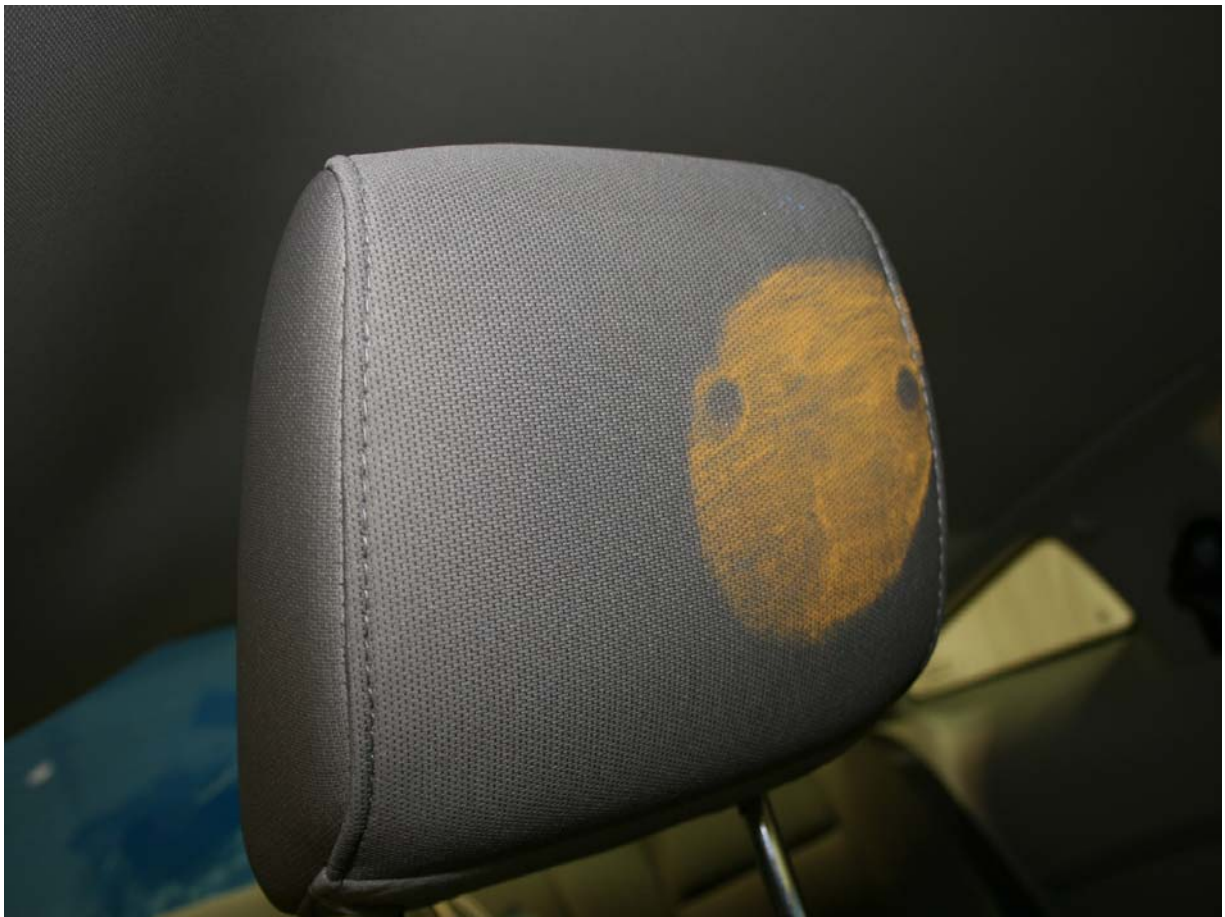
Post-Test Passenger Dummy Head Contact
