REPORT NUMBER: CAL-09-06

**NEW CAR ASSESSMENT PROGRAM (NCAP)  
FRONTAL BARRIER IMPACT TEST**

MAZDA MOTOR CORPORATION  
2010 MAZDA 3  
4-DOOR SEDAN

CALSPAN TEST NUMBER: 8865-NCAP-06

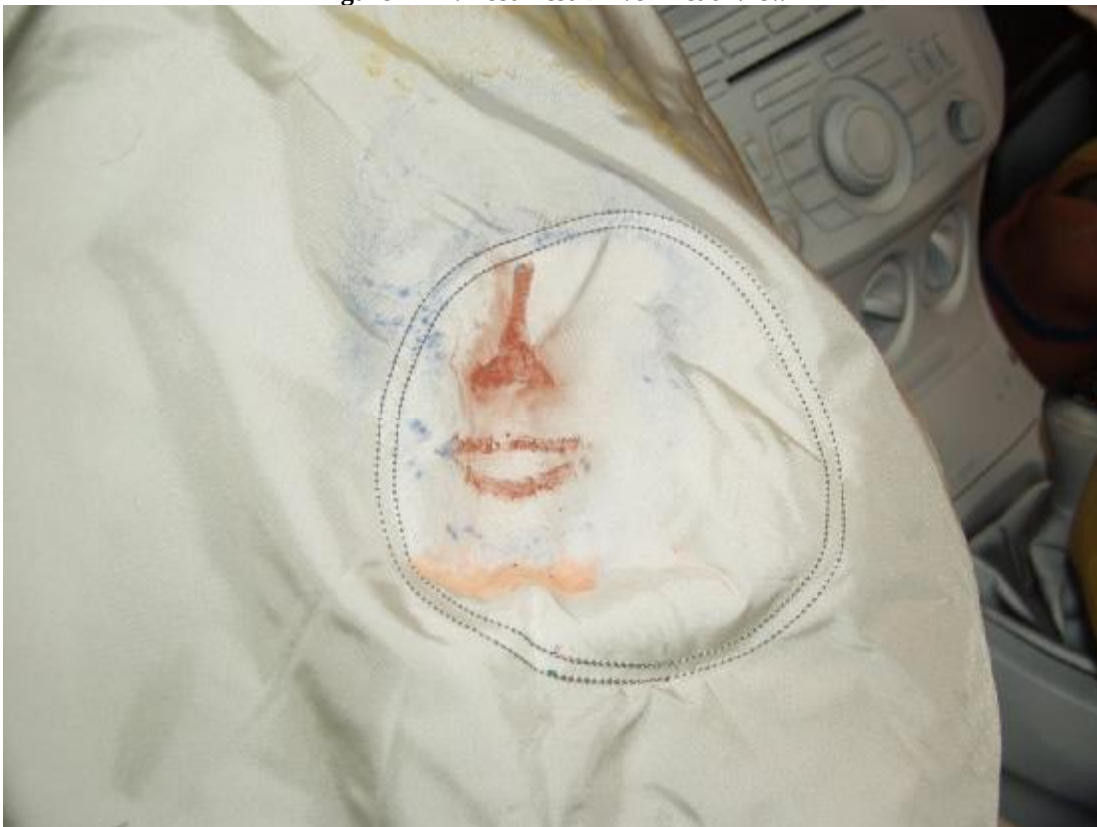
**Figure A-43: Post-Test Driver Contact to Airbag**

| | DRIVER | PASSENGER |
|---|---|---|
| Head Contact: | Face to airbag , Back of head to head restraint | Face to airbag , Back of head to head restraint |
| Chest Contact: | Airbag | Airbag |
