REPORT NUMBER TR-P28003-14-NC

**NEW CAR ASSESSMENT PROGRAM
SIDE IMPACT TEST**

**KIA MOTORS CORPORATION
2010 KIA SOUL PLUS
5-DOOR MPV**

NHTSA NUMBER: MA0507

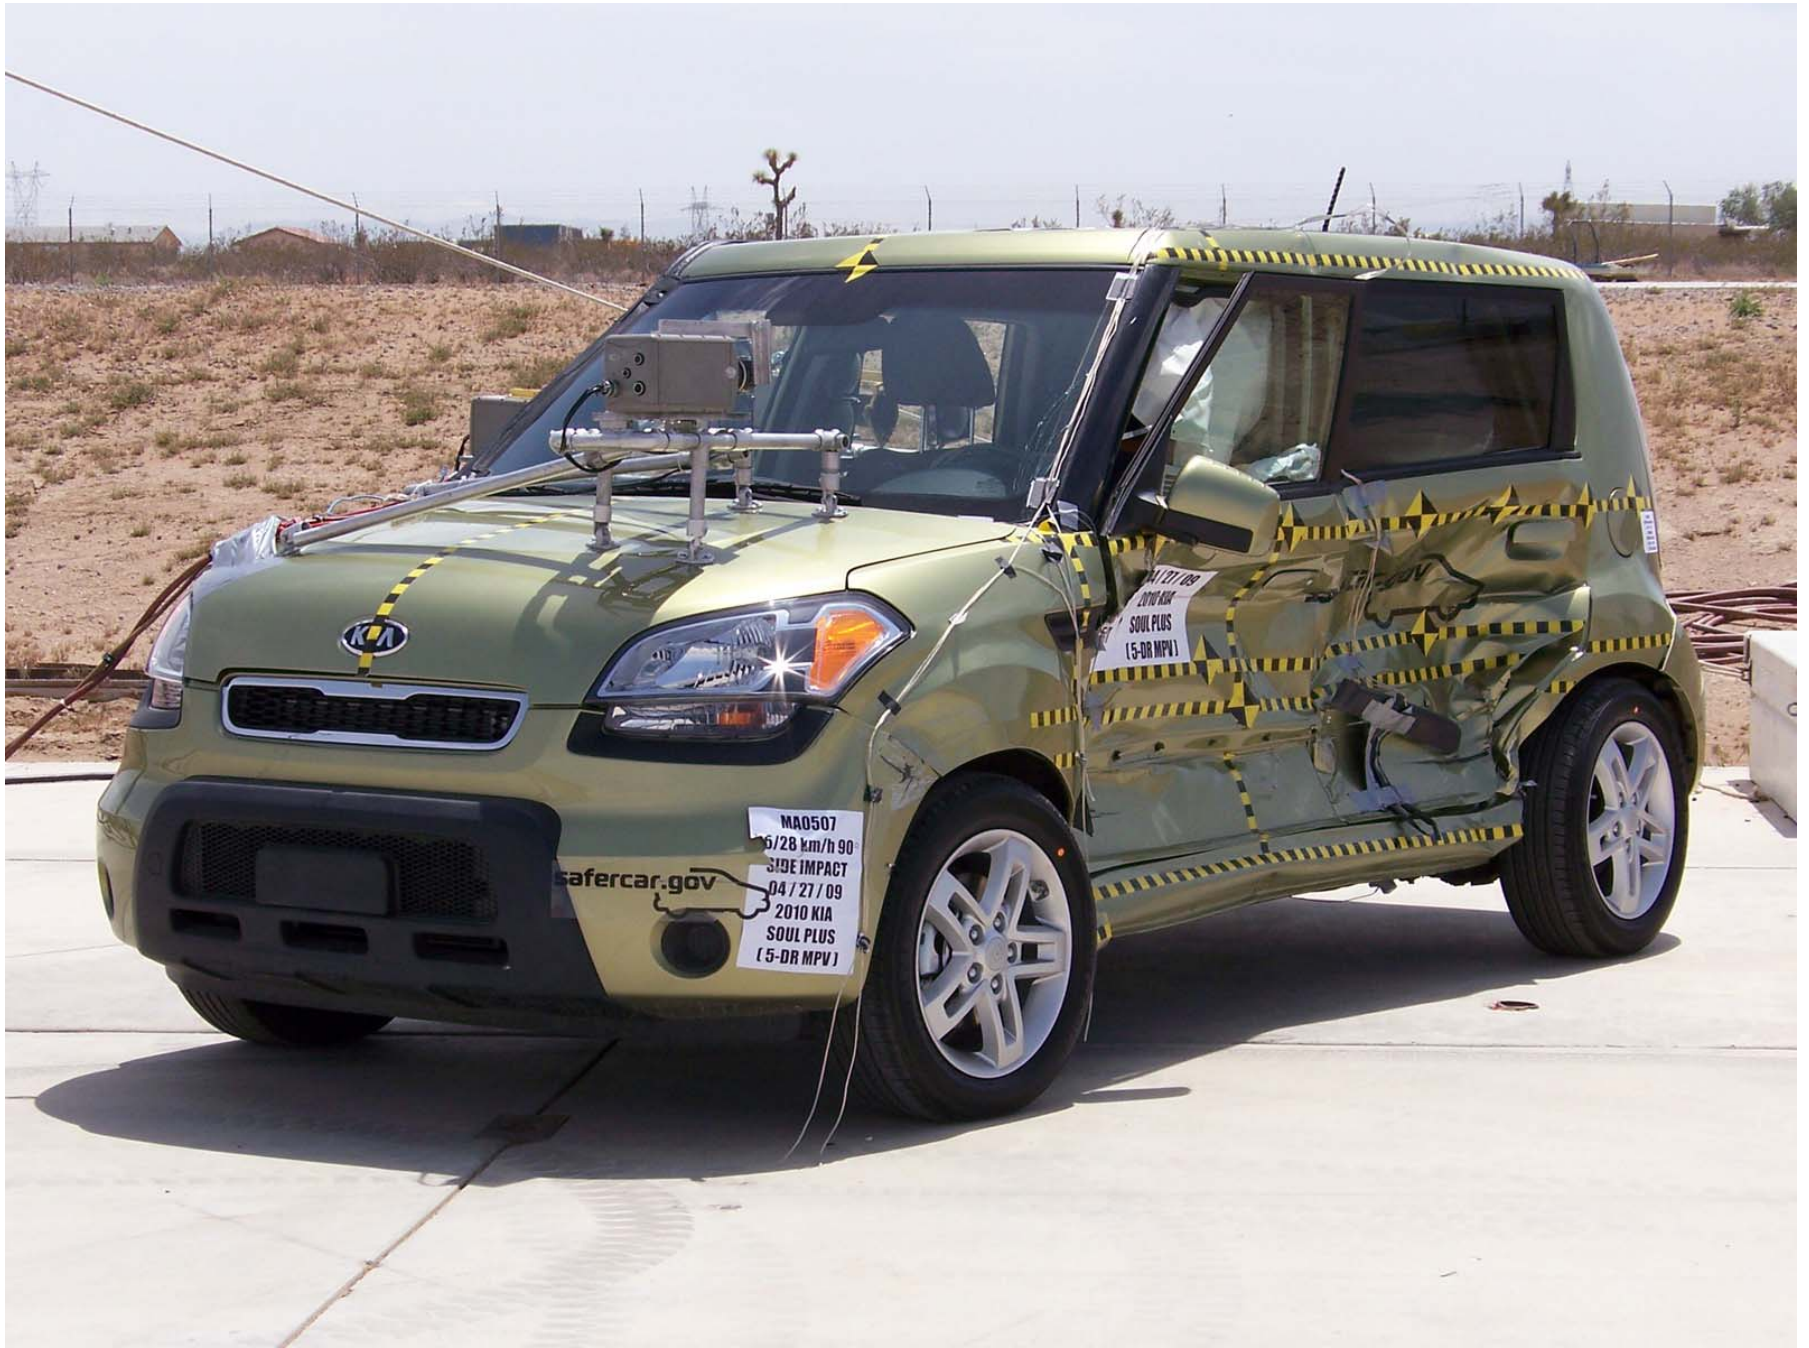
Figure A-8: Post-Test Left Front 3/4 View

Both the driver and passenger doors remained closed during the impact. The test vehicle sustained a maximum static crush of 270 mm at level 3, 1350 mm rearward of the left vertical impact point. The driver SID/Hybrid III, Serial No. 275 and the passenger SID/Hybrid III, Serial No. 274 were calibrated prior to this test. The SID/Hybrid III injury criteria are summarized as follows:

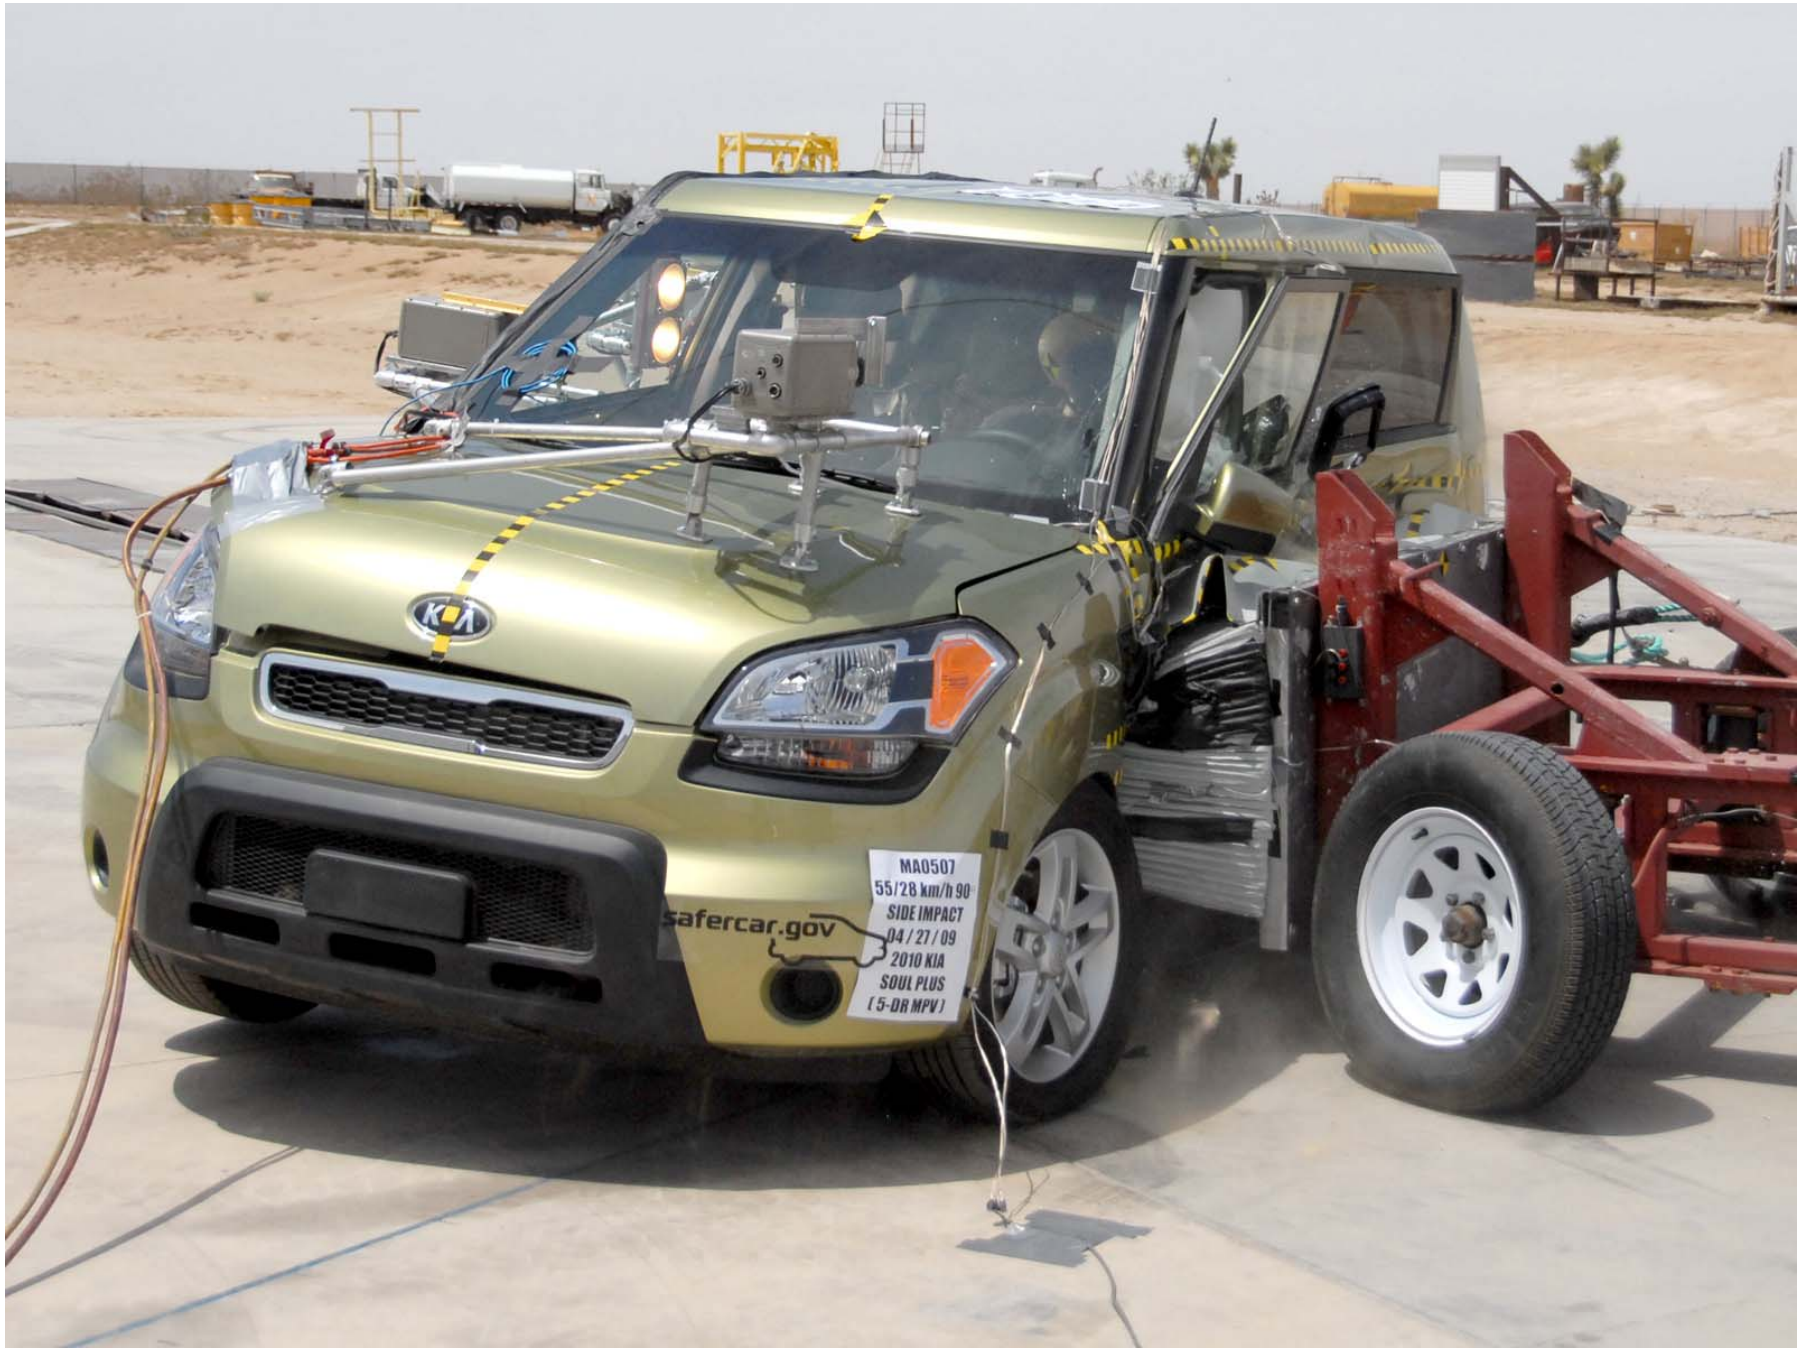
Figure A-66: Vehicle Impact

A model year 2010 Kia Soul Plus 5-Door MPV was impacted on the left (driver's) side by a Moving Deformable Barrier (MDB) which was moving forward in a 27° crabbed position to the tow road guidance system at a velocity of 61.67 km/h. The specified impact velocity range is from 61.14 to 62.75 km/h. The test (target) vehicle was stationary and positioned 63° to the line of forward motion. The weight of the vehicle as tested was 1502.0 kg and the test weight of the MDB was 1361 kg. The test was conducted at KARCO Engineering, LLC in Adelanto, California, on April 27, 2009.
