**REPORT NUMBER: SNCAP-CAL-10-01**

**Validation Testing  
Moving Deformable Barrier Side Impact Test**

**MAZDA MOTOR CORPORATION  
2010 Mazda 3  
4-Door Sedan**

**NHTSA NUMBER: MA5404**

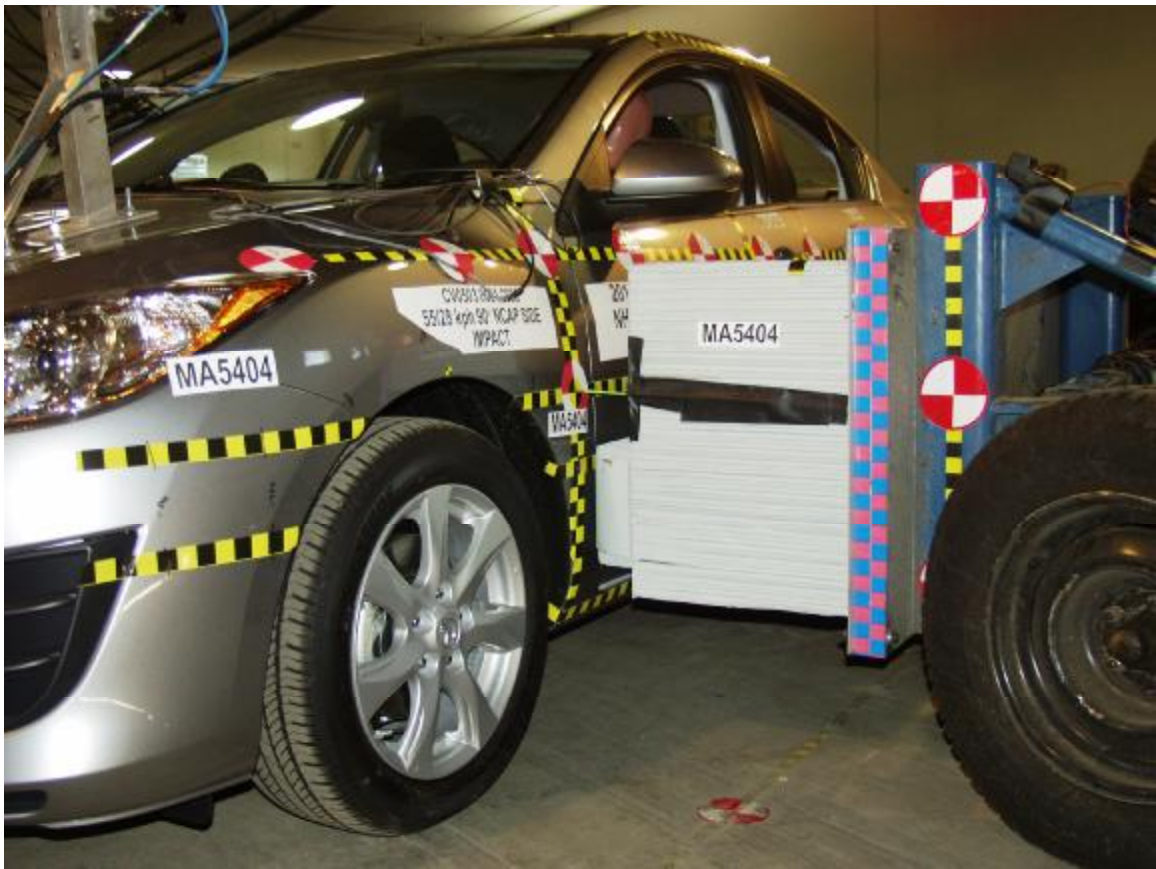
**Figure A-17: Pre-test left side view of MDB positioned against vehicle**

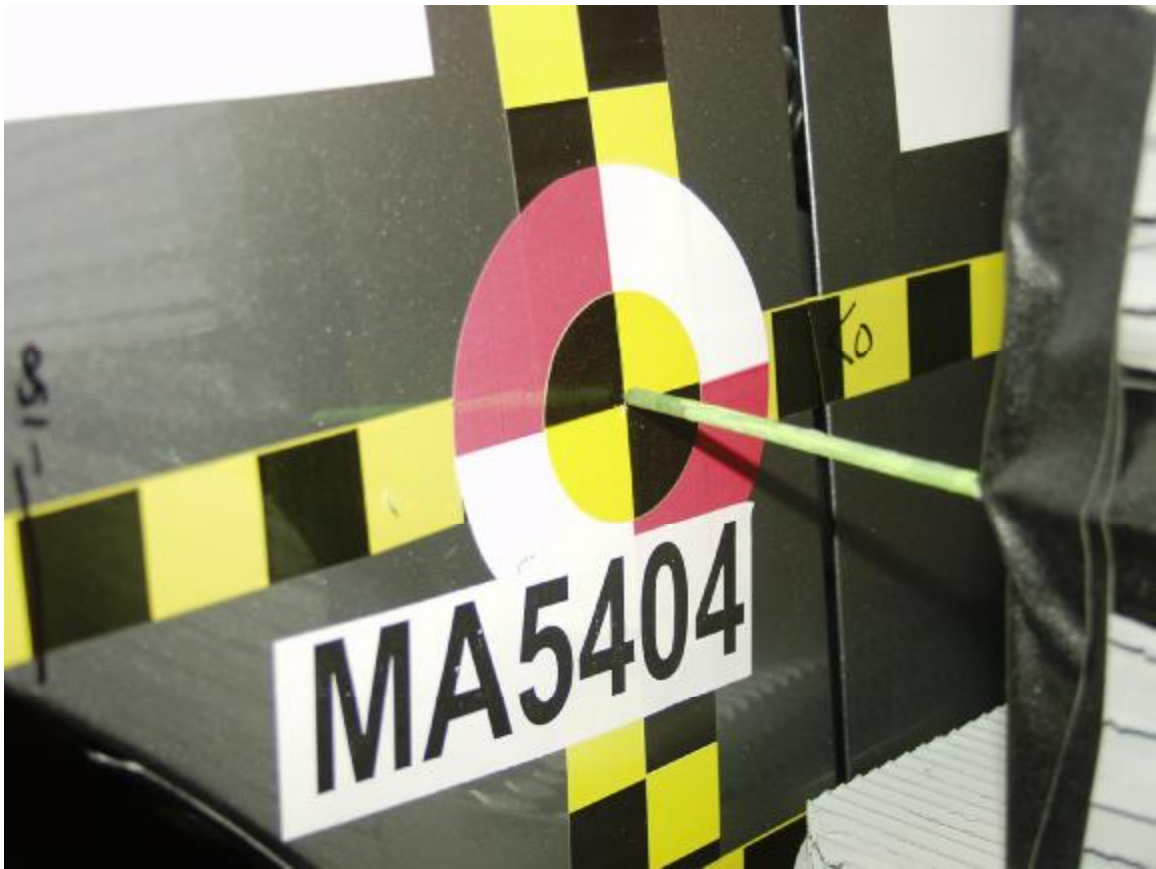
**Figure A-19: Pre-test close-up view of impact point target**

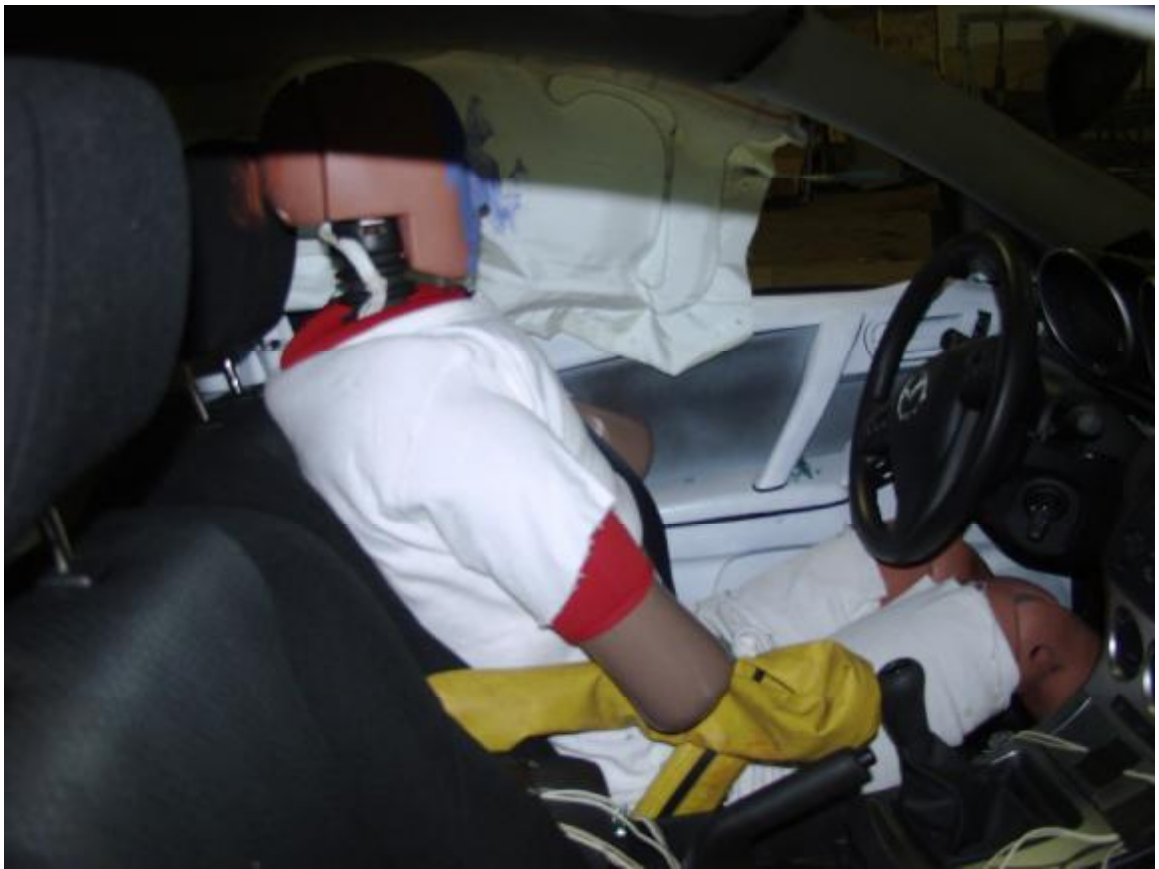
**Figure A-35: Post-test right side view of front seat of occupant compartment**

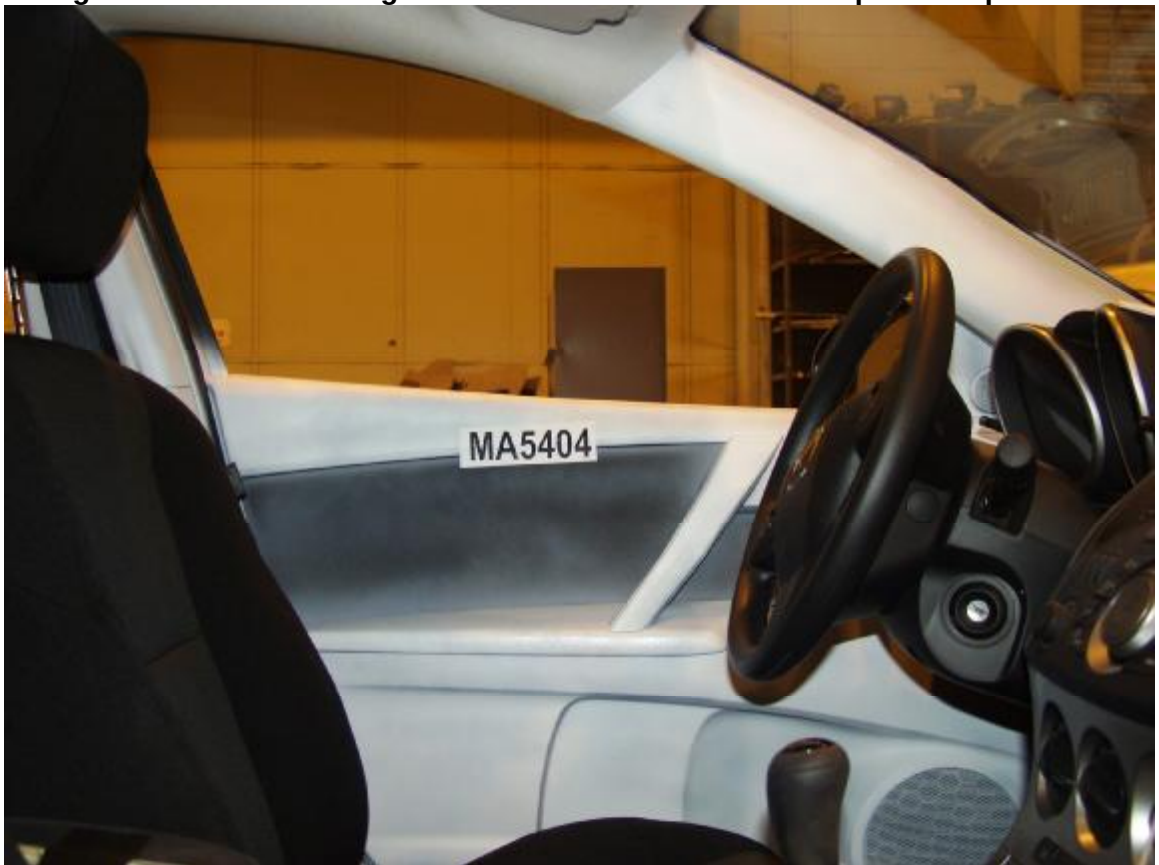
**Figure A-36: Pre-test driver inner door panel view**

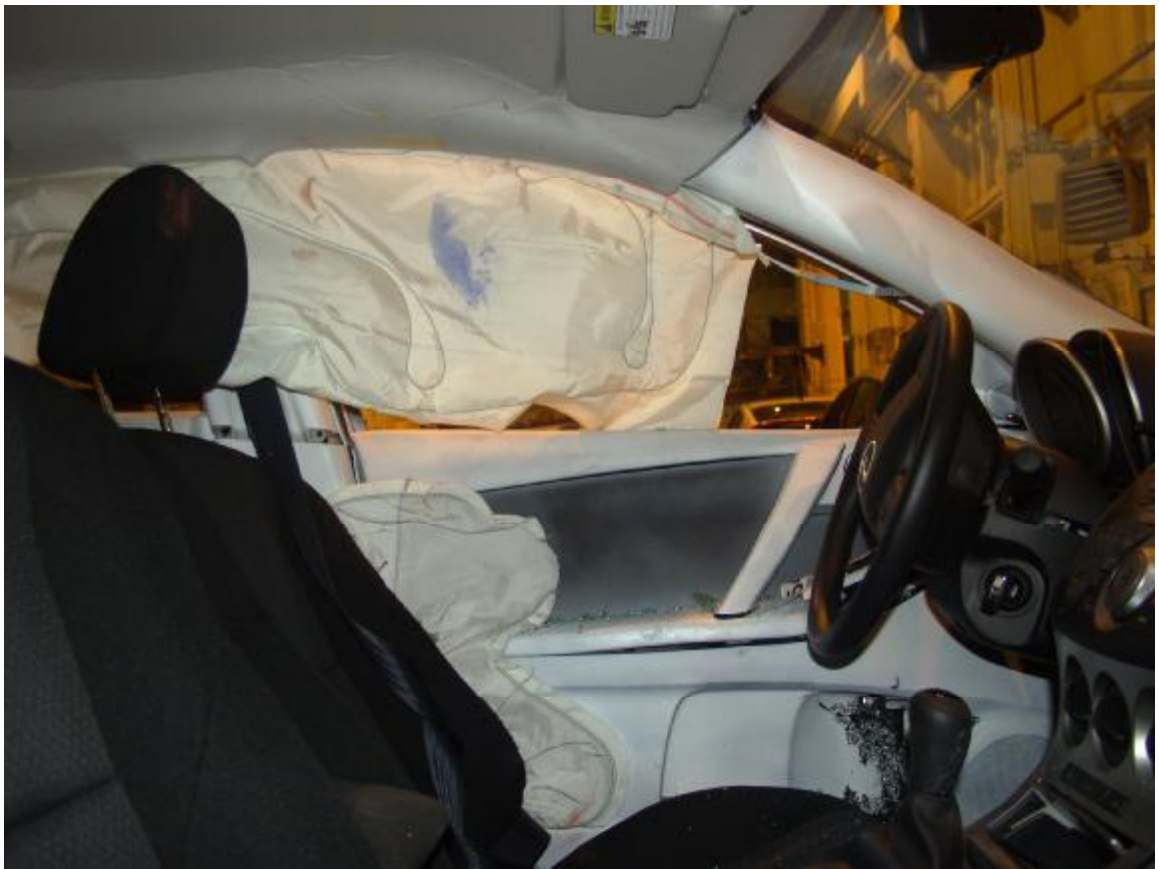
**Figure A-37: Post-test driver inner door panel view**

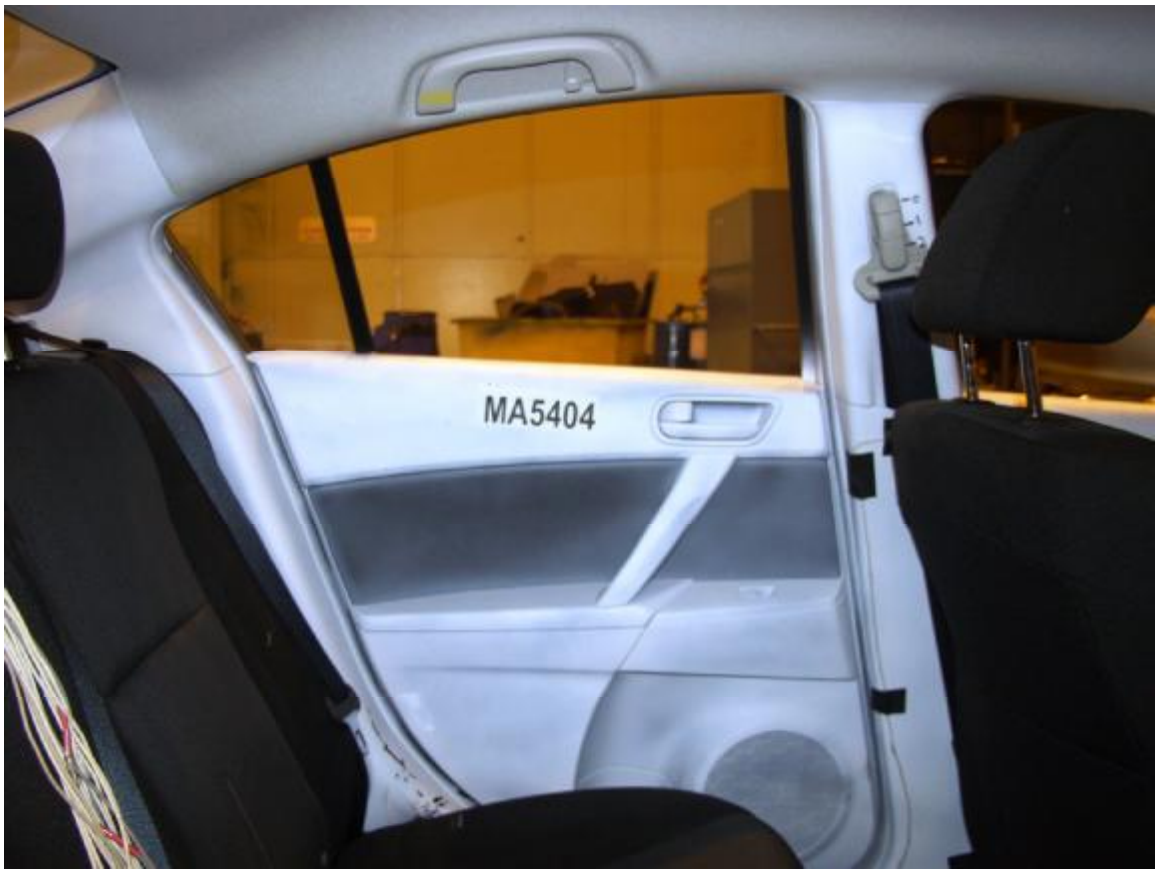
**Figure A-49: Pre-test passenger inner door panel view**

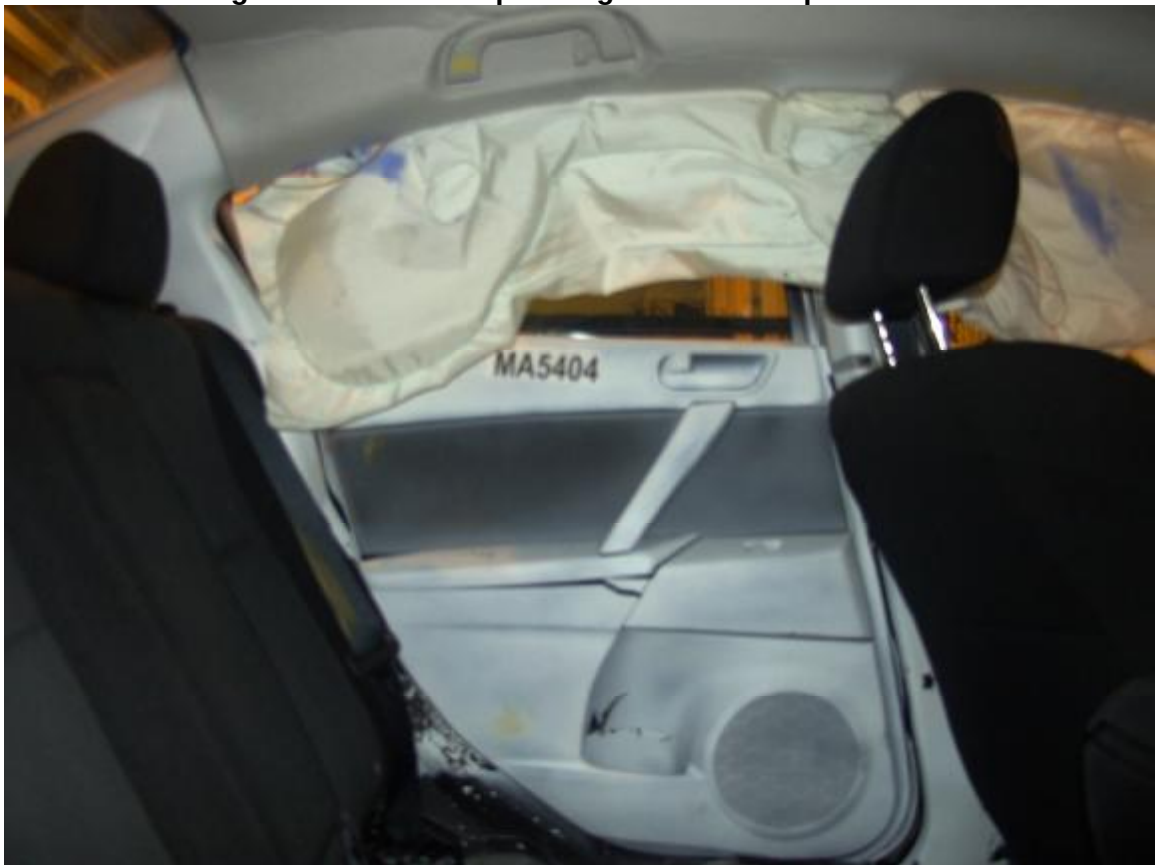
**Figure A-50: Post-test passenger inner door panel view**

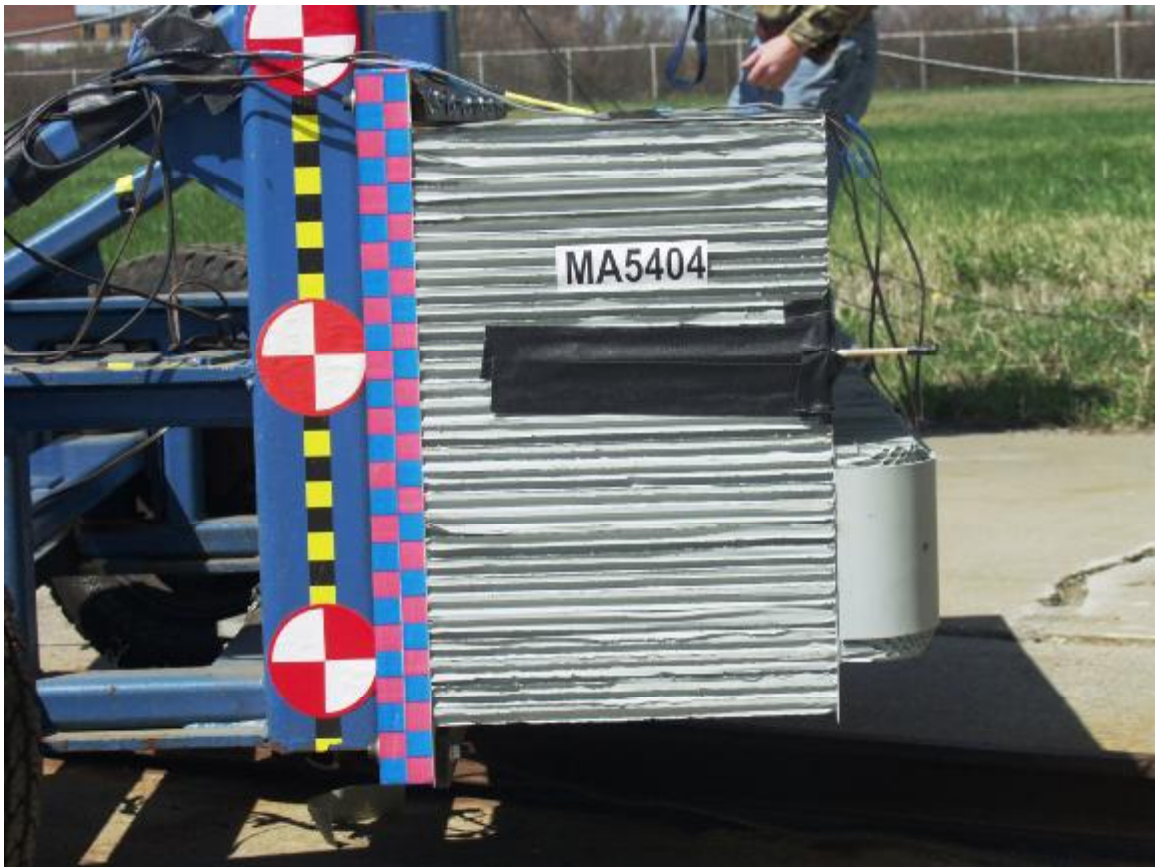
Figure A-61: Pre-test right side view of MDB impactor face

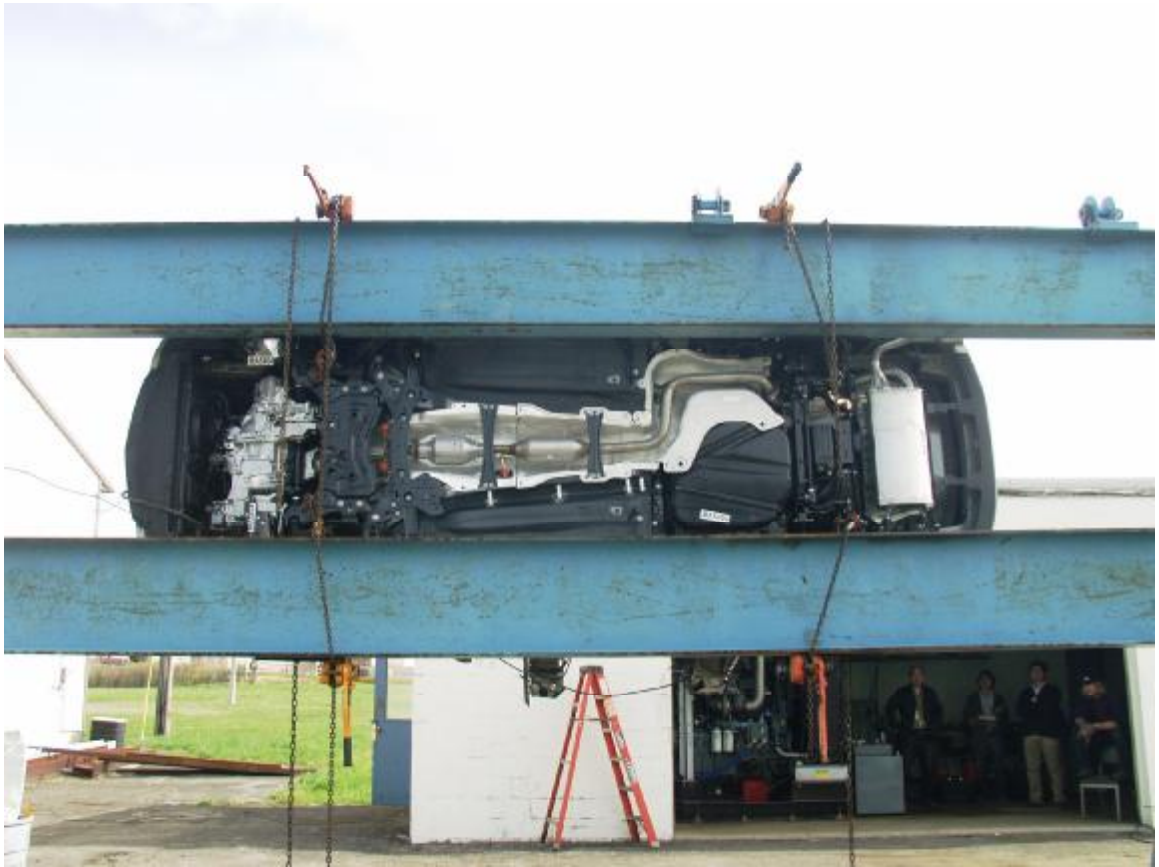
**Figure A-65: FMVSS 301/305 rollover 90°**

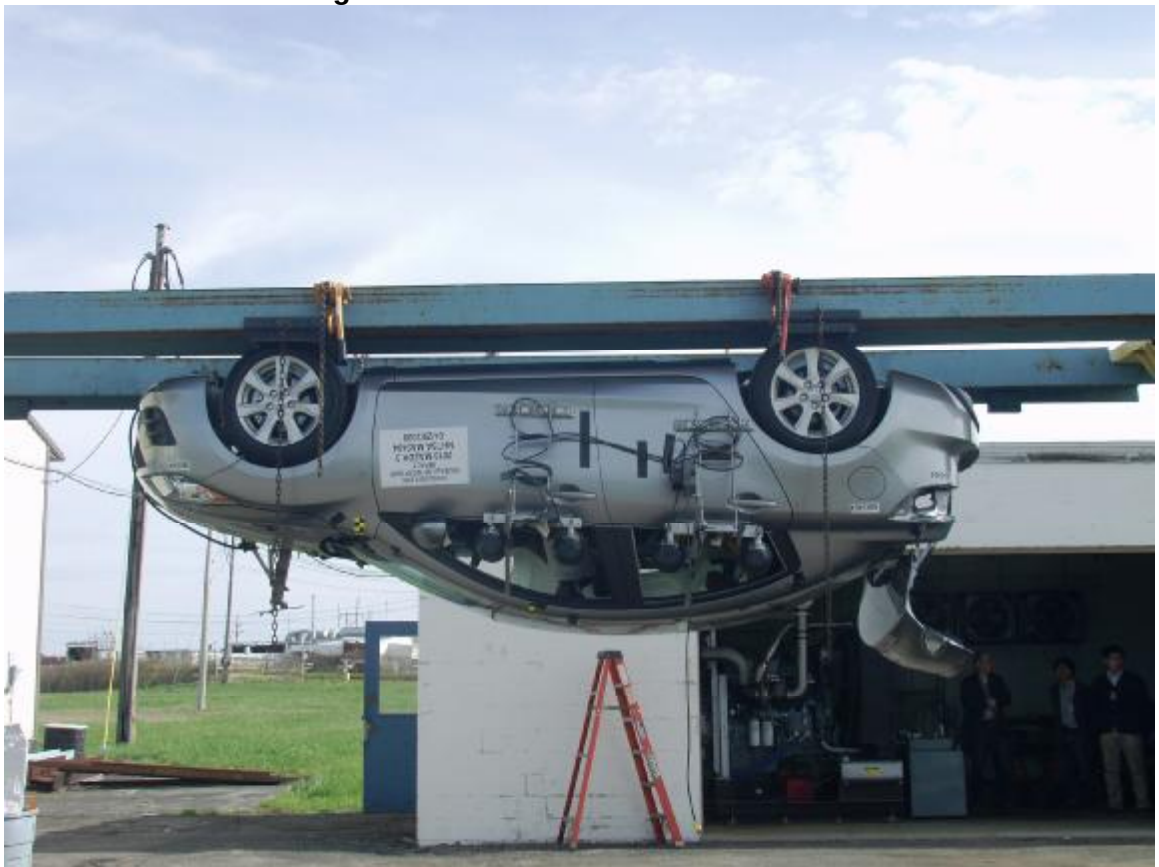
**Figure A-66: FMVSS 301/305 rollover 180°**

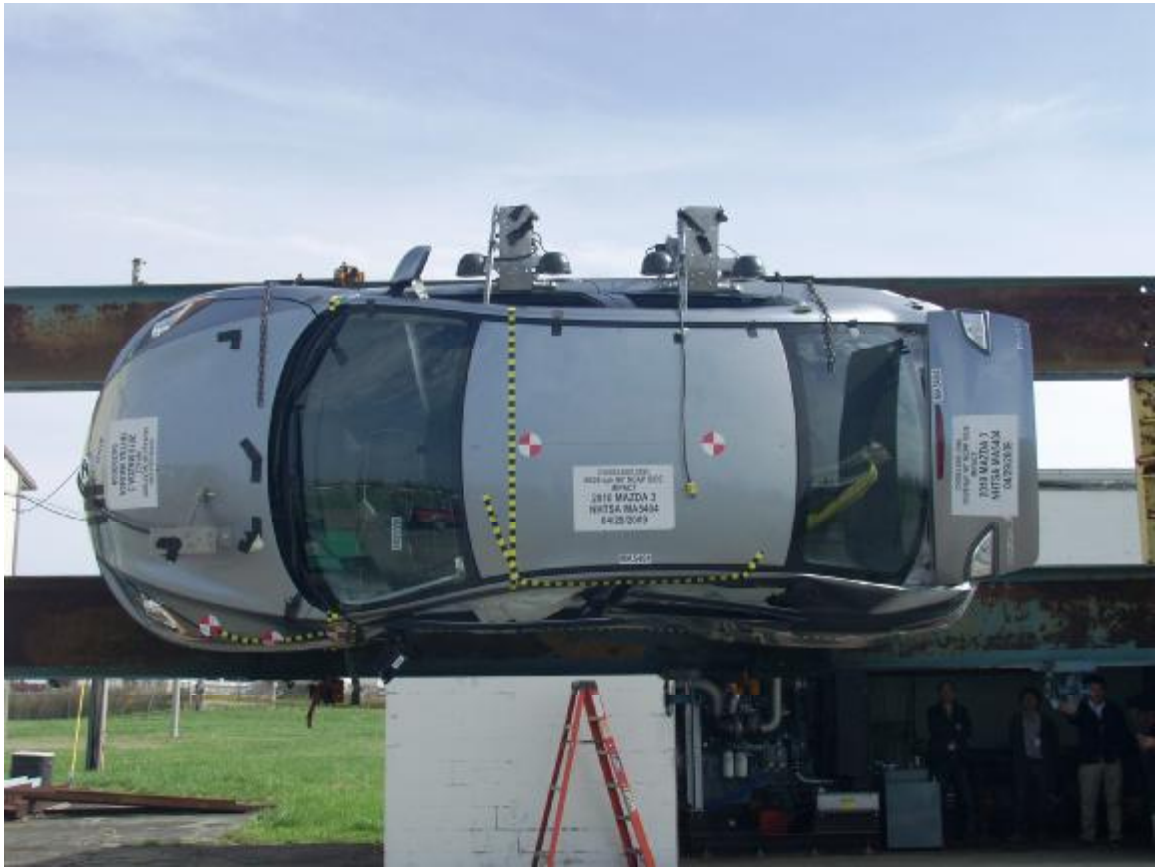
Figure A-67: FMVSS 301/305 rollover 270°

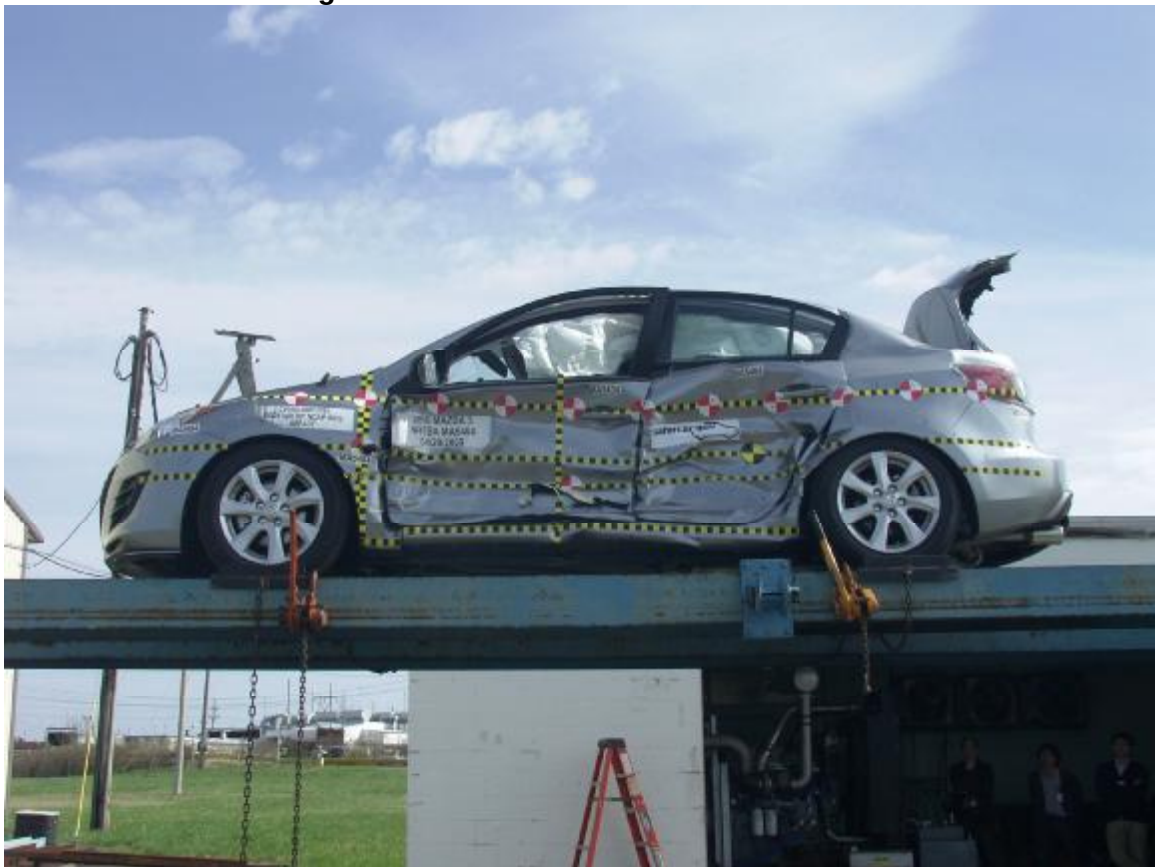
Figure A-68: FMVSS 301/305 rollover 360°
