**REPORT NUMBER: NCAPSIDE-MGA-2009-008**

**NEW CAR ASSESSMENT PROGRAM  
SIDE IMPACT TEST**

**FORD MOTOR COMPANY  
2010 FORD MUSTANG 2-DR COUPE  
NHTSA NUMBER: MA0203**

**FINAL REPORT**

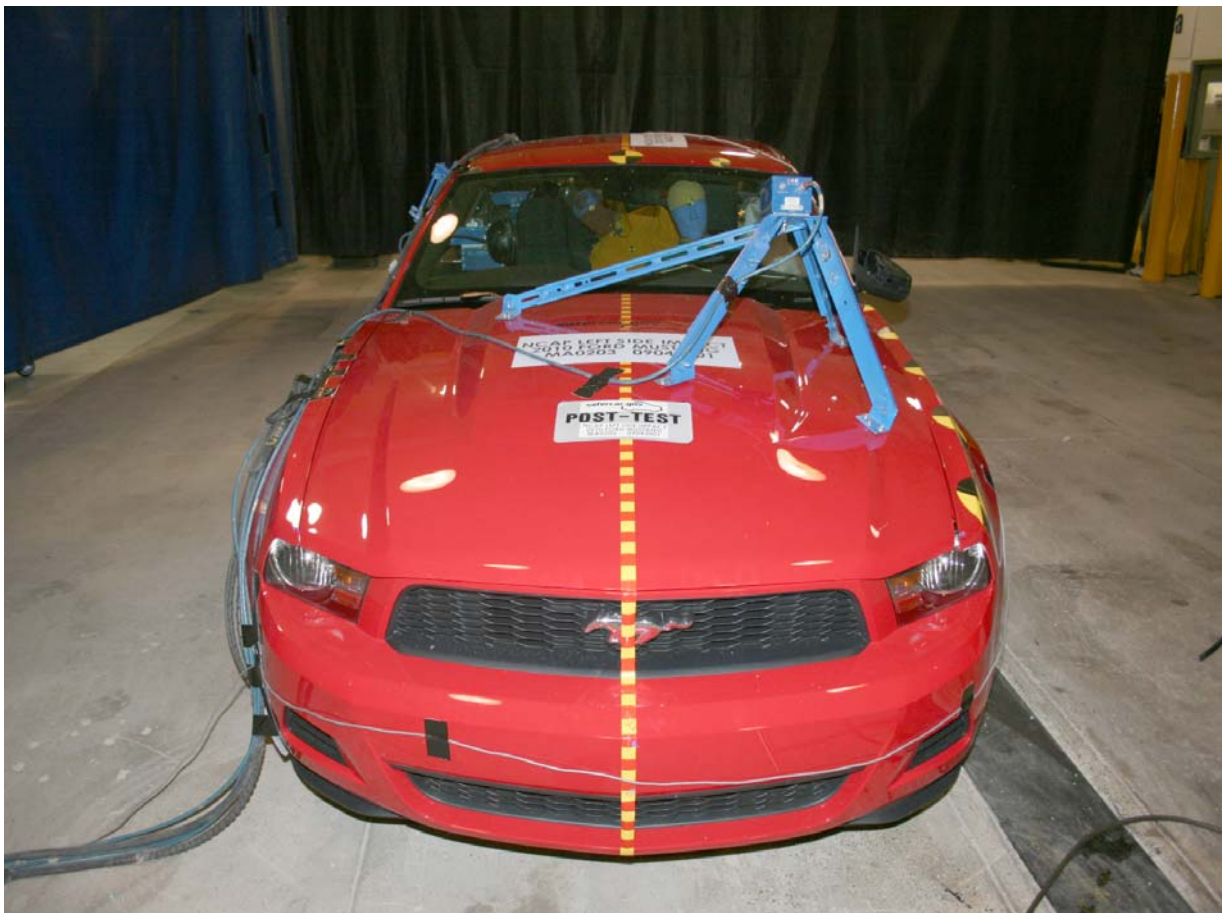
Post-Test Front View

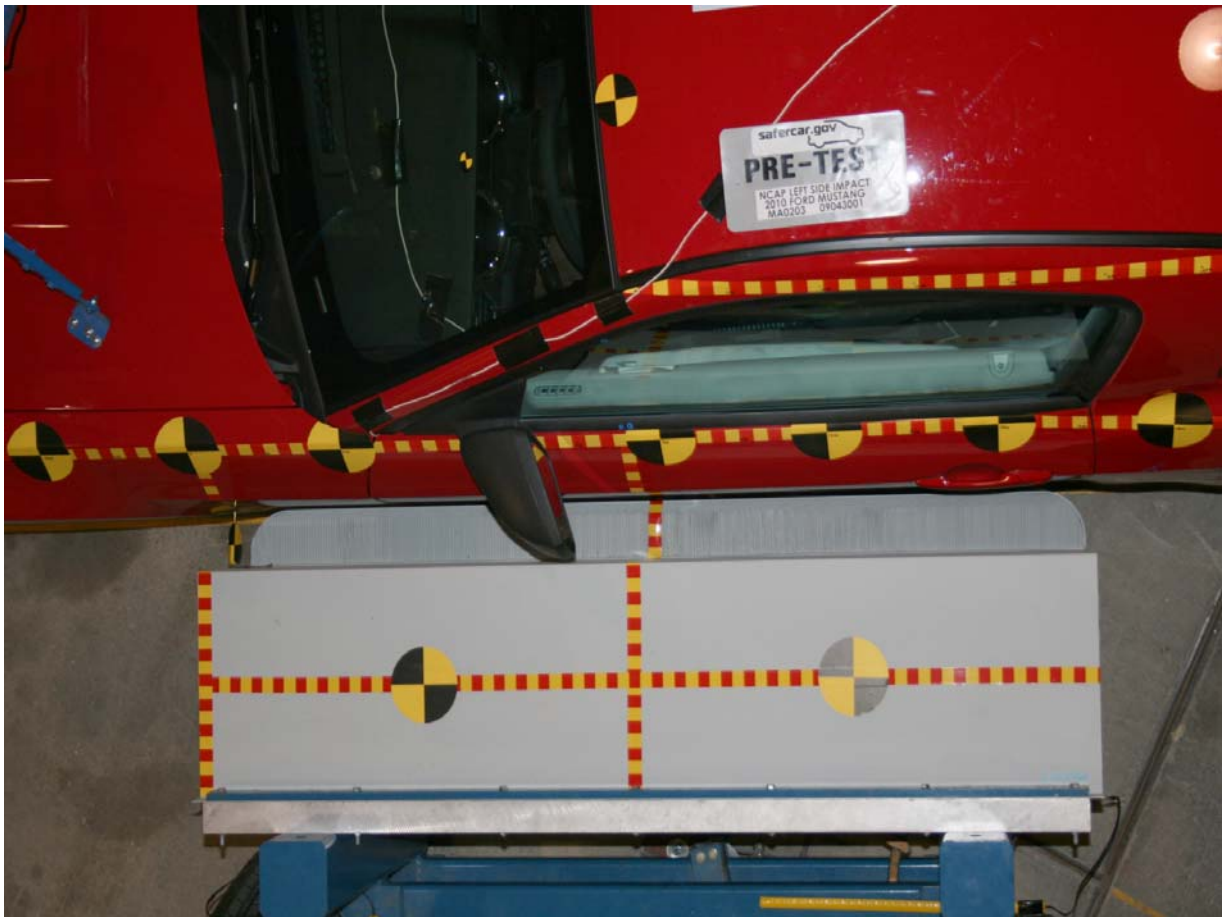
Pre-Test Overhead Close-up View

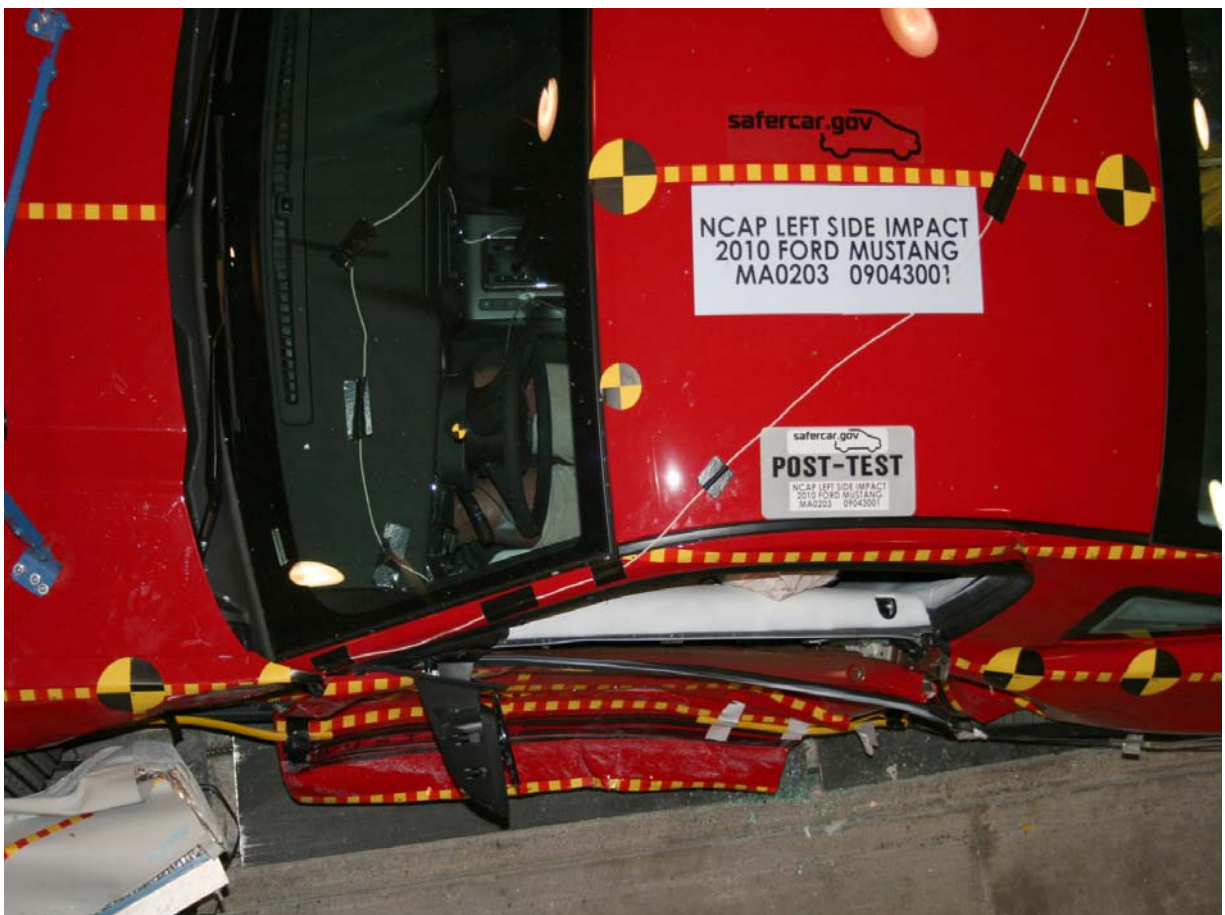
Post-Test Overhead Close-up View

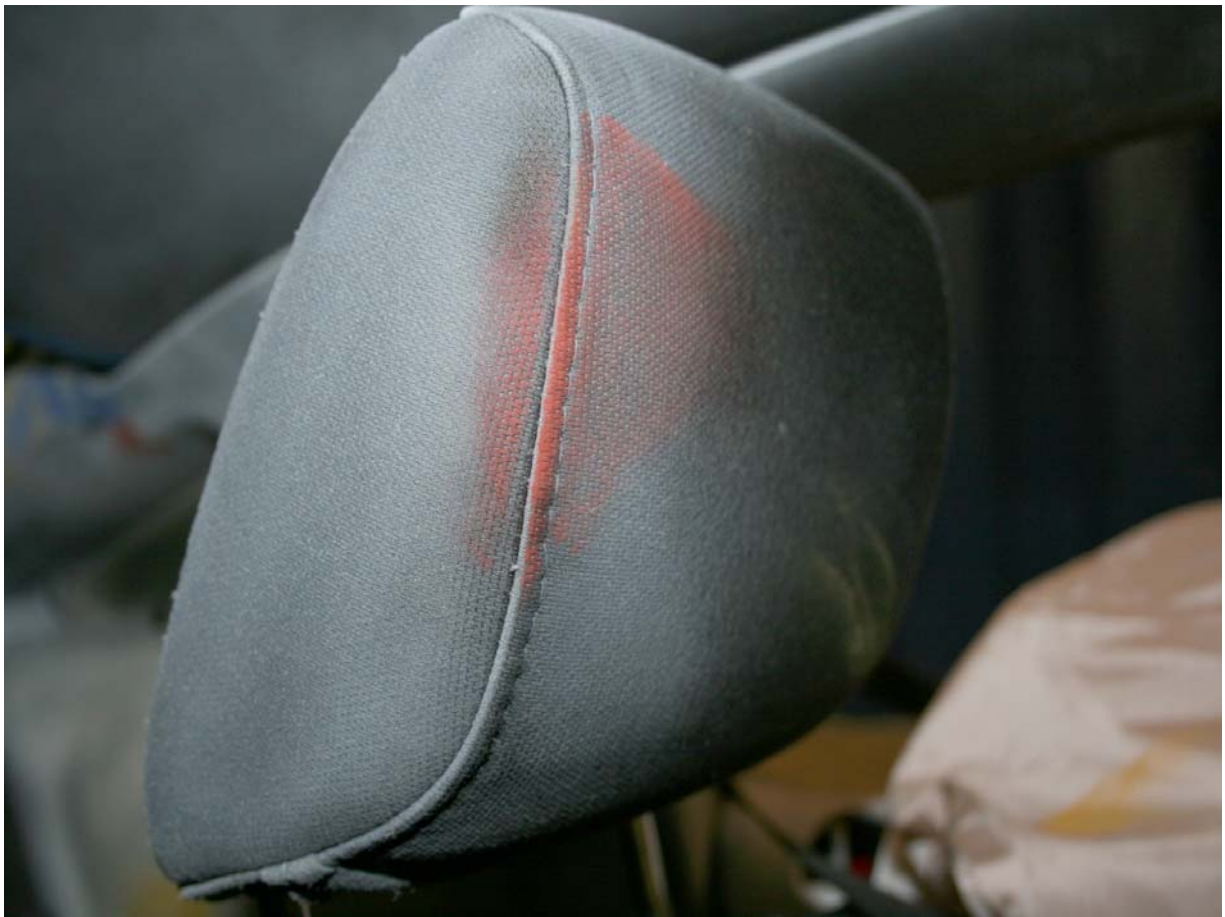
Post-Test Driver Dummy Head Contact View 1

Post-Test Driver Dummy Head Contact View 2

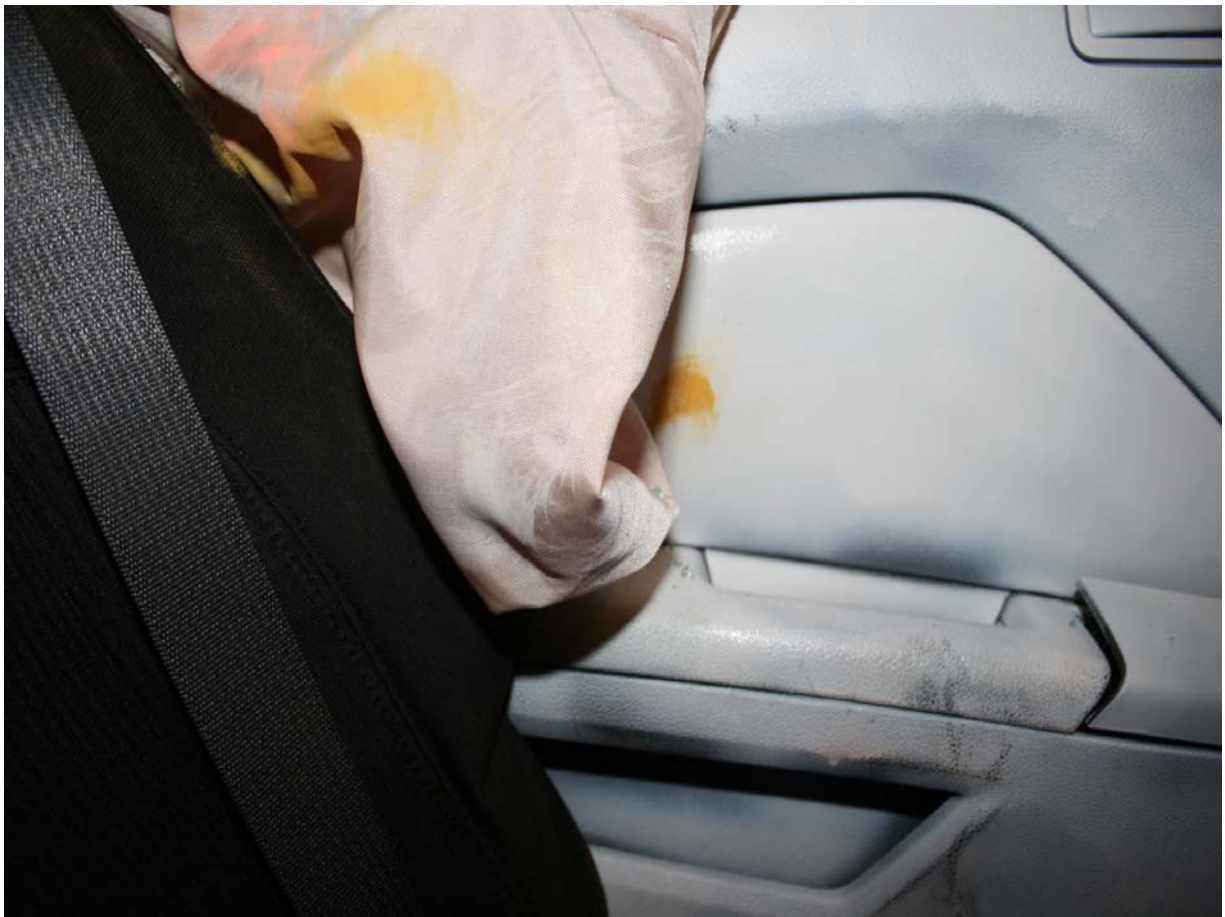
Post-Test Driver Dummy Upper Torso Contact

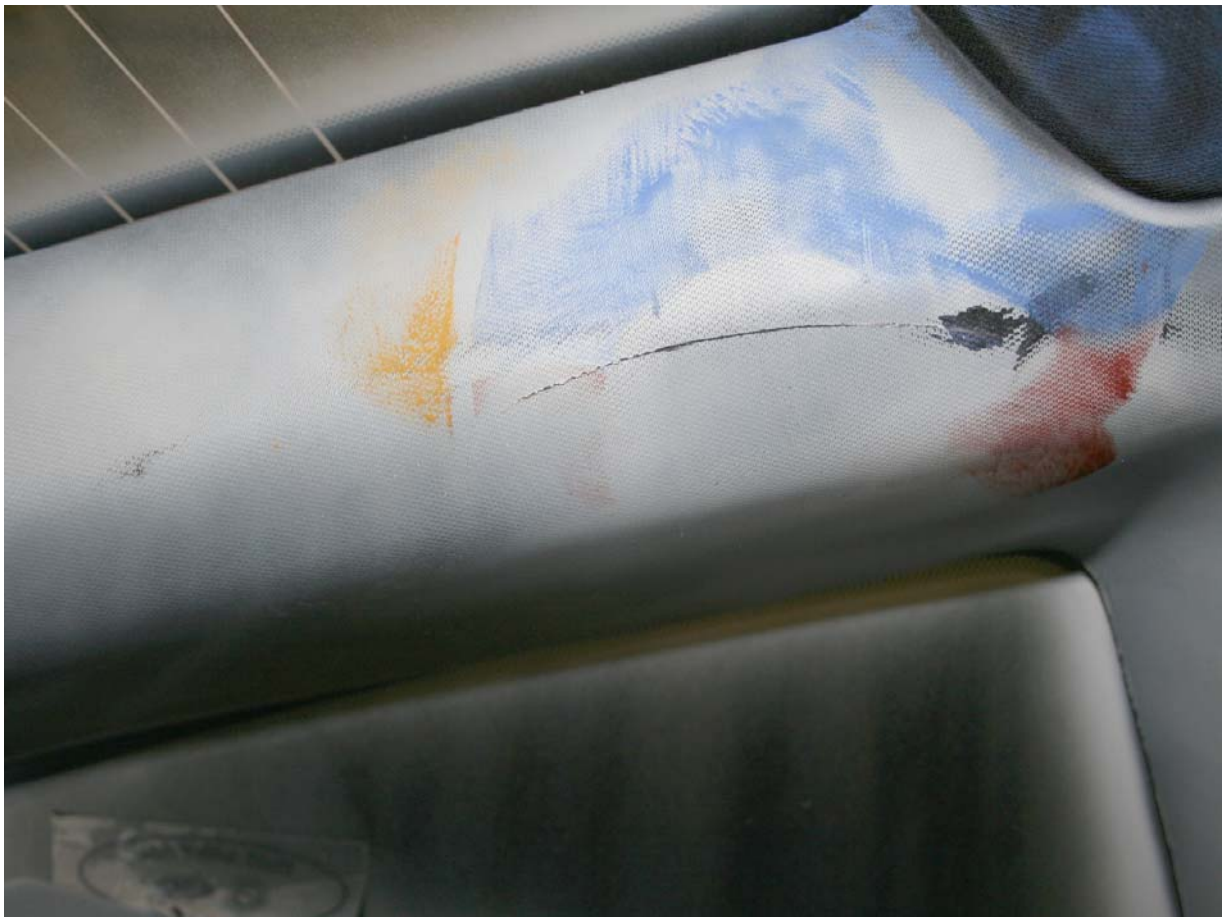
Post-Test Passenger Dummy Head Contact View 1

Post-Test Passenger Dummy Head Contact View 2
