**REPORT NUMBER: SNCAP-CAL-09-02**

**VALIDATION  
SIDE IMPACT POLE TEST**

**HYUNDAI MOTOR COMPANY  
2010 HYUNDAI GENESIS  
2-DOOR COUPE**

**FINAL REPORT**

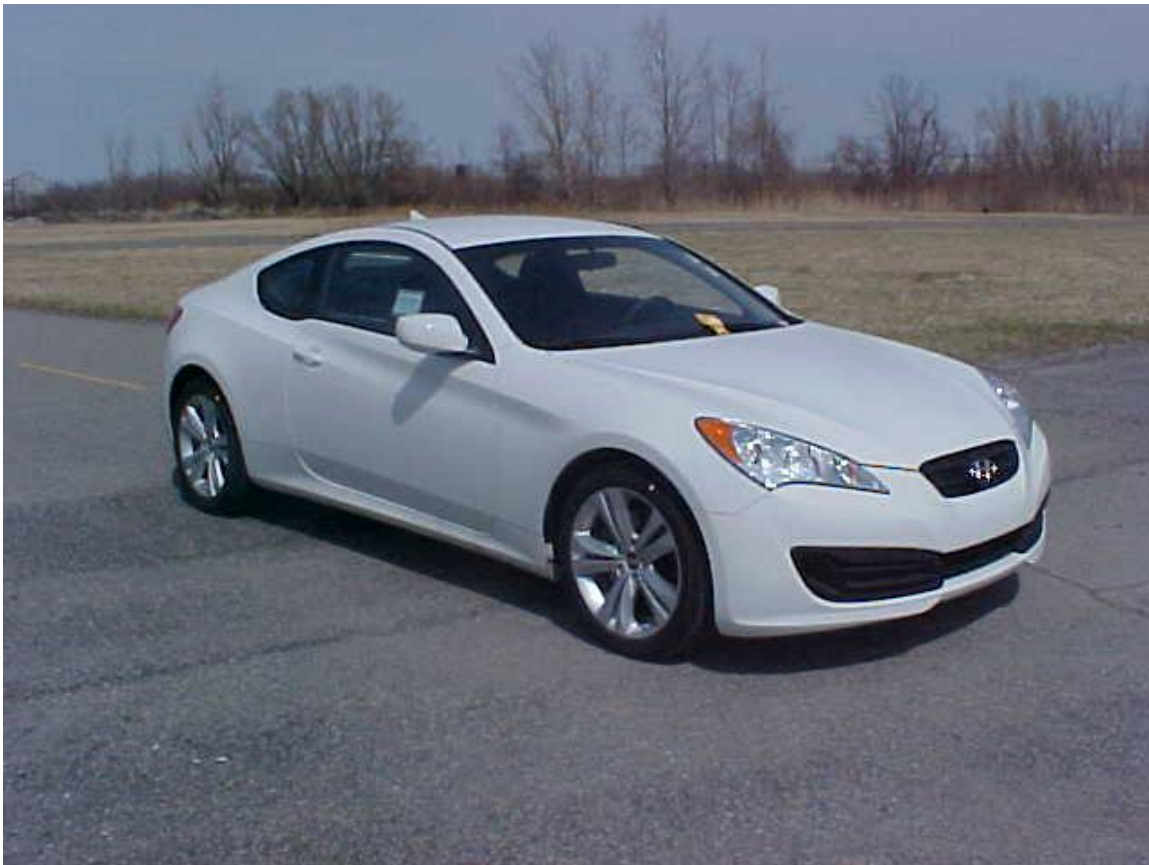
**Figure A-1: As Delivered Right Front  $\frac{3}{4}$  View of Test Vehicle**

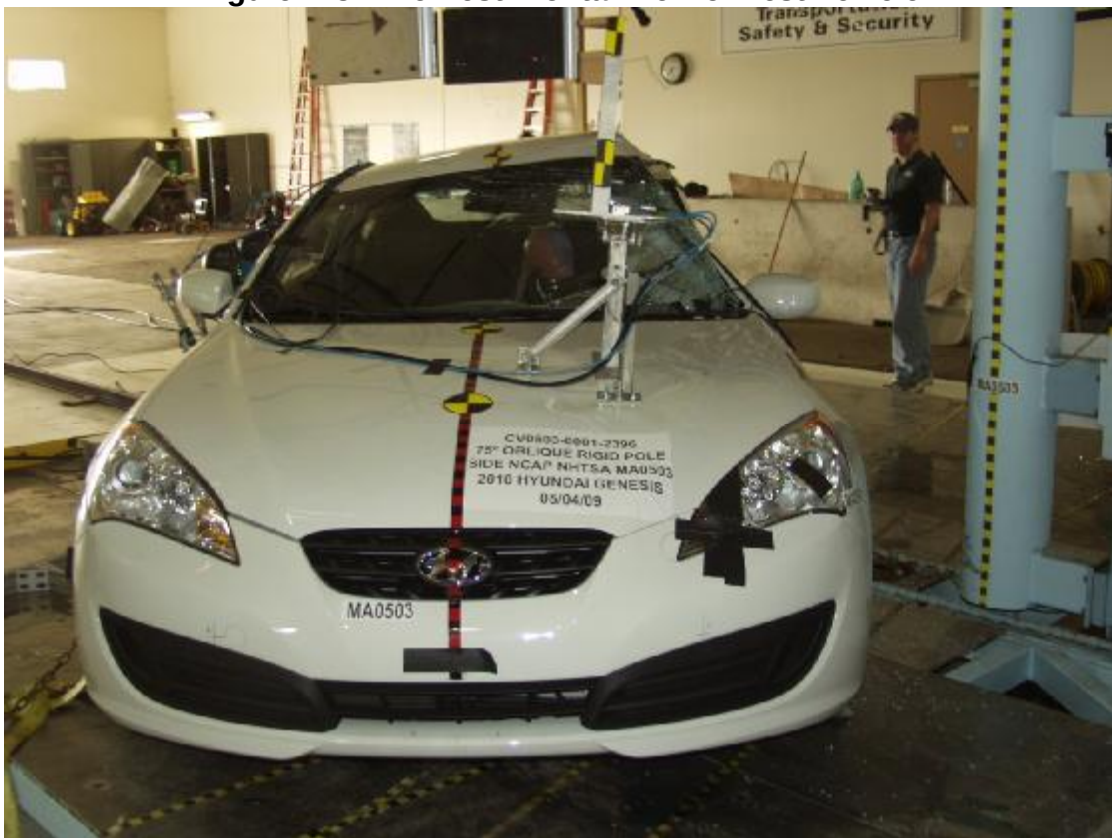
**Figure A-4: Post-Test Frontal View of Test Vehicle**

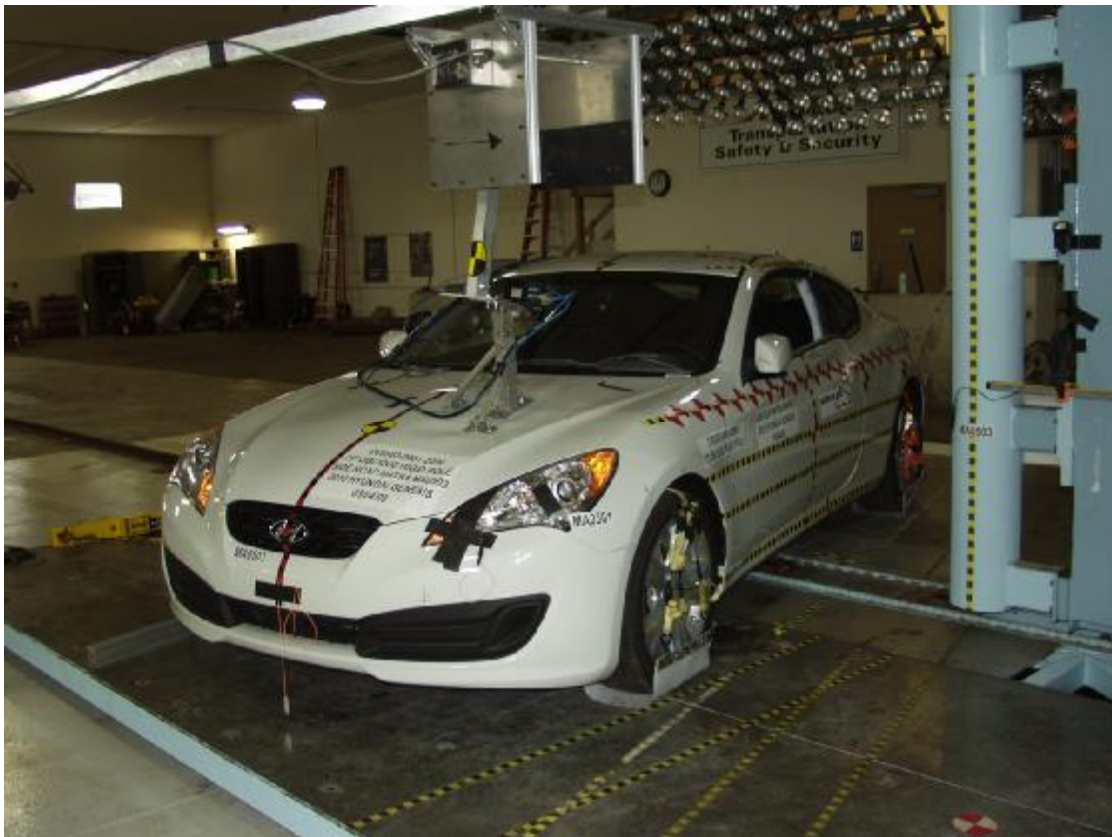
**Figure A-5: Pre-Test Left  $\frac{3}{4}$  Front View of Vehicle with Pole in Position**

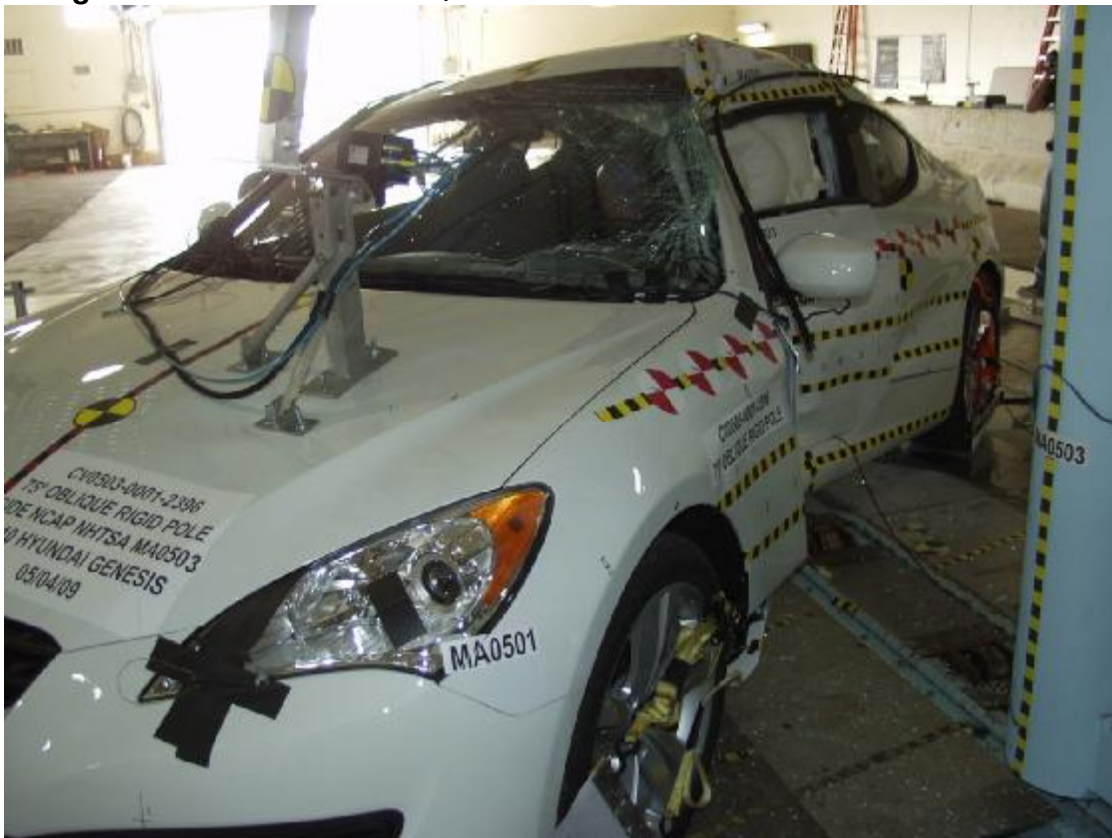
**Figure A-6: Post-Test Left  $\frac{3}{4}$  Front View of Impact Zone**

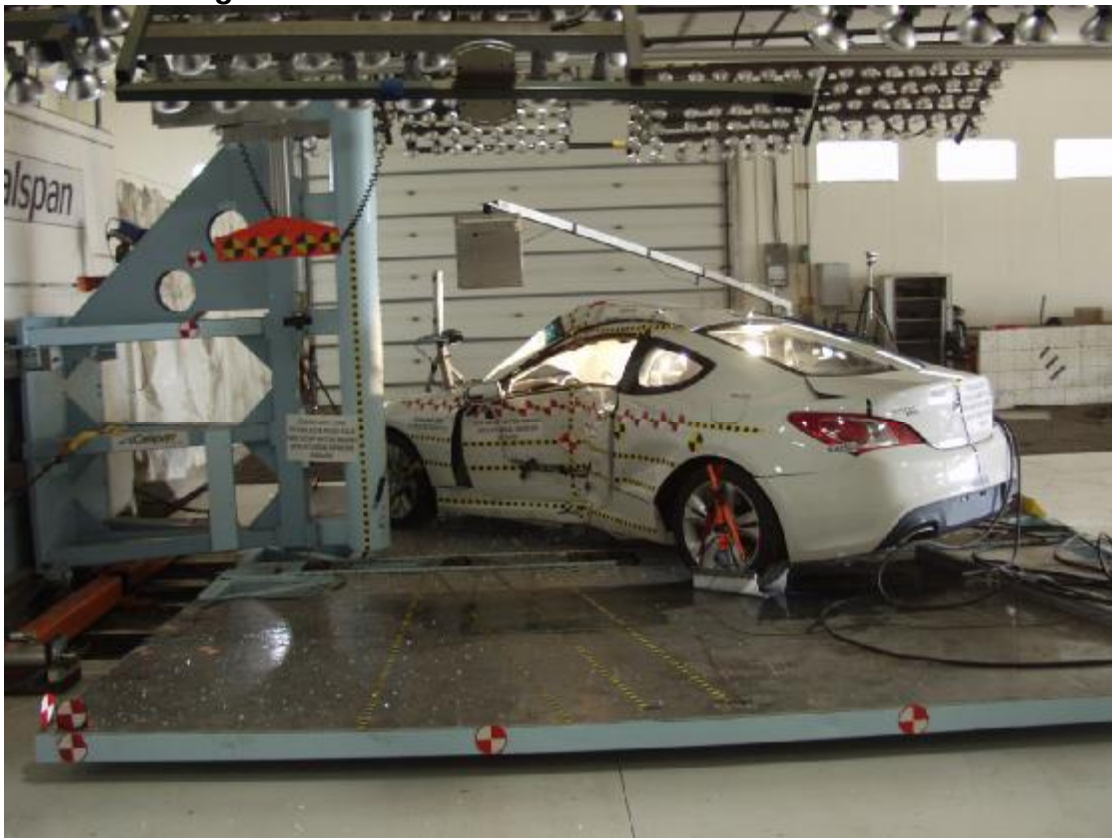
**Figure A-8: Post-Test Left Side View of Test Vehicle**

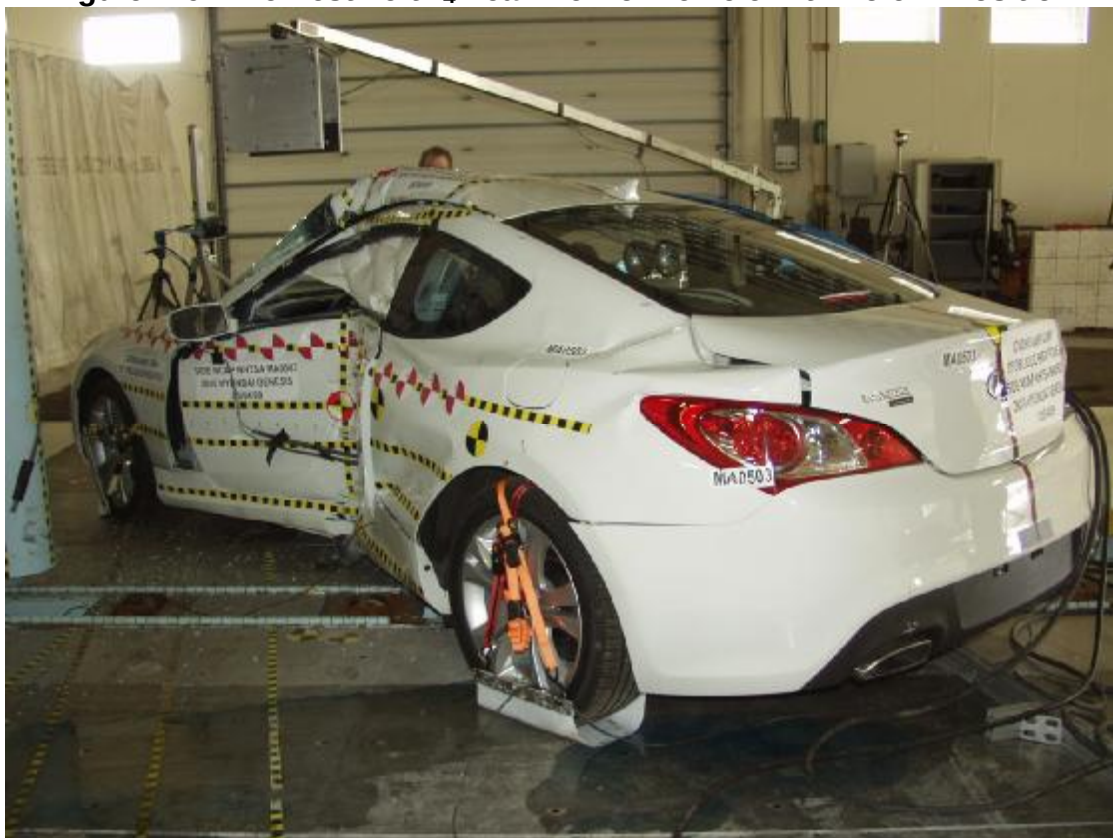
**Figure A-10: Post-Test Left  $\frac{3}{4}$  Rear View of Impact Zone**

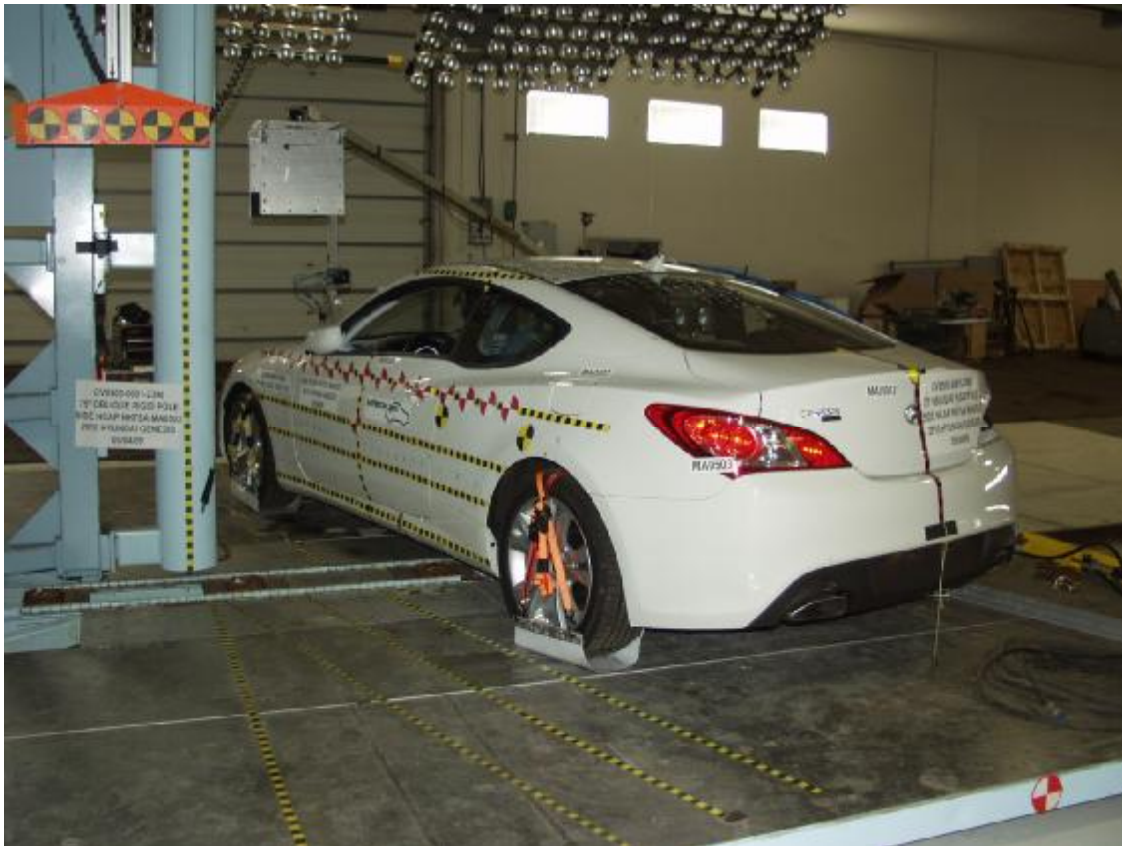
**Figure A-17: Pre-Test Left Side View of Pole Positioned Against Side of Vehicle at Ideal Impact Point**

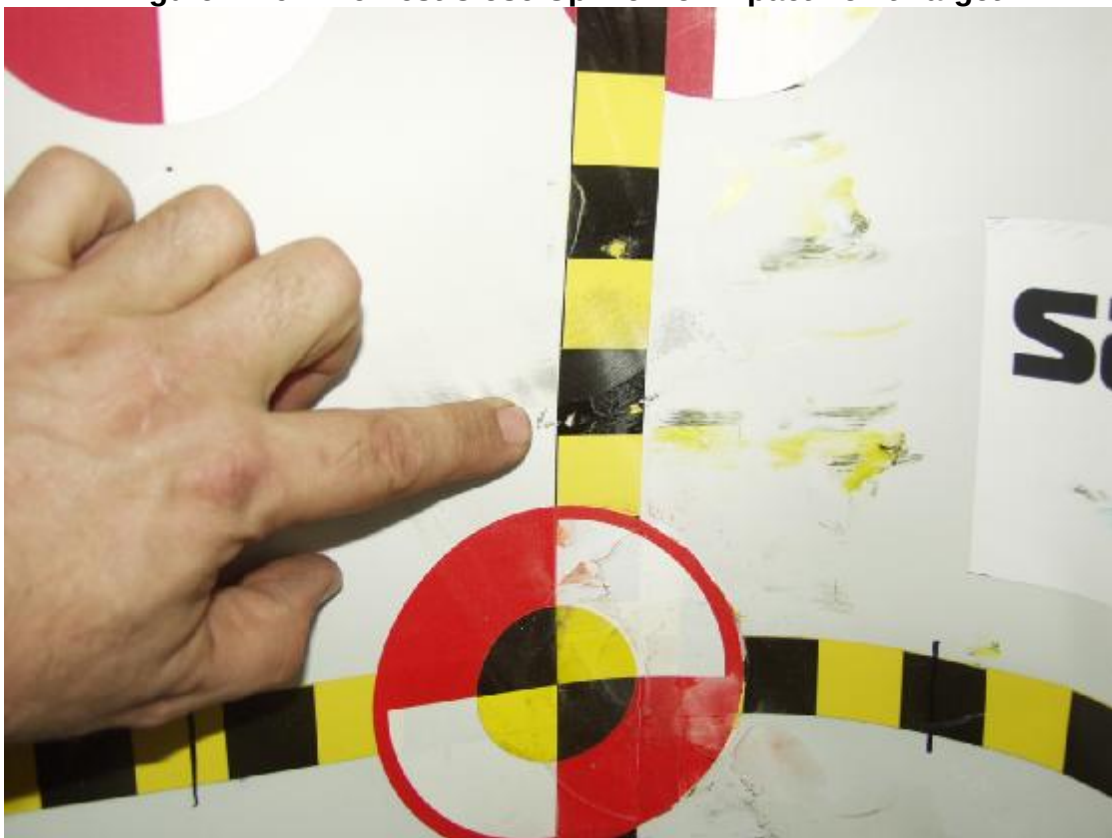
**Figure A-20: Post-Test Close-Up View of Impact Point Target Showing Impact Location**

| Measurement Parameter | Units | Value |
|---|---|---|
| Actual Impact Point (Aft of Front Axle) | mm | 1398 |
| Impact Point Difference | mm | 10 |

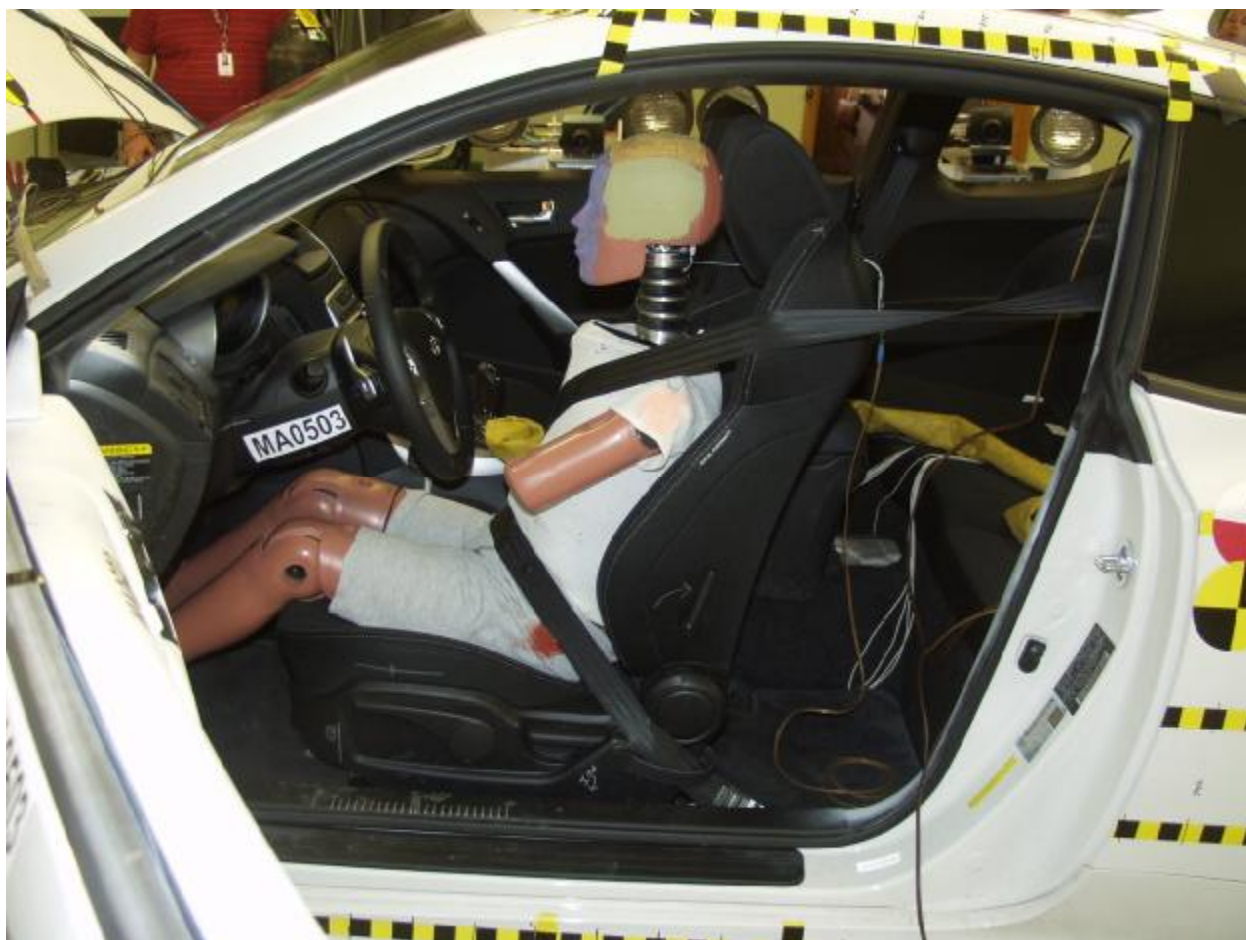
**Figure A-23:** Pre-Test Left Side View of Dummy Showing Belt, Chalking, and Contact Switches (Door Open)

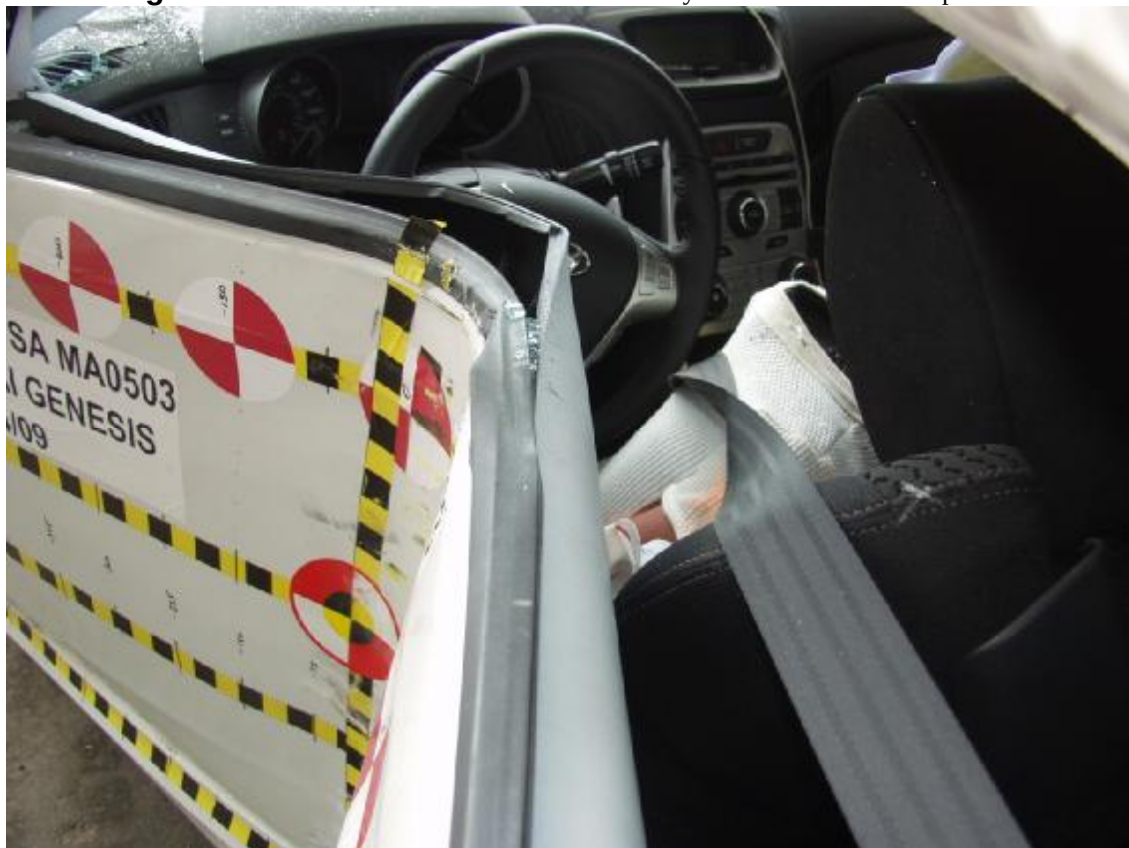
**Figure A-25:** Post-Test Left Side View of Dummy Shoulder and Door Top View

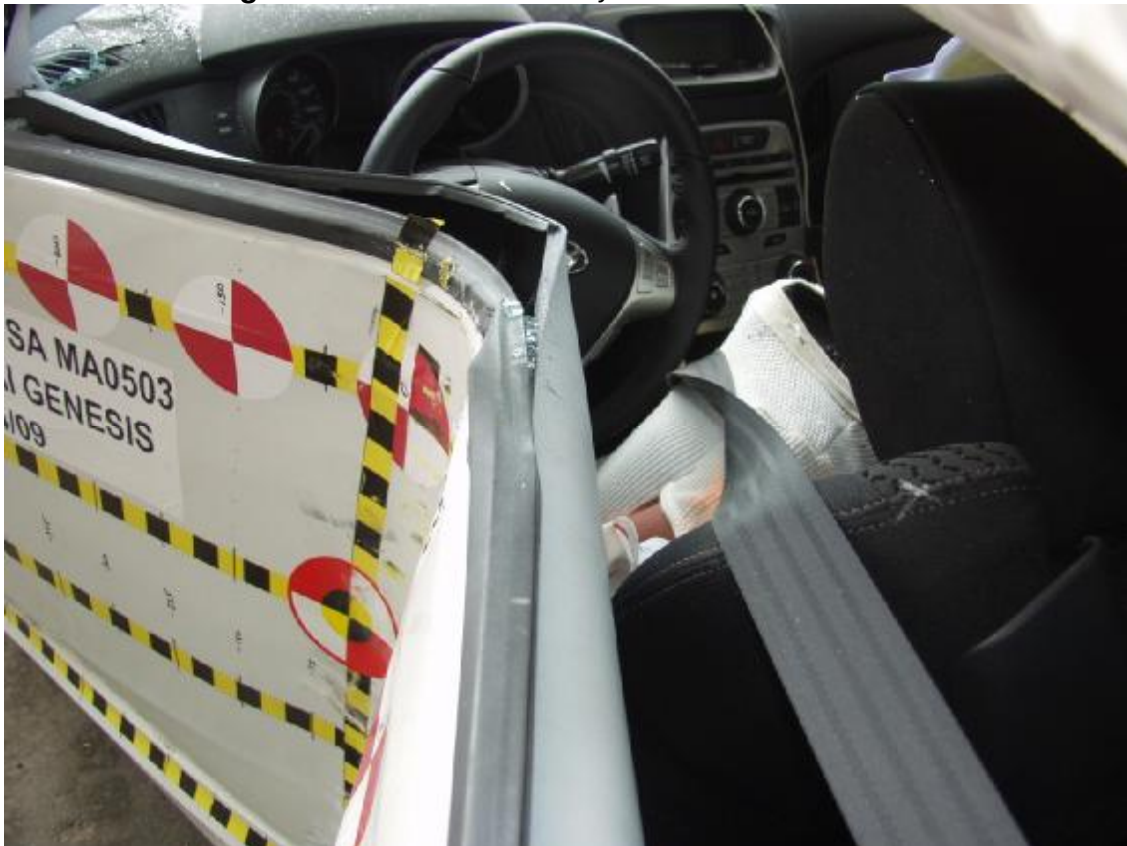
**Figure A-40:** Post-Test Dummy and Door Clearance View

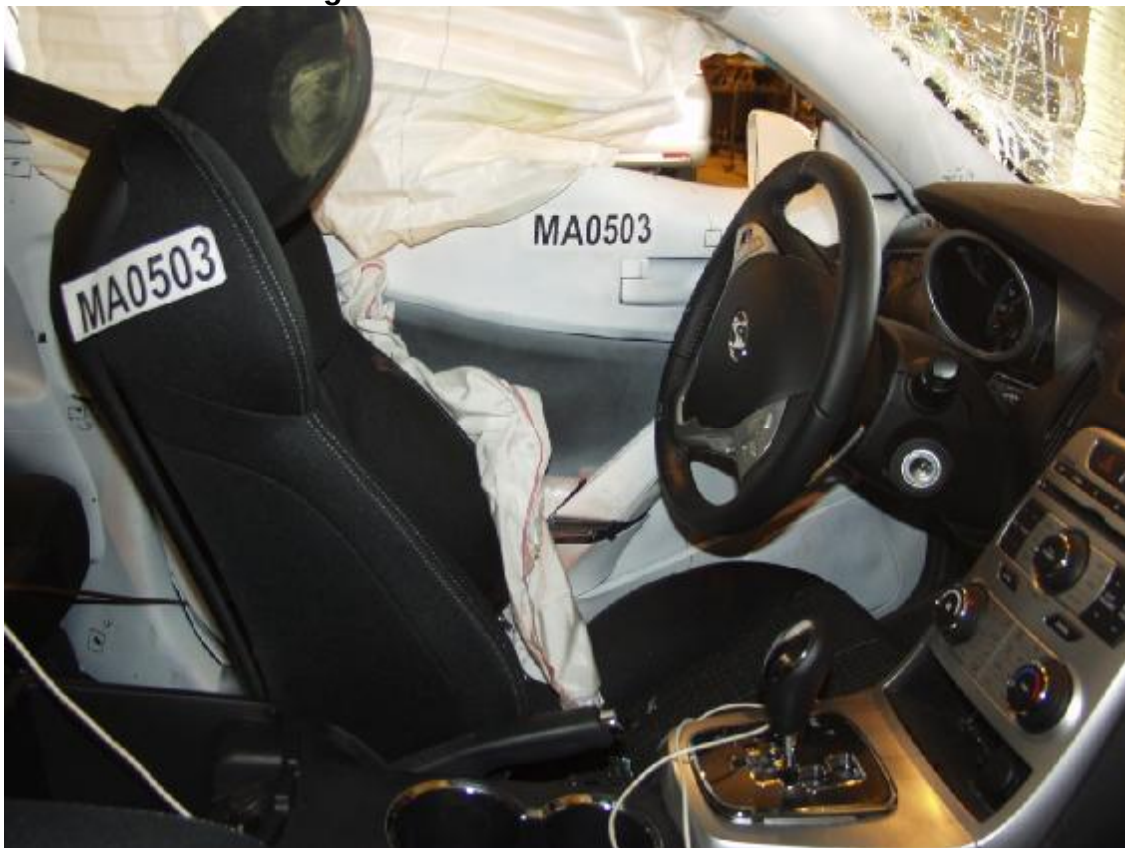
**Figure A-44:** Post-Test Inner Door Panel View Showing Dummy Contact Location

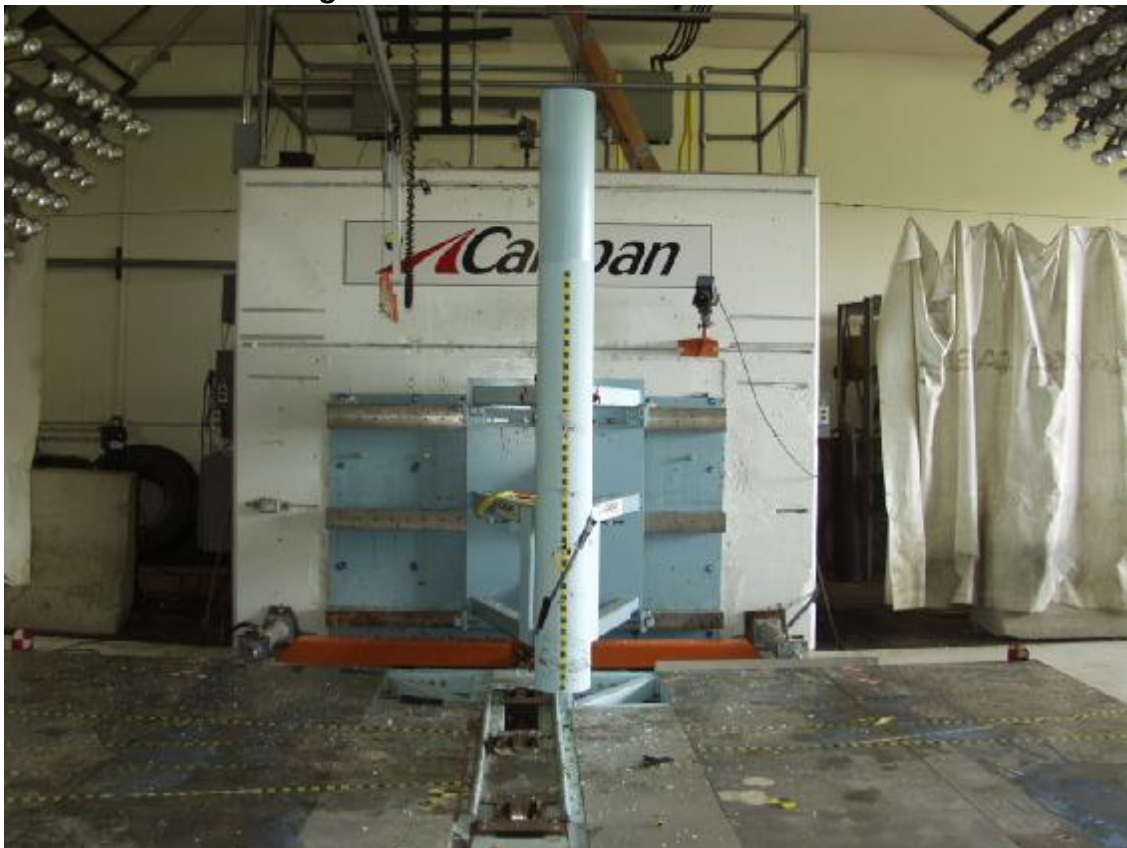
**Figure A-46:** Post-Test Pole Barrier Front View

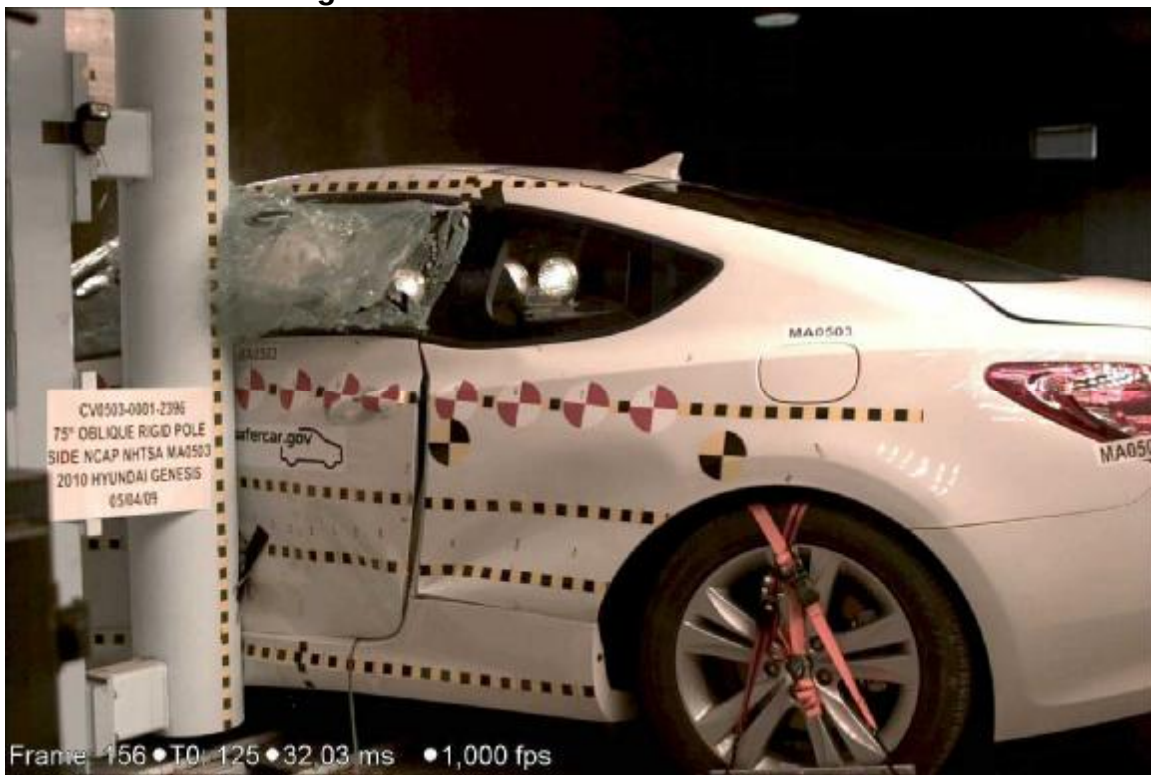
**Figure A-46:** Impact Event (Impact Side)

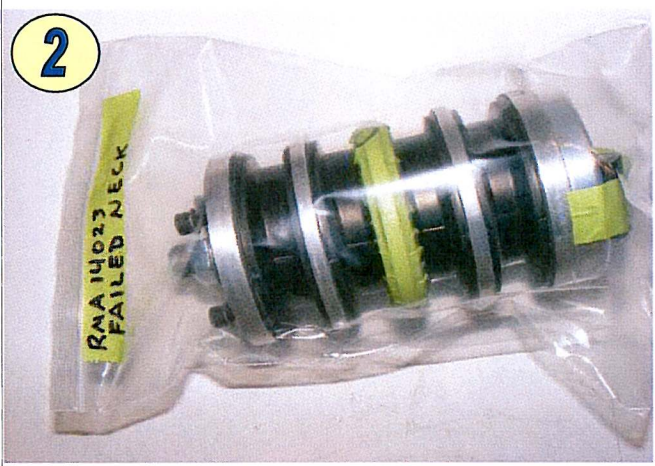
Failed Certification - Neck S/N = 705

Failed Certification - Failed Neck S/N = 705

No Sensor cals. VRTC to supply replacement parts if needed. Parts replaced - Neck = 787 &amp; Left Arm S/N = 822

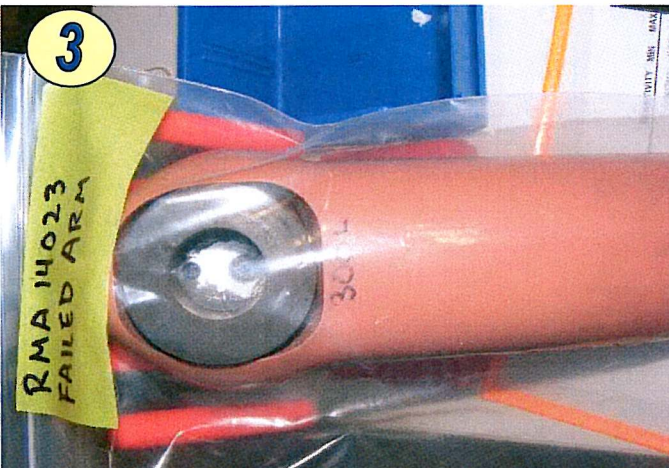
Left Arm - Failed Certification - S/N = 943

Failed Certification Failed Arm S/N = 943
