**REPORT NUMBER: TR-P29008-02-NC**

**VALIDATION  
SIDE IMPACT POLE TEST**

**MAZDA MOTOR CORPORATION  
2010 MAZDA3 I SPORT  
4-DOOR SEDAN**

**PREPARED BY:  
KARCO ENGINEERING, LLC.  
9270 HOLLY ROAD  
ADELANTO, CA 92301**

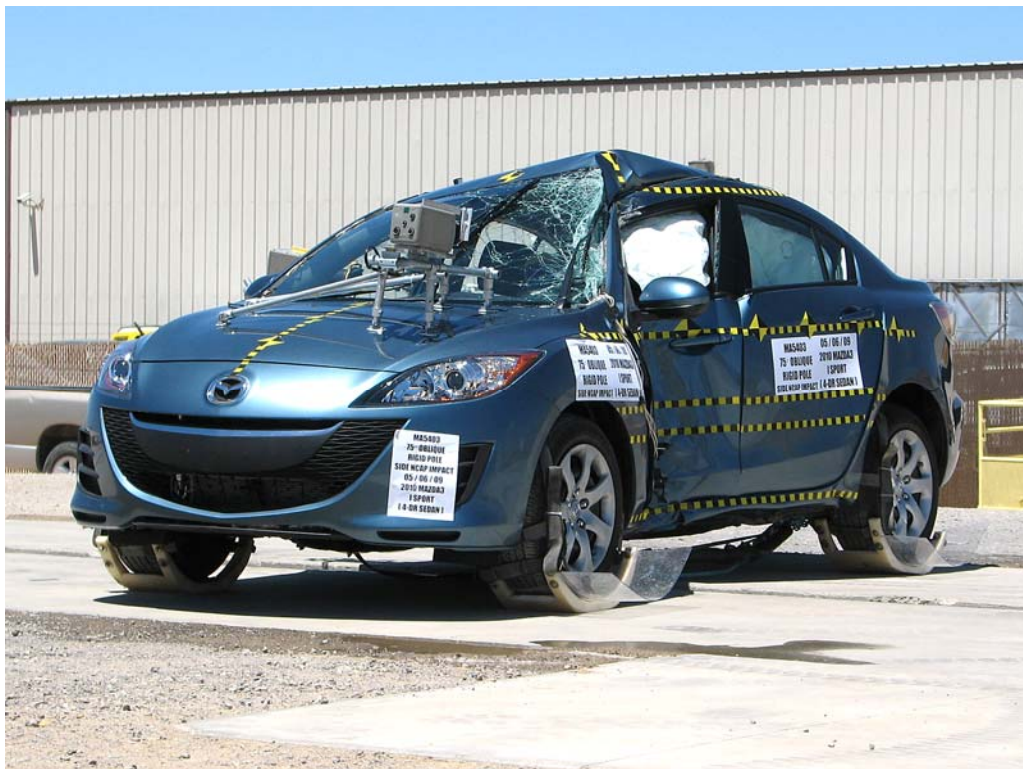
FIGURE 6. Post-Test Left Front  $\frac{3}{4}$  View of Test Vehicle

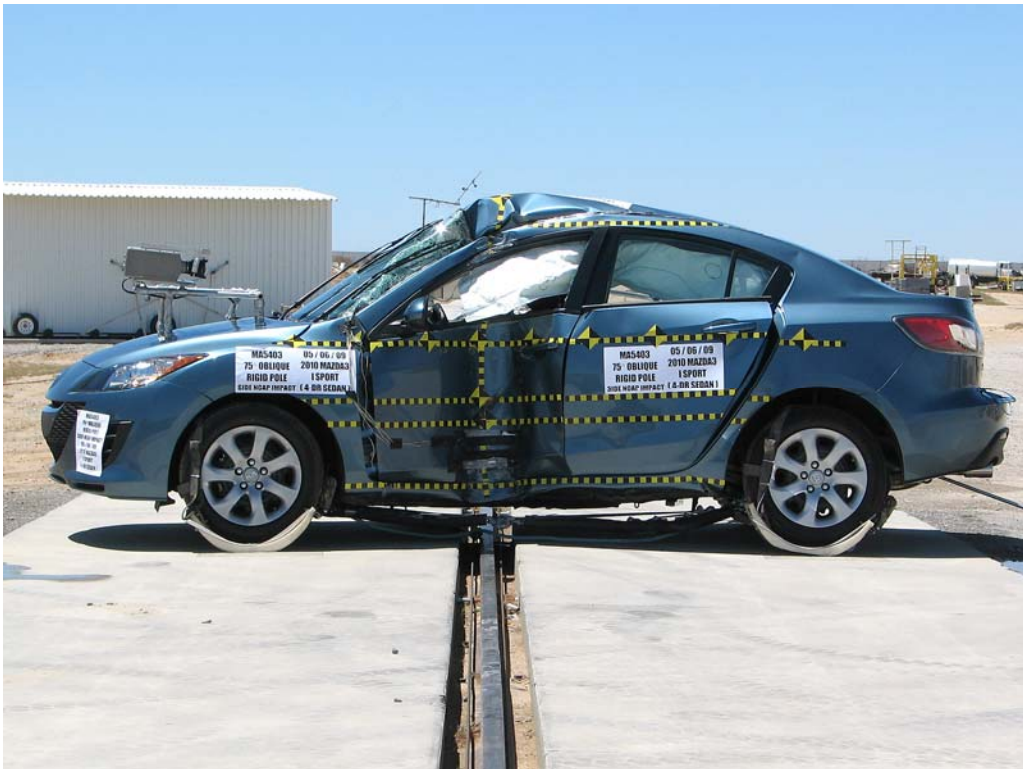
FIGURE 8. Post-Test Left Side View of Test Vehicle

Both the driver and left rear passenger doors remained closed and latched during and after the impact event. Neither door separated at the latch or hinge. The non-struck side doors remained closed and latched during the test. No Stoddard solvent spillage was observed during or after the impact test. The curtain airbag on the driver's side ruptured near the region of ATD head contact during the side impact pole test. The HIC<sub>36</sub> injury value exceeded the threshold. Resultant Lower Spine and Combined Pelvic Force values were all under the threshold values.

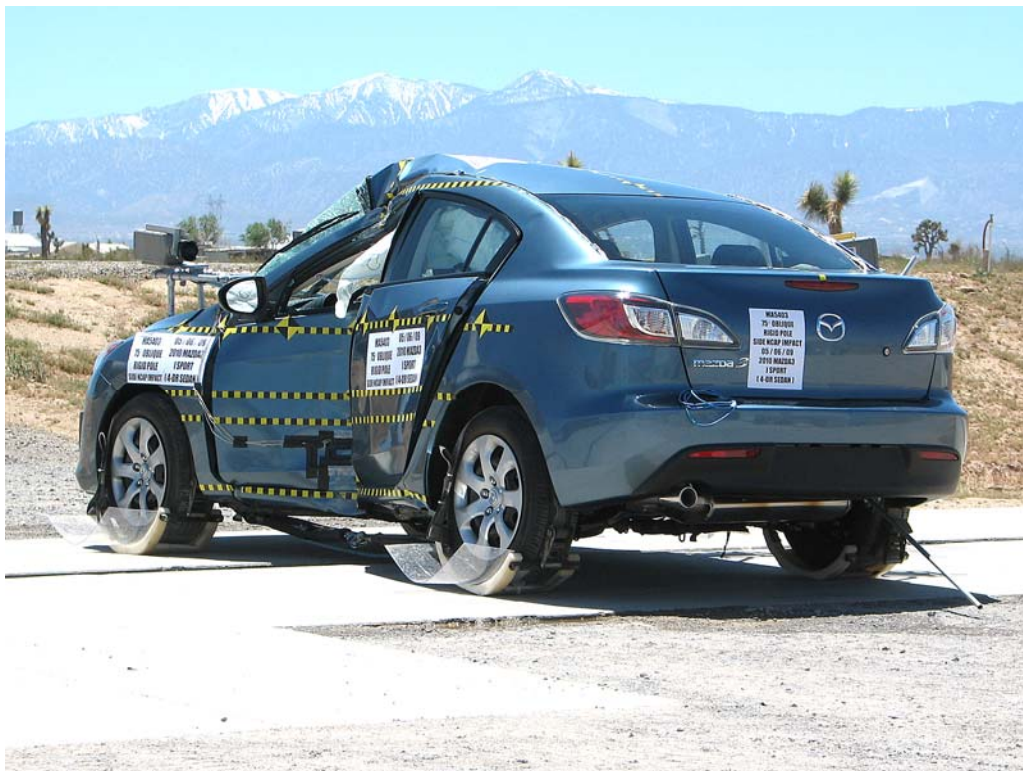
FIGURE 10. Post-Test Left Rear ¾ View of Test Vehicle

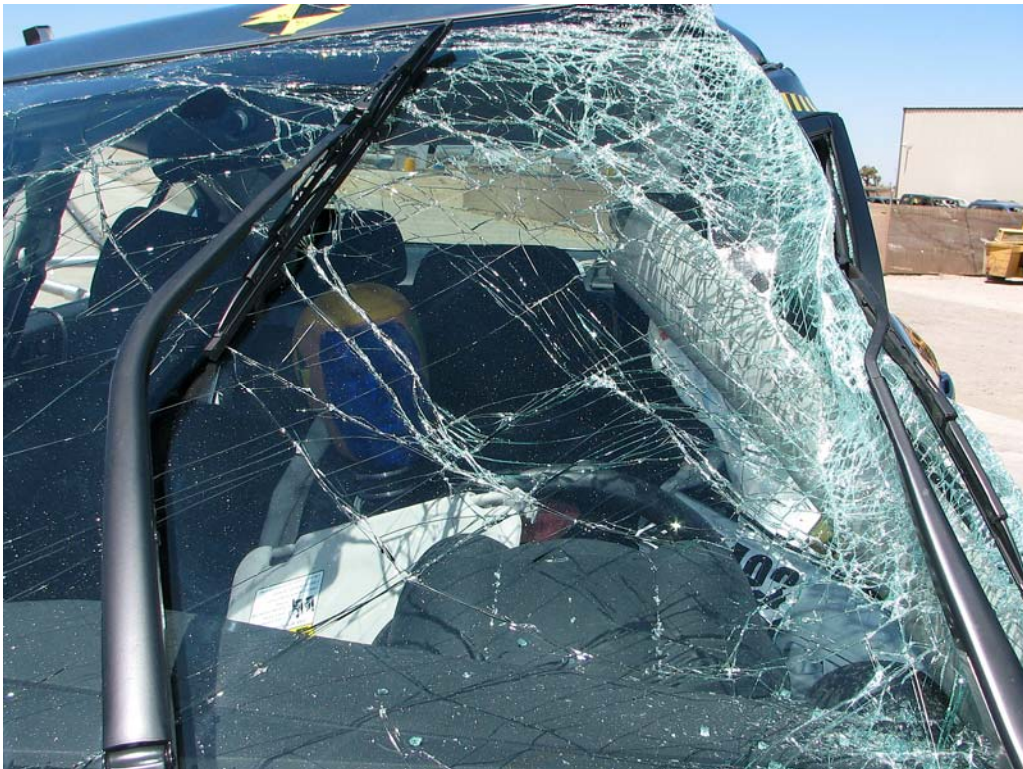
FIGURE 22. Post-Test Front Close-Up View of Dummy (Through Front Window)

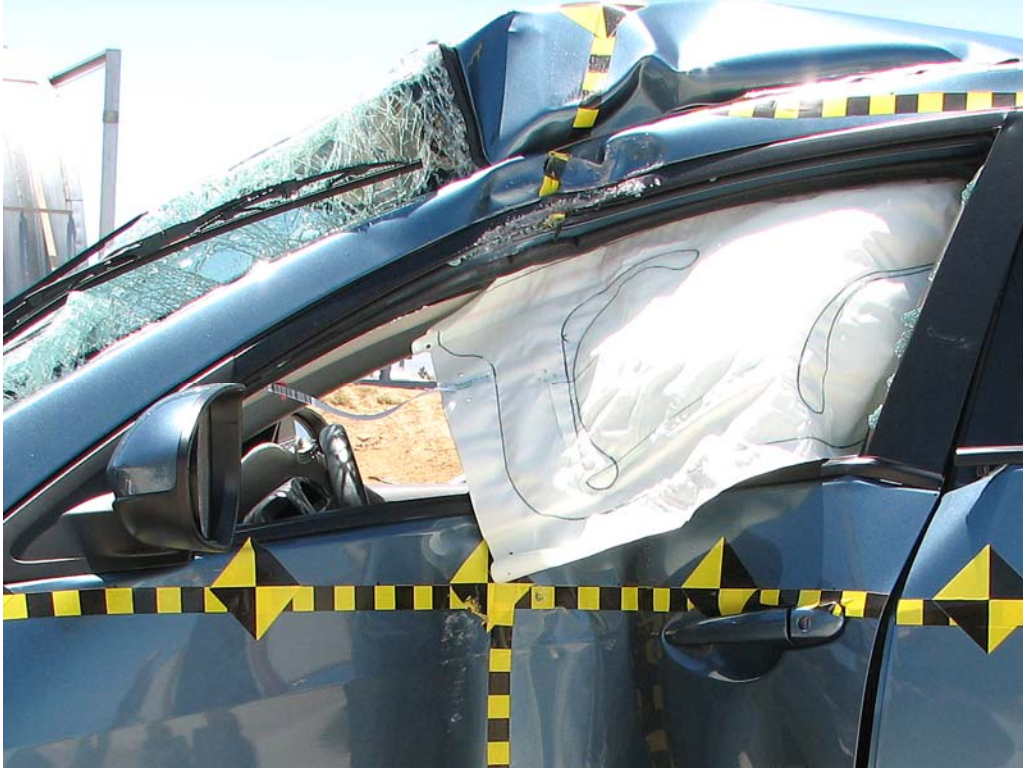
FIGURE 25. Post-Test Left Side View of Dummy Shoulder and Door Top View

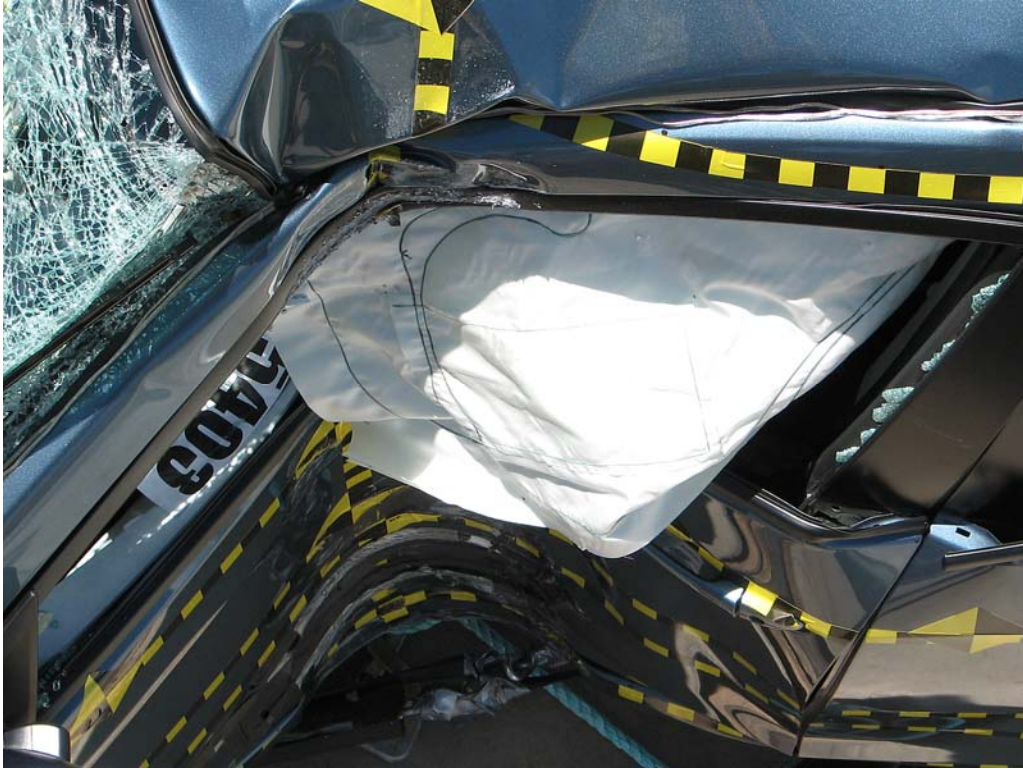
FIGURE 31. Post-Test Dummy and Door Clearance View

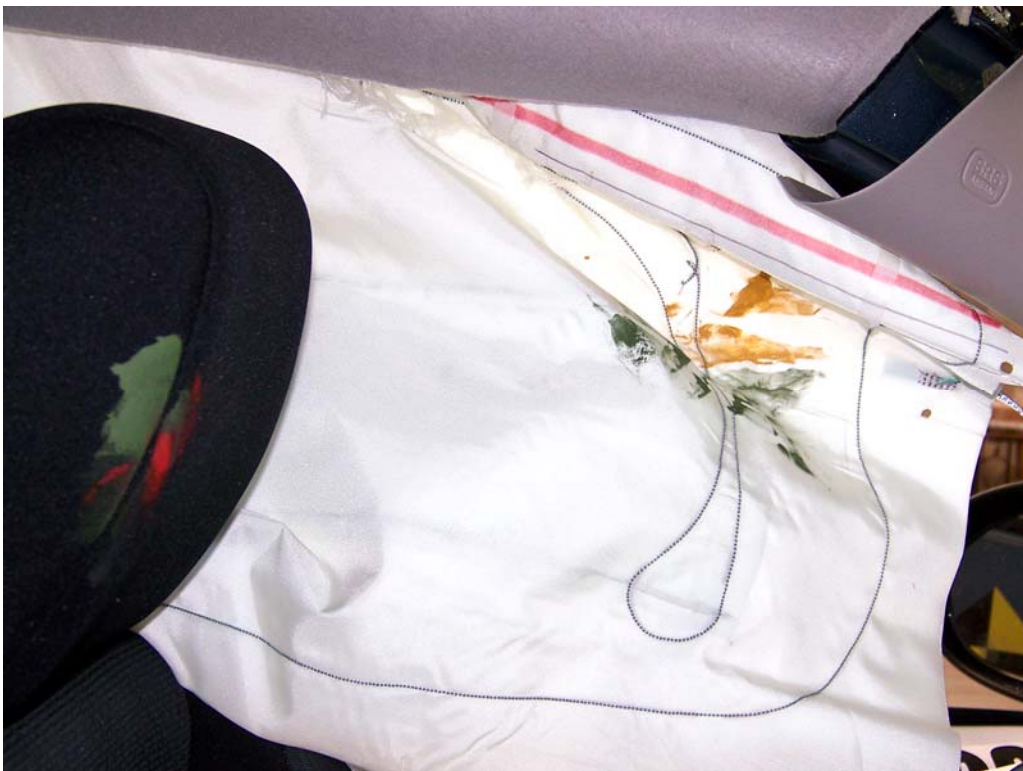
FIGURE 36. Post-Test Dummy Head Contact View

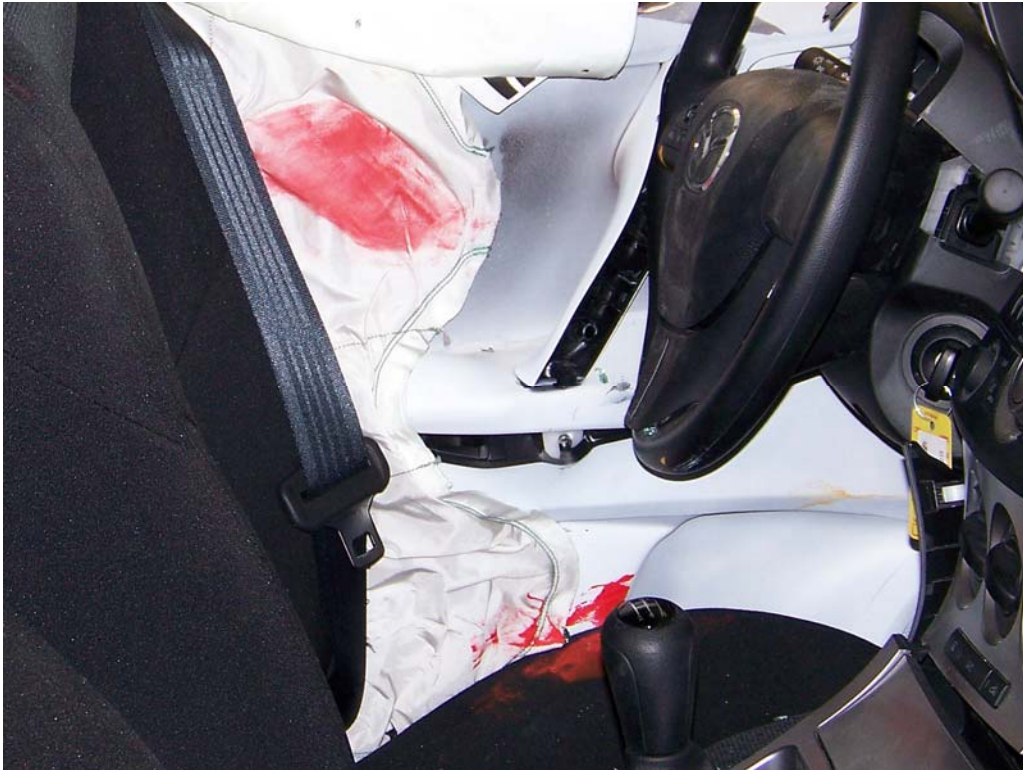
FIGURE 37. Post-Test Dummy Pelvis Contact View

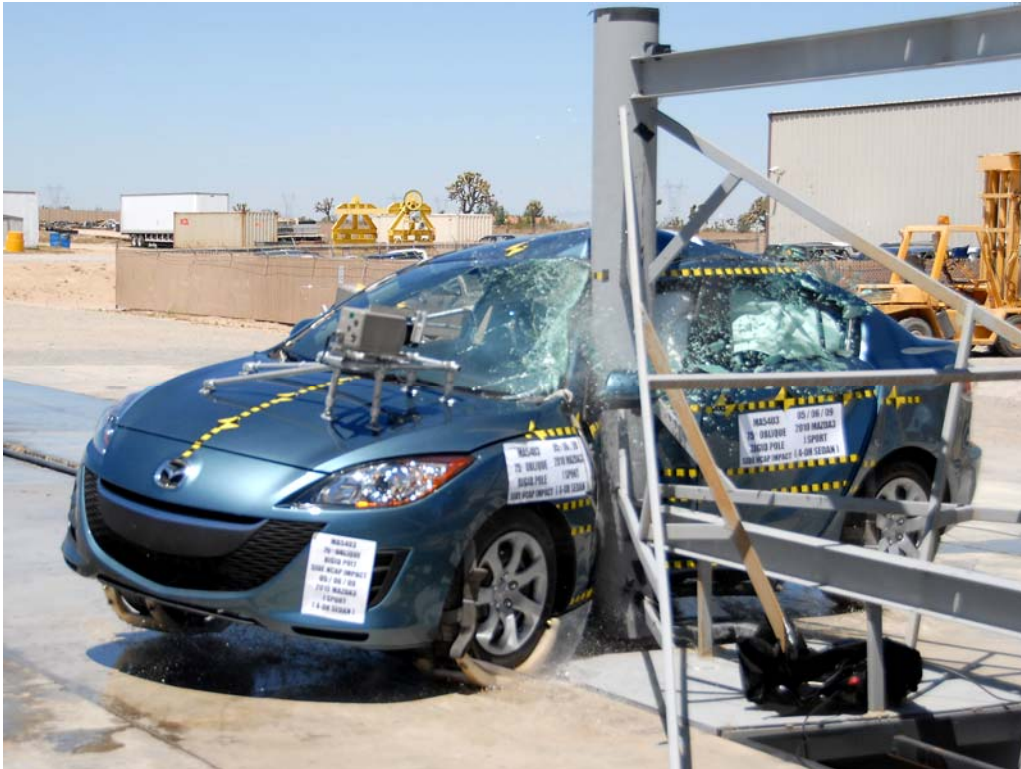
FIGURE 49. Impact Event
