**REPORT NUMBER: TR-P29001-06-NC**

**VALIDATION FRONTAL BARRIER IMPACT TEST**

**2010 MAZDA3 I SPORT**

**FINAL REPORT**

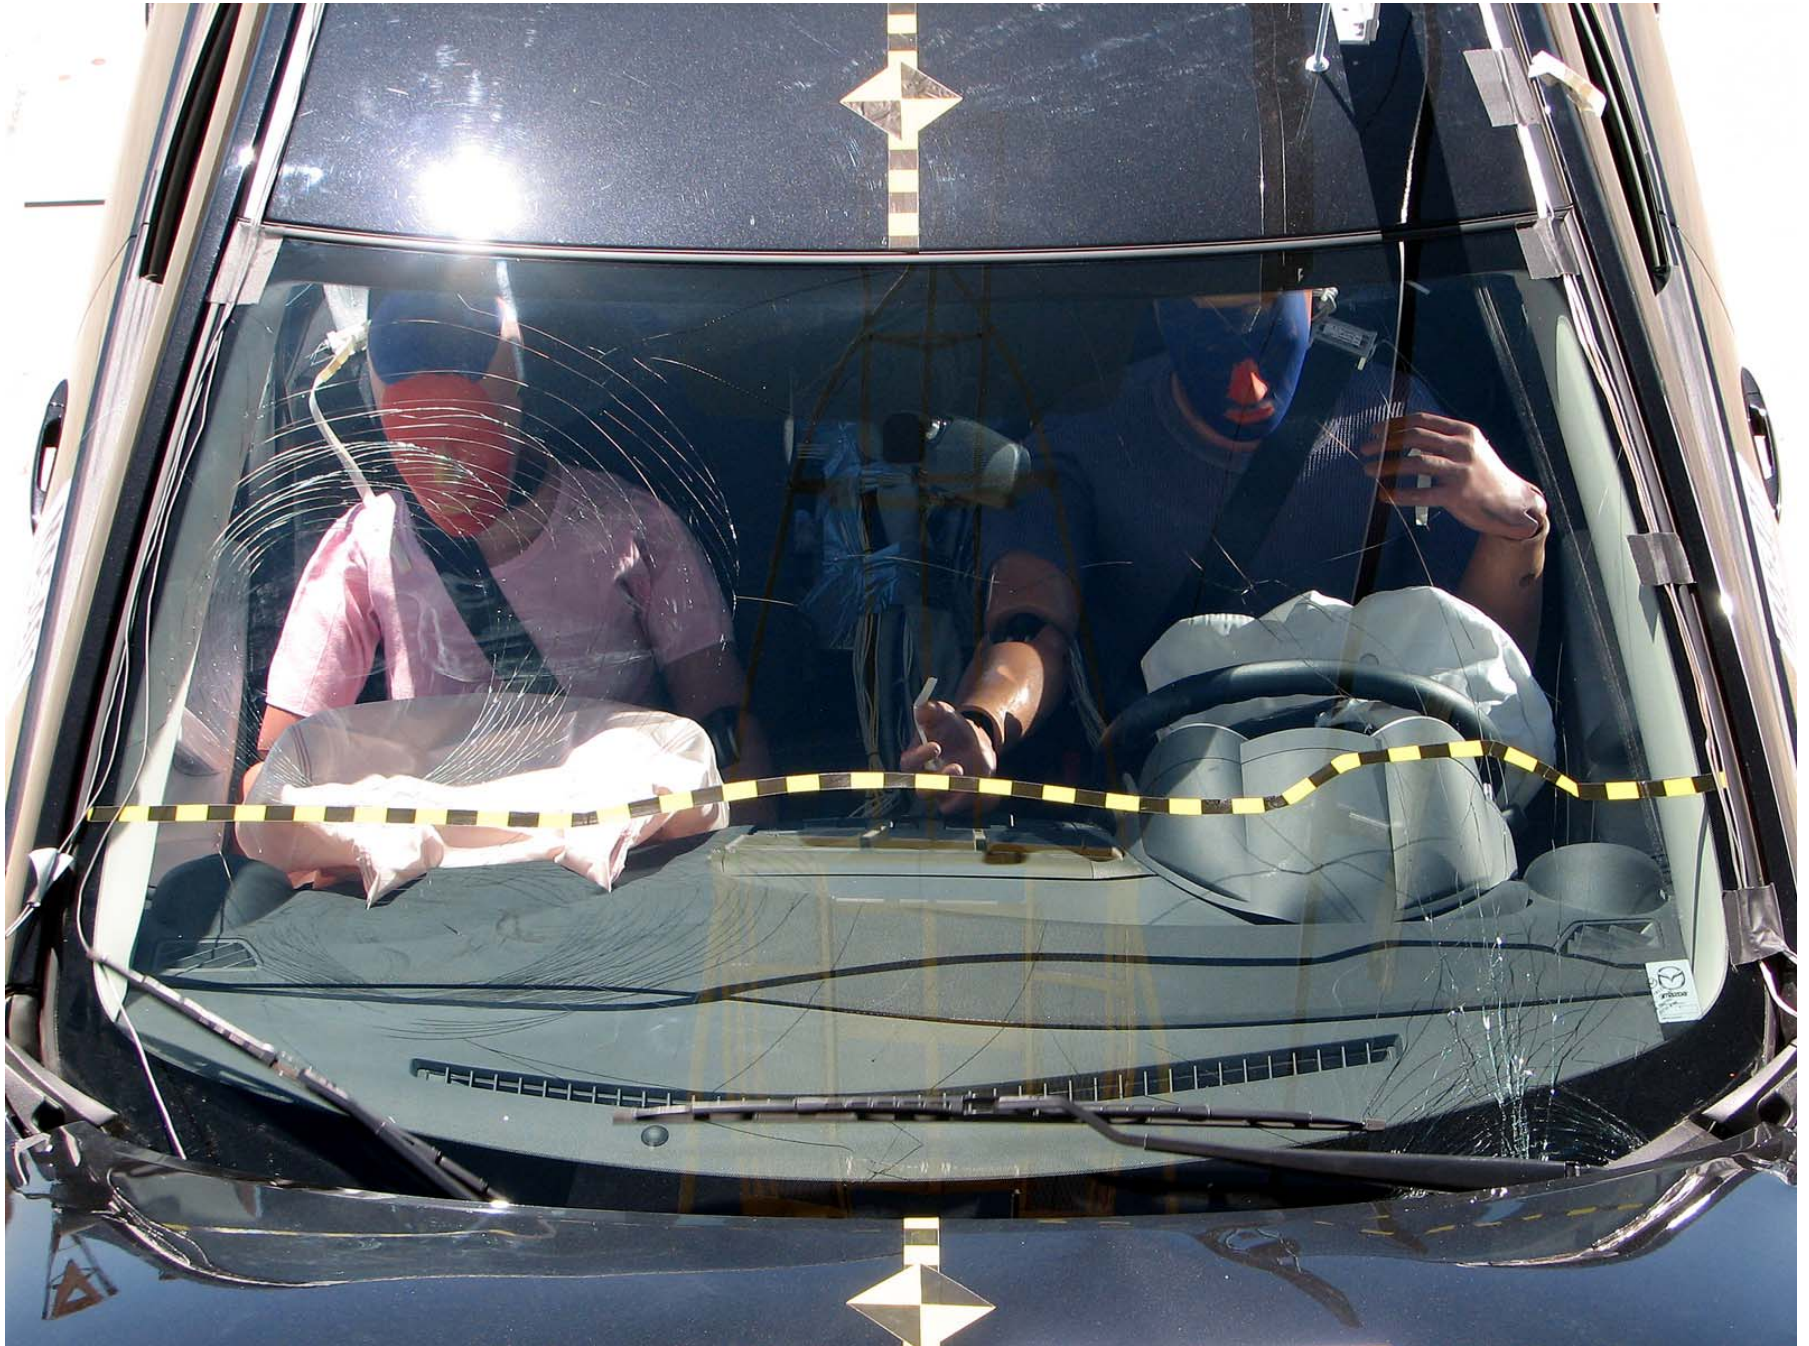
Figure A-17: Post-Test Windshield View

There was 100% windshield retention and no intrusion into the protected zone of the windshield during the event. There was no Stoddard solvent leakage after the event or during any phase of the static rollover.

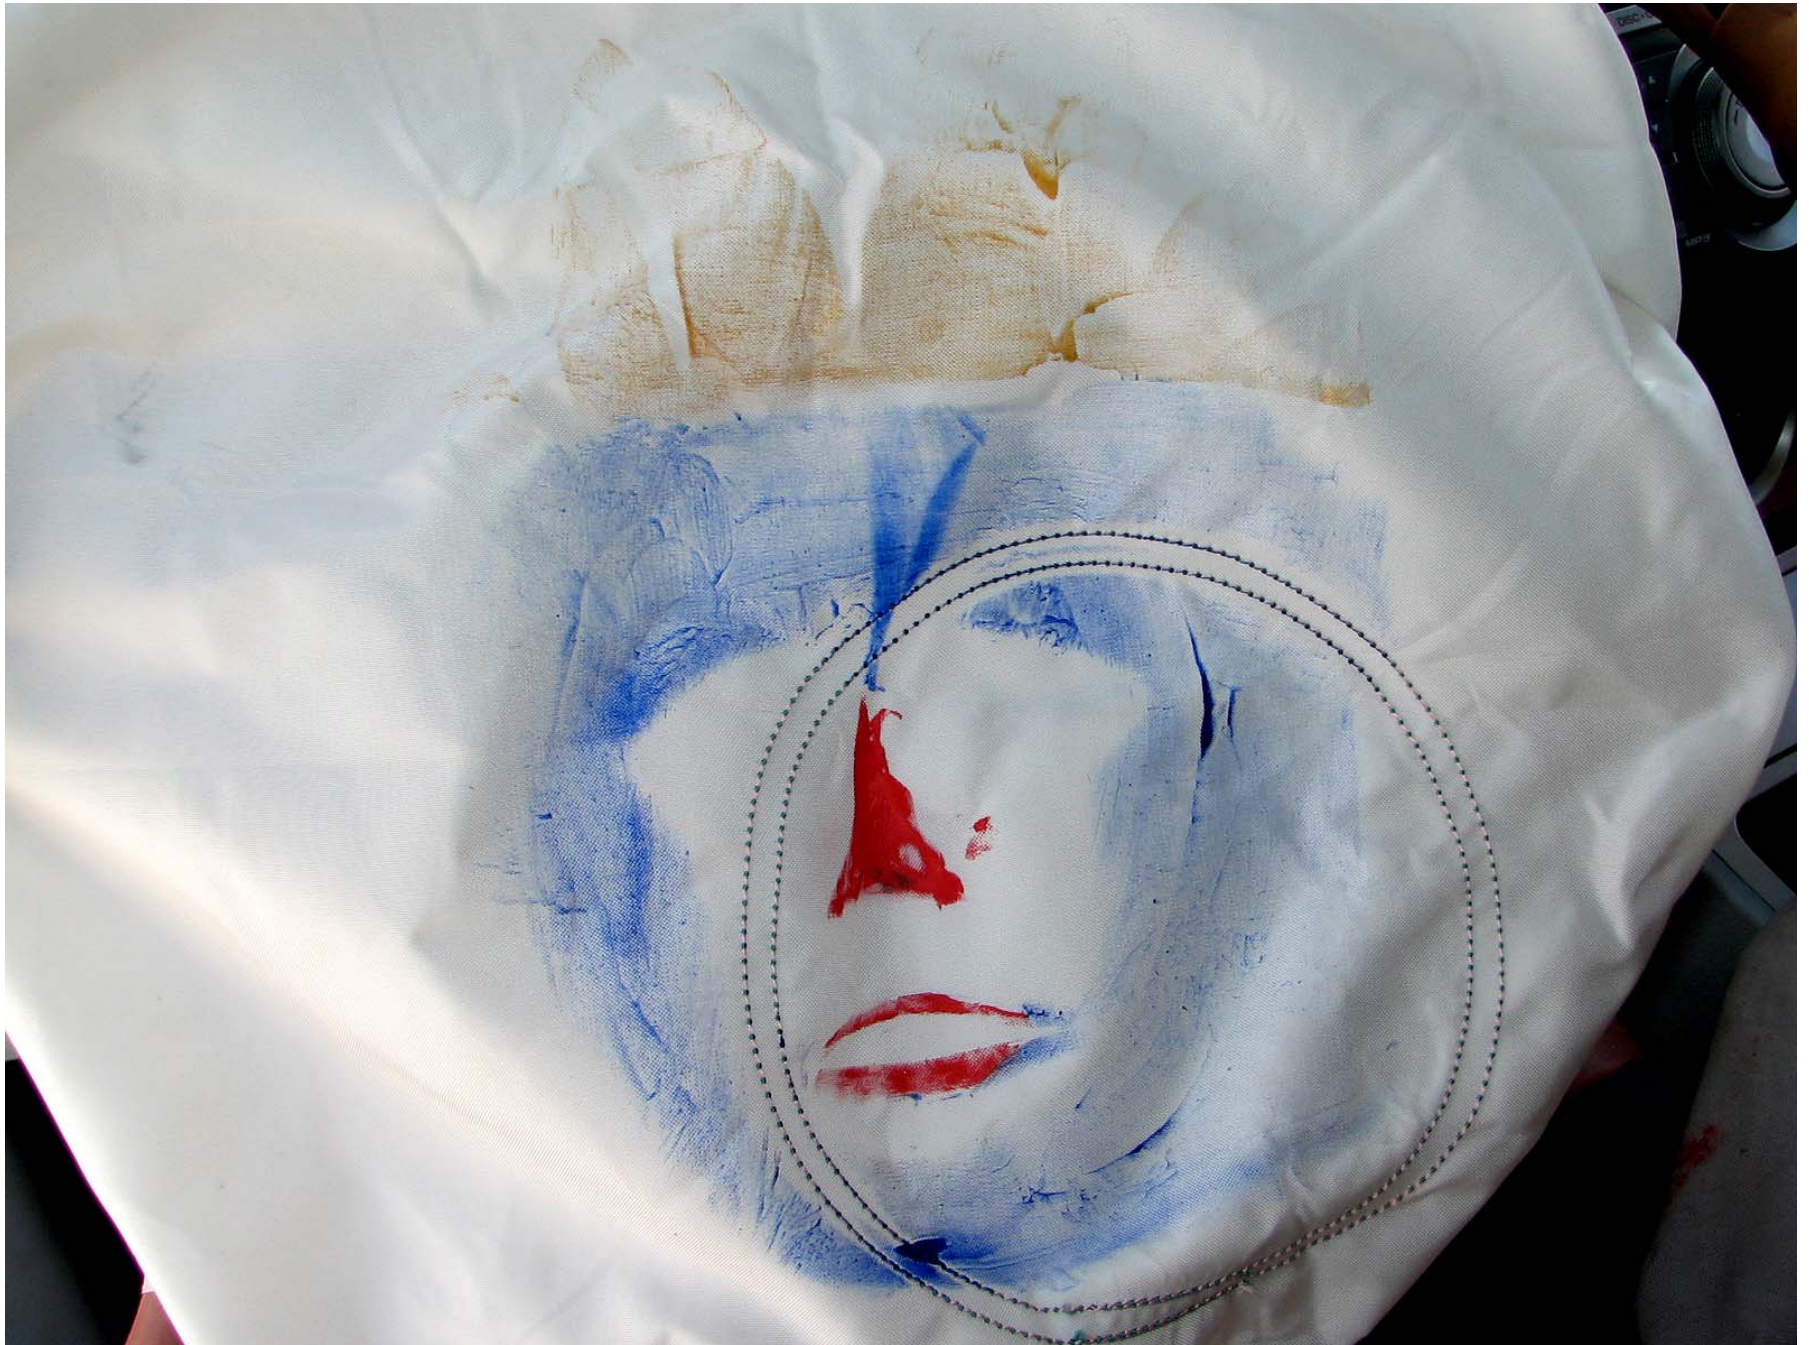
Figure A-43: Post-Test Driver Dummy Contact with Airbag

The driver's visible contact points were as follows: The driver ATD's head and chest contacted the airbag. The head also contacted the headrest. Both the left and right knees contacted the knee bolster. The left knee also contacted the steering column.

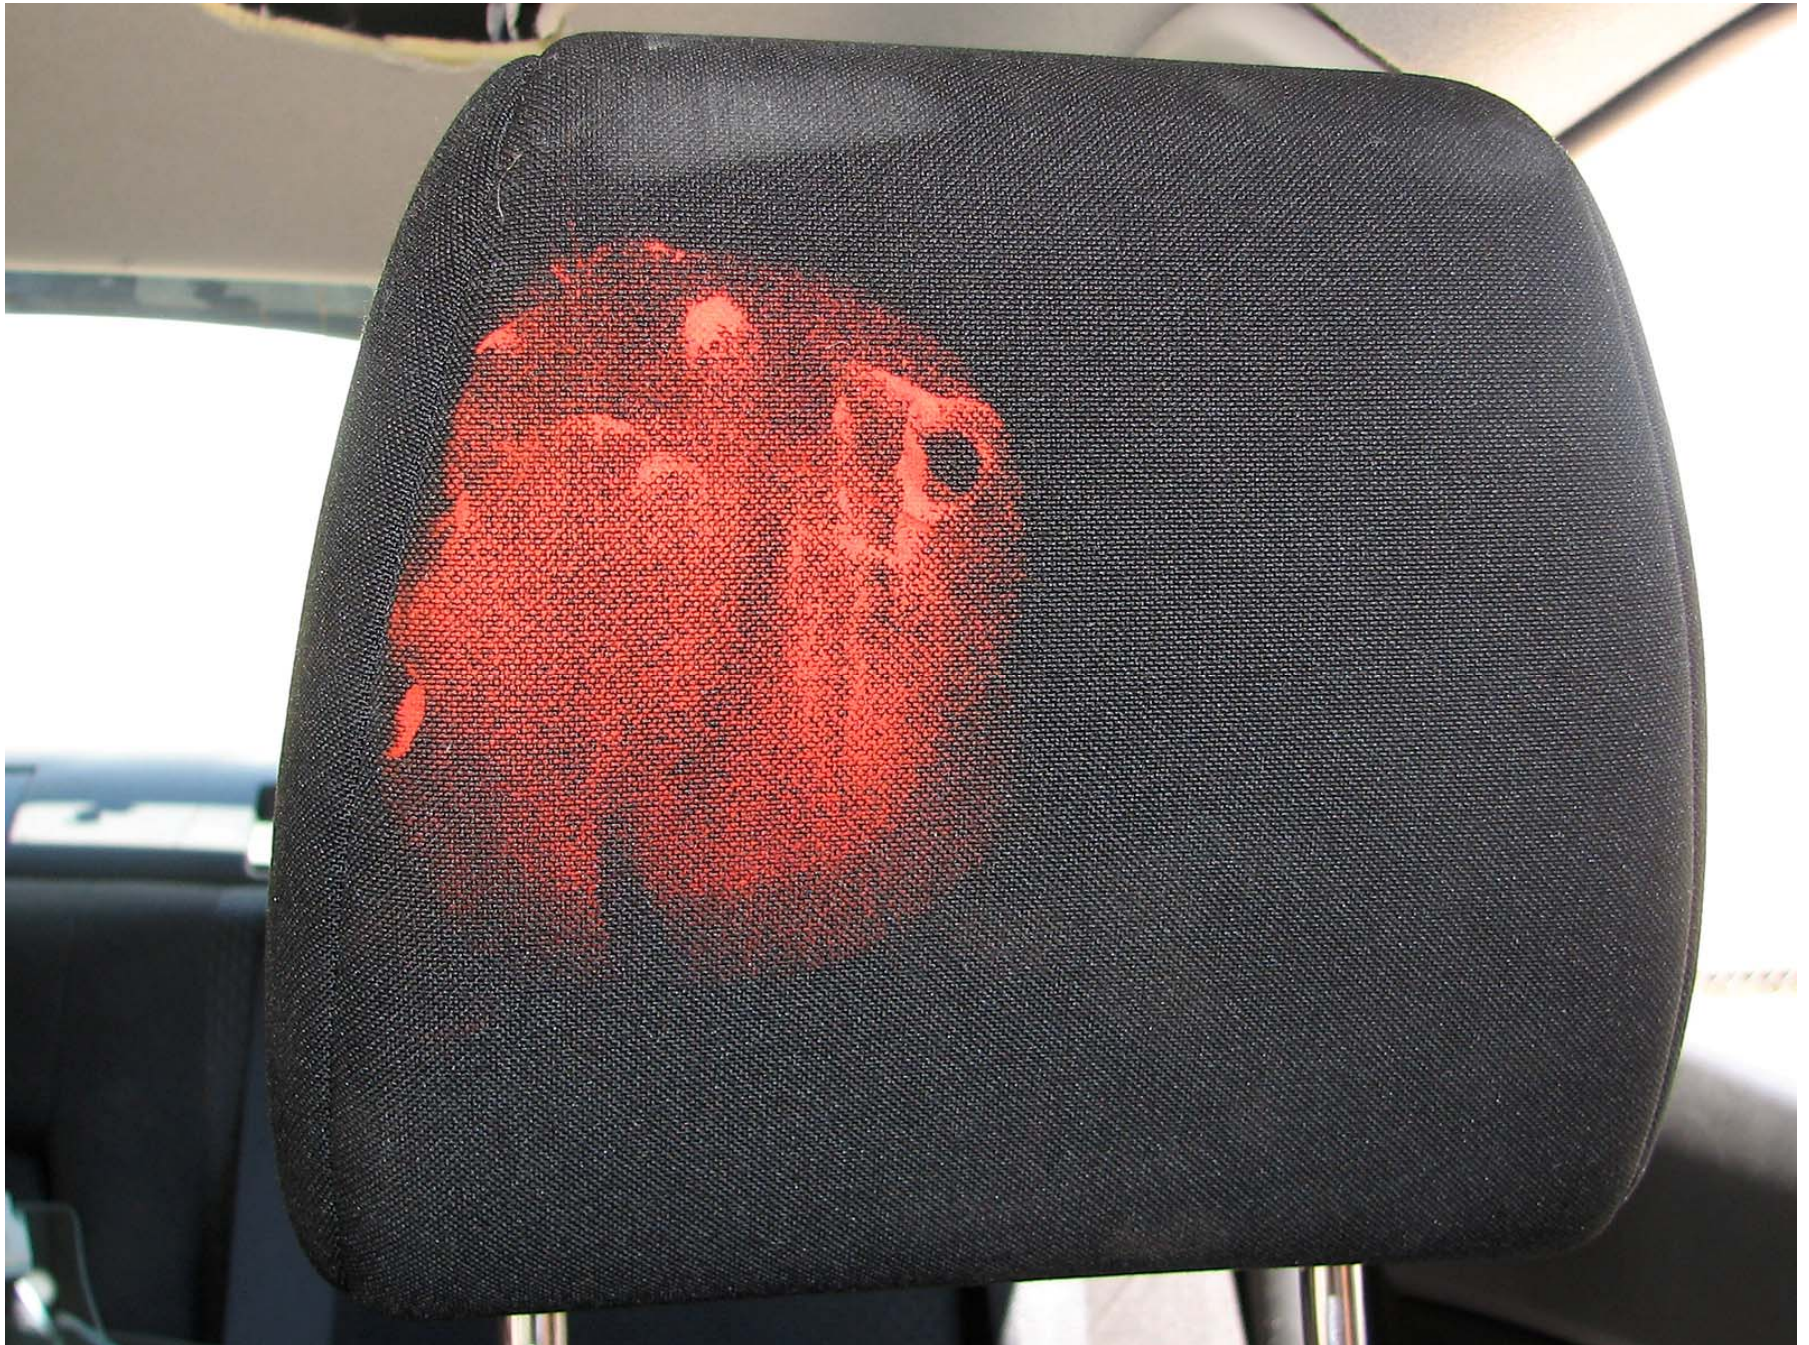
Figure A-44: Post-Test Driver Dummy Contact with Headrest

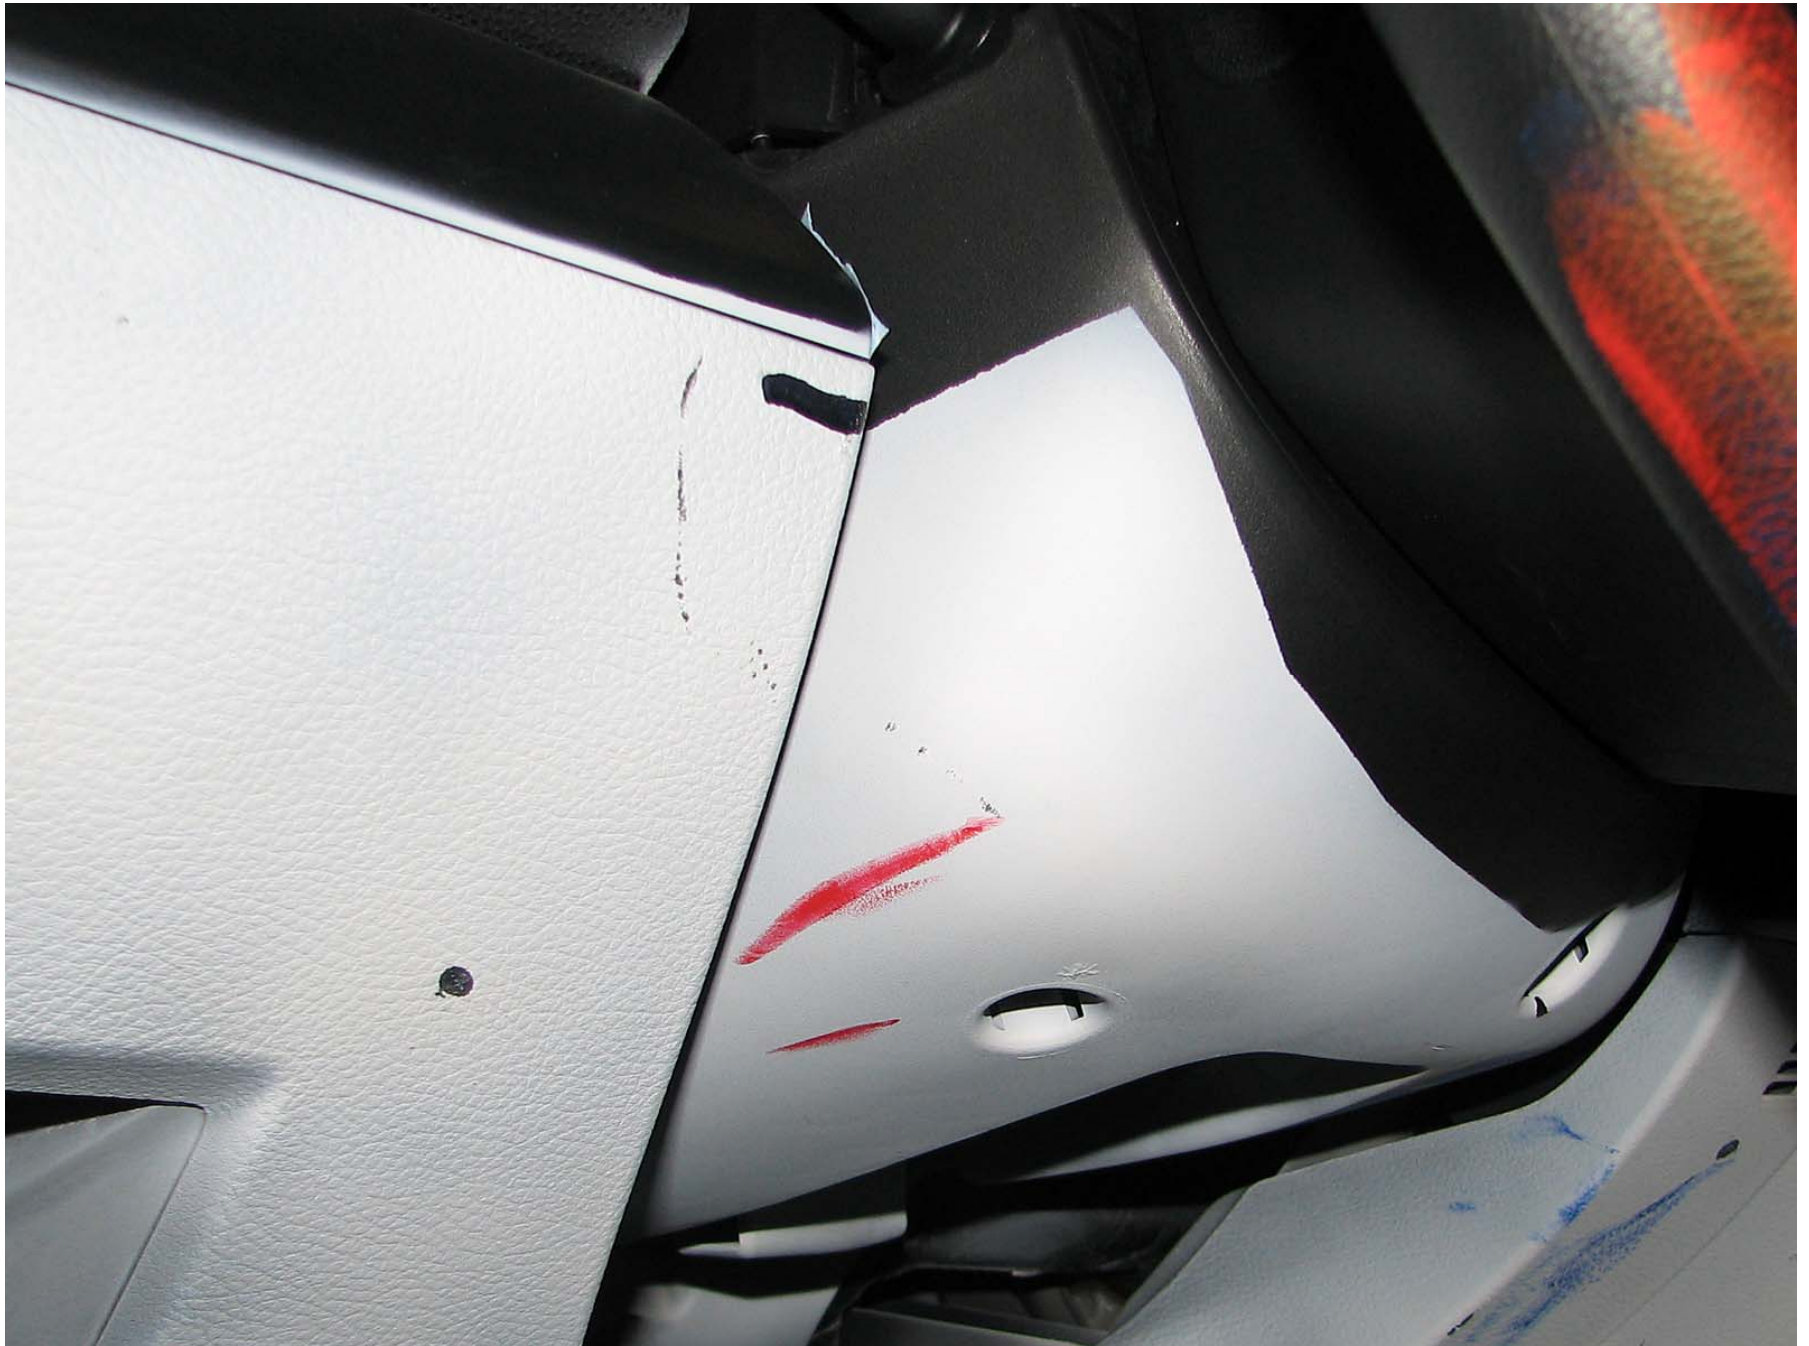
Figure A-46: Post-Test View of the Steering Column Shear Capsule

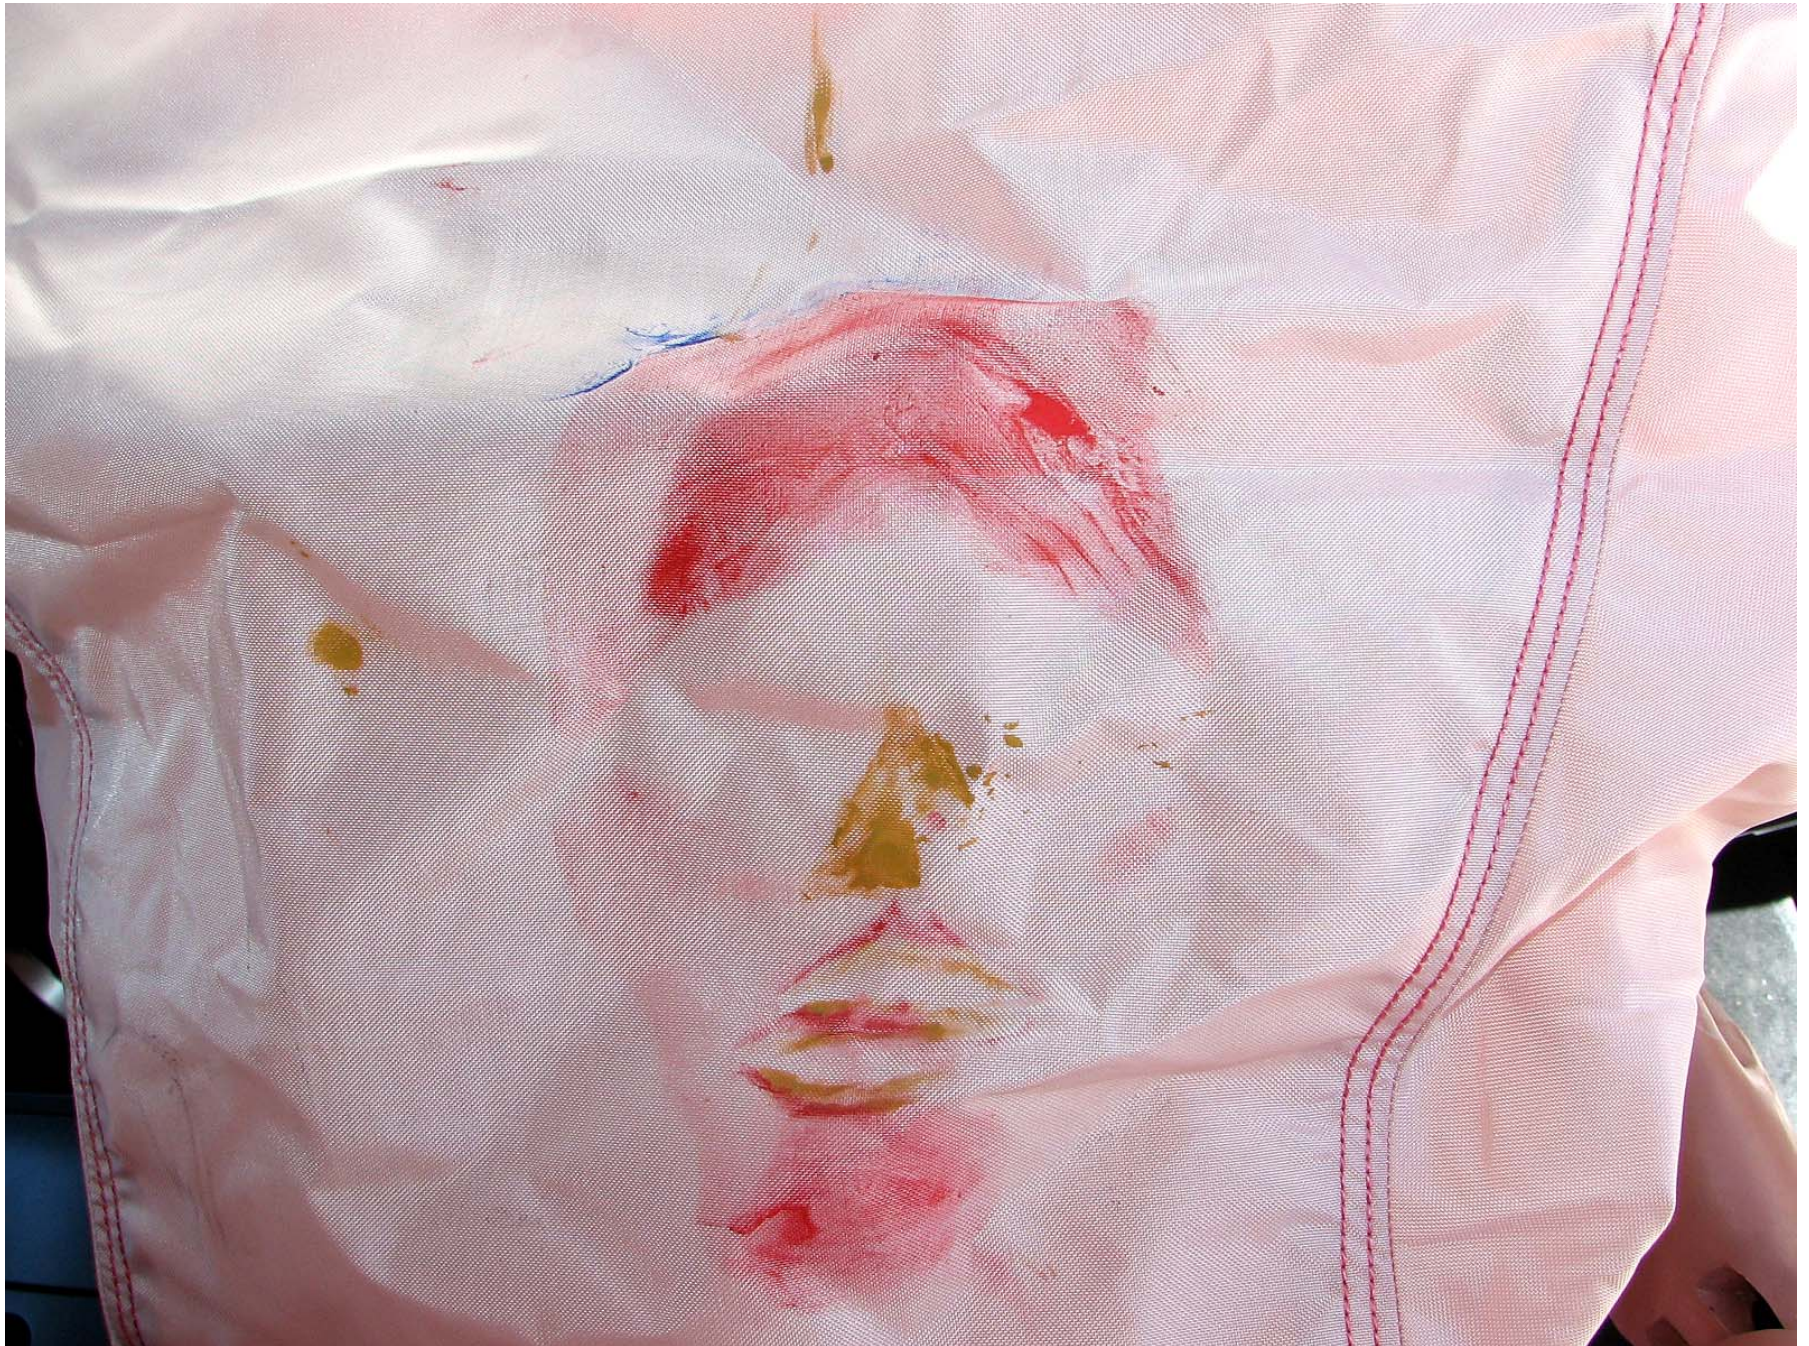
Figure A-62: Post-Test Passenger Dummy Contact with Airbag

The passenger's visible contact points were as follows: The passenger ATD's head and chest contacted the airbag. The head also contacted the headrest. Both the left and right knees contacted the glovebox.

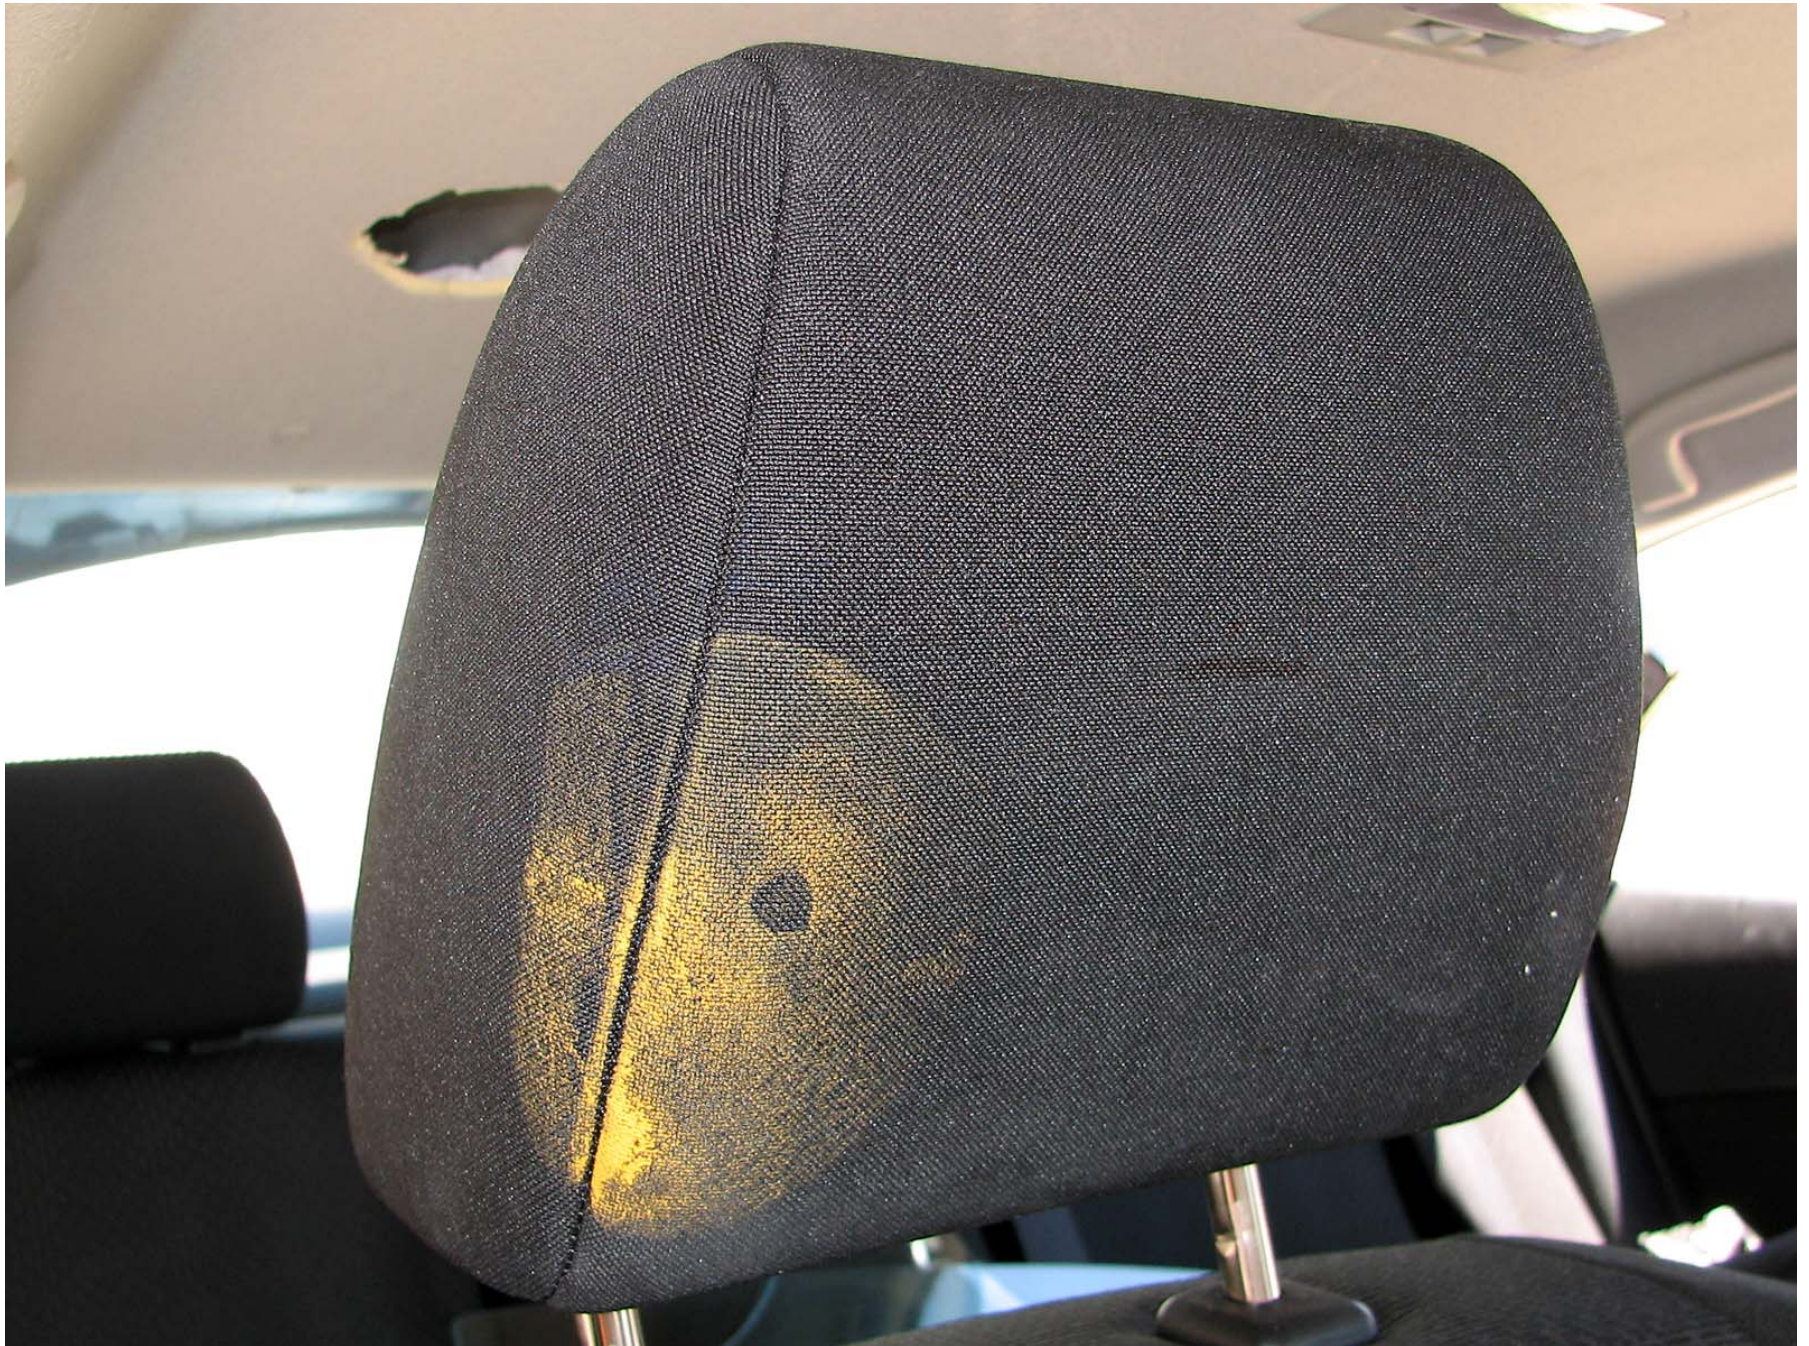
Figure A-63: Post-Test Passenger Dummy Contact With Headrest
