**REPORT NUMBER: TR-P29001-06-NC**

**VALIDATION FRONTAL BARRIER IMPACT TEST**

**2010 MAZDA3 I SPORT**

**FINAL REPORT**

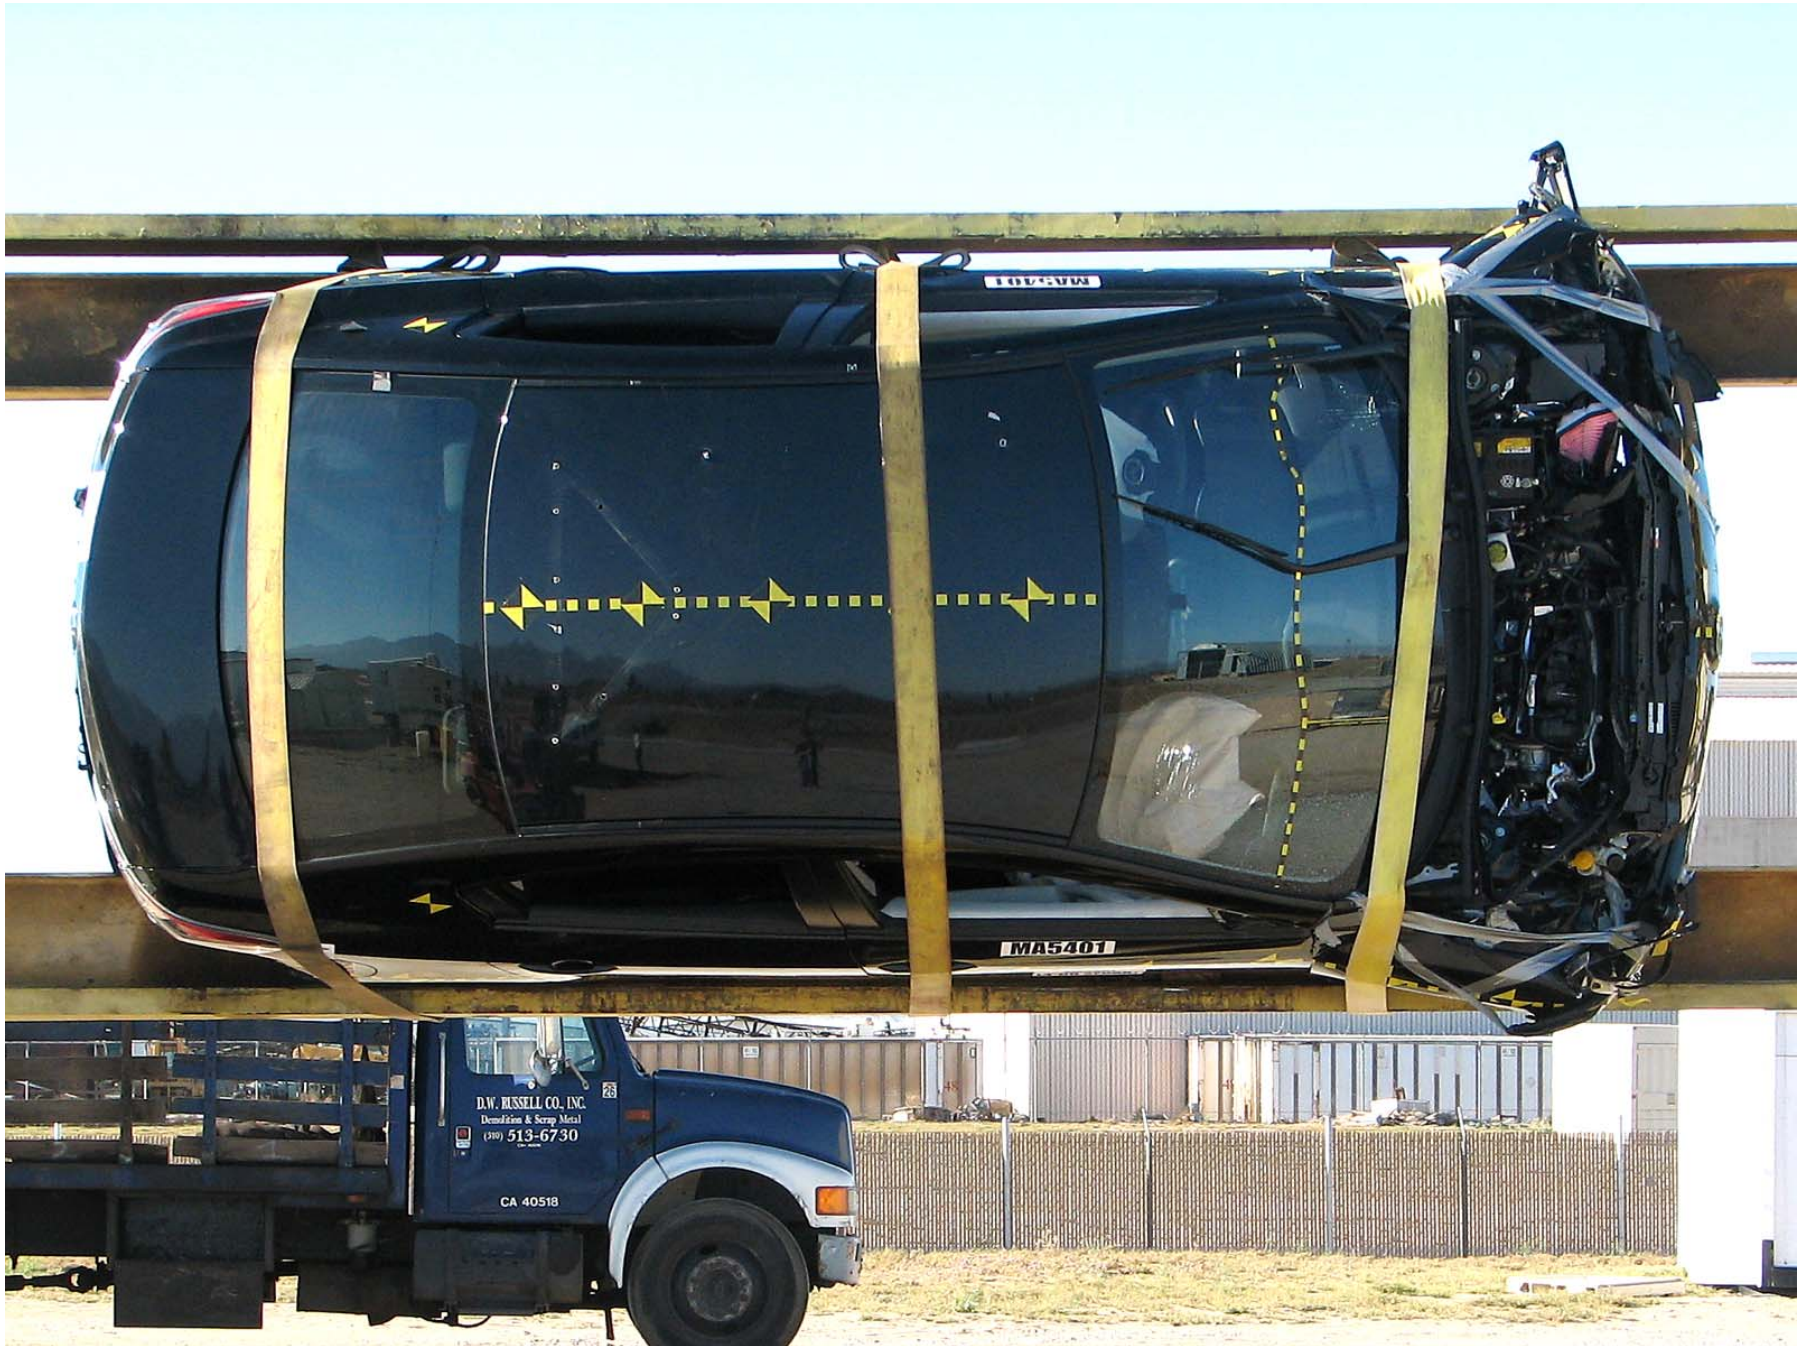
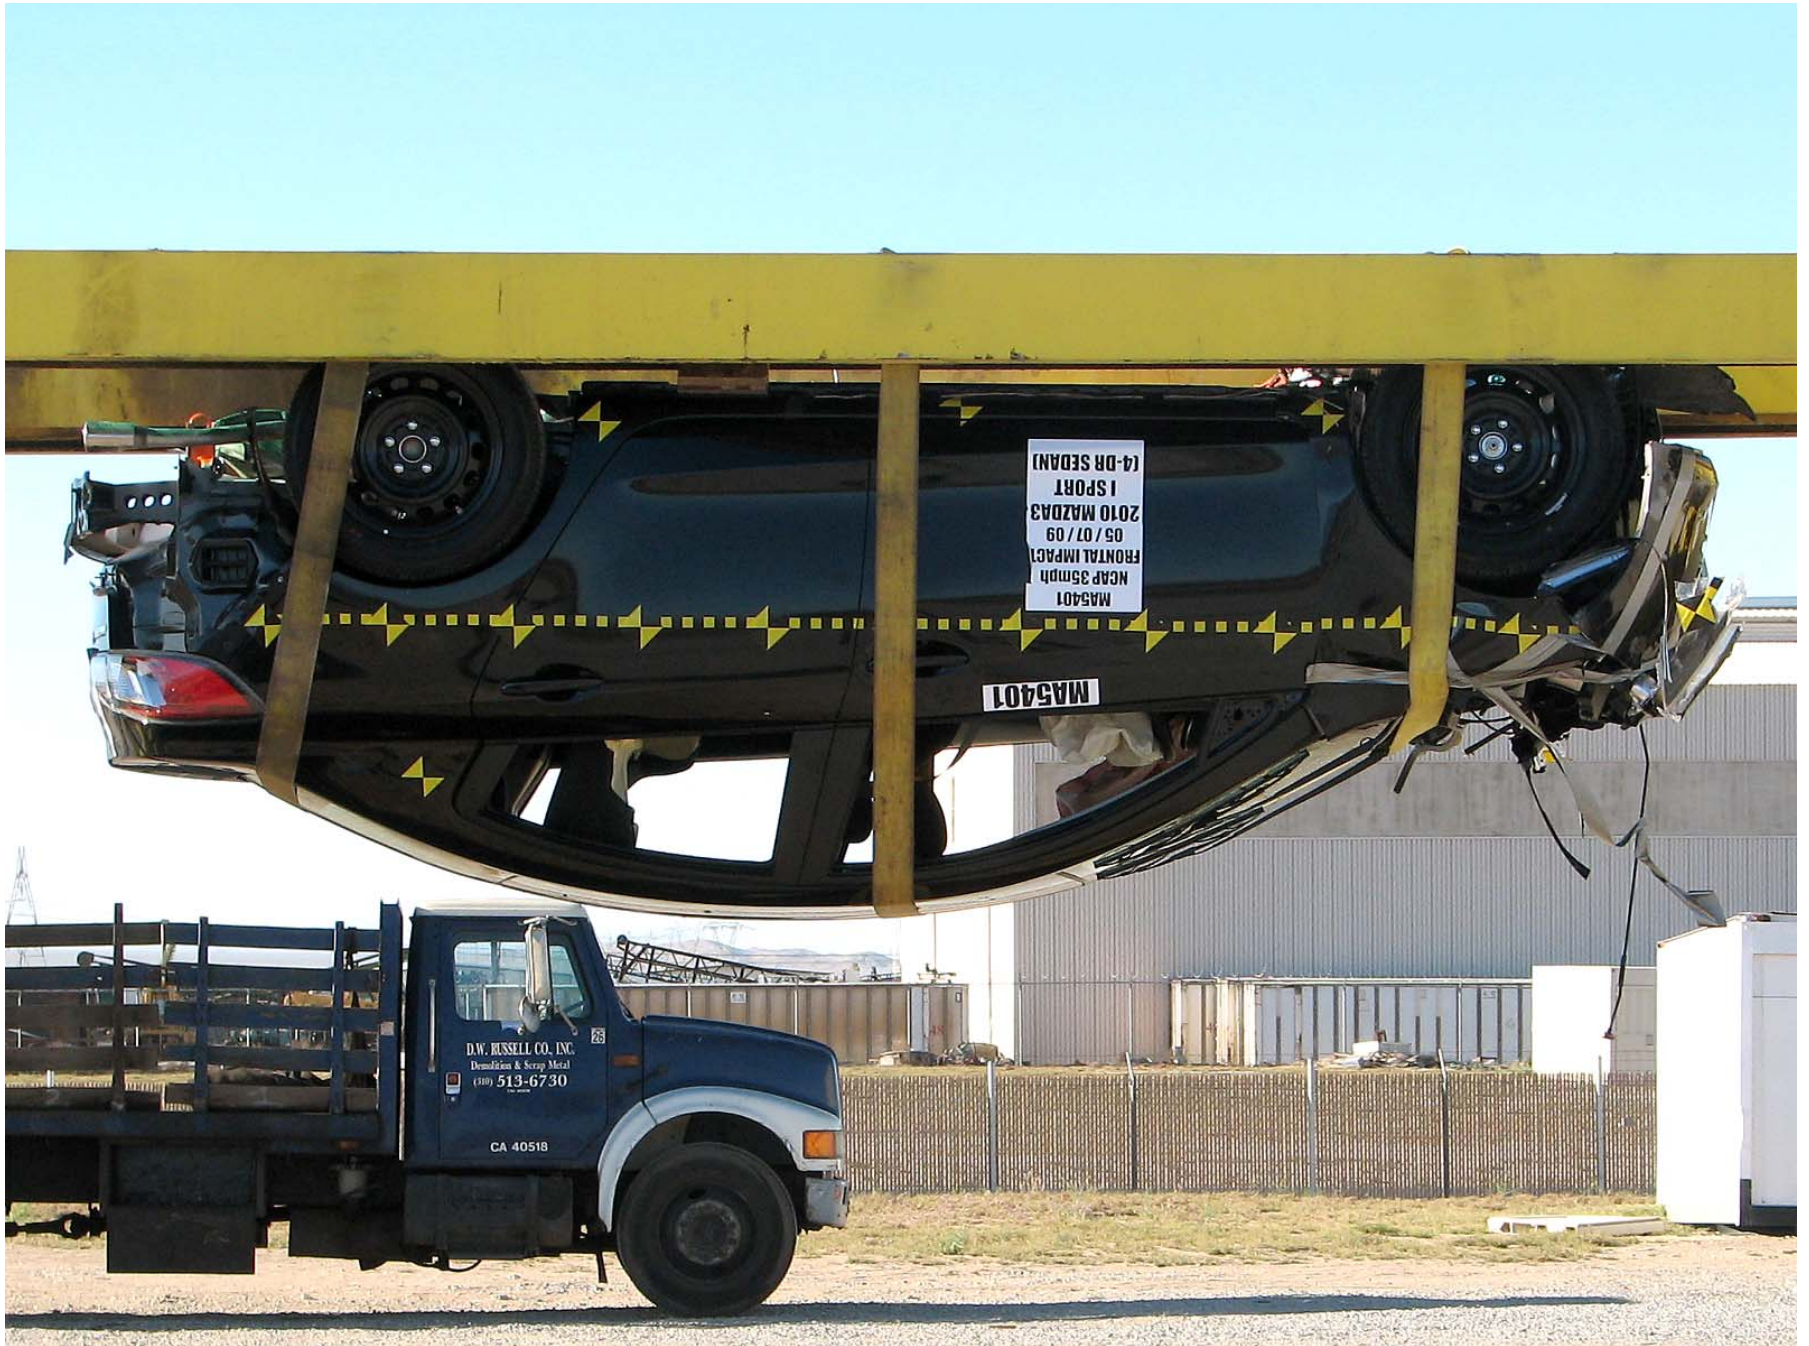
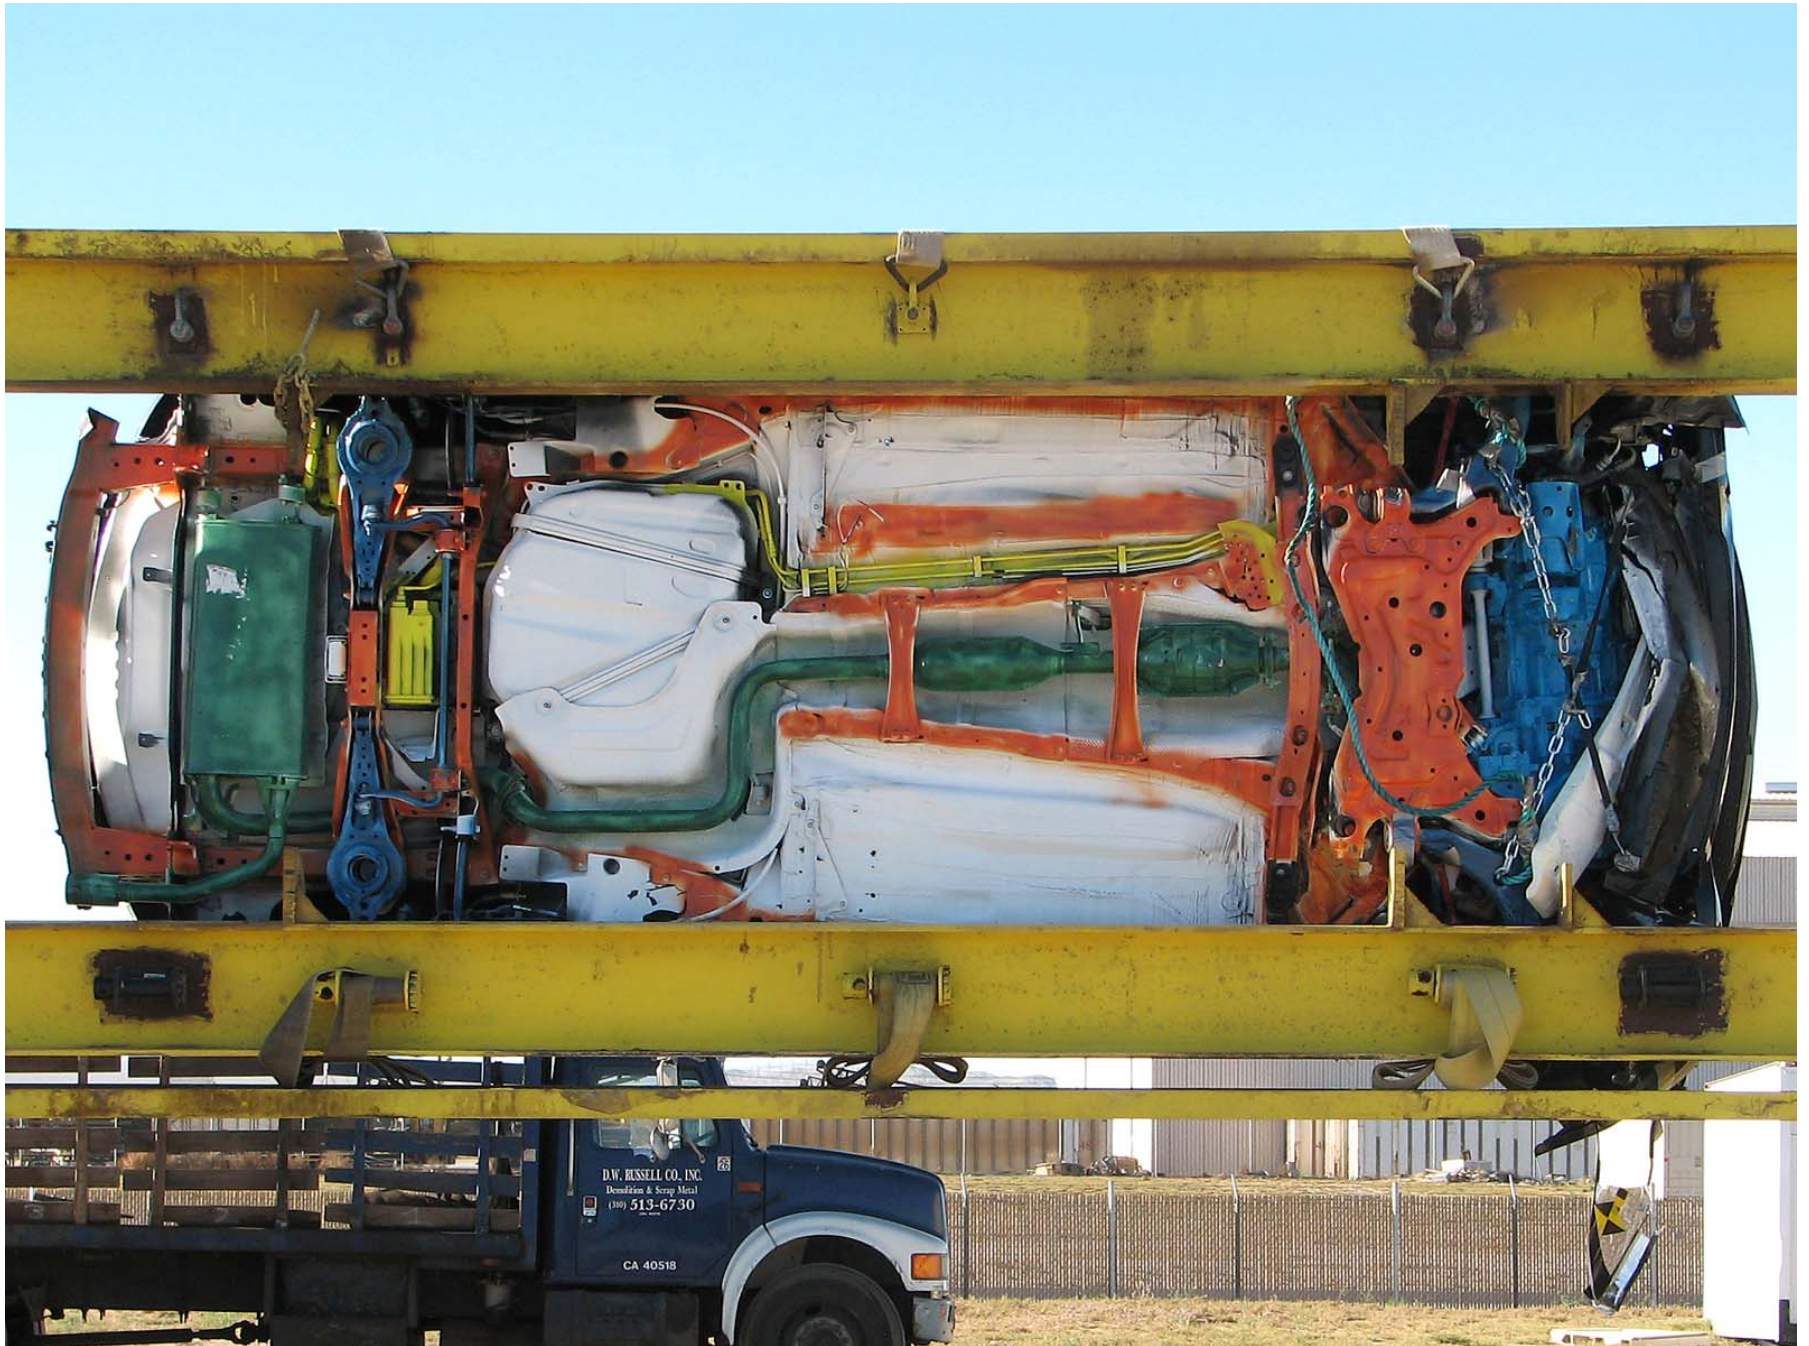
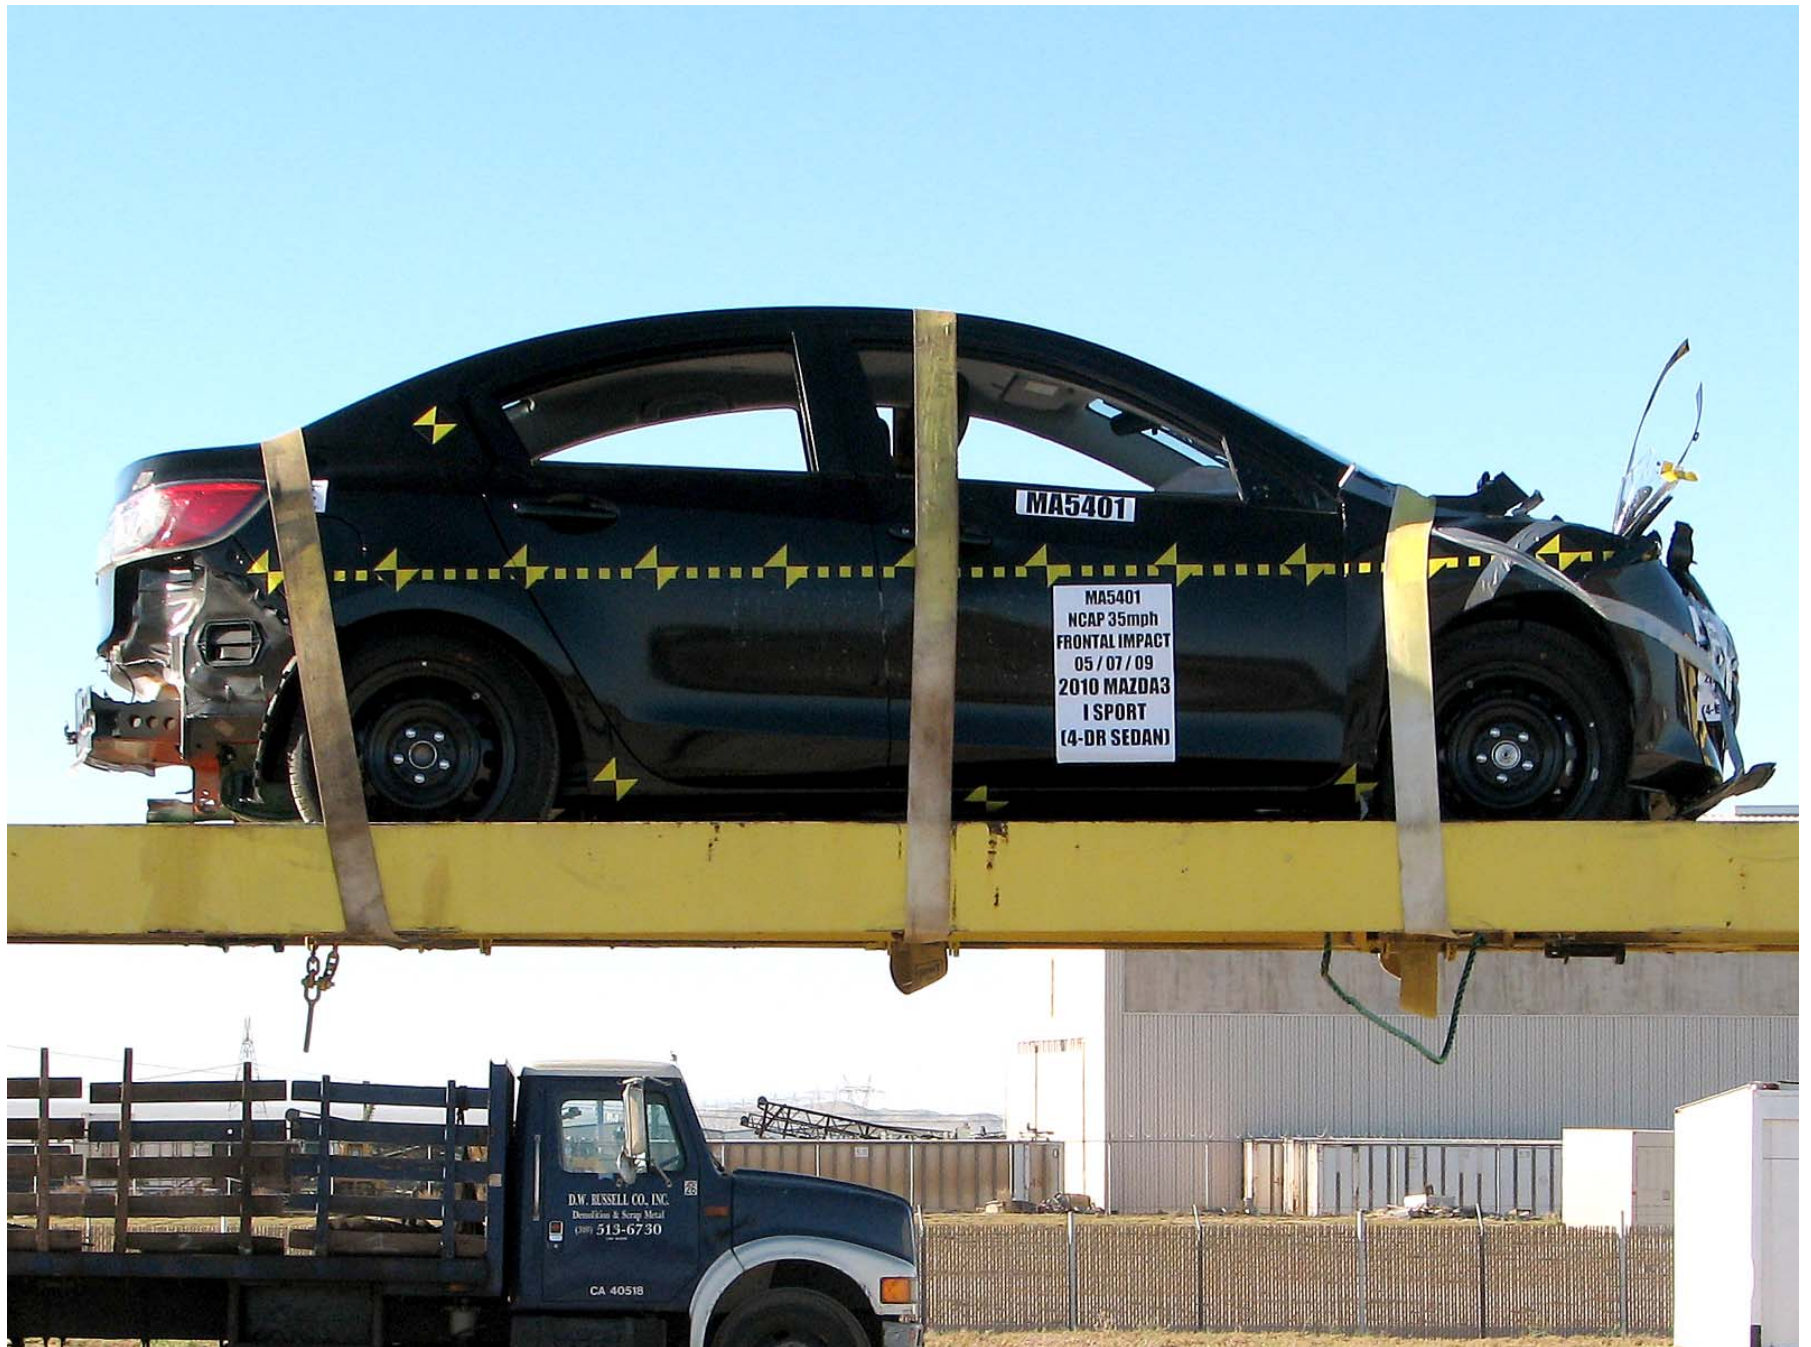
Figure A-66: Vehicle at 0° on Static Rollover Device

Figure A-67: Vehicle at 90° on Static Rollover Device

Figure A-68: Vehicle at 180° on Static Rollover Device

Figure A-69: Vehicle at 270° on Static Rollover Device

Figure A-70: Vehicle at 360° on Static Rollover Device

There was 100% windshield retention and no intrusion into the protected zone of the windshield during the event. There was no Stoddard solvent leakage after the event or during any phase of the static rollover.
