**REPORT NUMBER: SNCAP-CAL-10-03**

**VALIDATION  
SIDE IMPACT POLE TEST**

**FORD MOTOR COMPANY  
2010 FORD MUSTANG  
2-DOOR COUPE**

**FINAL REPORT**

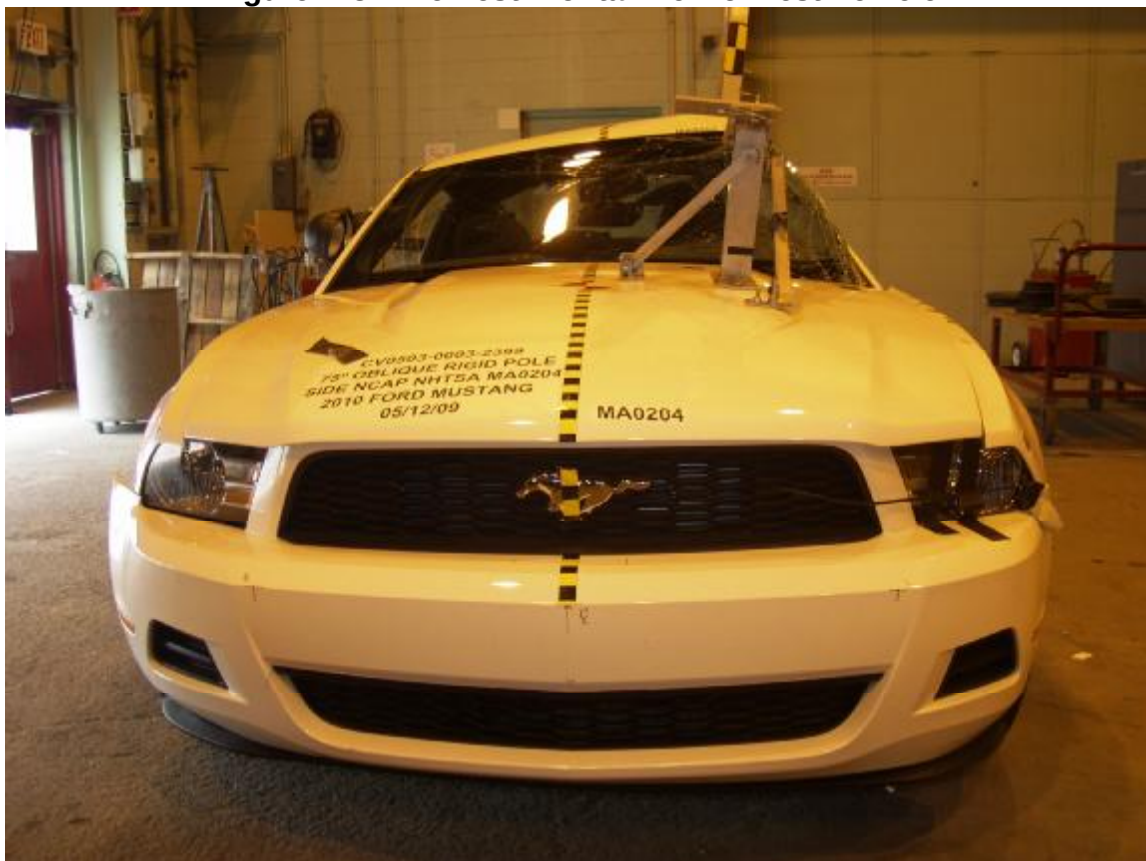
**Figure A-4: Post-Test Frontal View of Test Vehicle**

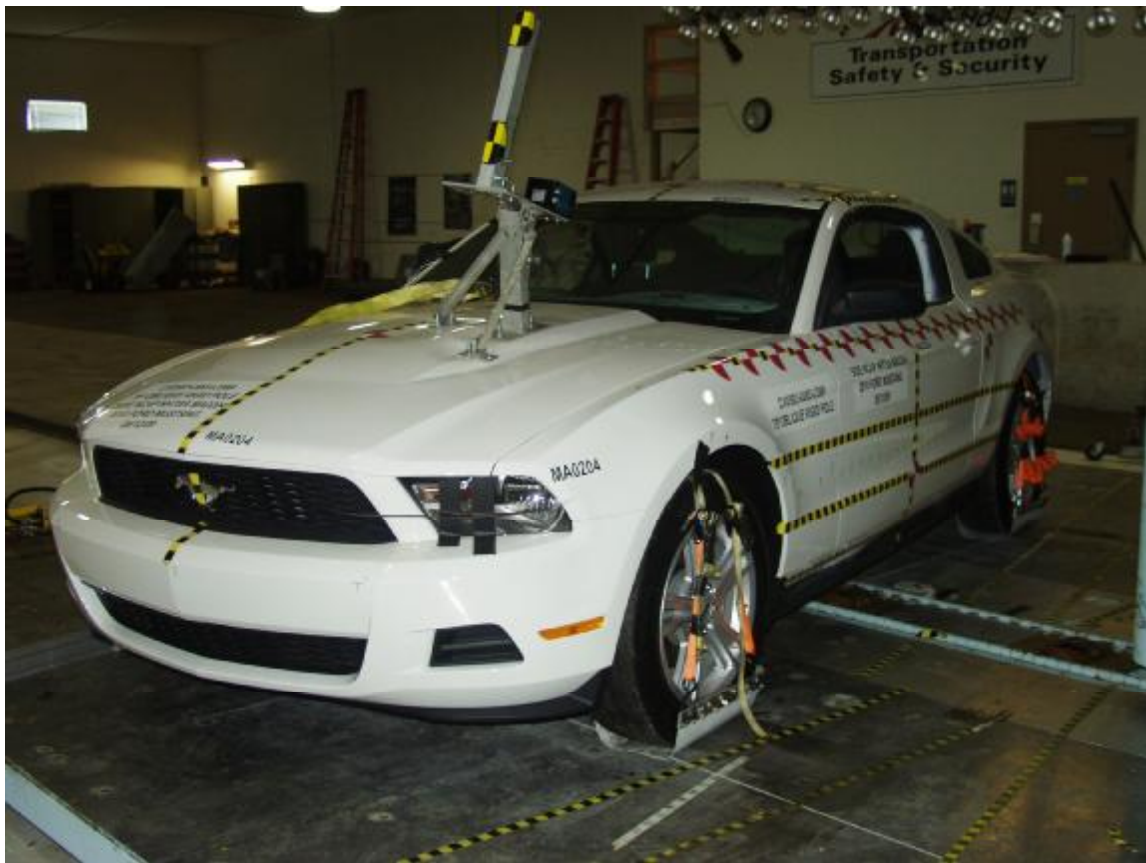
**Figure A-5: Pre-Test Left  $\frac{3}{4}$  Front View of Vehicle with Pole in Position**

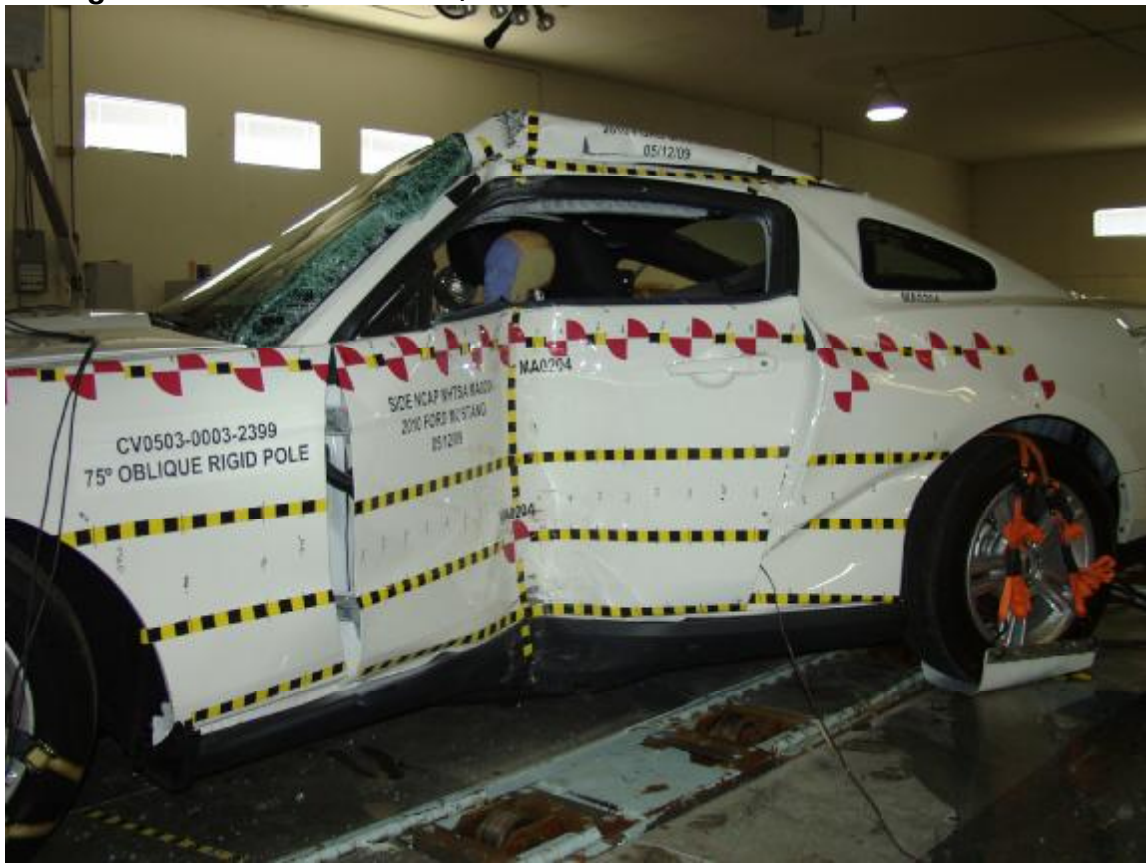
**Figure A-6: Post-Test Left  $\frac{3}{4}$  Front View of Impact Zone**

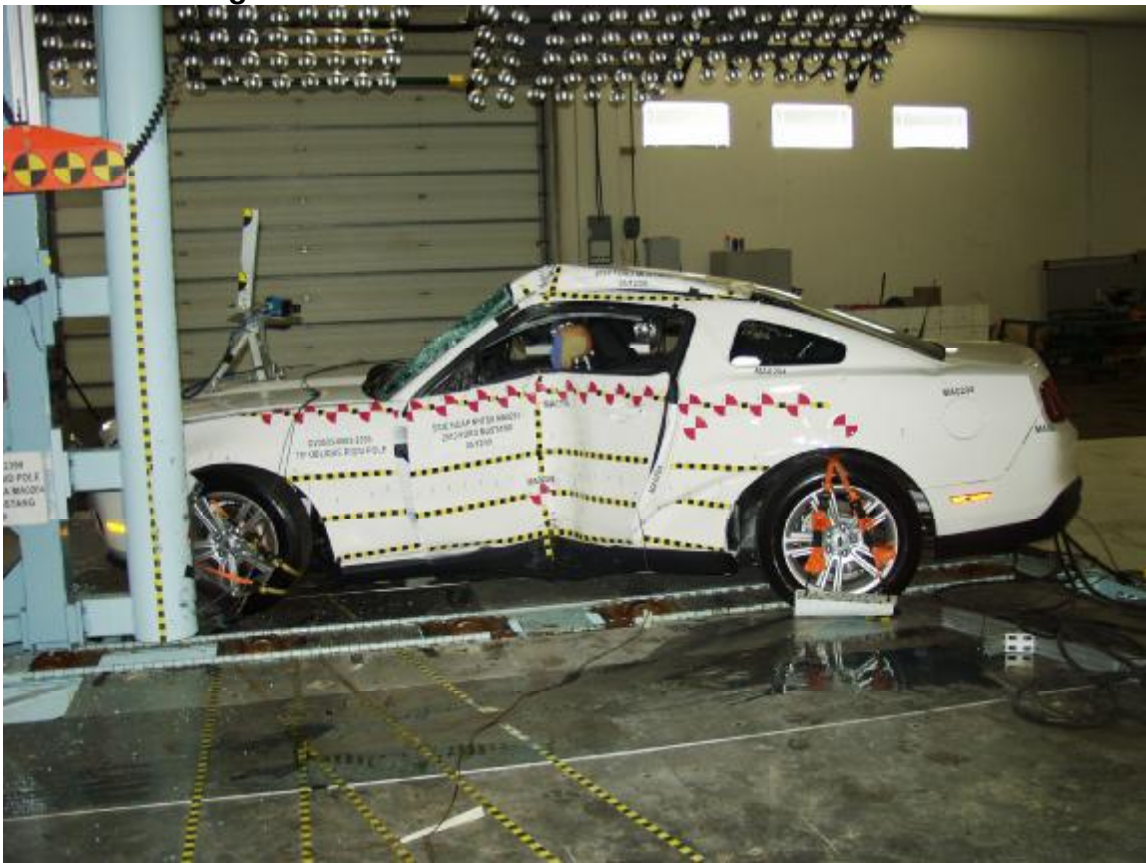
**Figure A-8: Post-Test Left Side View of Test Vehicle**

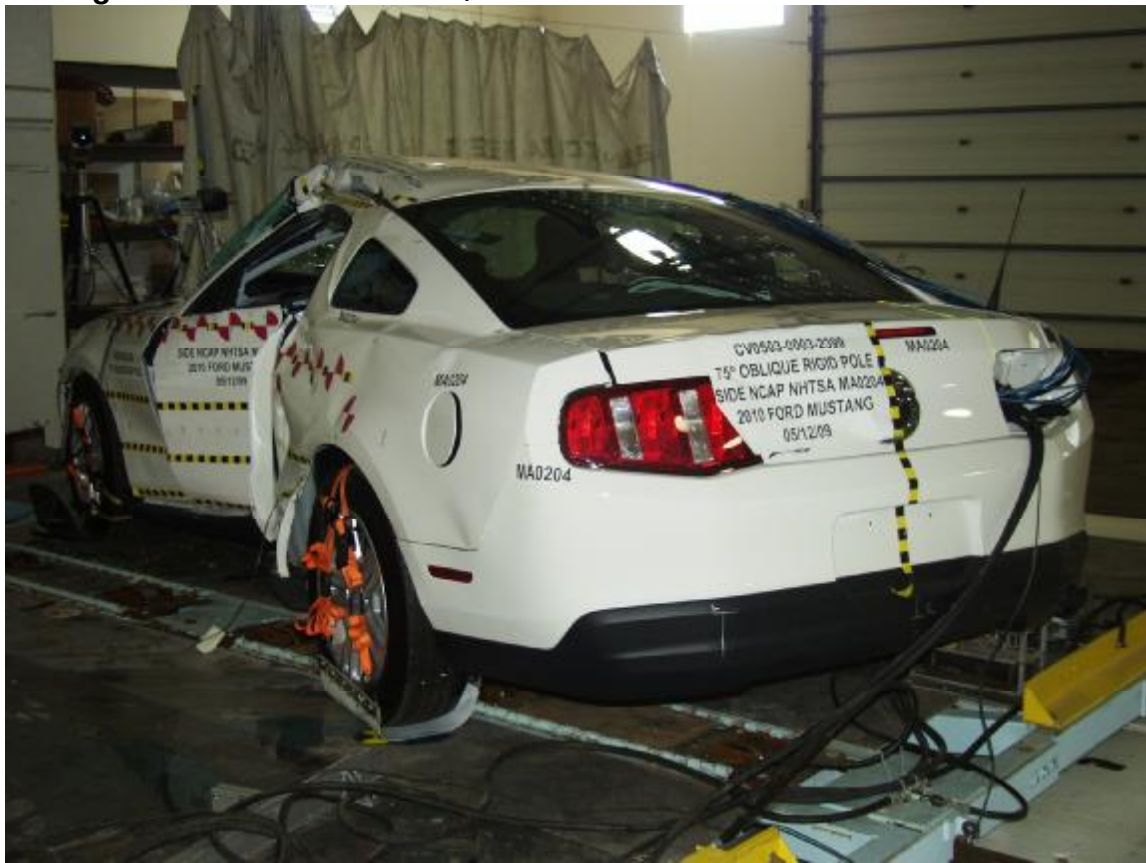
**Figure A-10: Post-Test Left  $\frac{3}{4}$  Rear View of Impact Zone**

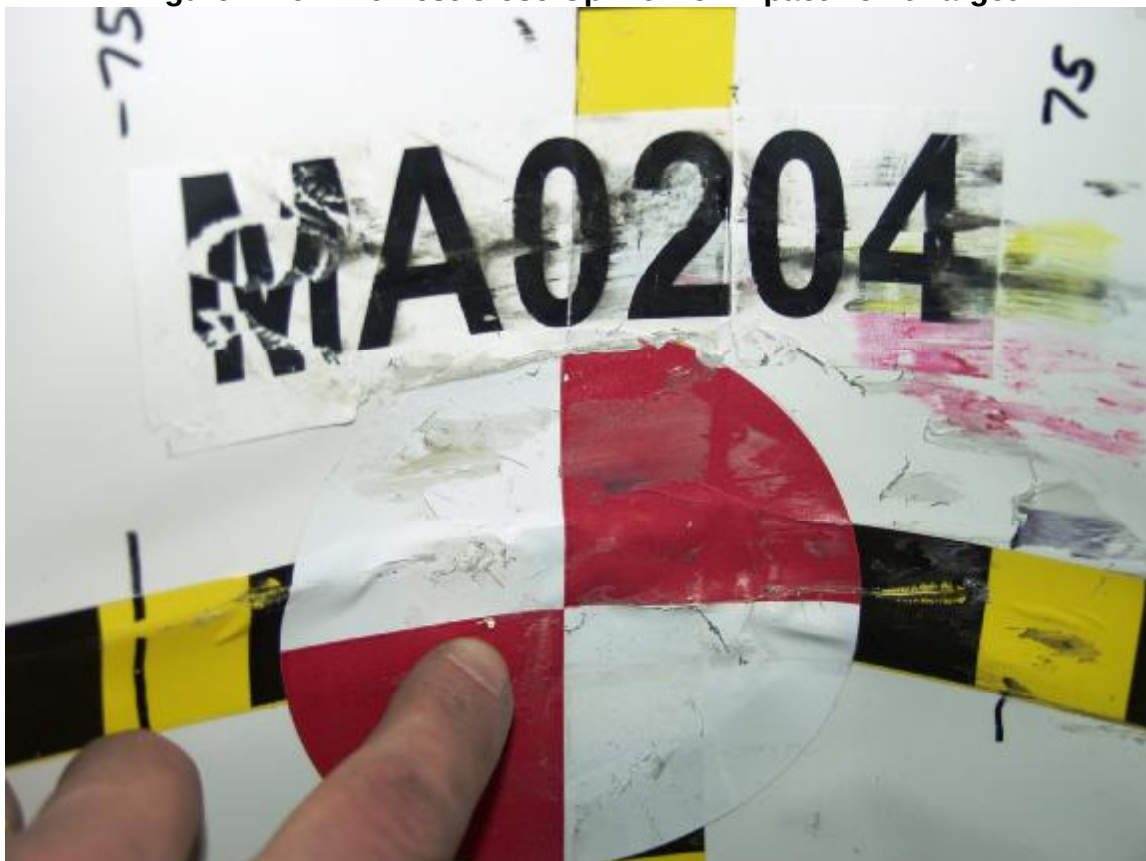
**Figure A-20: Post-Test Close-Up View of Impact Point Target Showing Impact Location**

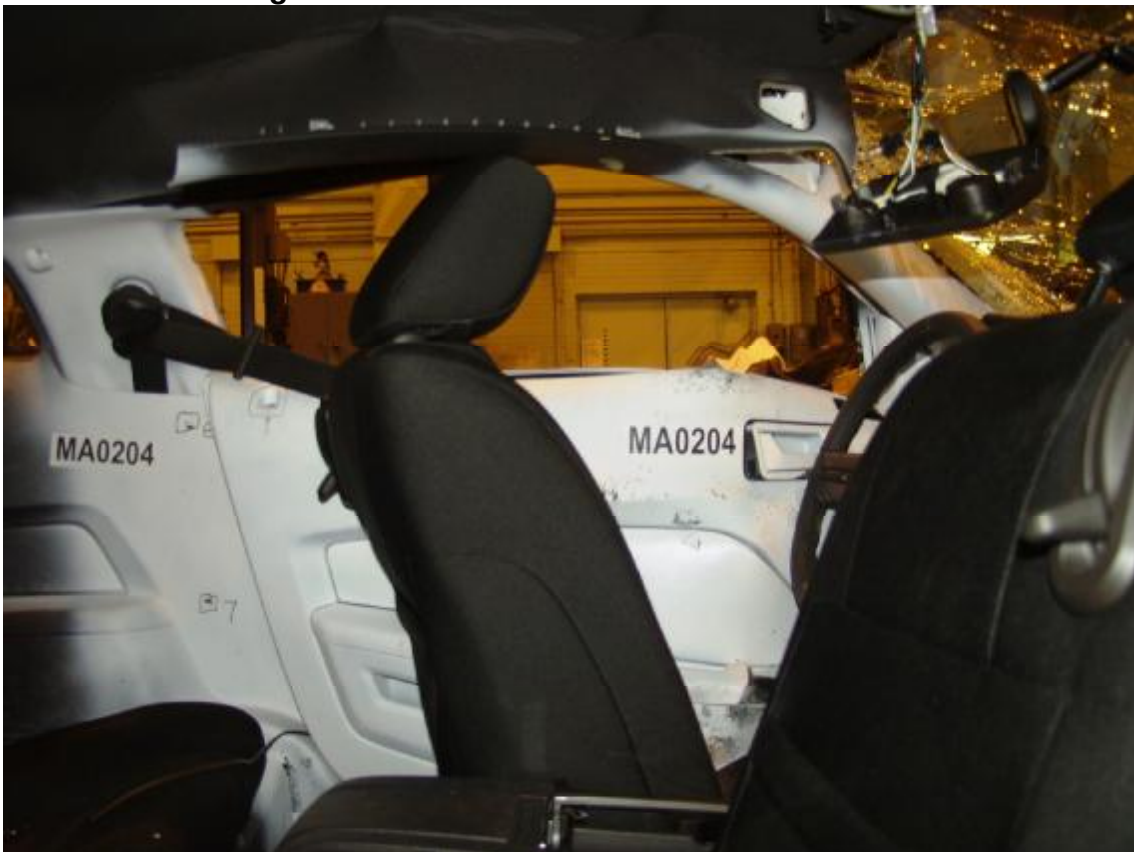
**Figure A-44: Post-Test Inner Door Panel View**

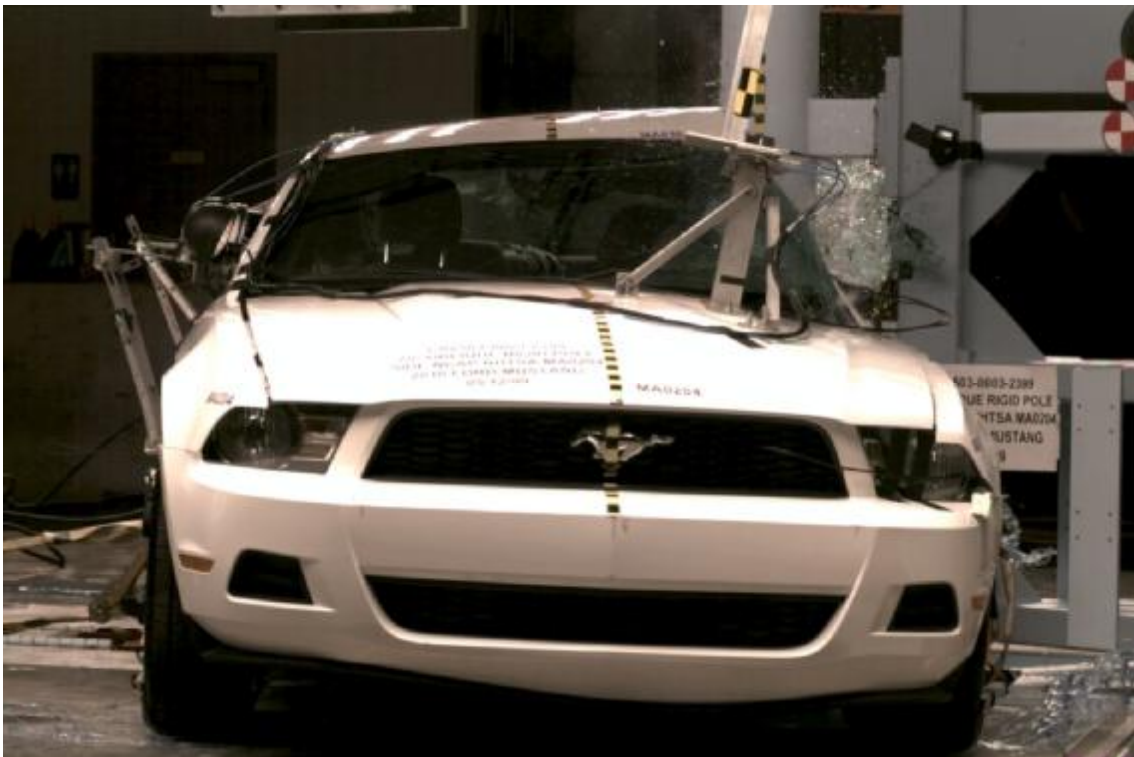
**Figure A-66: Impact Event**
