**NEW CAR ASSESSMENT PROGRAM  
SIDE IMPACT TEST**

**HONDA MOTOR COMPANY, LTD  
2010 HONDA INSIGHT 5-DR LX  
NHTSA NUMBER: MA5302**

**PREPARED BY:  
MGA RESEARCH CORPORATION  
5000 WARREN ROAD  
BURLINGTON, WI 53105**

**FINAL REPORT**

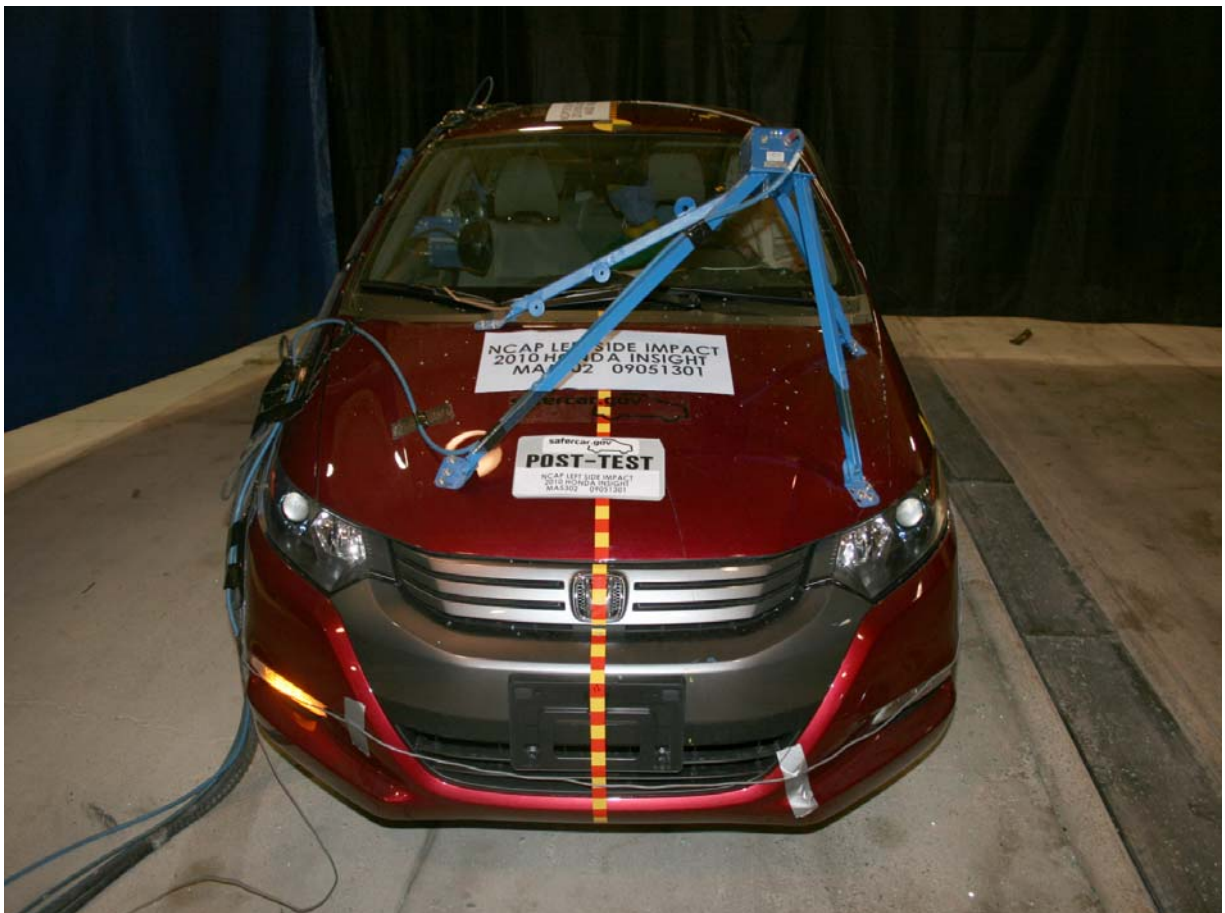
Post-Test Front View

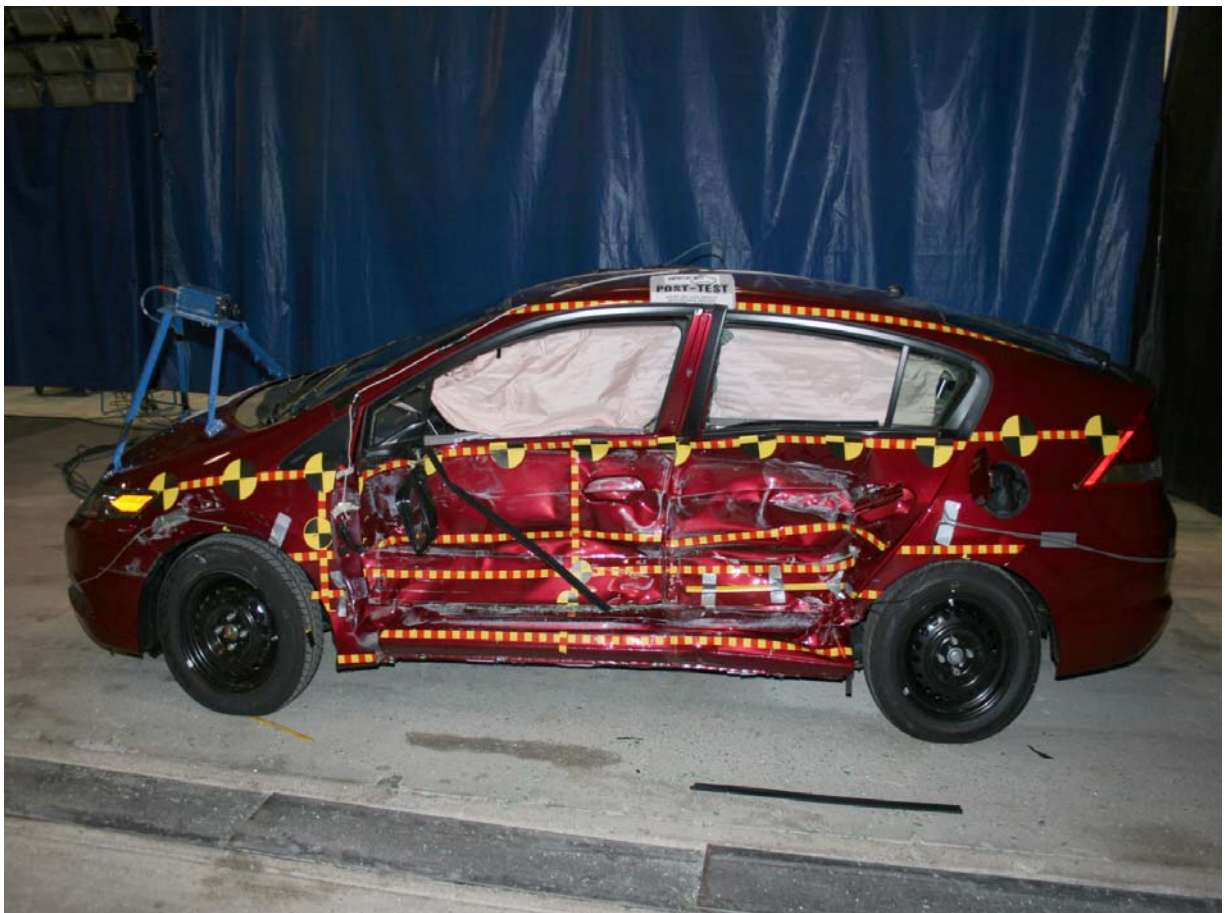
Post-Test Left Side View

| Critical Areas of Performance | Observations and Conclusions |
|---|---|
| Window Damage | Left Front and Left Rear Windows were broken. |

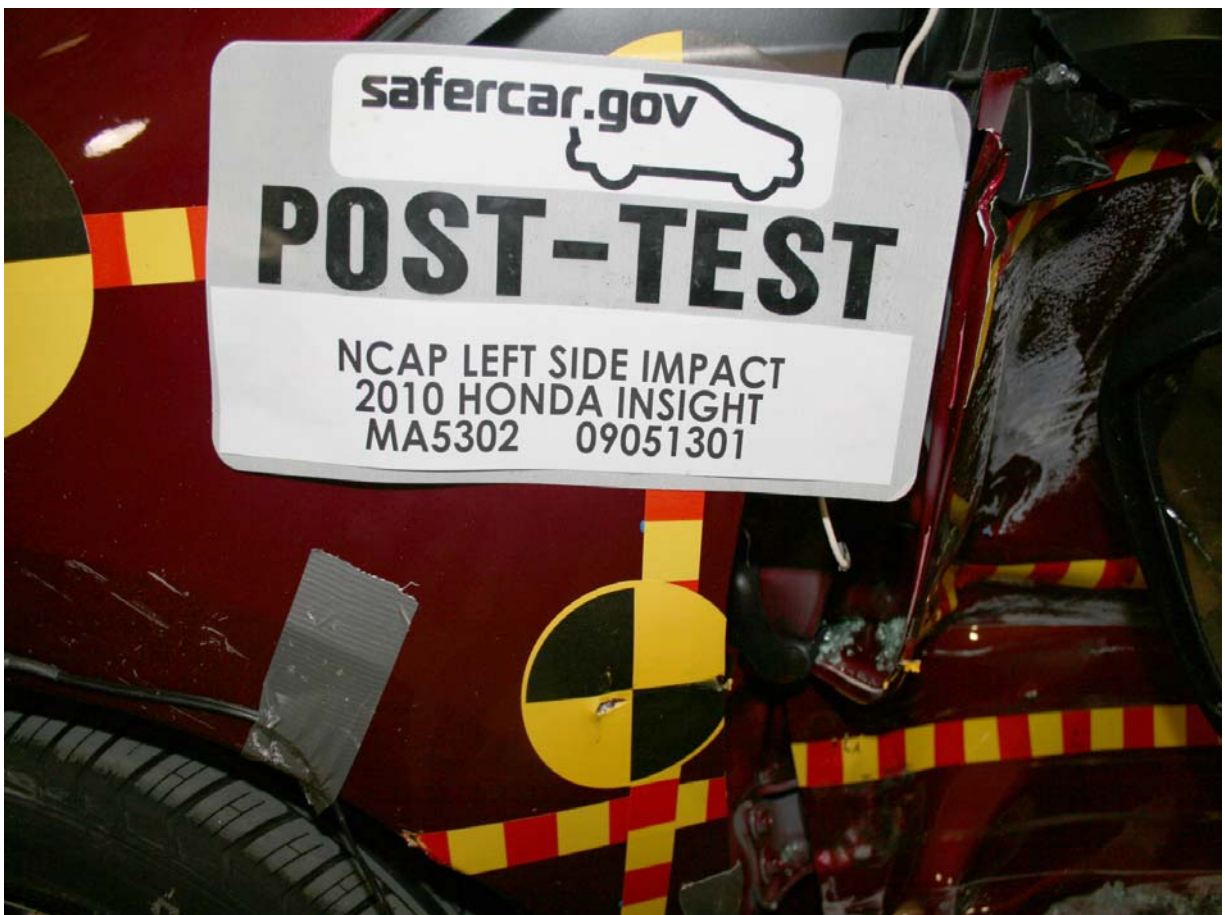
Post-Test Left Impact Point

The test vehicle sustained a maximum static crush of 251 mm at level 3, 900 mm rearward of the vertical impact point. The driver and passenger SID/HIIIs, Serial Nos. 272 and 271 respectively, were calibrated just prior to this test.

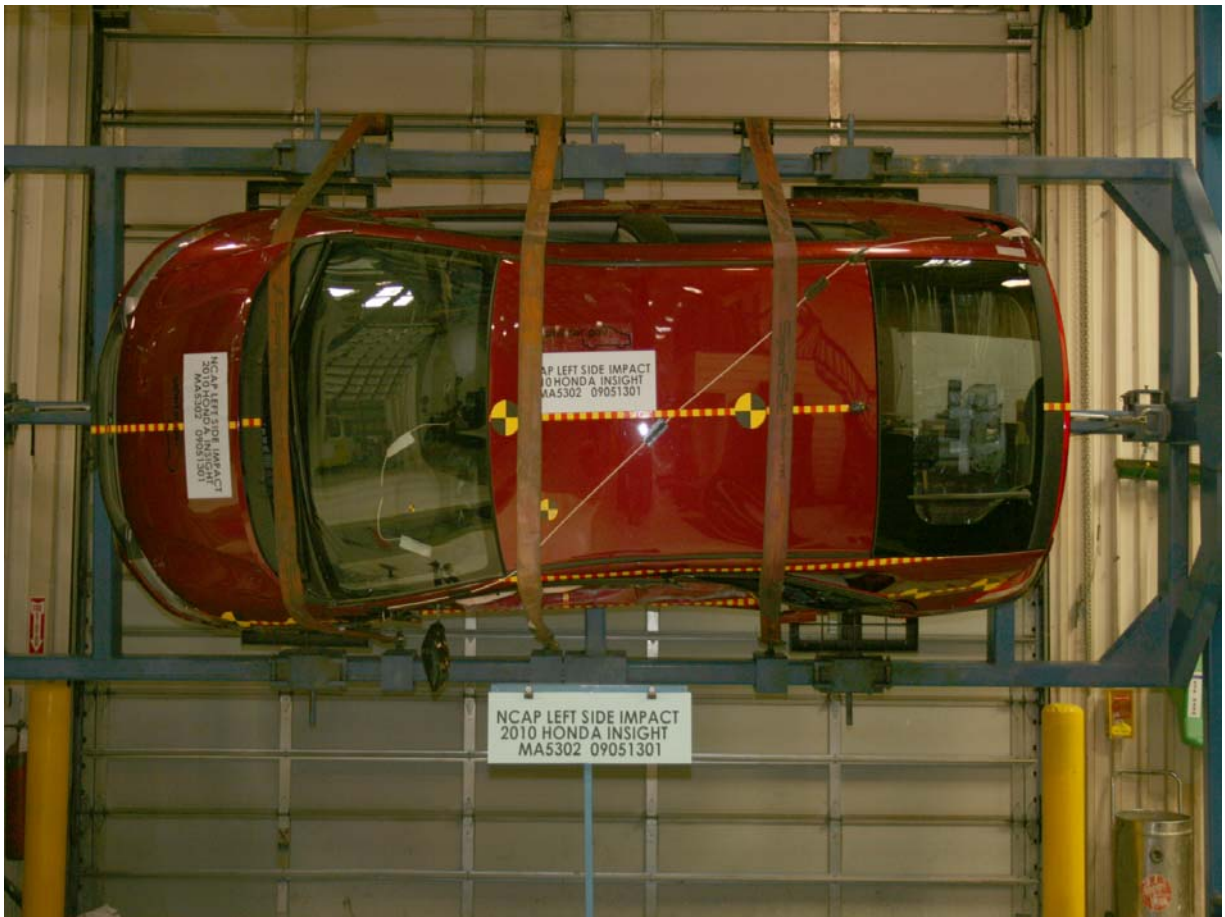
Vehicle on Rollover Device (90 Degrees)

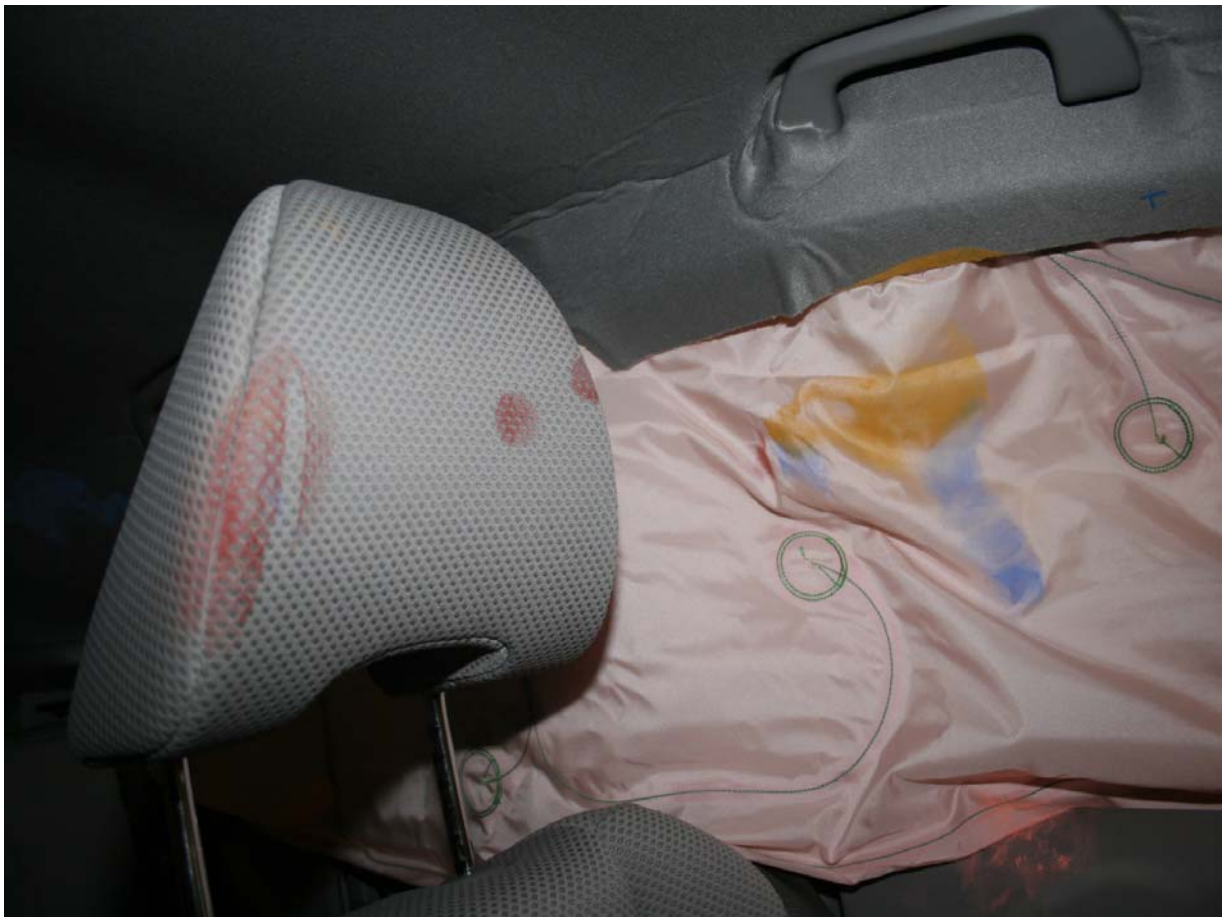
Post-Test Driver Dummy Head Contact View

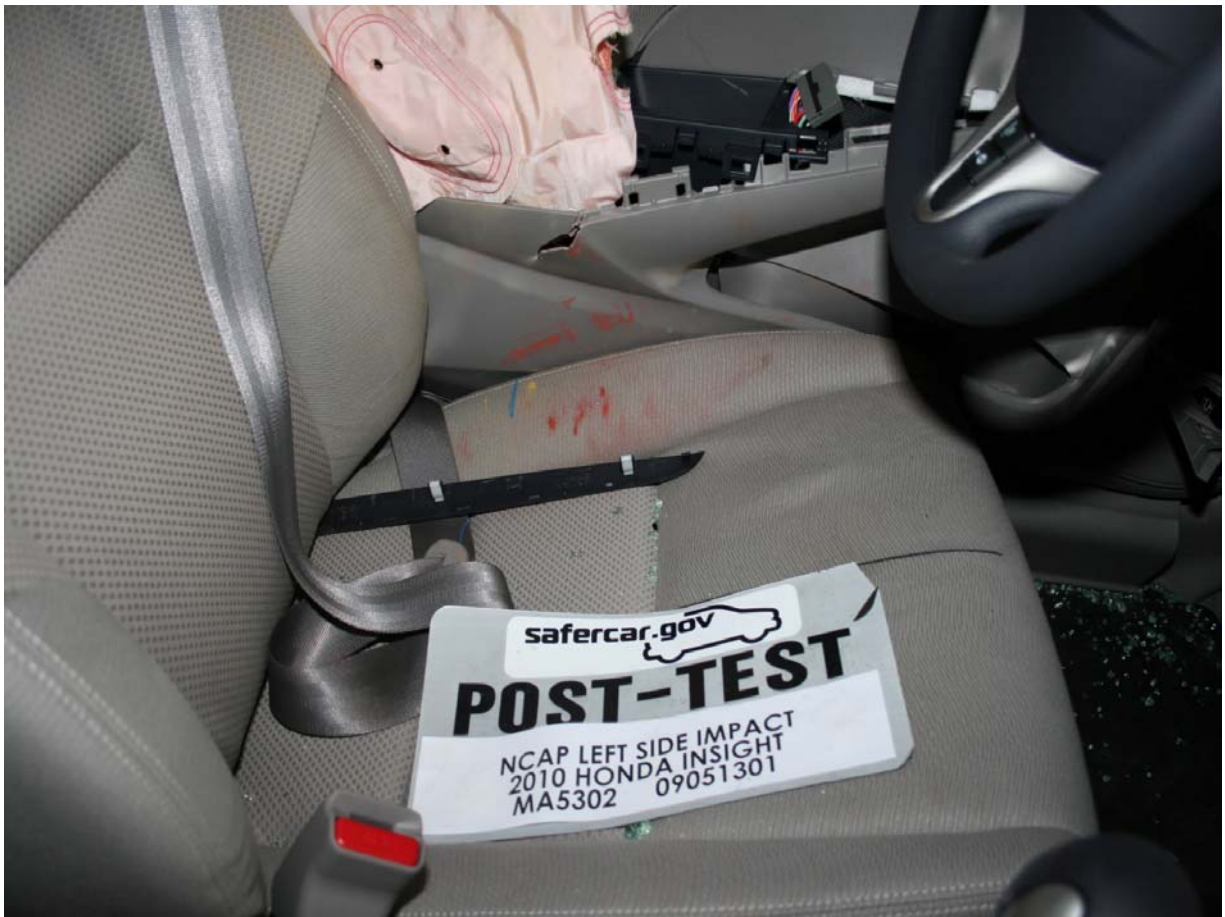
Post-Test Driver Dummy Lower Torso Contact

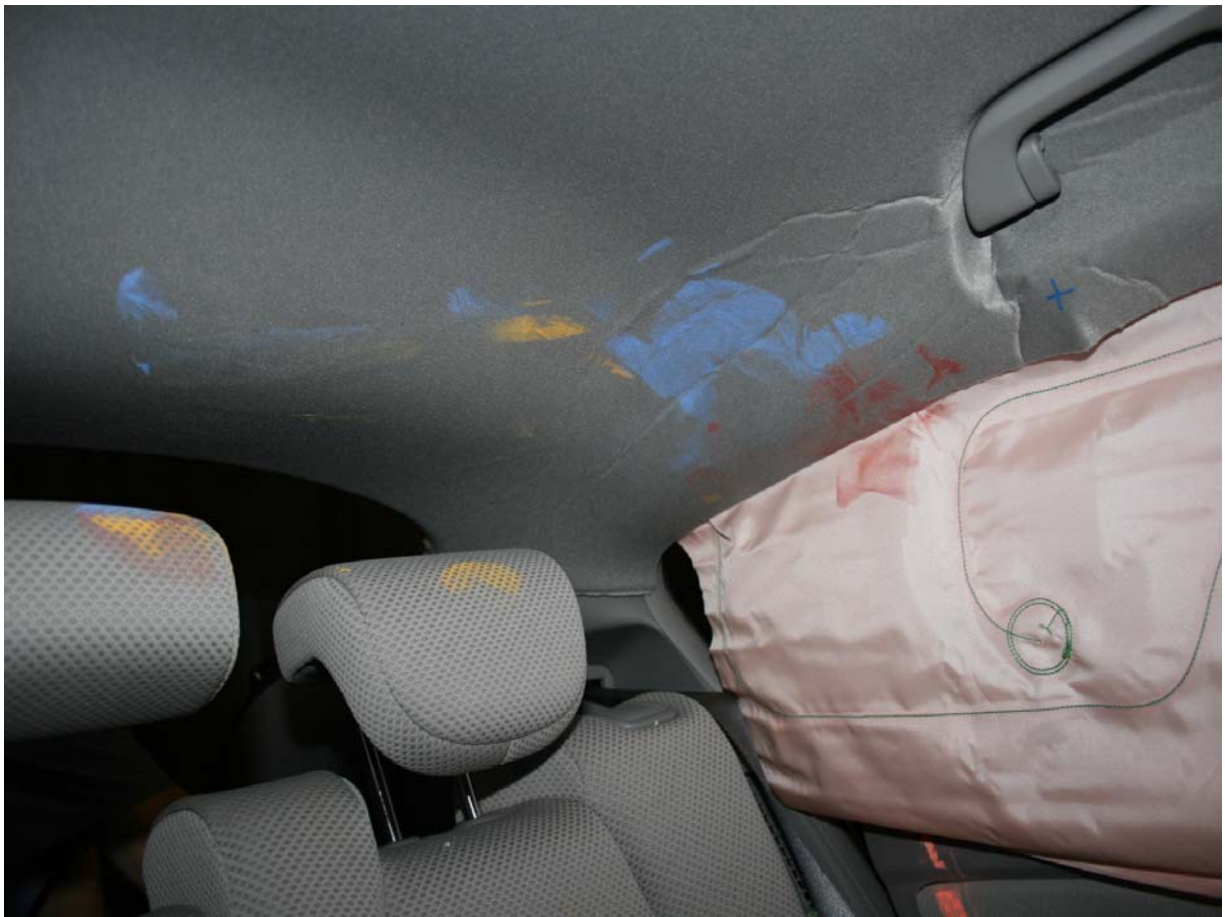
Post-Test Passenger Dummy Head Contact View

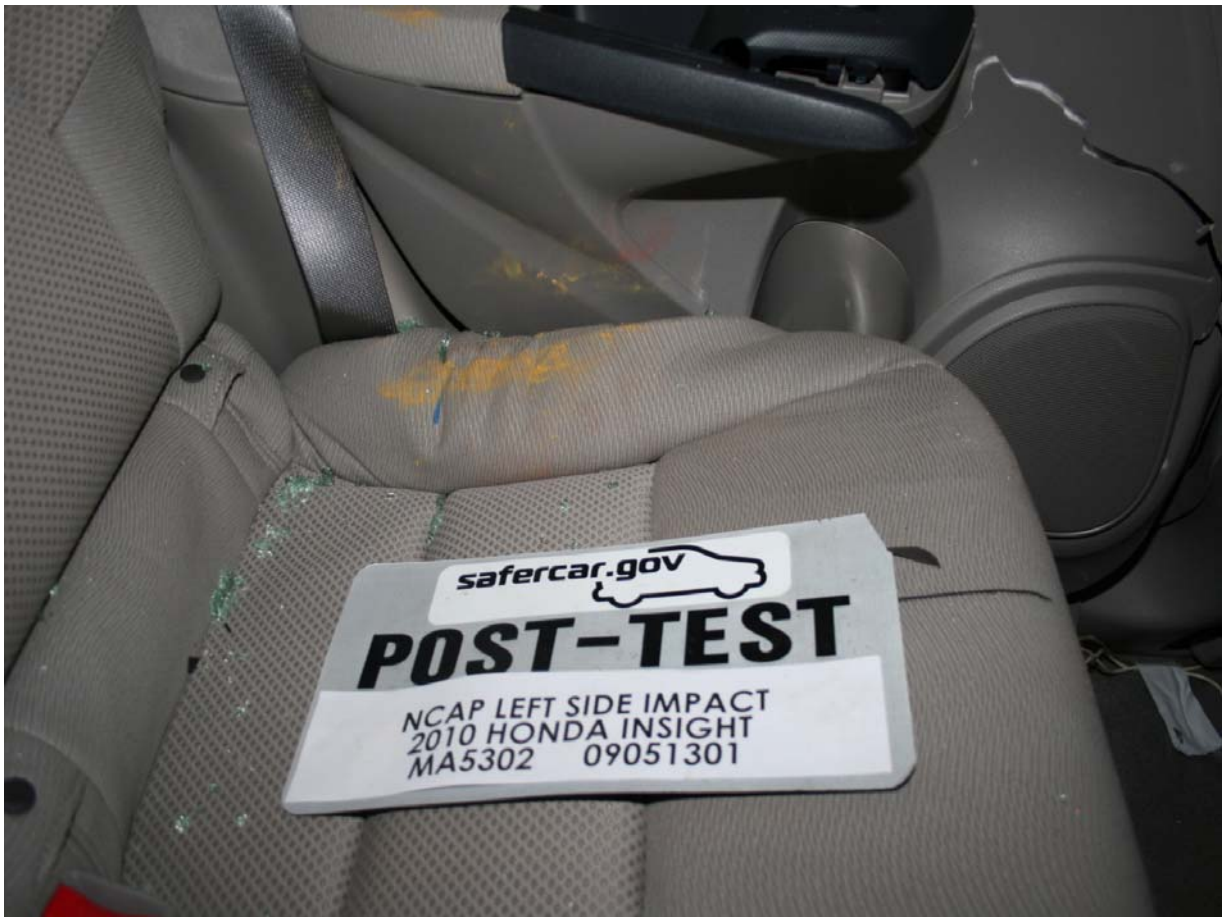
Post-Test Passenger Dummy Lower Torso Contact
