REPORT NUMBER TR-P29047-01-NC

NEW CAR ASSESSMENT PROGRAM  
SIDE IMPACT TEST

AUDI AG  
2009 AUDI Q5 3.2 QUATTRO TIPTRONIC  
5-DOOR MPV

NHTSA NUMBER: V95801

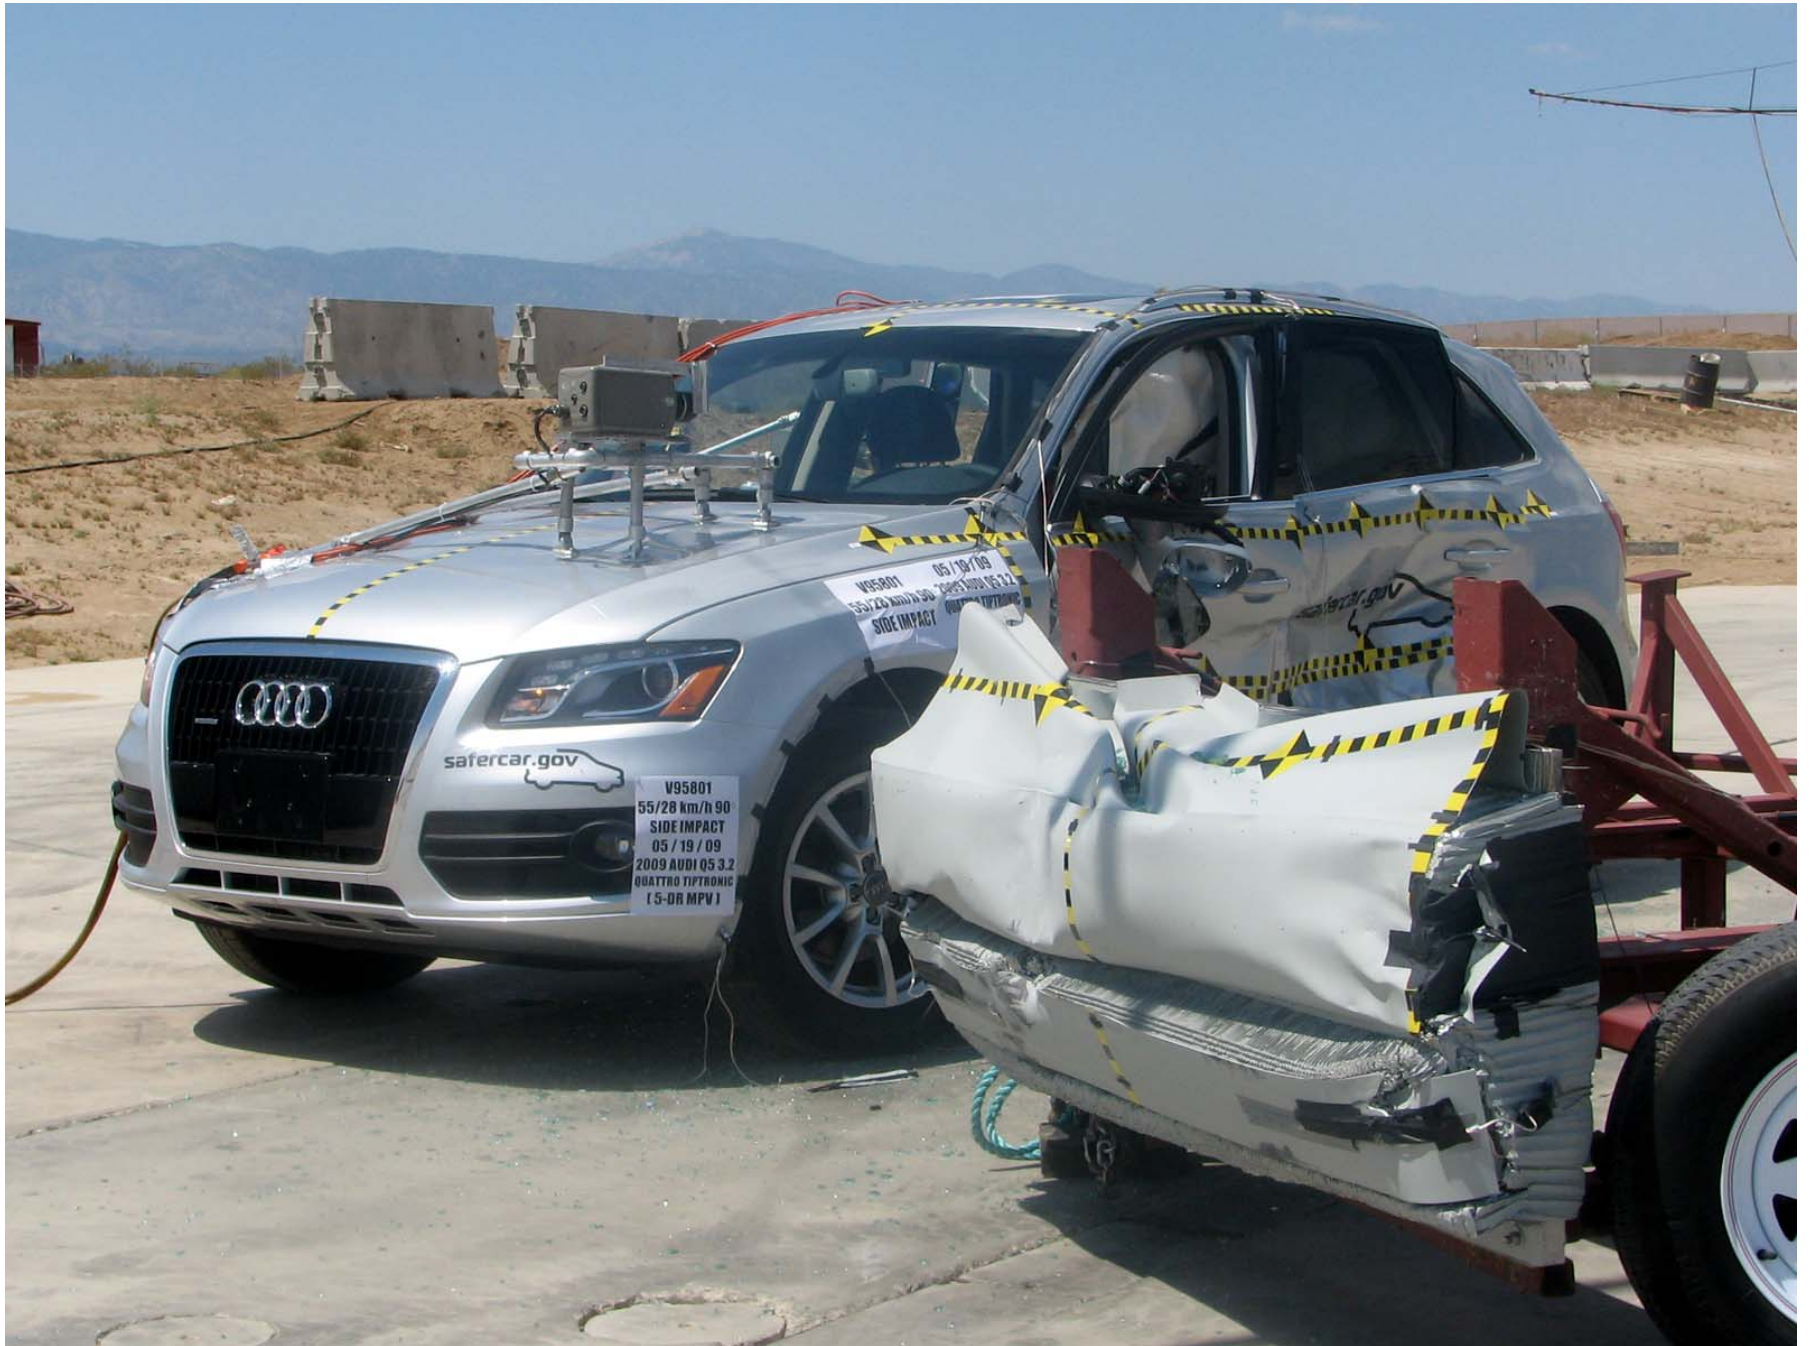
Figure A-8: Post-Test Left Front  $\frac{3}{4}$  View

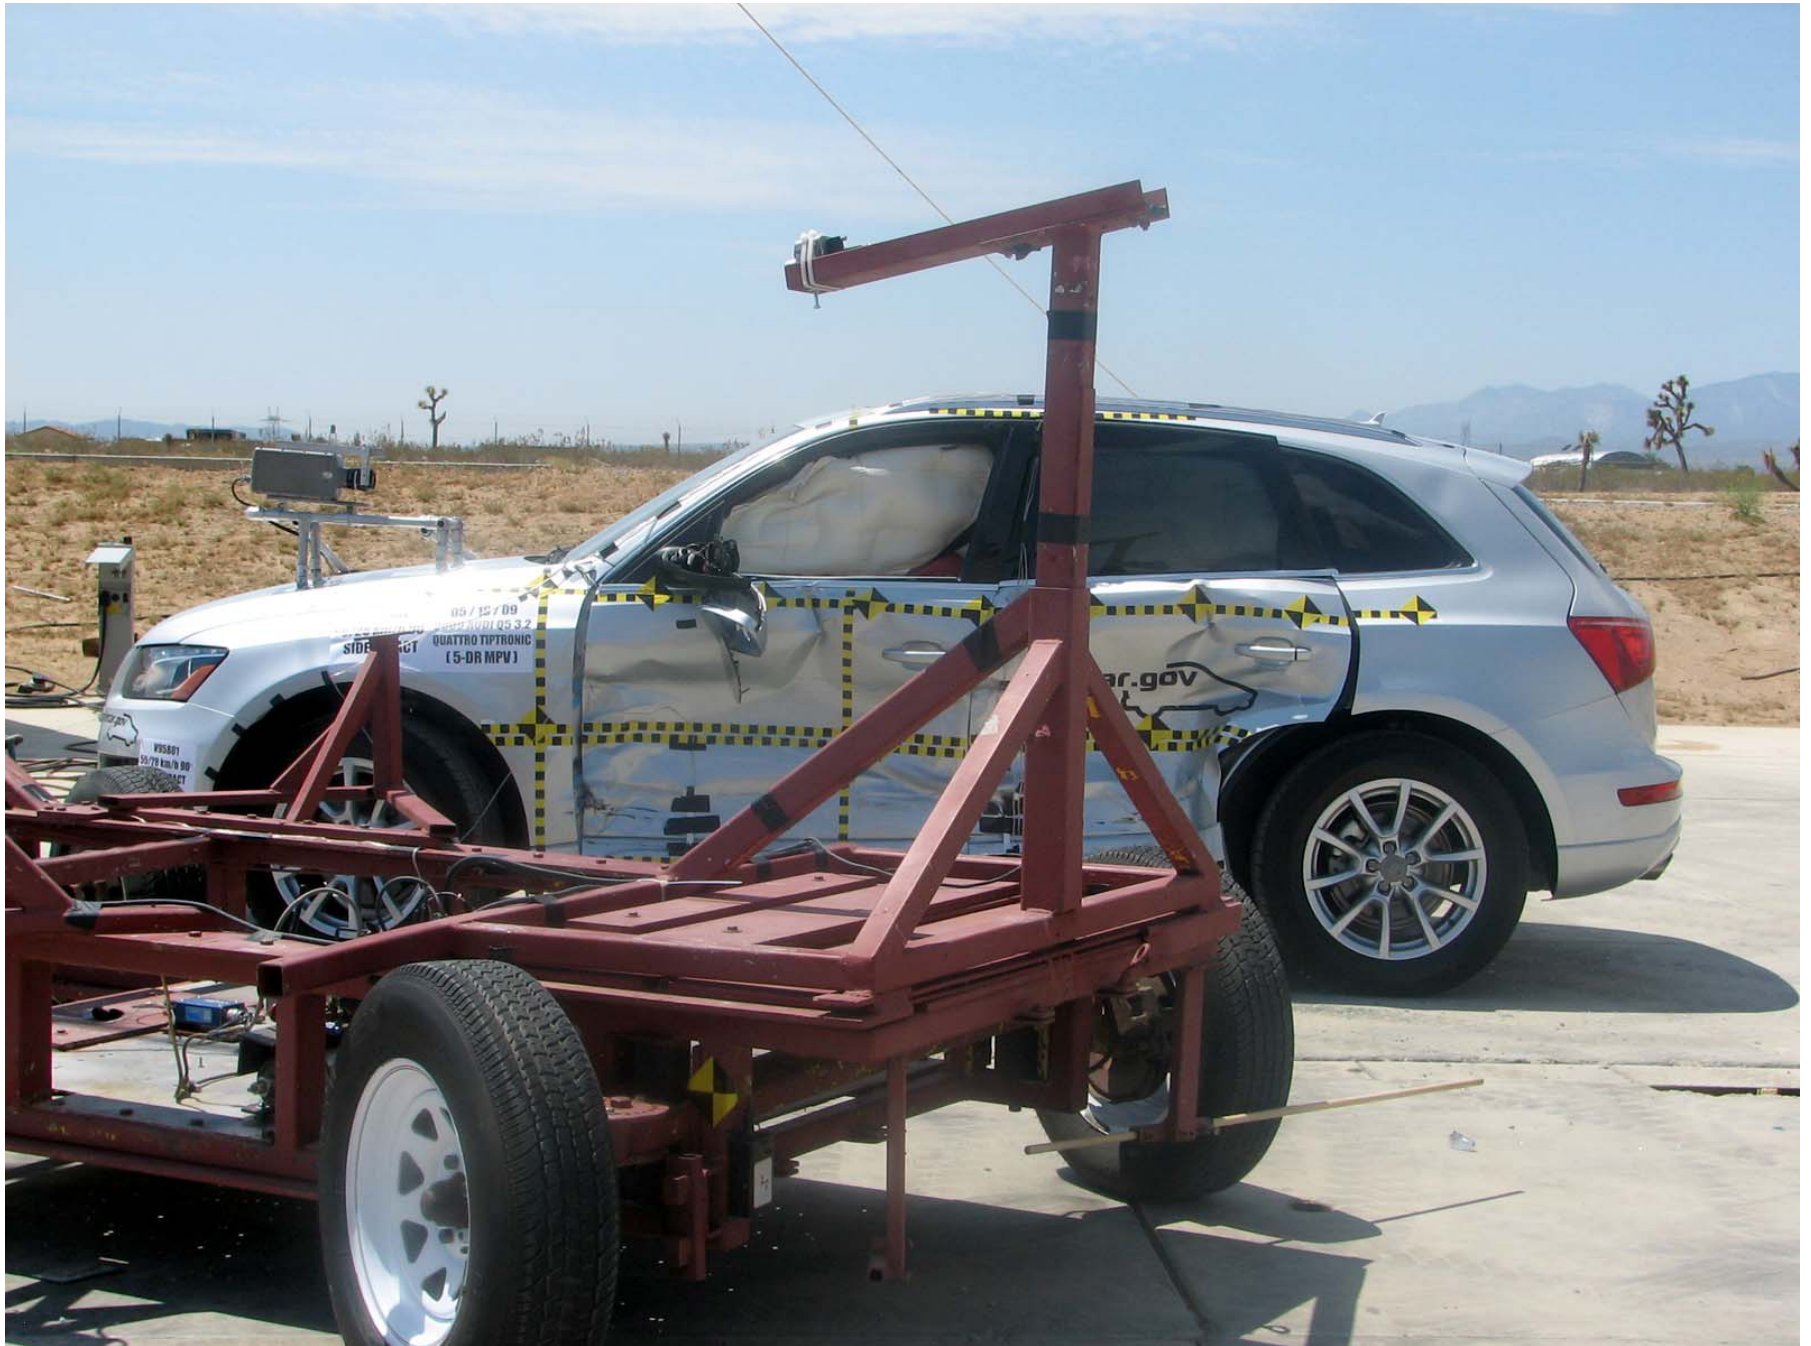
Figure A-10: Post-Test Left Side View

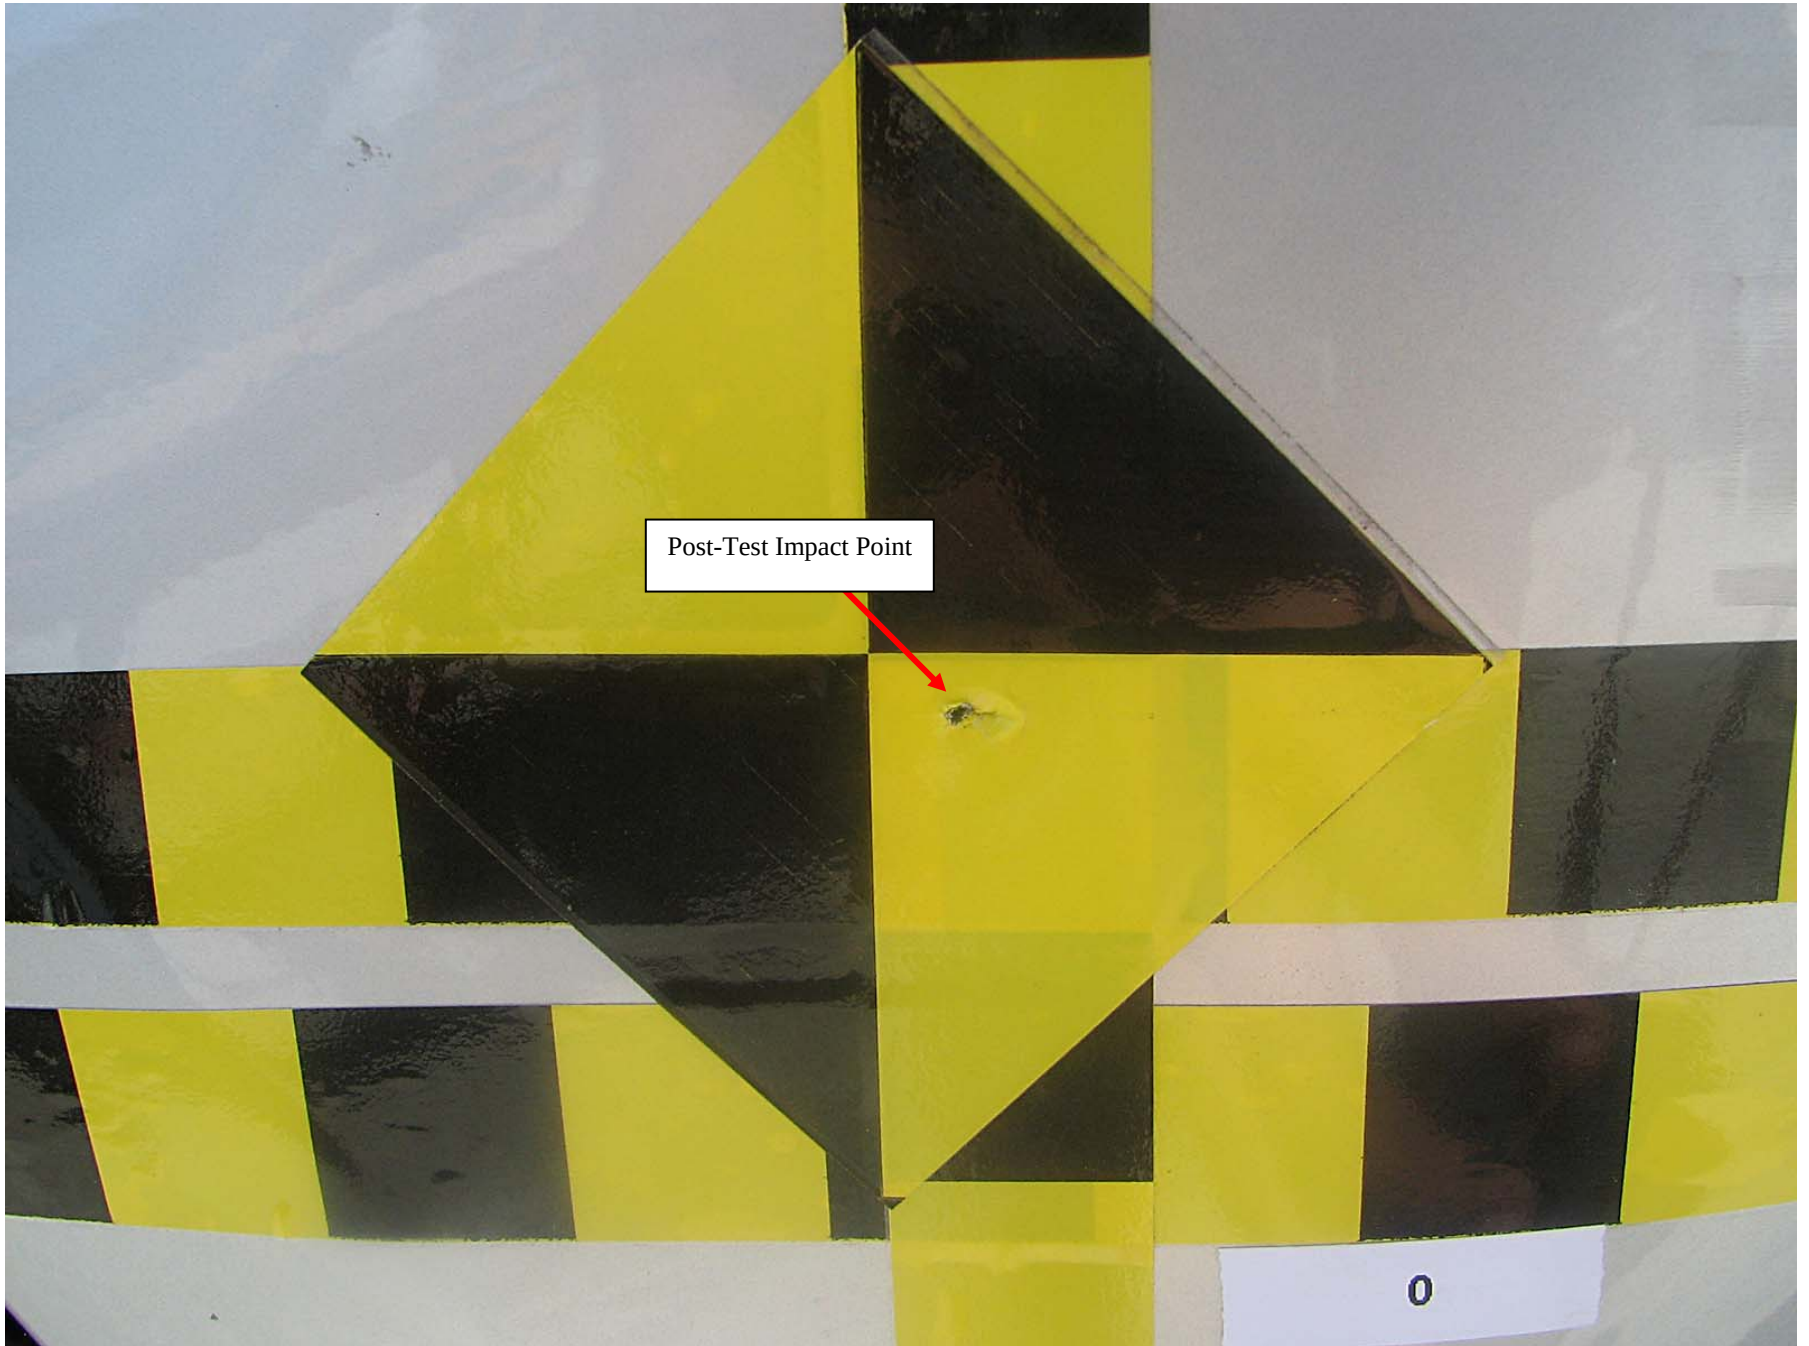
Figure A-26: Post-Test Left Impact Point

Both the driver and passenger doors remained closed during the impact. The test vehicle sustained a maximum static crush of 175 mm at level 3, 750 mm rearward of the left vertical impact point. The driver SID/Hybrid III, Serial No. 274 and the passenger SID/Hybrid III, Serial No. 275 were calibrated prior to this test. The SID/Hybrid III injury criteria are summarized as follows:

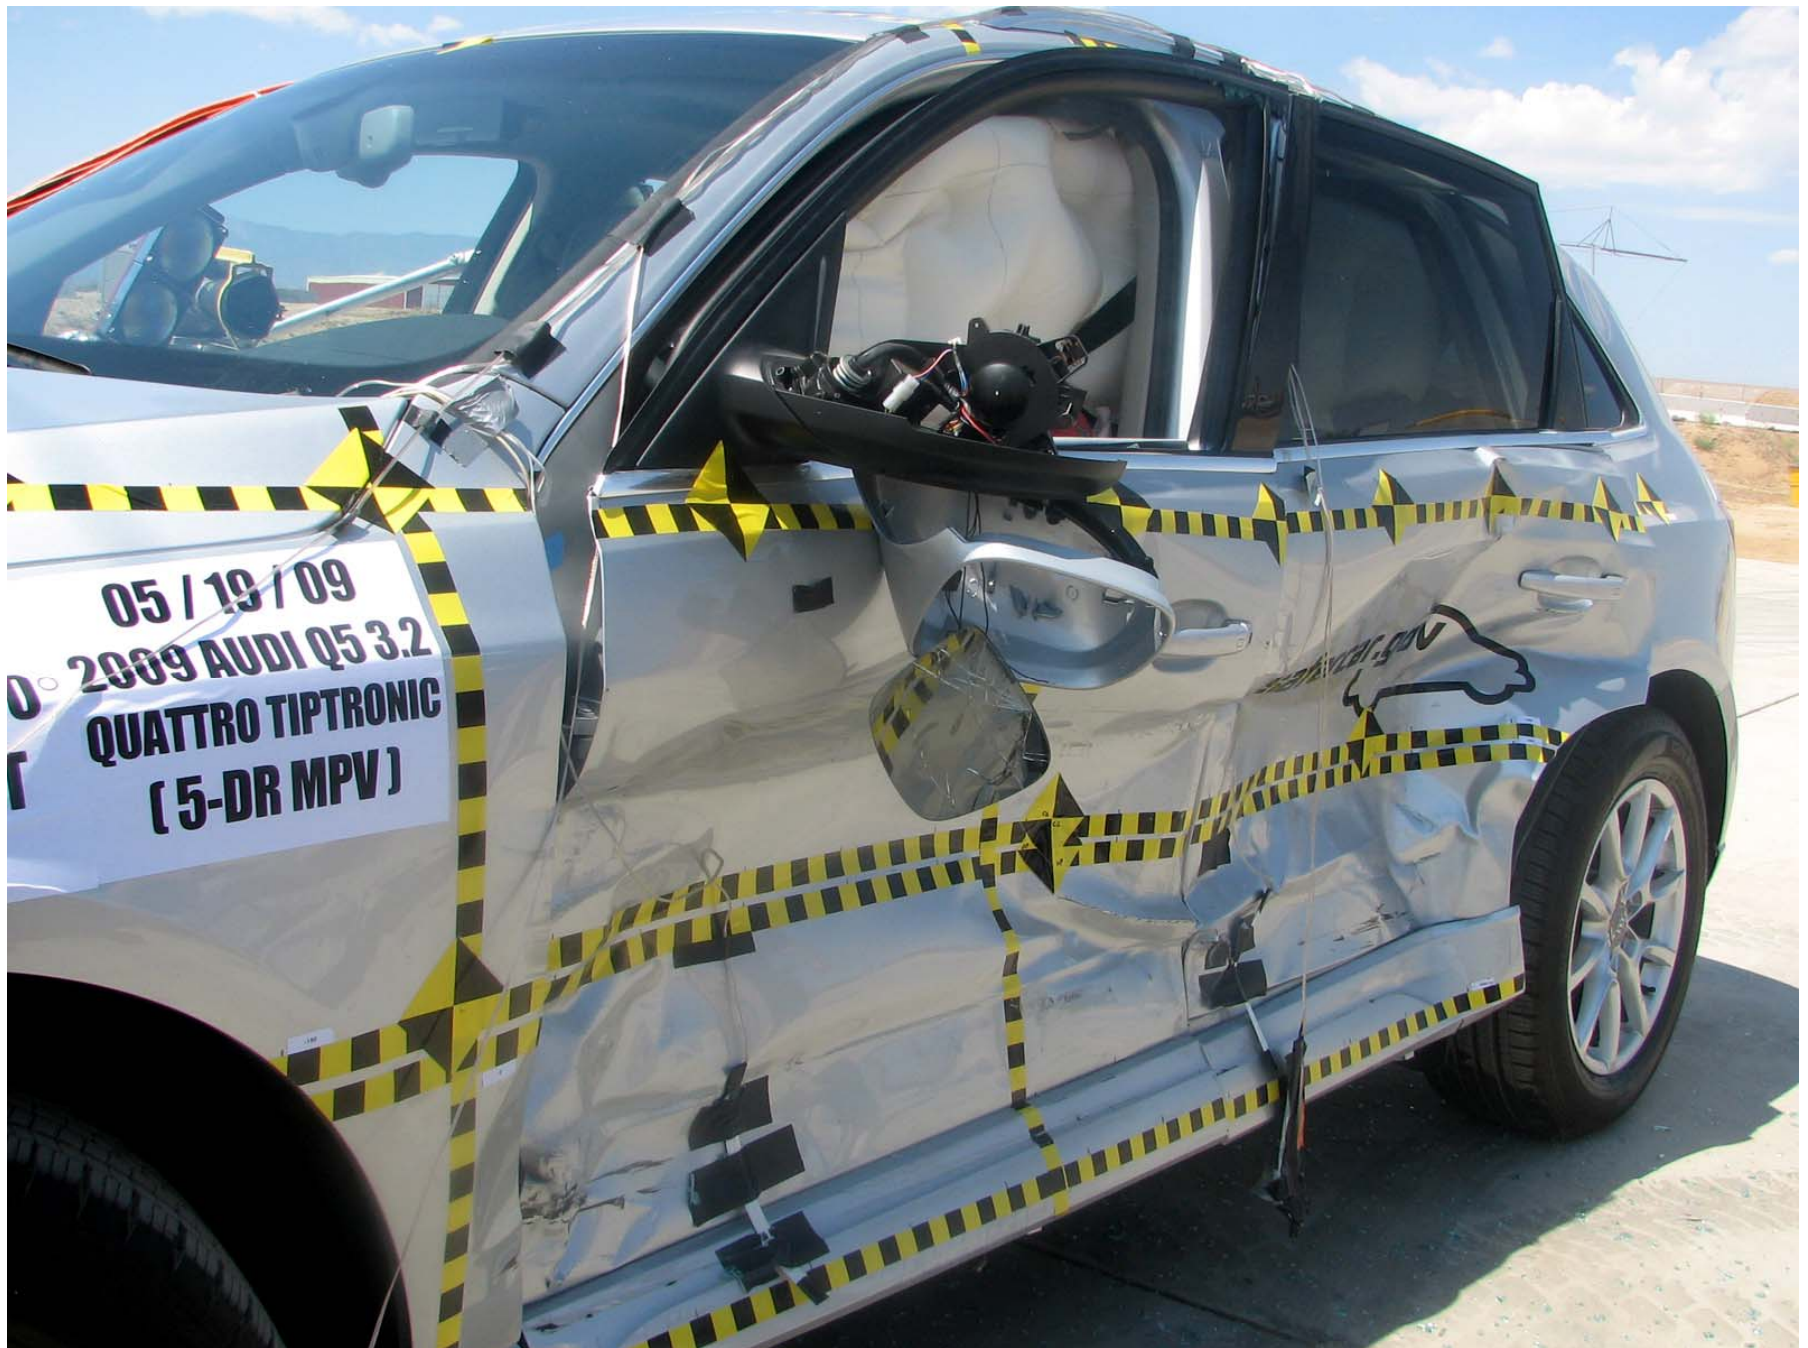
Figure A-28: Post-Test Front  $\frac{3}{4}$  View of Left Side Door

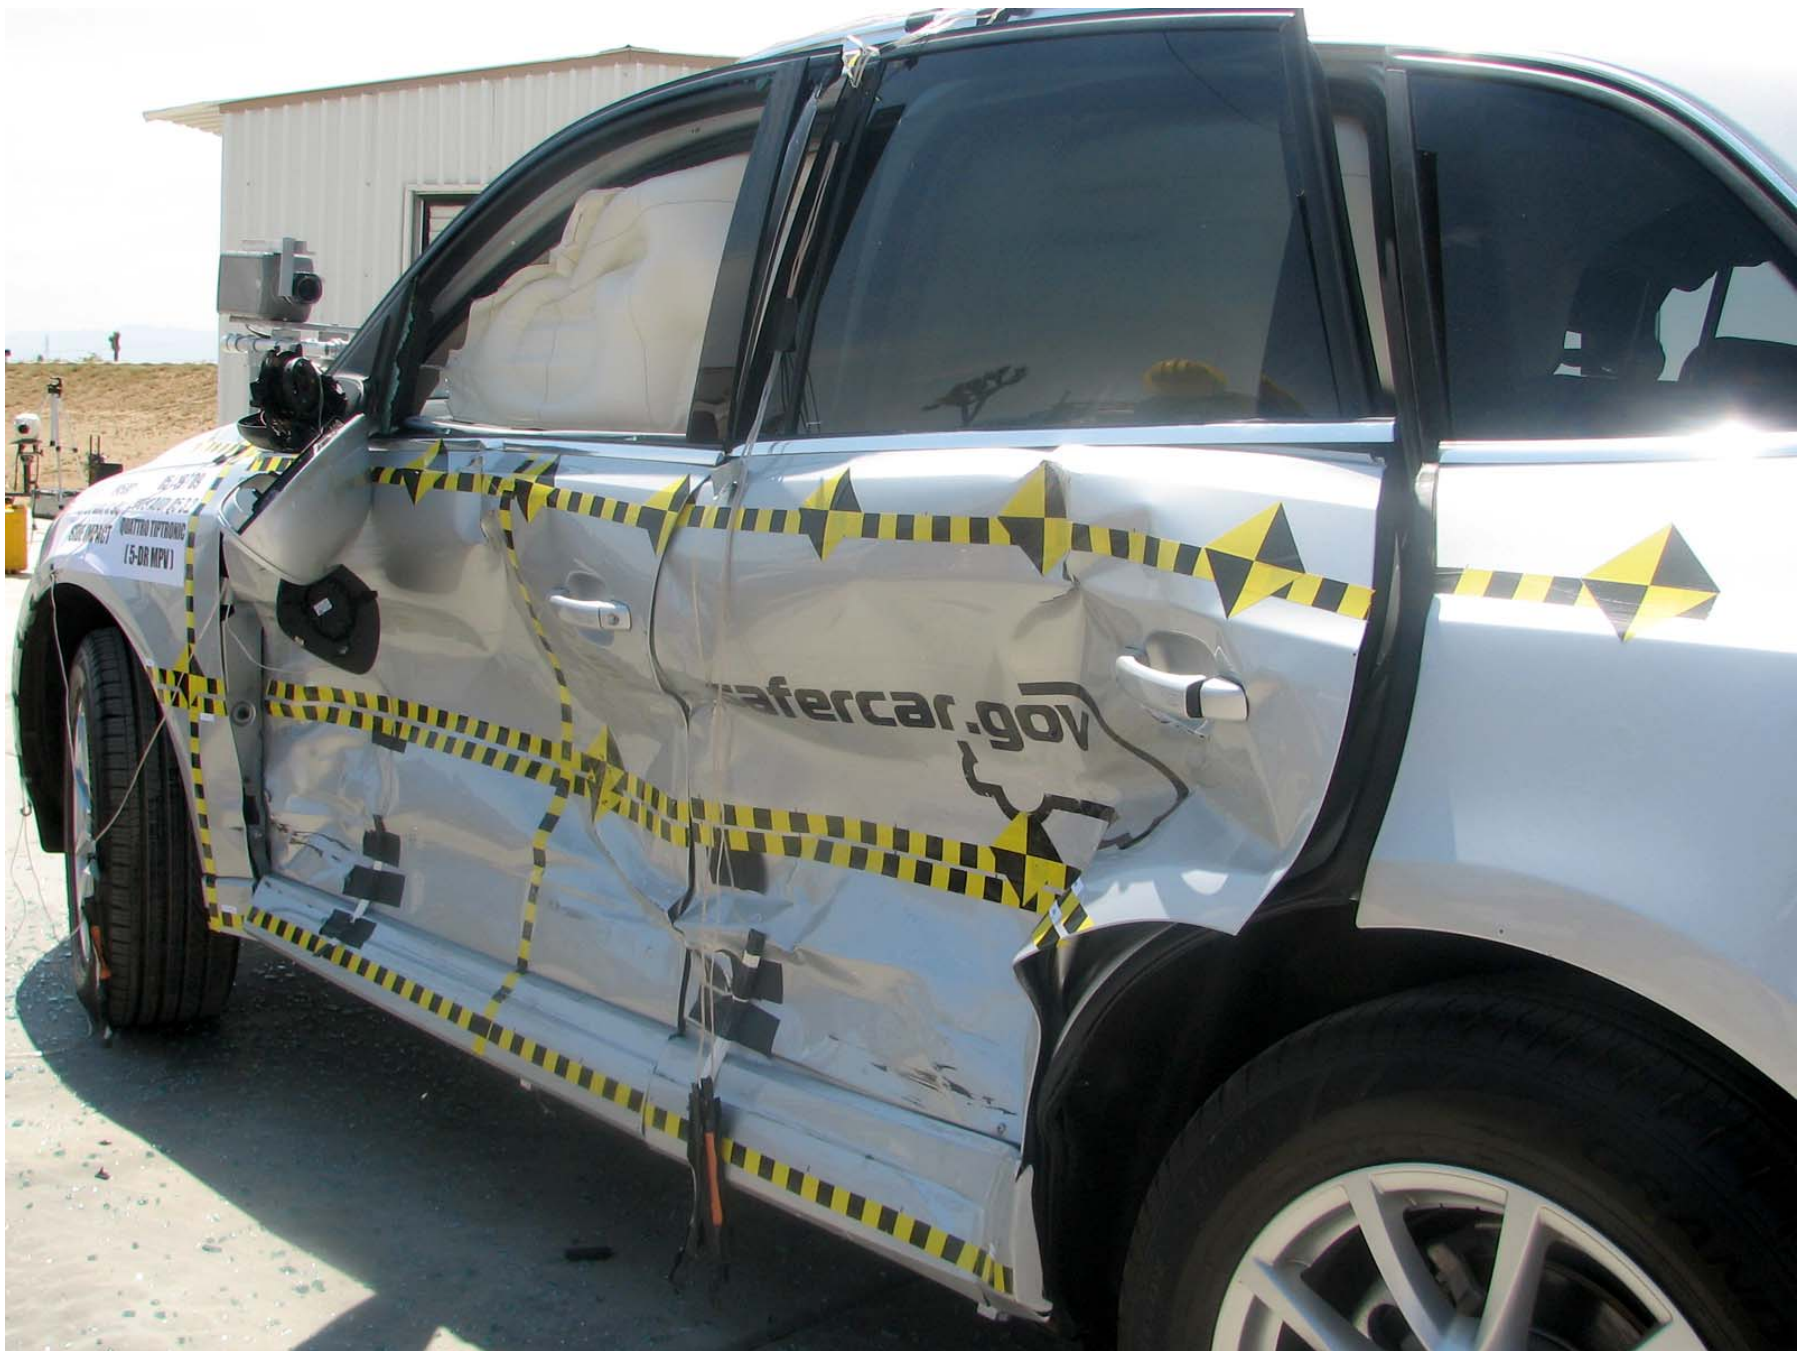
Figure A-30: Post-Test Rear  $\frac{3}{4}$  View of Left Side Door

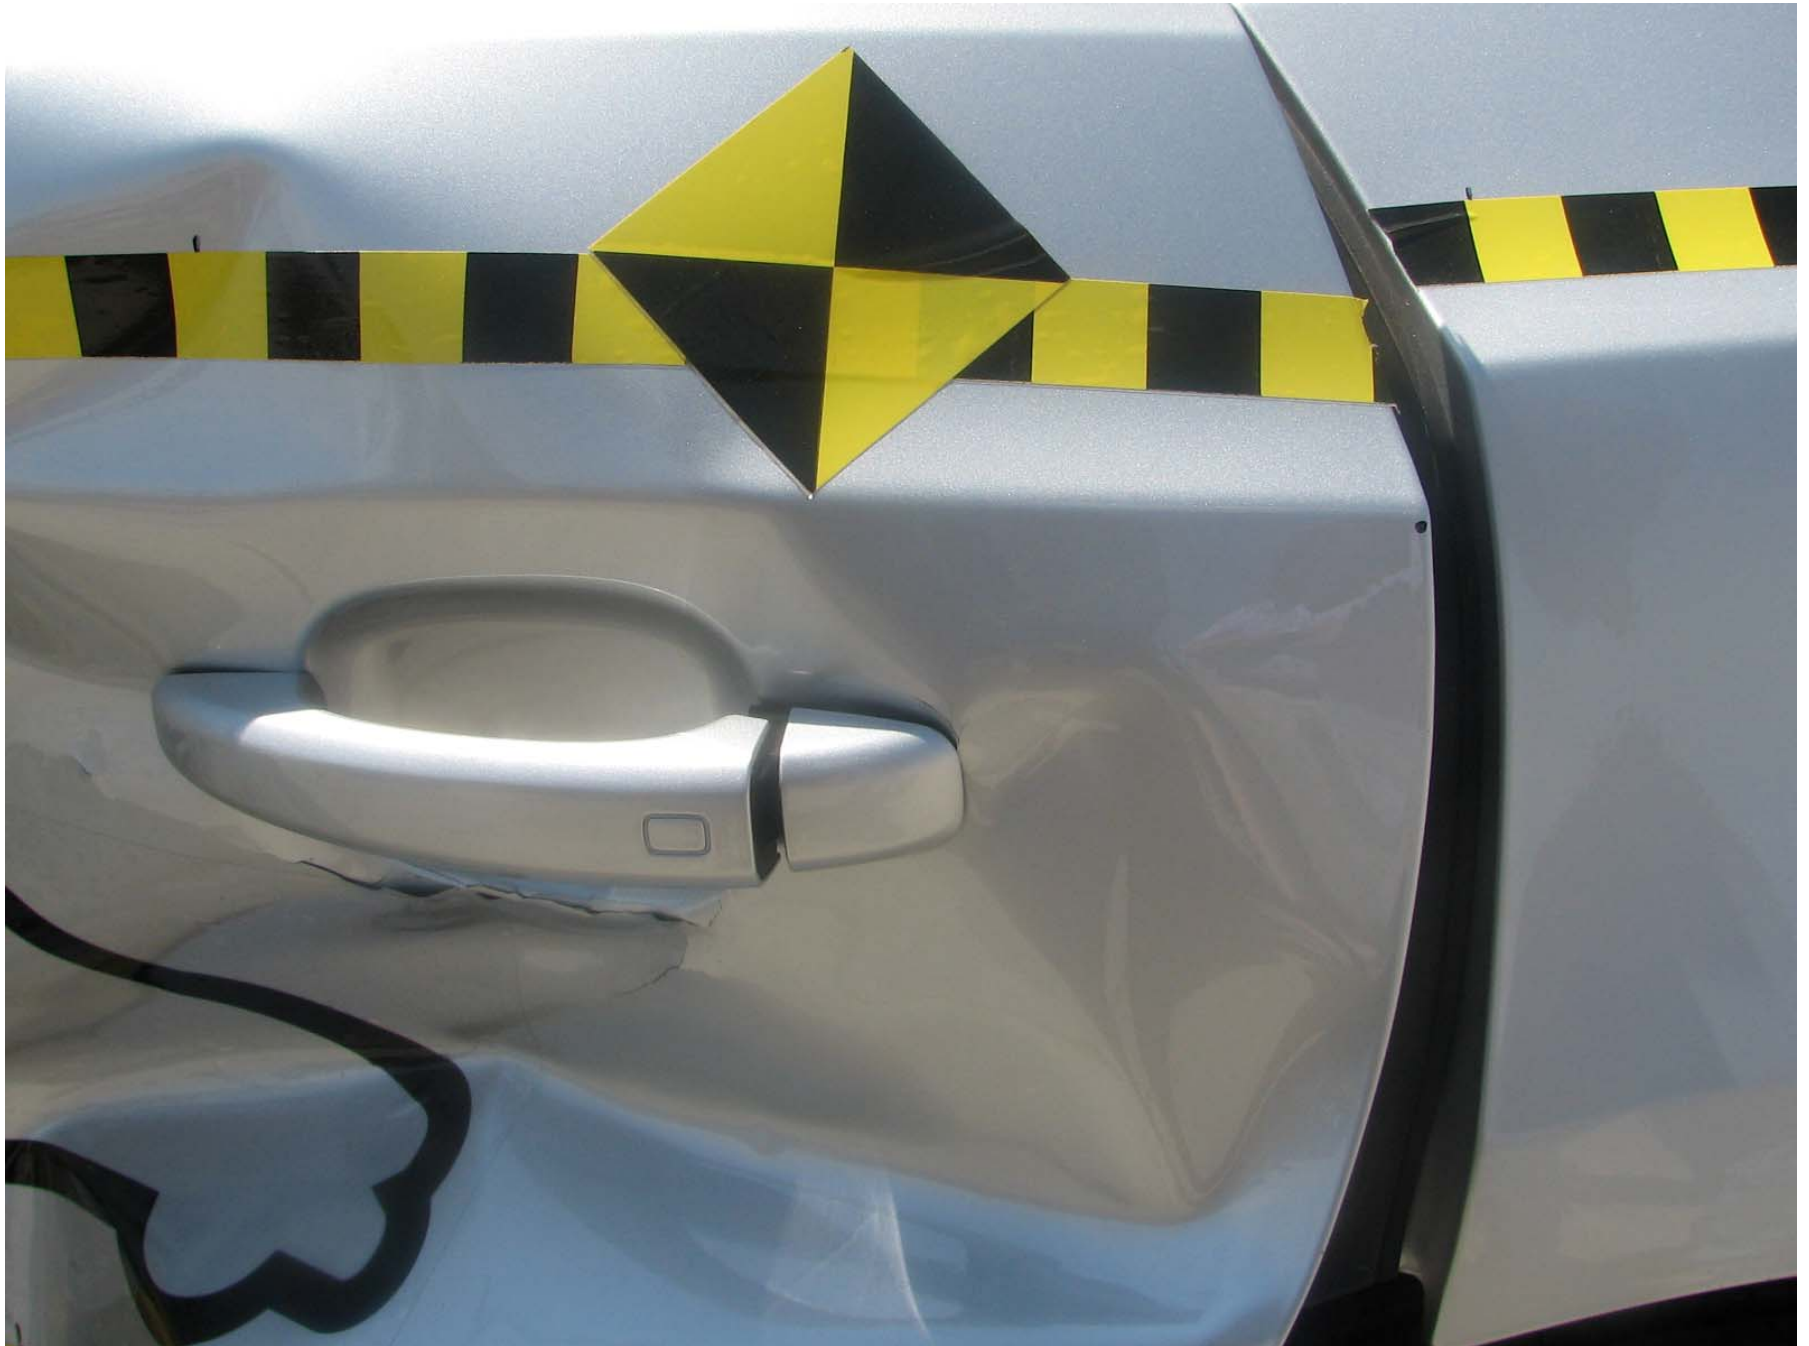
Figure A-34: Post-Test Left Rear Door

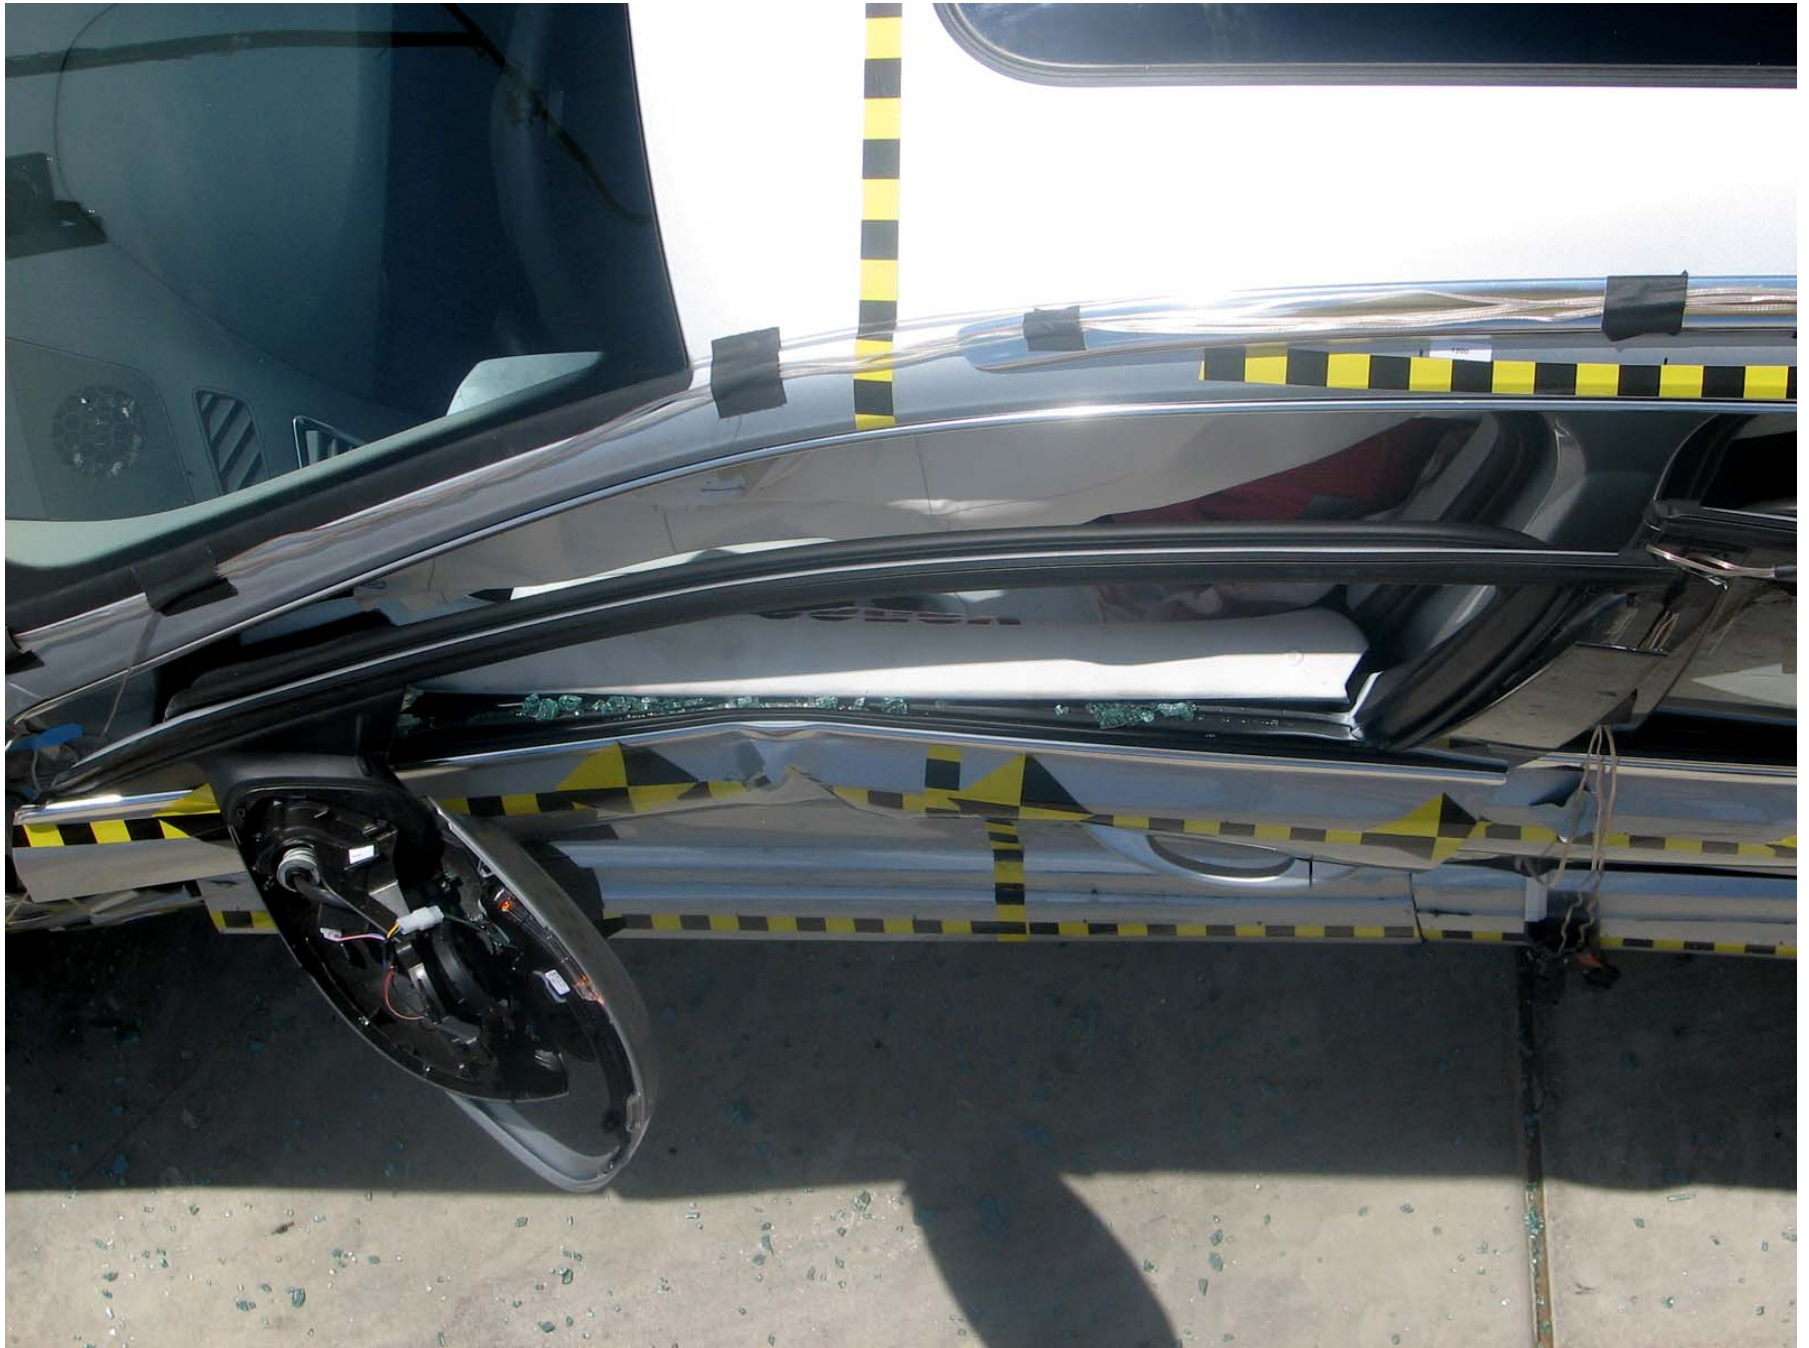
Figure A-39: Post-Test Driver Dummy Clearance From Door

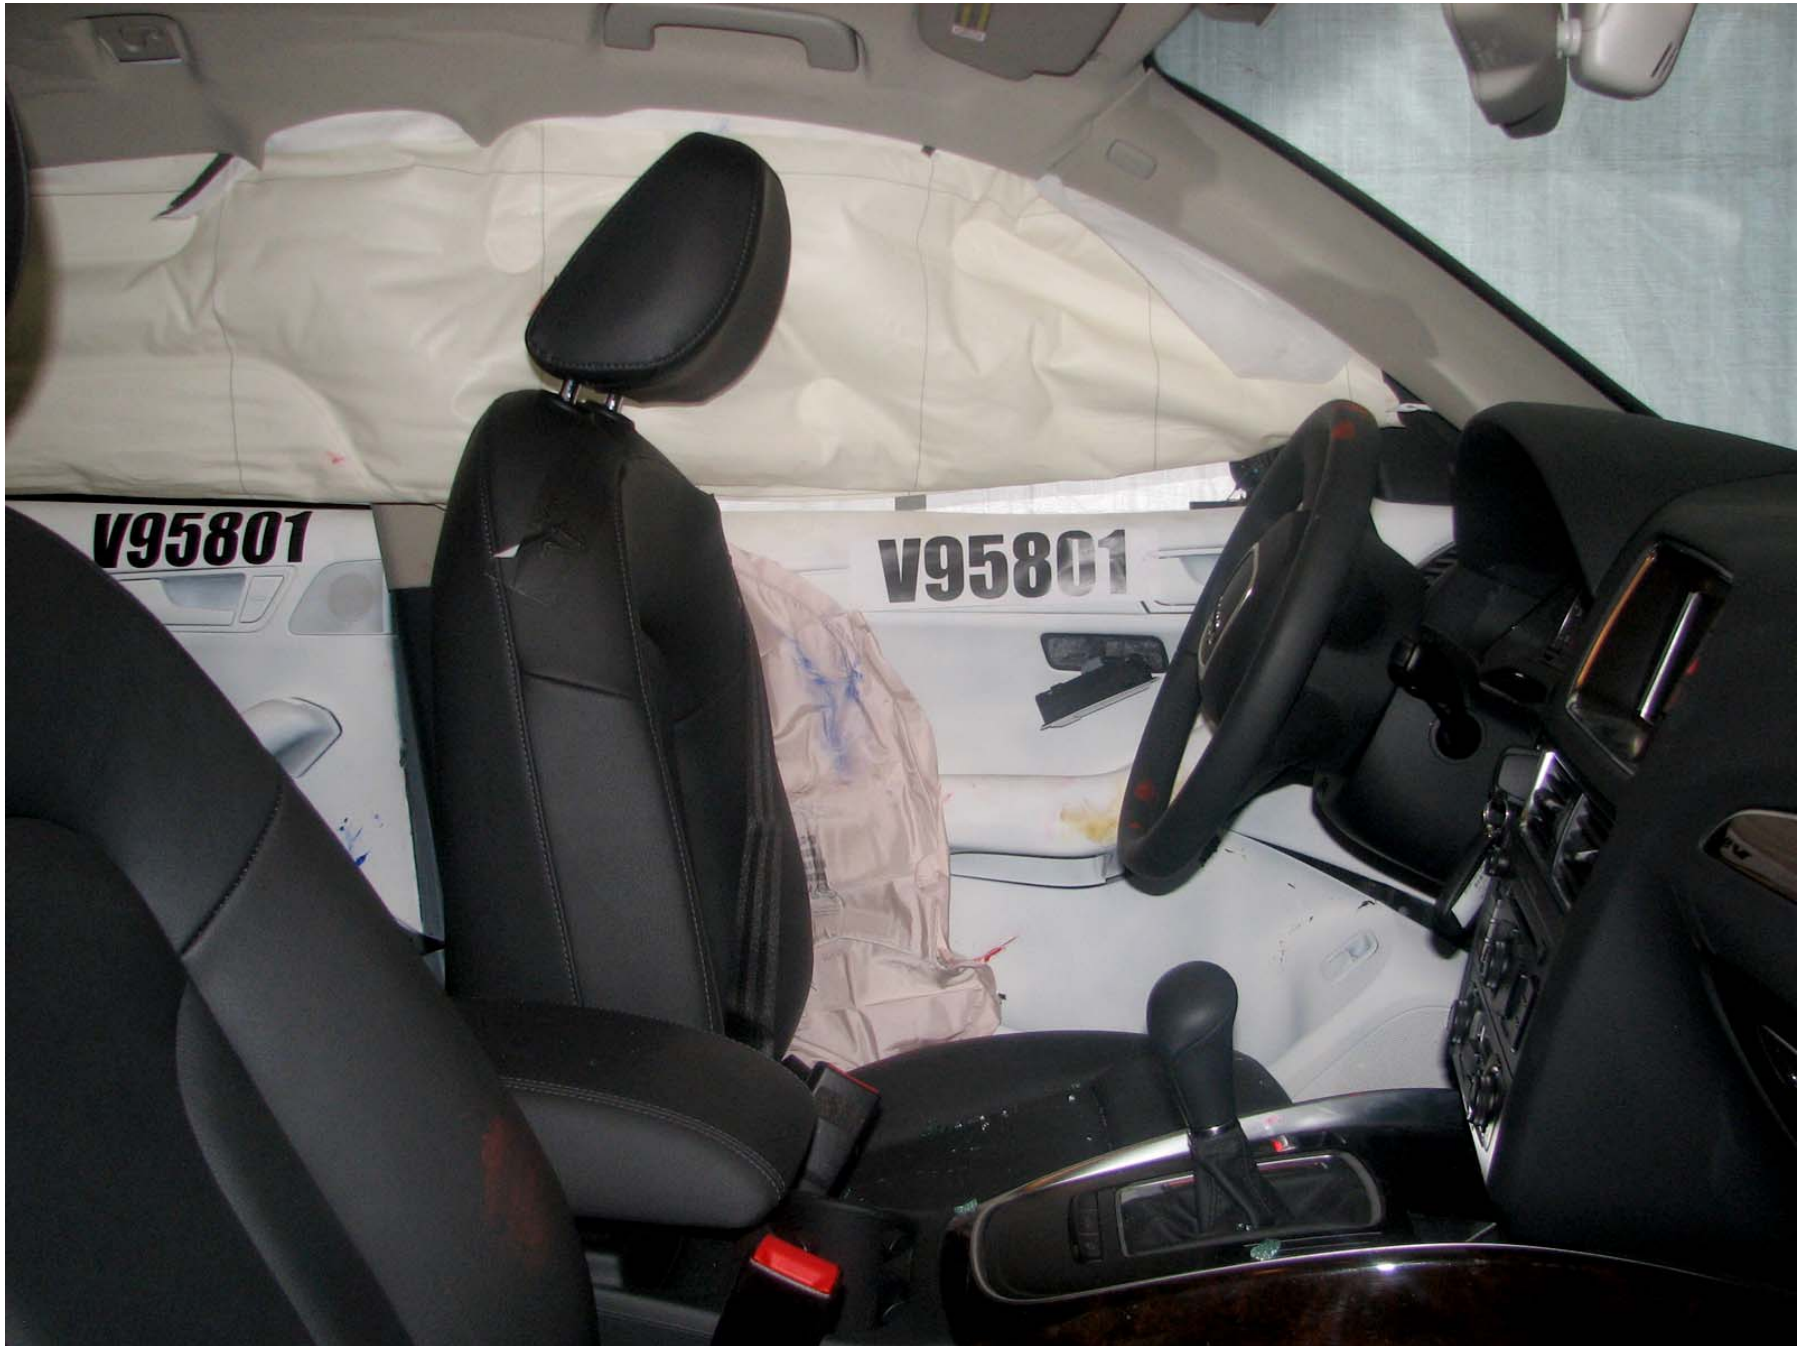
Figure A-43: Post-Test Front Door Panel (Interior)

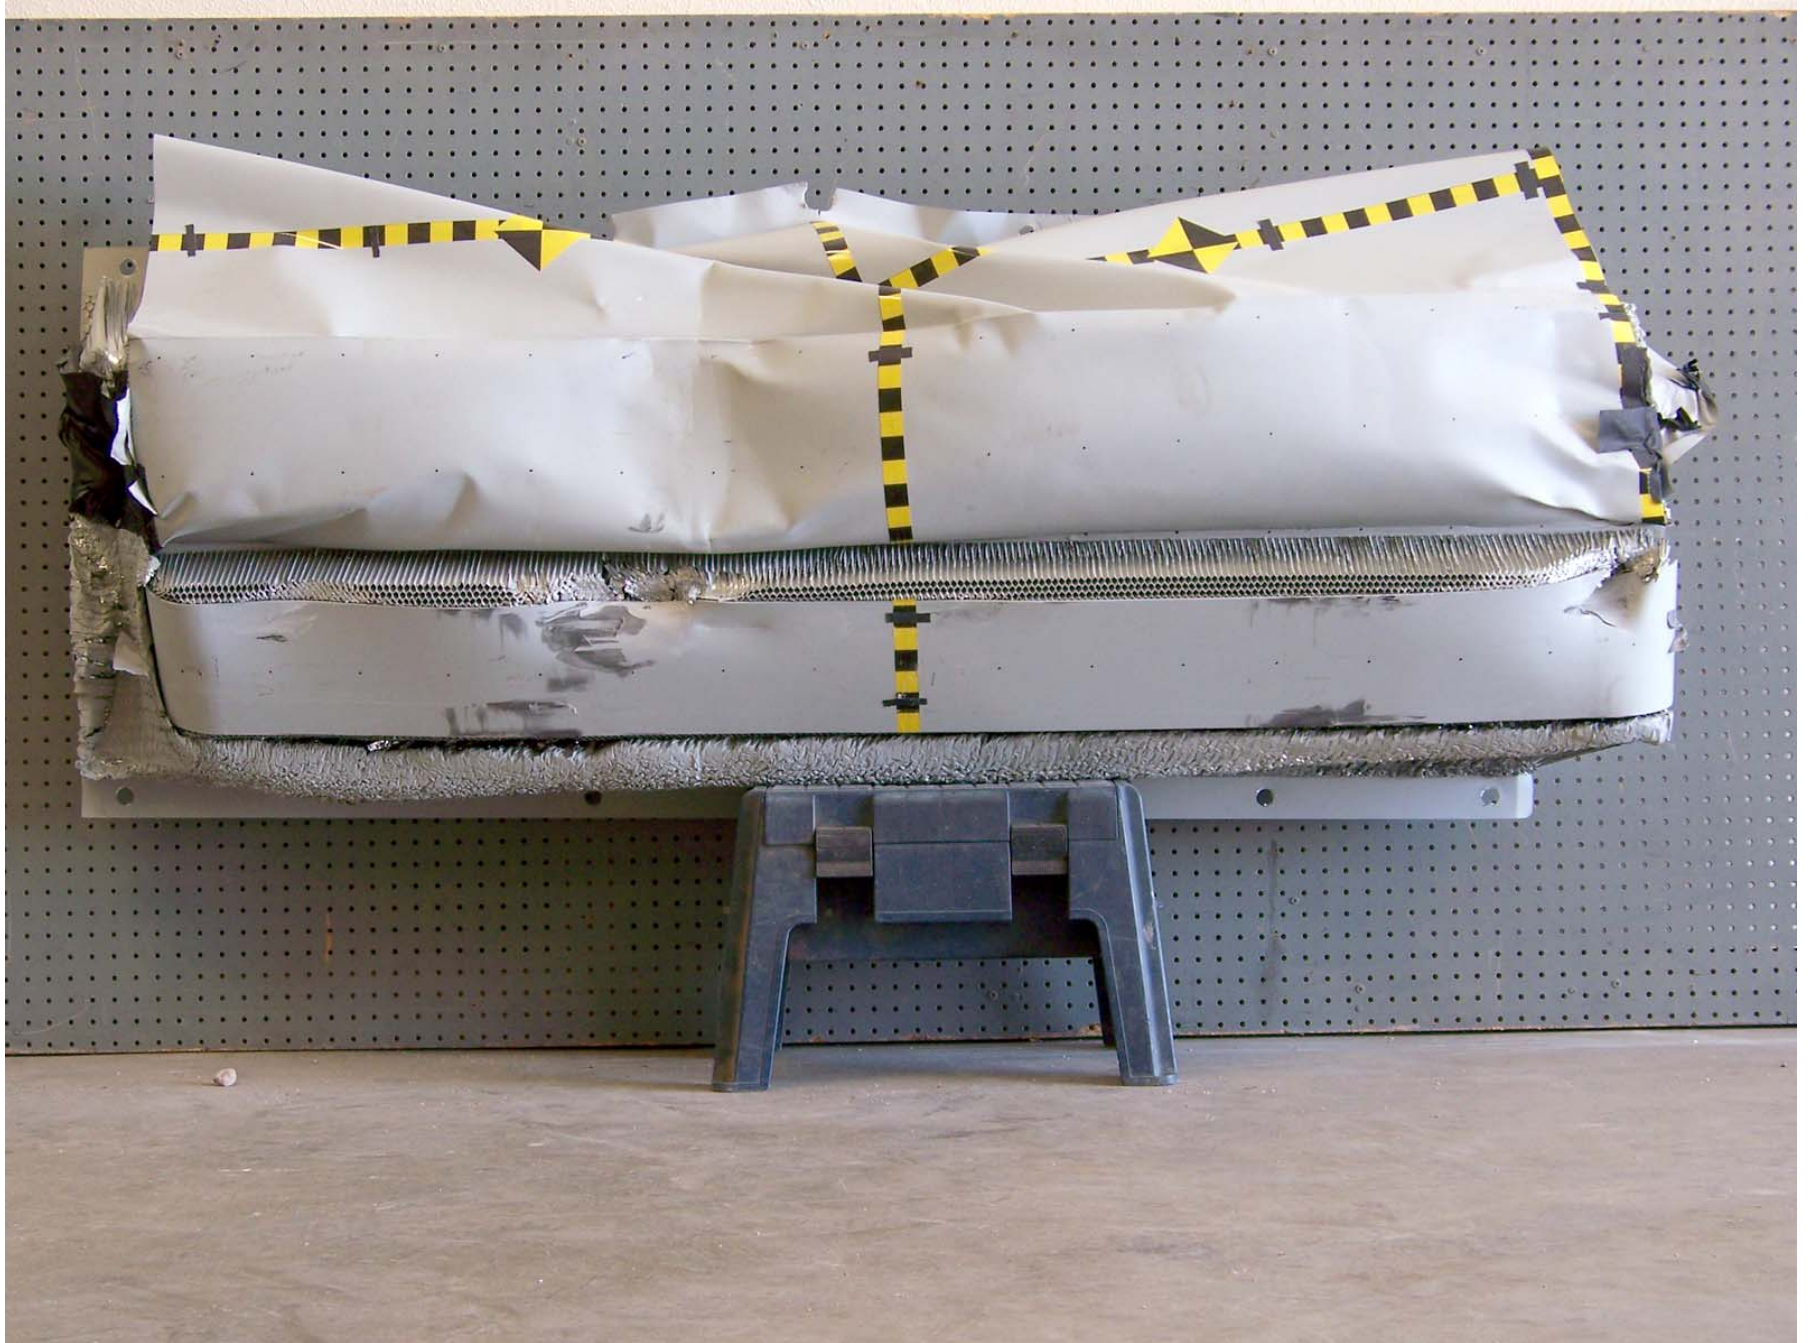
Figure A-54: Post-Test Front View of Deformable Barrier
