REPORT NUMBER TR-P29047-01-NC

NEW CAR ASSESSMENT PROGRAM  
SIDE IMPACT TEST

AUDI AG  
2009 AUDI Q5 3.2 QUATTRO TIPTRONIC  
5-DOOR MPV

NHTSA NUMBER: V95801

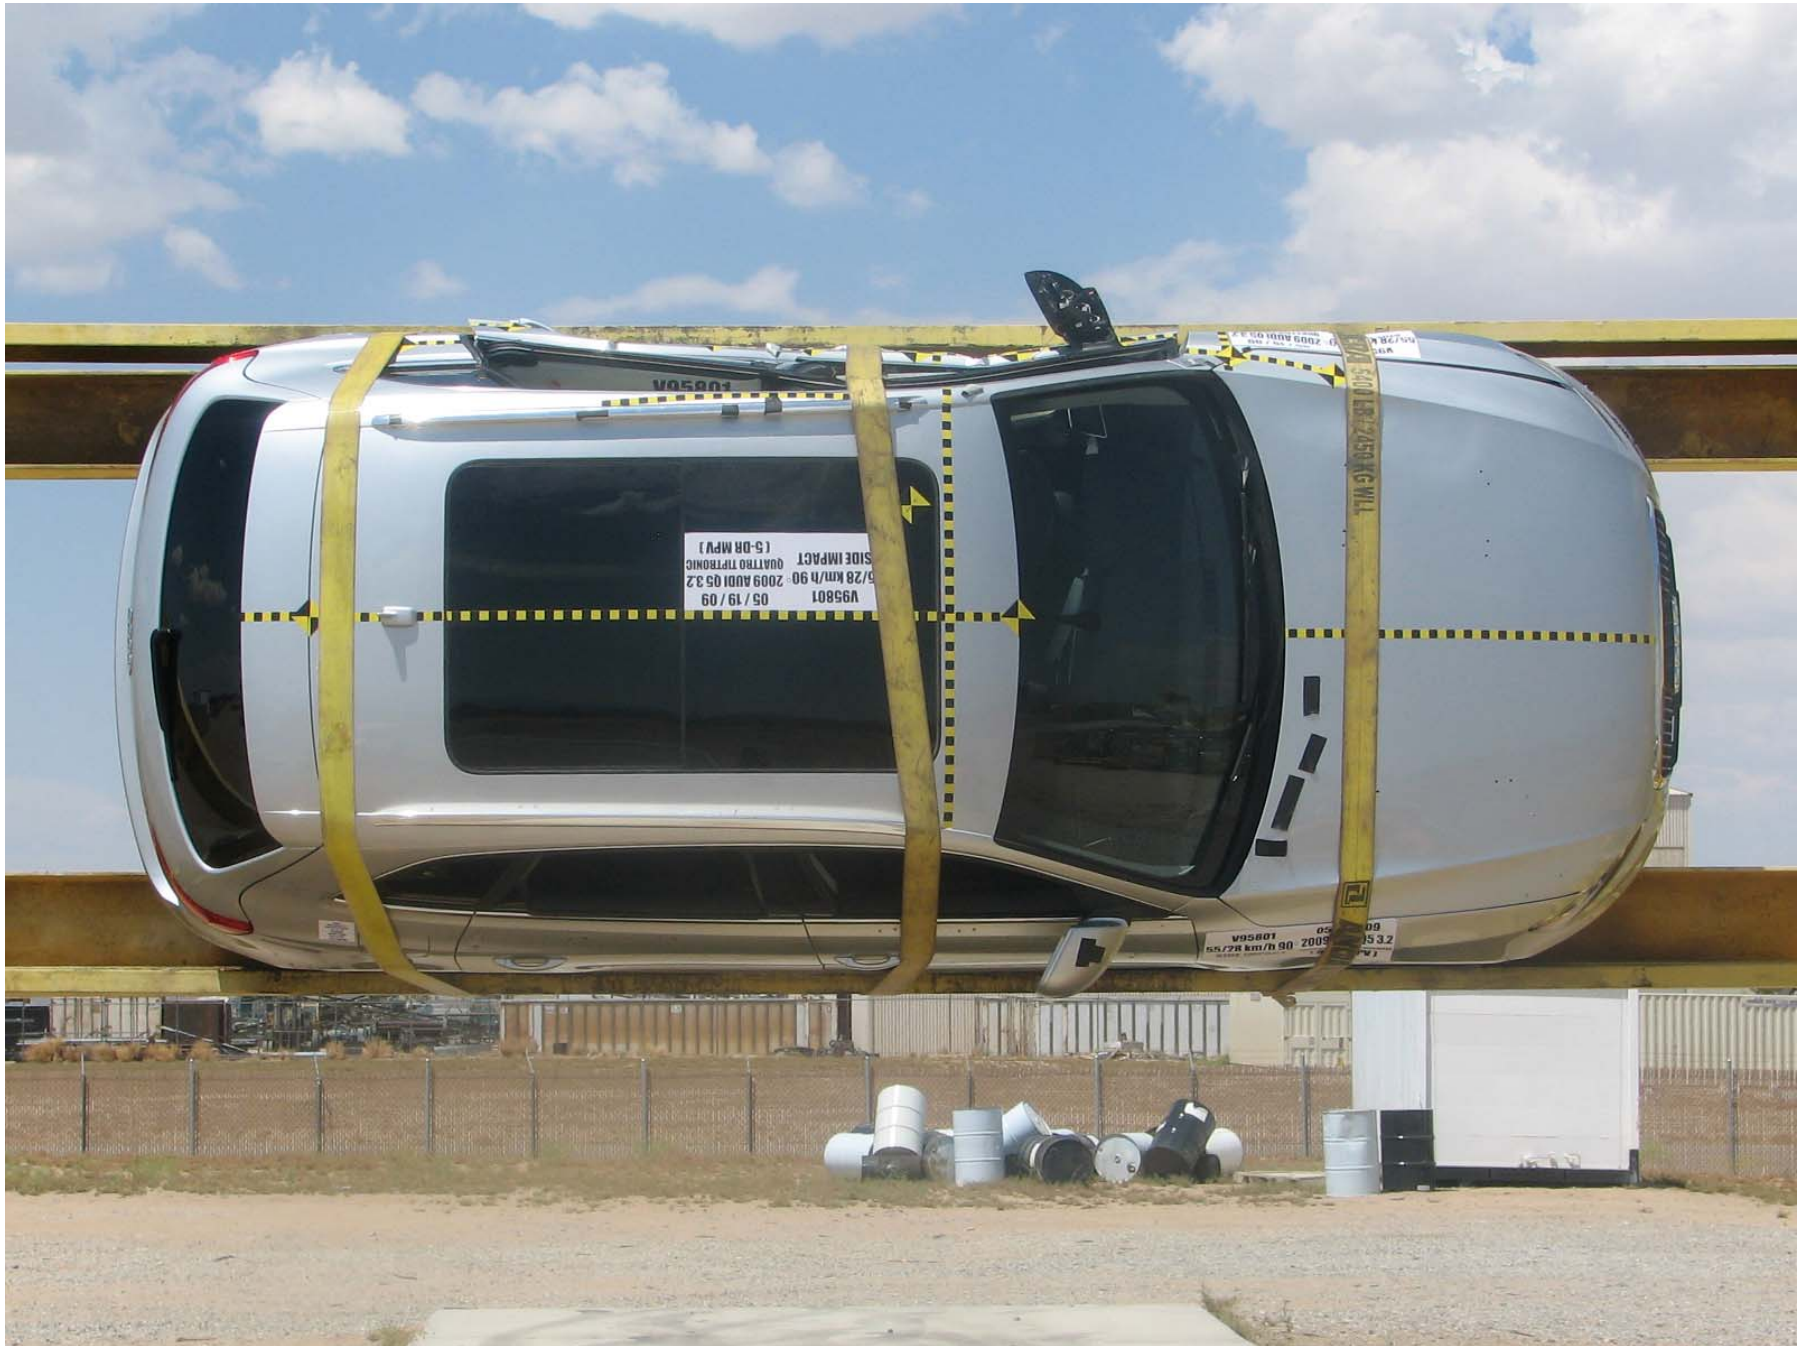
Figure A-62: Vehicle on Rollover Device (90°)

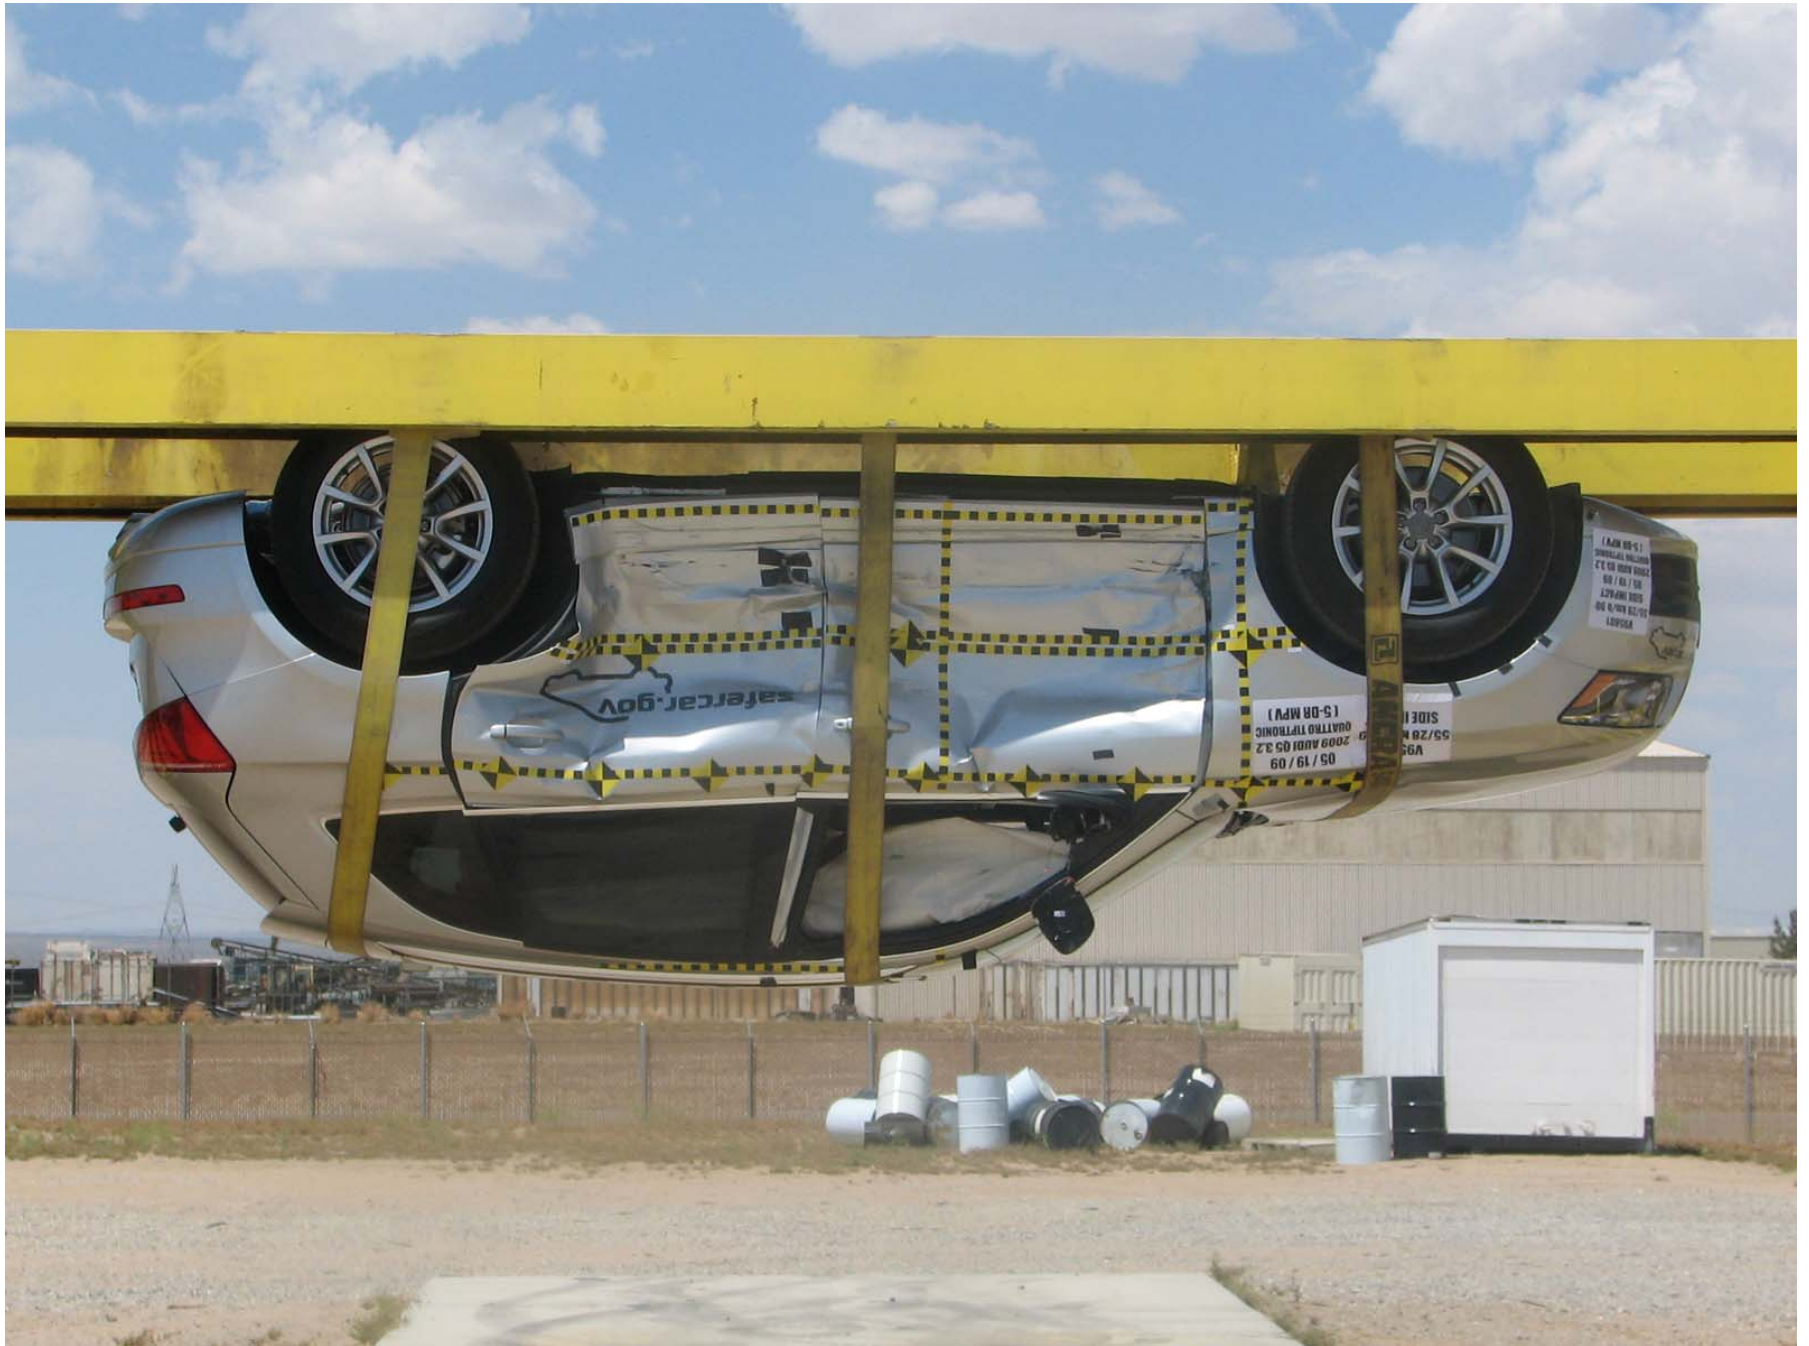
Figure A-63: Vehicle on Rollover Device (180°)

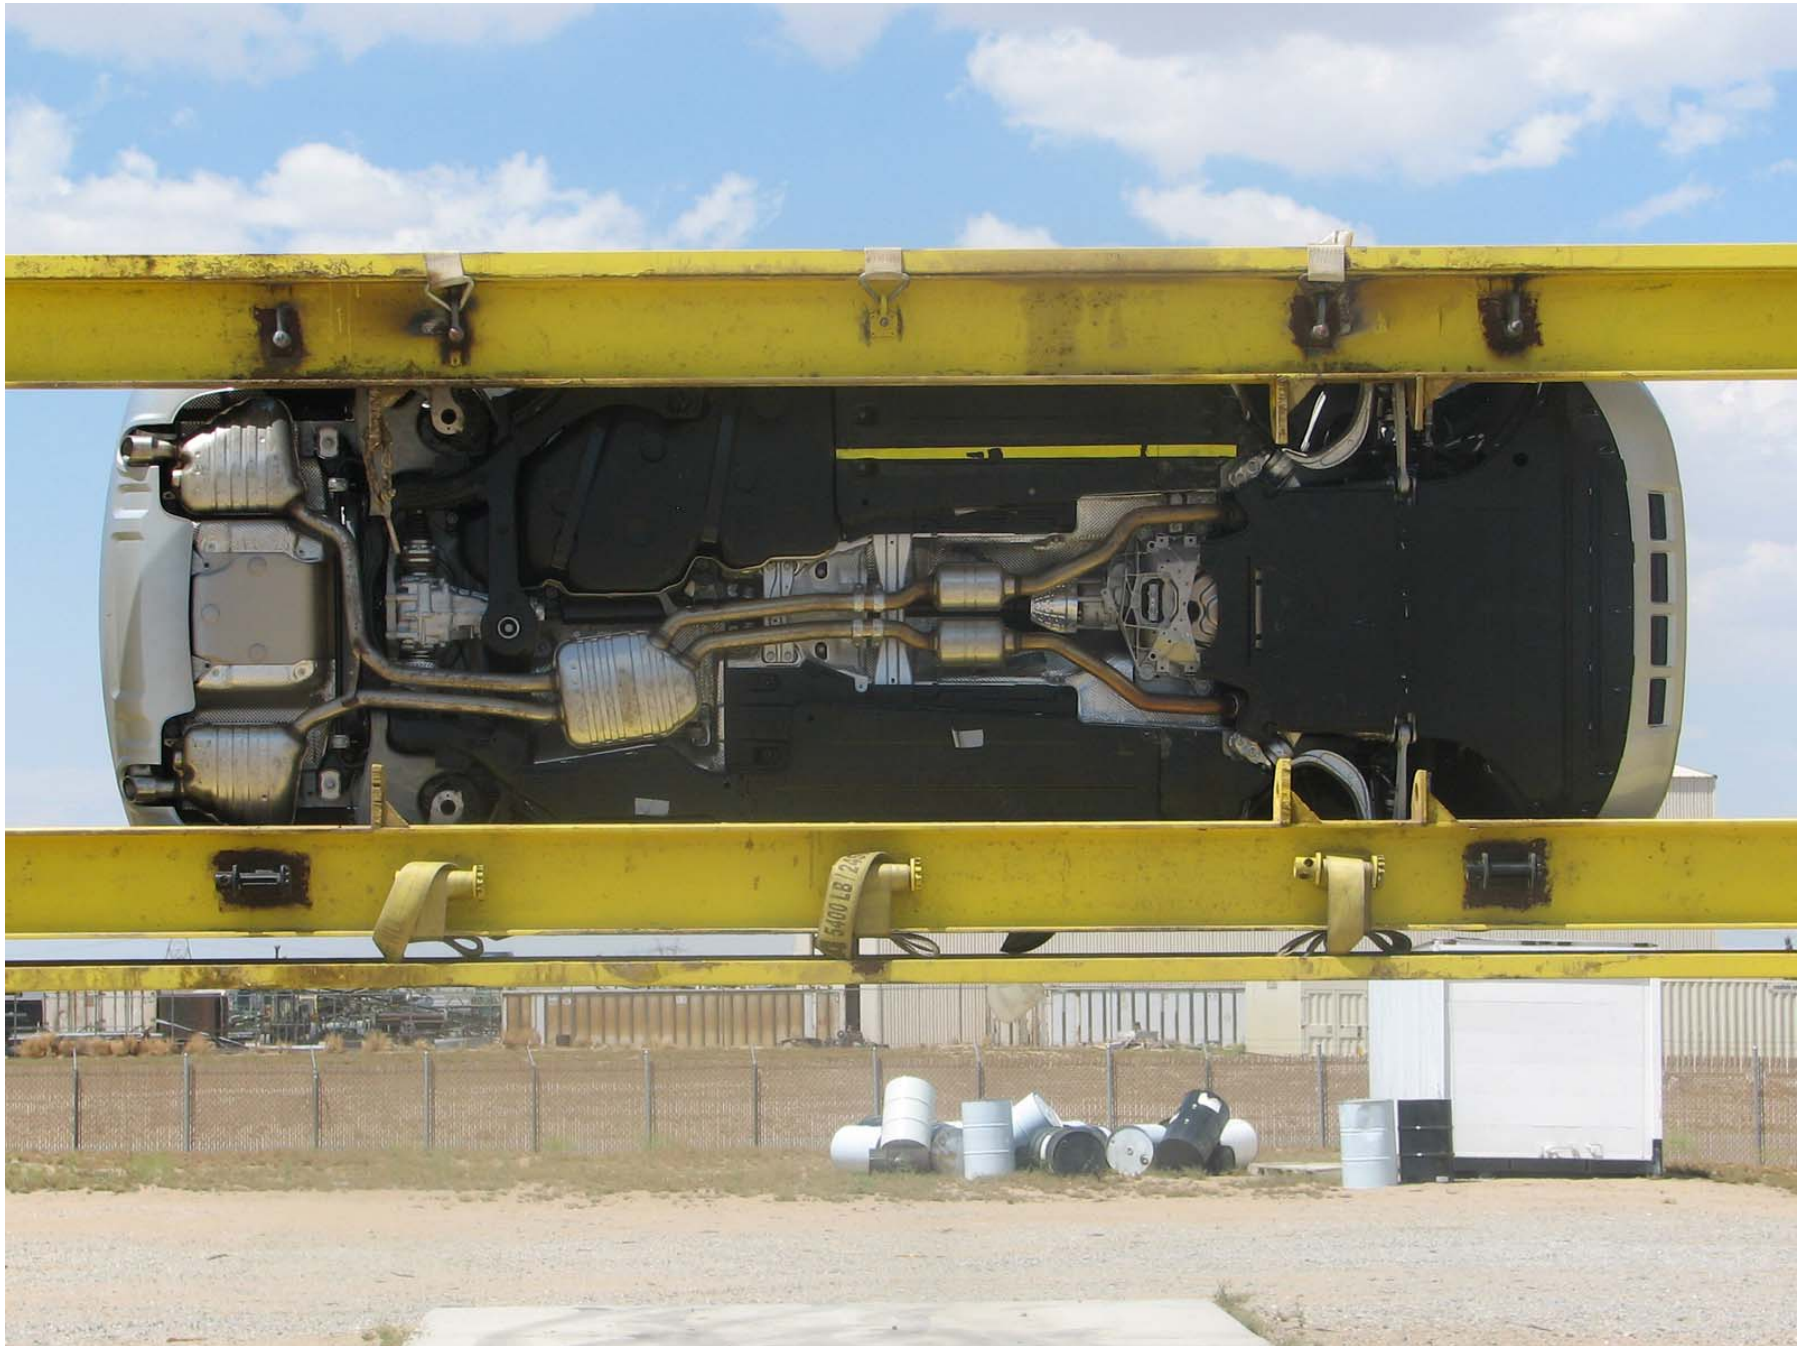
Figure A-64: Vehicle on Rollover Device (270°)

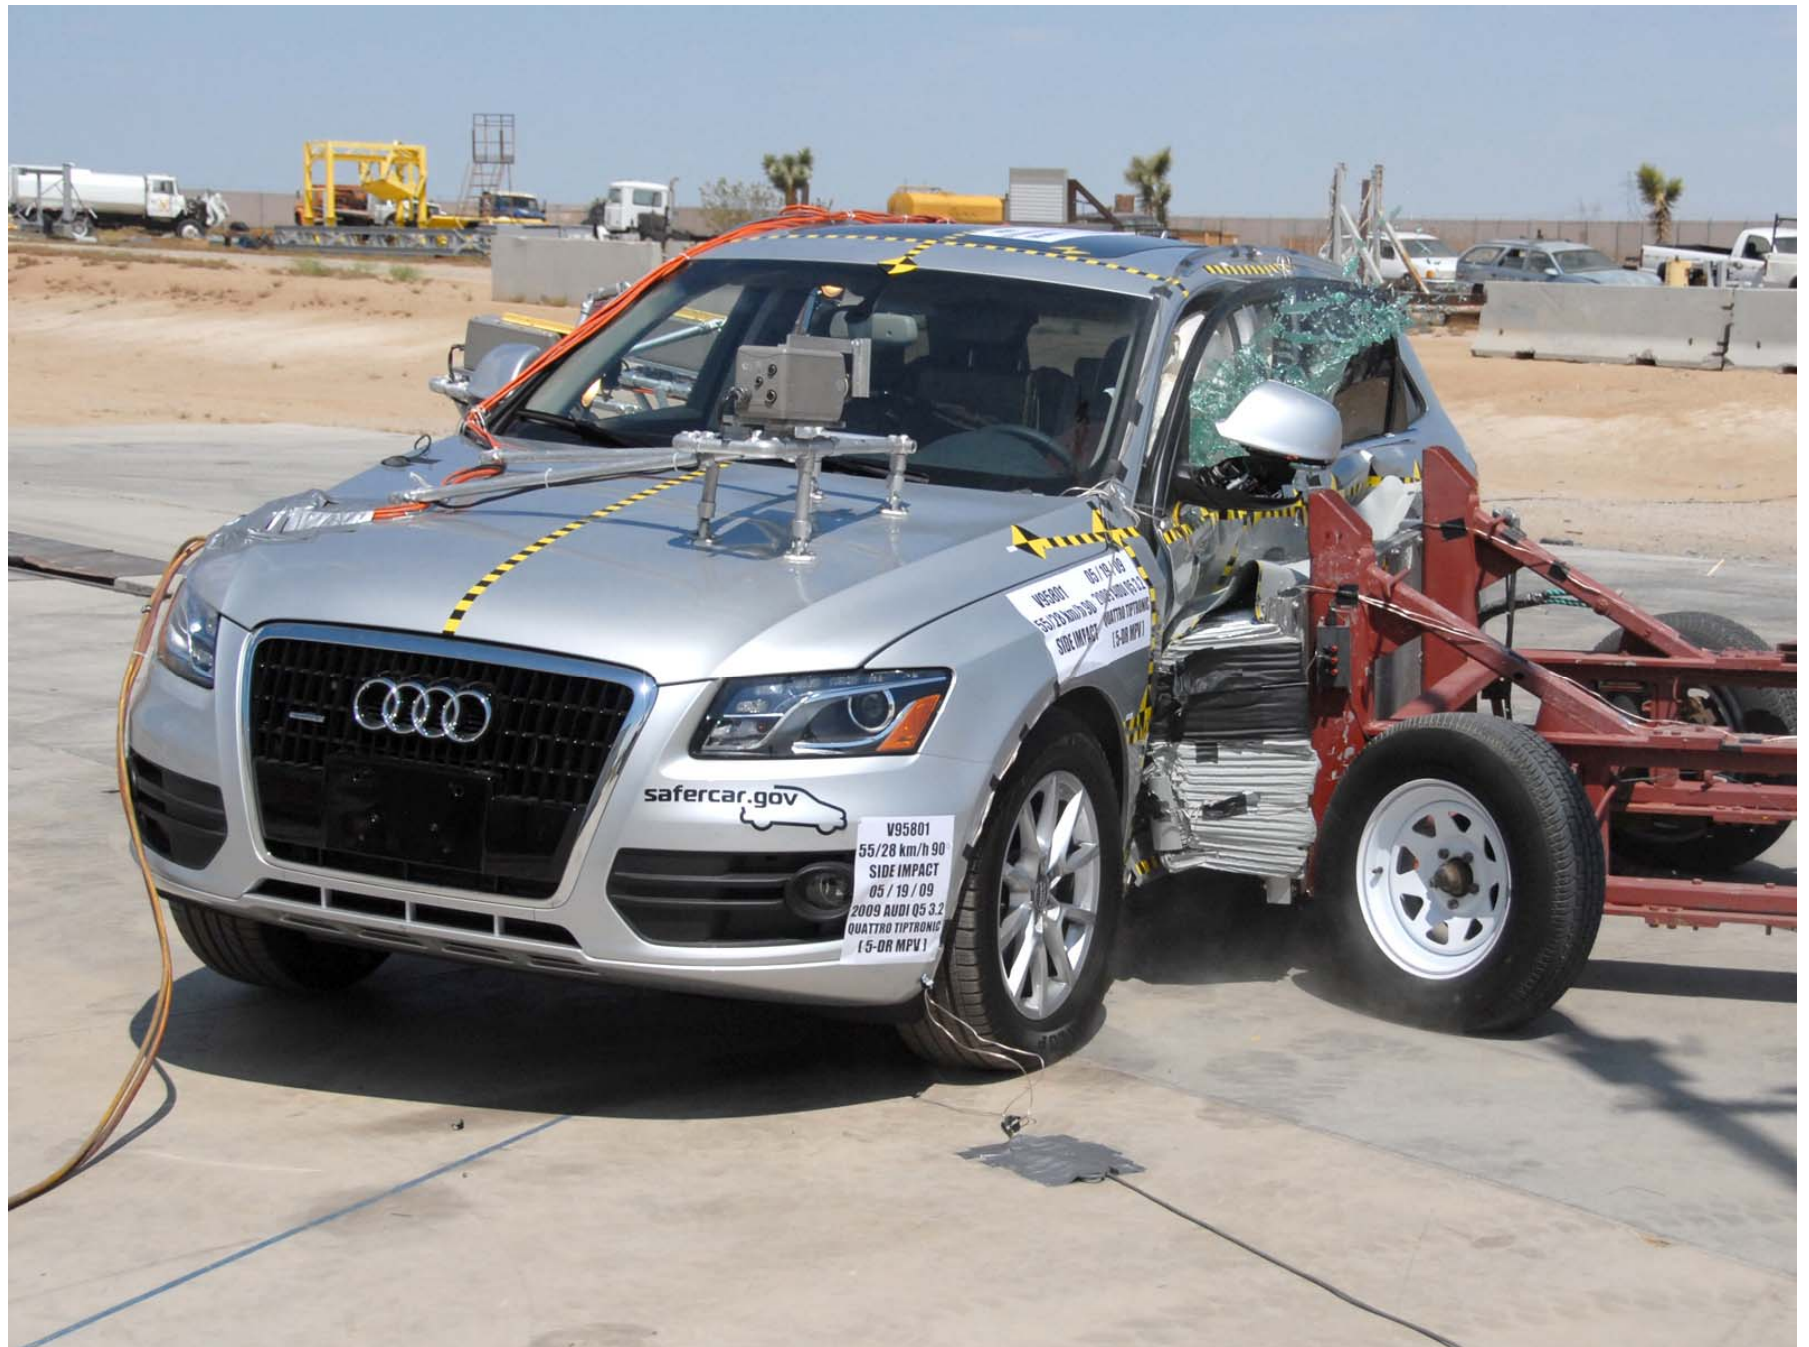
Figure A-66: Vehicle Impact
