**VALIDATION  
SIDE IMPACT POLE TEST**

**TOYOTA MOTOR CORPORATION  
2010 TOYOTA COROLLA 4-DR SEDAN  
NHTSA NUMBER: MA5117**

**PREPARED BY:  
MGA RESEARCH CORPORATION  
5000 WARREN ROAD  
BURLINGTON, WI 53105**

**FINAL REPORT**

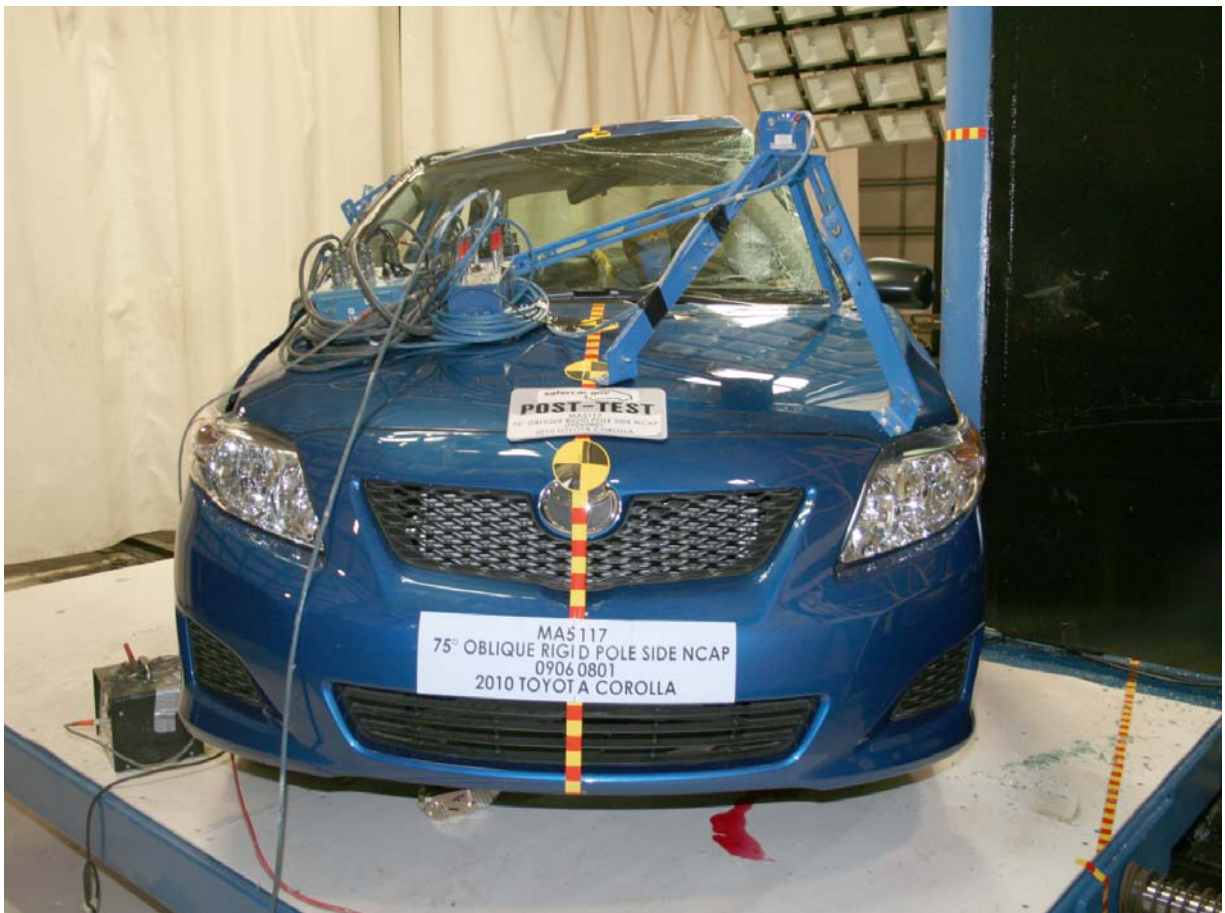
Post-Test Frontal View of Test Vehicle

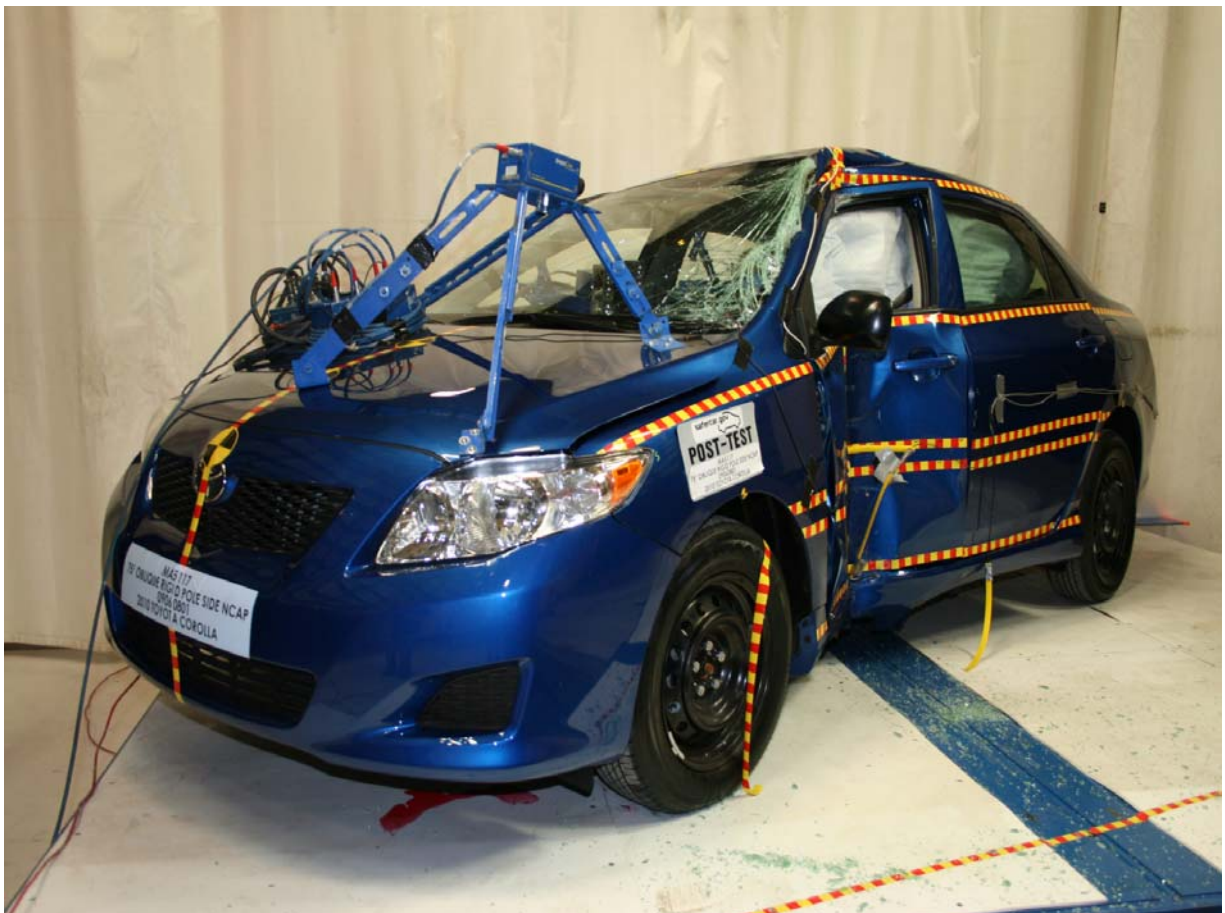
Post-Test Left Front  $\frac{3}{4}$  View of Test Vehicle

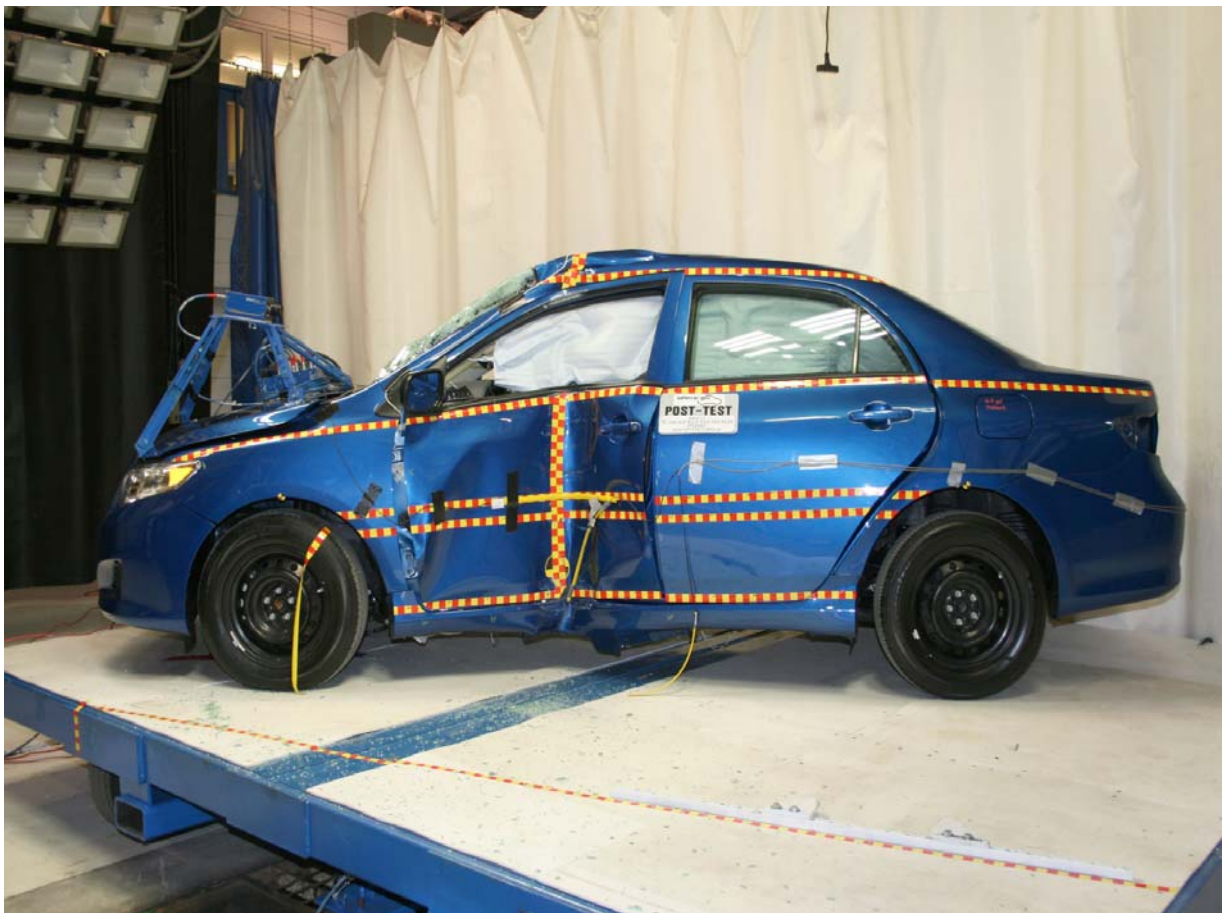
Post-Test Left Side View of Test Vehicle

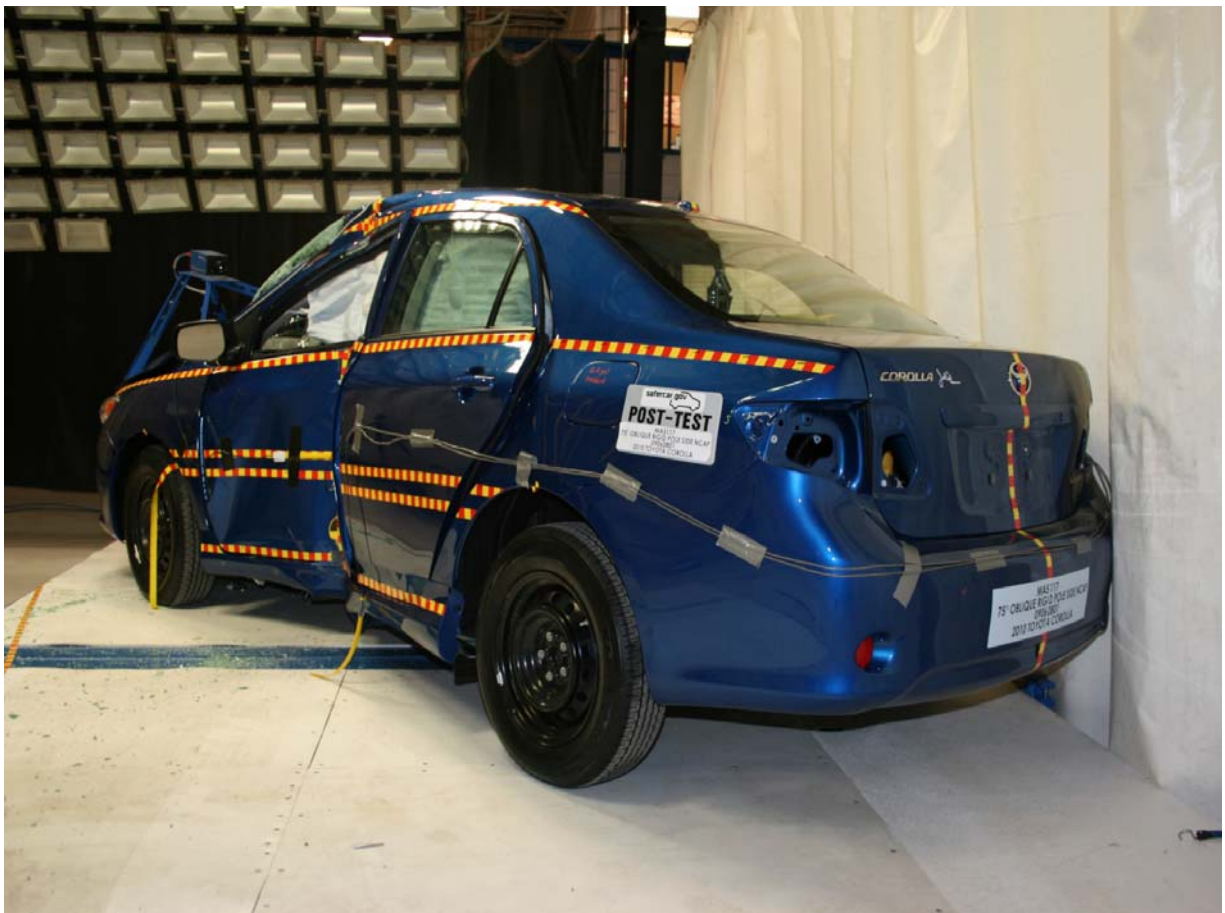
Post-Test Left Rear  $\frac{3}{4}$  View of Test Vehicle

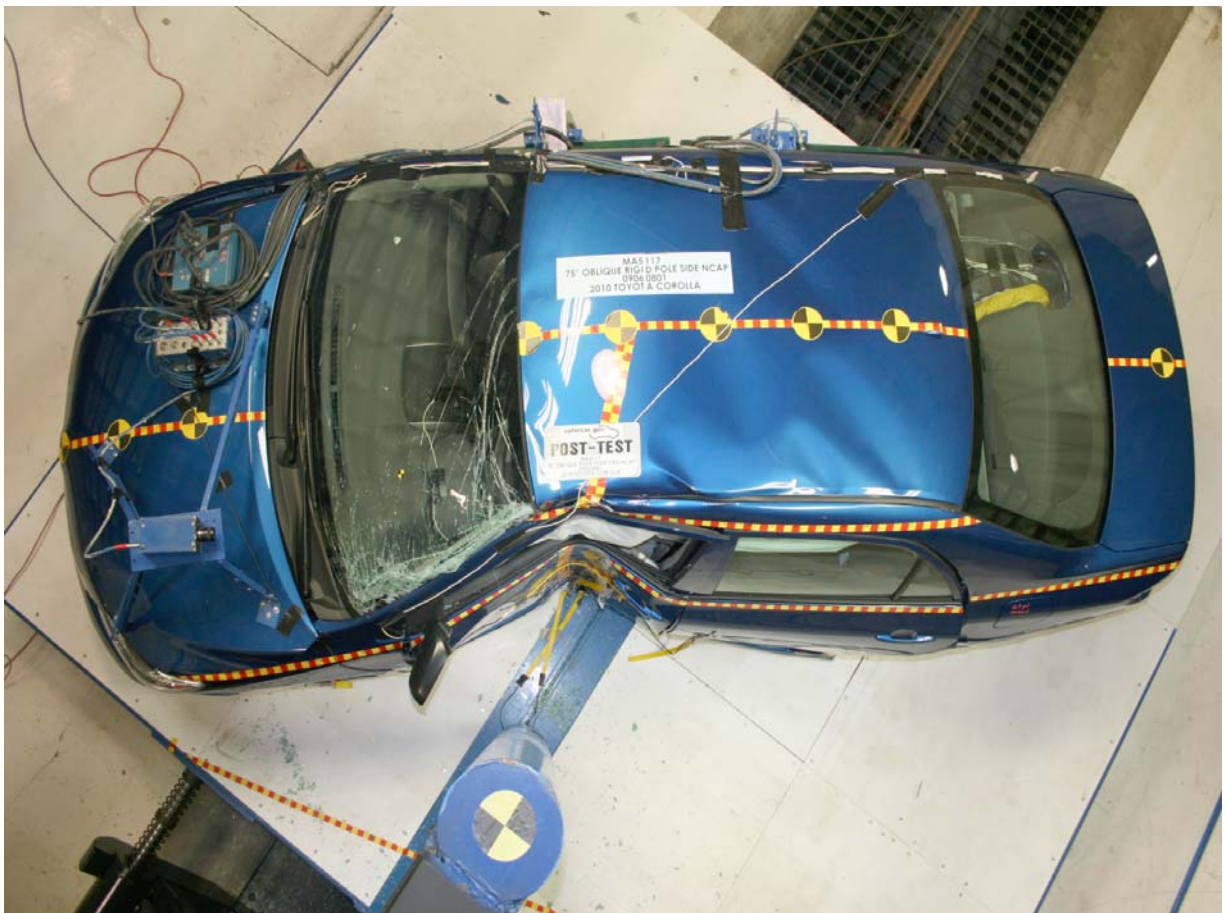
Post-Test Overhead View of Test Vehicle and Pole

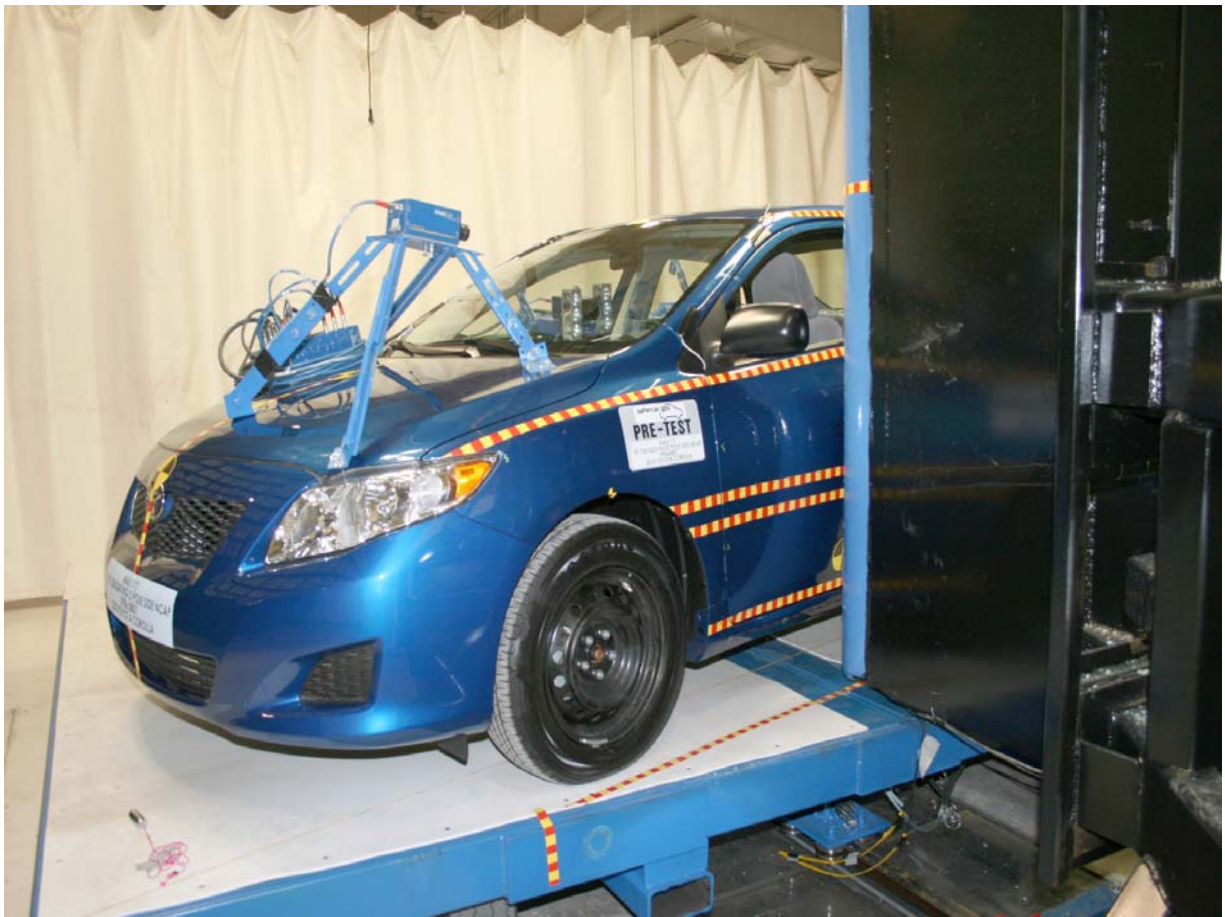
Pre-Test Left Side View of Pole Positioned Against Side of Vehicle at Ideal Impact Point

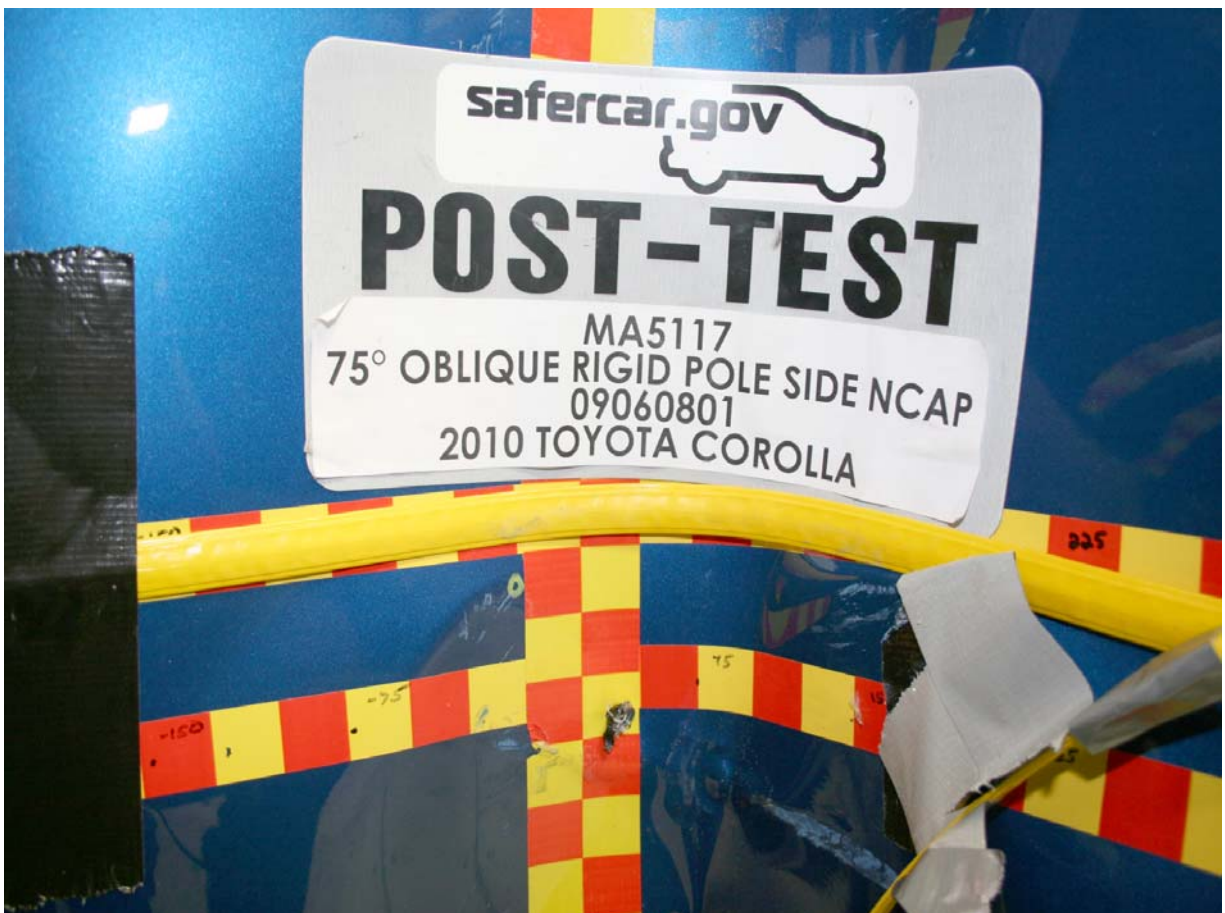
Post-Test Close-Up View of Impact Point Target Showing Impact Location

| Measurement Parameter | Units | Value |
|---|---|---|
| Actual Impact Point (Aft of Front Axle) | mm | 1049 |
| Impact Point Difference | mm | 13 |

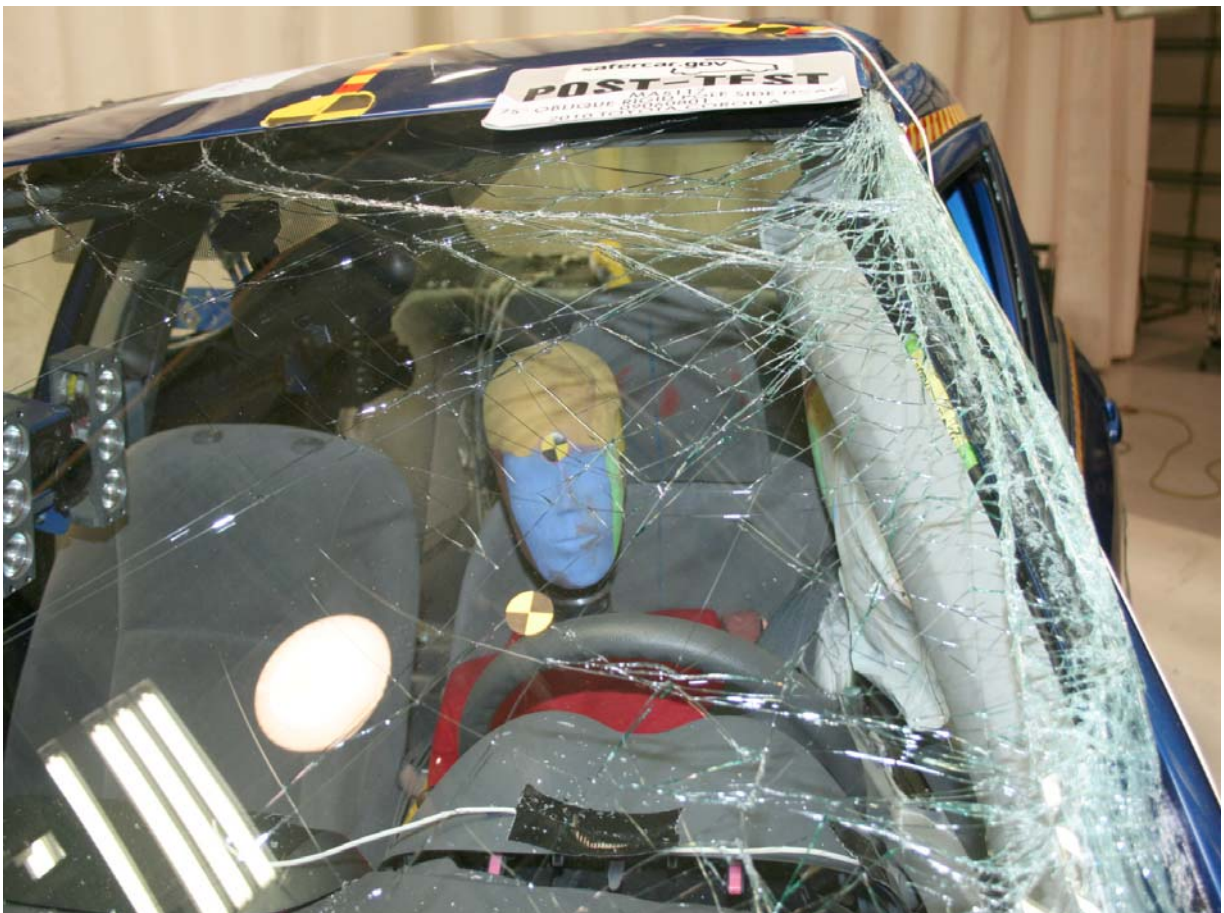
Post-Test Front Close-Up View of Dummy (through front window)

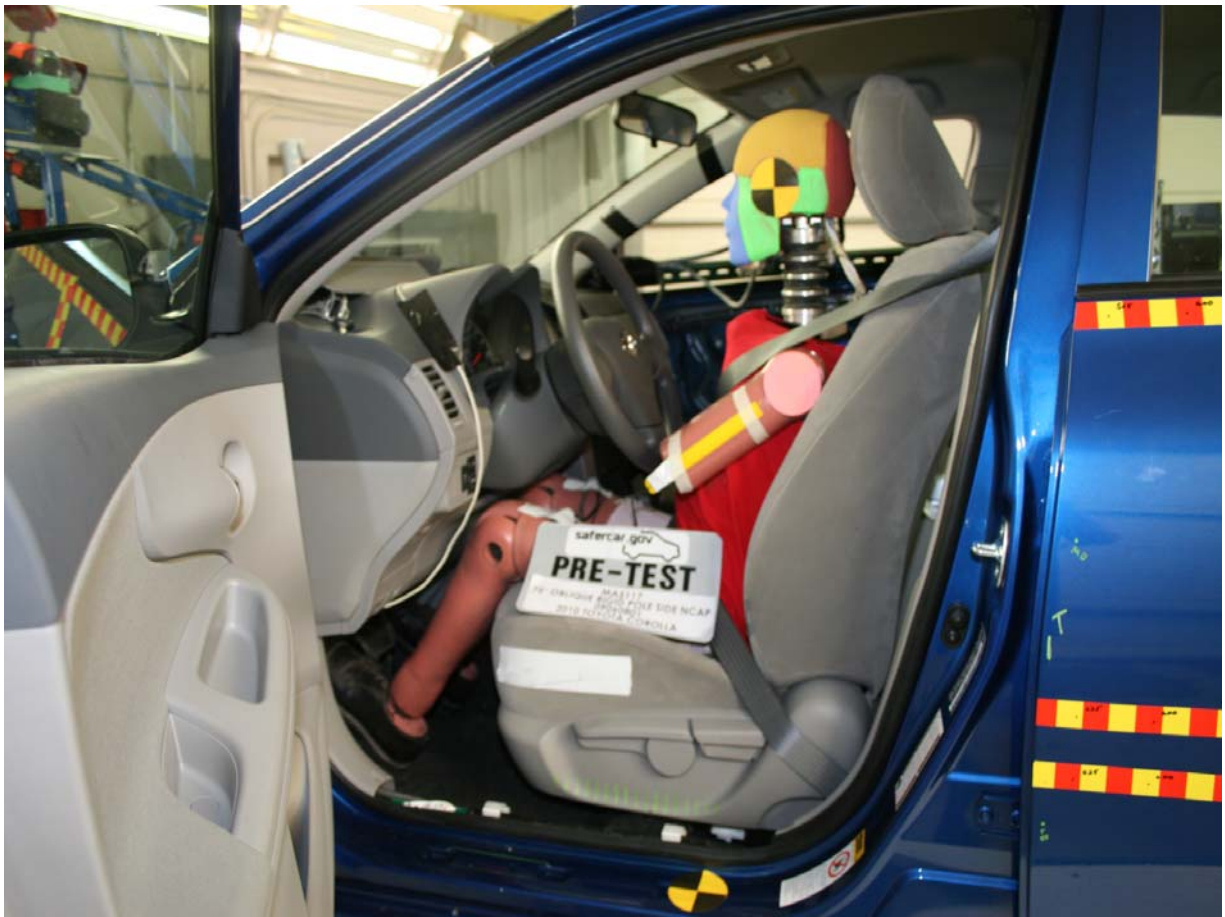
Pre-Test Left Side View of Dummy Showing Belts, Chalking, and Contact Switches (Door Open)

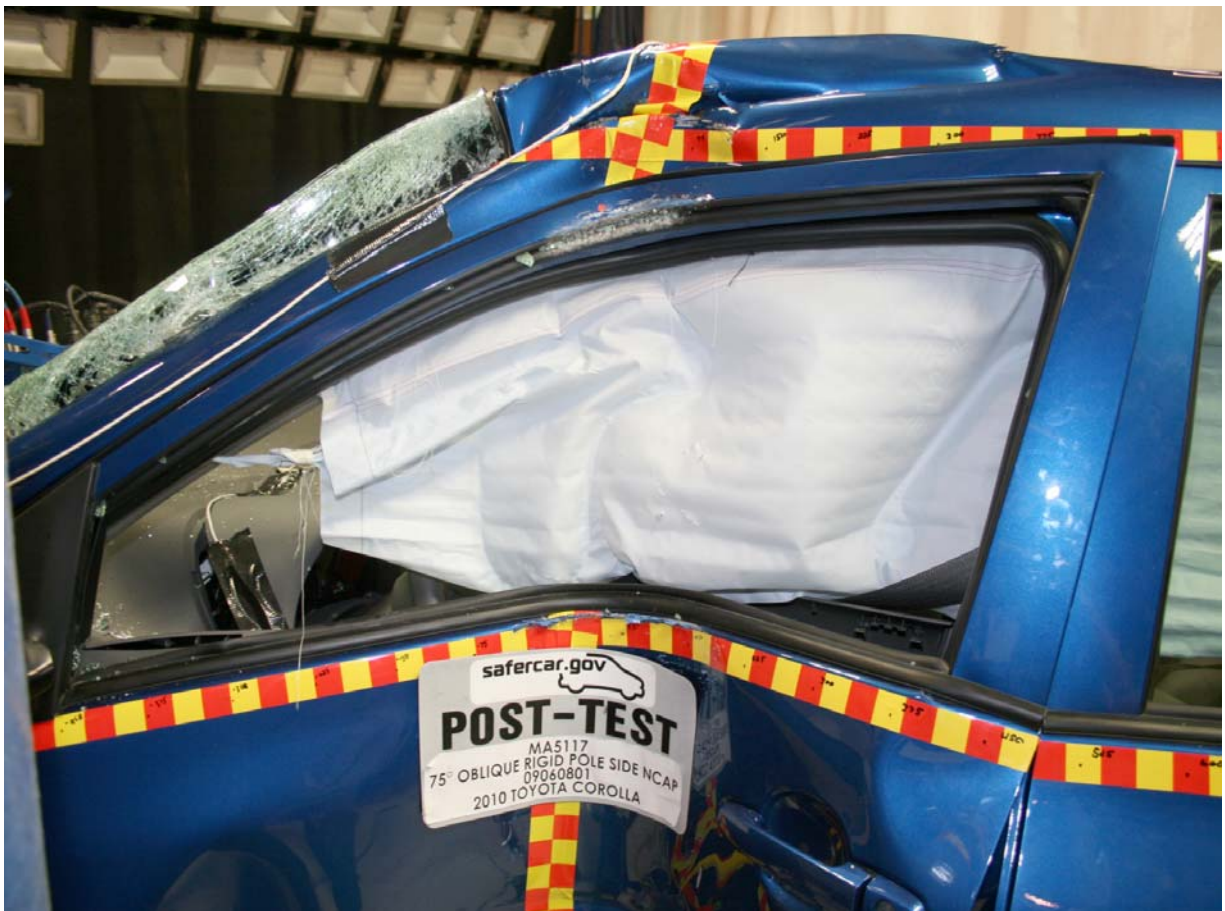
Post-Test Left Side View of Dummy Shoulder and Door Top View

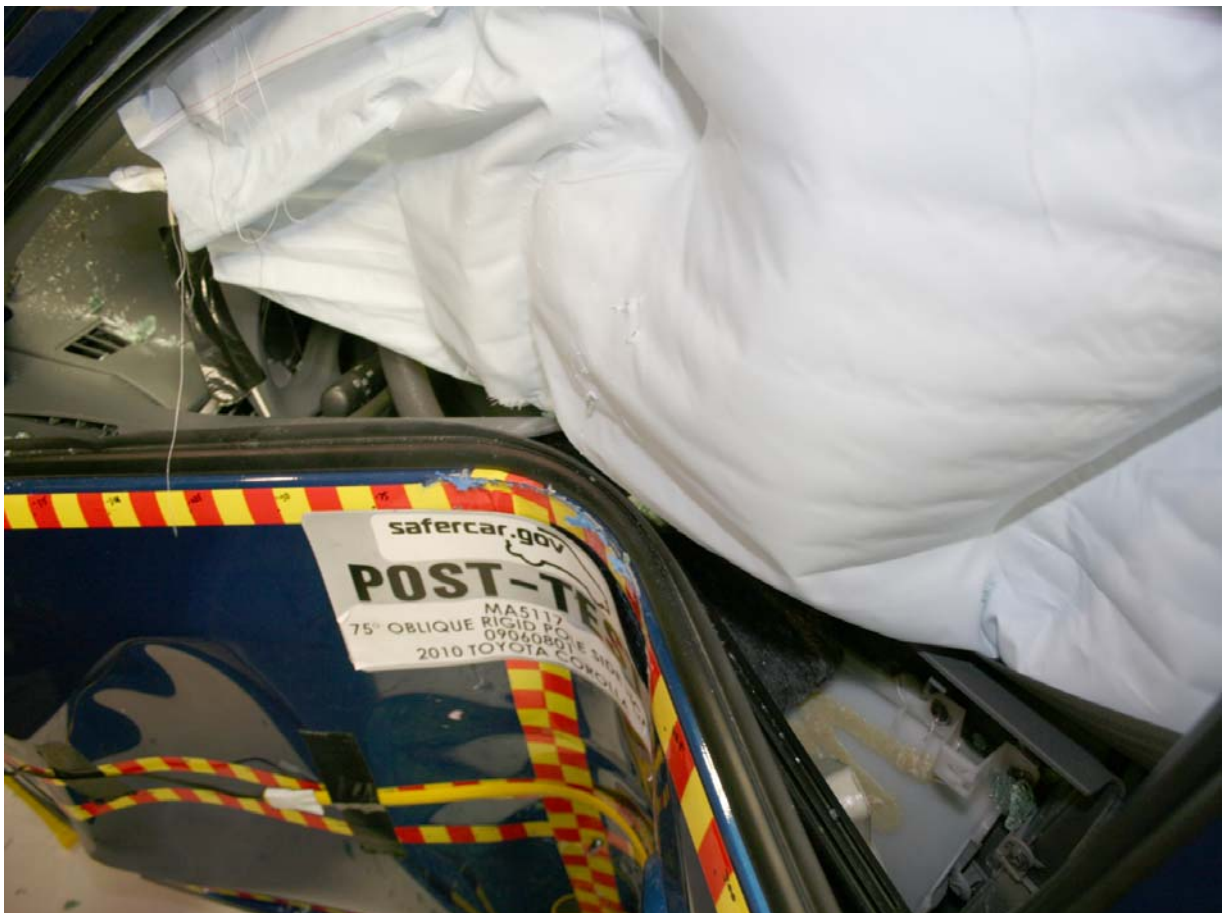
Post-Test Dummy and Door Clearance View

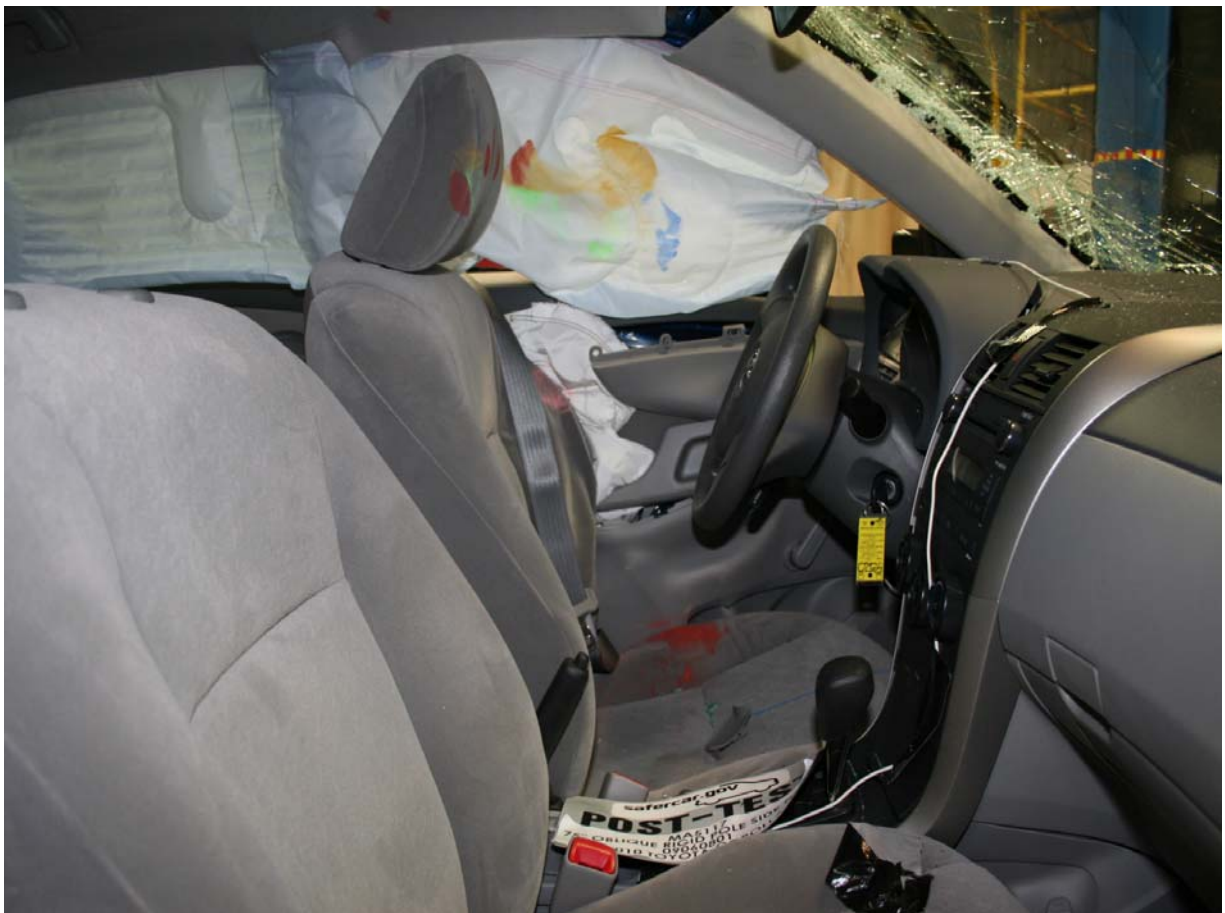
Post-Test Inner Door Panel View Showing Dummy Contact Location

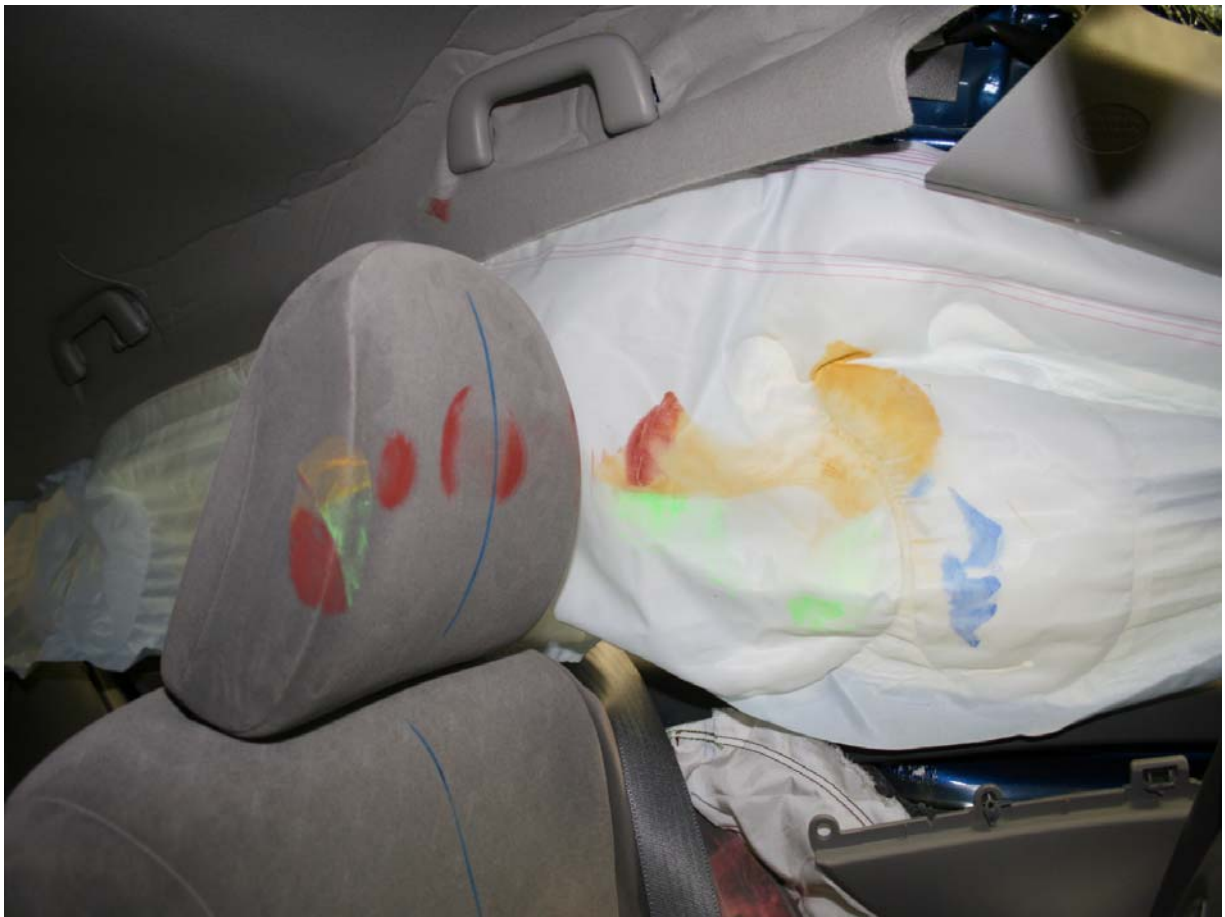
Post-Test Dummy Close-Up Head Contact with Vehicle View, if applicable

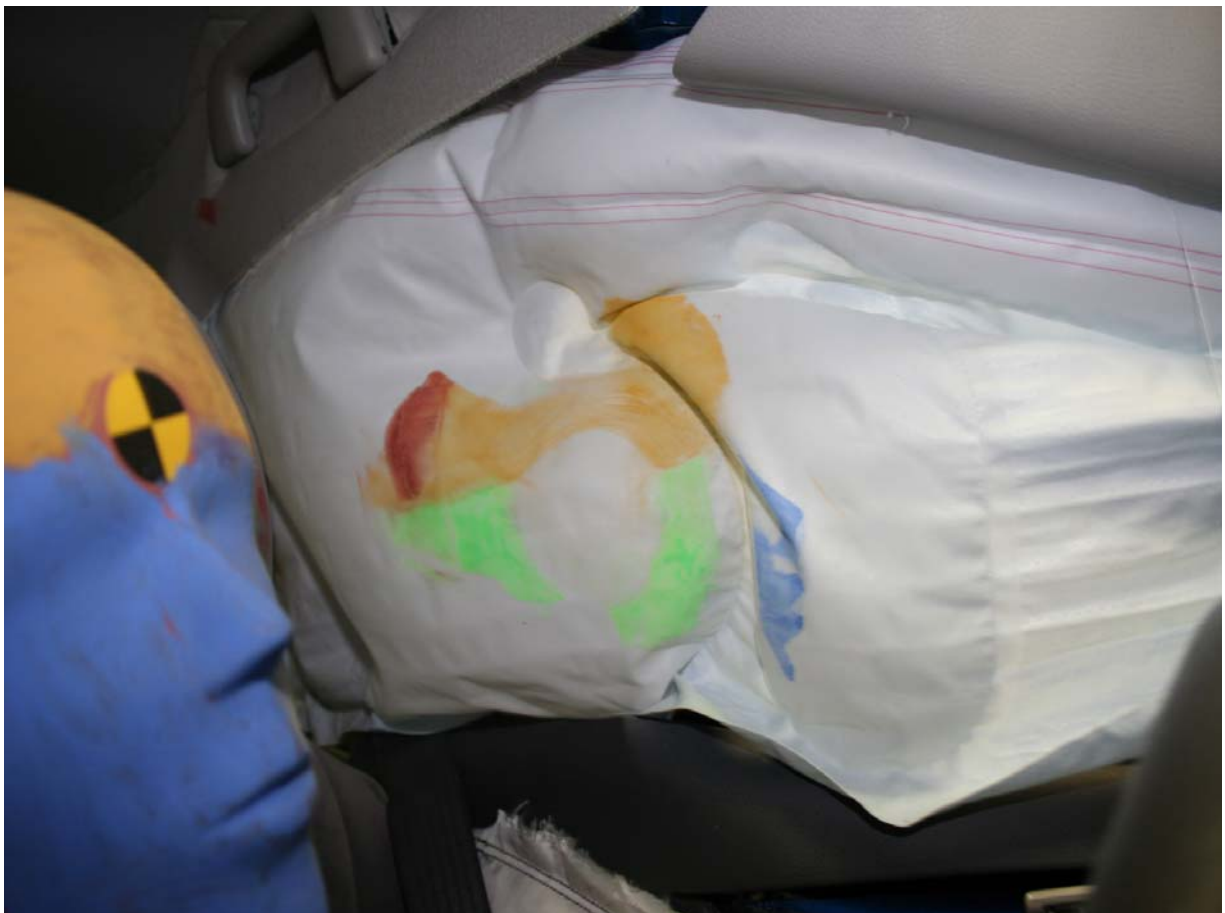
Post-Test Dummy Close-Up Head Contact with Side Airbag View, if applicable

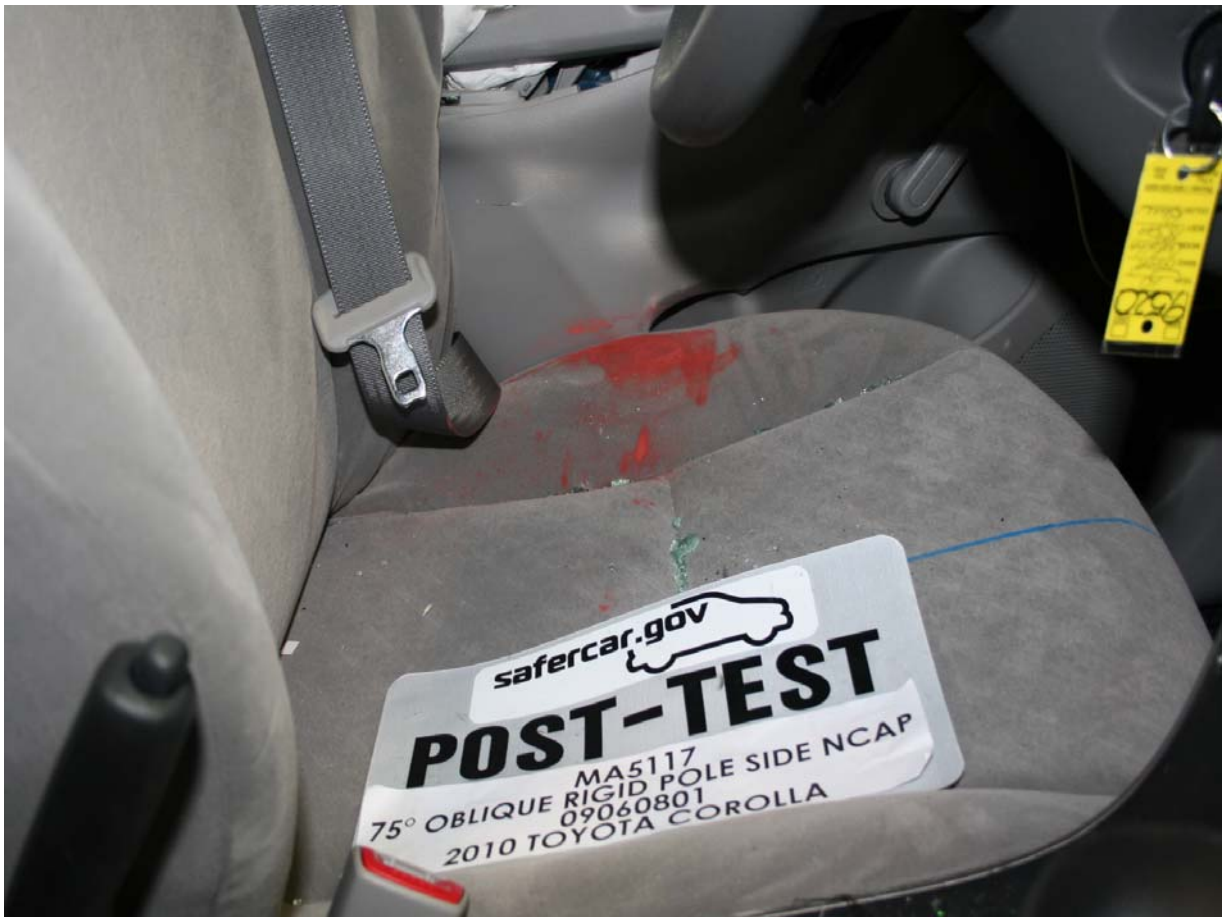
Post-Test Dummy Close-Up Pelvis Contact View, if applicable

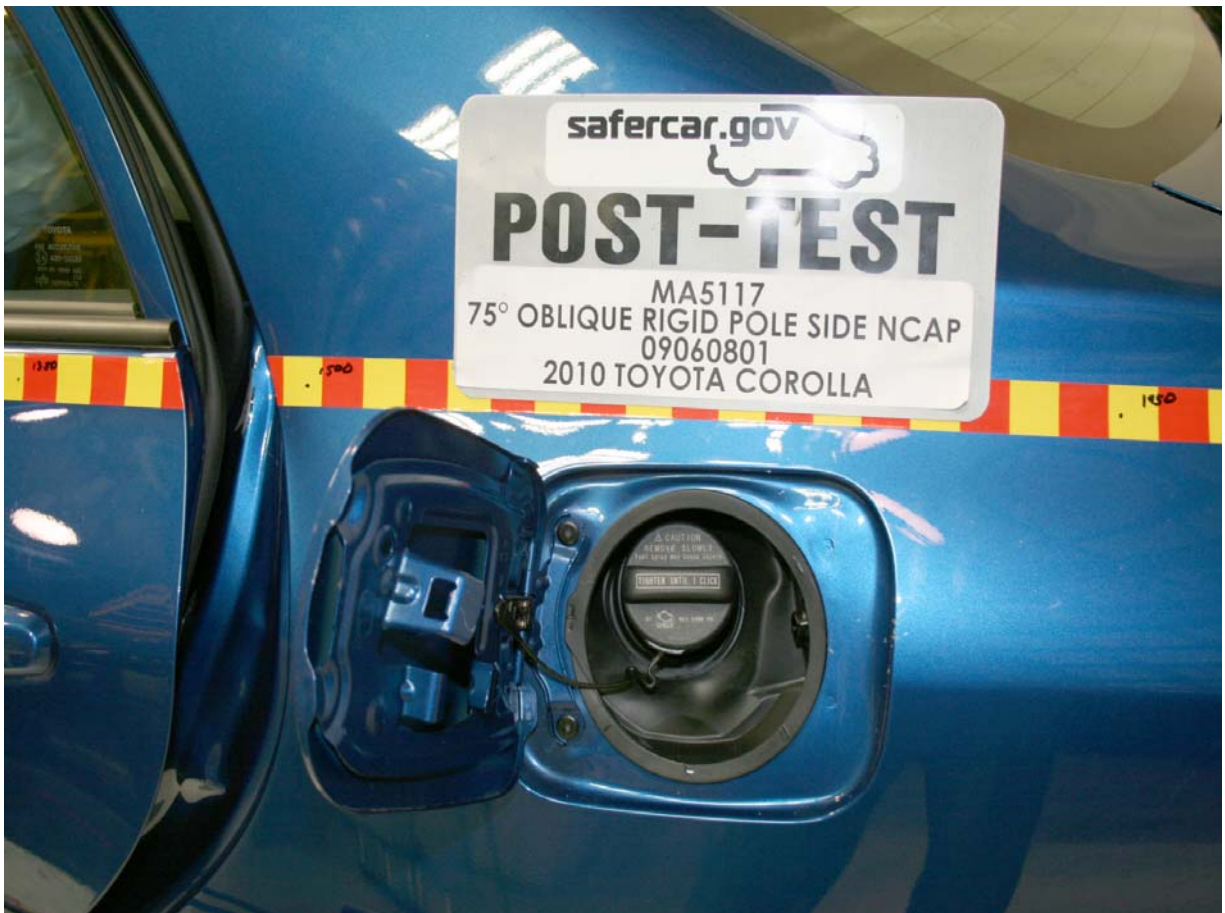
Post-Test View of Fuel Filler Cap or Fuel Filler Neck

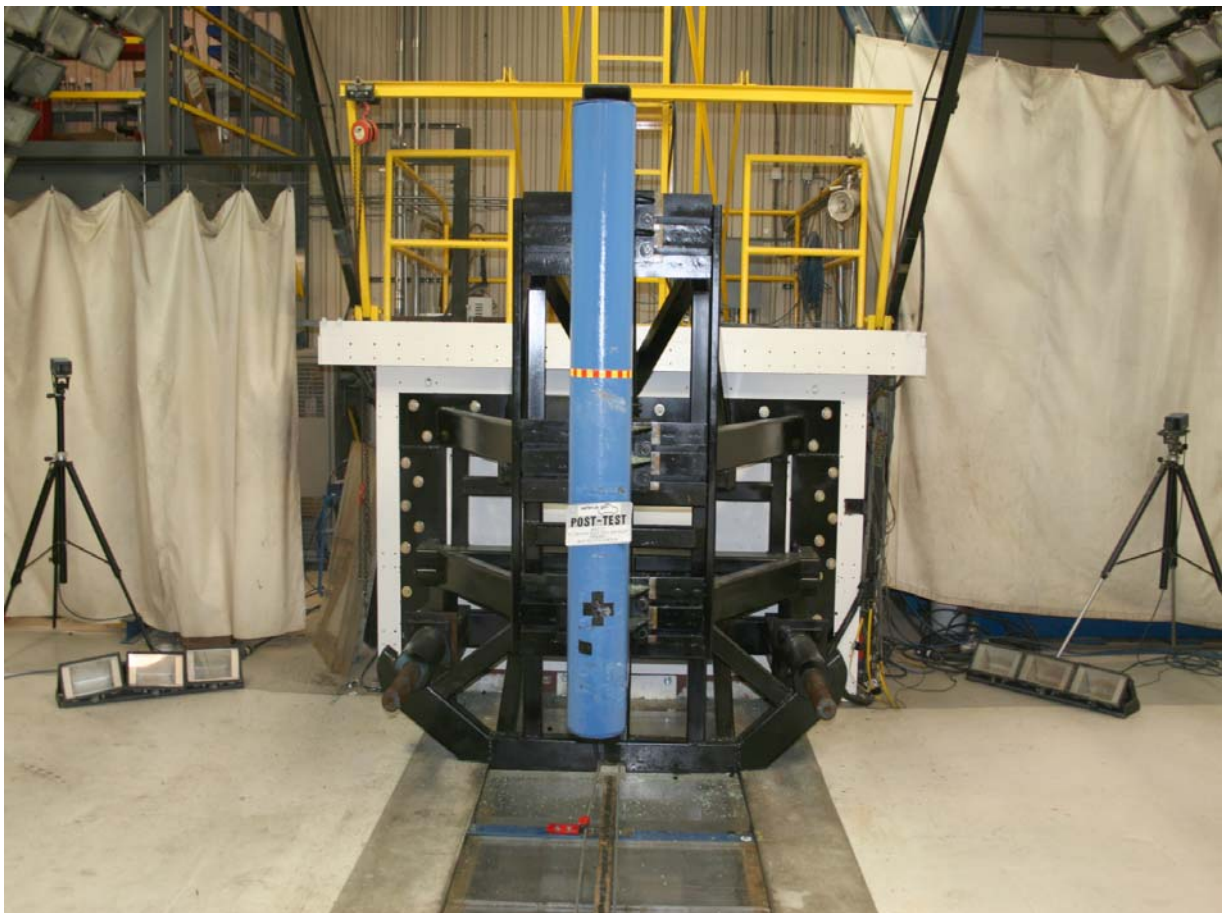
Post-Test Pole Barrier Front View

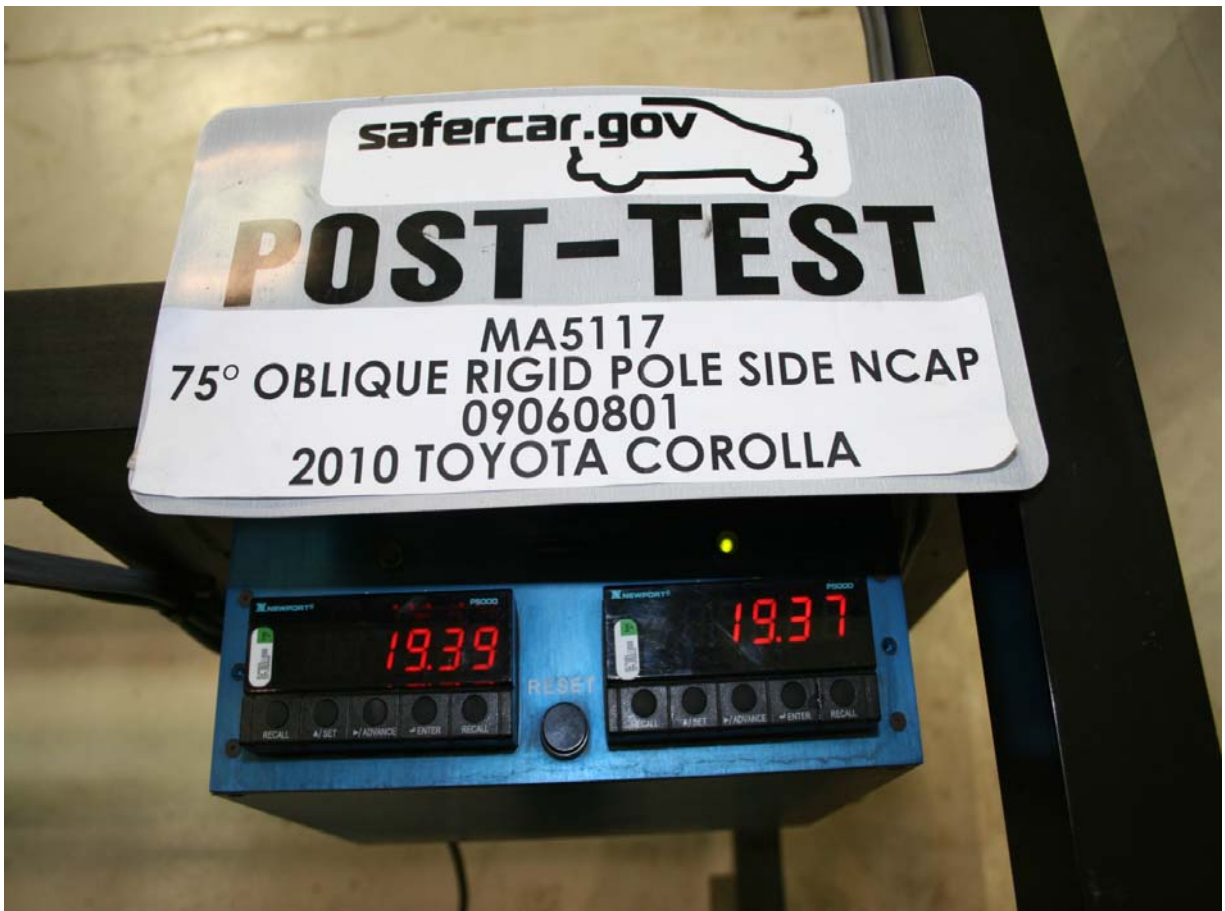
Post-Test Primary and Redundant Speed Trap Read-Out

A rigid pole side impact test was conducted on a 2010 Toyota Corolla 4-Dr Sedan. The subject vehicle was towed into the rigid pole at an angle of 75° and a velocity of 31.2 km/h. The test was conducted by MGA Research Corporation in Burlington, Wisconsin, on June 8, 2009. Pre-test and post-test photographs of the test vehicle and Side Impact Dummy (SID-IIs) are included in Appendix A of this report.

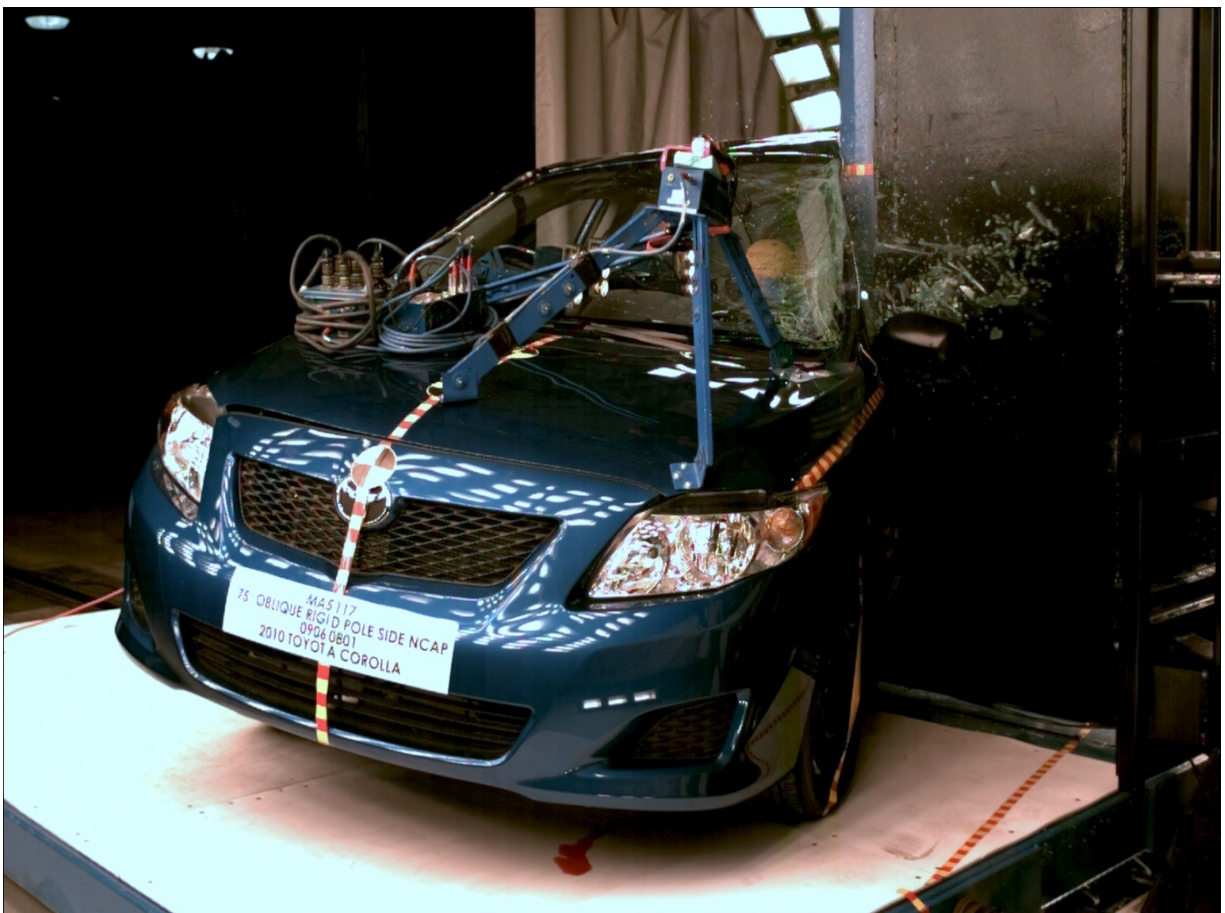
Impact Event (Impact Side)

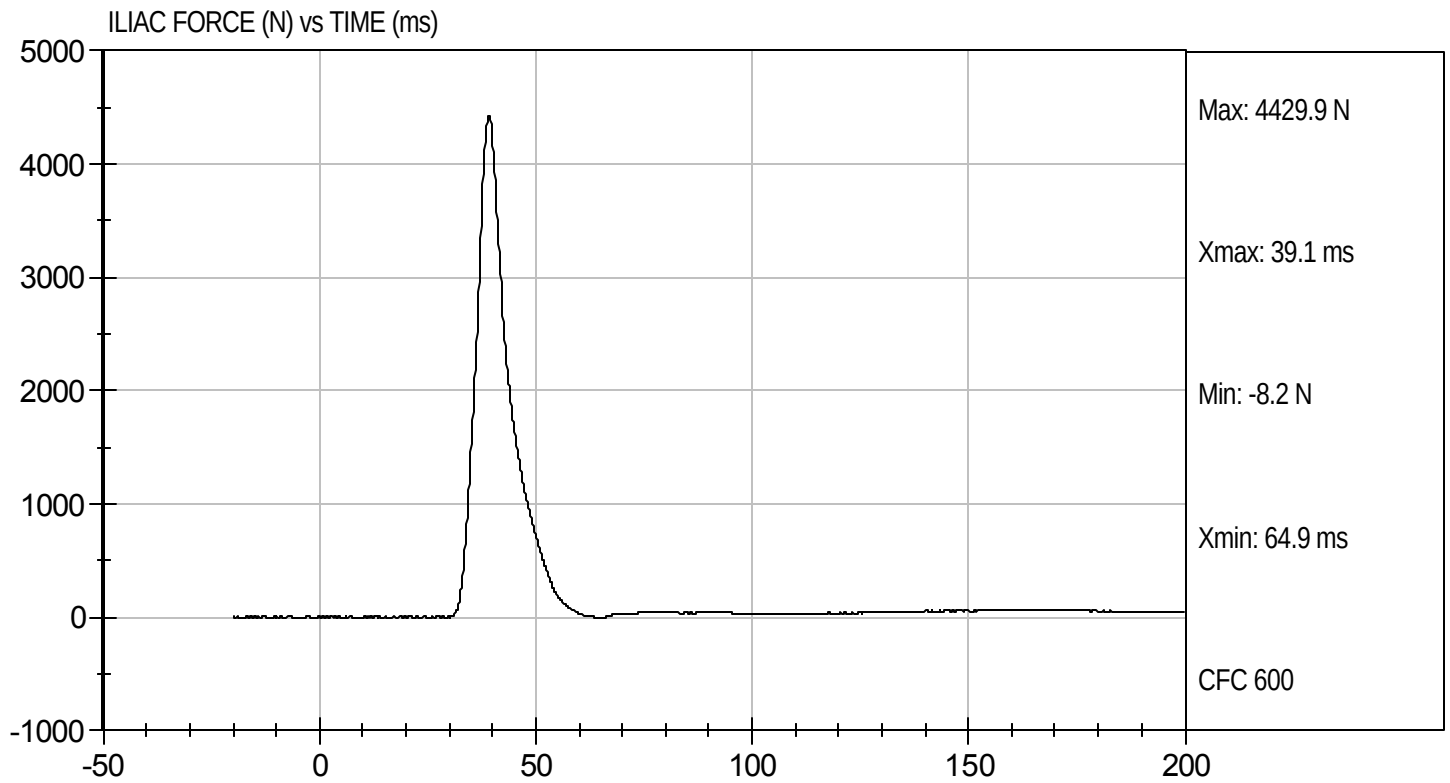
Test Desc: Iliac Impact  
Component ID: D091438

Test Date: 6/8/09  
Velocity: 14.1 ft/s, 4.30 m/s
