**REPORT NUMBER: SNCAP-MGA-2009-016**

**VALIDATION  
MOVING DEFORMABLE BARRIER SIDE IMPACT TEST**

**TOYOTA MOTOR CORPORATION  
2010 TOYOTA COROLLA 4-DR SEDAN  
NHTSA NUMBER: MA5116**

**PREPARED BY:  
MGA RESEARCH CORPORATION  
5000 WARREN ROAD  
BURLINGTON, WI 53105**

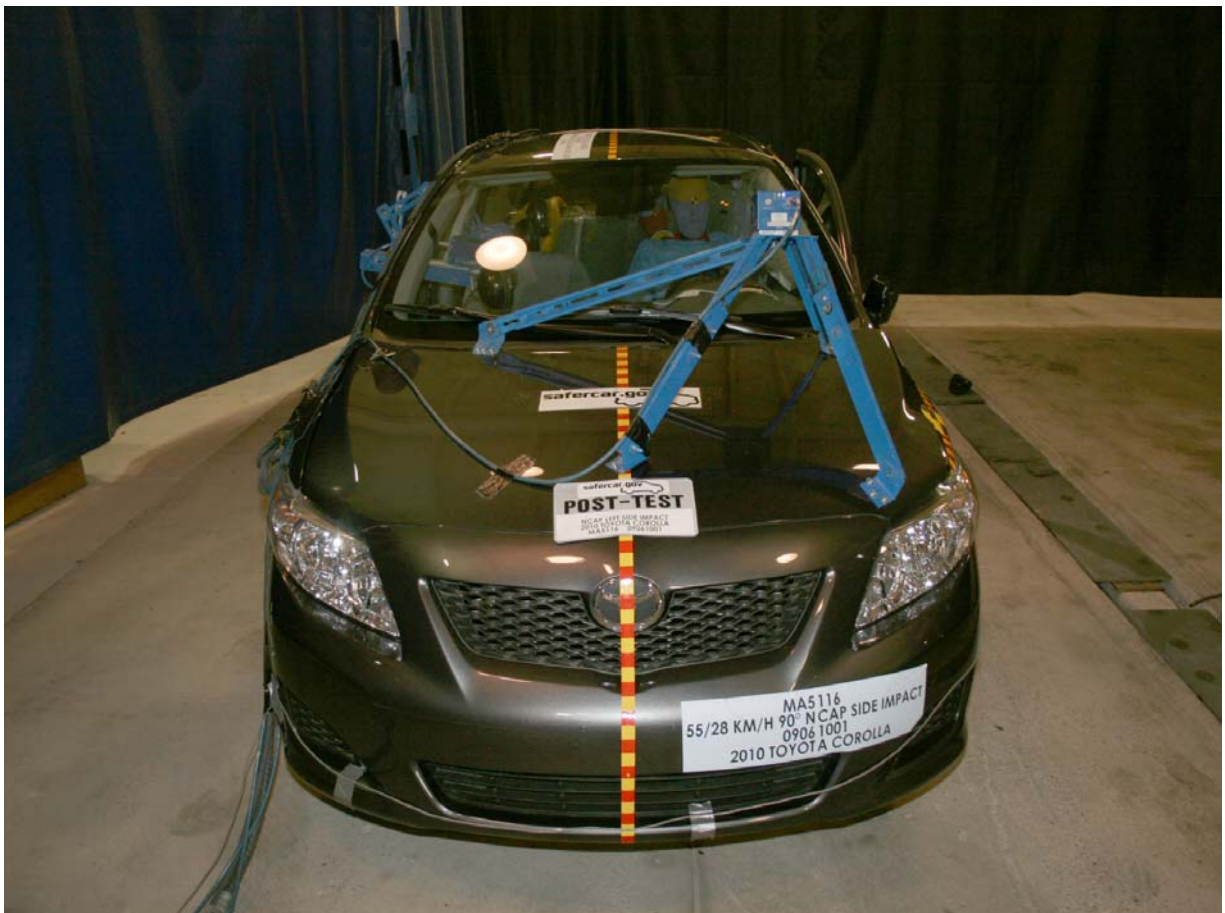
Post-Test Frontal View of Test Vehicle

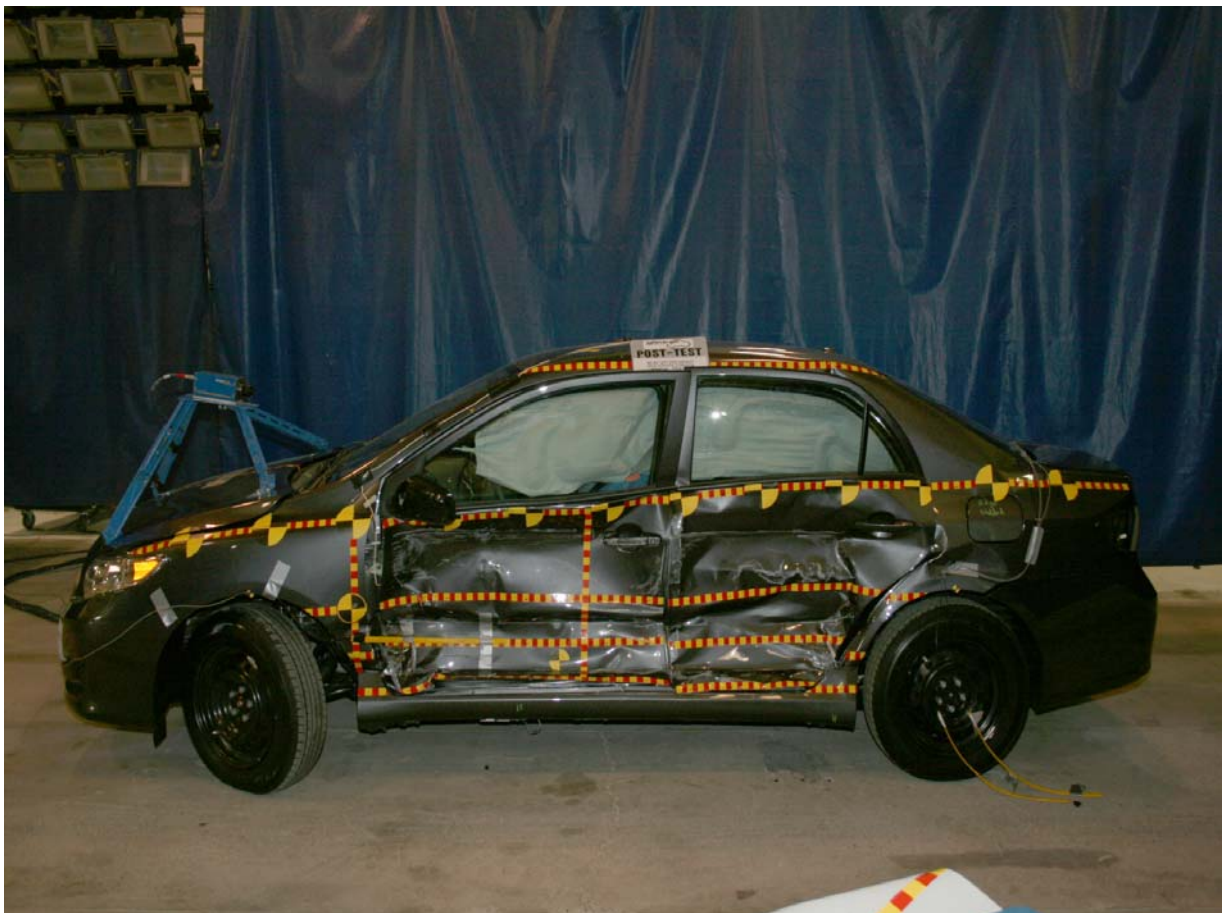
Post-Test Left Side View of Test Vehicle

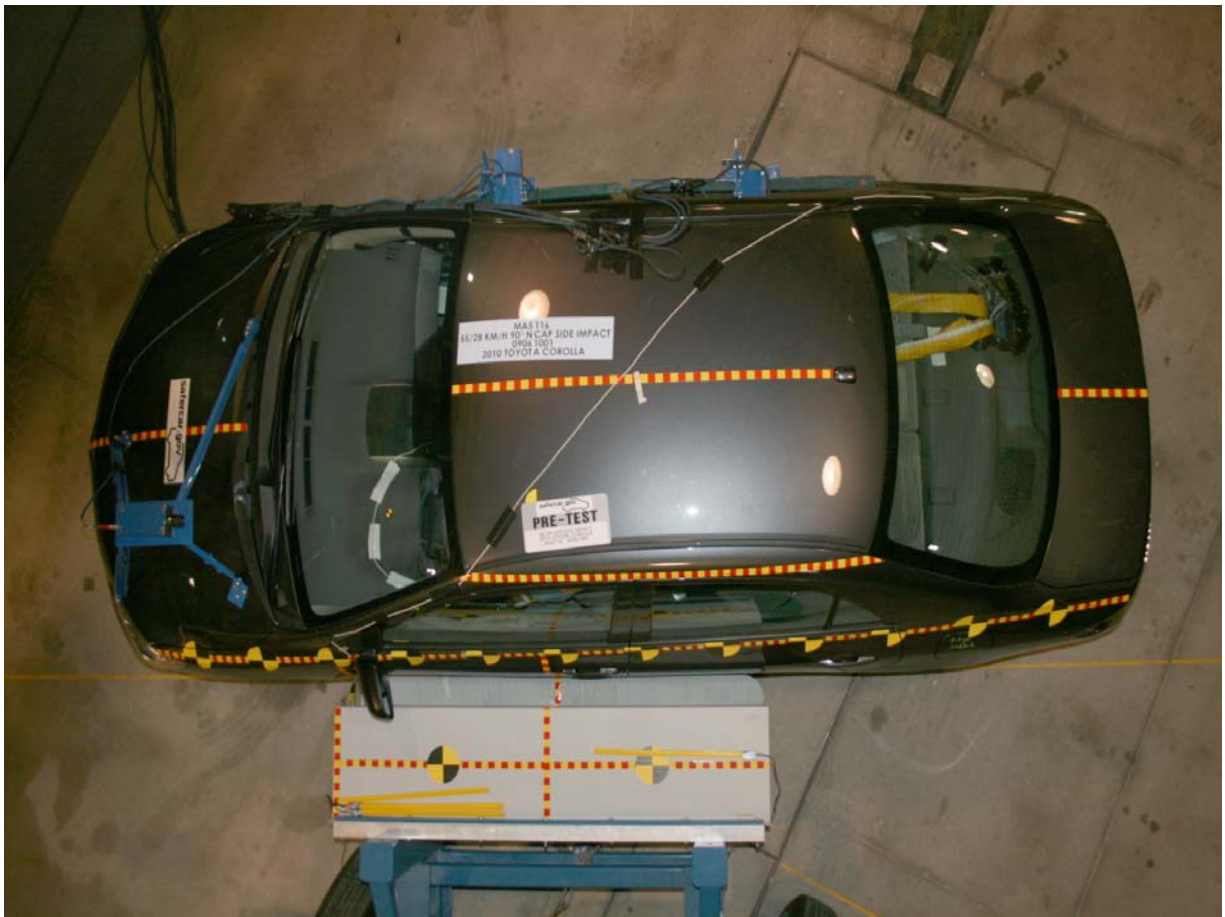
Pre-Test Overhead View of the Test Vehicle with MDB Positioned Against the Side of the Test Vehicle at the Ideal Impact Point

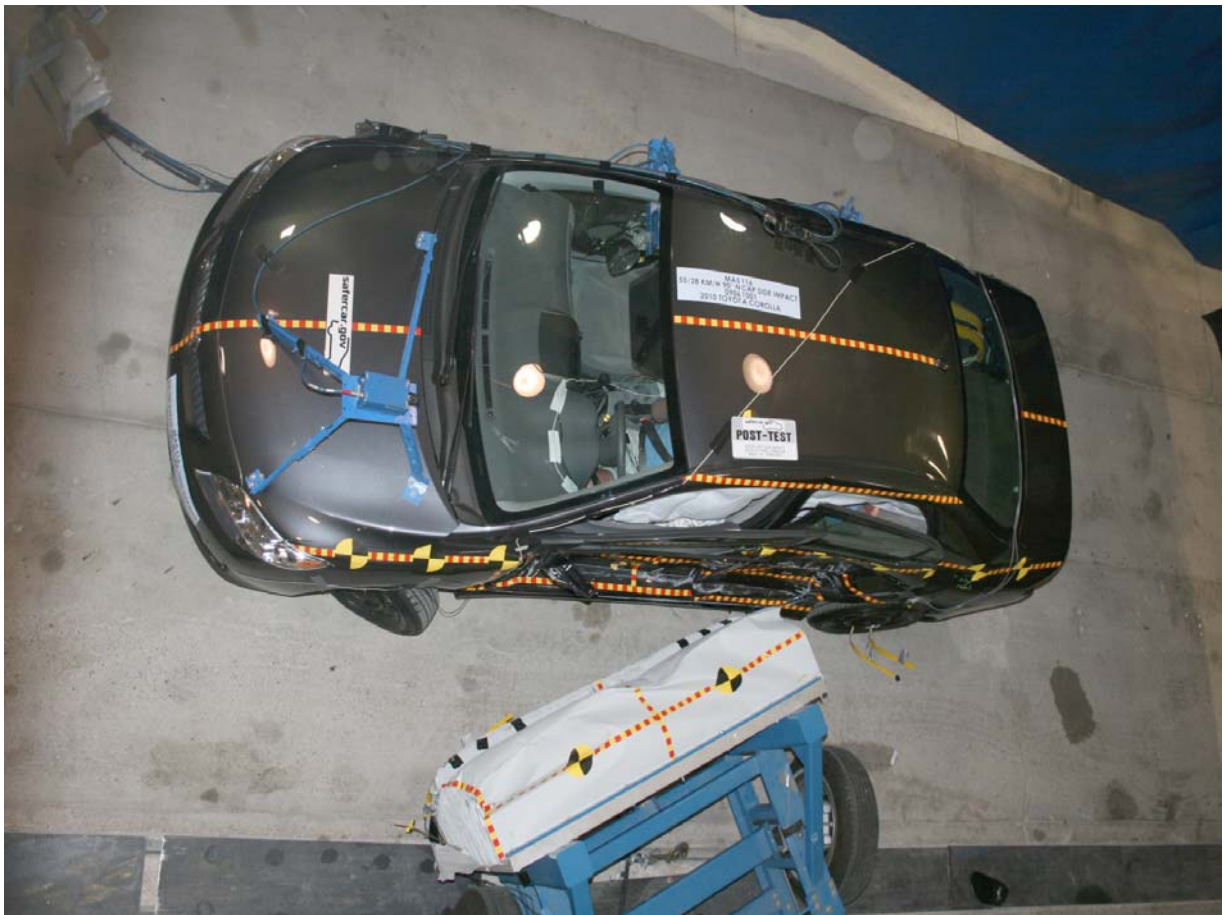
Post-Test Overhead View of the Test Vehicle and MDB

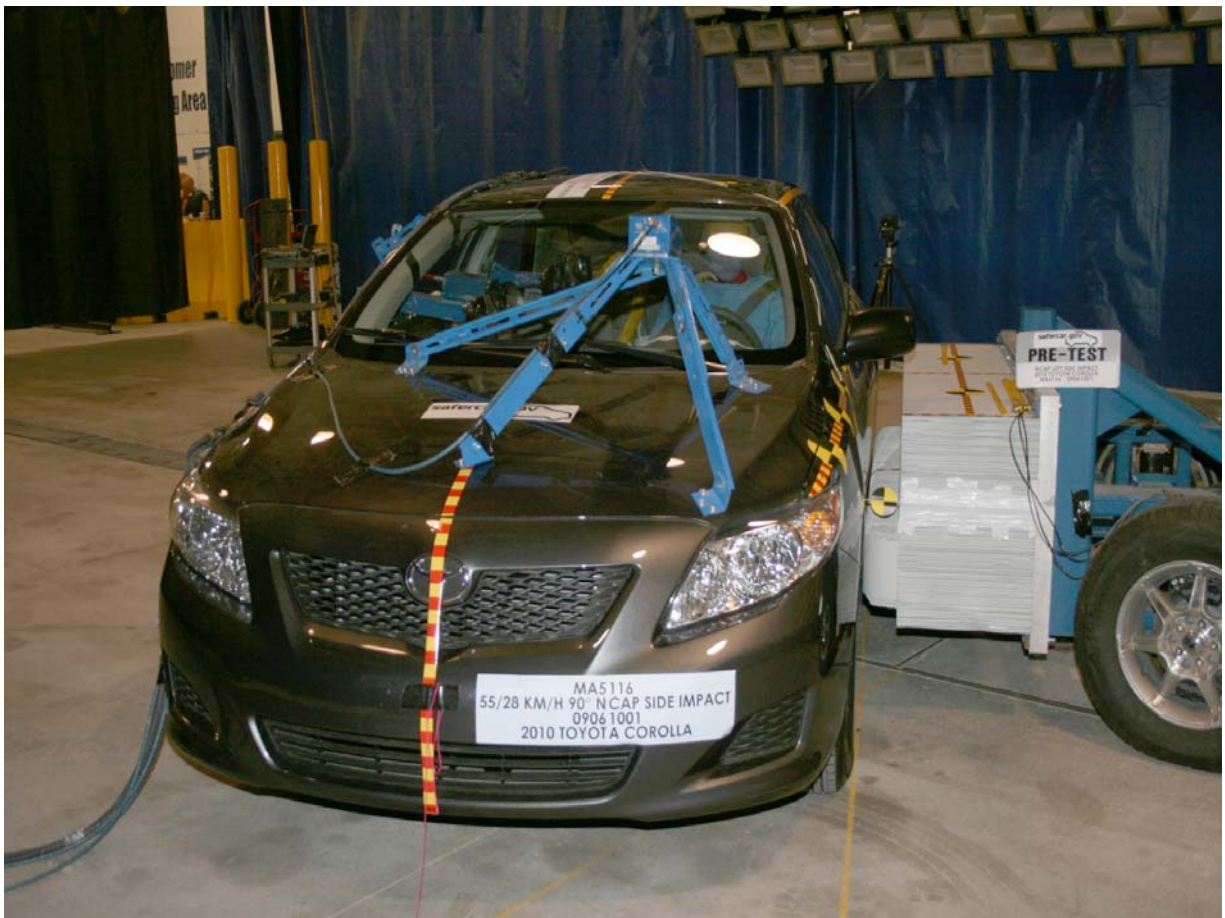
Pre-Test Left Side View of MDB Positioned Against the Side of the Test Vehicle at the Ideal Impact Point

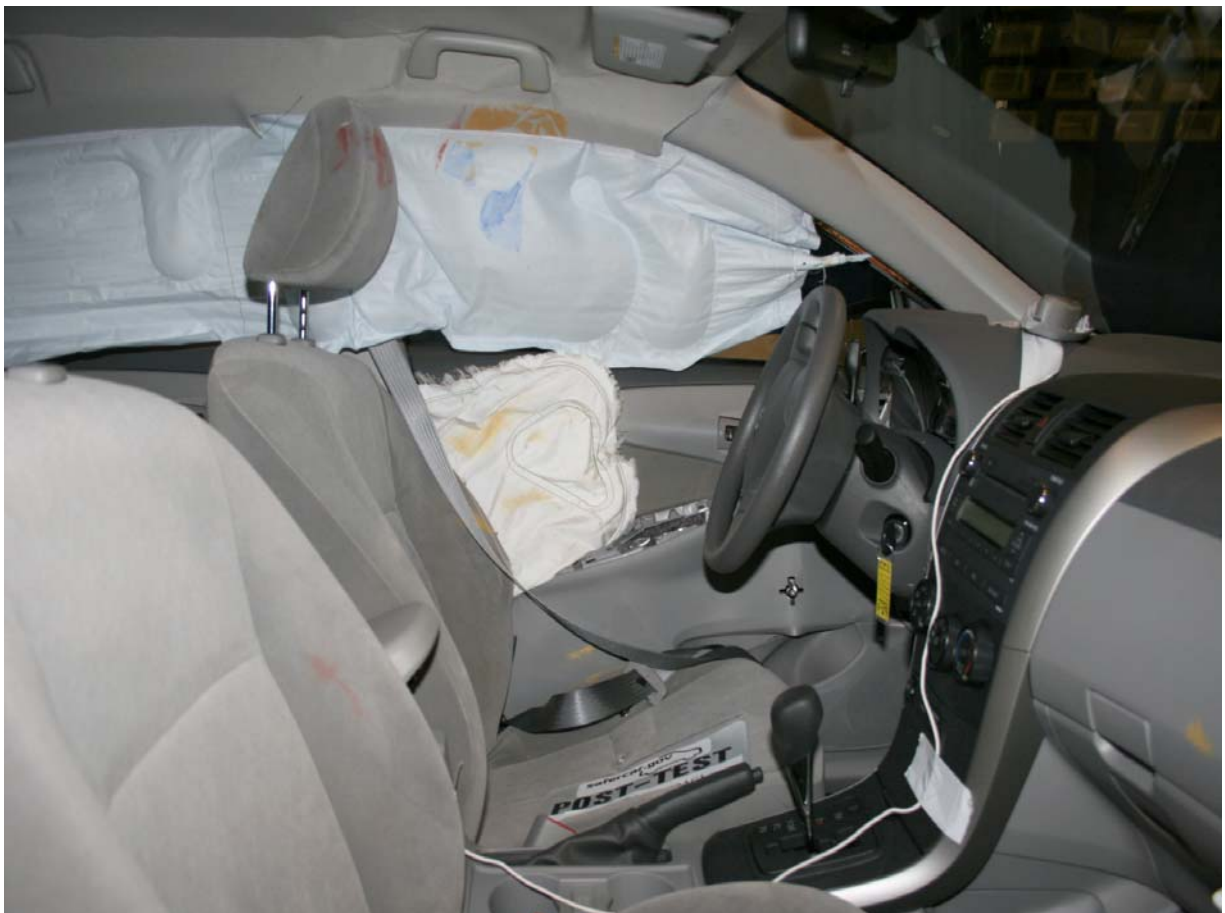
Post-Test Driver Inner Door Panel View (with dummy removed)

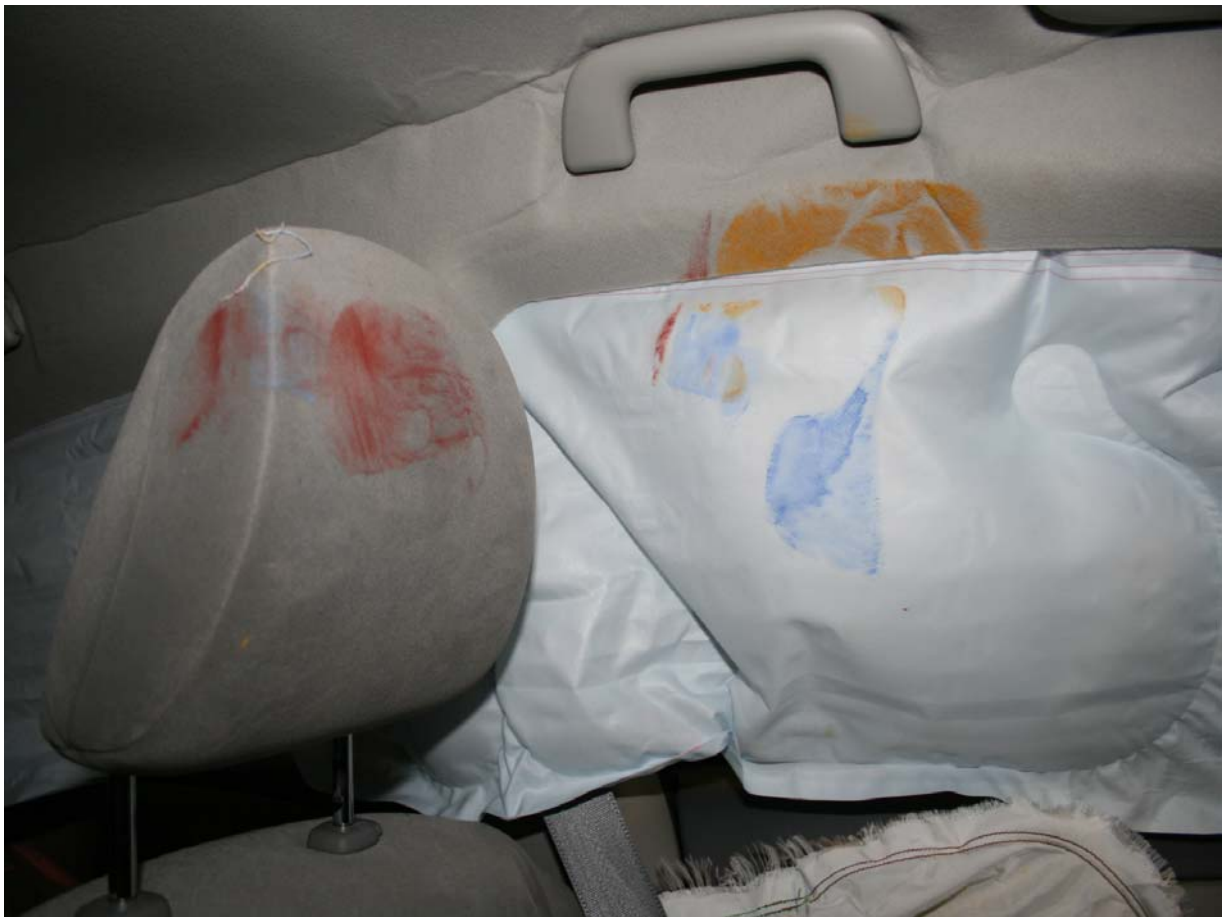
Post-Test Driver Dummy Head Contact View

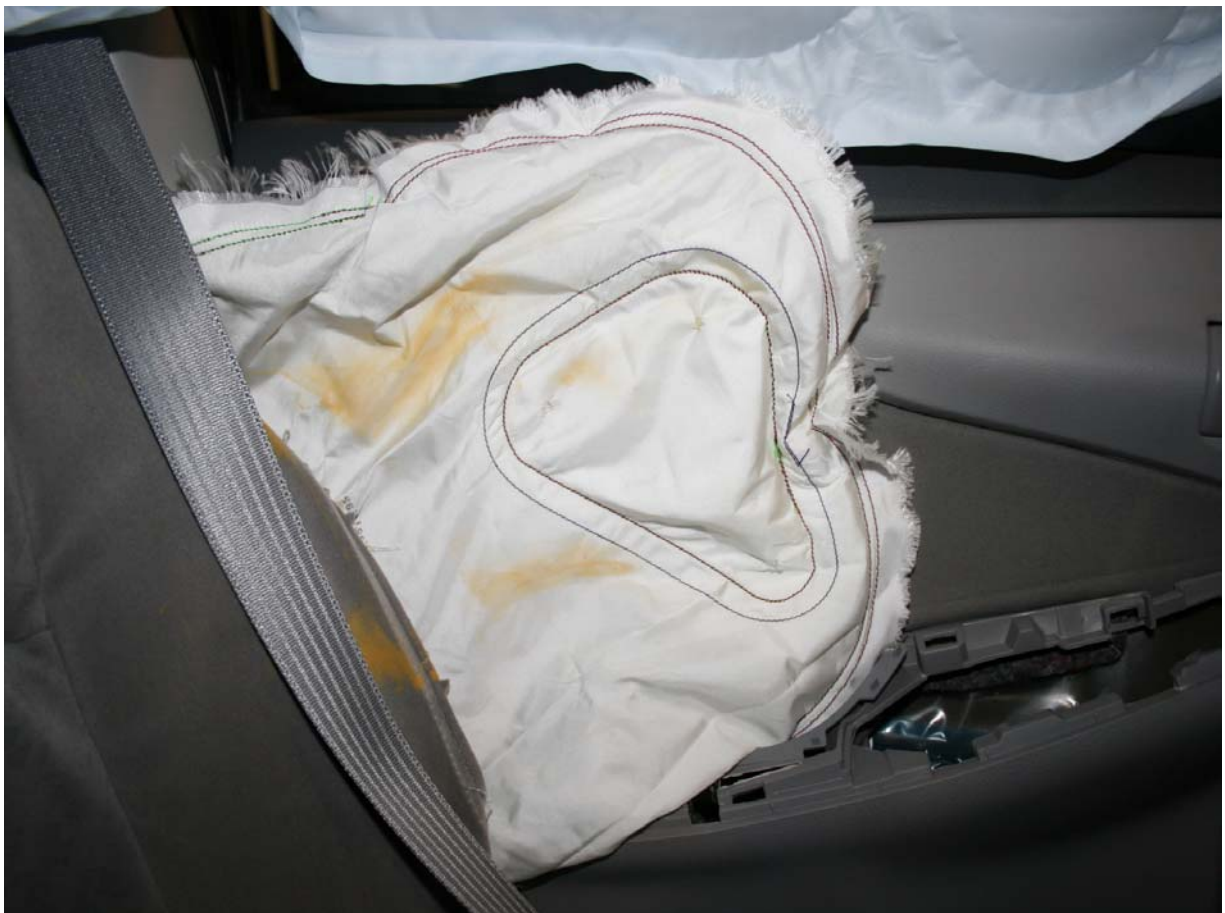
Post-Test Driver Dummy Door Contact View

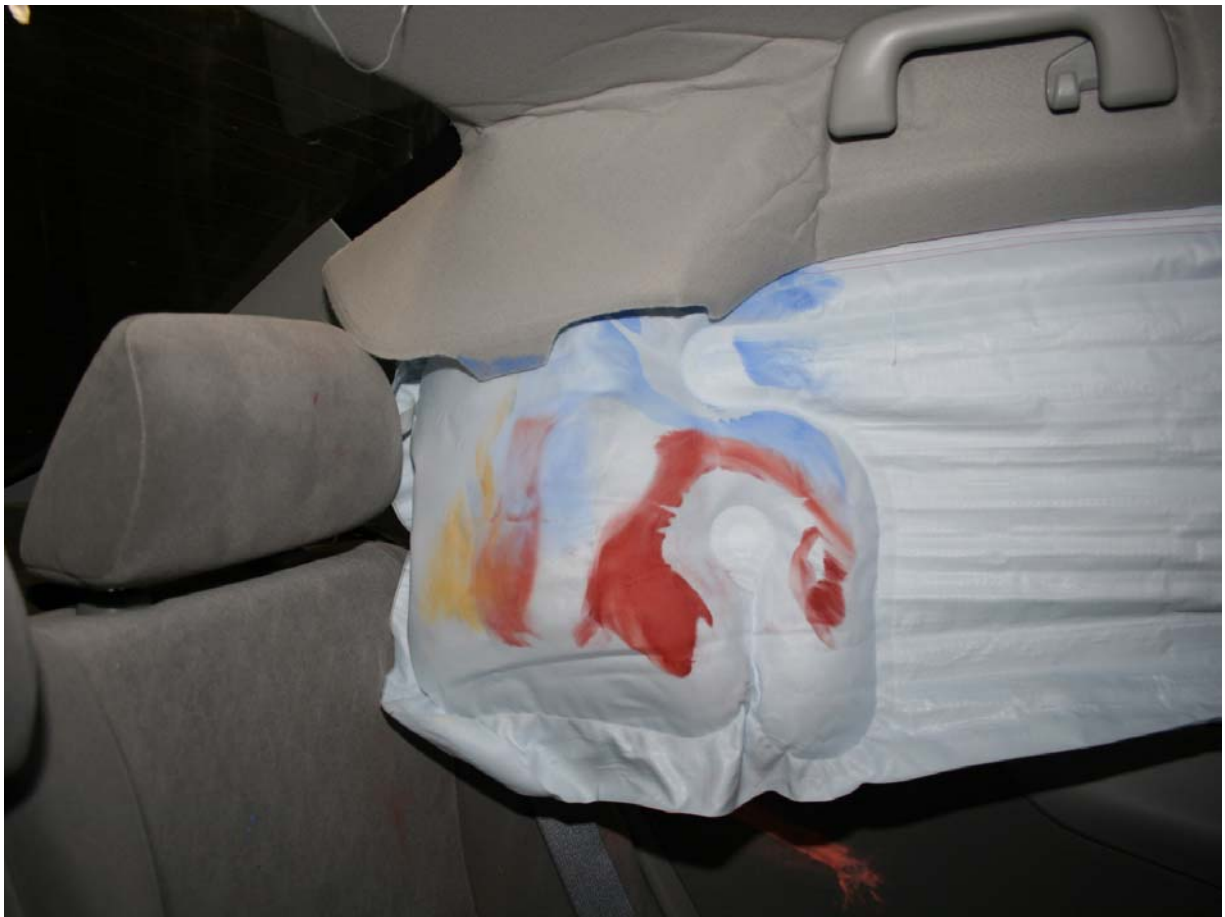
Post-Test Passenger Dummy Head Contact View

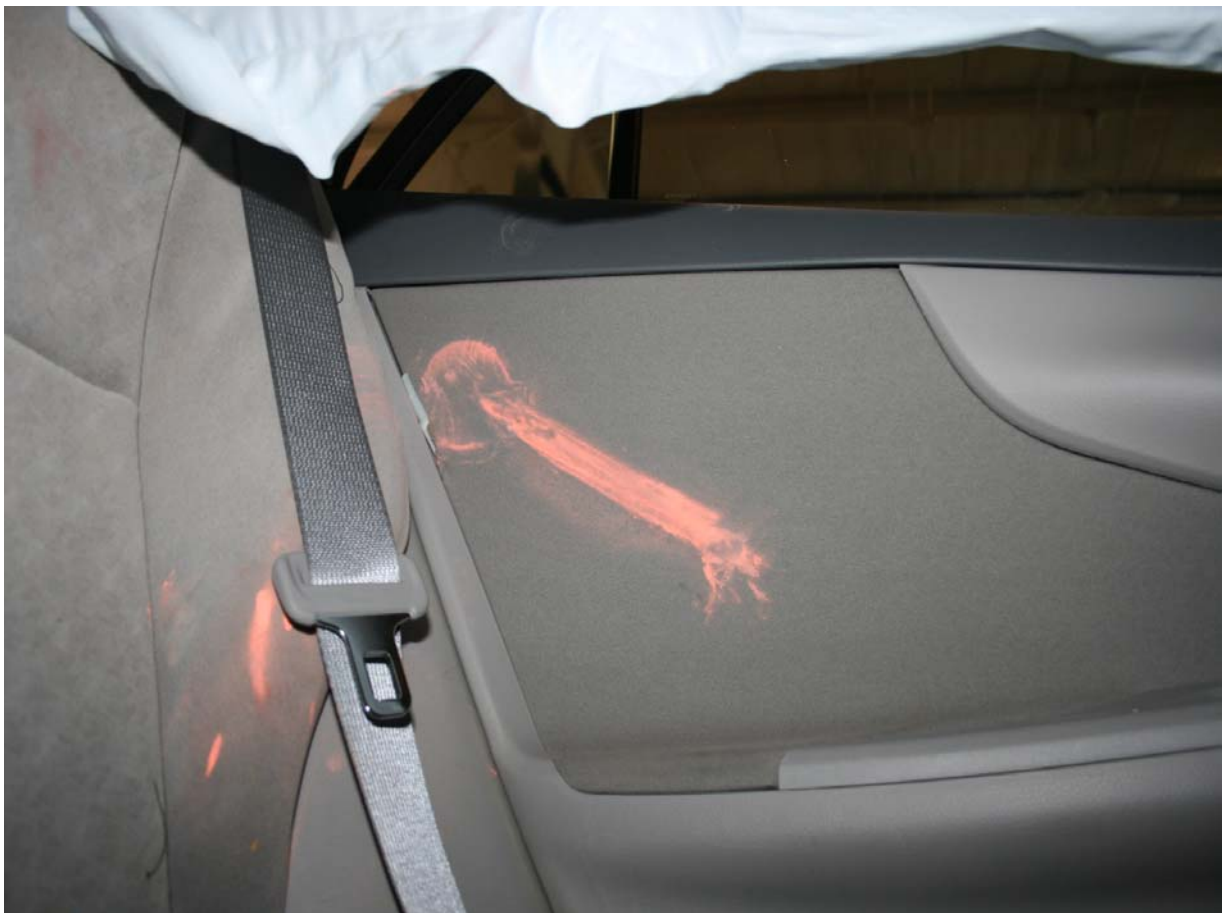
Post-Test Passenger Dummy Door Contact View

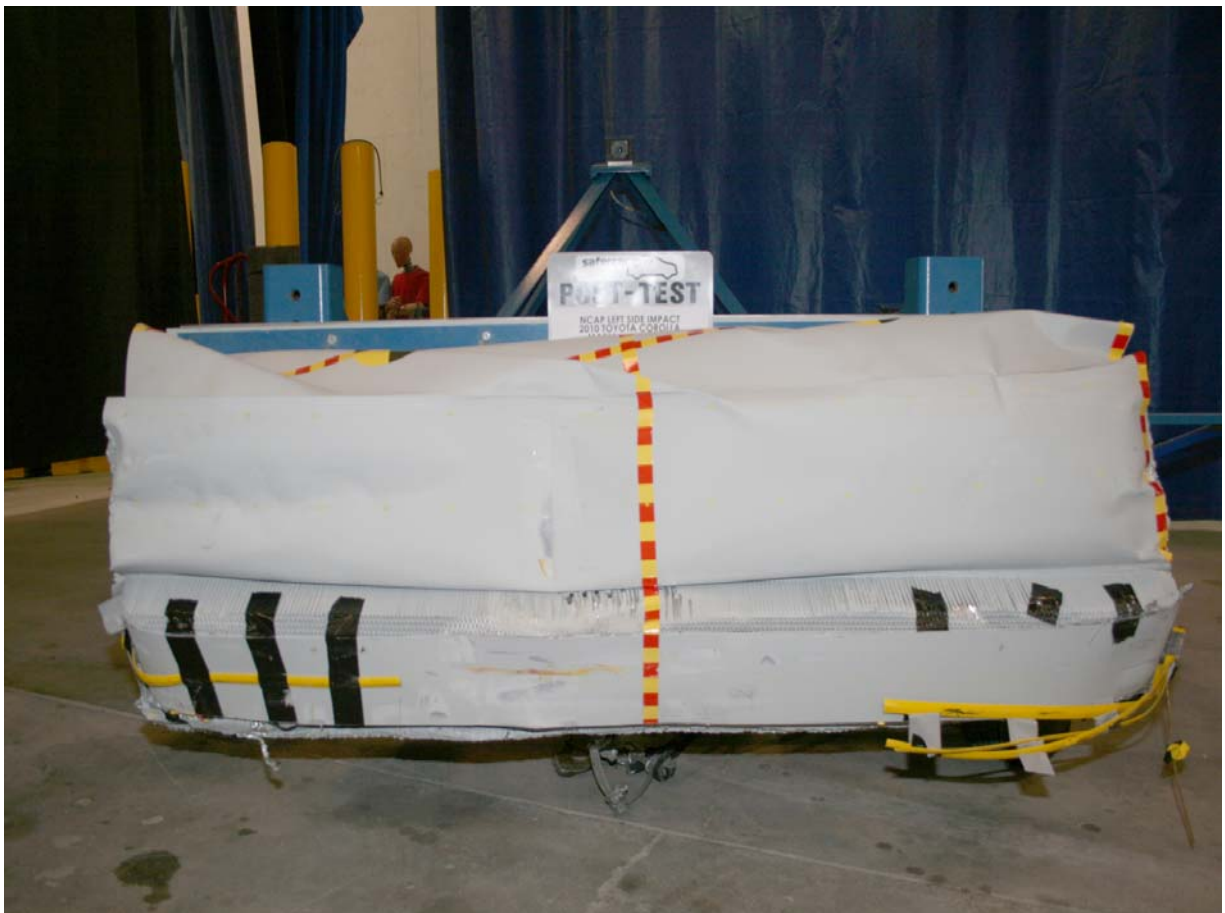
Post-Test Front View of MDB Impactor Face

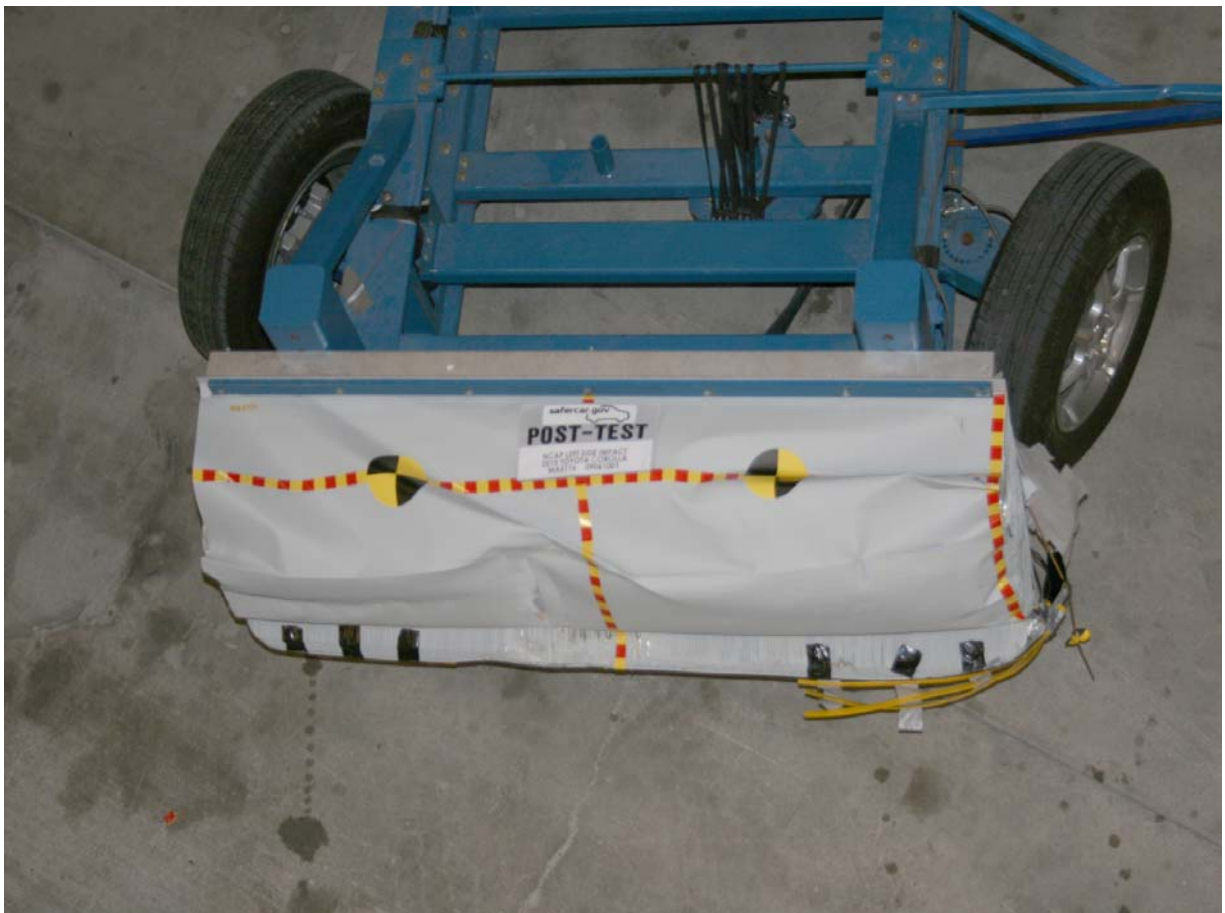
Post-Test Top View of MDB Impactor Face

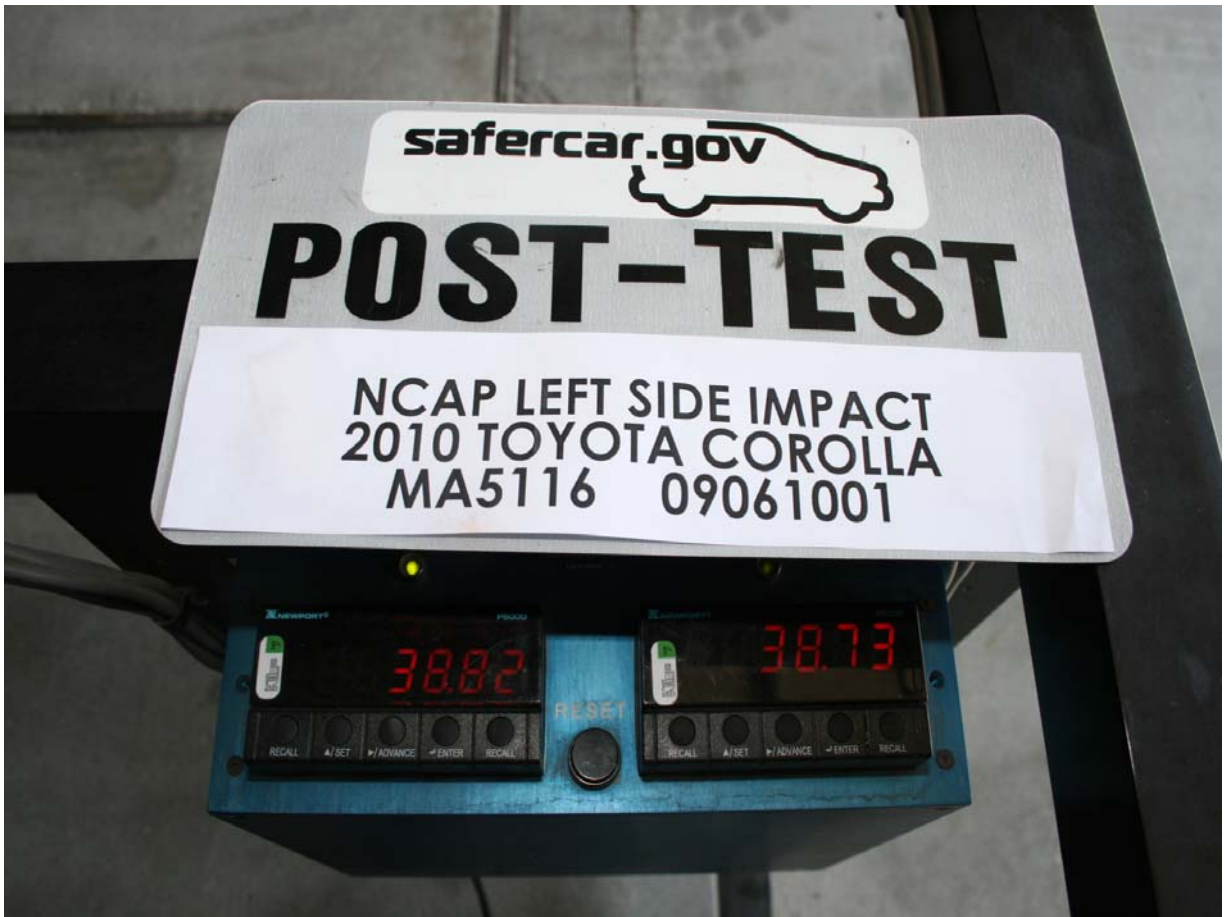
Post-Test Primary and Redundant Speed Trap Velocity Read-Out with Placard Showing NHTSA Number
