**REPORT NUMBER: NCAPSIDE-MGA-2009-017**

**NEW CAR ASSESSMENT PROGRAM  
SIDE IMPACT TEST**

**GENERAL MOTORS OF CANADA LTD.  
2010 CHEVROLET CAMARO 1LT 2-DR COUPE  
NHTSA NUMBER: MA0112**

**PREPARED BY:  
MGA RESEARCH CORPORATION  
5000 WARREN ROAD  
BURLINGTON, WI 53105**

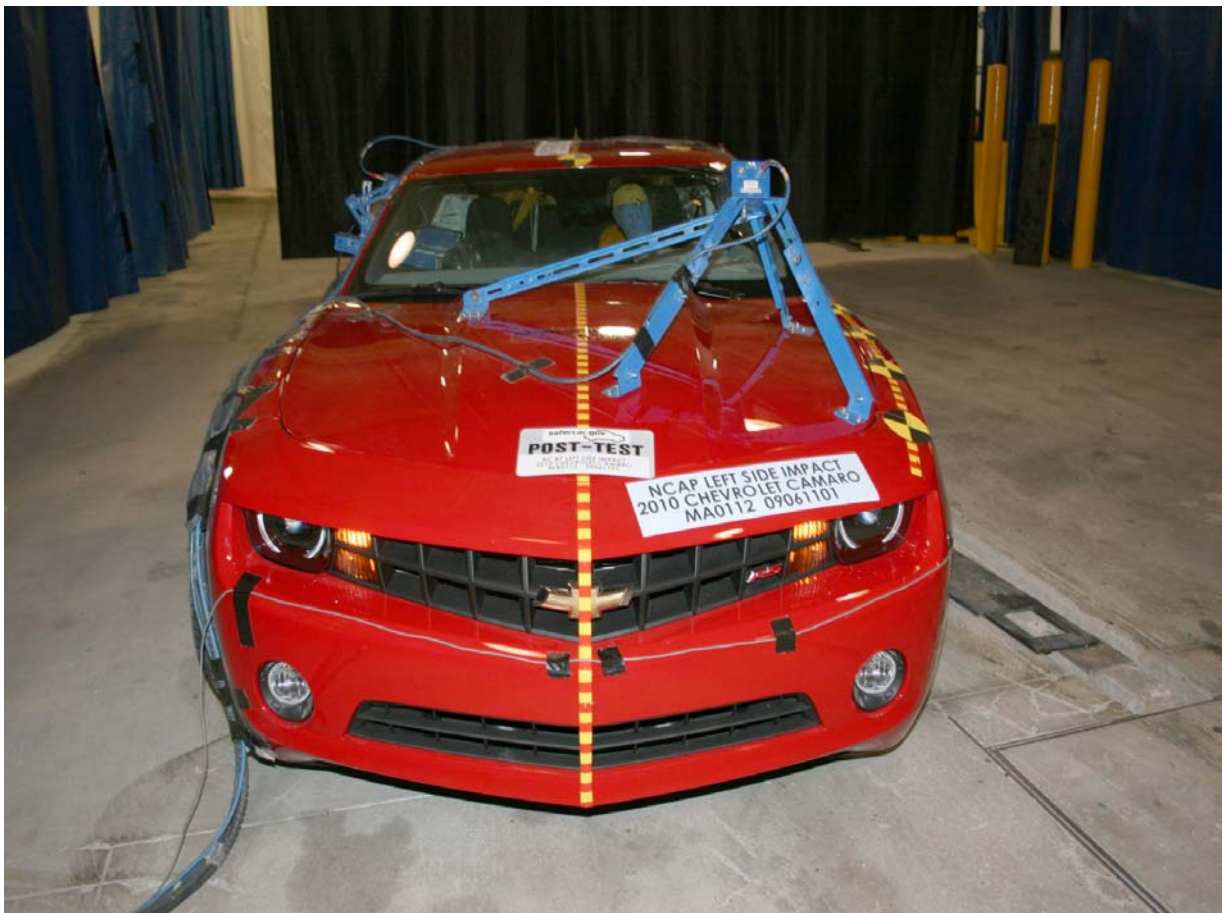
| Critical Areas of Performance | Observations and Conclusions |
|---|---|
| Windshield Damage | Windshield was cracked. |

Post-Test Front View

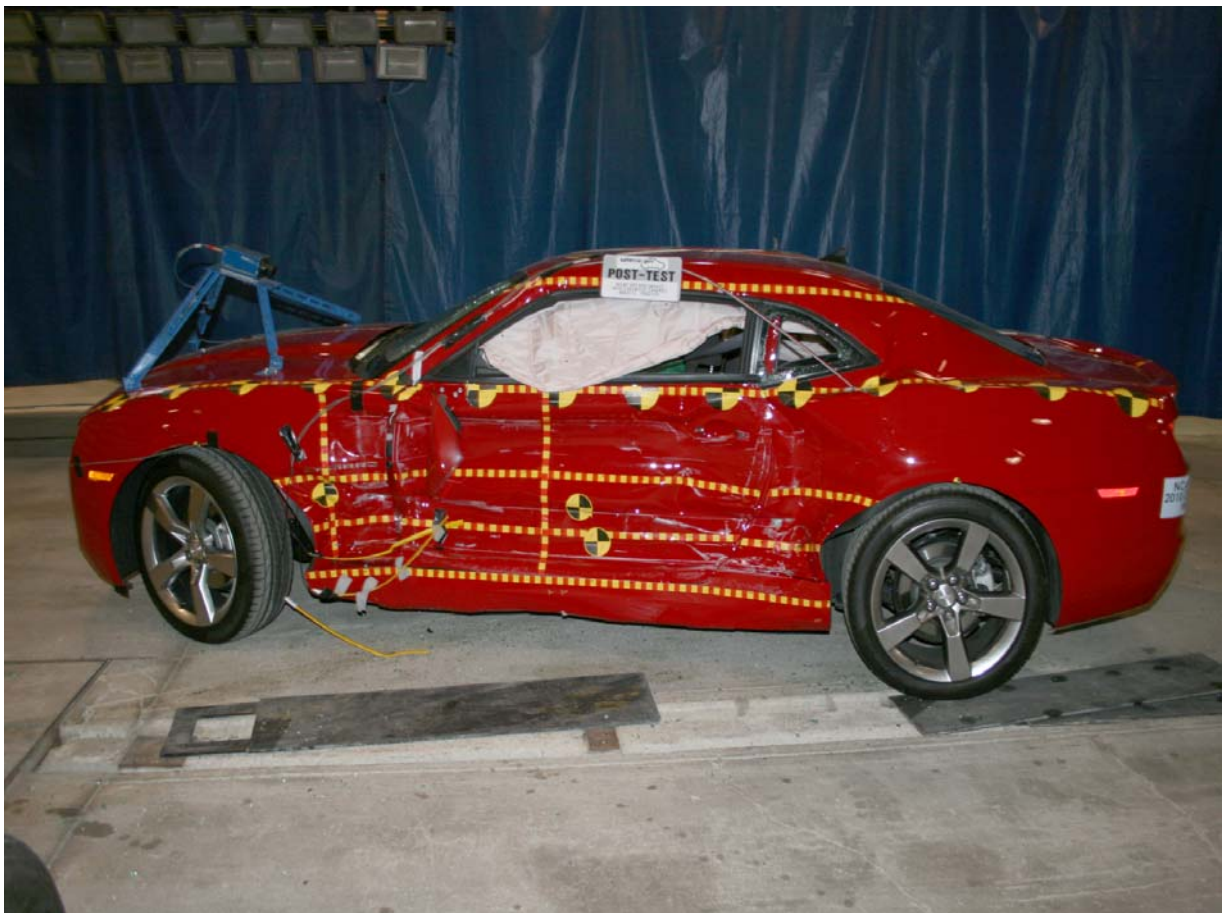
| Critical Areas of Performance | Observations and Conclusions |
|---|---|
| Window Damage | Left Front and Left Rear Windows were broken. |

Post-Test Left Side View

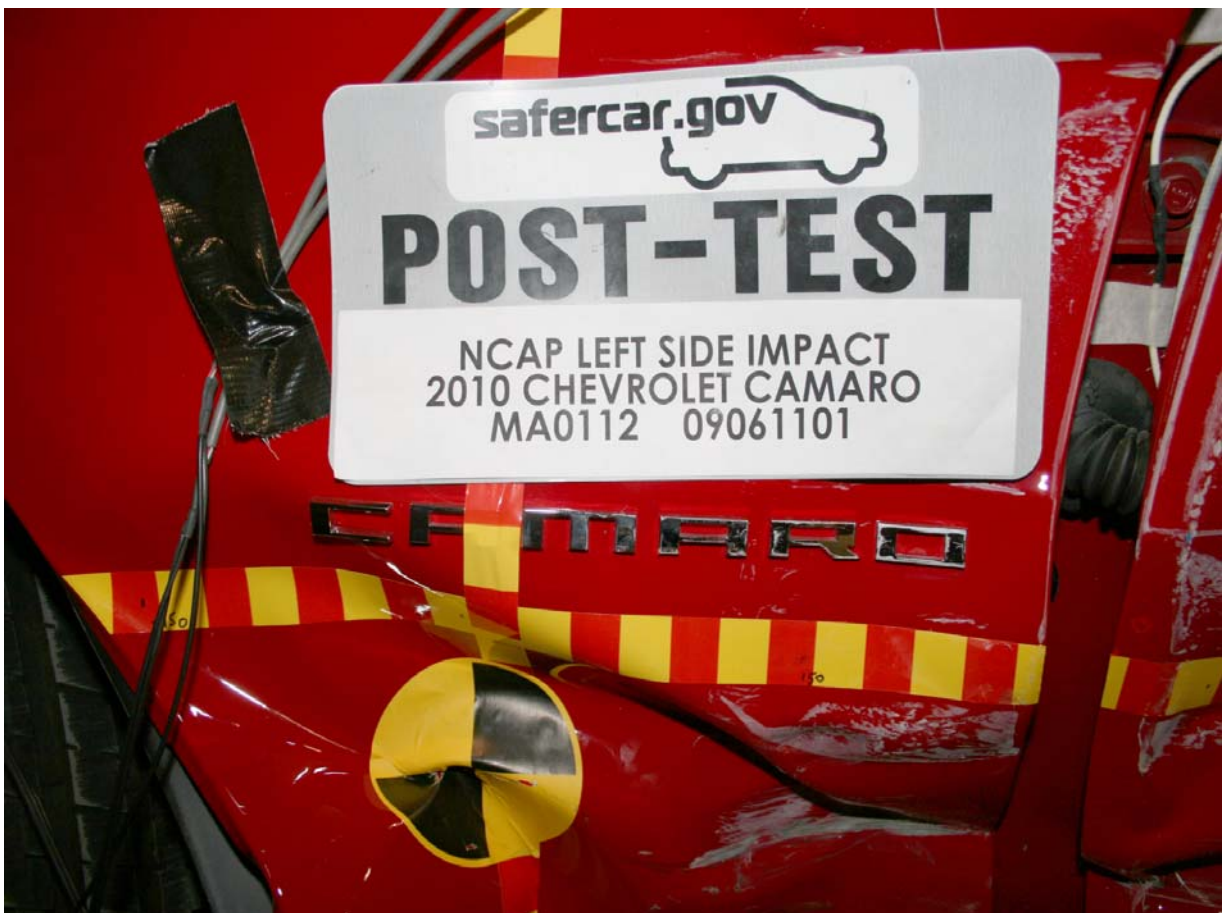
The test vehicle sustained a maximum static crush of 219 mm at level 3, 1500 mm rearward of the vertical impact point. The driver and passenger SID/HIIIs, Serial Nos. 271 and 272 respectively, were calibrated just prior to this test.

Post-Test Left Impact Point

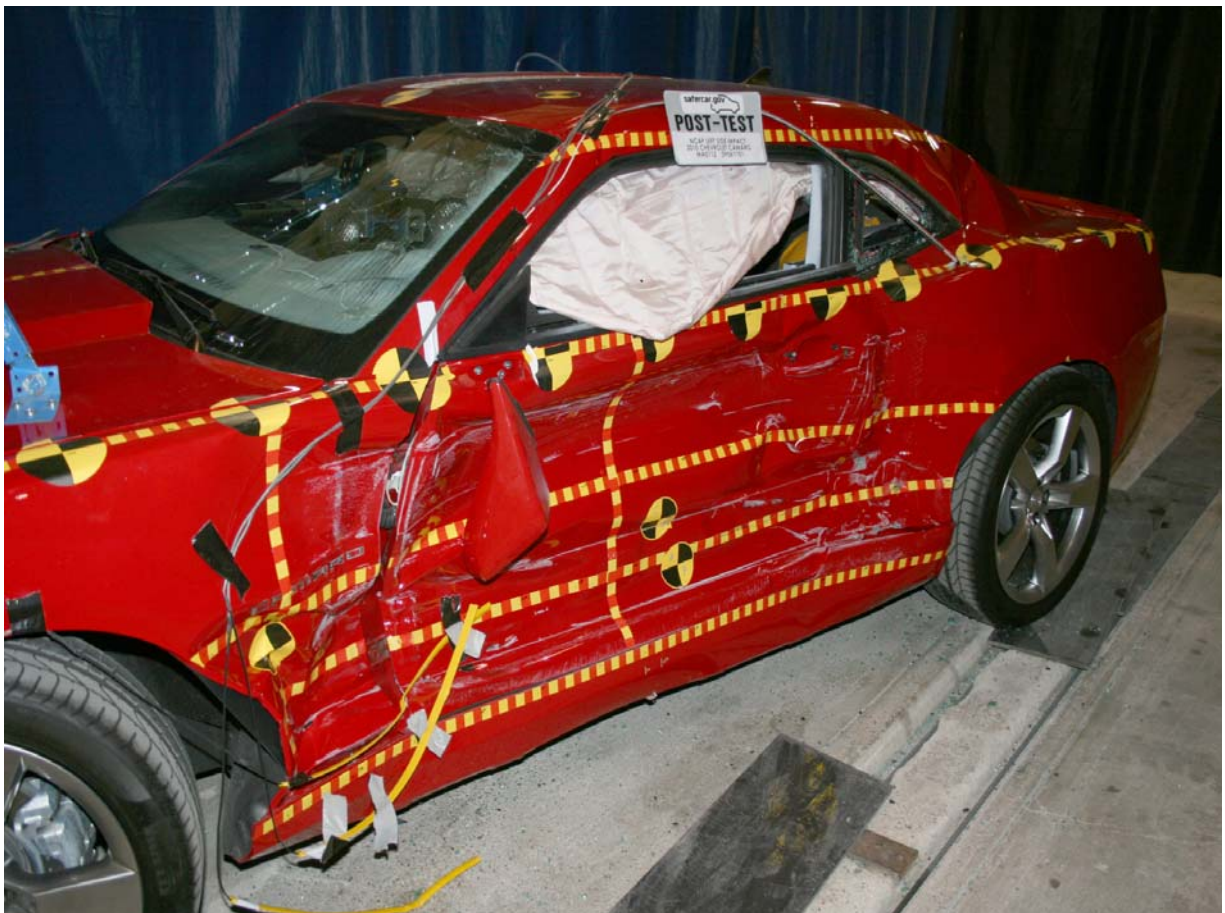
Post-Test Front  $\frac{3}{4}$  View of Left Side Door

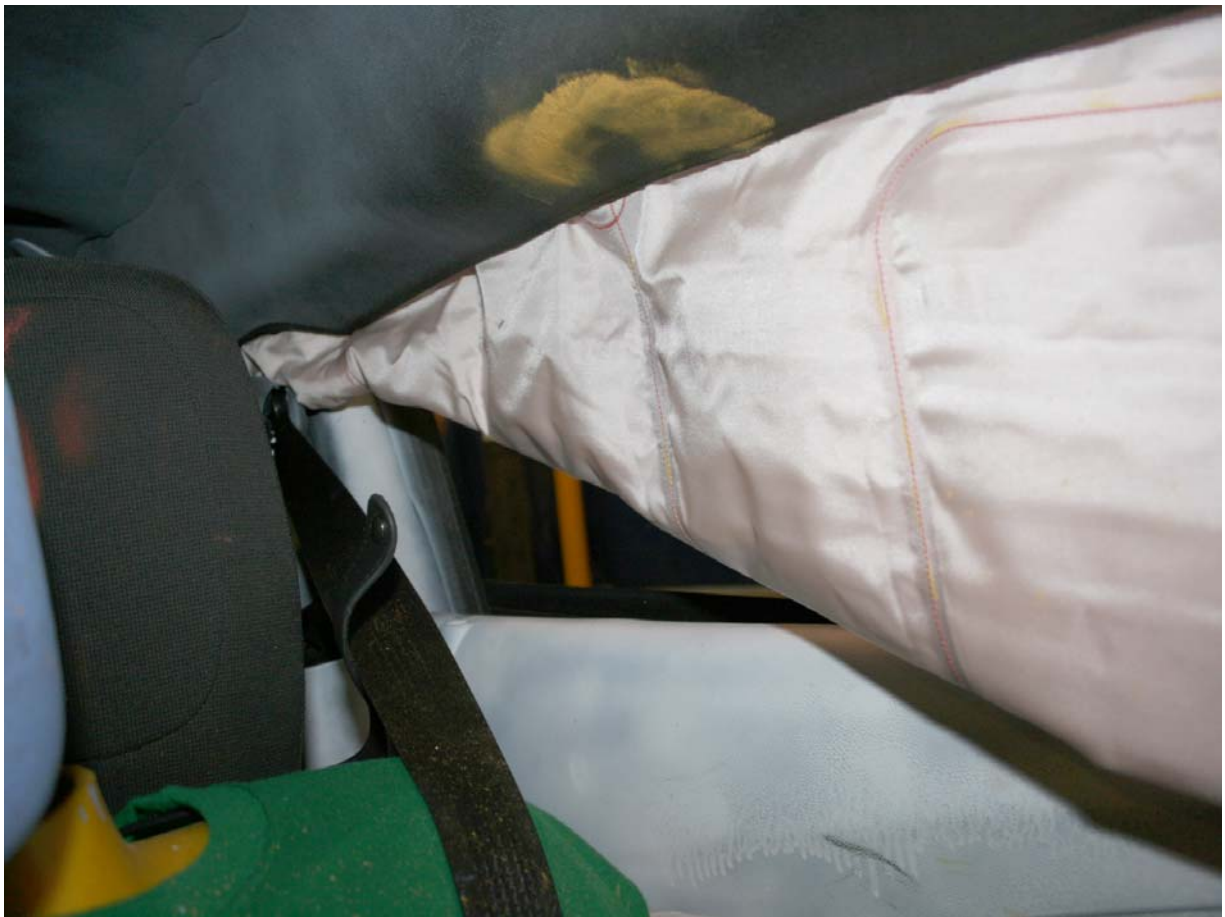
| Description | Front Seat SID/HIII | Rear Seat SID/HIII |
|---|---|---|
| Head Contact | Headliner, Headrest | |

Post-Test Driver Dummy Head Contact View
