NEW CAR ASSESSMENT PROGRAM  
SIDE IMPACT TEST

VOLKSWAGEN AG GERMANY  
2009 VOLKSWAGEN TIGUAN SE 4MOTION  
5-DOOR MPV

NHTSA NUMBER: V95803

FINAL REPORT

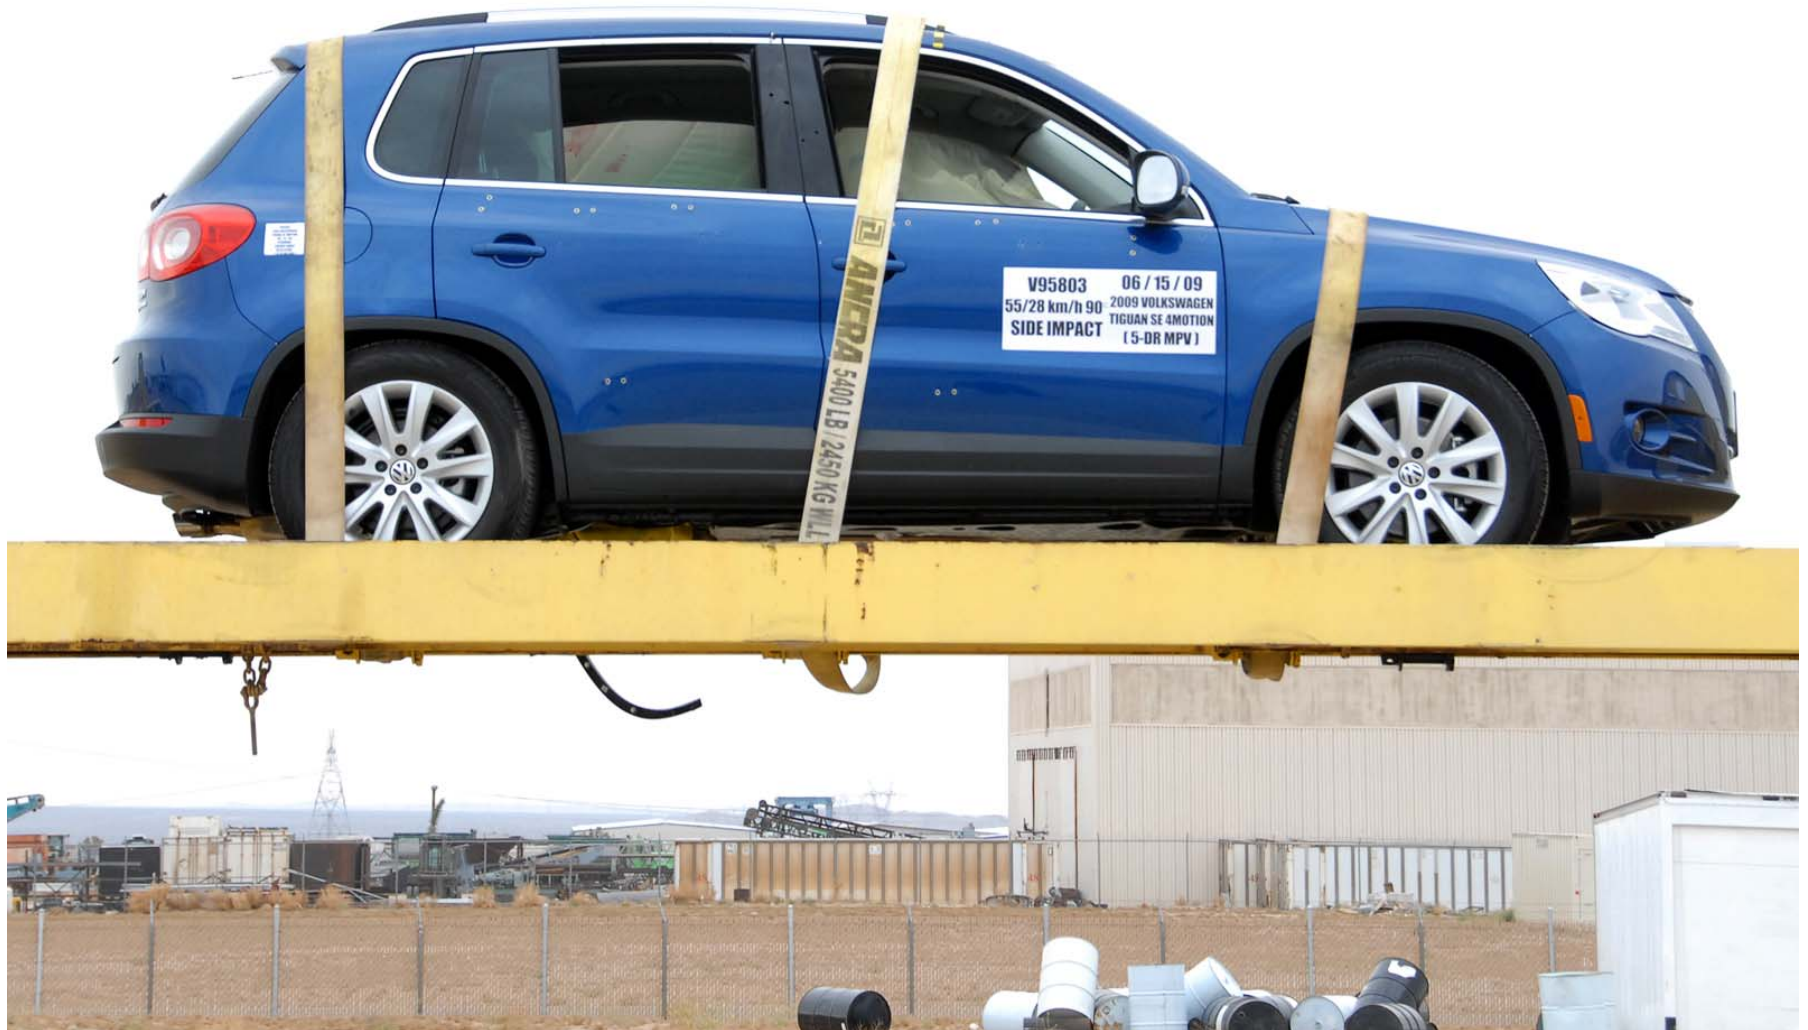
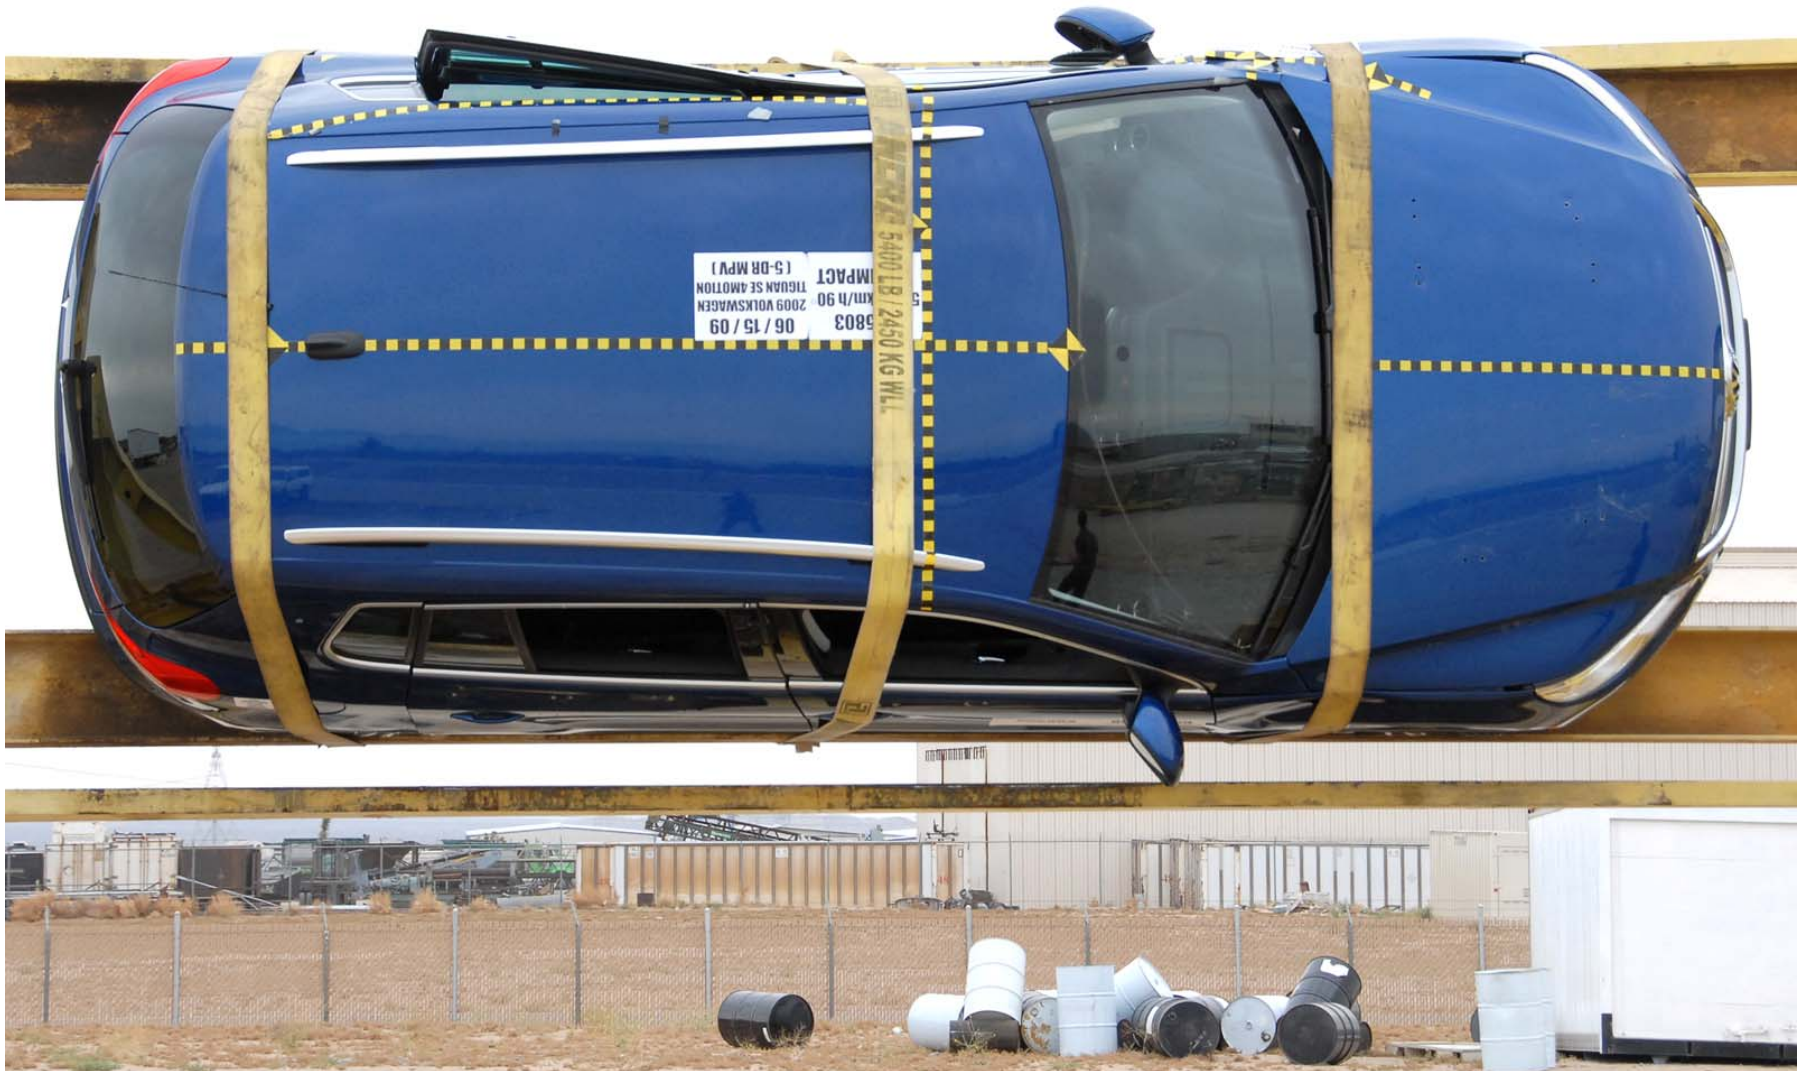
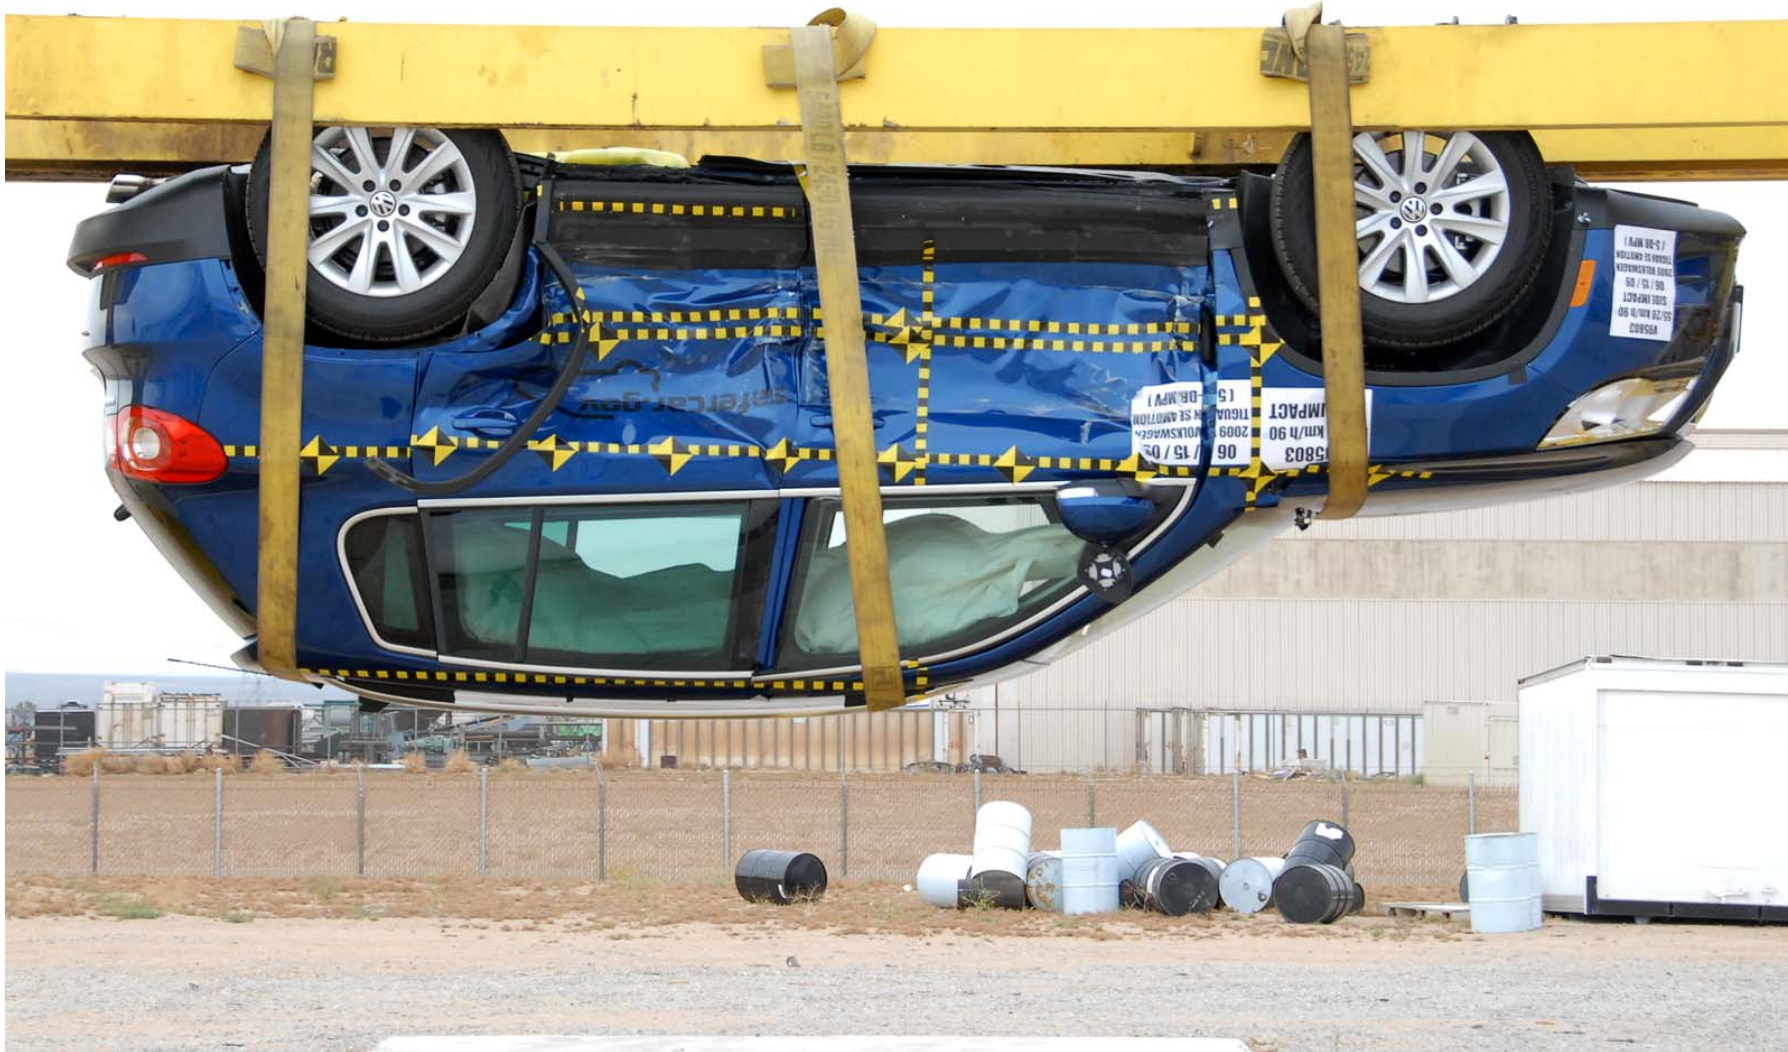
Figure A-61: Vehicle on Rollover Device (0°)

Figure A-62: Vehicle on Rollover Device (90°)

Figure A-63: Vehicle on Rollover Device (180°)

Figure A-64: Vehicle on Rollover Device (270°)

1. The specified fixture rollover rate for each 90° of rotation is 60 to 120 seconds.
2. The position hold time at each position is 300 seconds (minimum).
3. Details of Stoddard Solvent spillage locations.  
No solvent leakage occurred during static rollover testing.
