**NEW CAR ASSESSMENT PROGRAM (NCAP)  
FRONTAL BARRIER IMPACT TEST**

**HYUNDAI MOTOR COMPANY  
2010 HYUNDAI GENESIS  
2-DOOR COUPE**

NHTSA NUMBER: MA0501

CALSPAN TEST NUMBER: 8865-NCAP-09

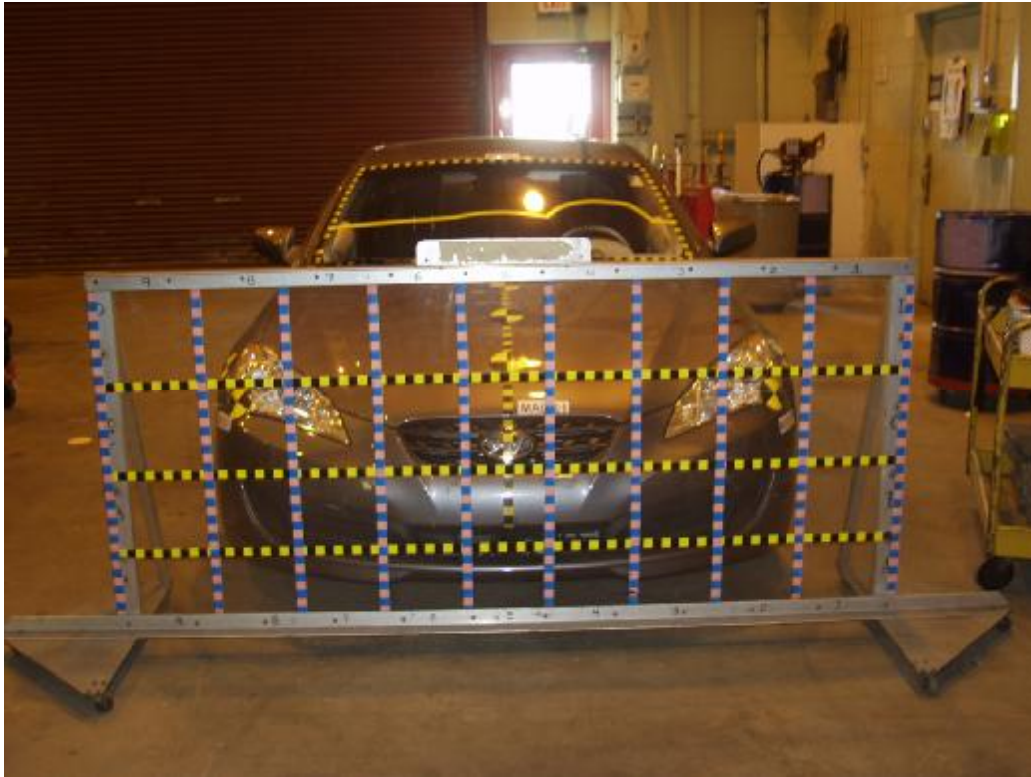
**Figure A-1: Load Cell Locations**

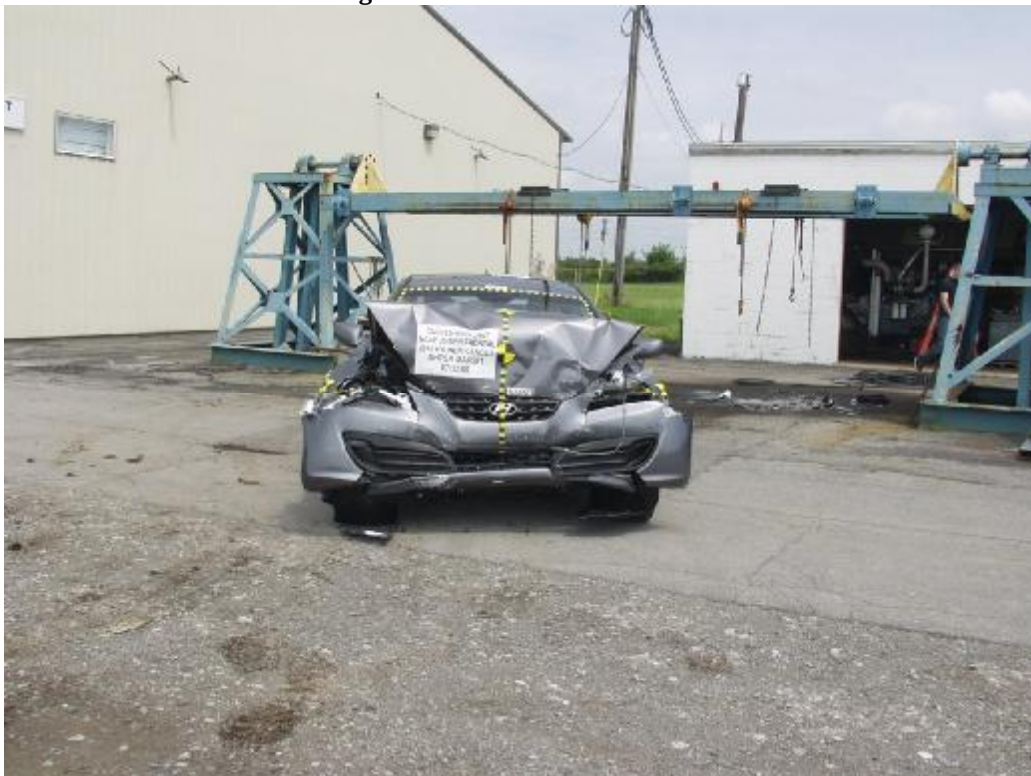
**Figure A-7: Post-Test Front View**

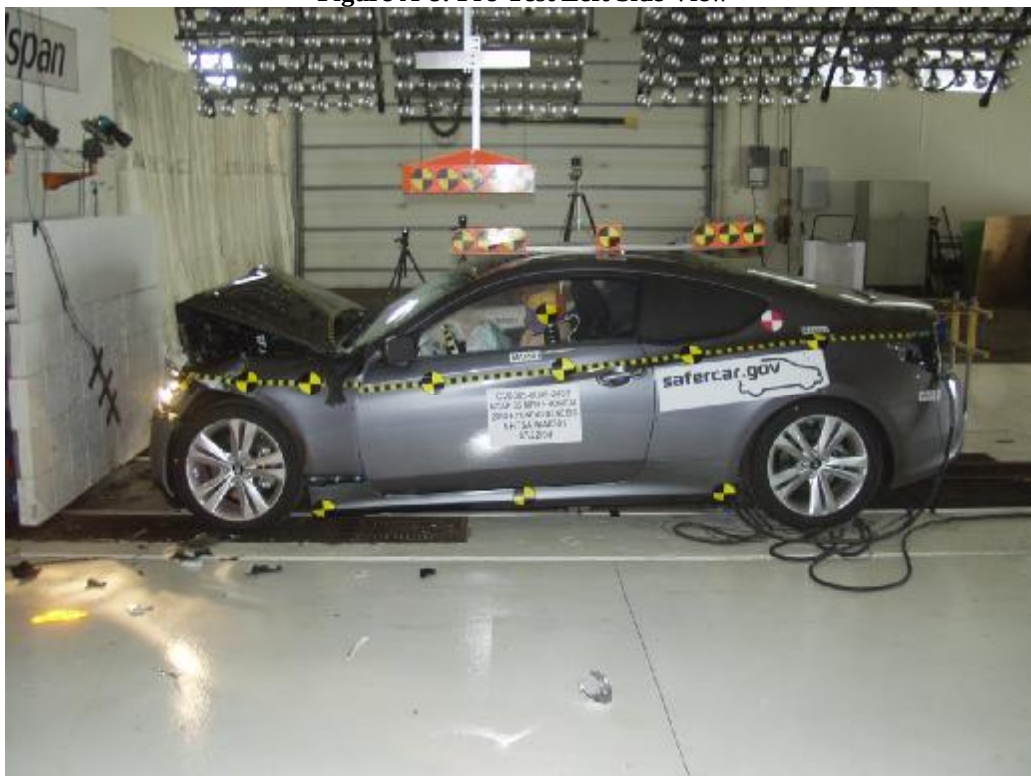
**Figure A-9: Post-Test Left Side View**

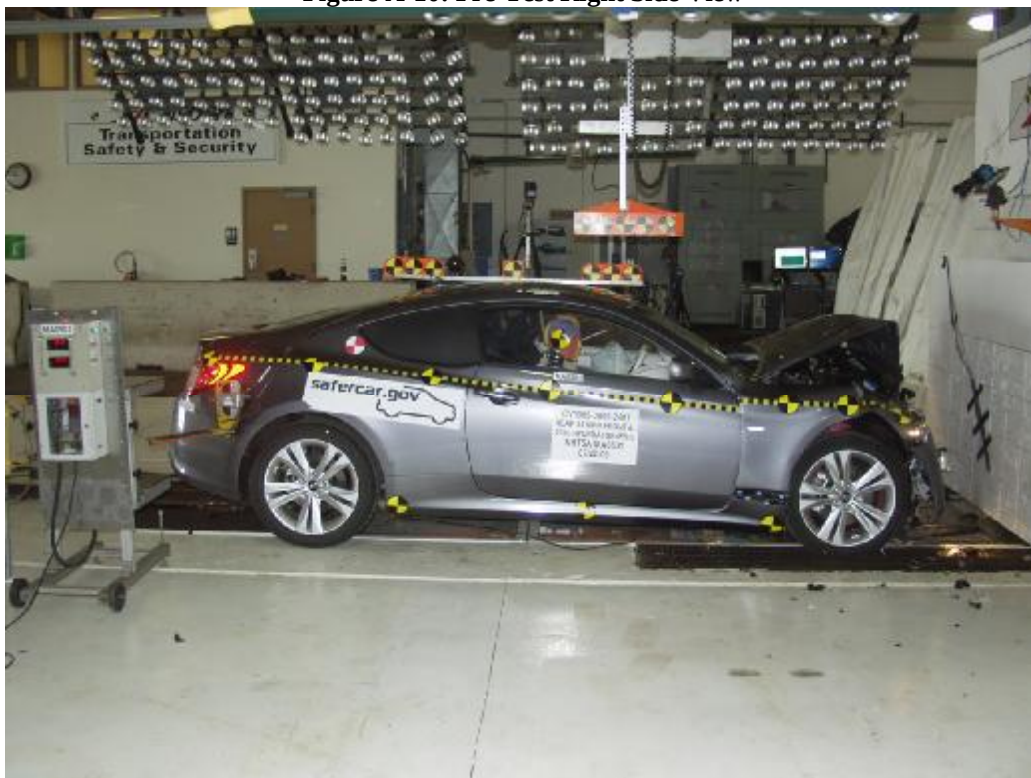
**Figure A-11: Post-Test Right Side View**

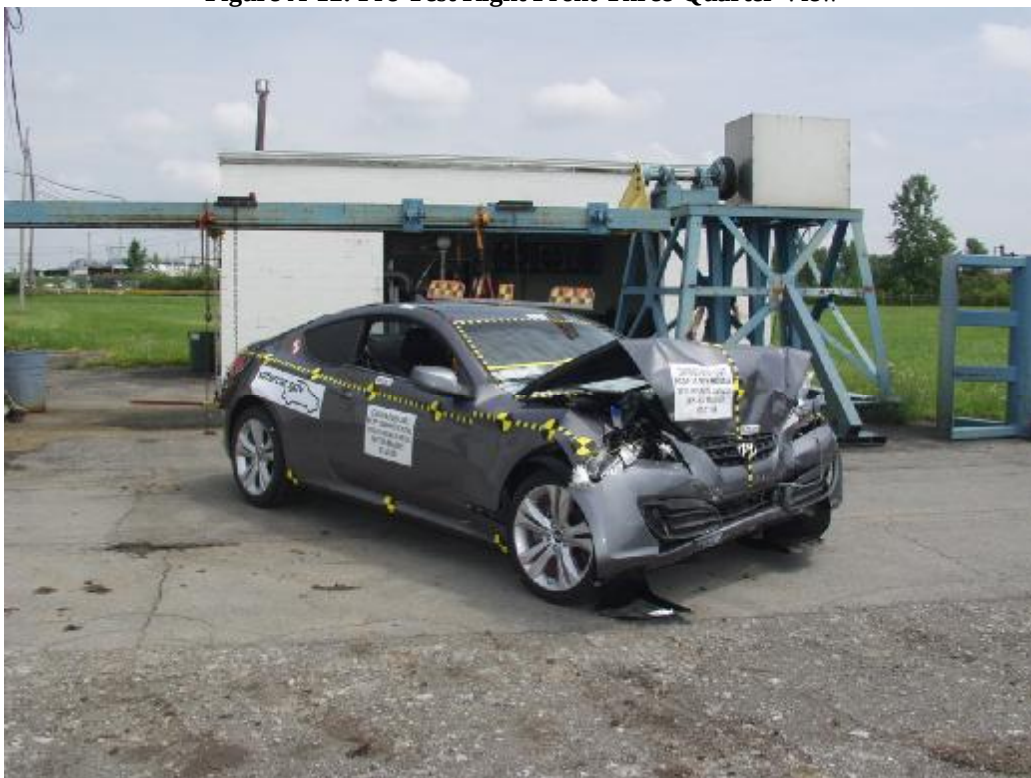
**Figure A-13: Post-Test Right Front Three-Quarter View**

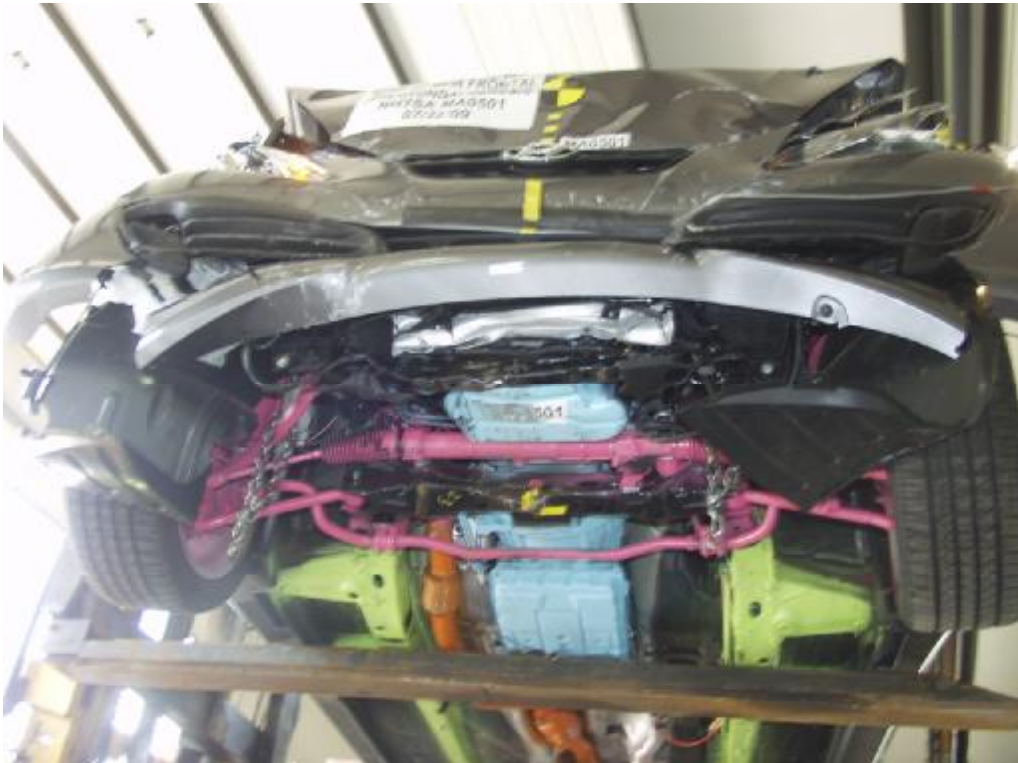
**Figure A-25: Post-Test Front Underbody View**

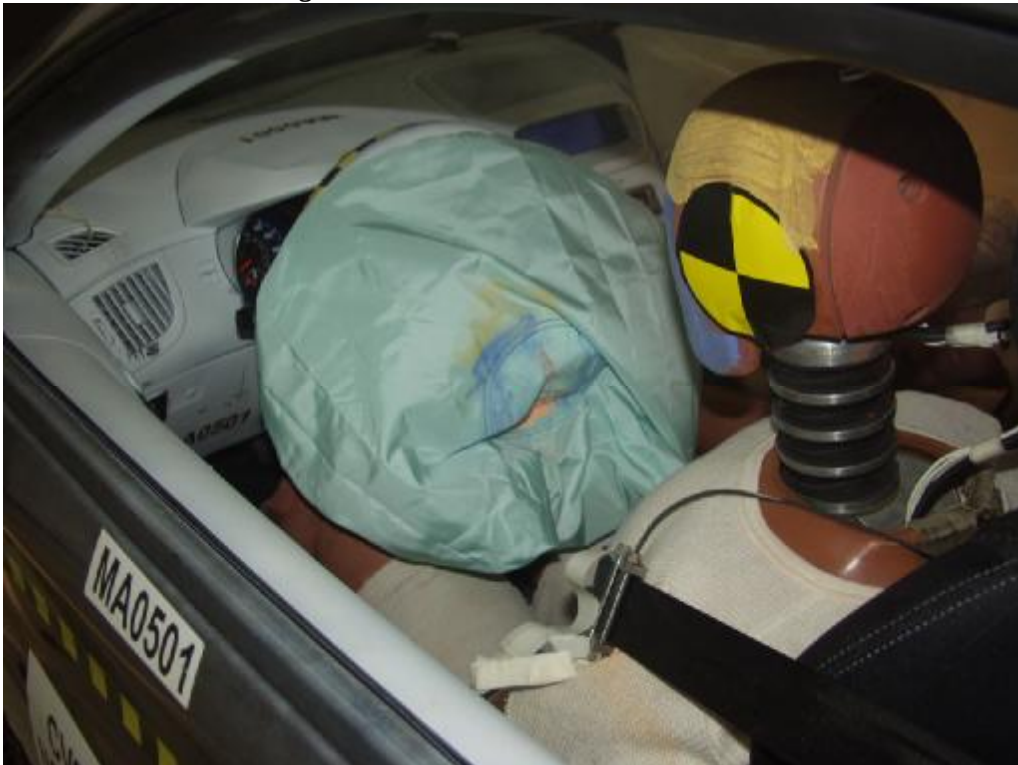
**Figure A-43: Post-Test Driver Contact to Airbag**

| | DRIVER | PASSENGER |
|---|---|---|
| Chest Contact: | Airbag | Airbag |
