**REPORT NUMBER: NCAP-MGA-2010-001**

**NEW CAR ASSESSMENT PROGRAM  
FRONTAL BARRIER IMPACT TEST**

**TOYOTA MOTOR CORPORATION  
2010 TOYOTA PRIUS III  
NHTSA NUMBER: MA5105**

**PREPARED BY:  
MGA RESEARCH CORPORATION  
5000 WARREN ROAD  
BURLINGTON, WI 53105**

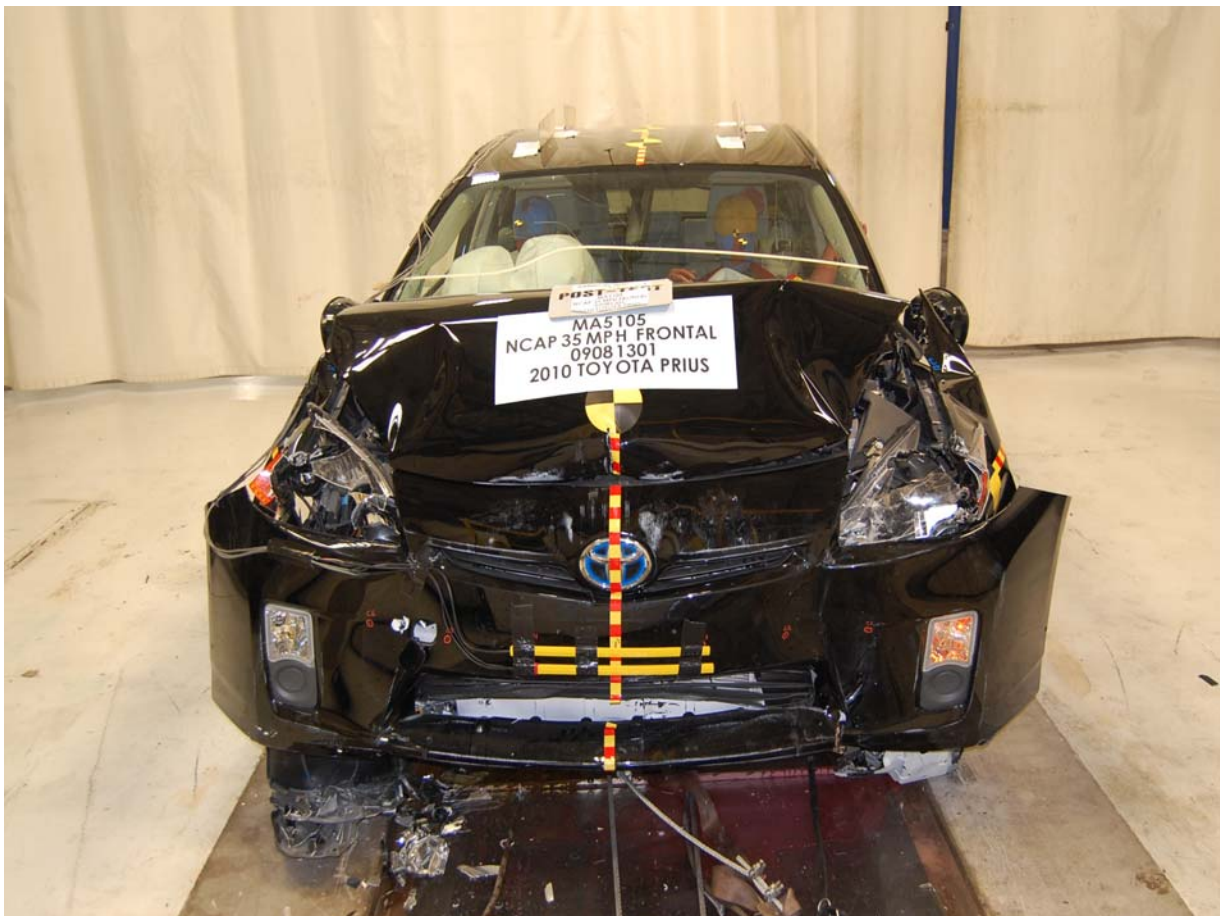
Post-Test Front View

The maximum static crush of the vehicle was 454 mm and both the driver and passenger side door remained closed and latched during the impact event and were operable after the impact.

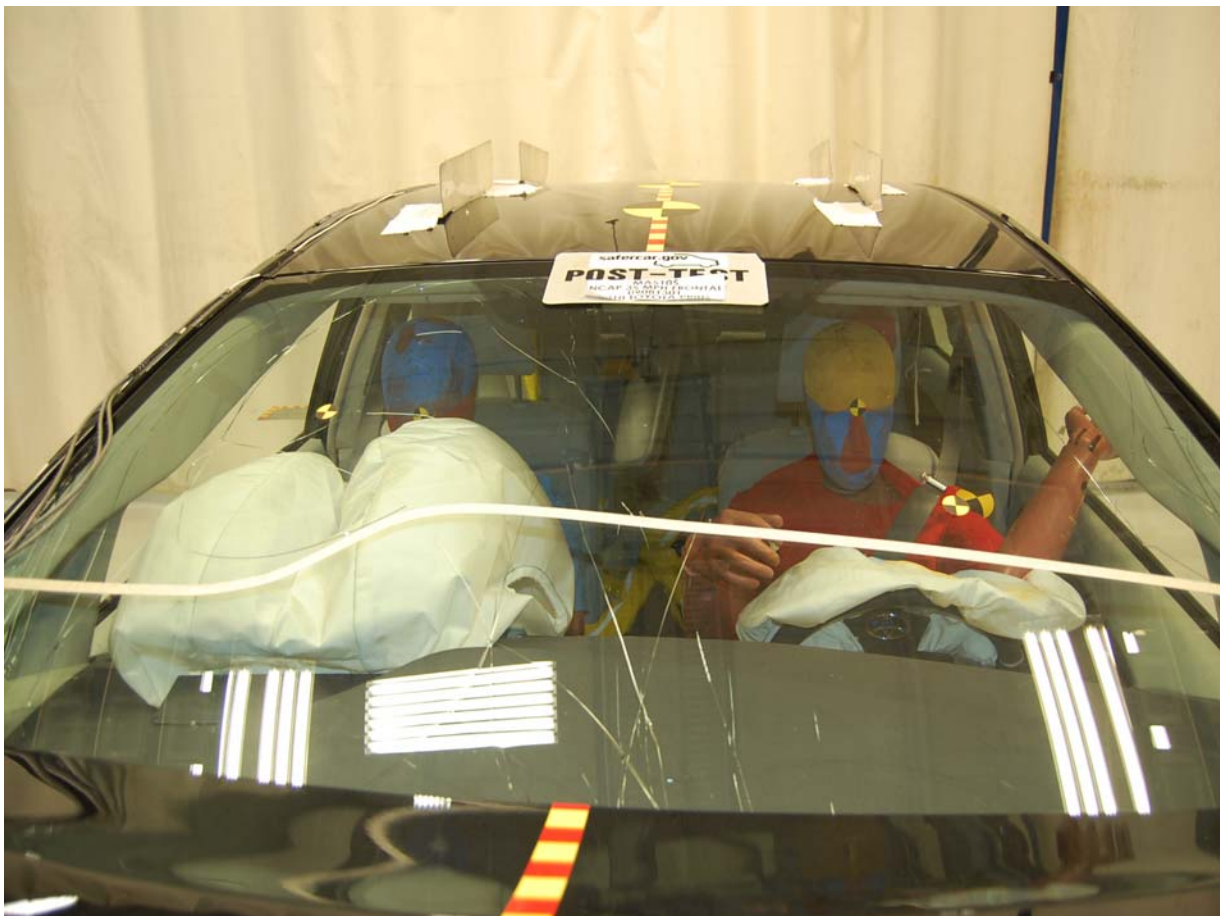
Post-Test Windshield View

There was 100 percent windshield retention and no intrusion into the protected zone of the windshield during the event. There was no Stoddard Solvent leakage after the event or during any phase of the static rollover.

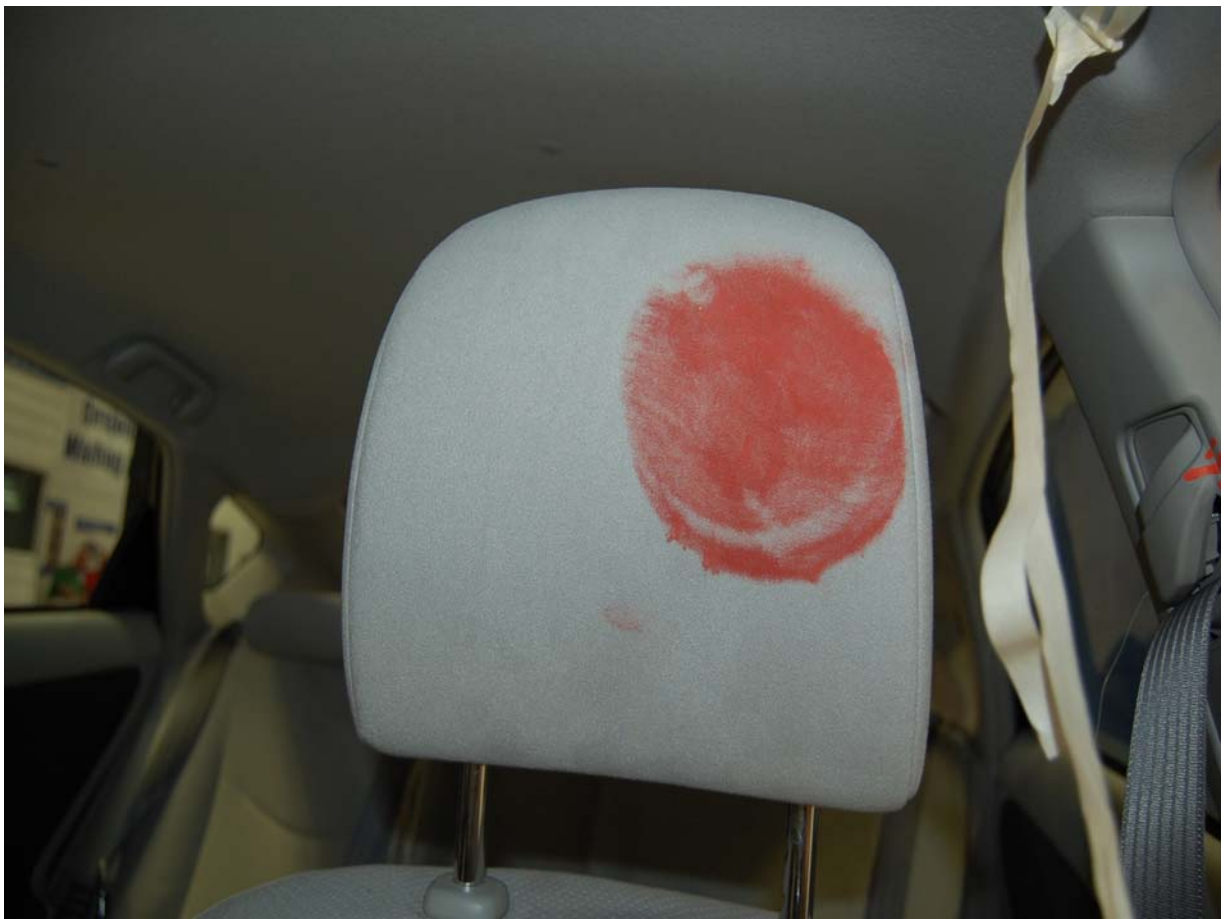
Post-Test Driver Dummy Head Contact

The driver's head and chest contacted the airbag. The driver's head also contacted the headrest. The driver's knees contacted the knee bag. The passenger's head and chest contacted the airbag. The passenger's head also contacted the side header. The passenger's knees contacted the glove box.

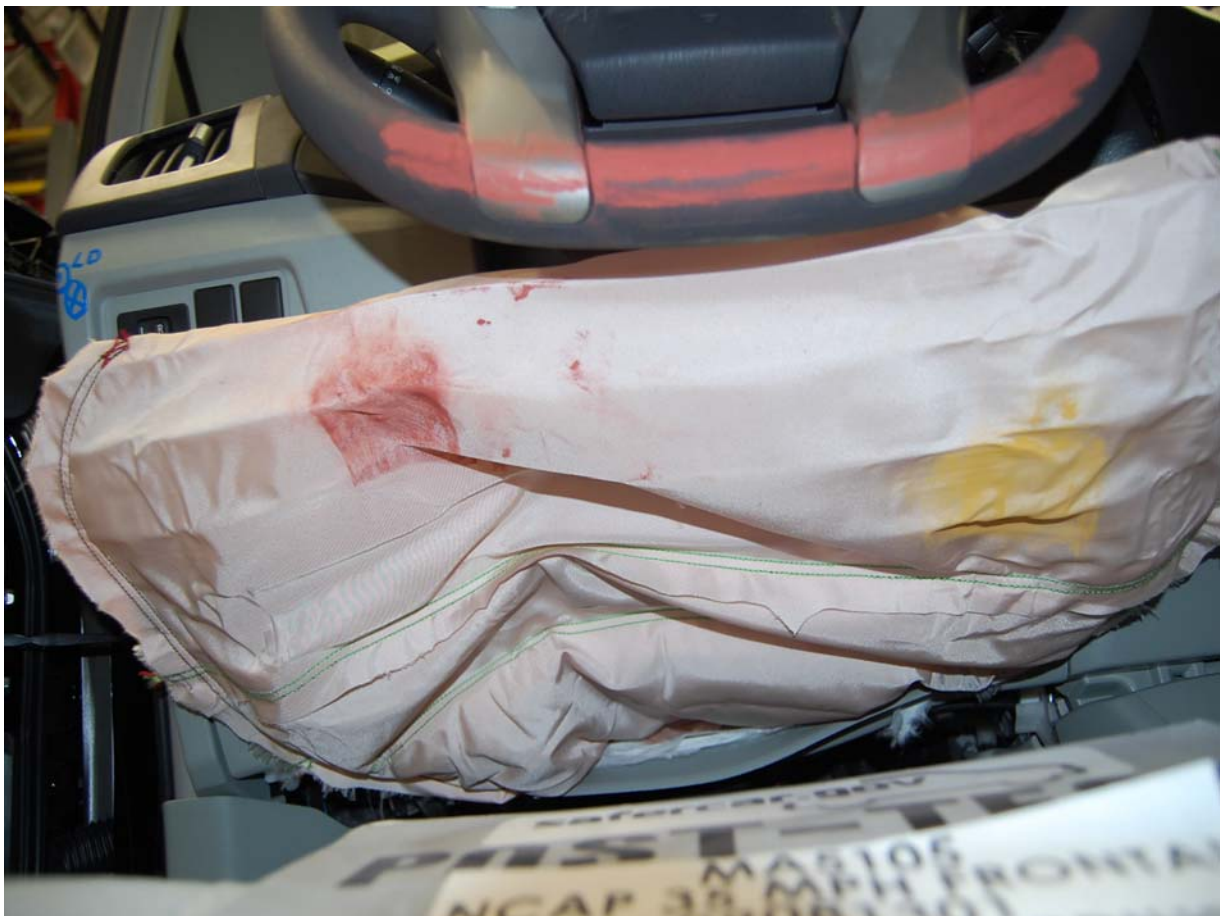
Post-Test Driver Dummy Knee Contact View

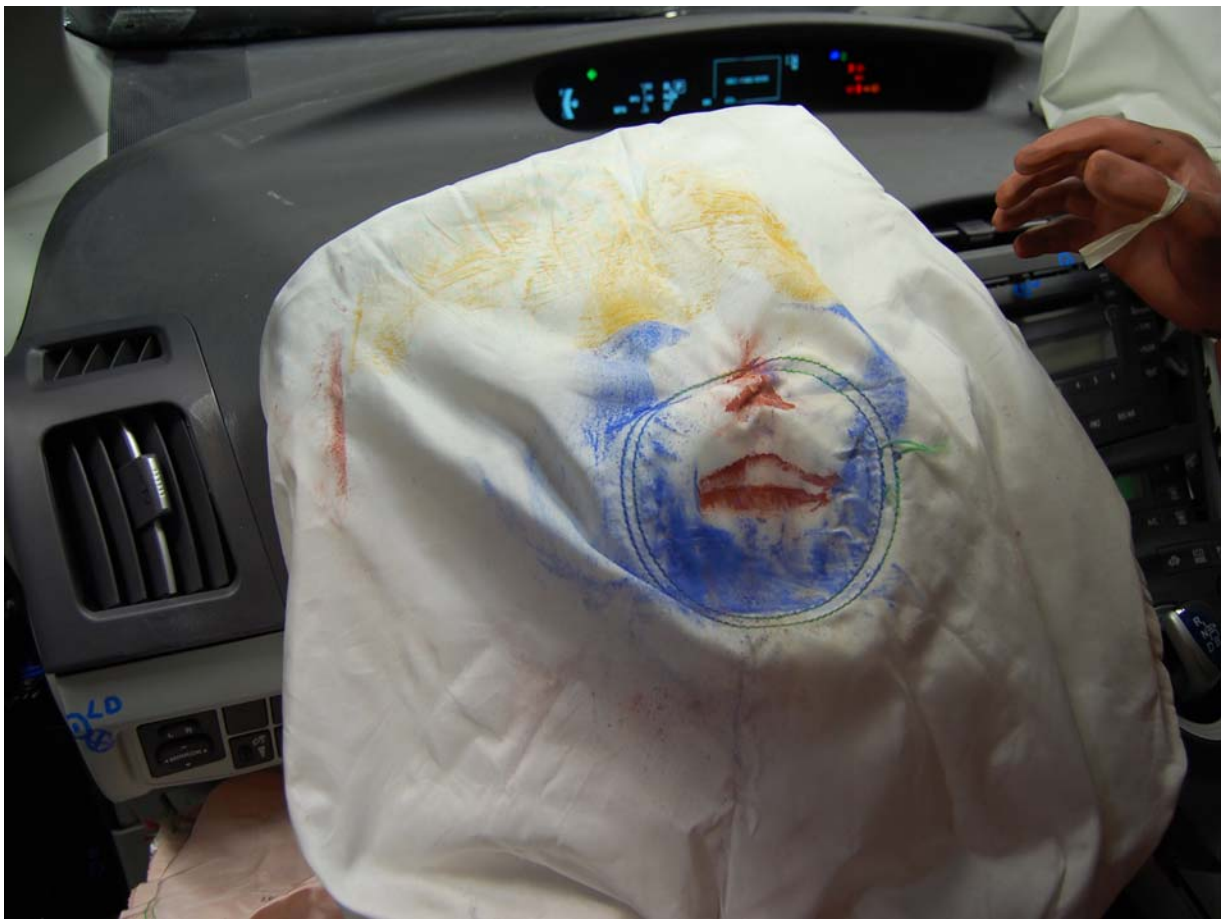
Post-Test Driver Dummy Airbag Contact

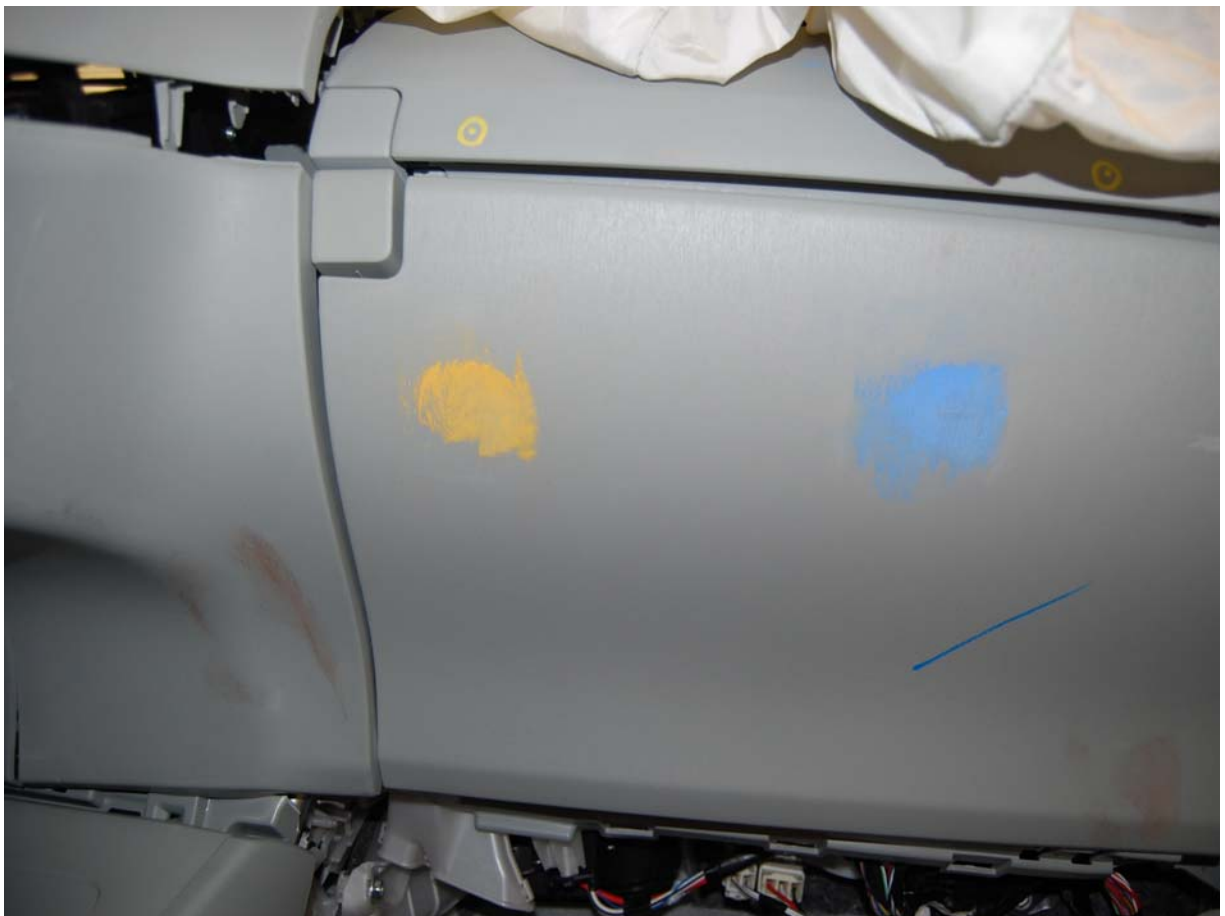
Post-Test Passenger Dummy Knee Contact

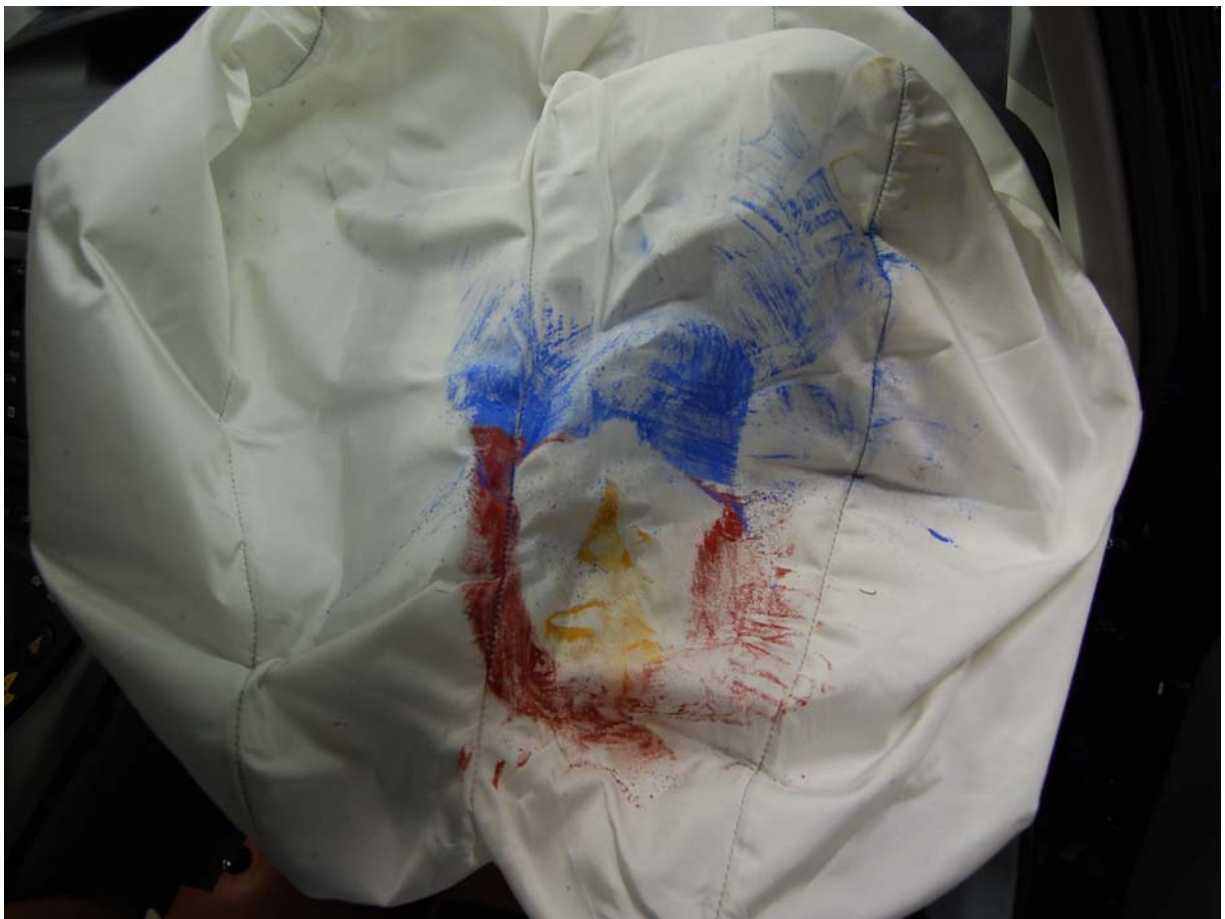
Post-Test Passenger Dummy Airbag Contact
