**REPORT NUMBER: NCAP-MGA-2010-002**

**VALIDATION  
FRONTAL BARRIER IMPACT TEST**

**HYUNDAI MOTOR COMPANY  
2010 HYUNDAI GENESIS 2-DR COUPE  
NHTSA NUMBER: MA0500**

**PREPARED BY:  
MGA RESEARCH CORPORATION  
5000 WARREN ROAD  
BURLINGTON, WI 53105**

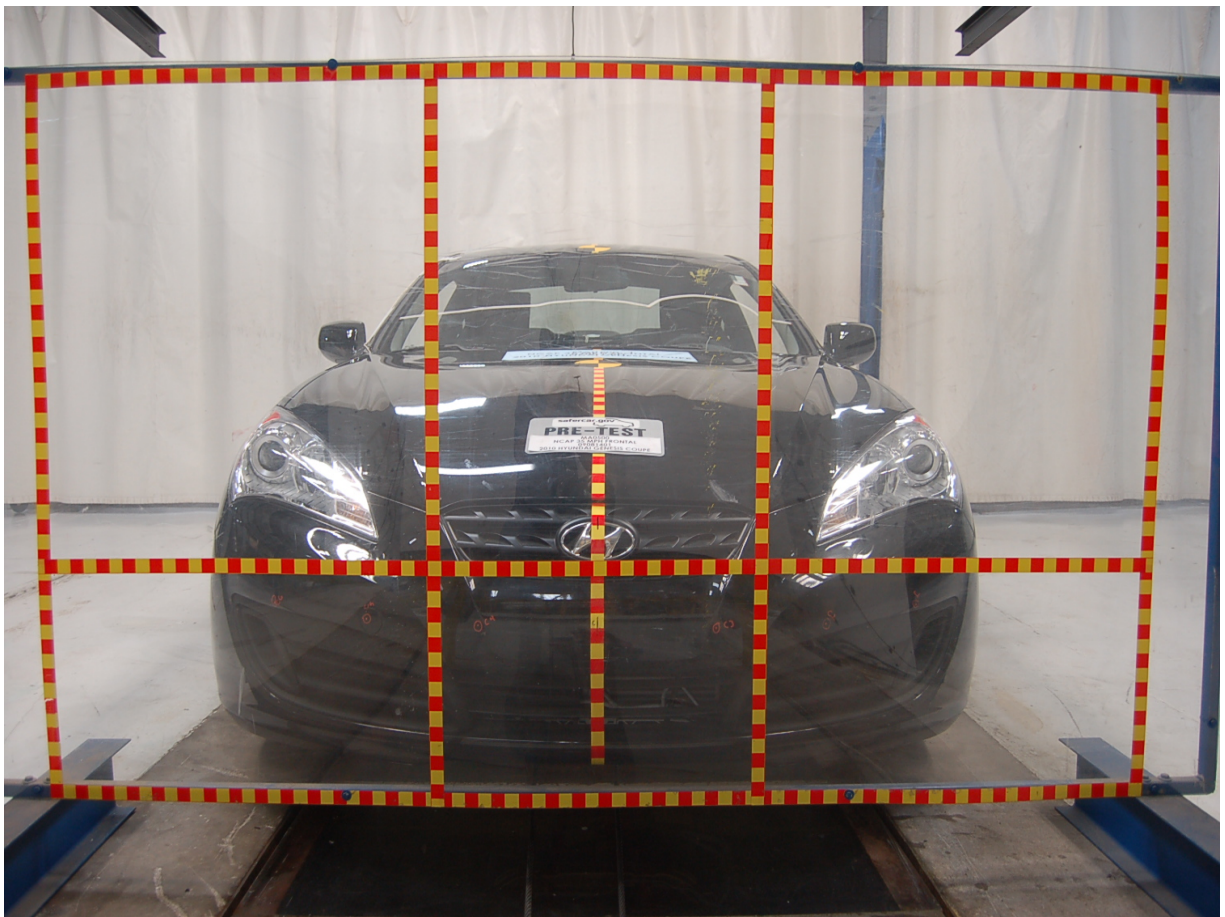
Load Cell Location

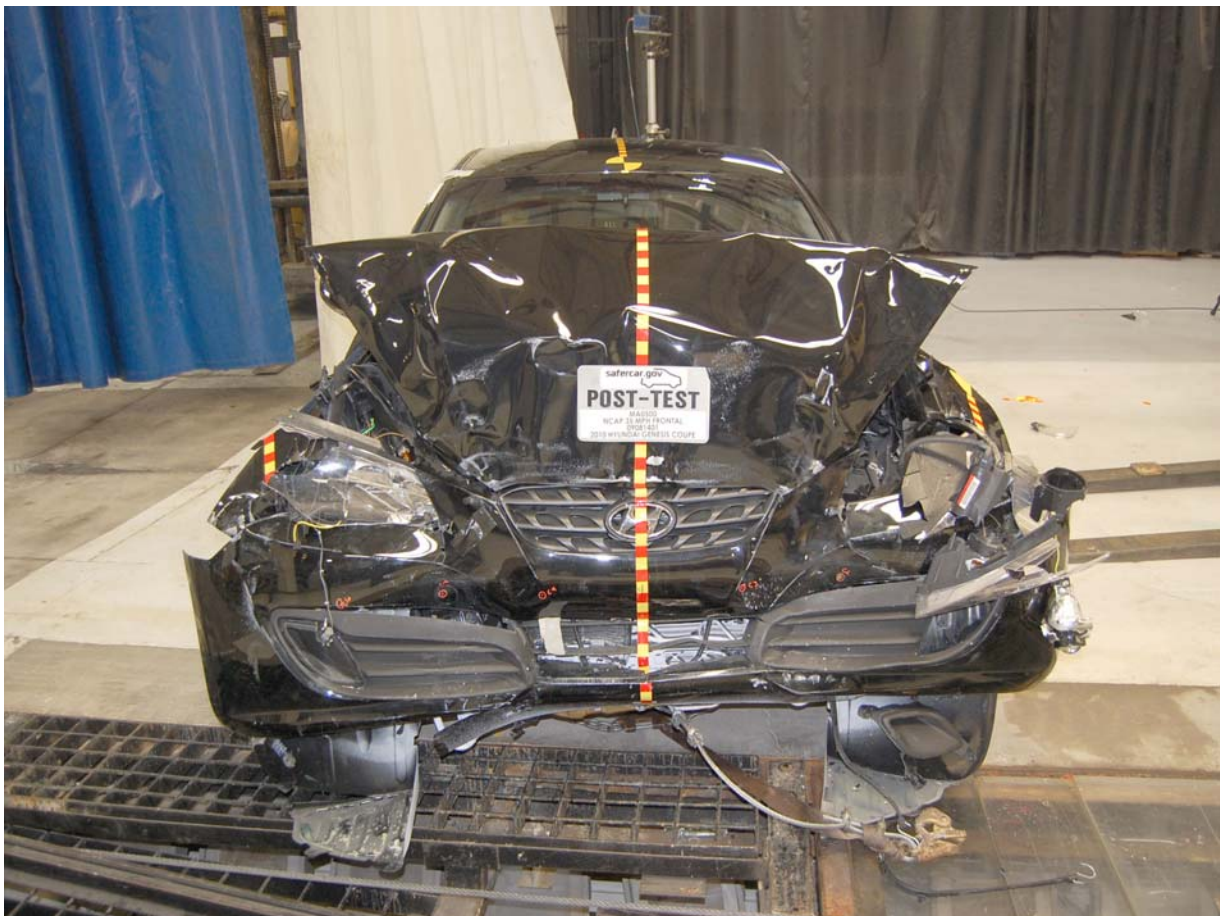
The maximum static crush of the vehicle was 477 mm and both the driver and passenger side doors remained closed during the impact event and were operable after the impact.

Post-Test Front View

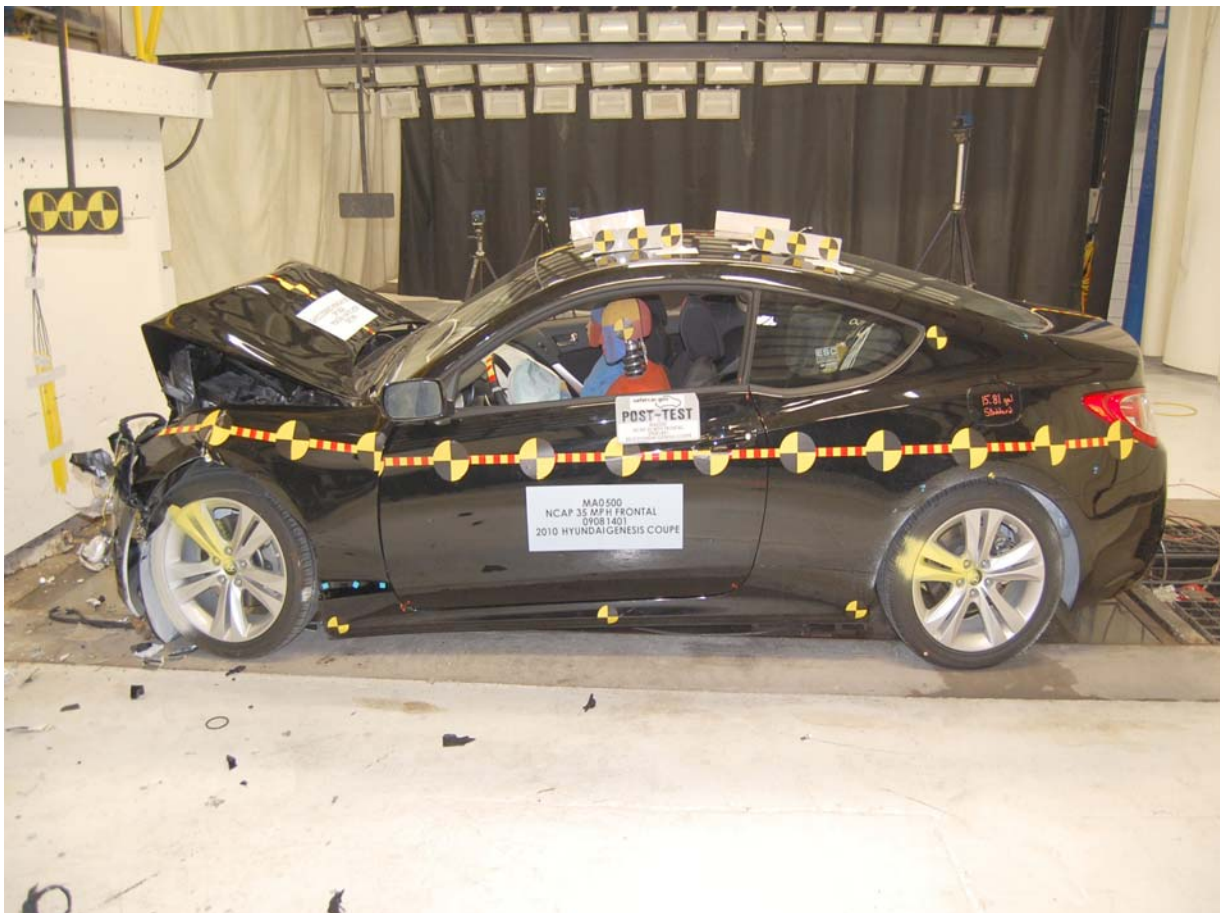
Post-Test Left Side View

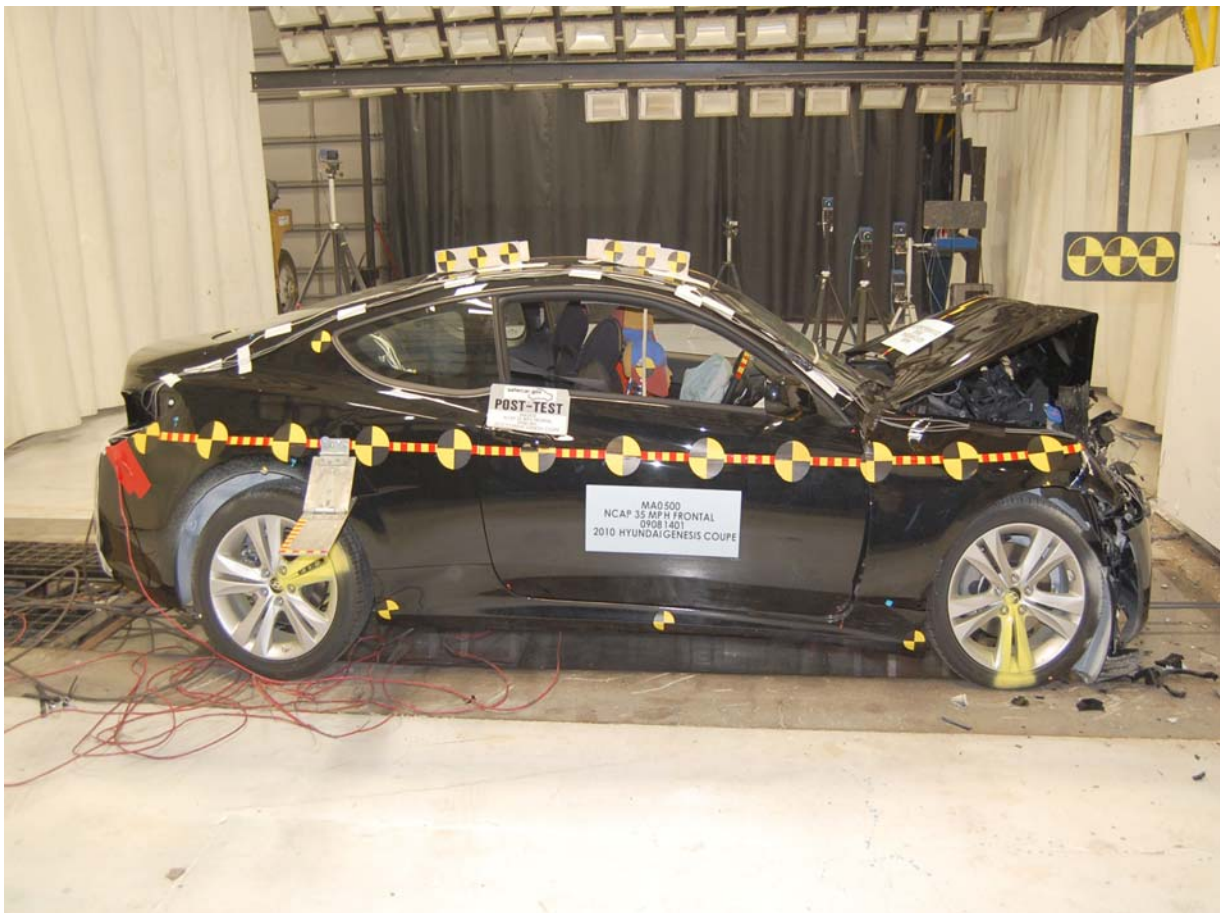
Post-Test Right Side View

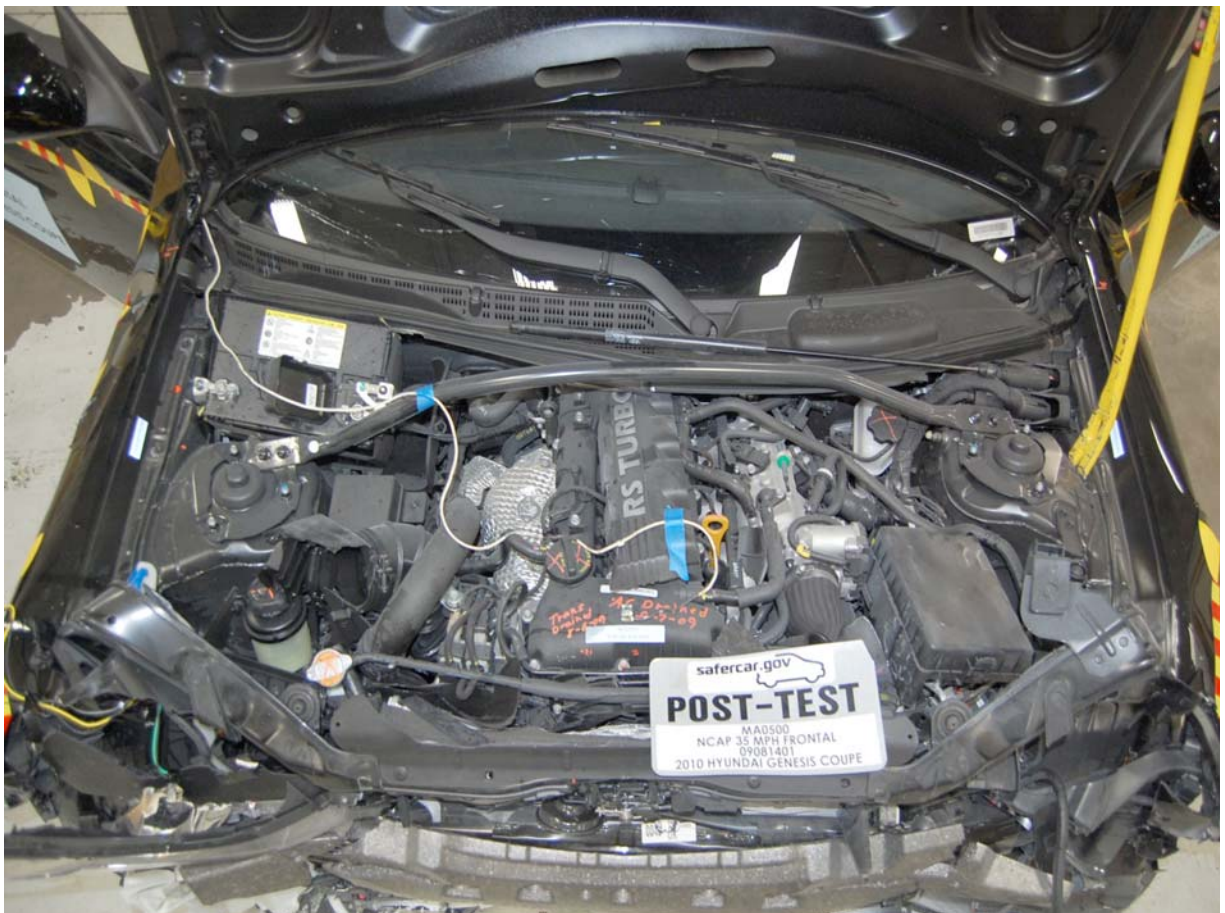
Post-Test Engine Compartment View

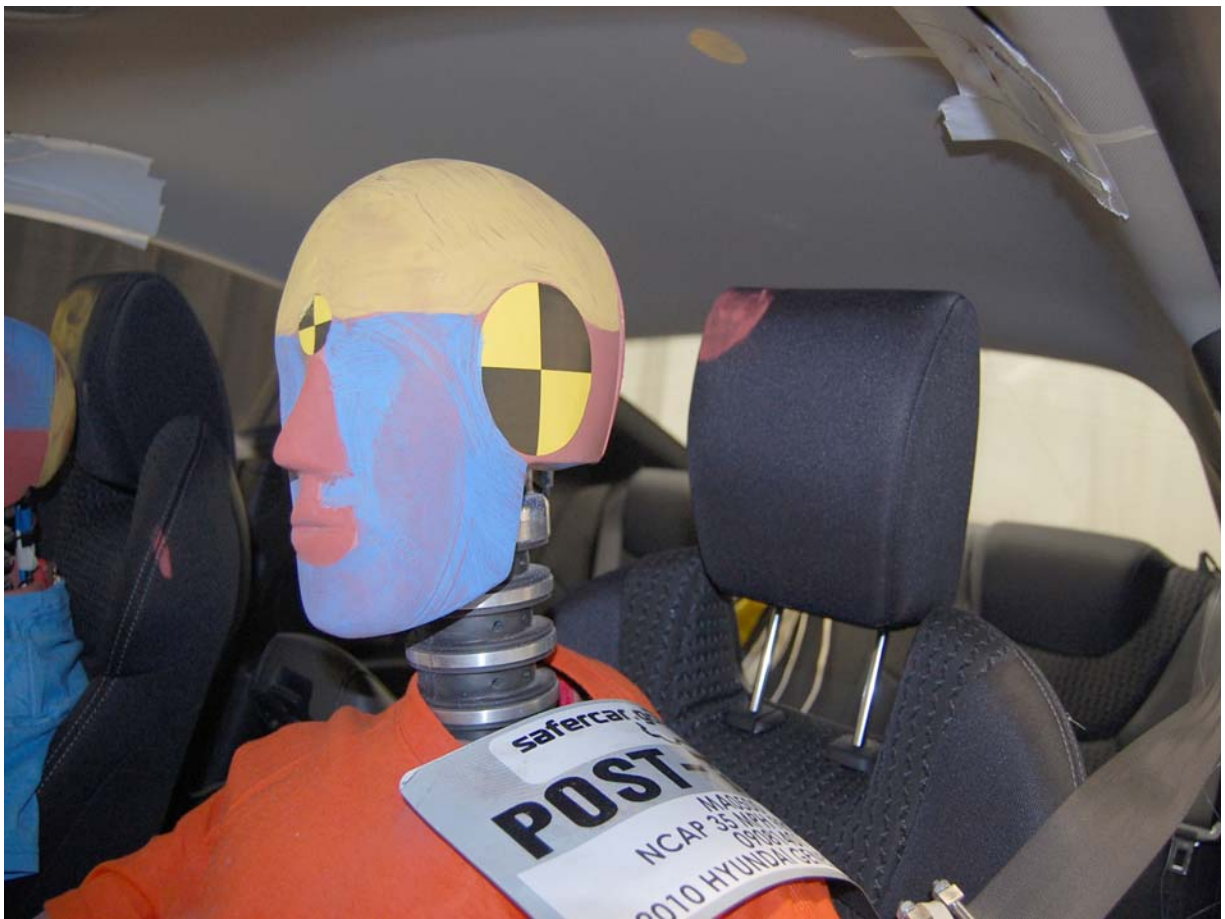
The driver's head and chest contacted the airbag. The driver's head also contacted the headrest and headliner. The driver's left knee contacted the steering column. The passenger's head and chest contacted the airbag. The passenger's head also contacted the headrest. The passenger's knees had no contact.

Post-Test Driver Dummy Head Contact

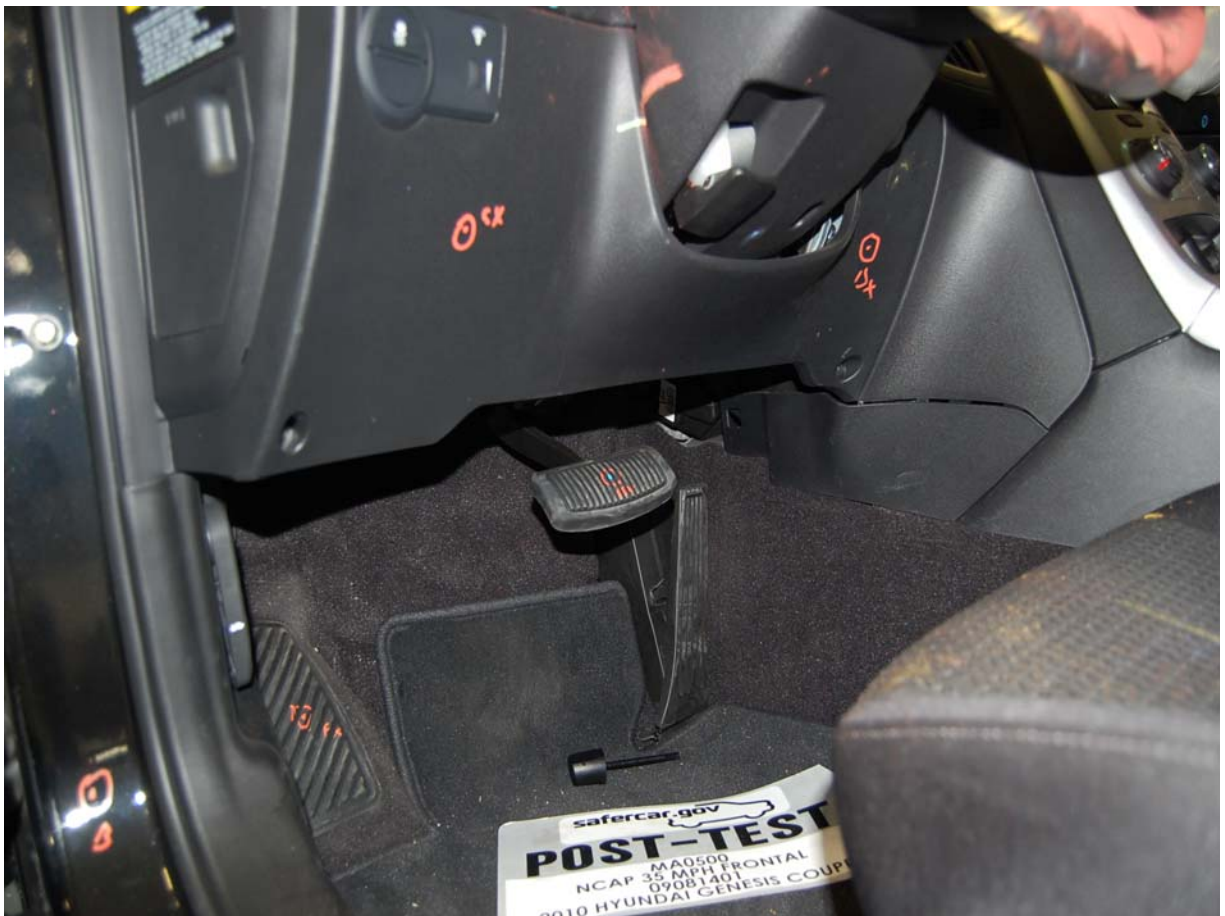
Post-Test Driver Dummy Knee Contact (steering column)

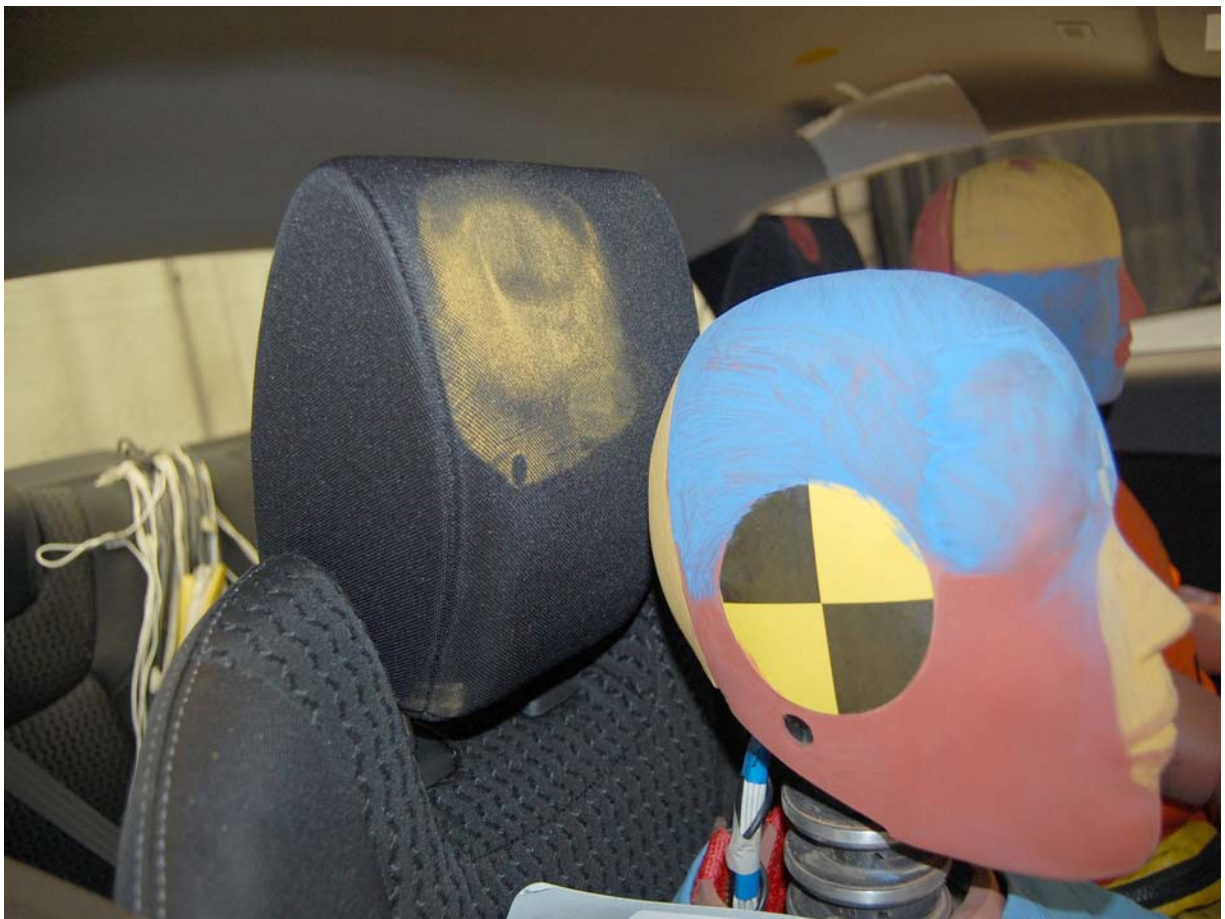
Post-Test Passenger Dummy Head Contact

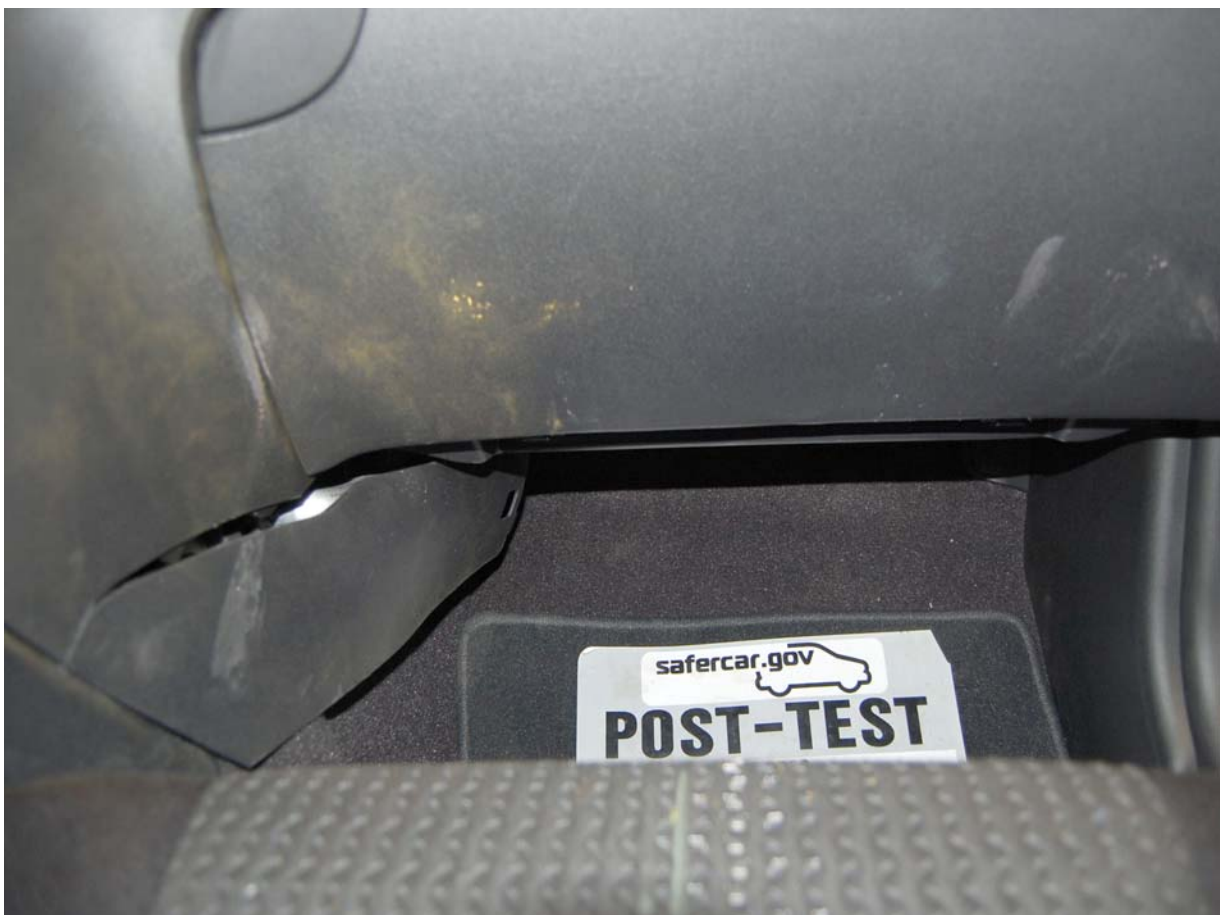
Post-Test Passenger Dummy Knee Contact (no contact)

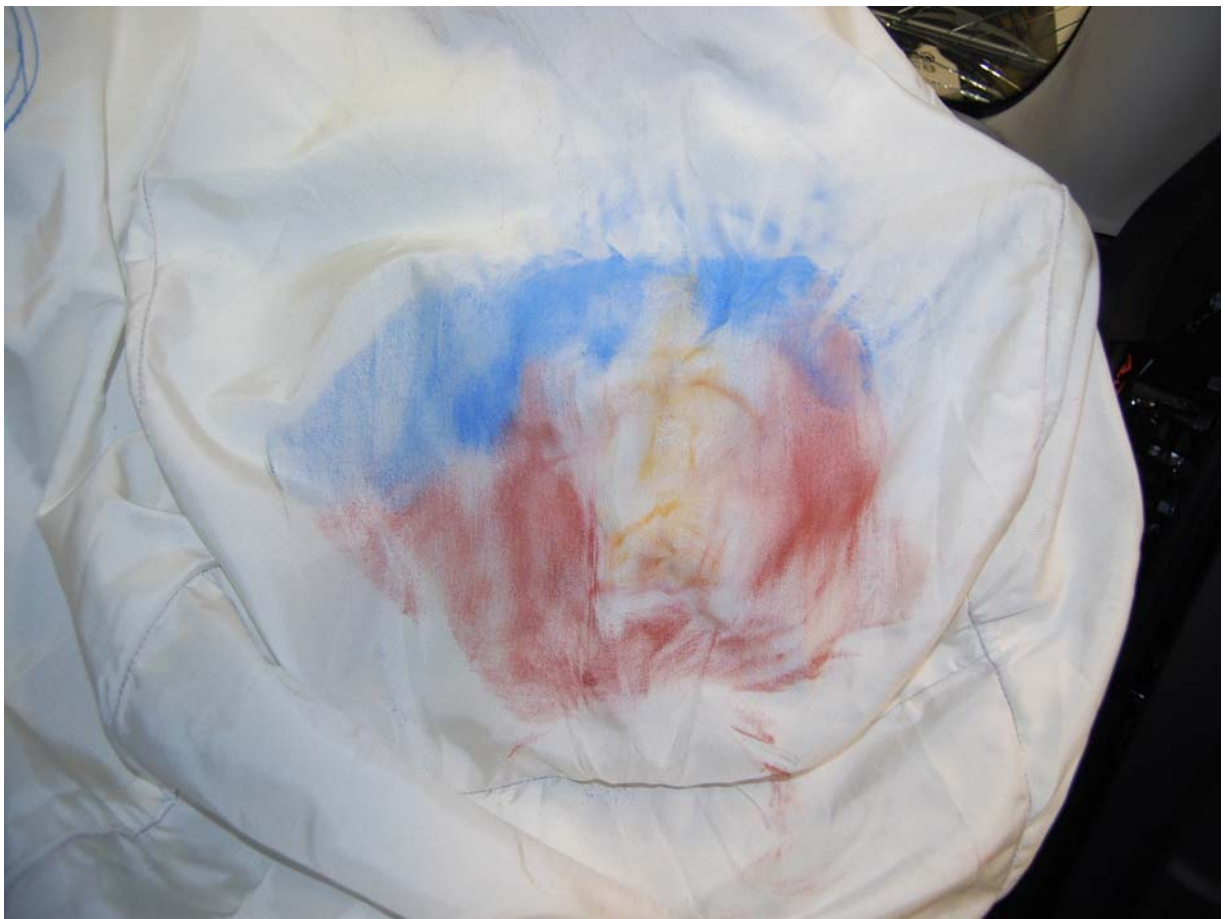
Post-Test Passenger Dummy Airbag Contact

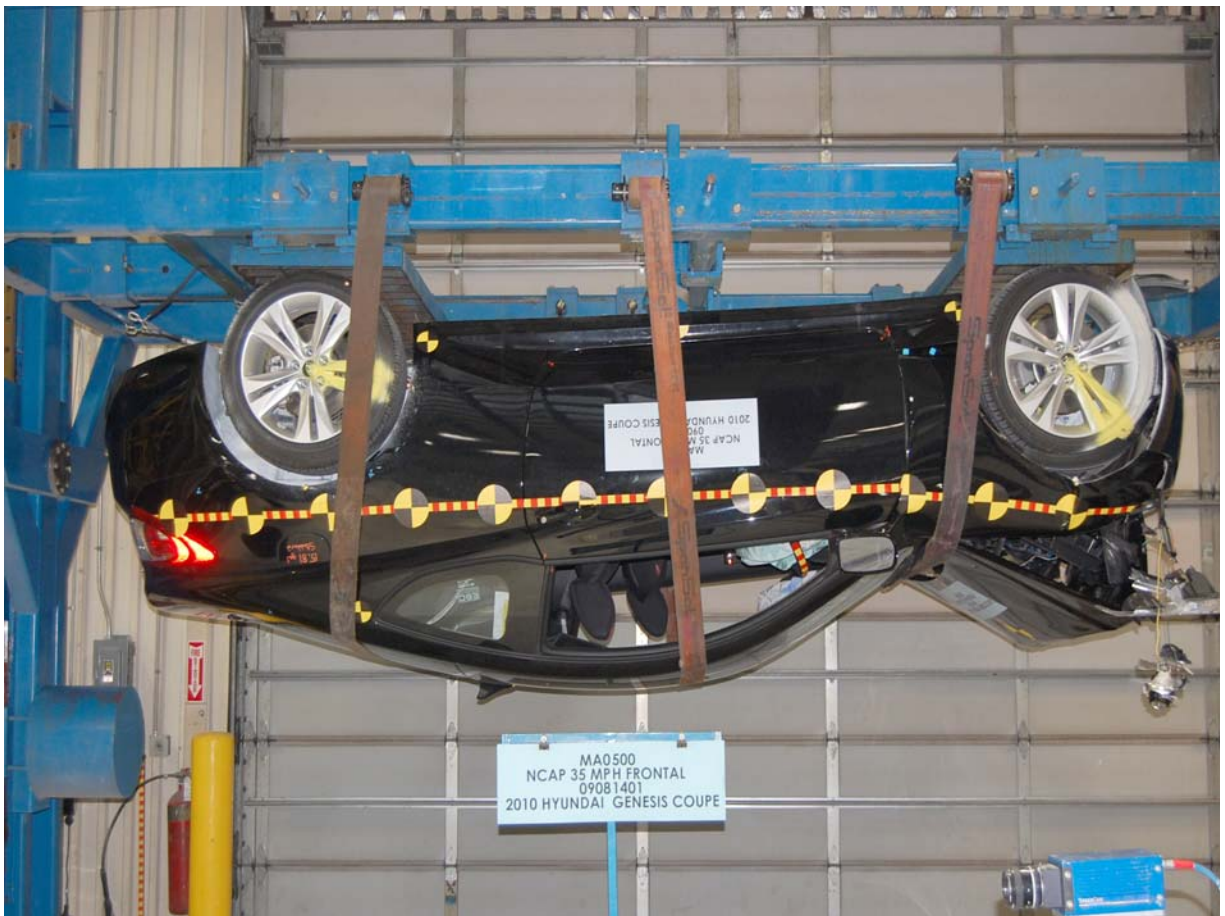
Vehicle at 180 Degrees on Static Rollover Device

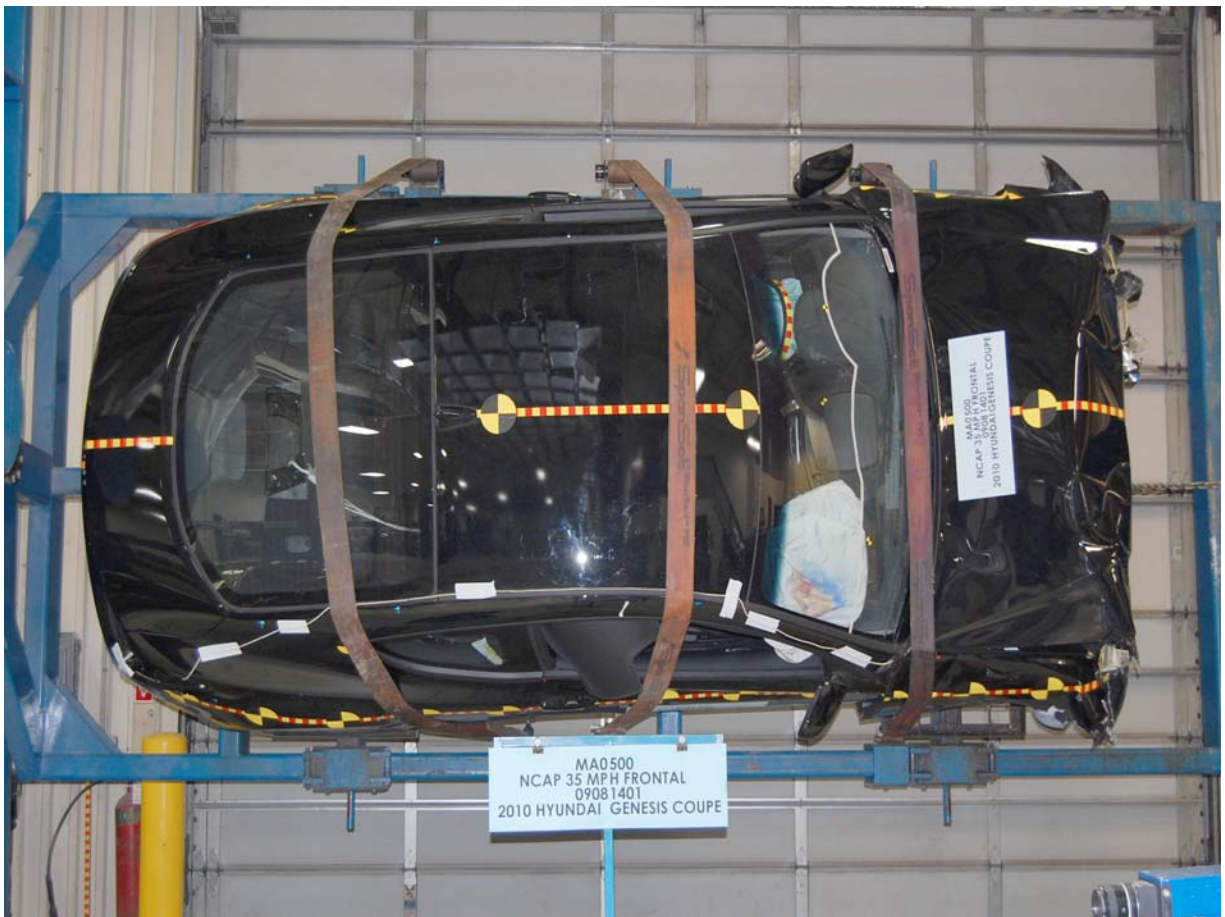
Vehicle at 270 Degrees on Static Rollover Device
