REPORT NUMBER: CAL-10-1

**NEW CAR ASSESSMENT PROGRAM (NCAP)  
FRONTAL BARRIER IMPACT TEST**

TOYOTA MOTOR MANUFACTURING  
2010 TOYOTA TUNDRA 4x4  
REGULAR CAB PICKUP

NHTSA NUMBER: MA5118

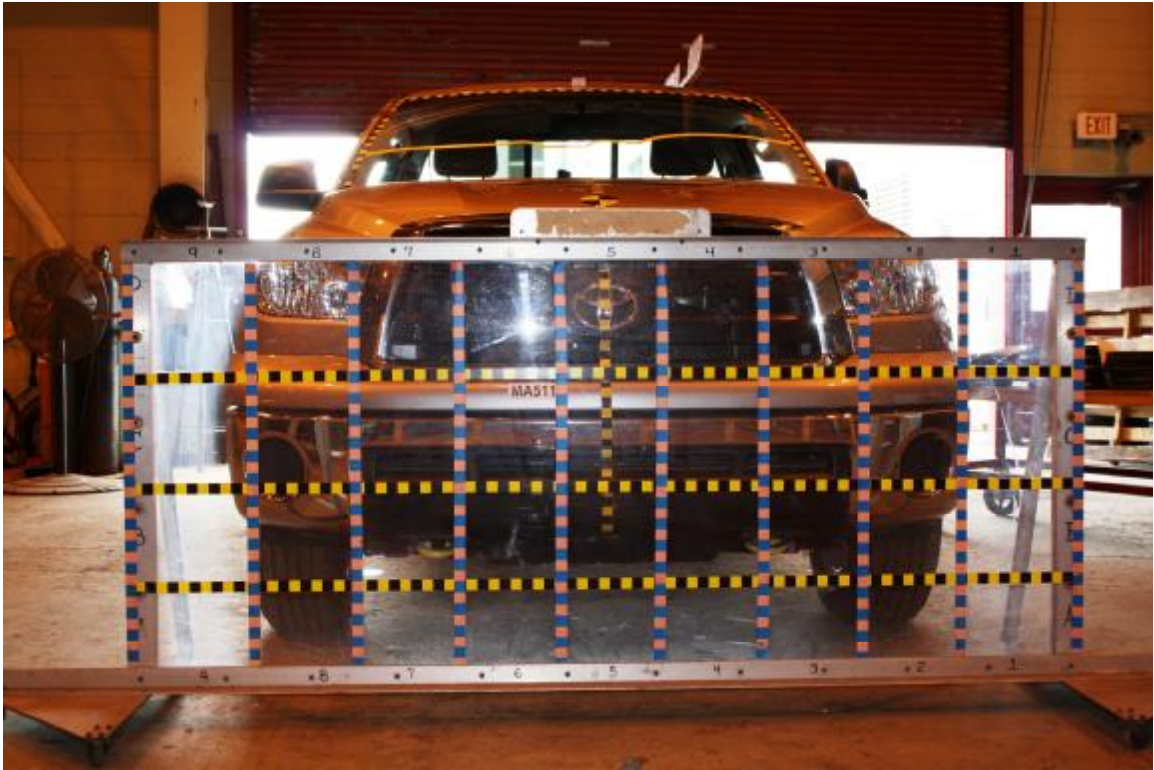
**Figure A-1: Load Cell Locations**

A load cell barrier consisting of 36 load cells was impacted by a 2010 Toyota Tundra 4x4 Regular Cab Pickup at a velocity of 56.62 kph. The test was performed at Calspan on September 15, 2009. Pre- and post-test photographs of the vehicle and dummies can be found in Appendix A.

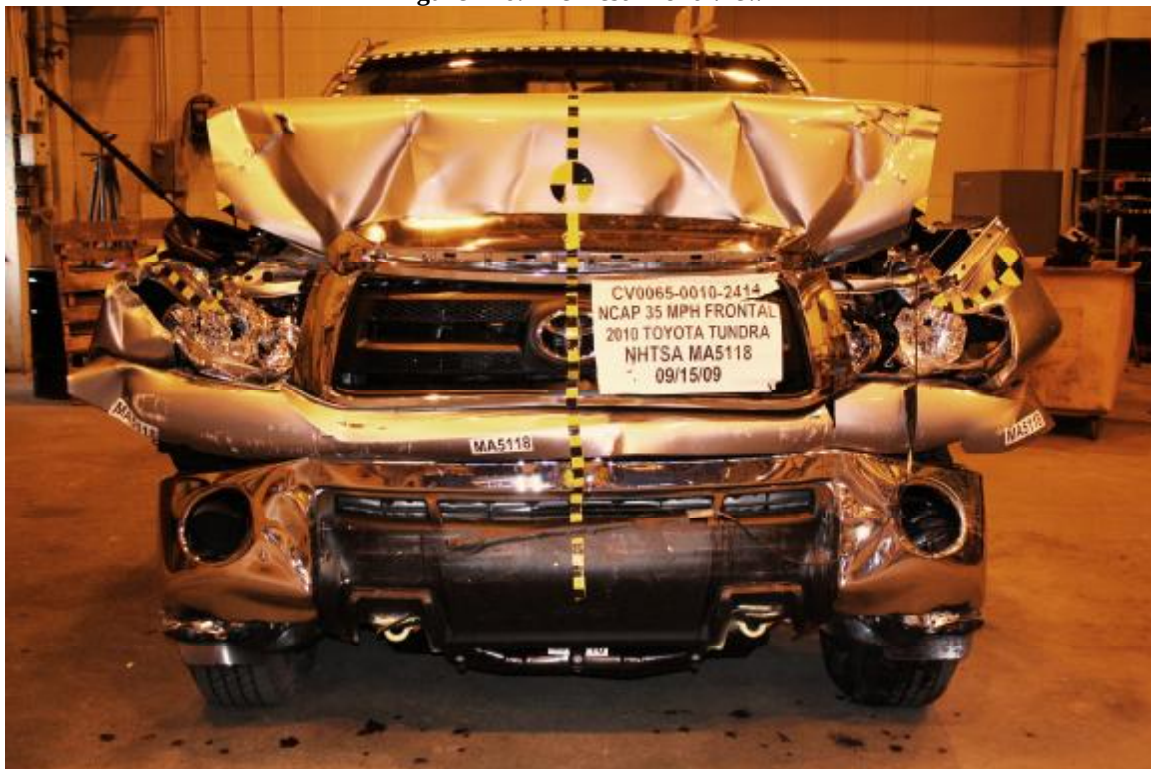
**Figure A-7: Post-Test Front View**

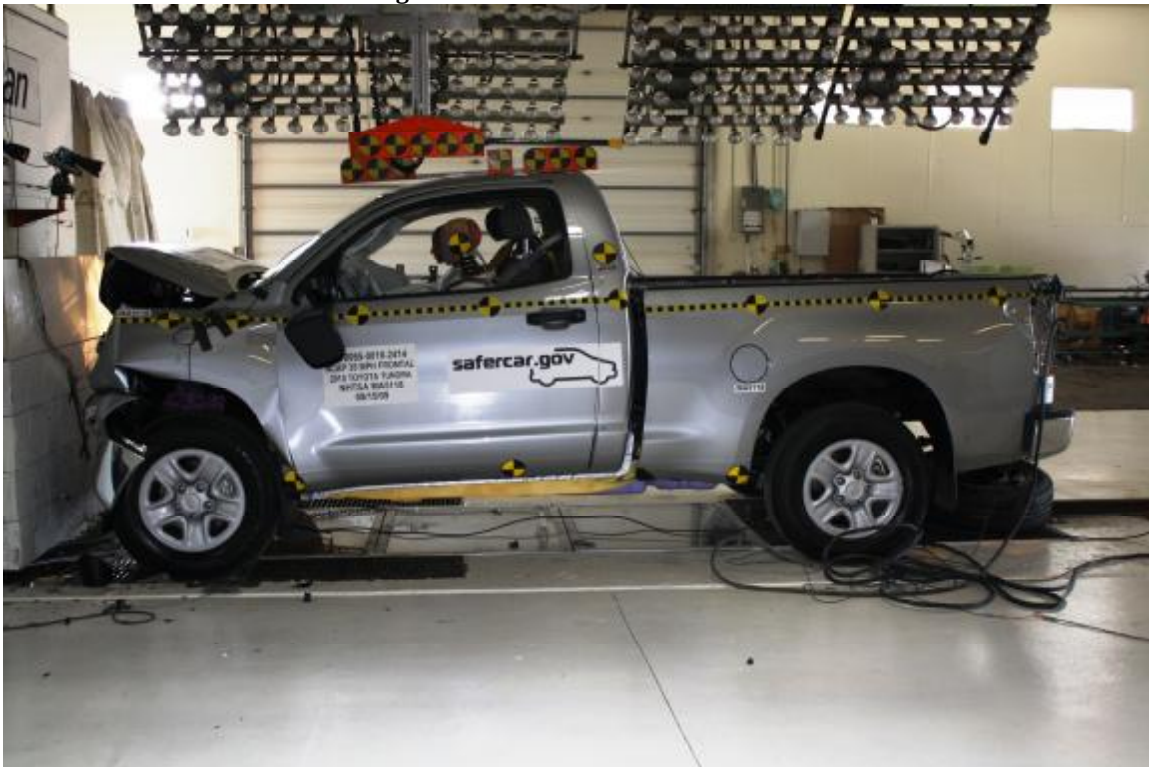
**Figure A-9: Post-Test Left Side View**

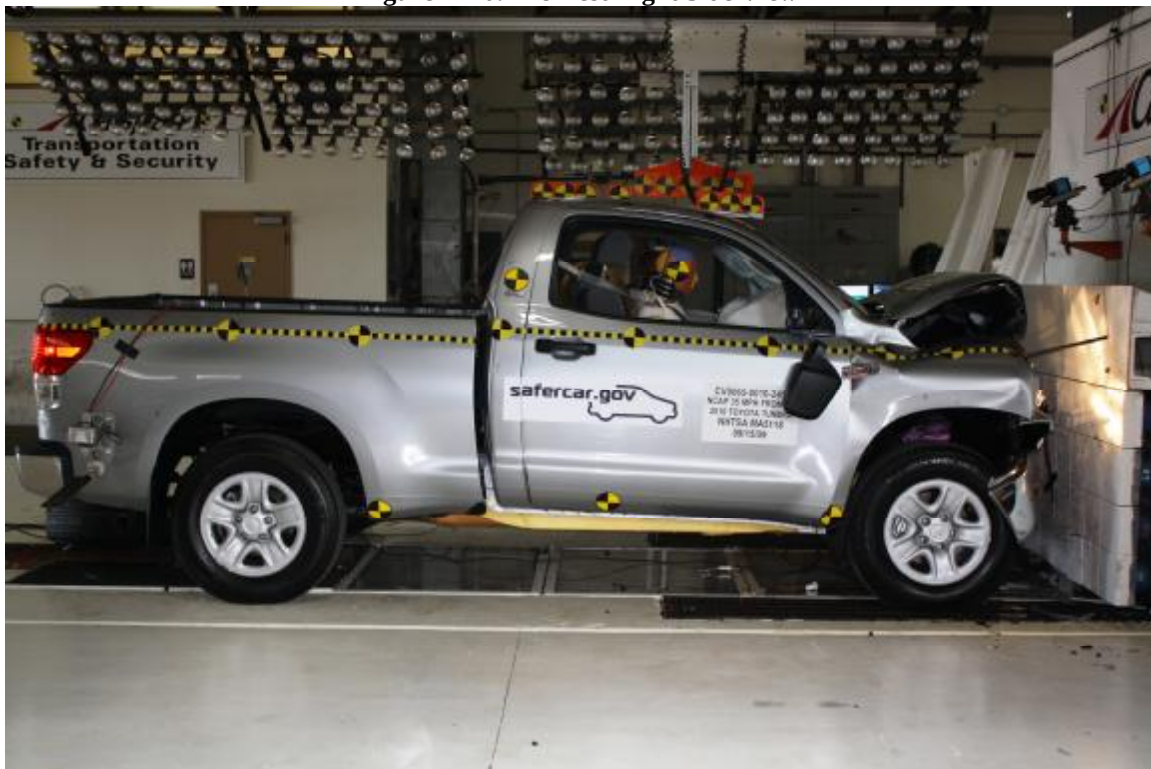
Figure A-11: Post-Test Right Side View

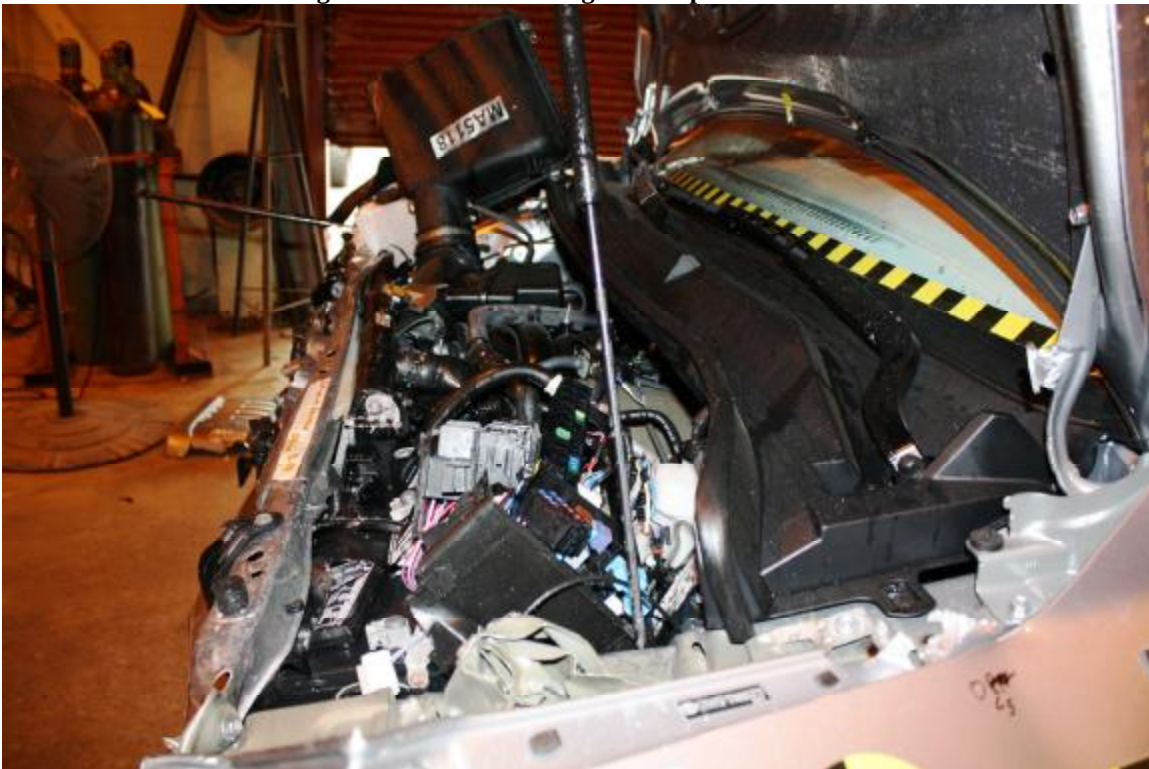
**Figure A-21: Post-Test Engine Compartment View**

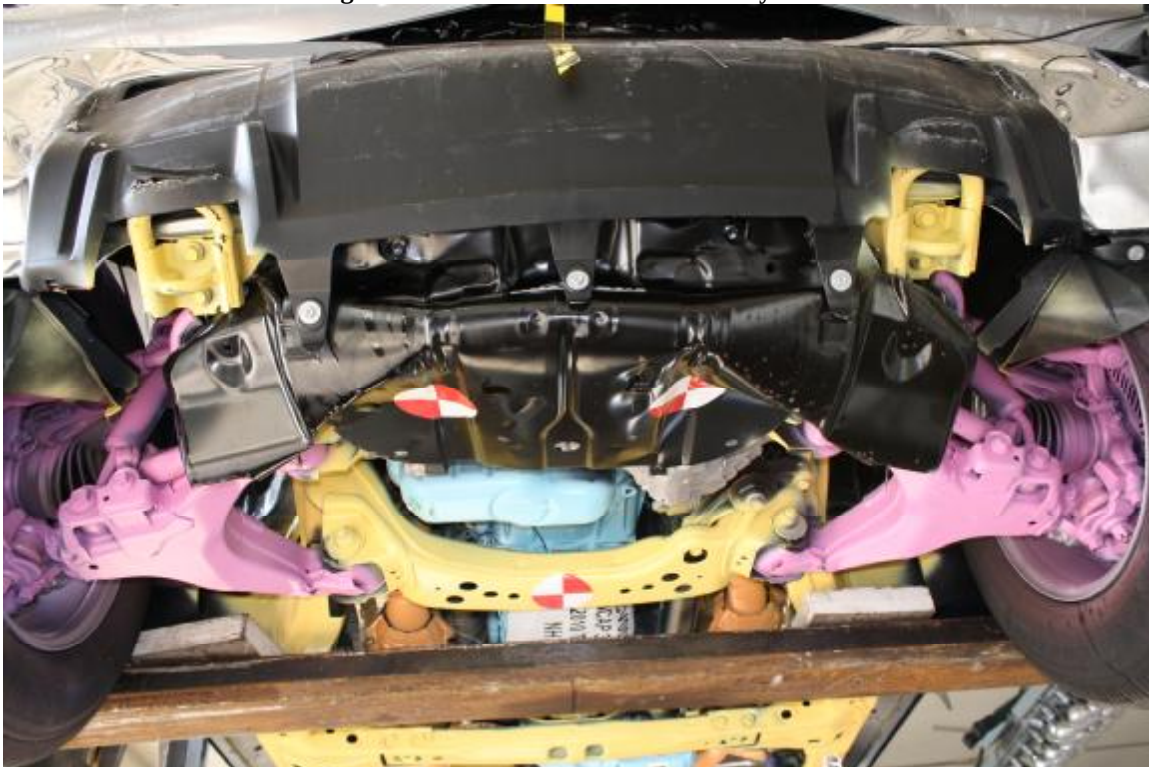
**Figure A-25: Post-Test Front Underbody View**

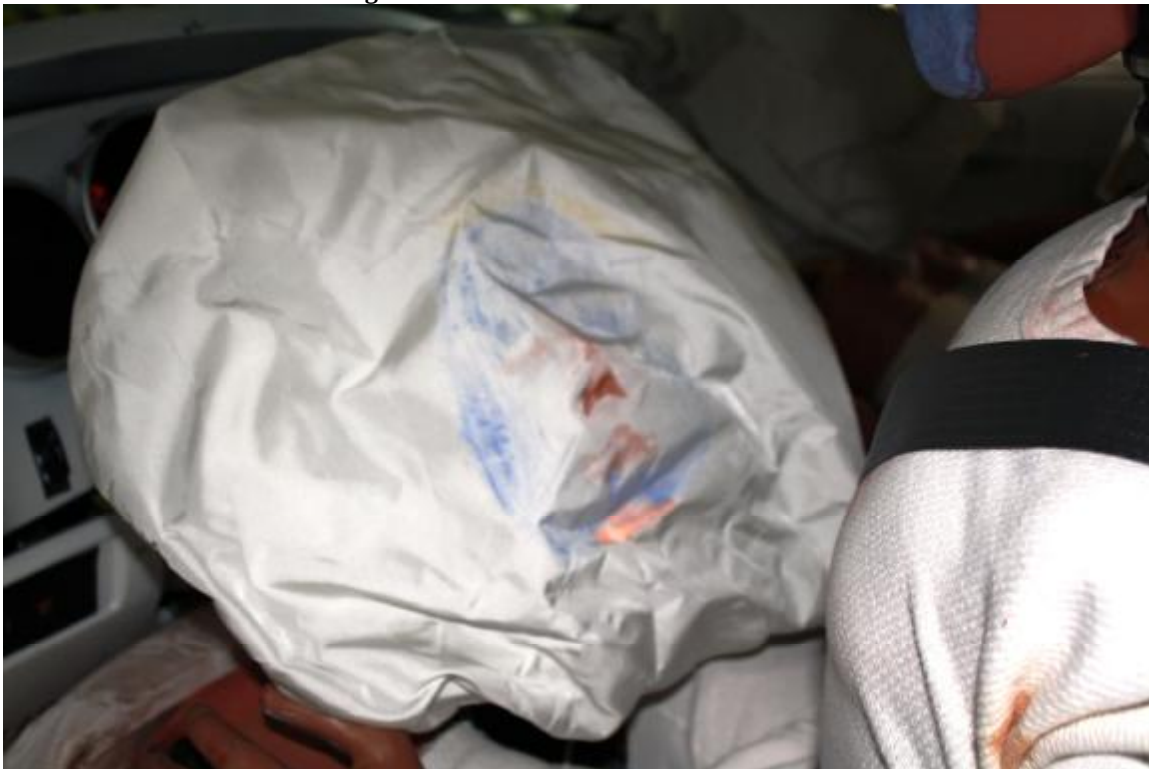
**Figure A-43: Post-Test Driver Contact to Airbag**

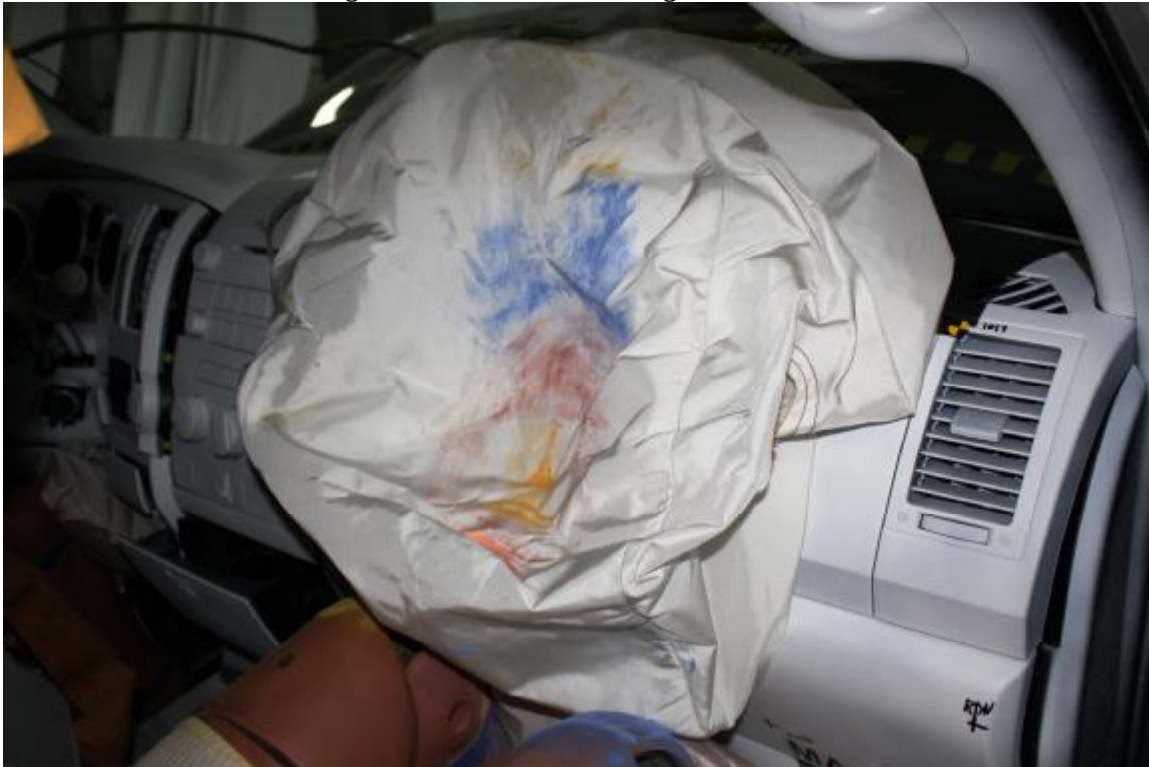
**Figure A-57: Post-Test Passenger Contact to Airbag**

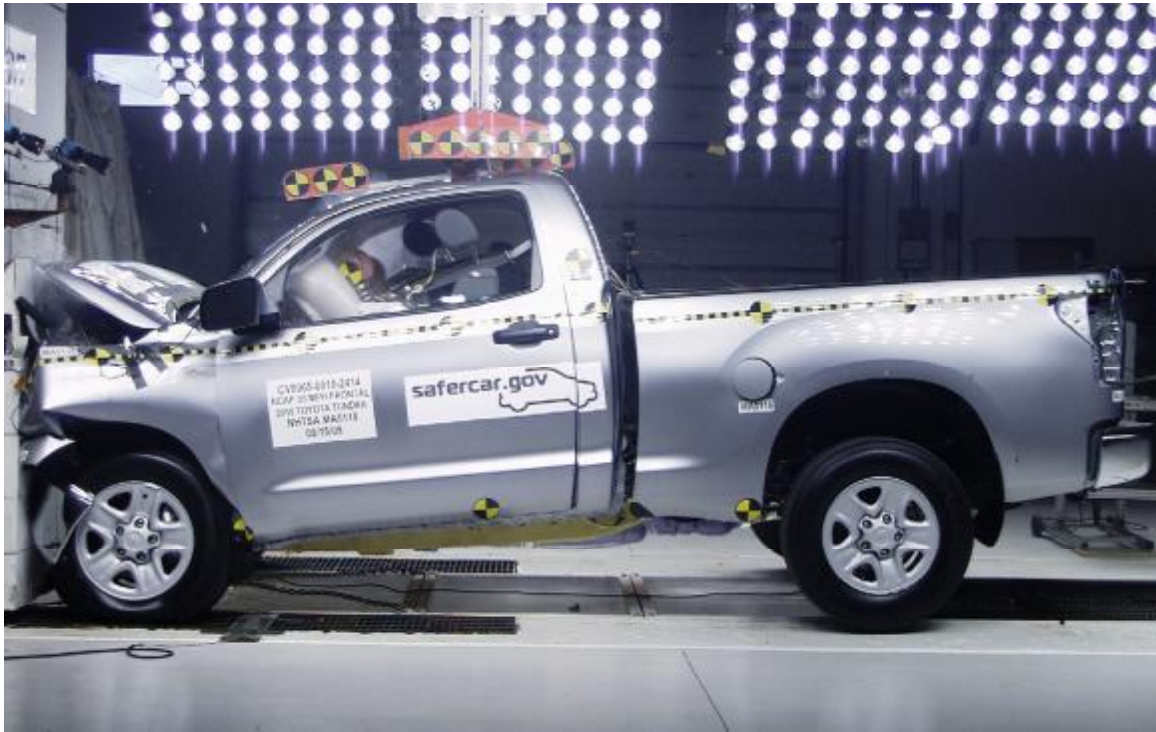
**Figure A-62: Impact View**
