**REPORT NUMBER: SNCAP-CAL-10-1**

**NEW CAR ASSESSMENT PROGRAM  
SIDE IMPACT TEST**

**CAMI AUTOMOTIVE INC.  
2010 CHEVROLET EQUINOX LS  
4-DOOR SUV**

**FINAL REPORT**

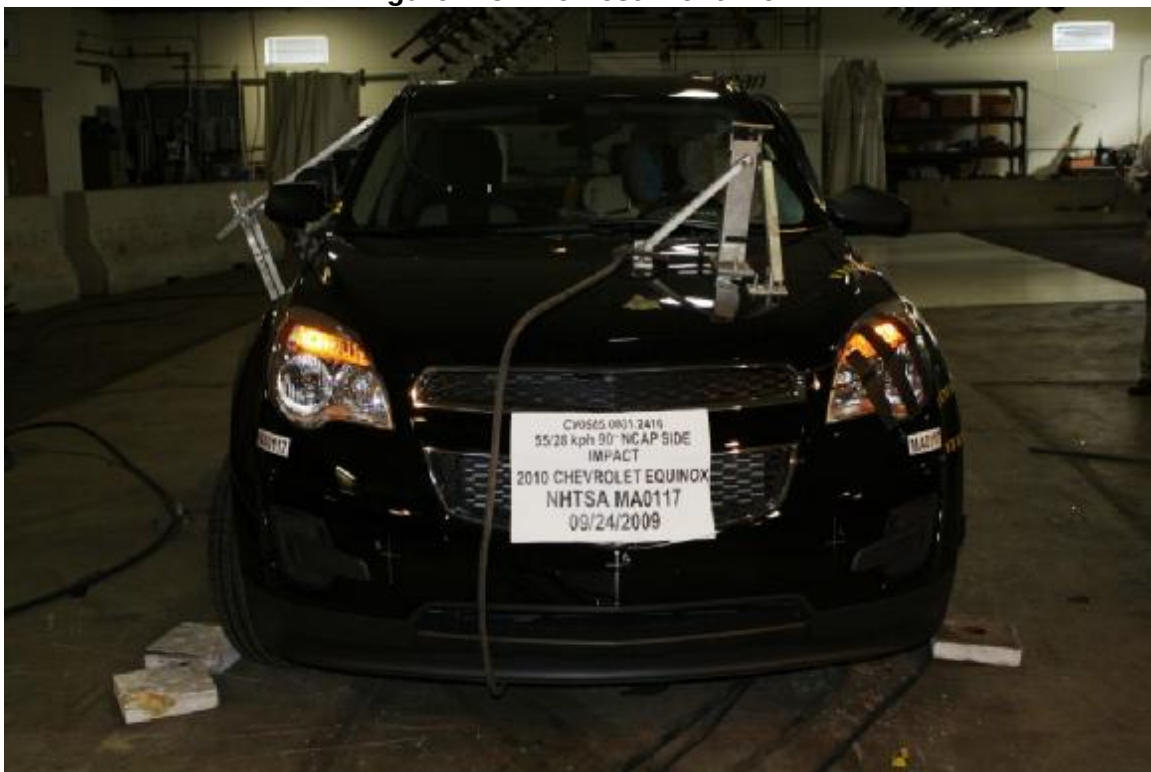
**Figure A-6: Post-Test Front View**

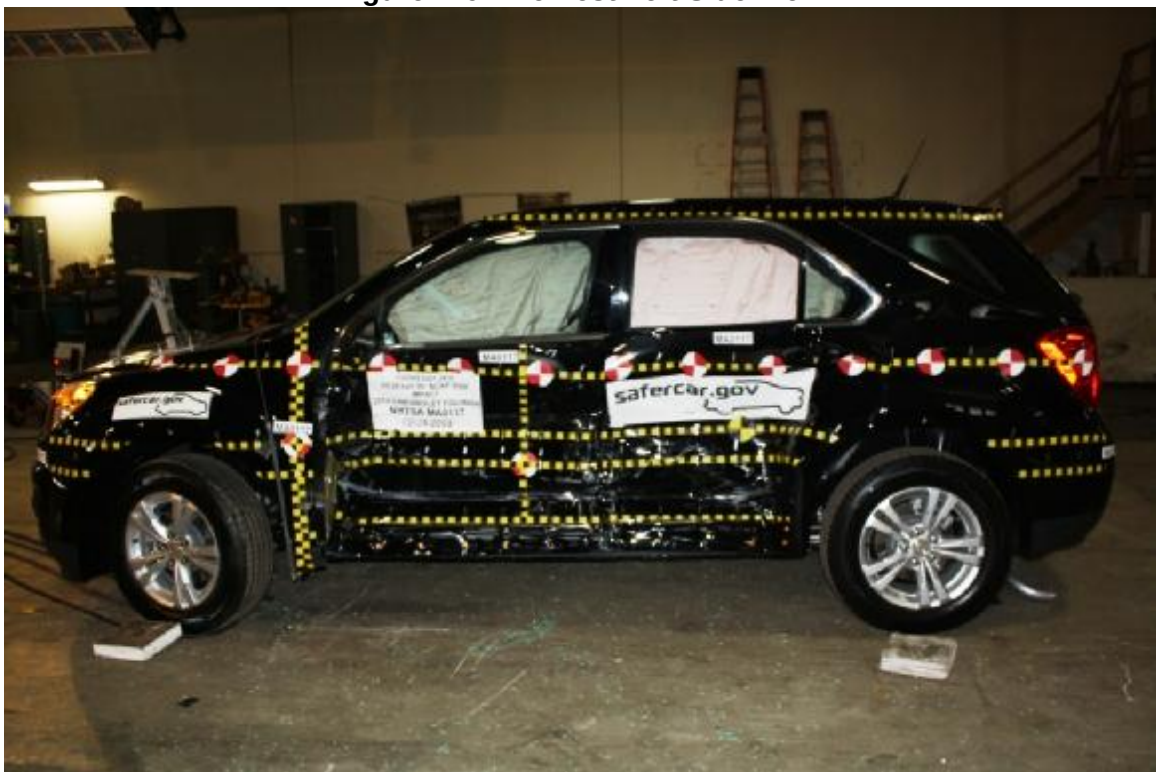
Figure A-10: Post-Test Left Side View

The test vehicle sustained a maximum static crush of 243 mm at level 3, 1500 mm rearward of the left vertical impact point. The driver and passenger SID/HIII's, Serial Nos. 270 and 269 respectively, were calibrated just prior to this test.

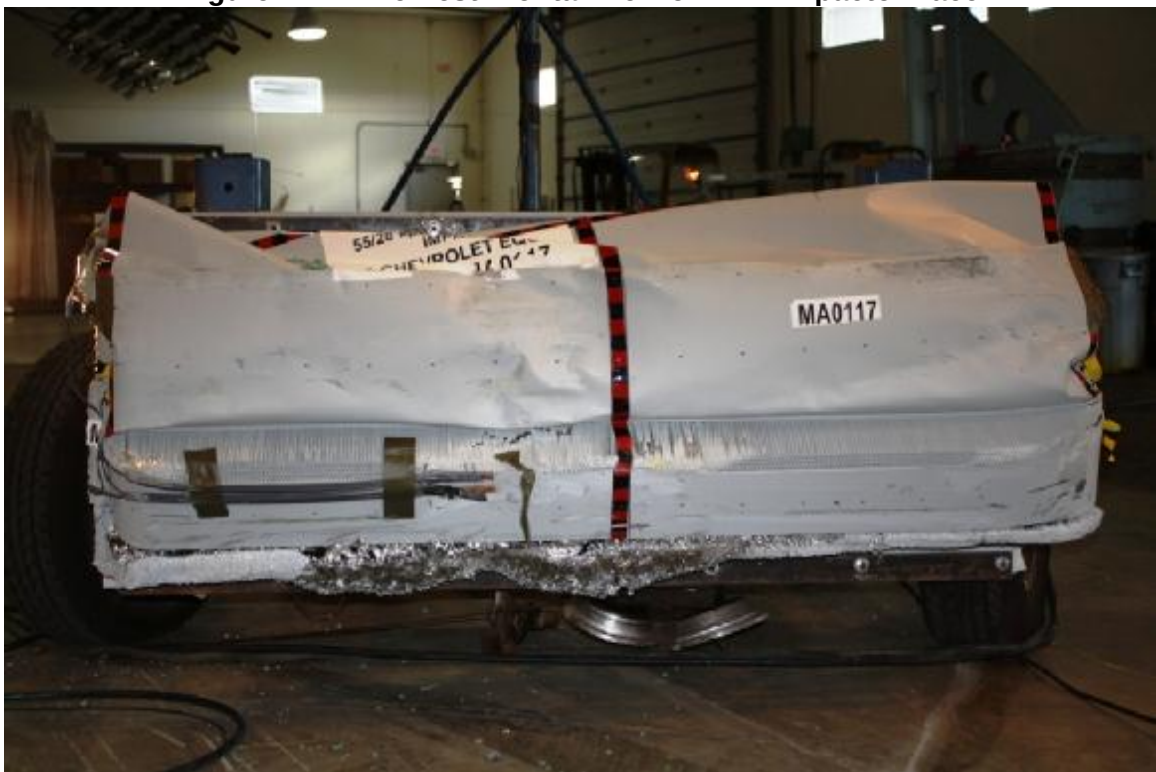
**Figure A-22: Post-Test Frontal View of MDB Impactor Face**

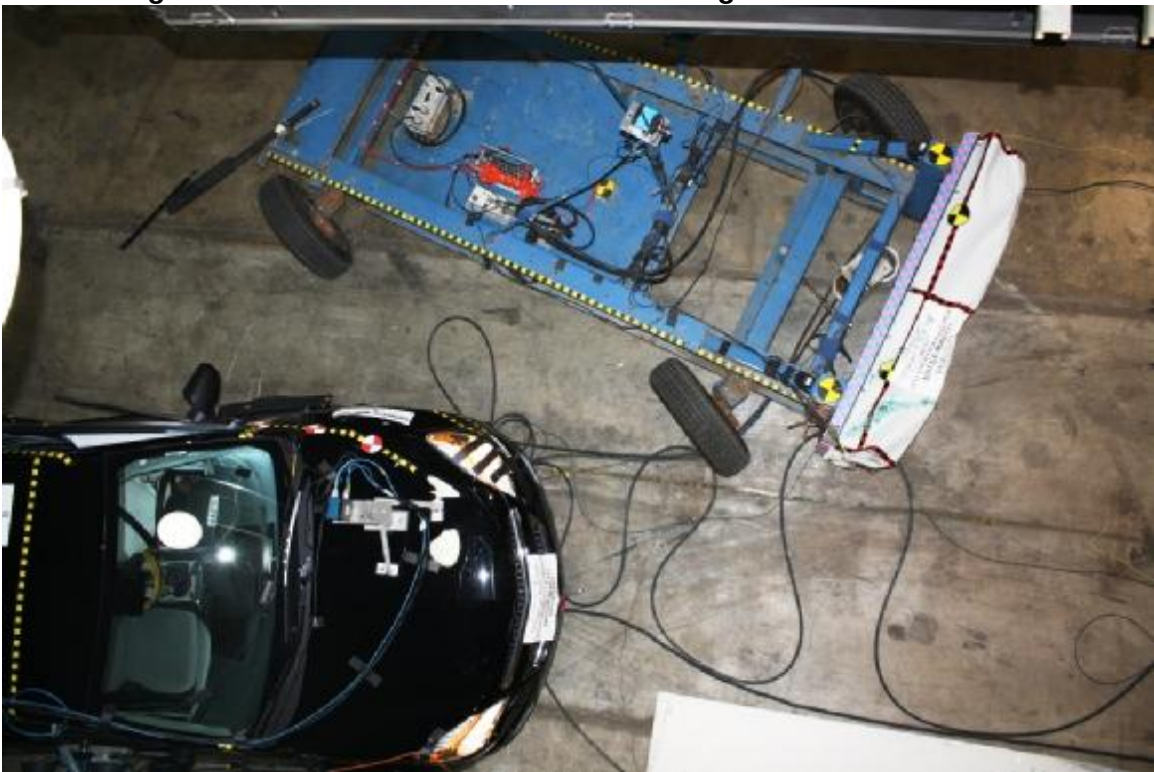
**Figure A-32: Post-Test Overhead View of MDB and Vehicle**

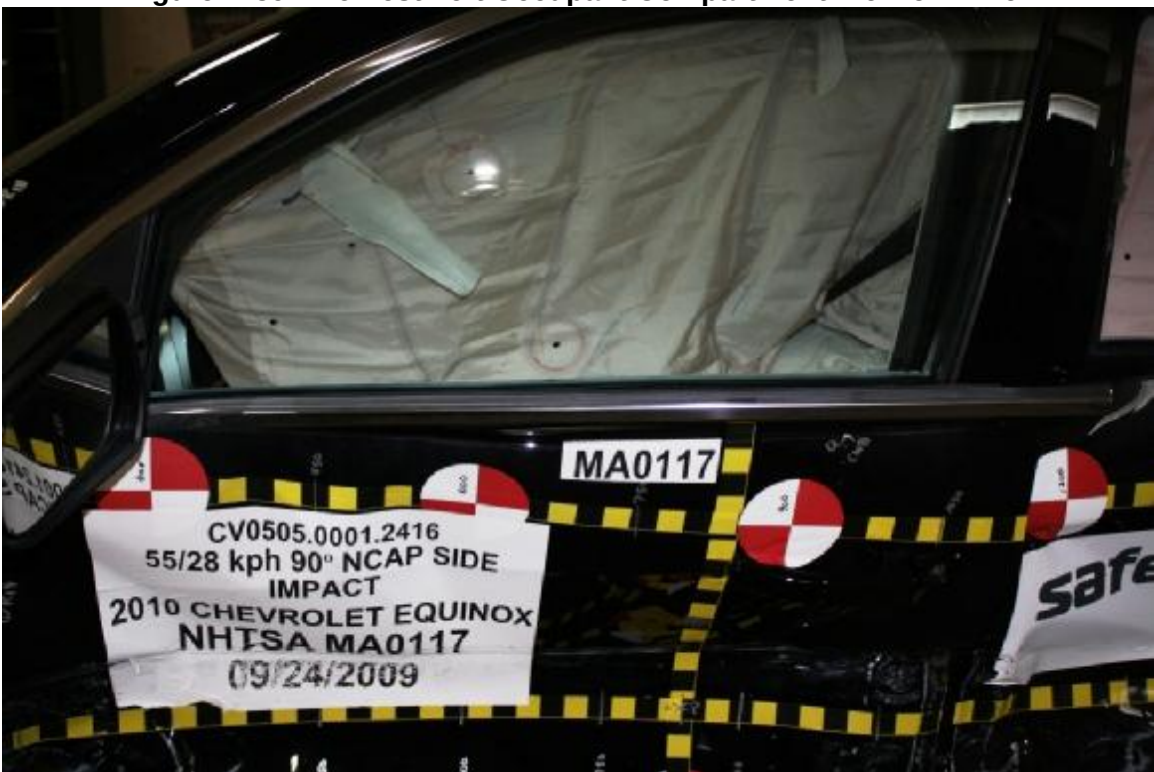
Figure A-40: Post-Test Left Occupant Compartment View of Driver

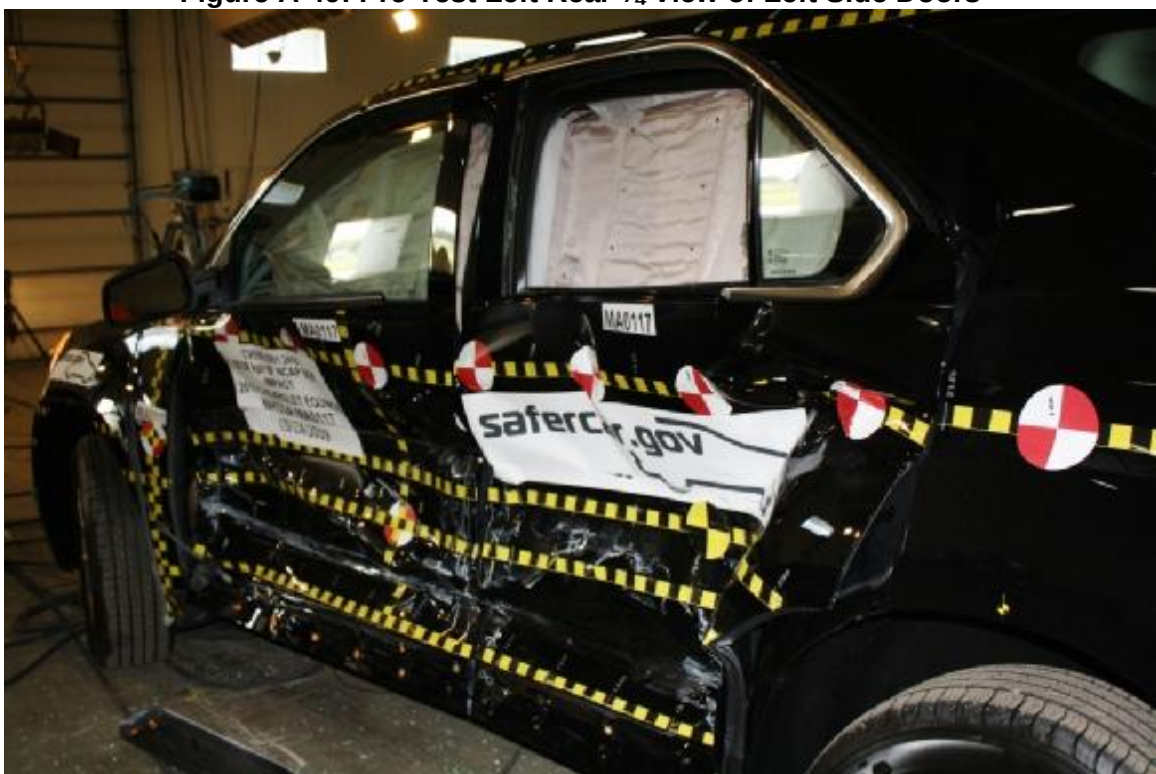
Figure A-50: Post-Test Left Rear  $\frac{3}{4}$  View of Left Side Doors
