**REPORT NUMBER: SNCAP-CAL-10-02**

**NEW CAR ASSESSMENT PROGRAM  
SIDE IMPACT TEST**

**FORD MOTOR COMPANY  
2010 FORD TRANSIT CONNECT  
WAGON**

**NHTSA NUMBER: MA0218**

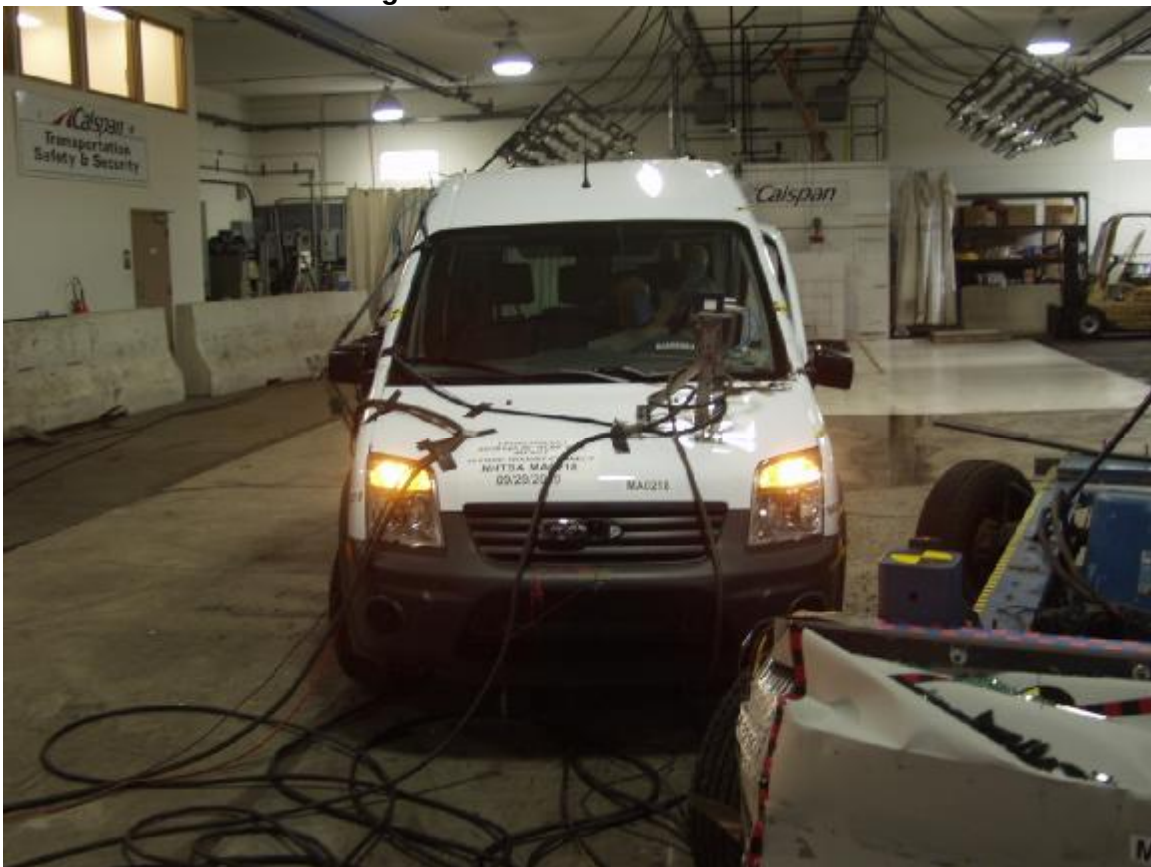
**Figure A-6: Post-Test Front View**

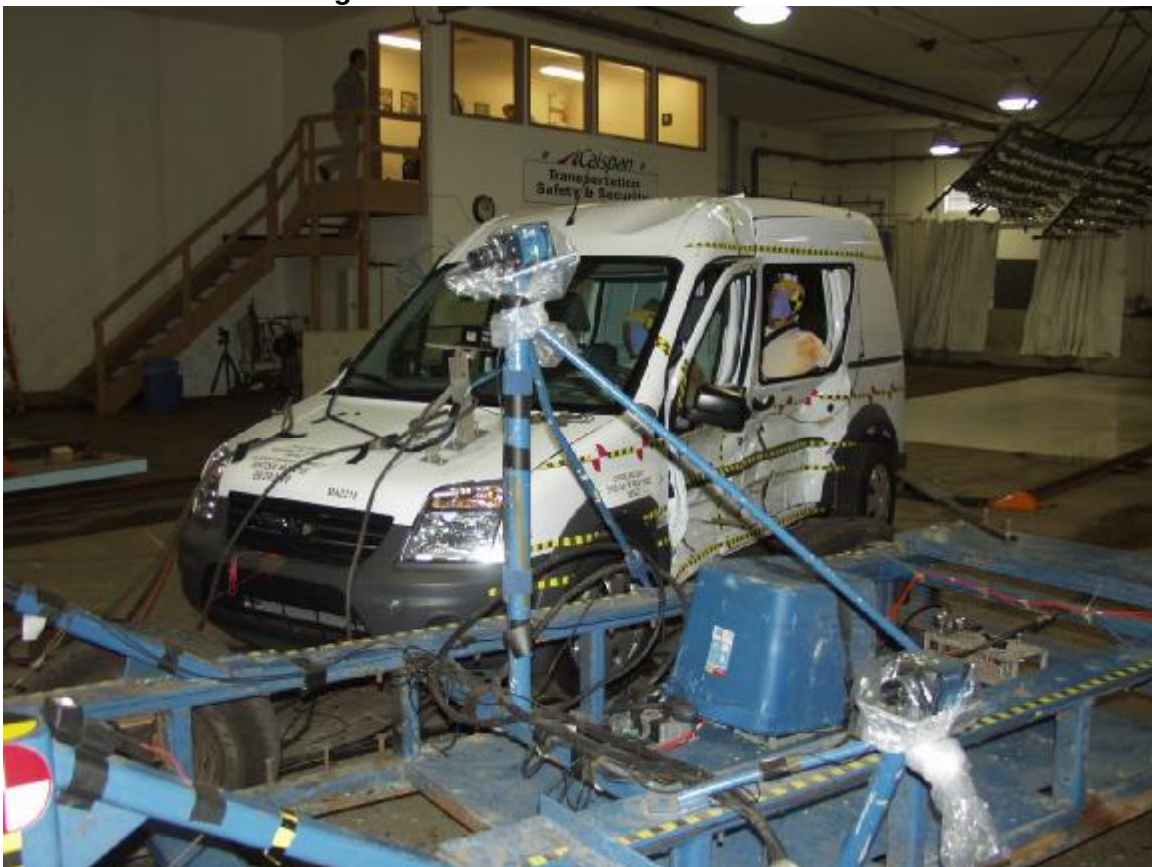
**Figure A-8: Post-Test Left Front  $\frac{3}{4}$  View**

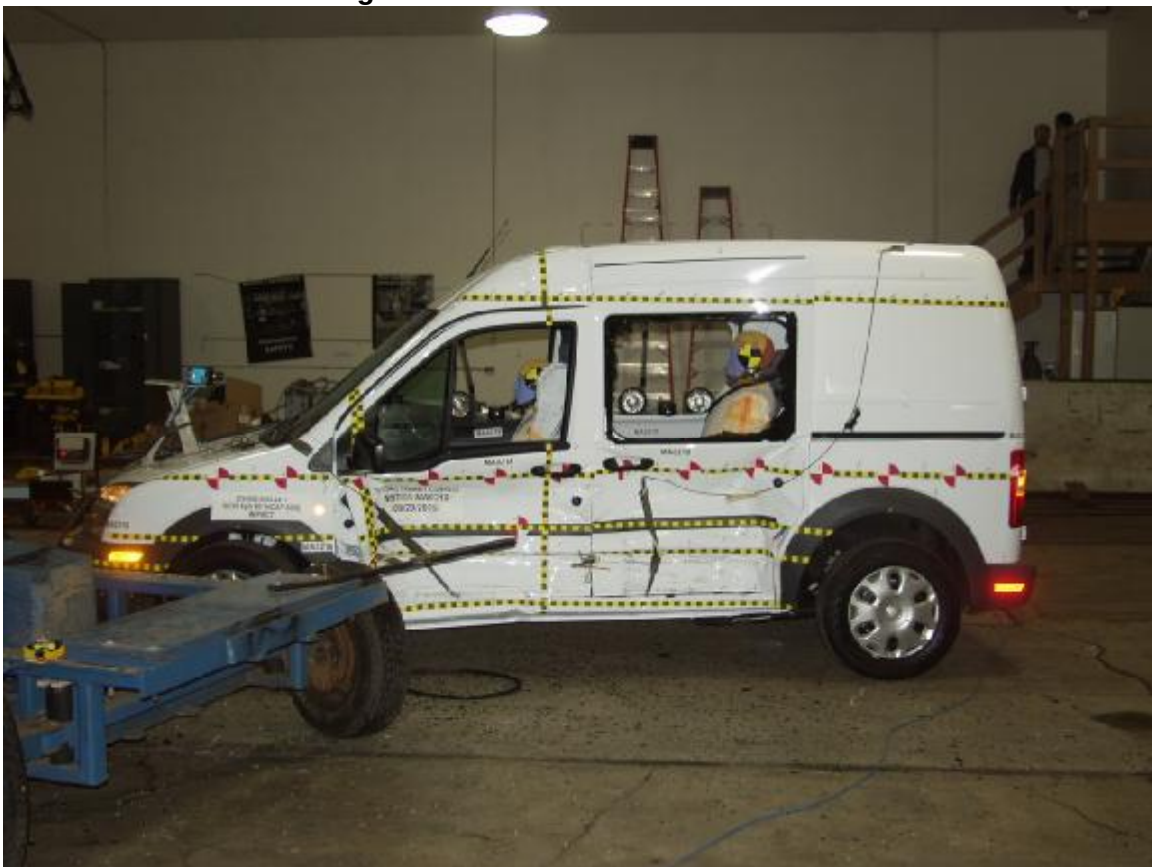
**Figure A-10: Post-Test Left Side View**

The test vehicle sustained a maximum static crush of 254 mm at level 3, 750 mm rearward of the left vertical impact point. The driver and passenger SID/HIII's, Serial Nos. 905 and 906 respectively, were calibrated just prior to this test.

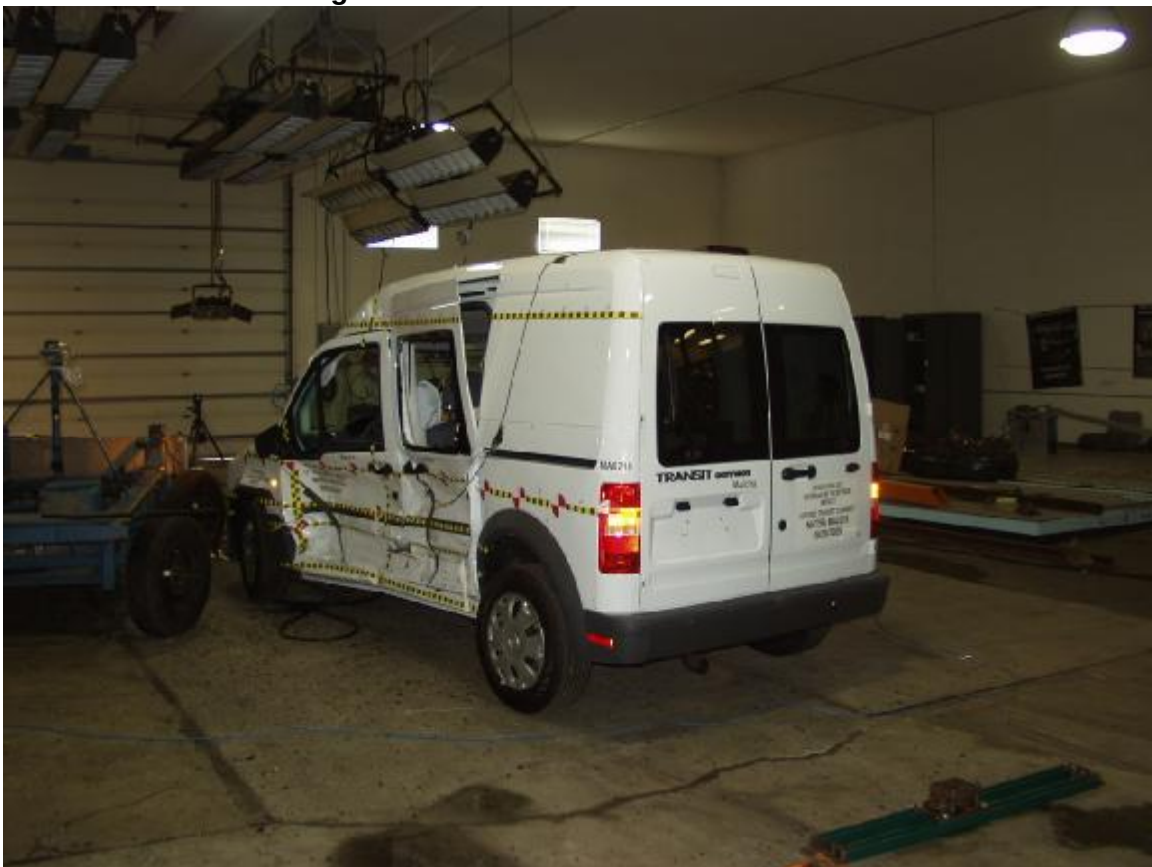
**Figure A-12: Post-Test Left Rear  $\frac{3}{4}$  View**

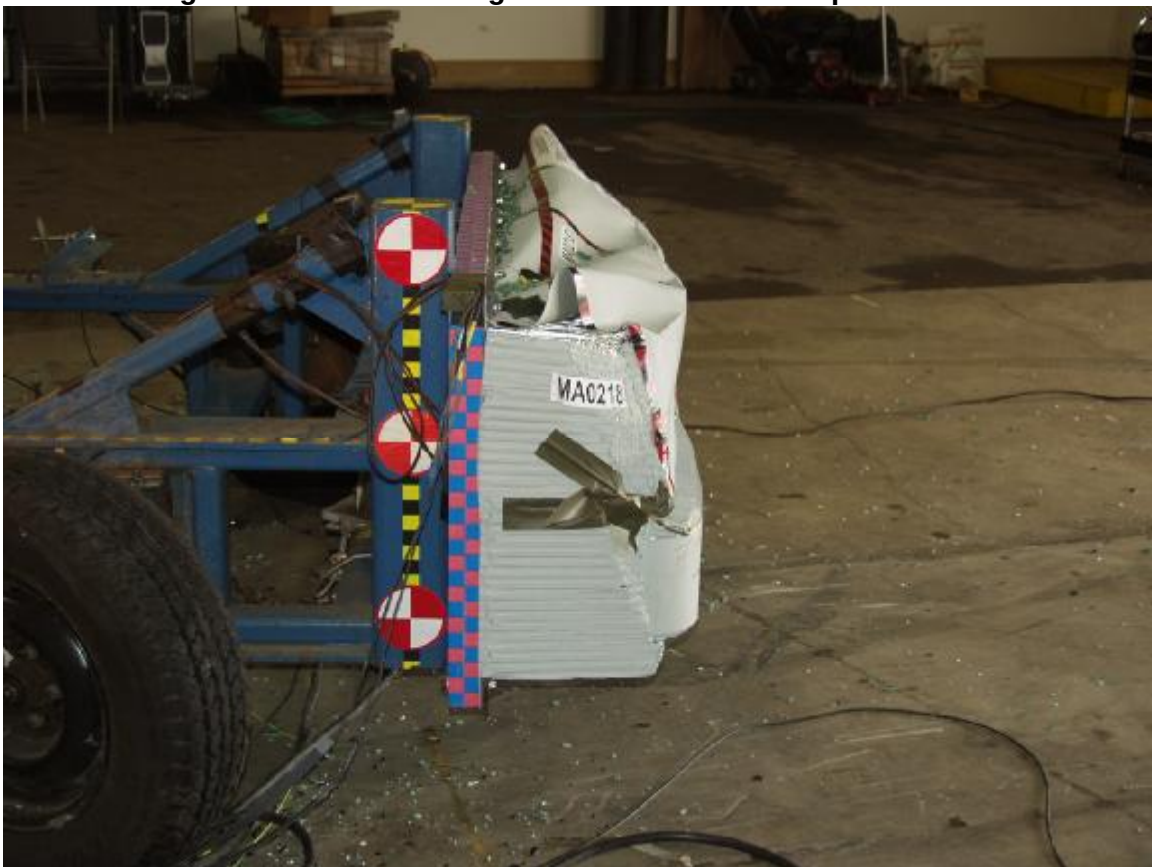
**Figure A-26: Post-Test Right Side View of MDB Impactor Face**

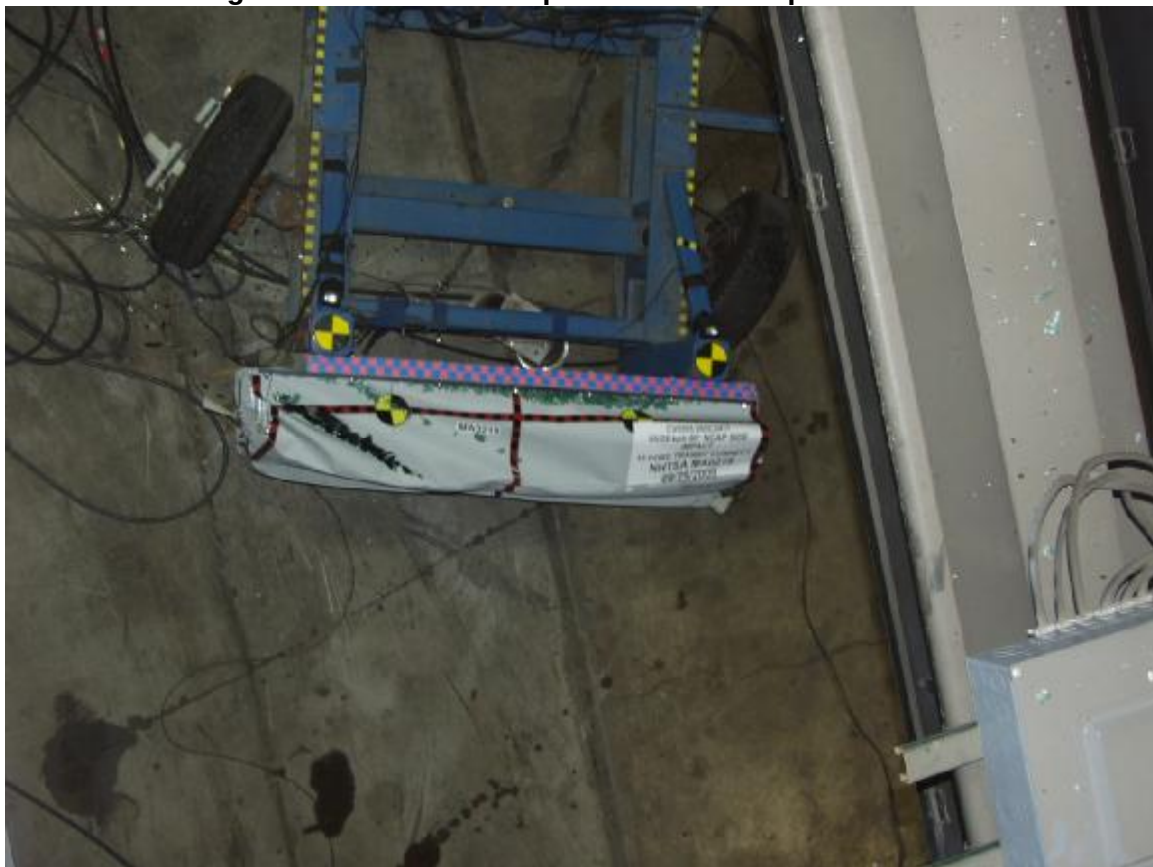
**Figure A-28: Post-Test Top View of MDB Impactor Face**

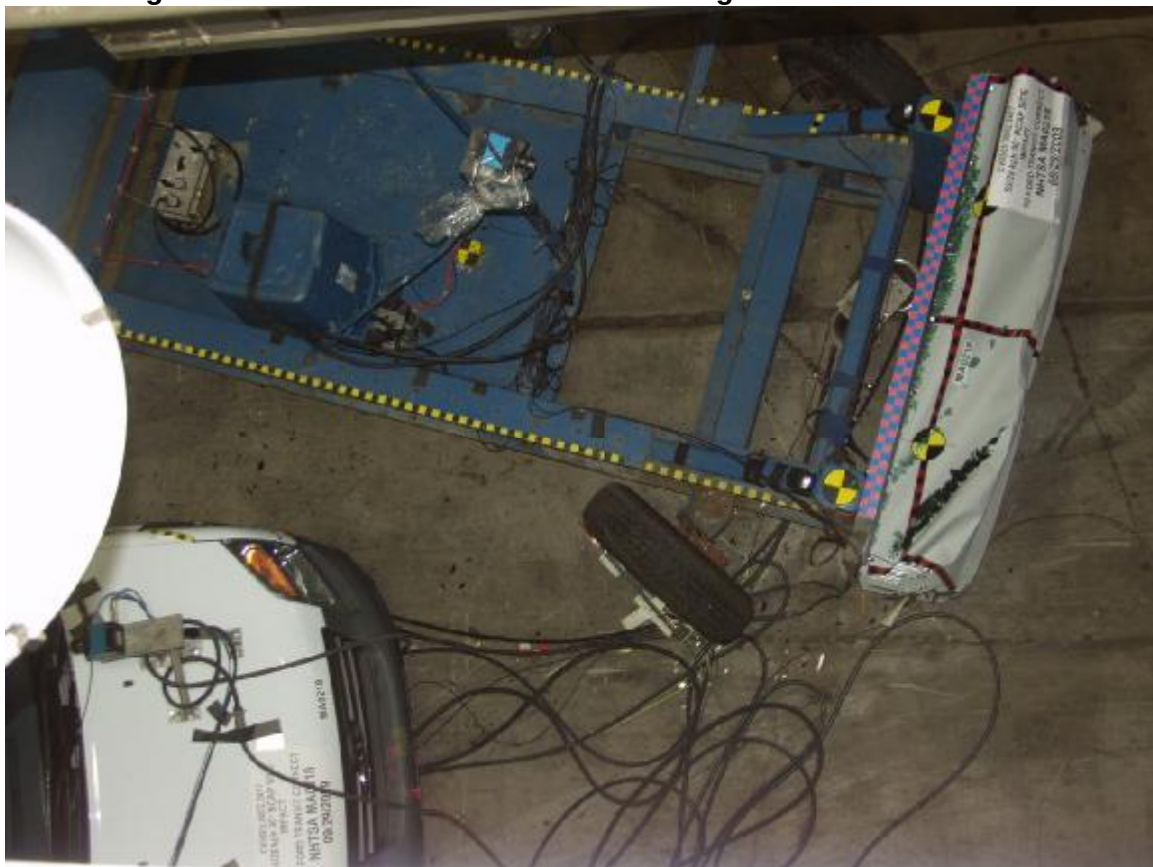
**Figure A-32: Post-Test Overhead View of MDB and Vehicle**

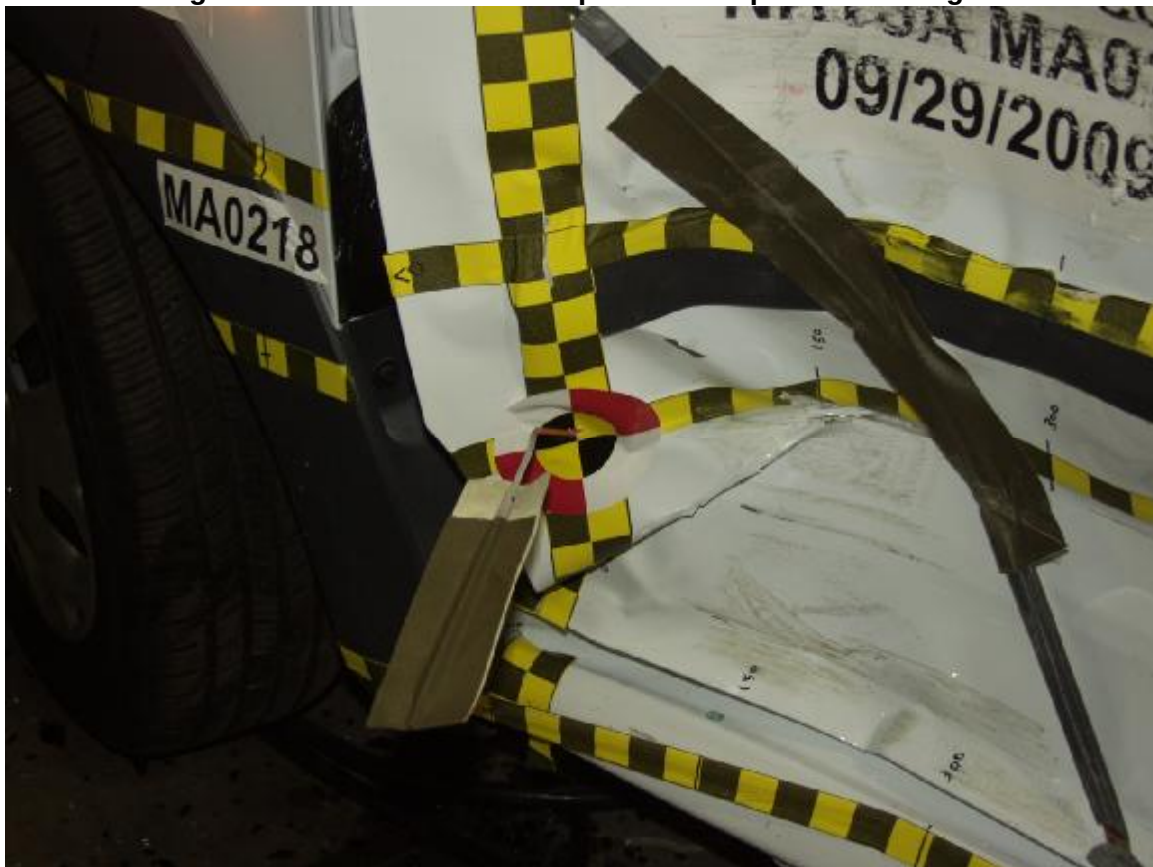
Figure A-34: Post-Test Close-Up View of Impact Point Target

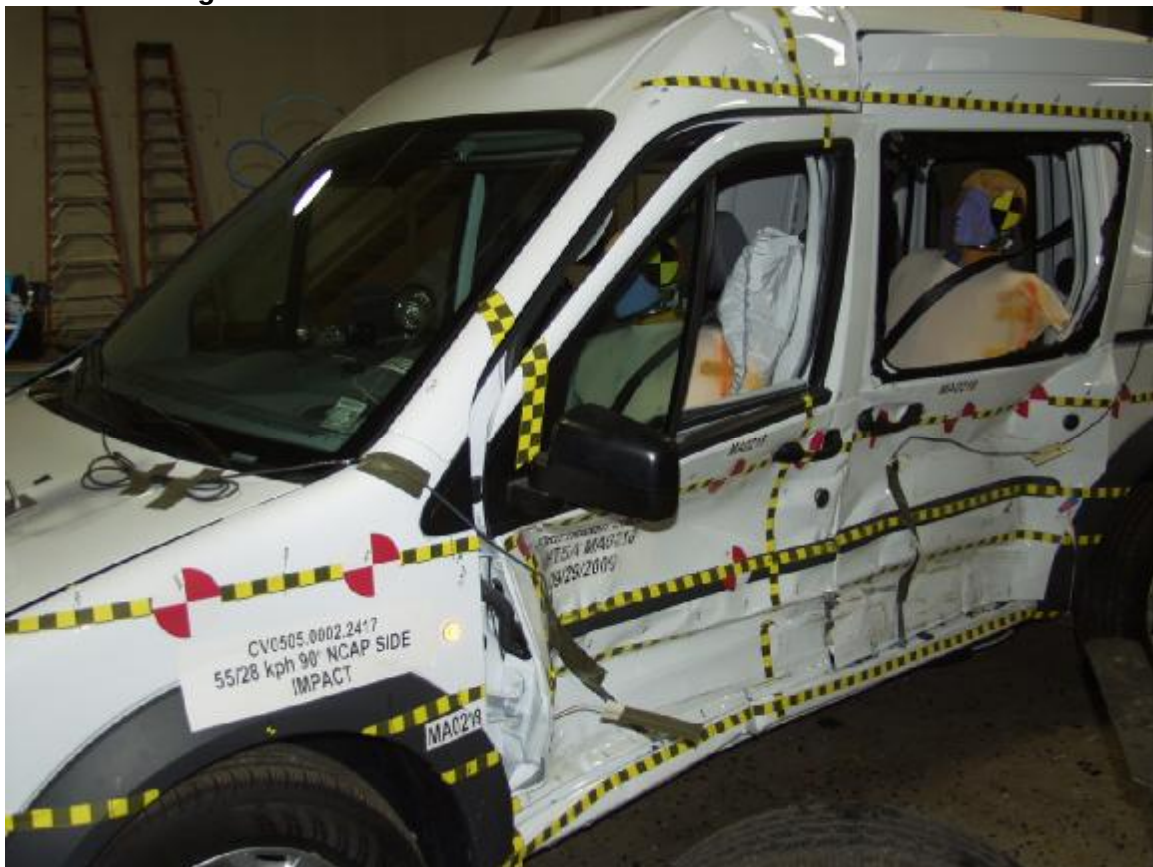
**Figure A-48: Post-Test Left Front ¾ View of Left Side Doors**

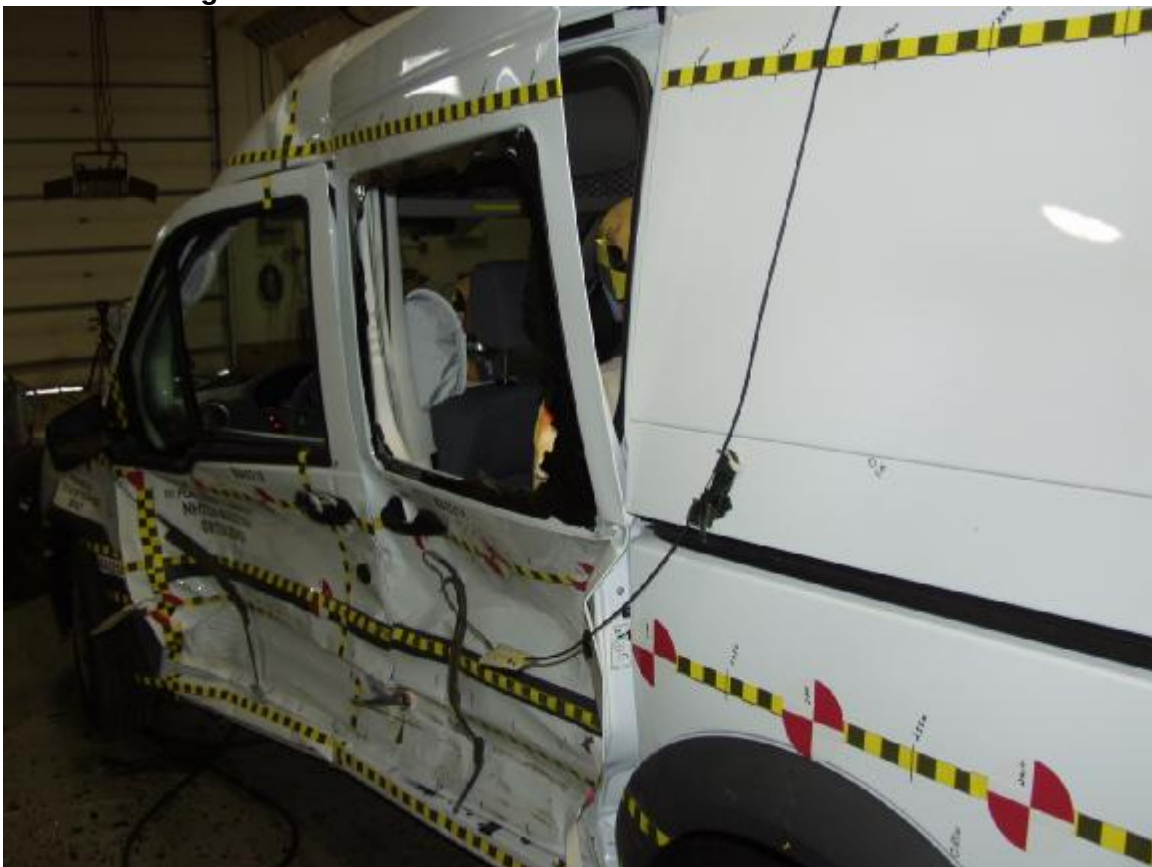
**Figure A-50: Post-Test Left Rear  $\frac{3}{4}$  View of Left Side Doors**
