**NEW CAR ASSESSMENT PROGRAM (NCAP)  
FRONTAL BARRIER IMPACT TEST**

FORD MOTOR COMPANY  
2010 FORD TRANSIT CONNECT XLT  
WAGON

NHTSA NUMBER: MA0217

FINAL REPORT

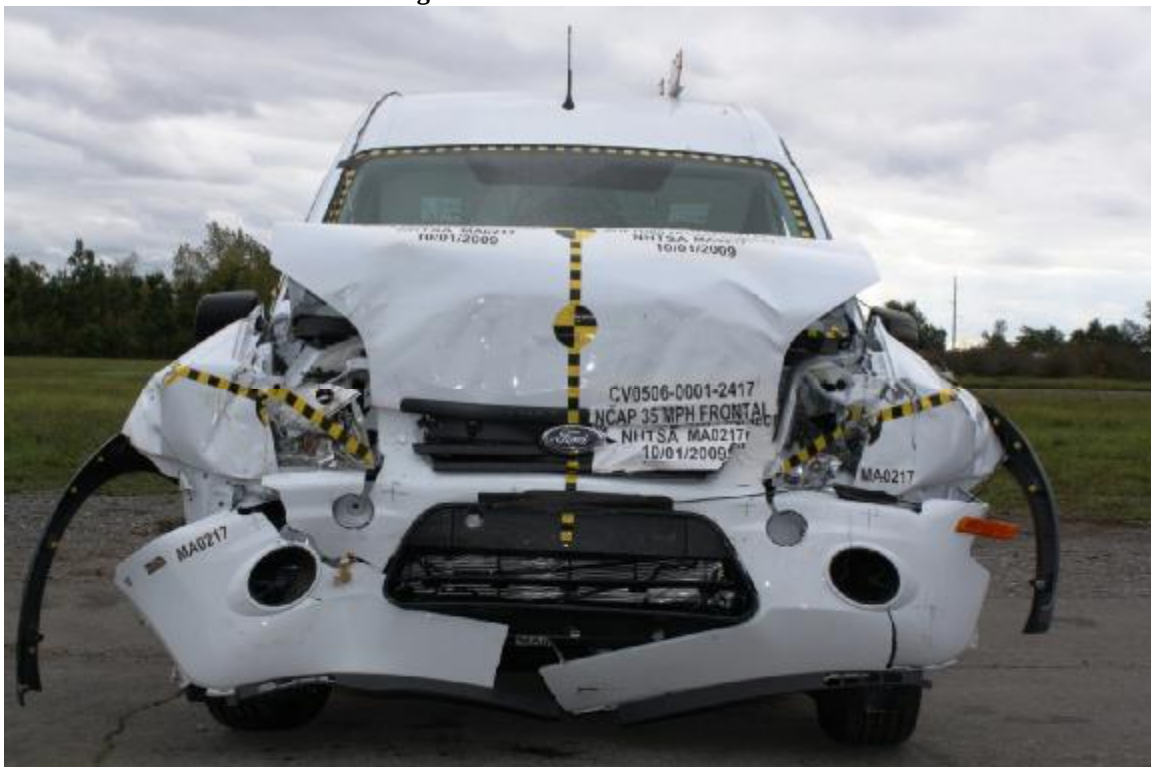
**Figure A-7: Post-Test Front View**

Vehicle NHTSA No.: MA0217 Test Mode: 56.3 kph Frontal Barrier  
 Test Date: October 1, 2009 Time: 14:12 Temperature: 21.7 °C  
 Vehicle Make/Model/Body Style: 2010 Ford Transit Connect XLT Wagon  
 Vehicle Test Weight: 1881.0 kg Impact Velocity: 56.6 kph (55.5 – 57.1 kph)  
 Vehicle/Barrier Impact Angle: 0 ° Max Static Crush: 611 mm

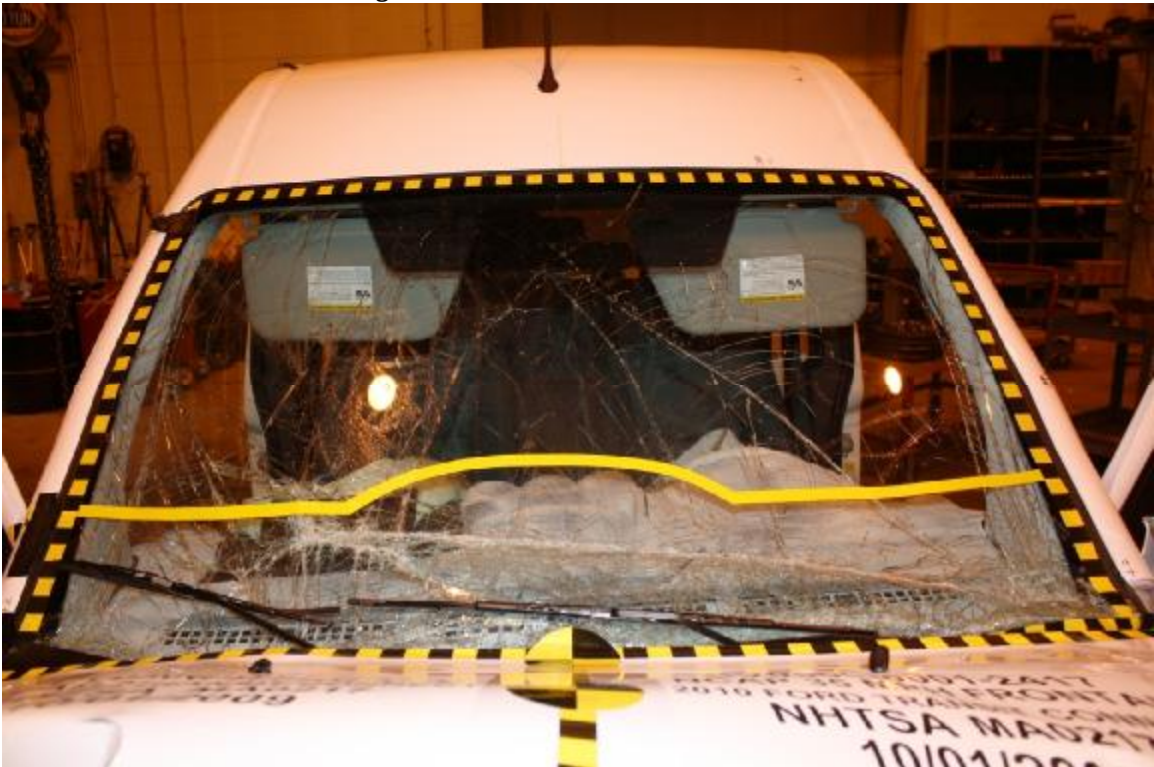
**Figure A-19: Post-Test Windshield View**

| Description | Driver Side | Passenger Side |
|---|---|---|
| Glazing Damage | Windshield shattered | |

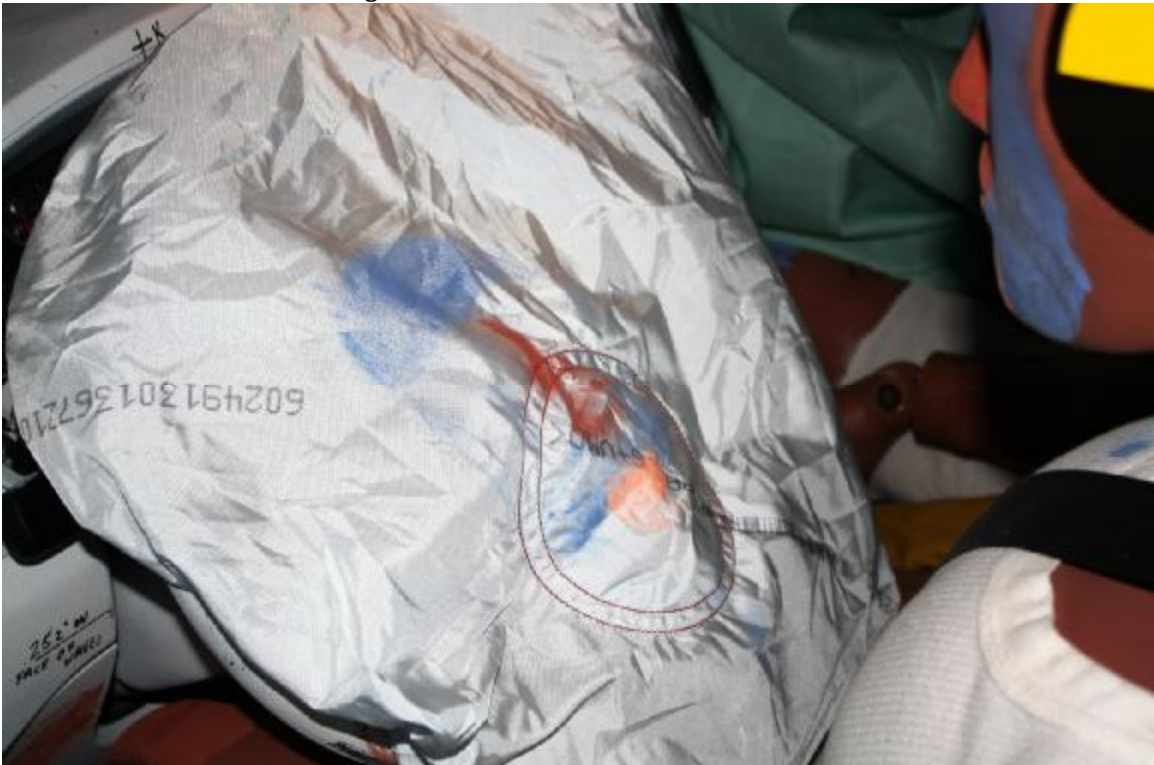
**Figure A-43: Post-Test Driver Contact to Airbag**

| | DRIVER | PASSENGER |
|---|---|---|
| Head Contact: | Face – Frontal Airbag | Face – Frontal Airbag |
| Chest Contact: | Frontal Airbag | Frontal Airbag |
