**REPORT NUMBER: NCAPSIDE-MGA-2010-003**

**NEW CAR ASSESSMENT PROGRAM  
SIDE IMPACT TEST**

**GENERAL MOTORS COMPANY  
2010 BUICK LACROSSE CX 4-DR SEDAN  
NHTSA NUMBER: MA0102**

**PREPARED BY:  
MGA RESEARCH CORPORATION  
5000 WARREN ROAD  
BURLINGTON, WI 53105**

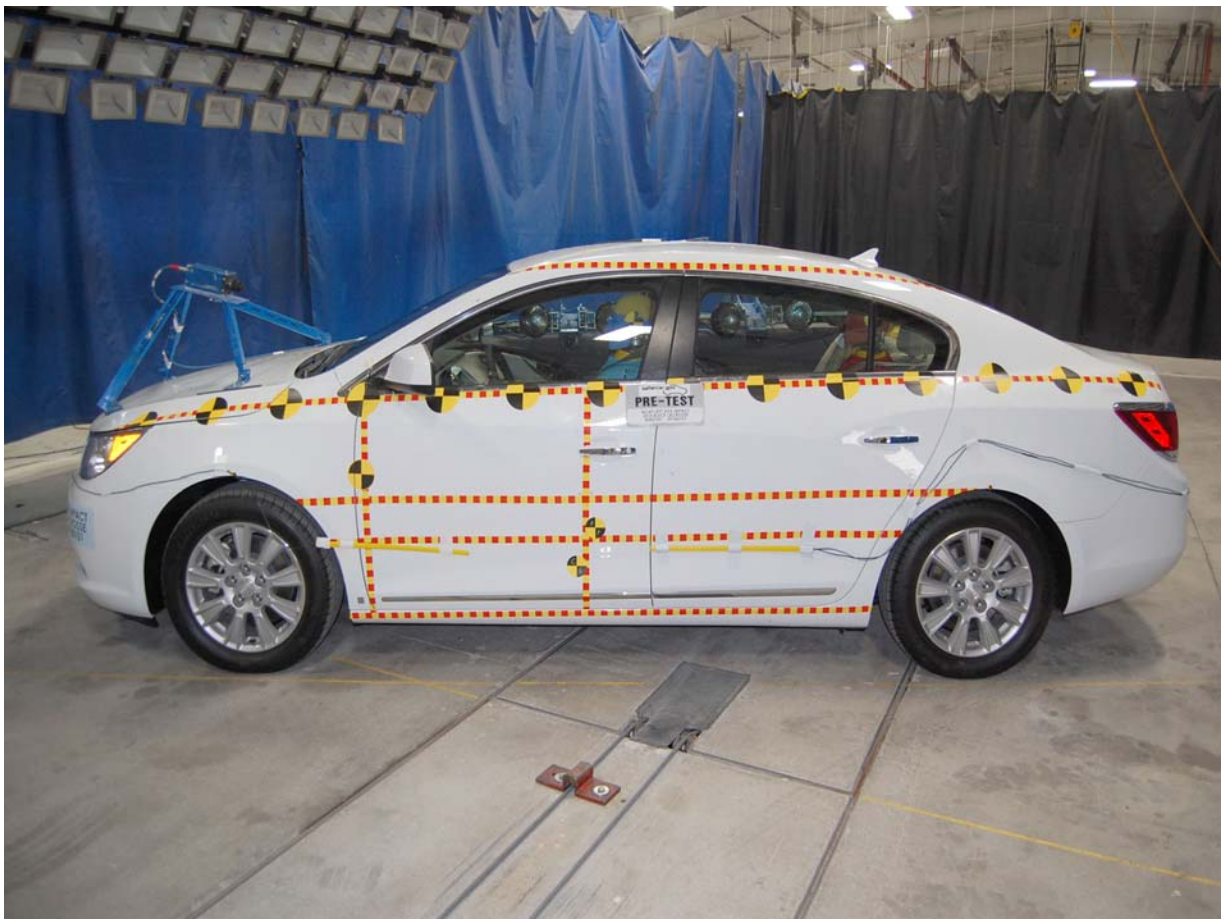
Pre-Test Left Side View

Post-Test Left Side View

The test vehicle sustained a maximum static crush of 221 mm at level 3, 1650 mm rearward of the vertical impact point. The driver and passenger SID/HIIIs, Serial Nos. 271 and 272 respectively, were calibrated just prior to this test.

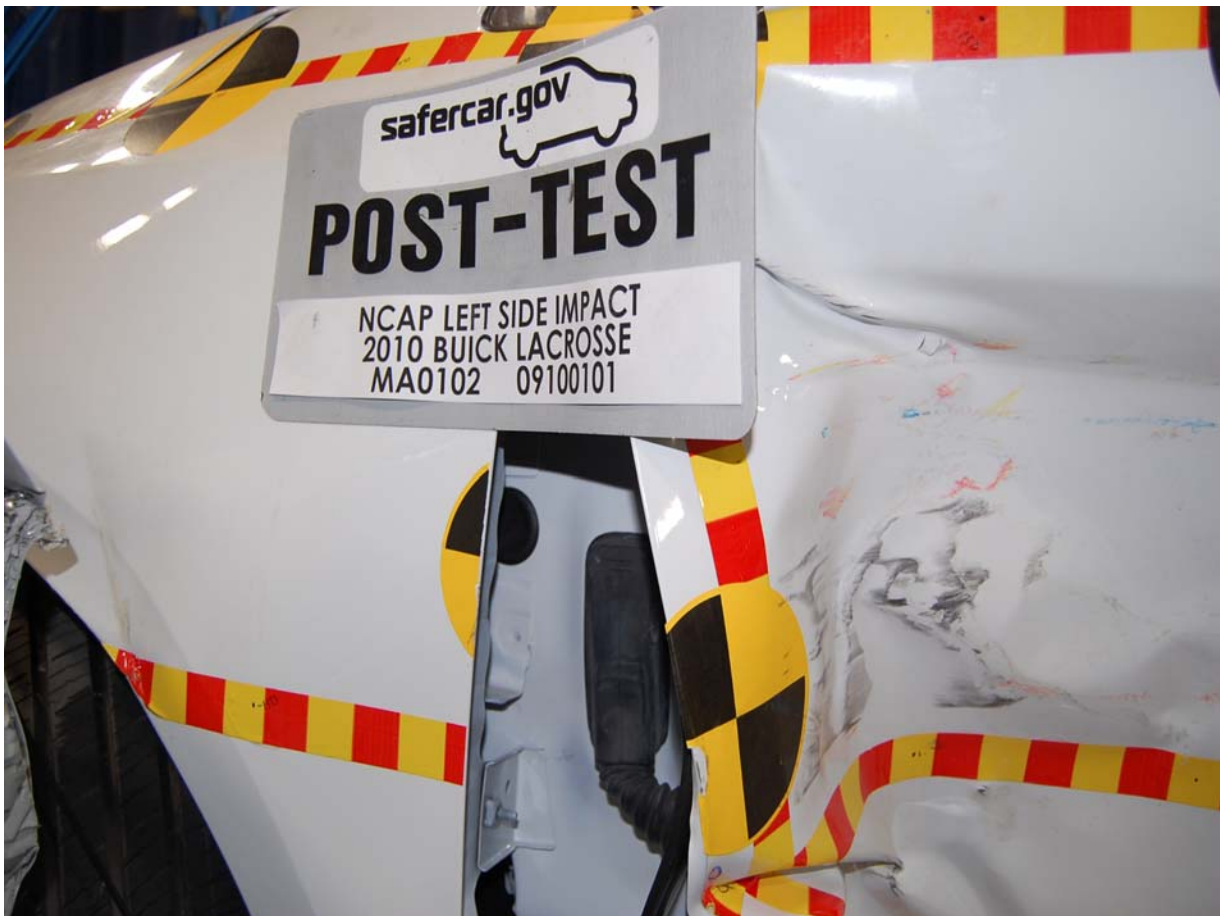
Post-Test Left Impact Point

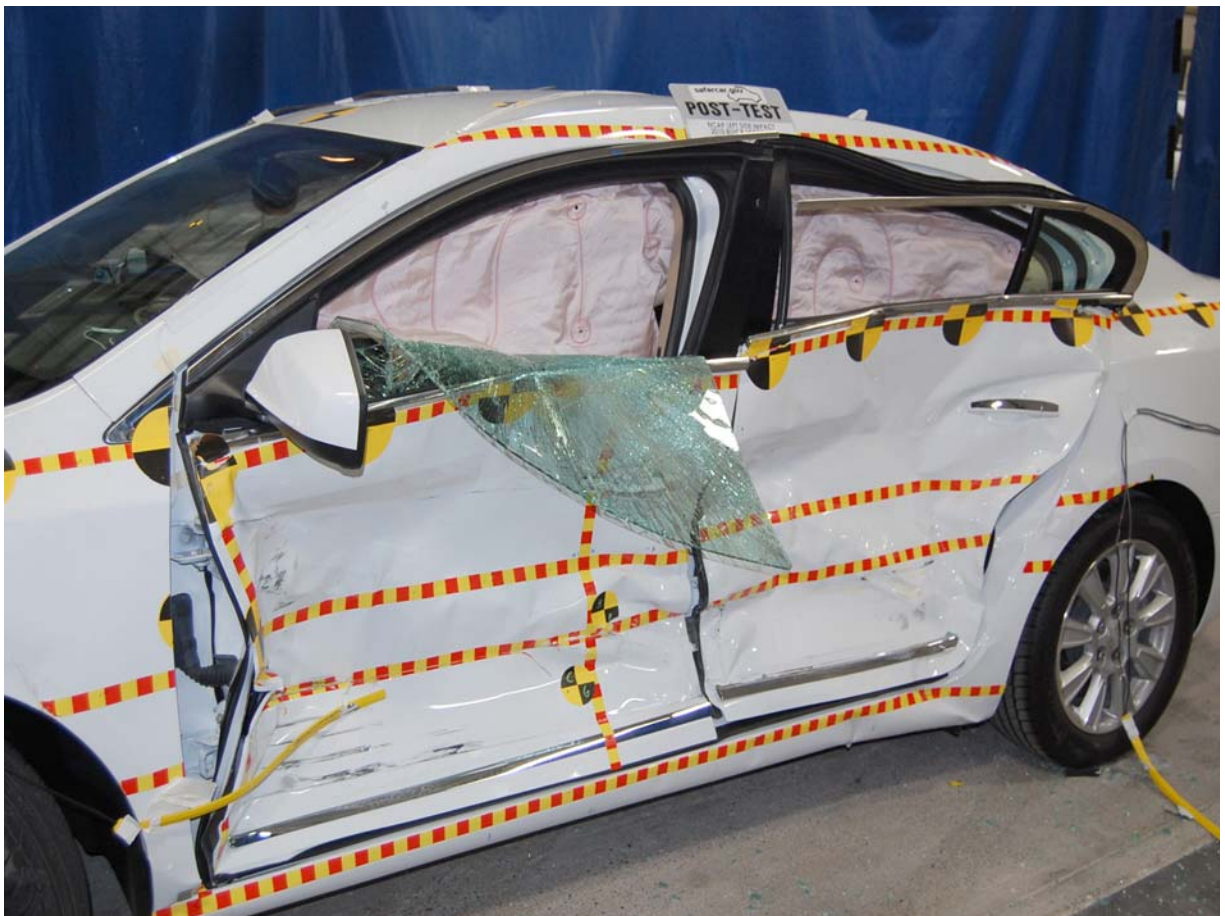
Post-Test Front  $\frac{3}{4}$  View of Left Side Doors

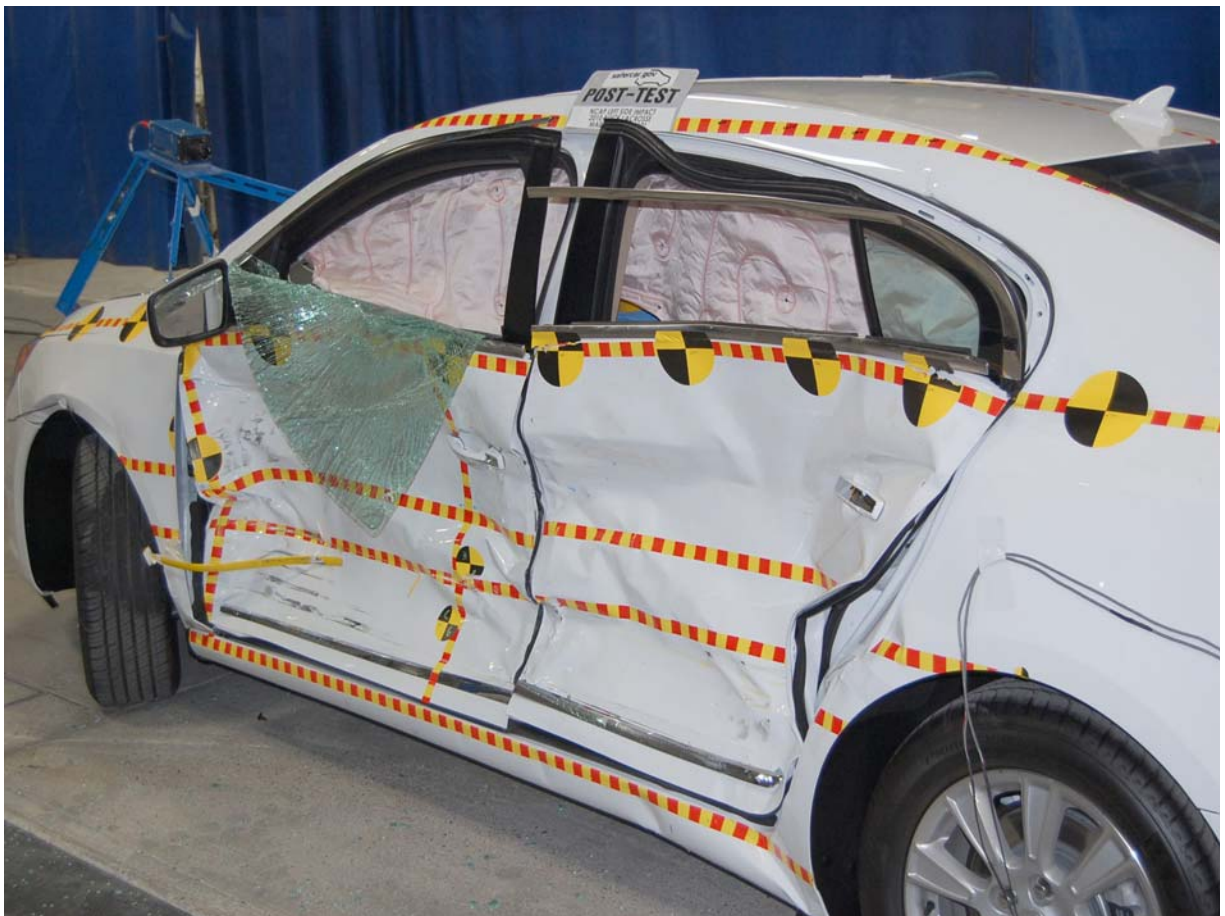
Post-Test Rear  $\frac{3}{4}$  View of Left Side Doors

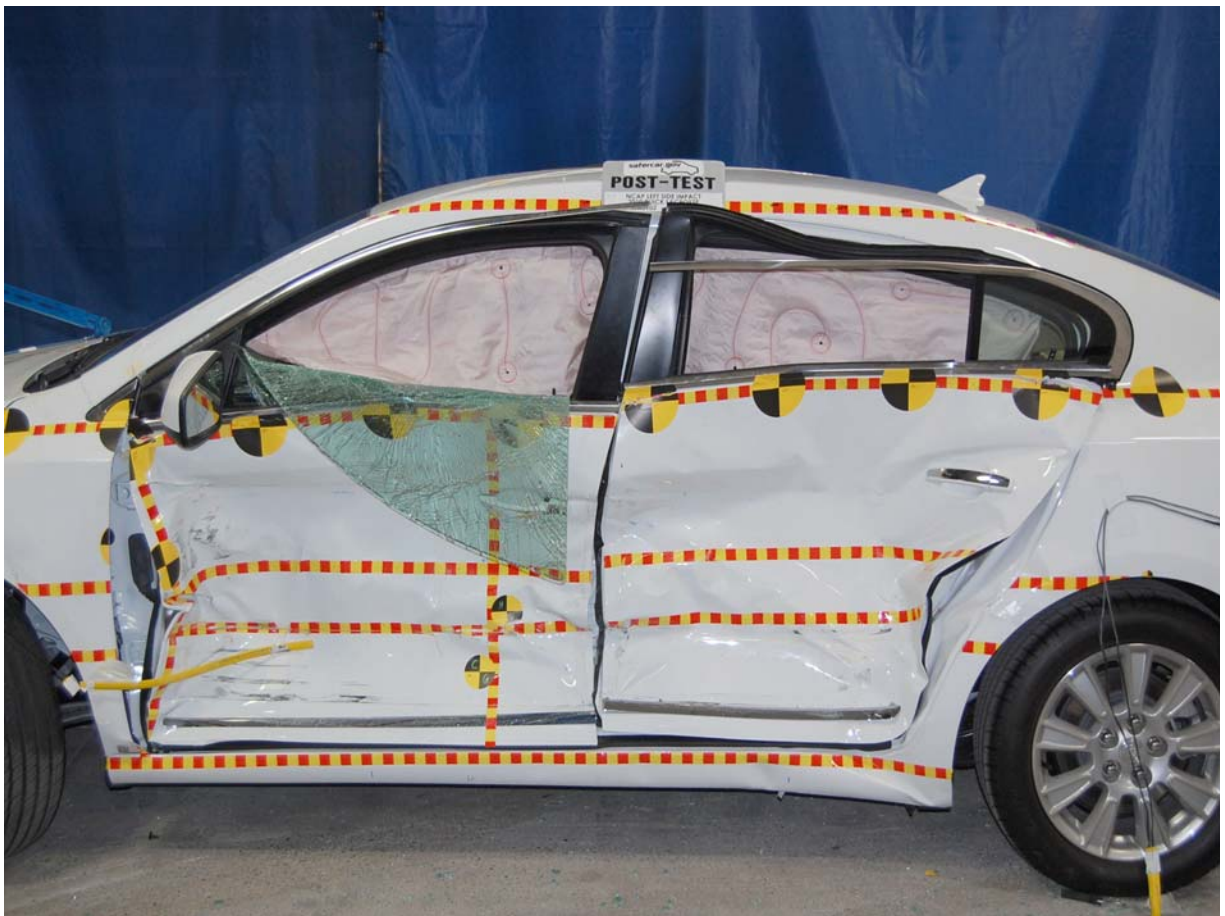
Post-Test Left Side Impact Close-up

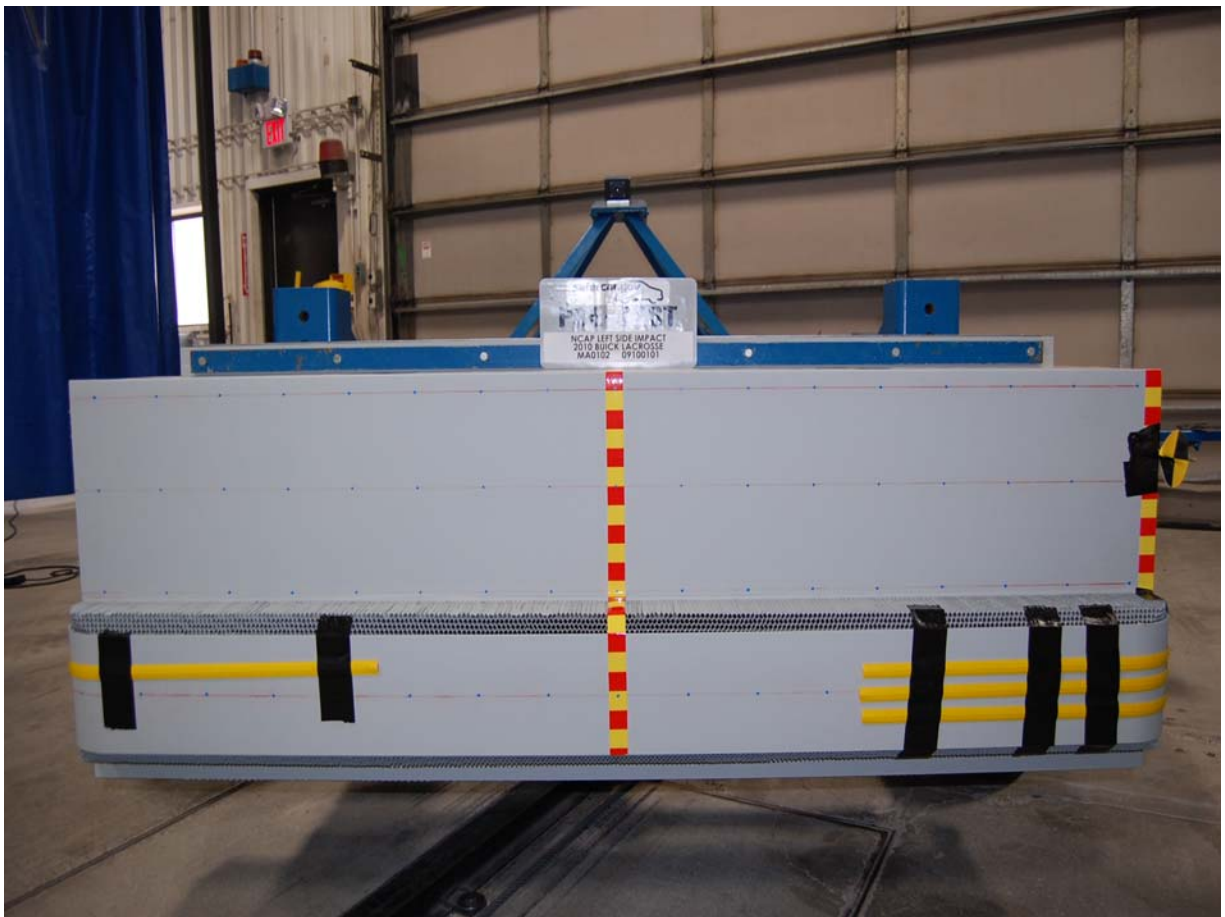
Pre-Test Front View of Deformable Barrier

Post-Test Front View of Deformable Barrier

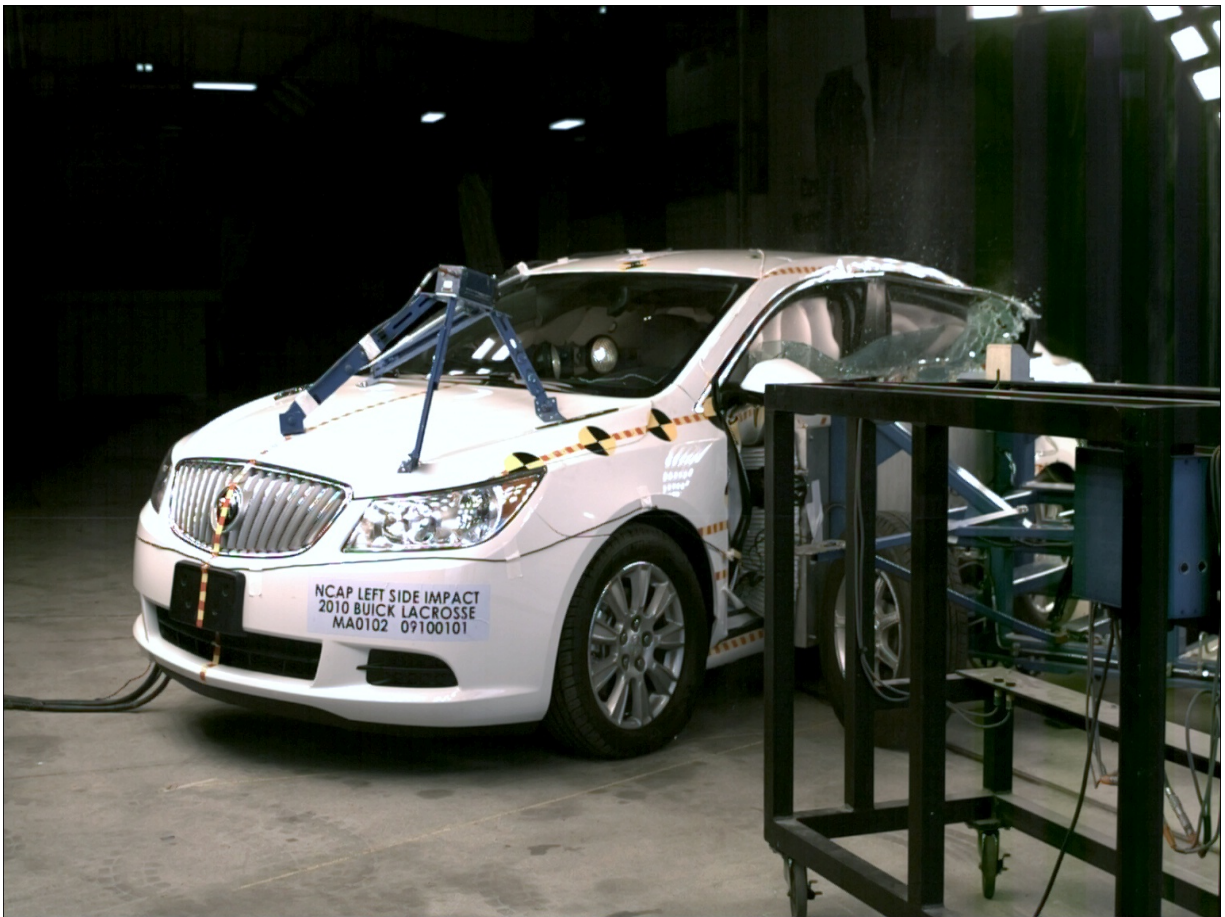
Vehicle Impact

Post-Test Driver Dummy Head Contact View

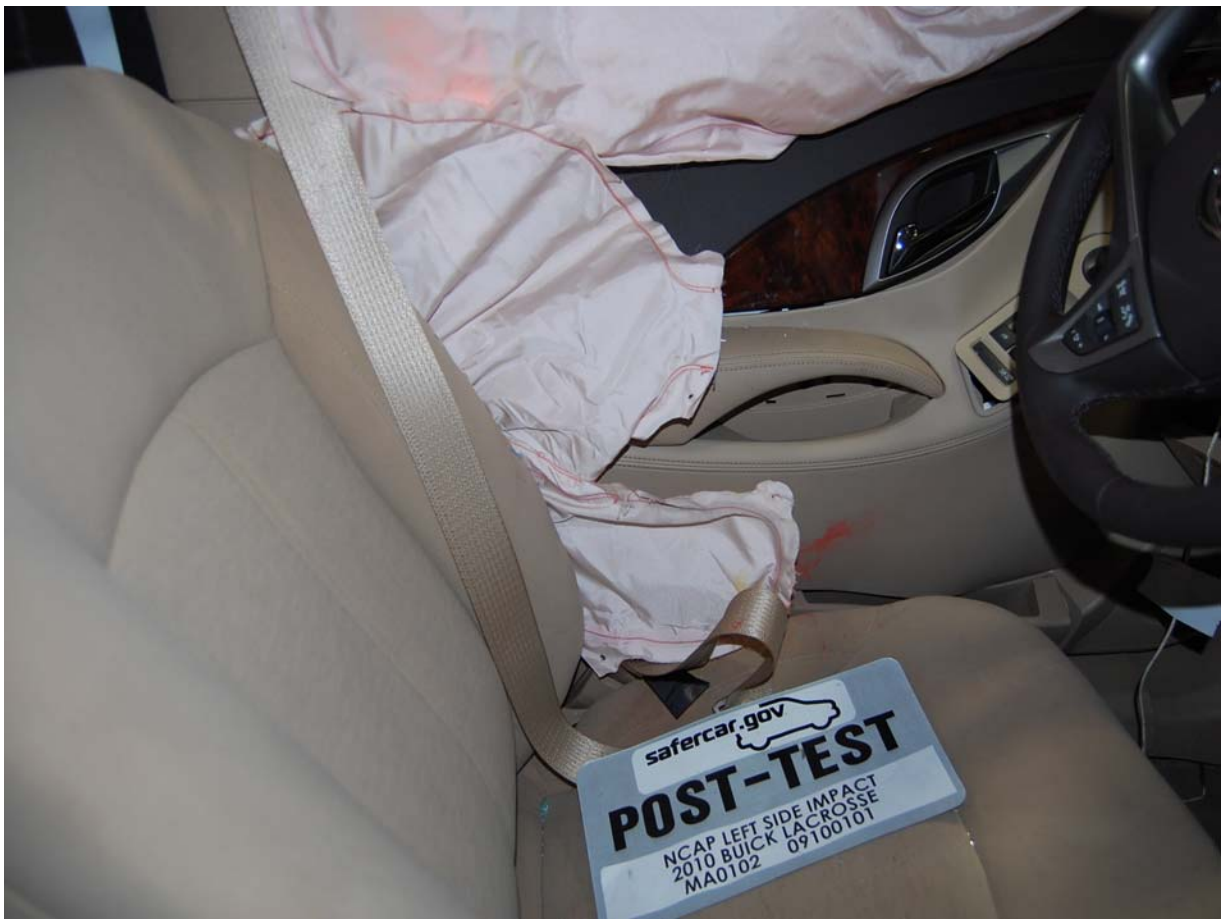
Post-Test Driver Dummy Torso Contact

Post-Test Driver Dummy Contact

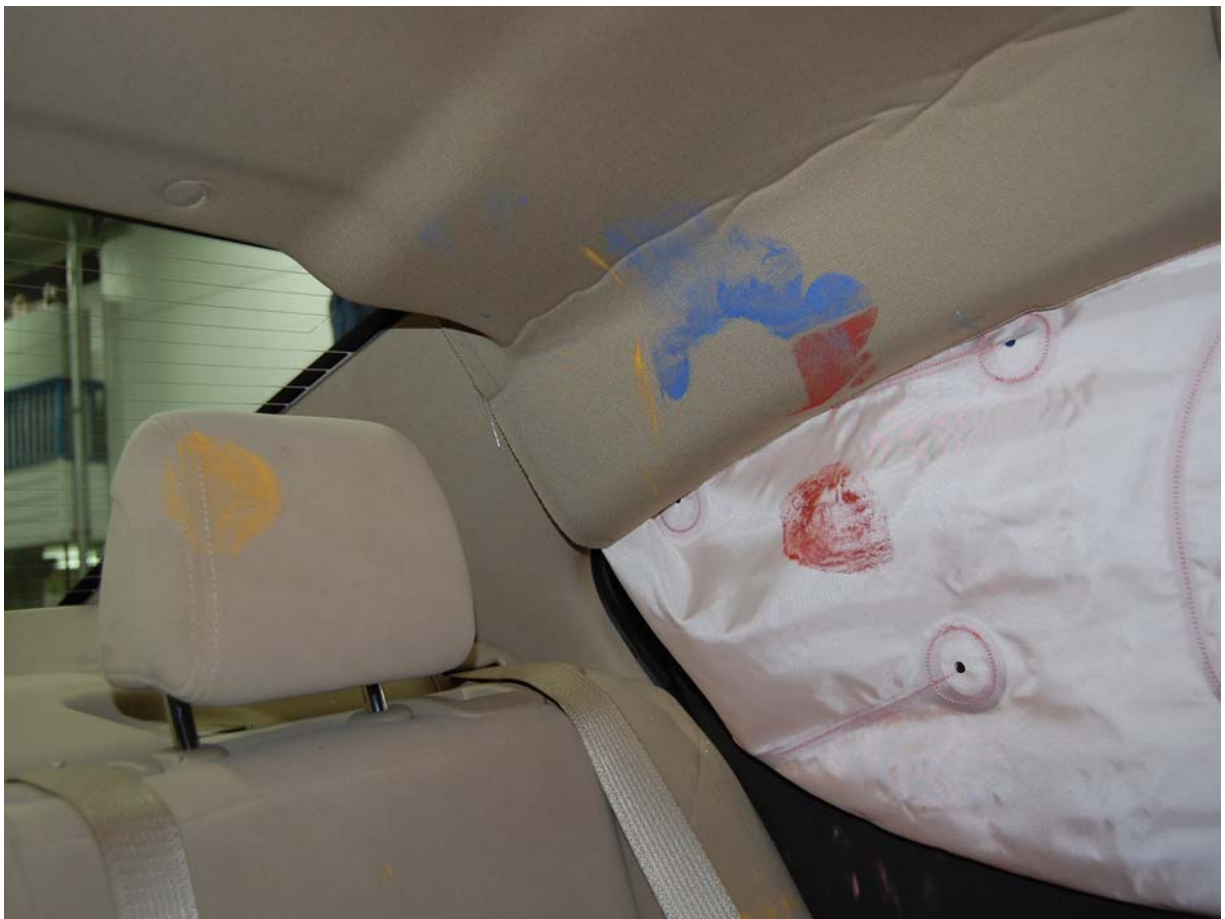
Post-Test Passenger Dummy Head Contact View

Post-Test Passenger Dummy Torso Contact

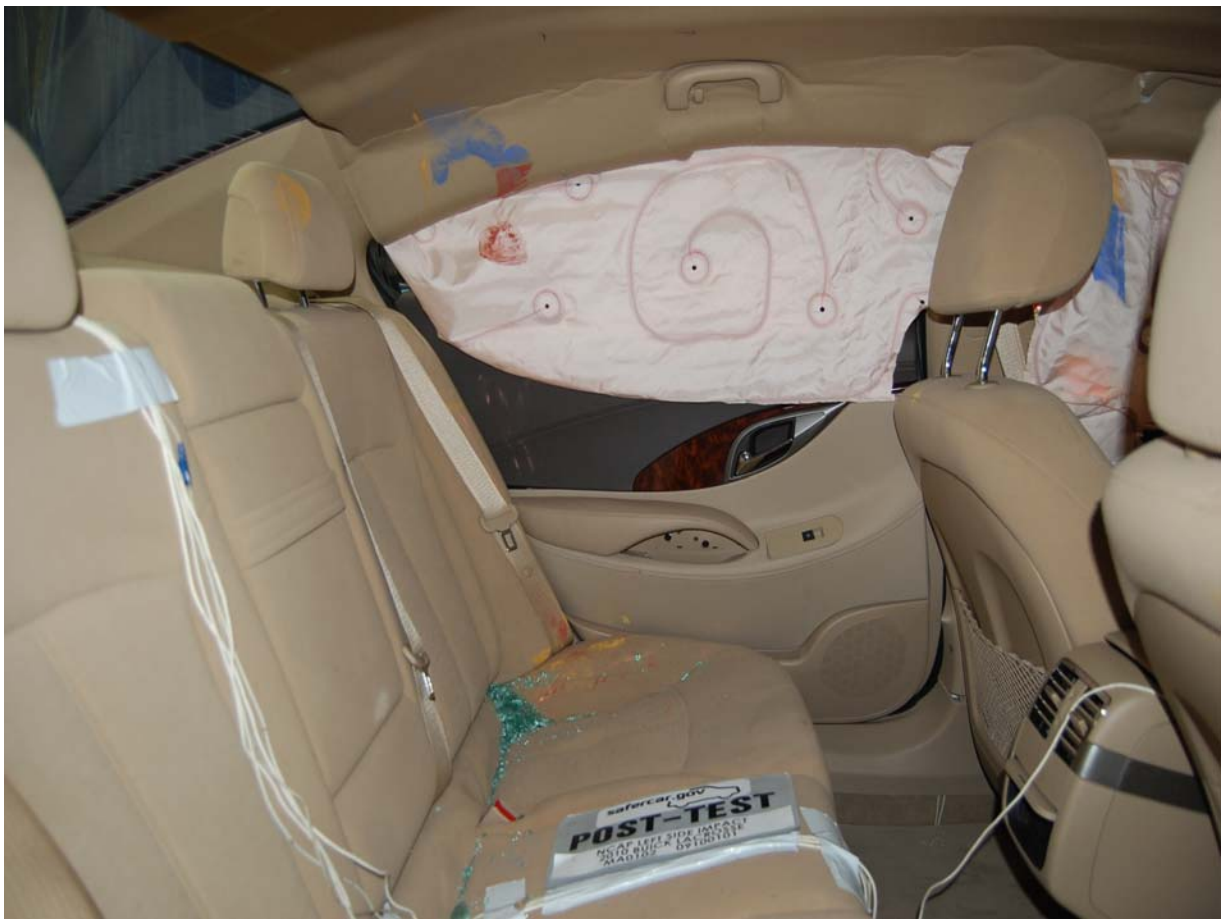
Post-Test Passenger Dummy Contact
