**REPORT NUMBER: NCAP-MGA-2010-006**

**NEW CAR ASSESSMENT PROGRAM  
FRONTAL BARRIER IMPACT TEST**

**FUJI HEAVY INDUSTRIES LTD.  
2010 SUBARU LEGACY 4-DR SEDAN  
NHTSA NUMBER: MA5500**

**PREPARED BY:  
MGA RESEARCH CORPORATION  
5000 WARREN ROAD  
BURLINGTON, WI 53105**

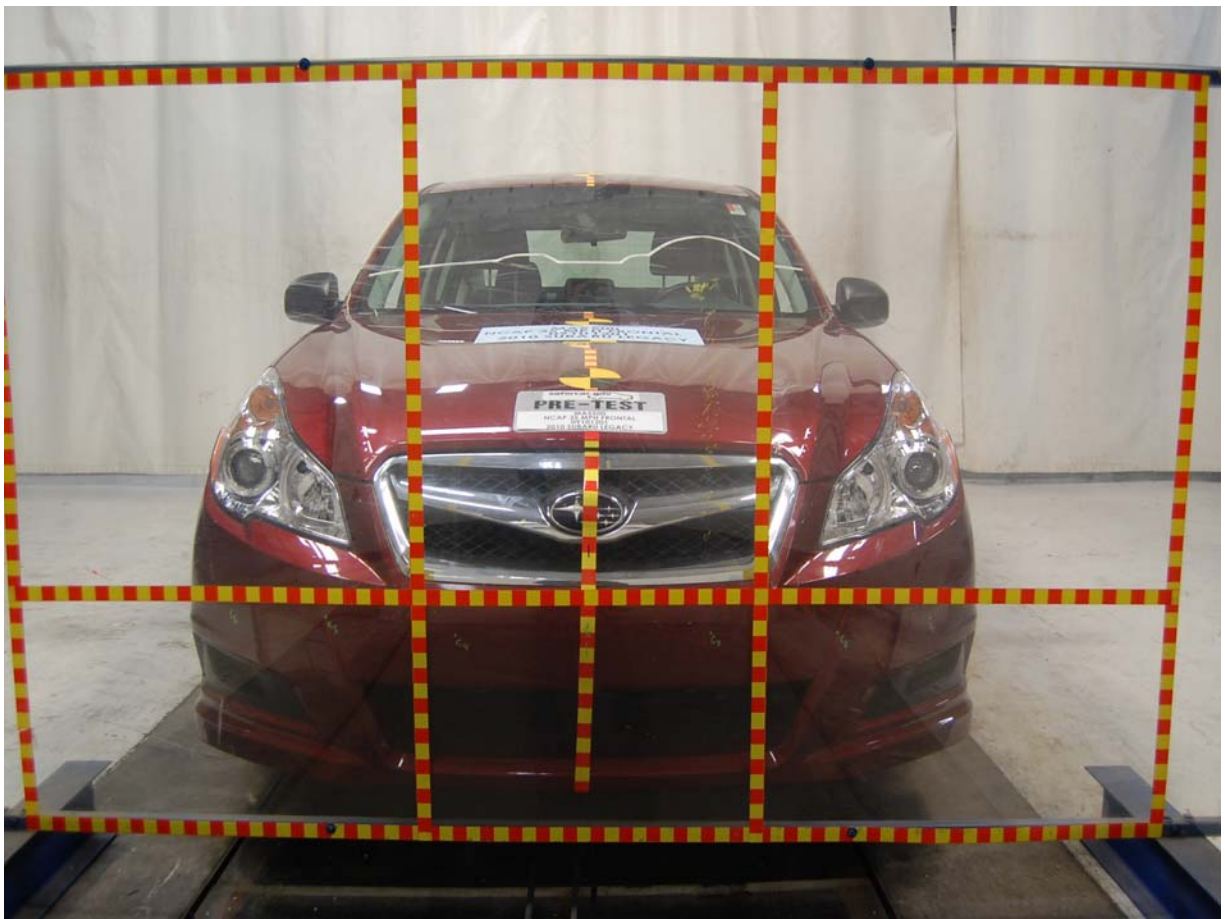
Load Cell Location

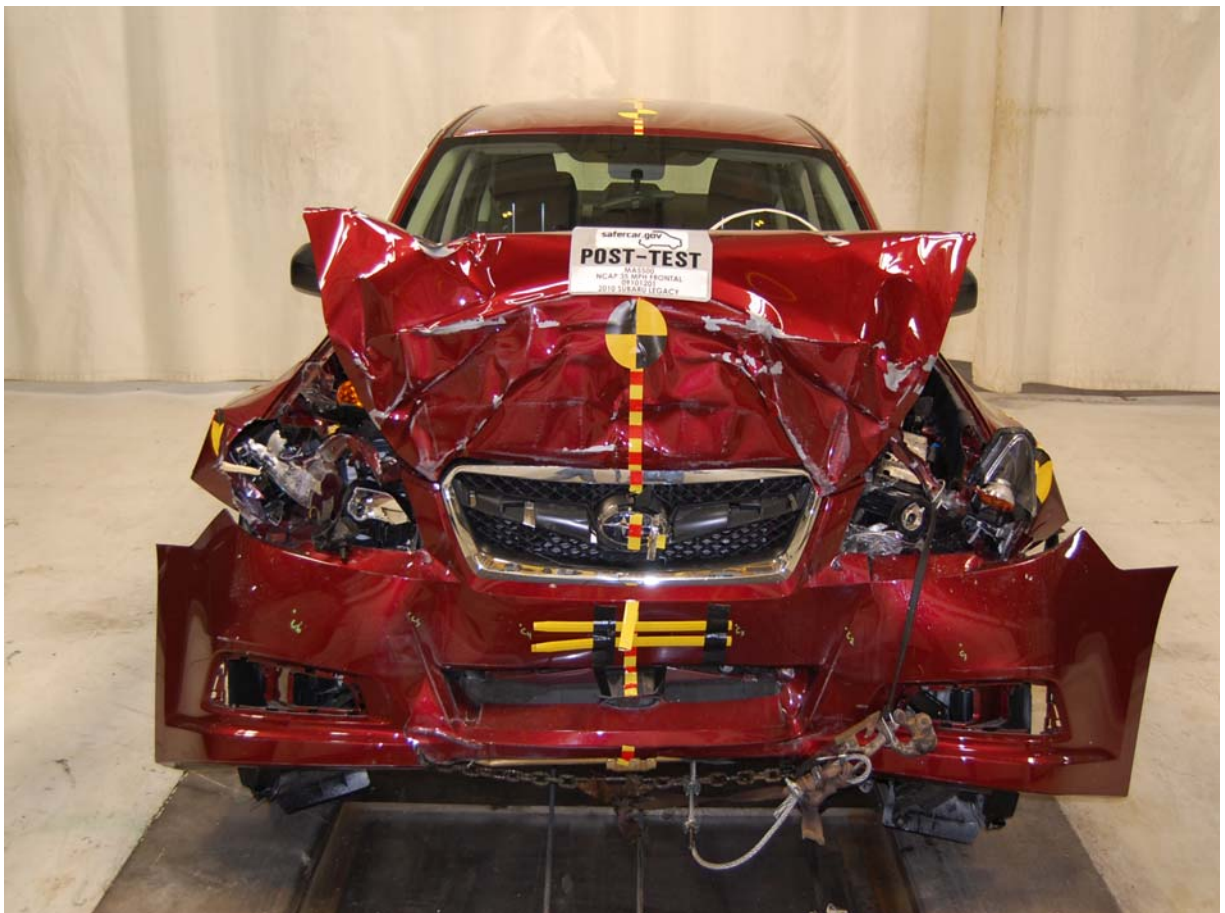
Post-Test Front View

The maximum static crush of the vehicle was 545 mm and both the driver and passenger side door remained closed and latched during the impact event and were operable after the impact.

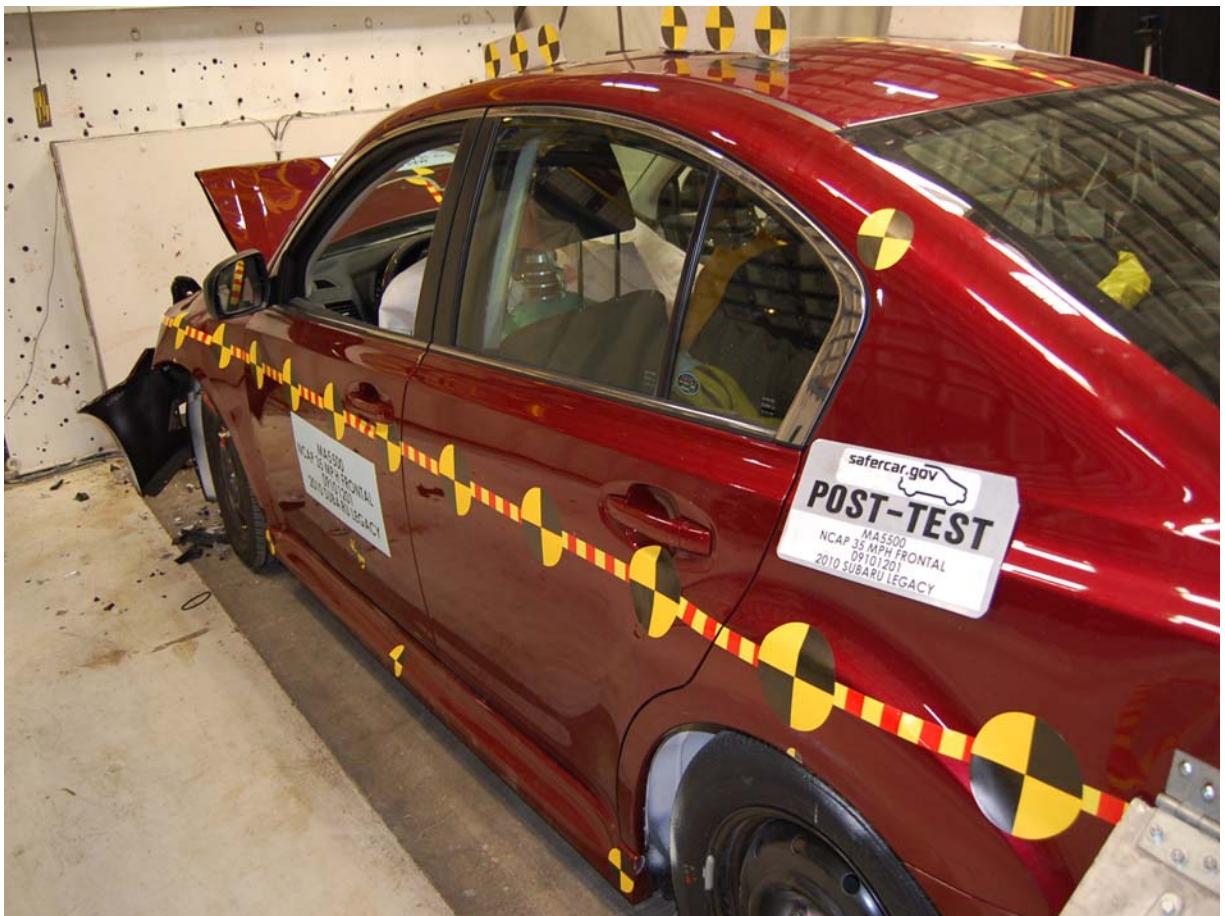
Post-Test Left Side  $\frac{3}{4}$  View of Doors After Impact

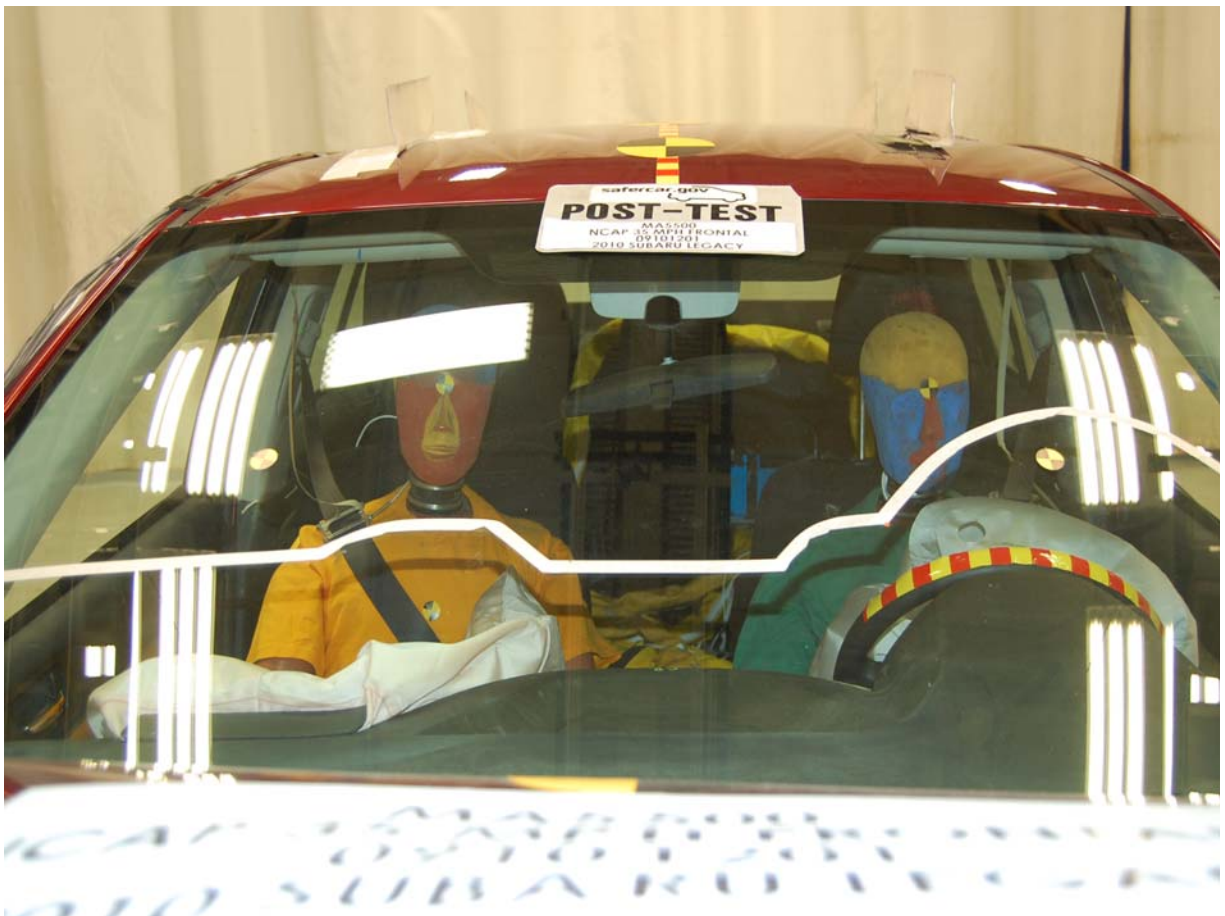
Post-Test Windshield View

There was 100 percent windshield retention and no intrusion into the protected zone of the windshield during the event. There was no Stoddard Solvent leakage after the event or during any phase of the static rollover.

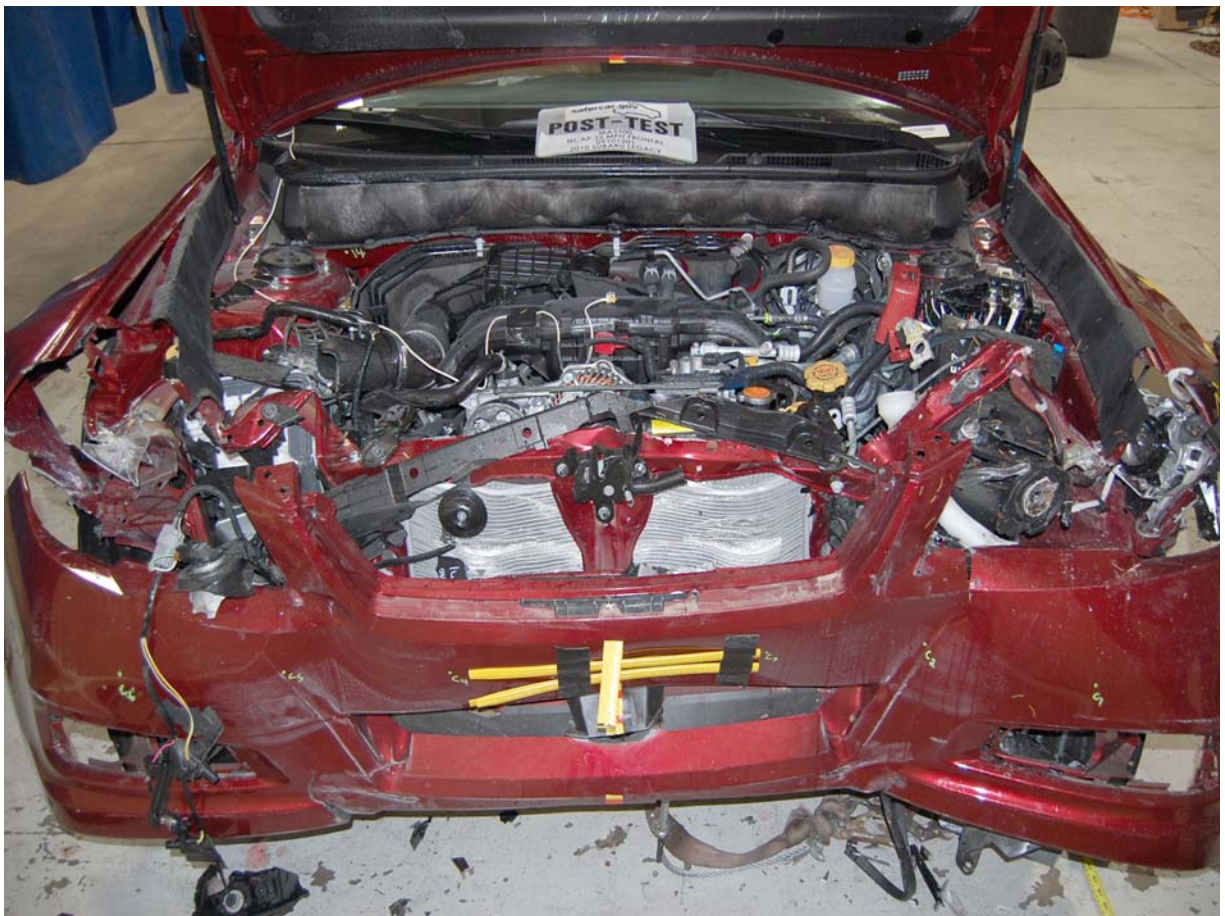
Post-Test Engine Compartment View

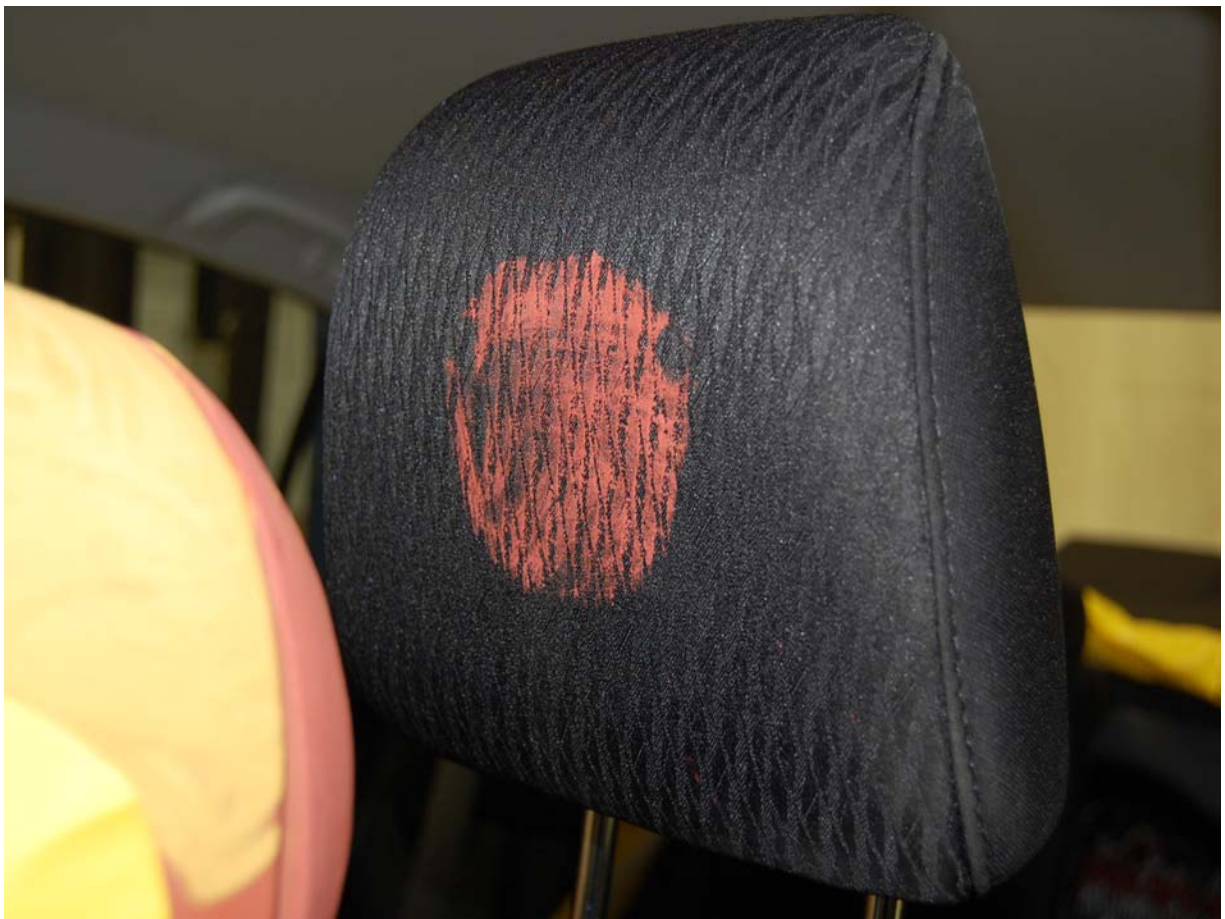
Post-Test Driver Dummy Head Contact

The driver's head and chest contacted the airbag. The driver's head also contacted the headrest. The driver's knees contacted the knee bolster. The passenger's head and chest contacted the airbag. The passenger's knees contacted the glove box and frontal airbag.

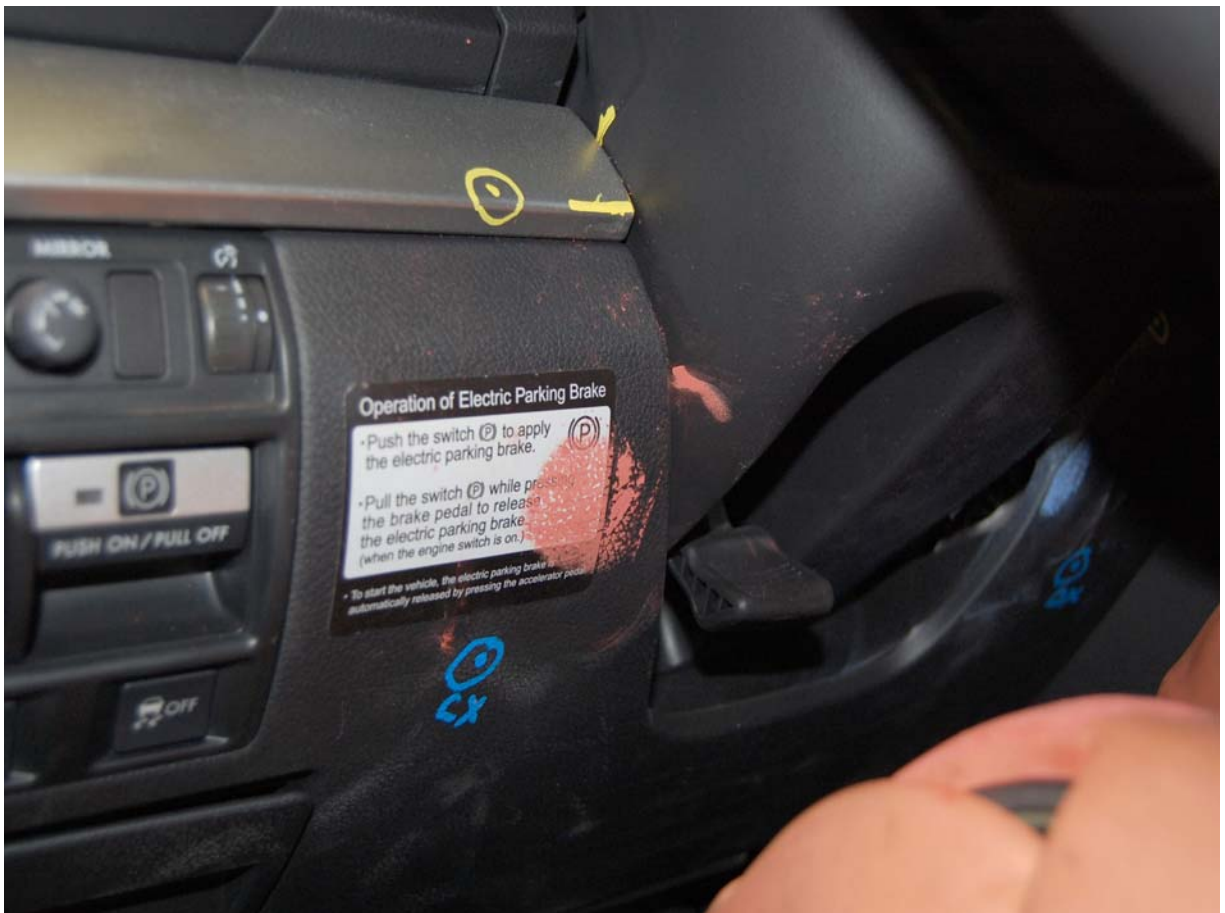
Post-Test Driver Dummy Left Knee Contact

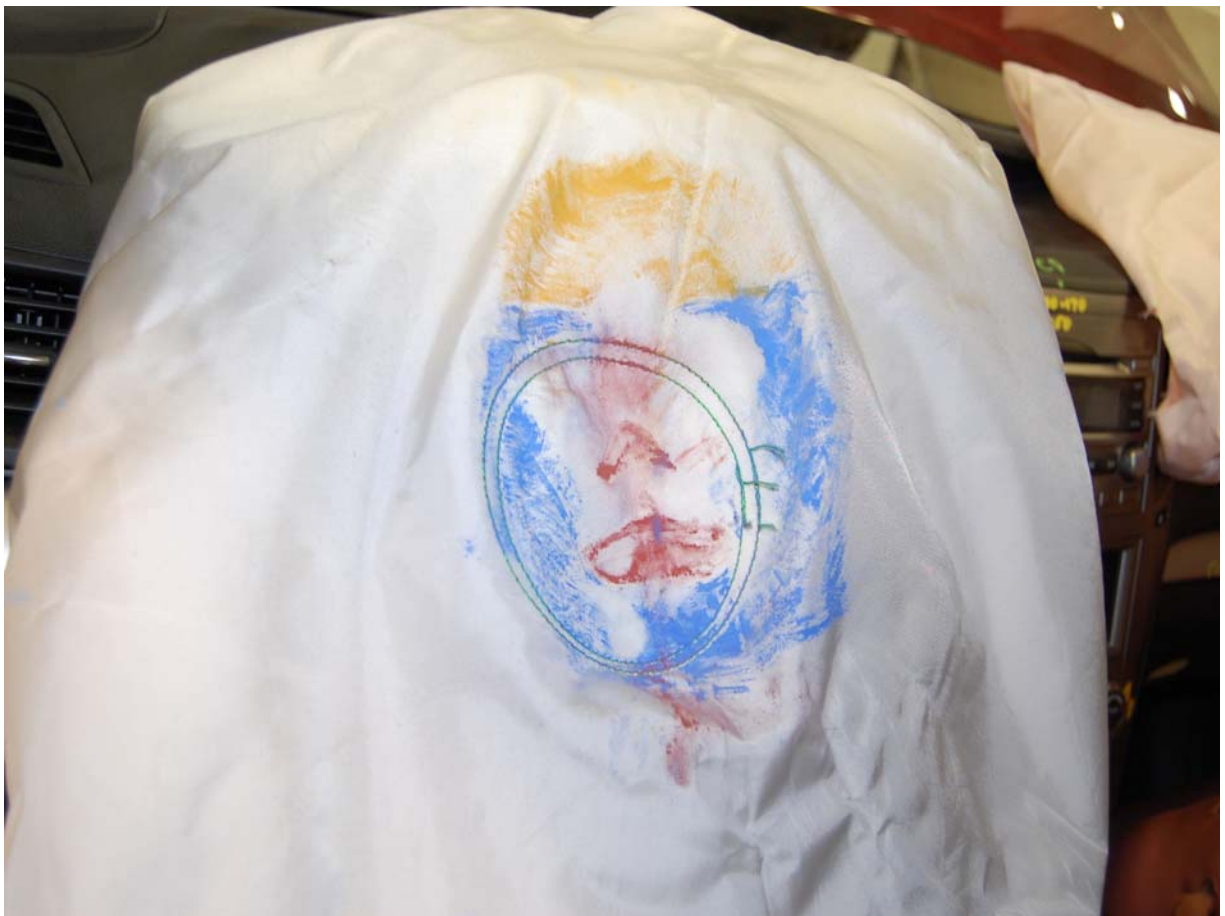
Post-Test Driver Dummy Airbag Contact

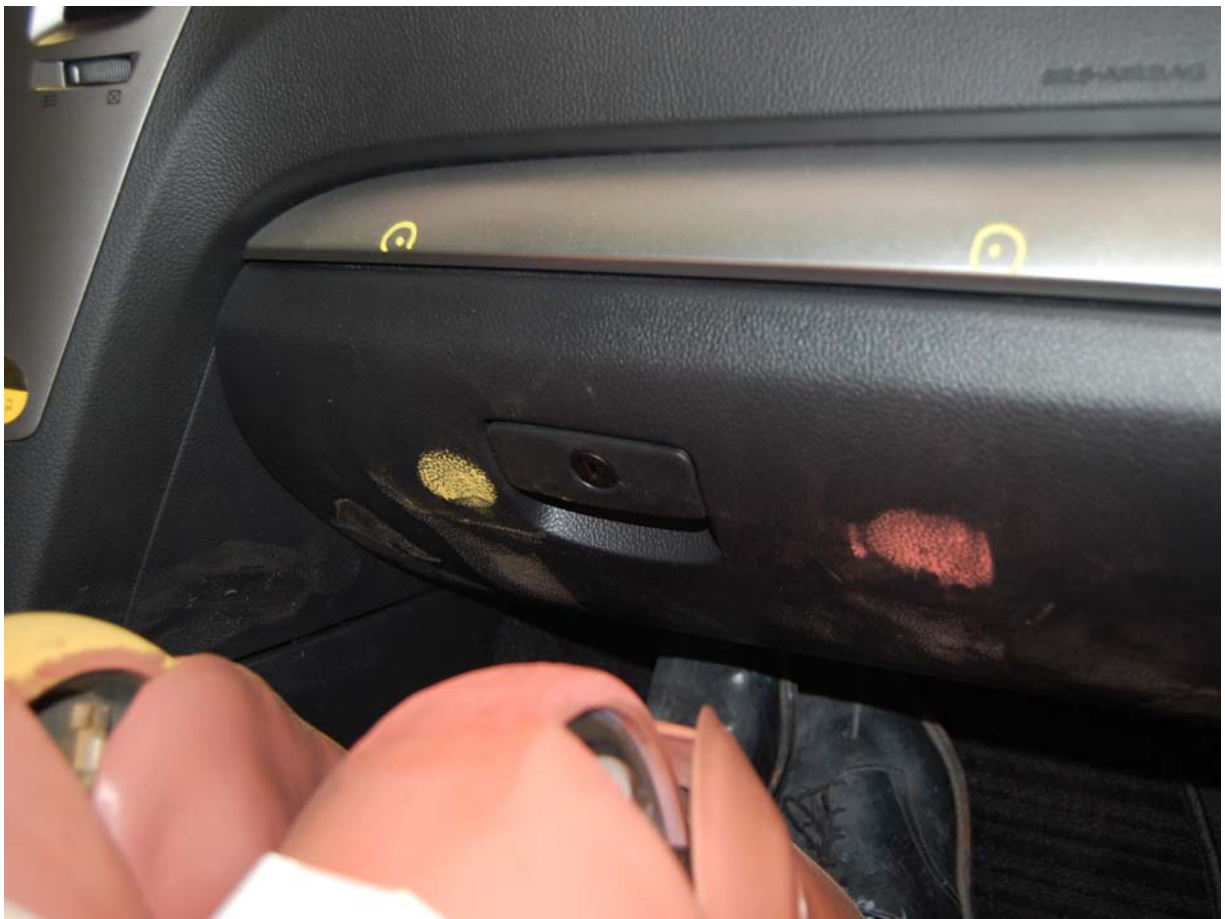
Post-Test Passenger Dummy Knee Contact

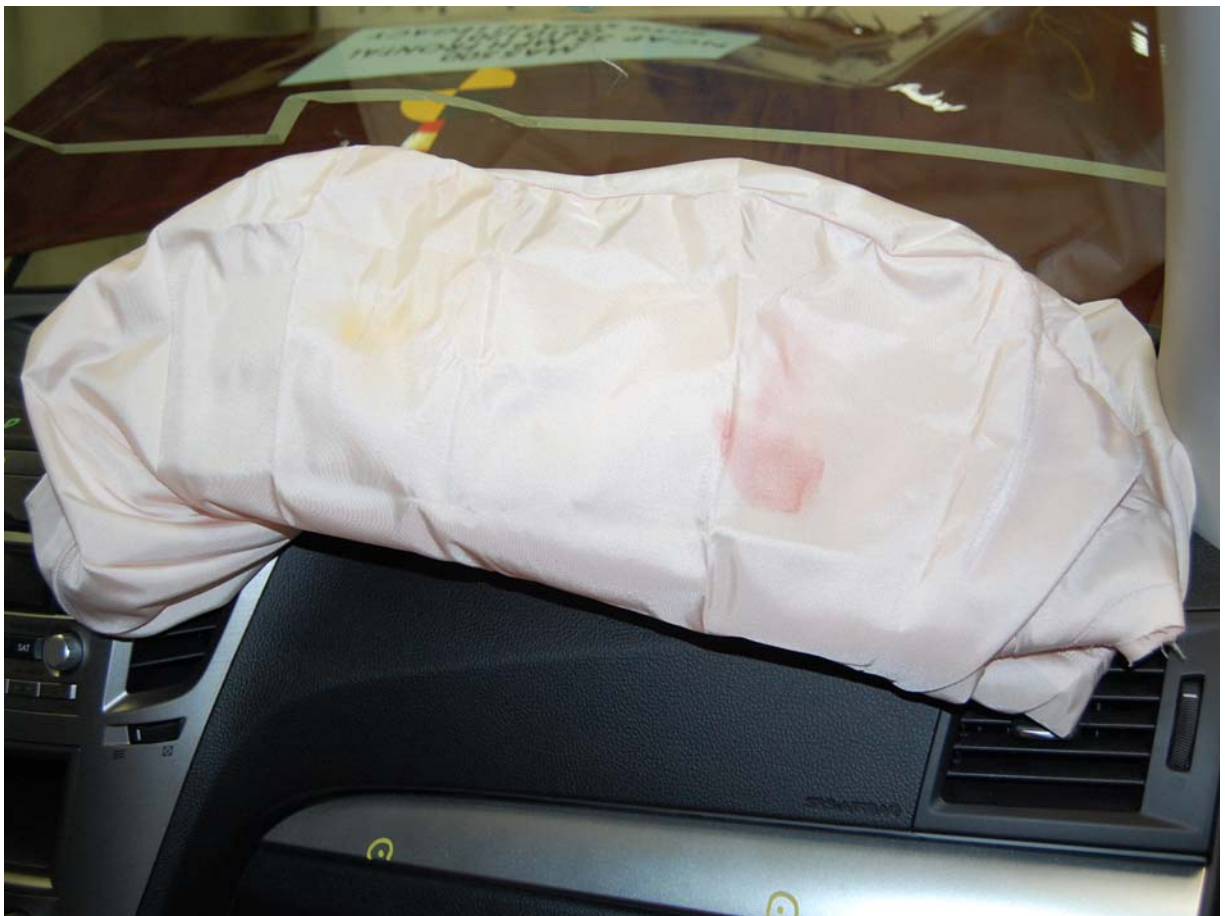
Post-Test Passenger Dummy Knee Contact w/Airbag

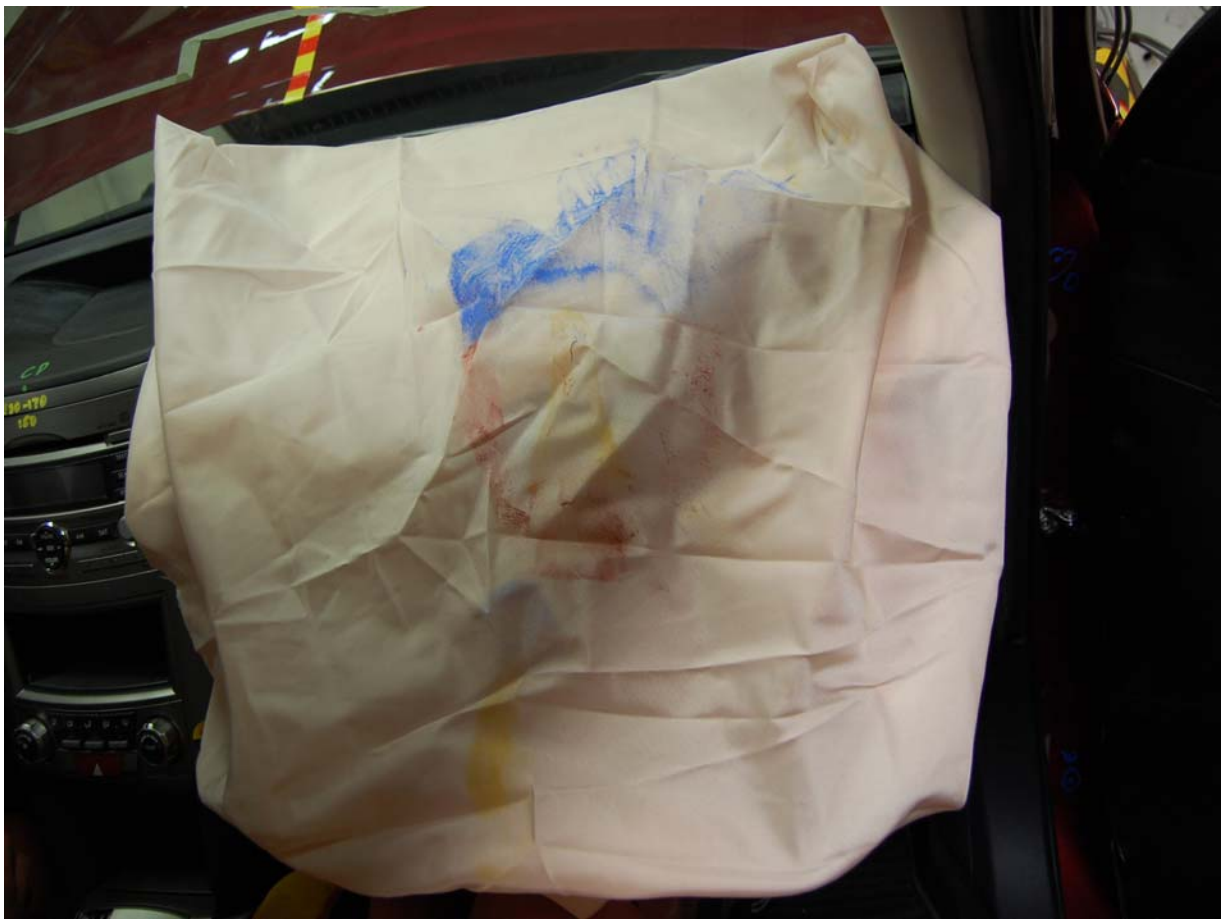
Post-Test Passenger Dummy Airbag Contact

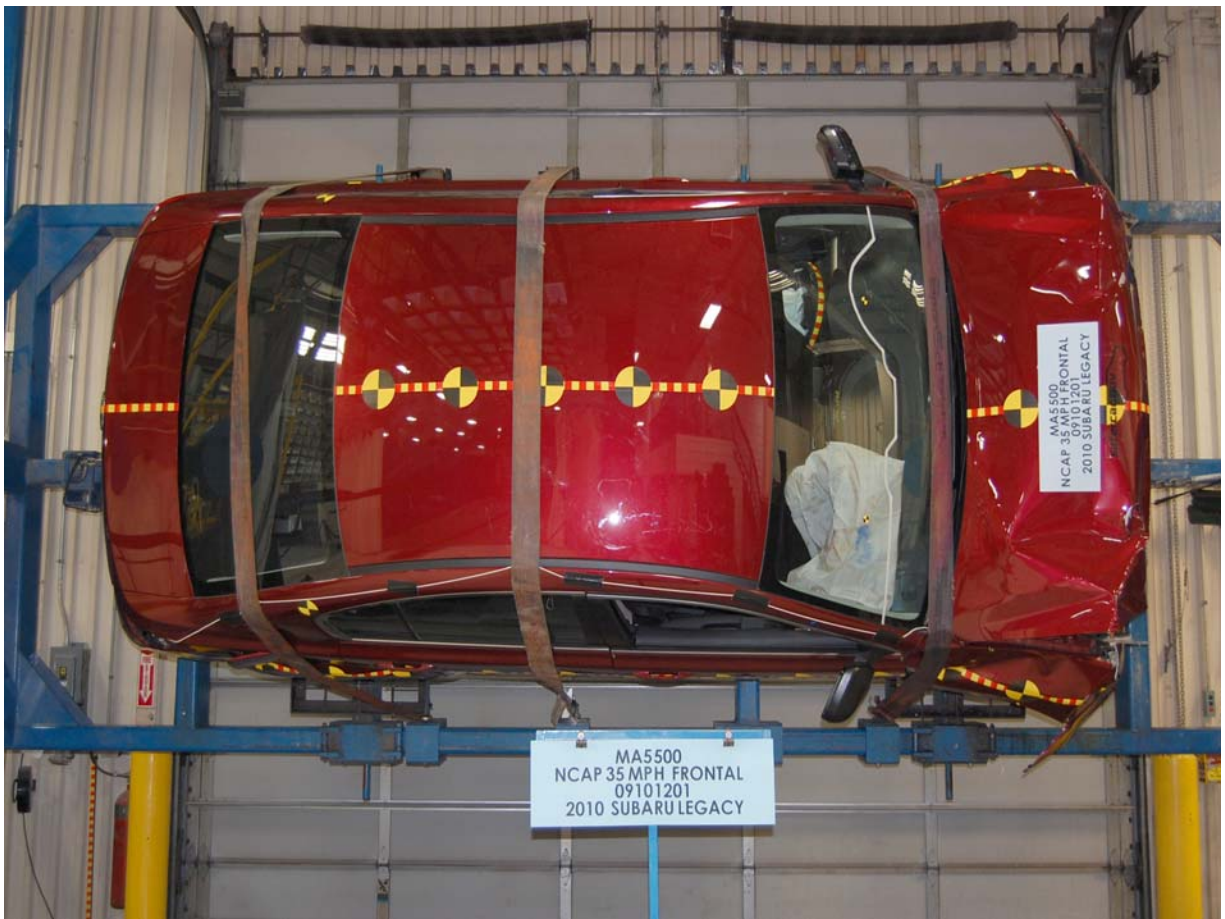
Rollover 90 Degrees

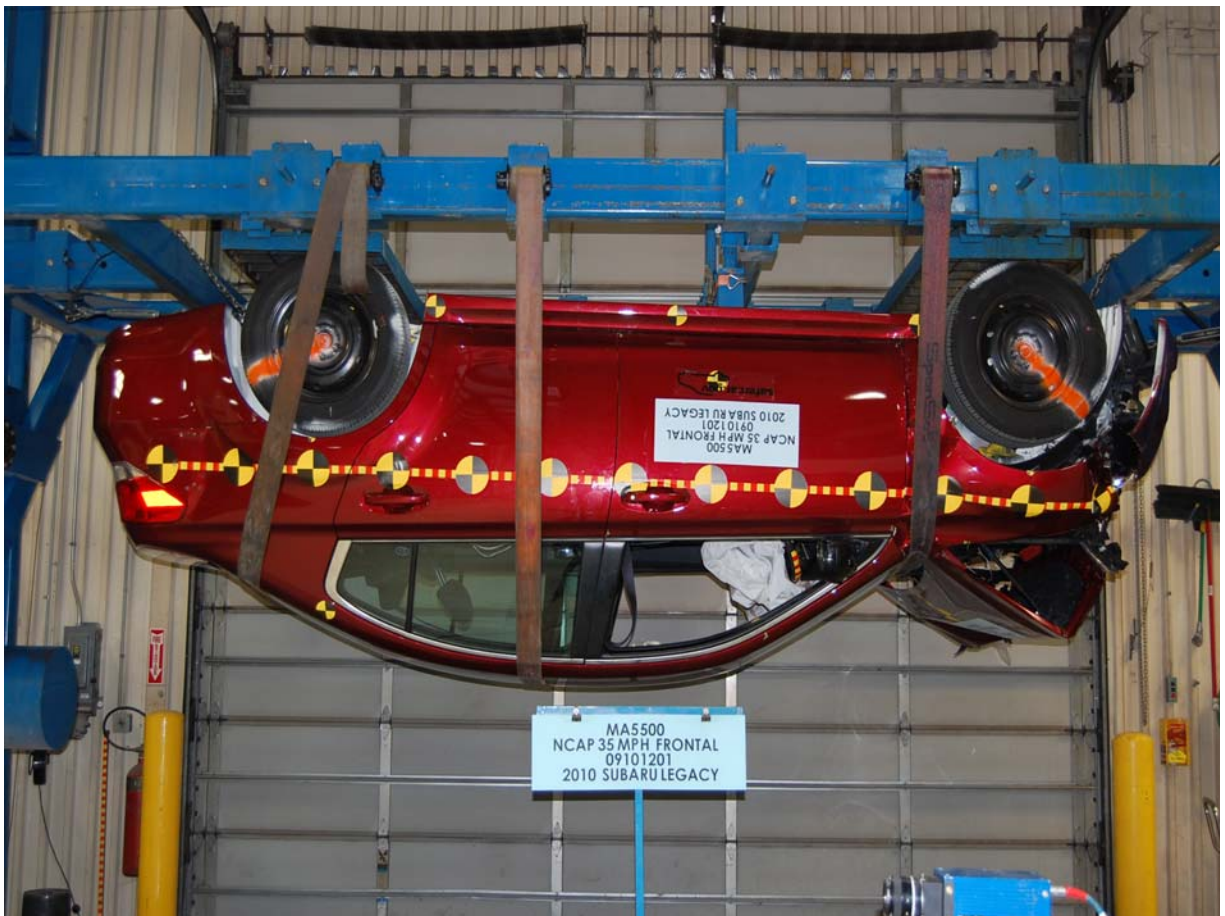
Rollover 180 Degrees
