REPORT NUMBER: CAL-10-02

**NEW CAR ASSESSMENT PROGRAM (NCAP)  
FRONTAL BARRIER IMPACT TEST**

**NISSAN MOTOR CO. LTD  
2010 NISSAN ROGUE S AWD  
4-DOOR**

NHTSA NUMBER: MA5203

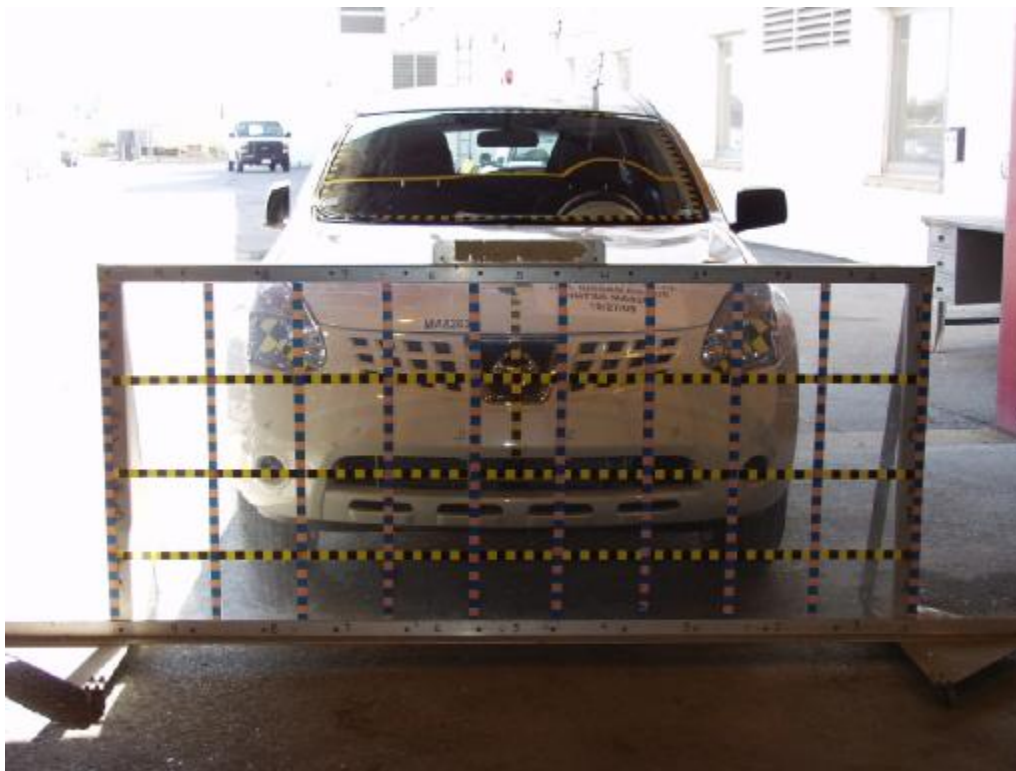
**Figure A-1: Load Cell Locations**

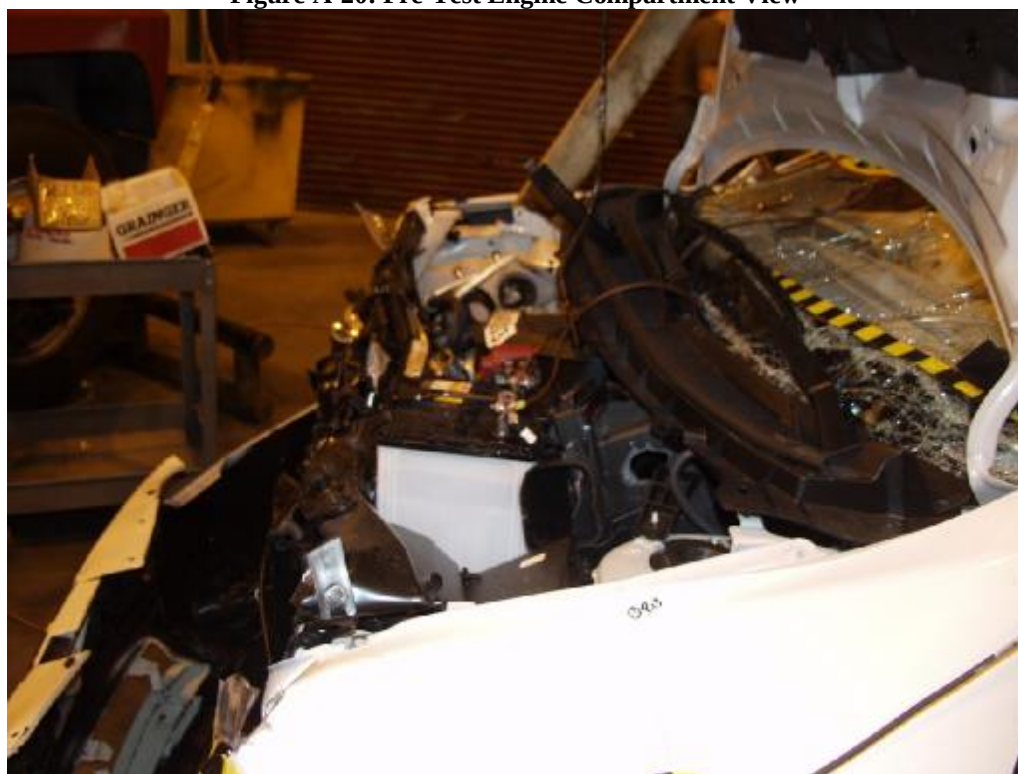
**Figure A-21: Post-Test Engine Compartment View**

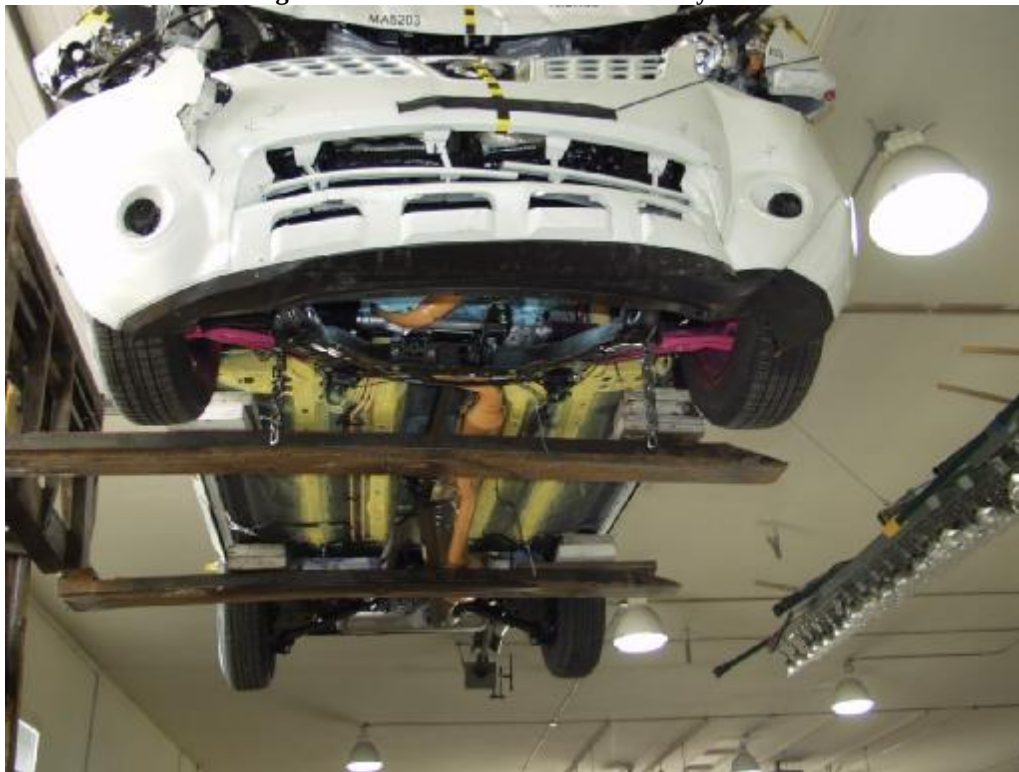
**Figure A-25: Post-Test Front Underbody View**

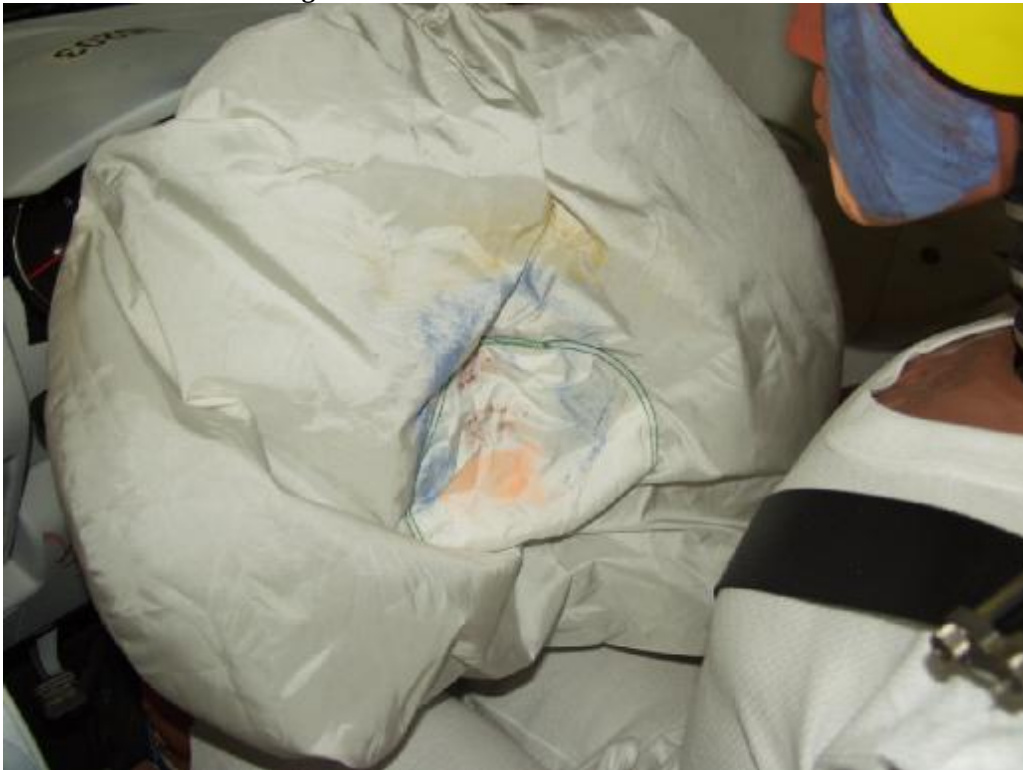
**Figure A-43: Post-Test Driver Contact to Airbag**

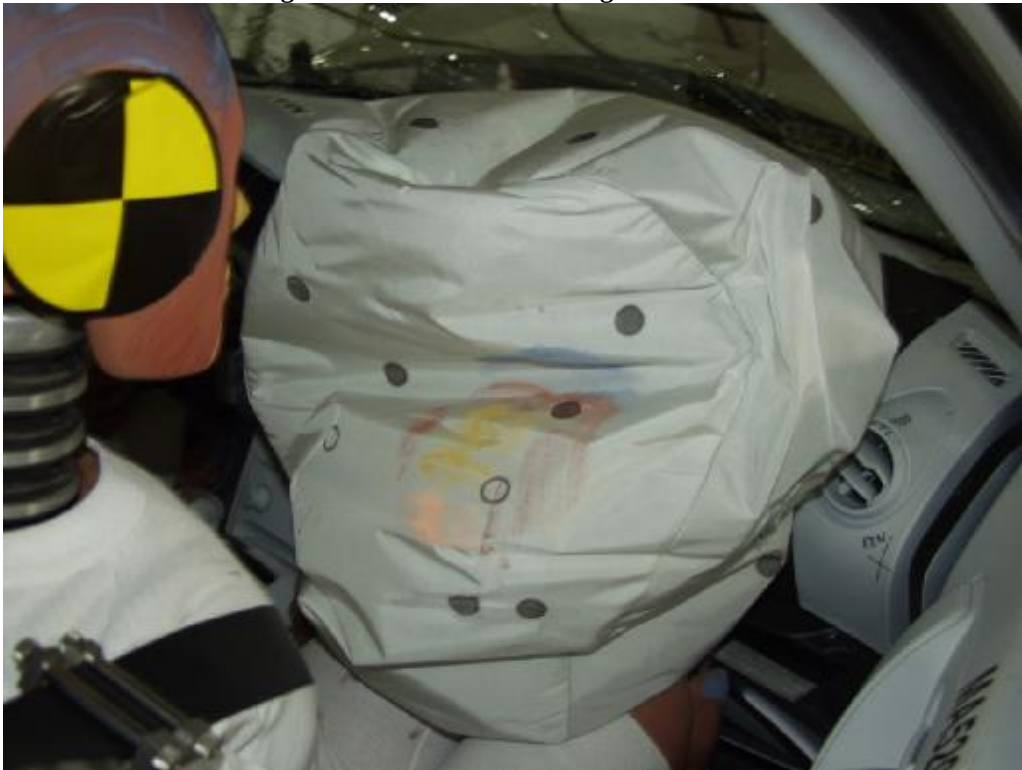
**Figure A-57: Post-Test Passenger Contact to Airbag**
