**REPORT NUMBER TR-P29001-10-NC**

**NEW CAR ASSESMENT PROGRAM  
FRONTAL BARRIER IMPACT TEST**

**TOYOTA MOTOR CORPORATION  
2010 LEXUS HS 250H  
4-DOOR SEDAN**

**NHTSA NUMBER: MA5119**

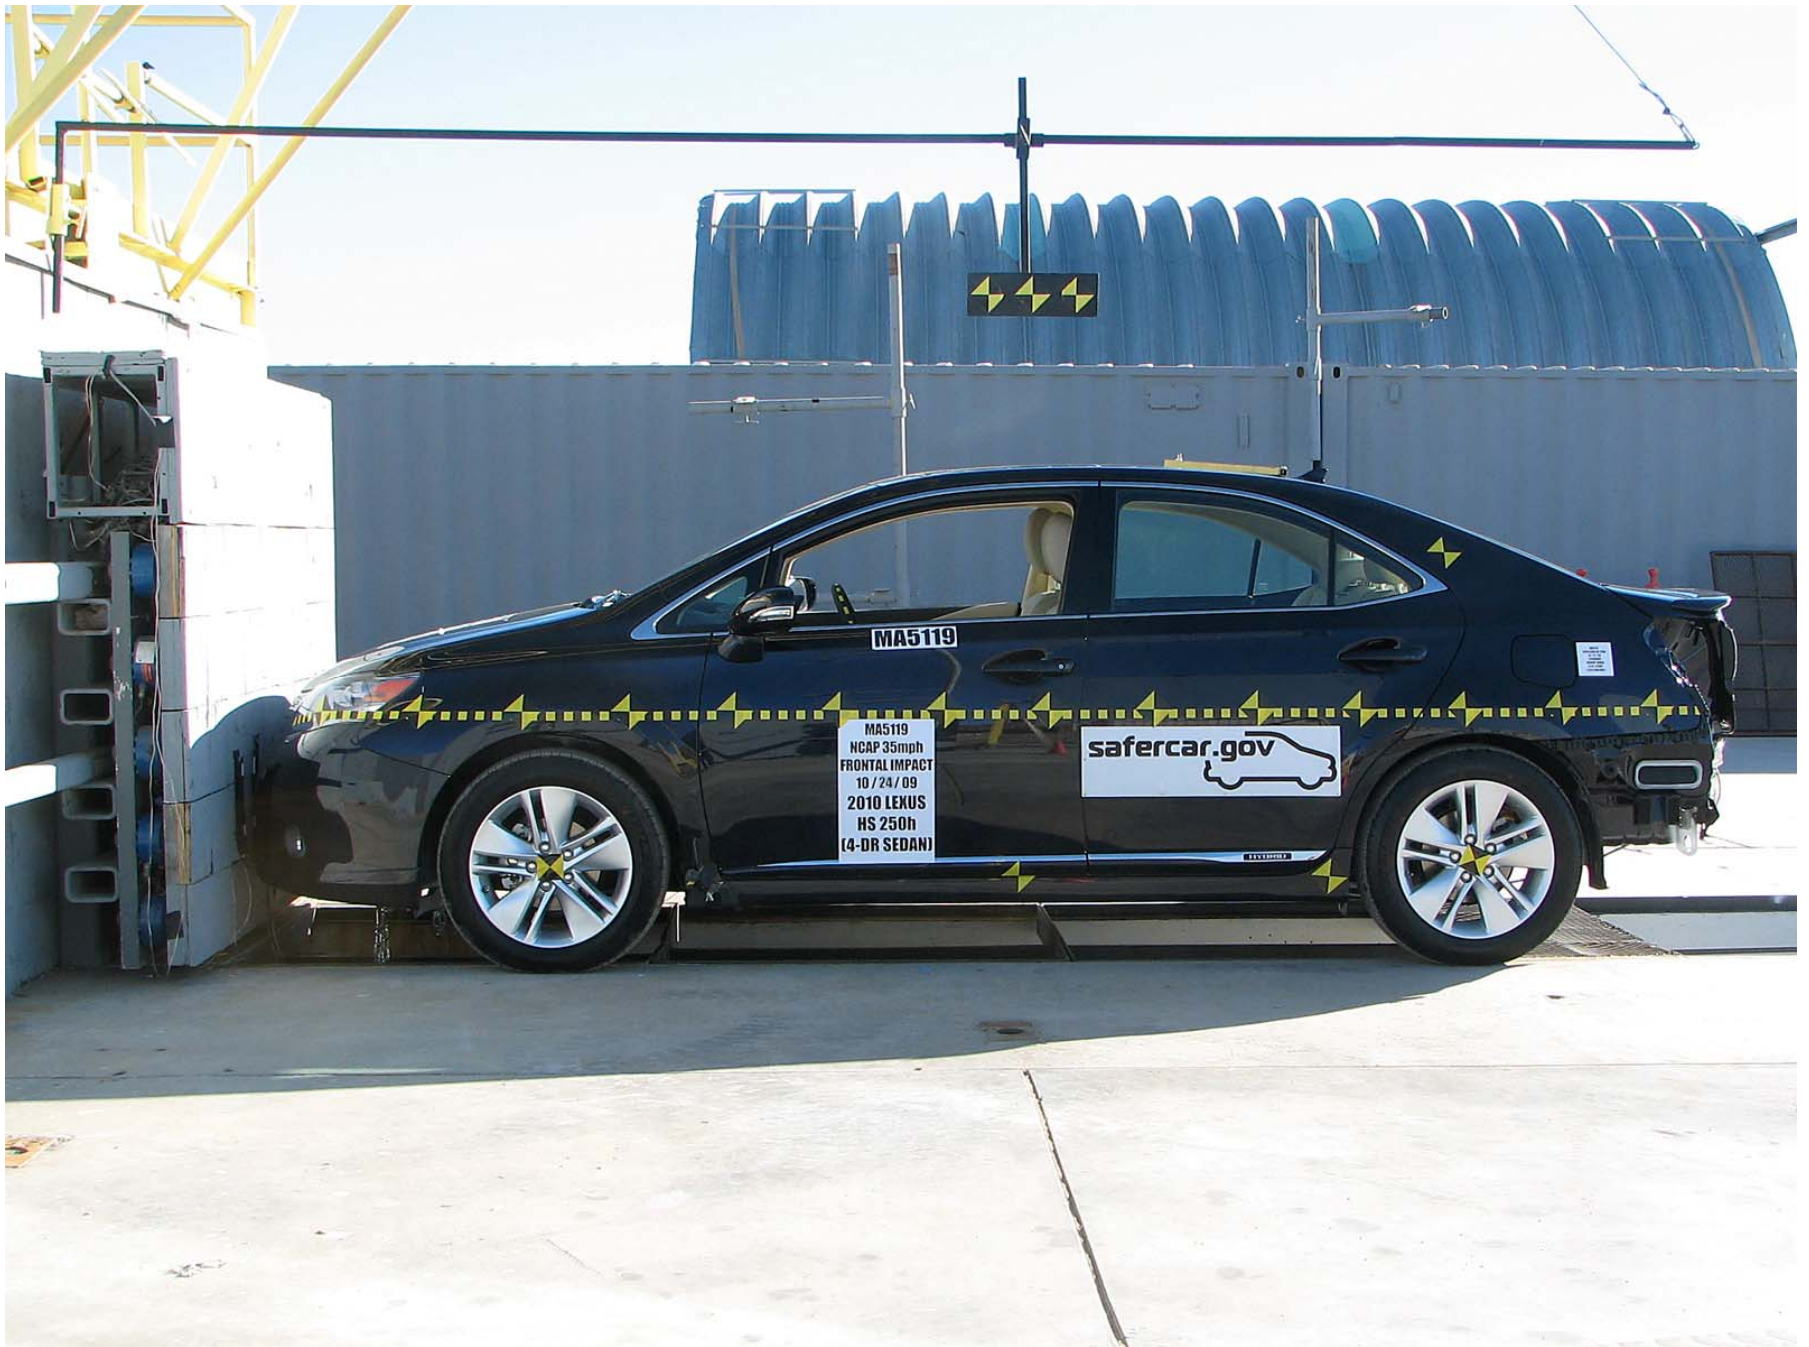
Figure A-12: Post-Test Front View (Vehicle Moved)

The maximum static crush of the vehicle was 453 mm at DPD 4, to the right of the vehicle's centerline. Both the driver and passenger side doors remained closed and latched during the impact event, and were operable after the impact.

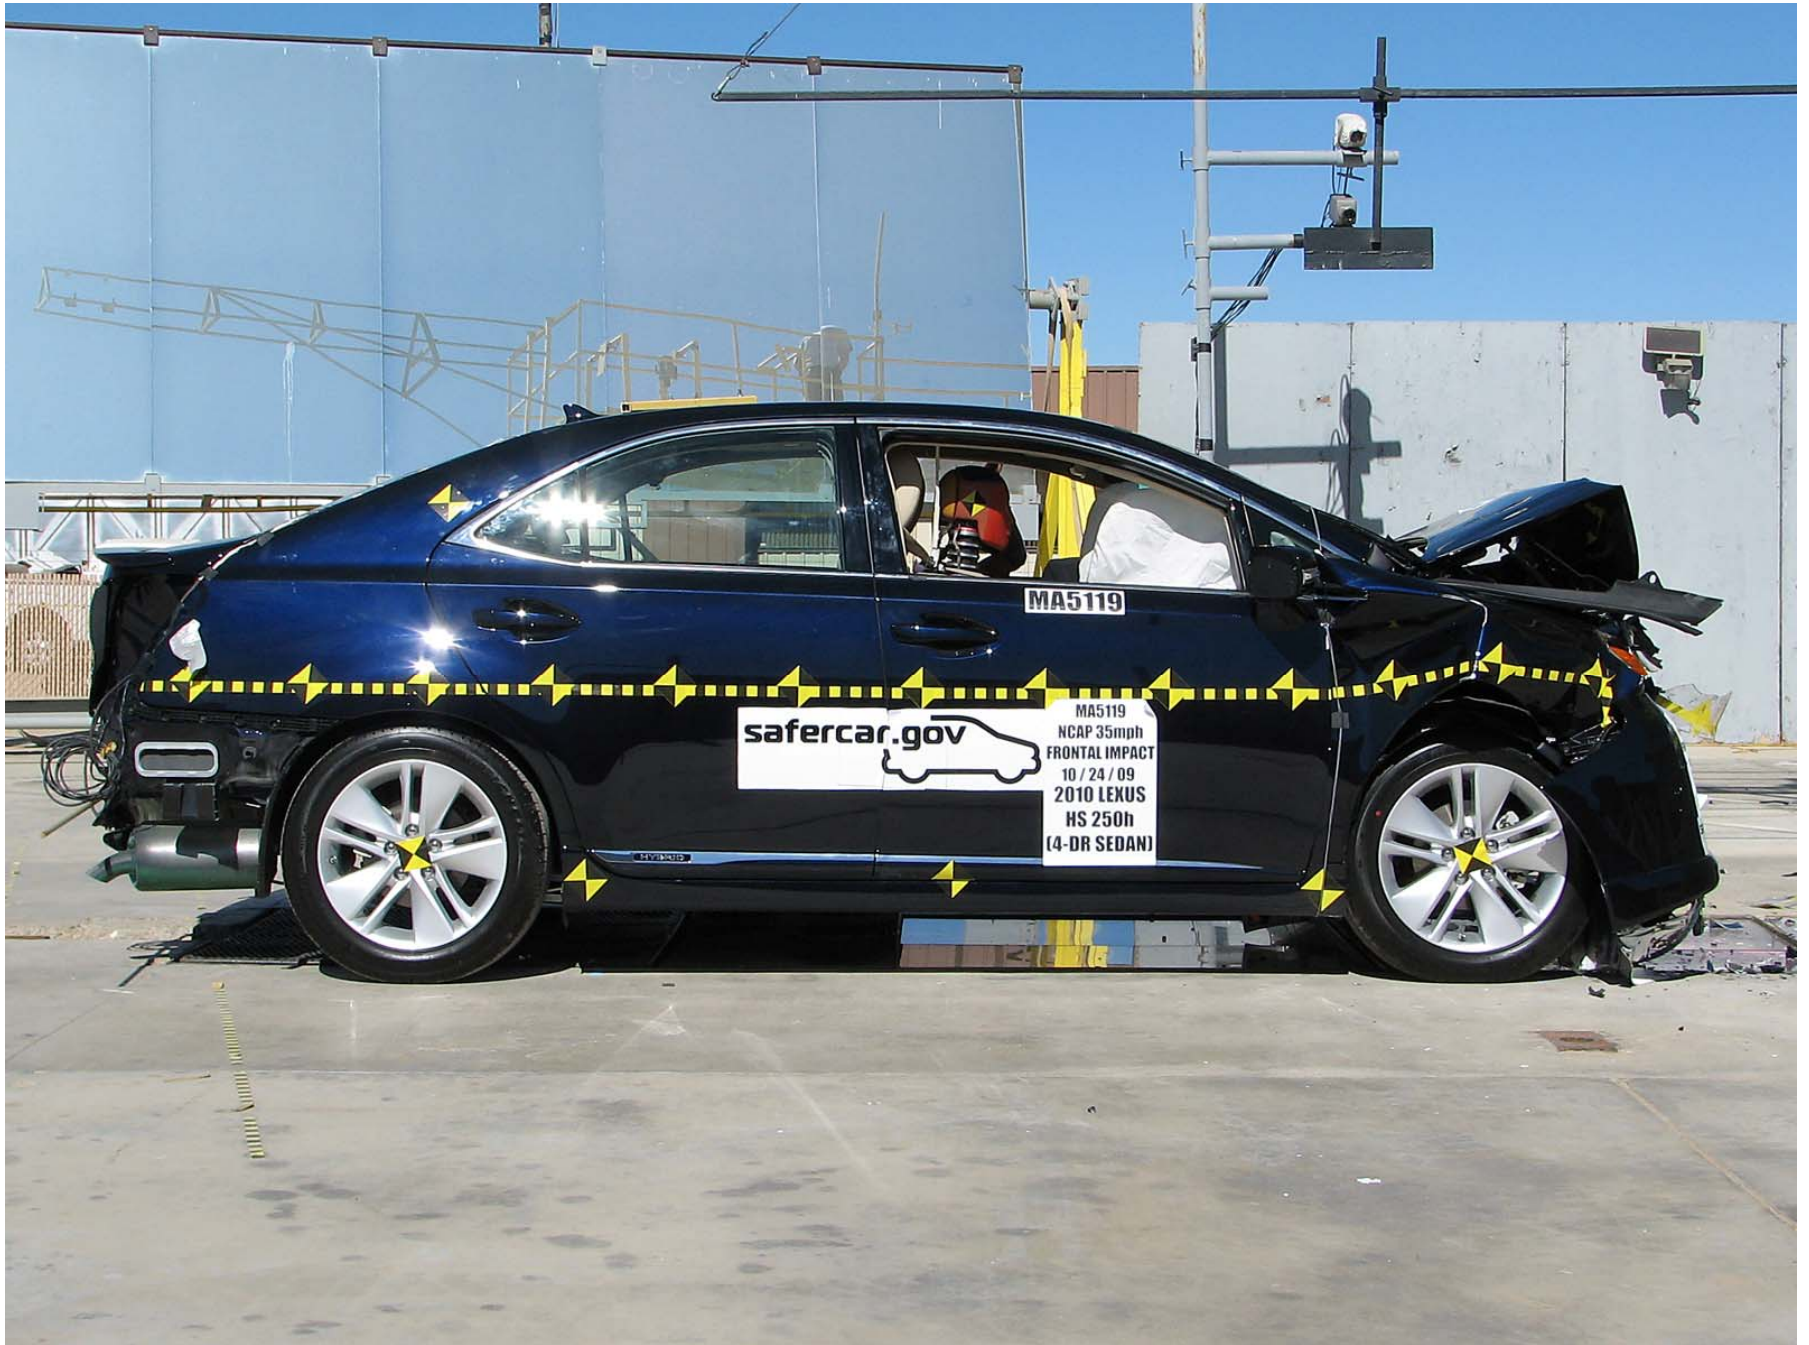
Figure A-16: Post-Test Right Side View

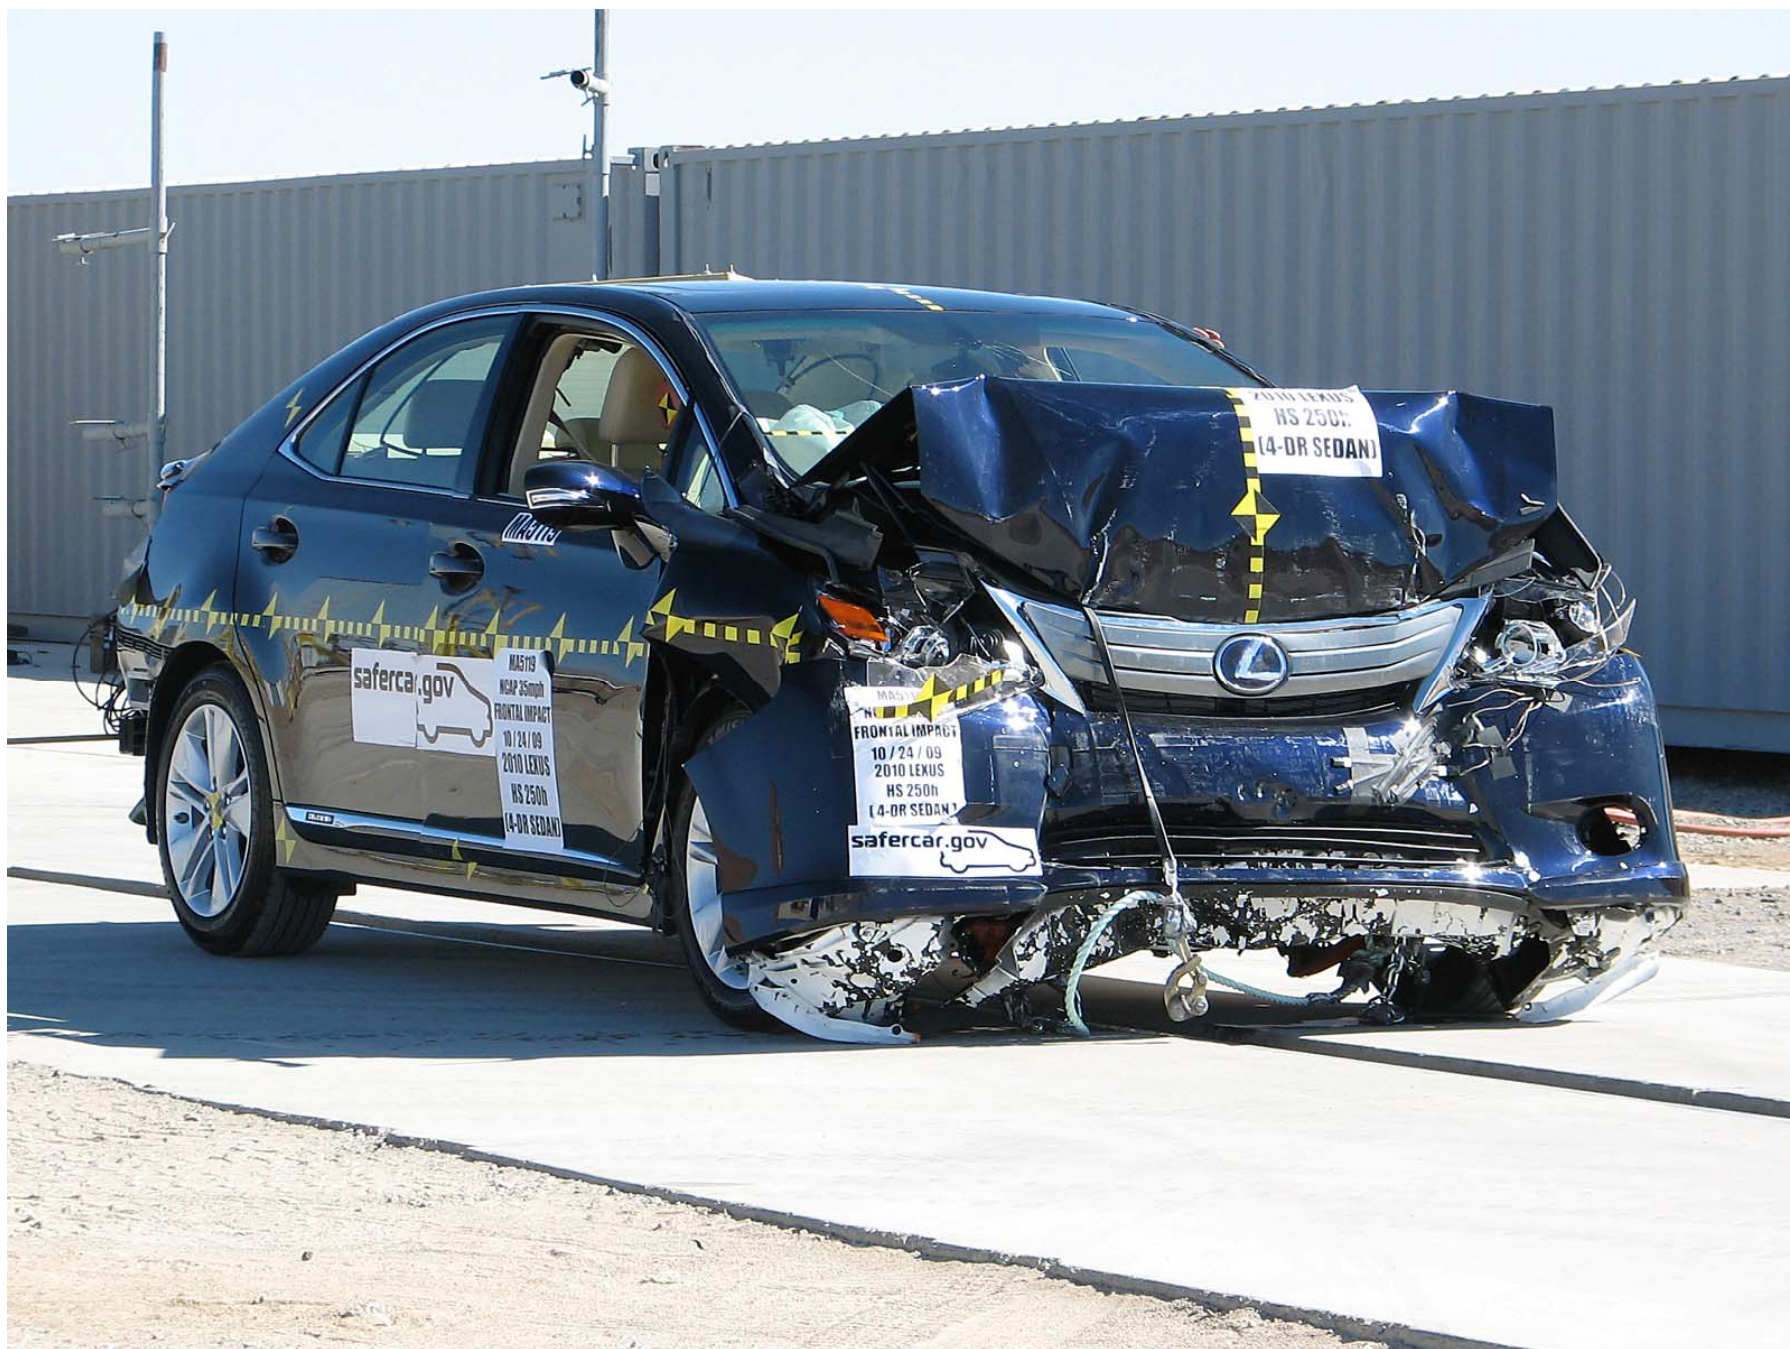
Figure A-18: Post-Test Right Front  $\frac{3}{4}$  View (Vehicle Moved)

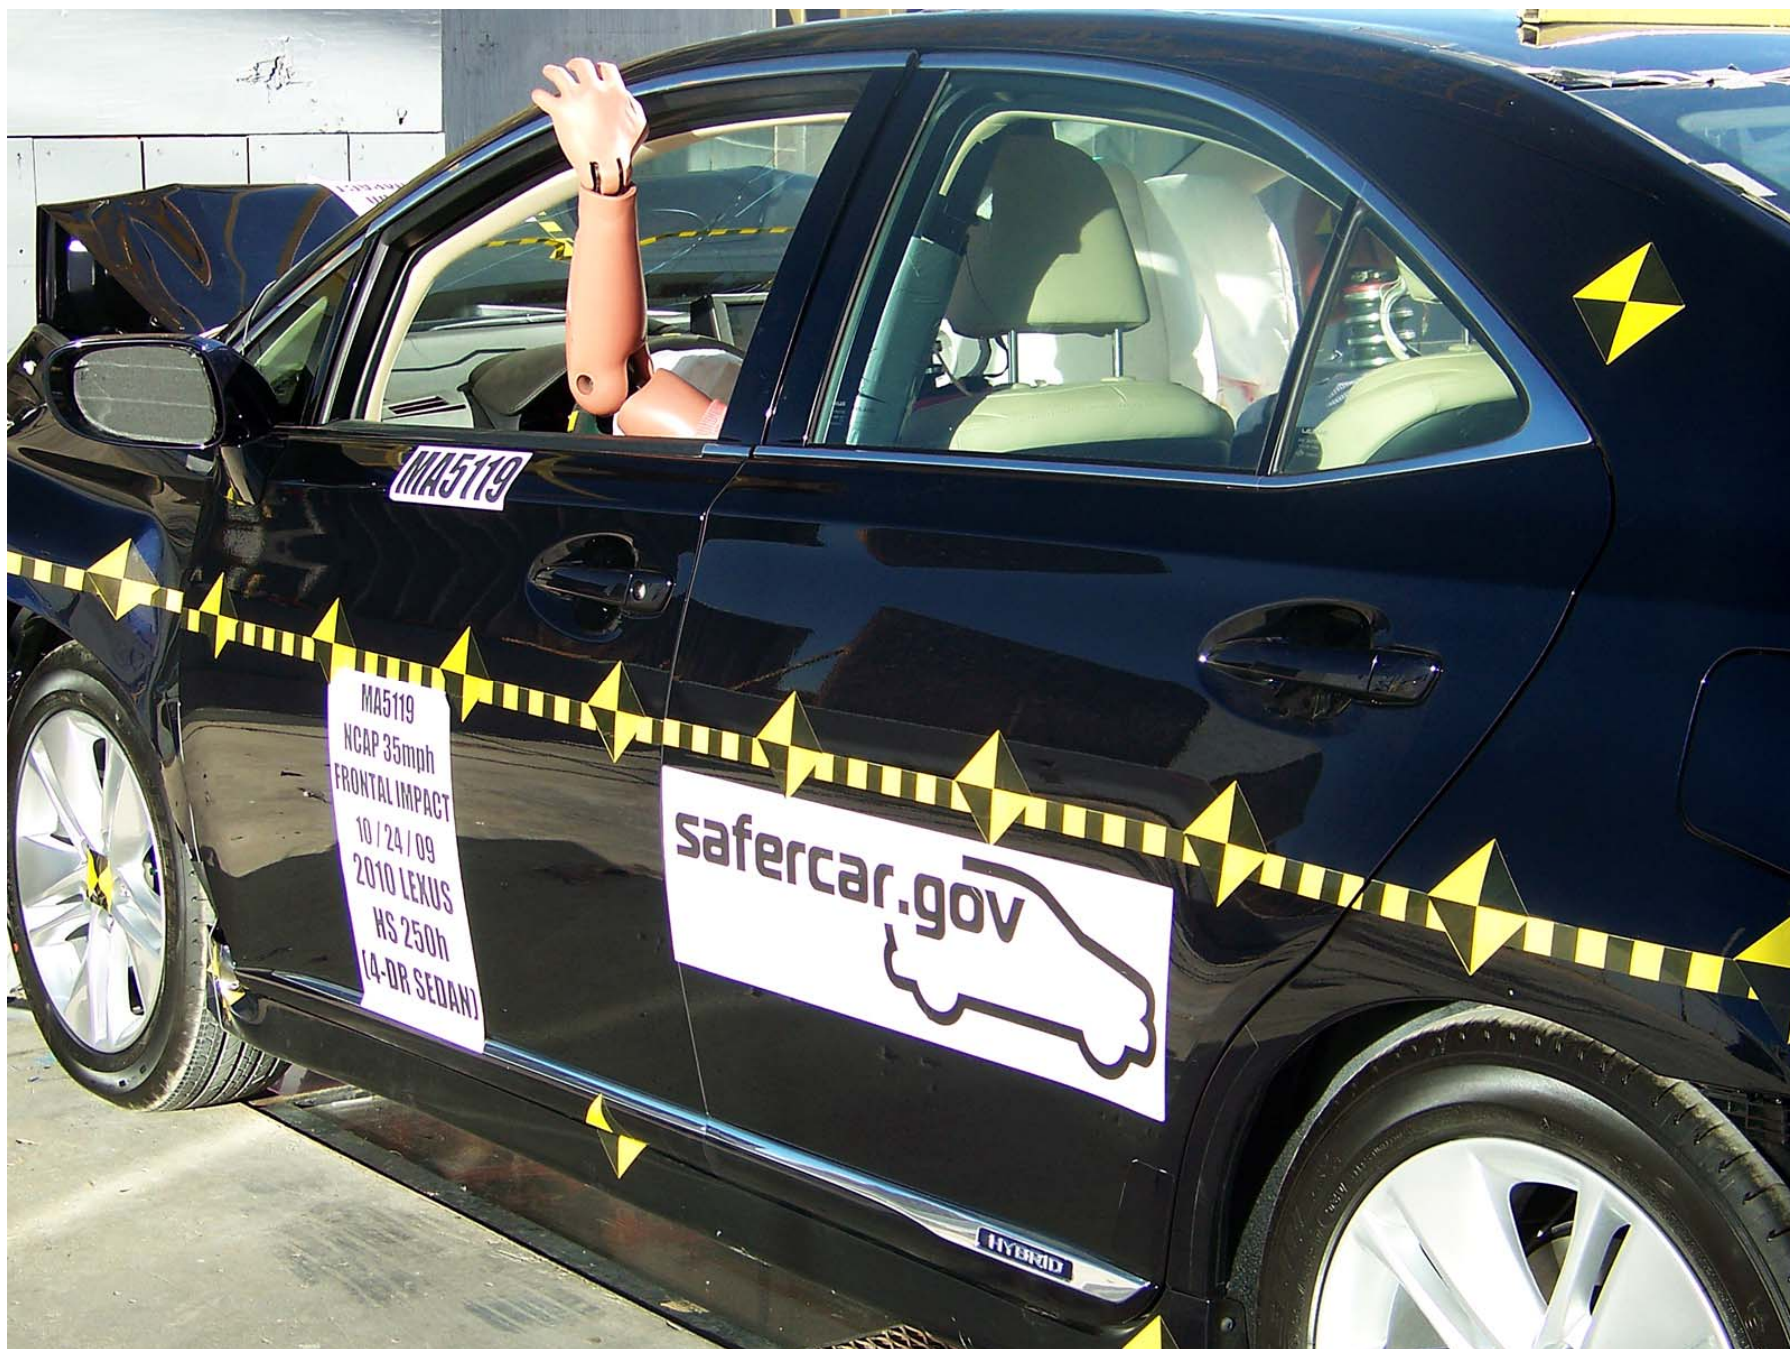
Figure A-21: Post-Test Left Side ¾ View of Doors After Impact

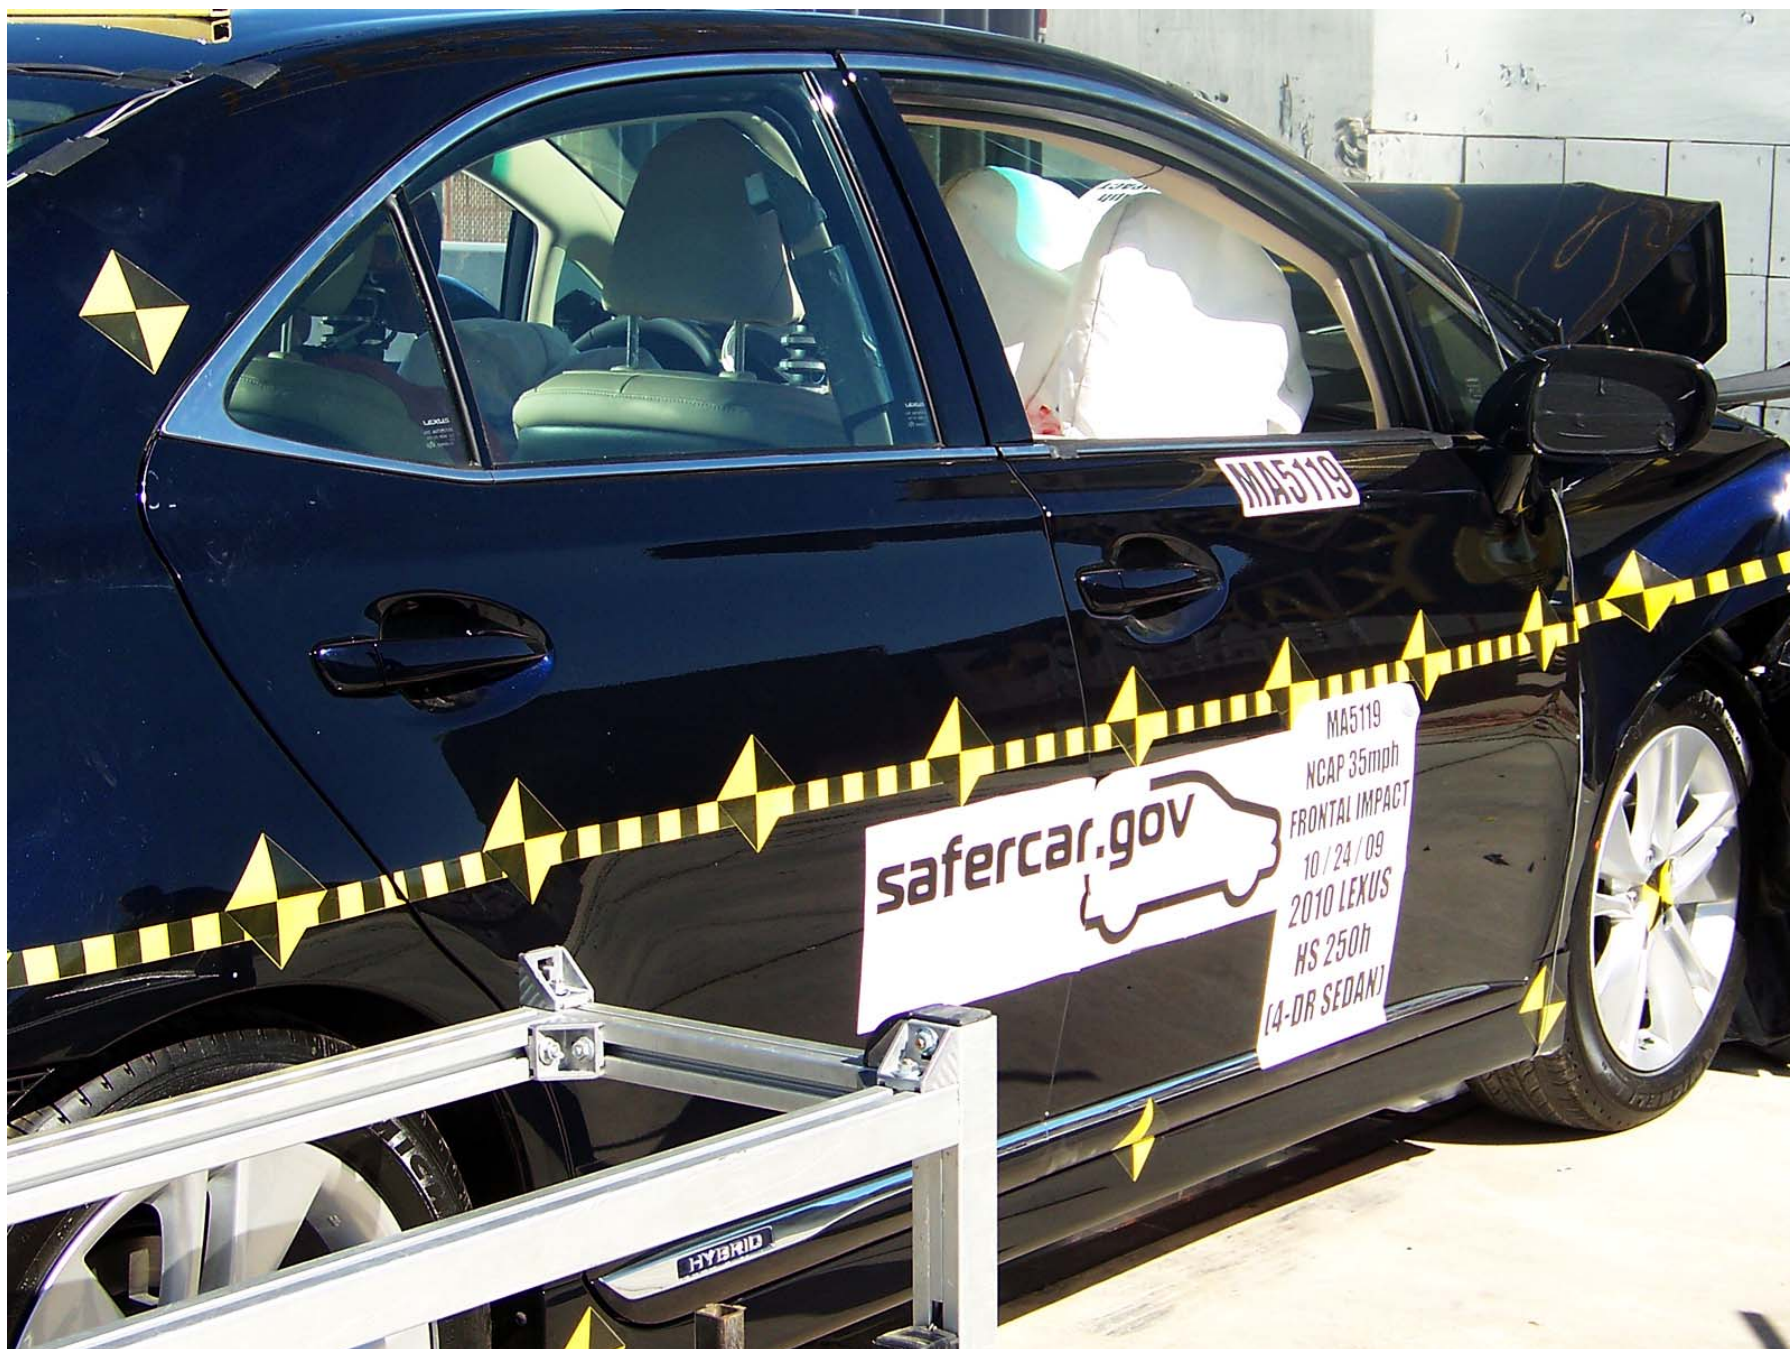
Figure A-22: Post-Test Right Side  $\frac{3}{4}$  View of Doors After Impact

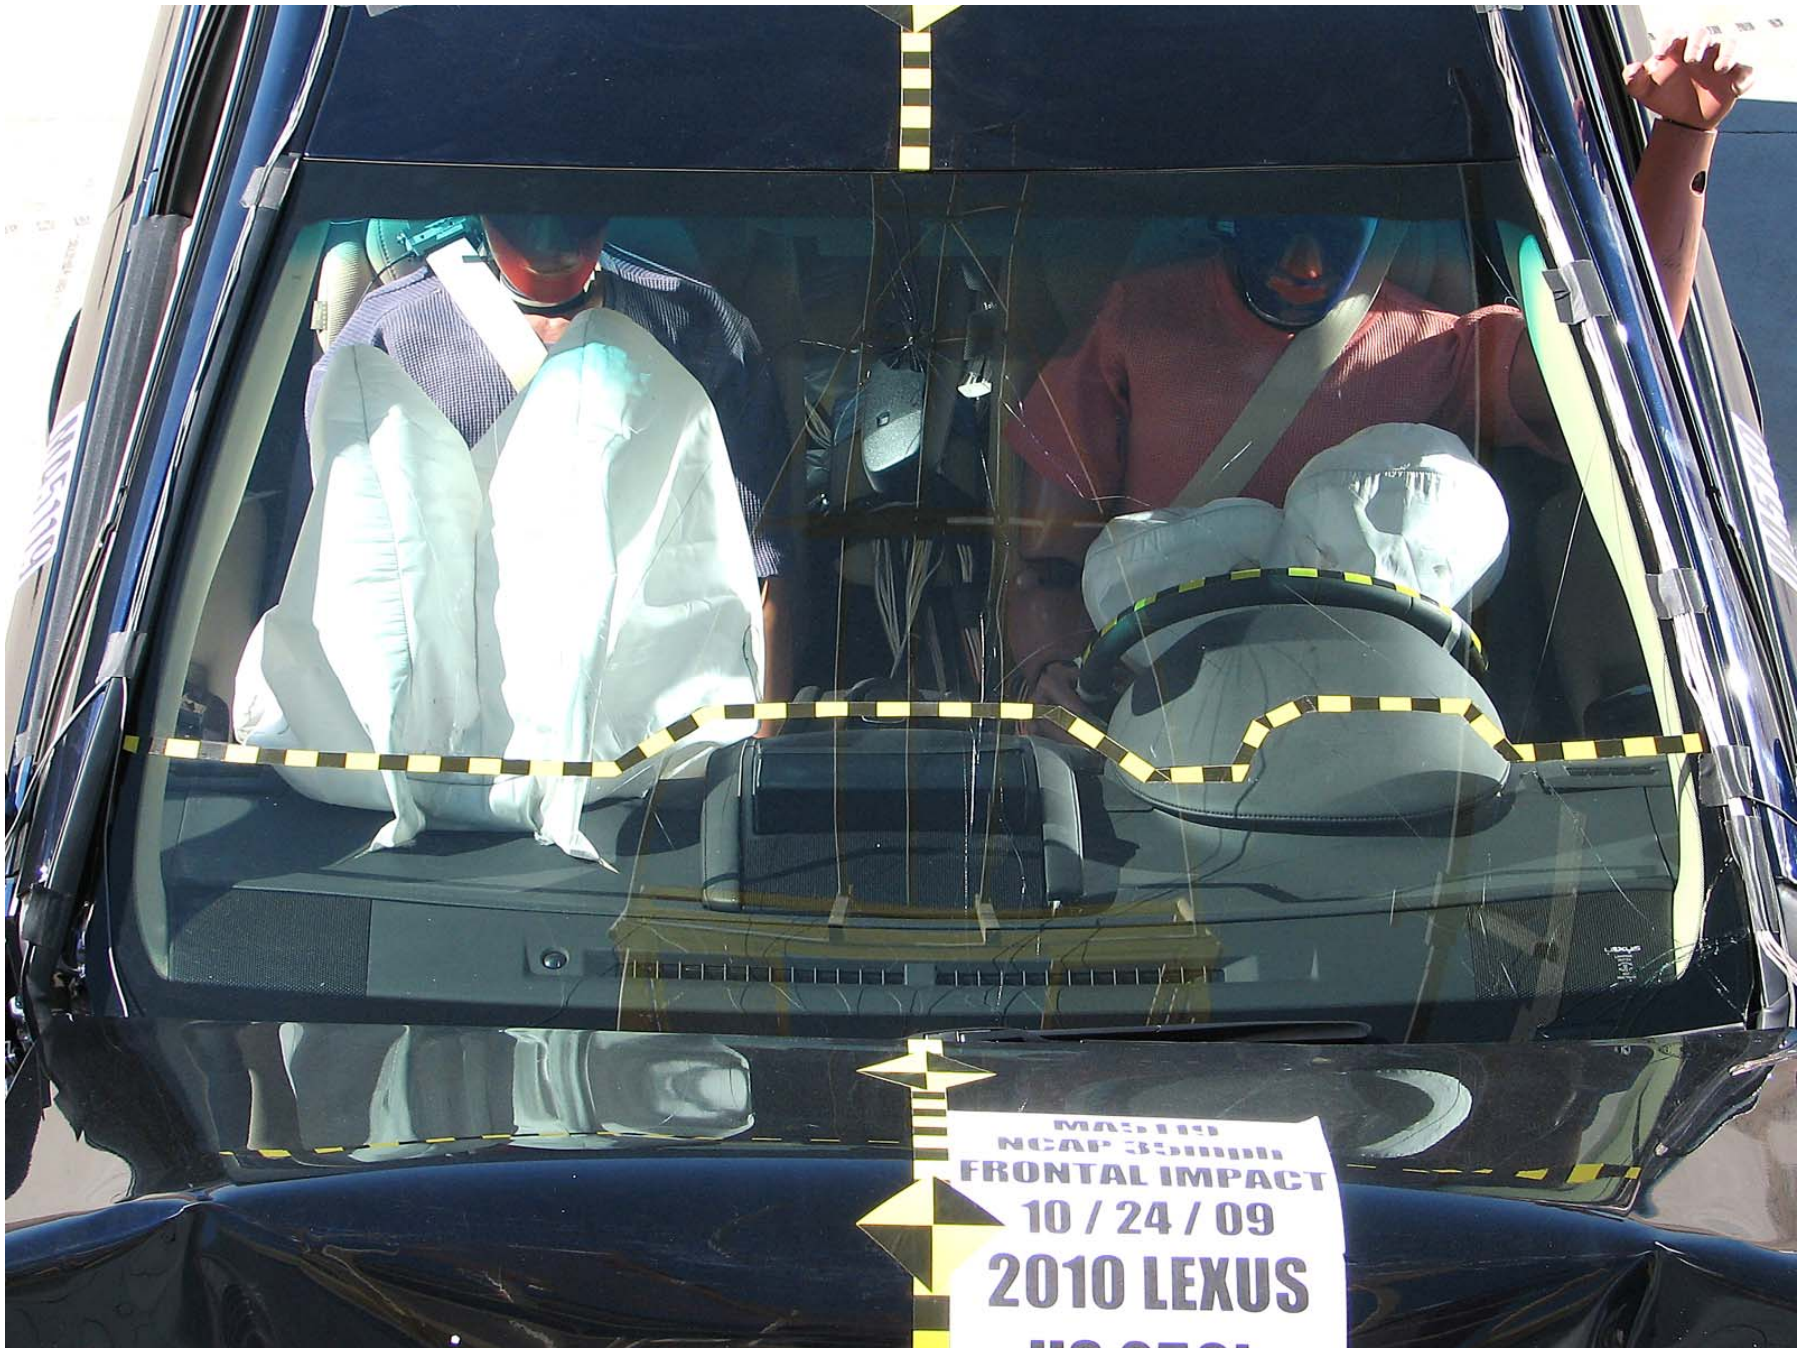
Figure A-24: Post-Test Windshield

There was 100% windshield retention and no intrusion into the protected zone of the windshield during impact. There was no Stoddard solvent leakage after the event, or during any phase of the static rollover. There was also no electrolyte leakage or propulsion battery shorting to chassis after the event or at any phase of the static rollover.

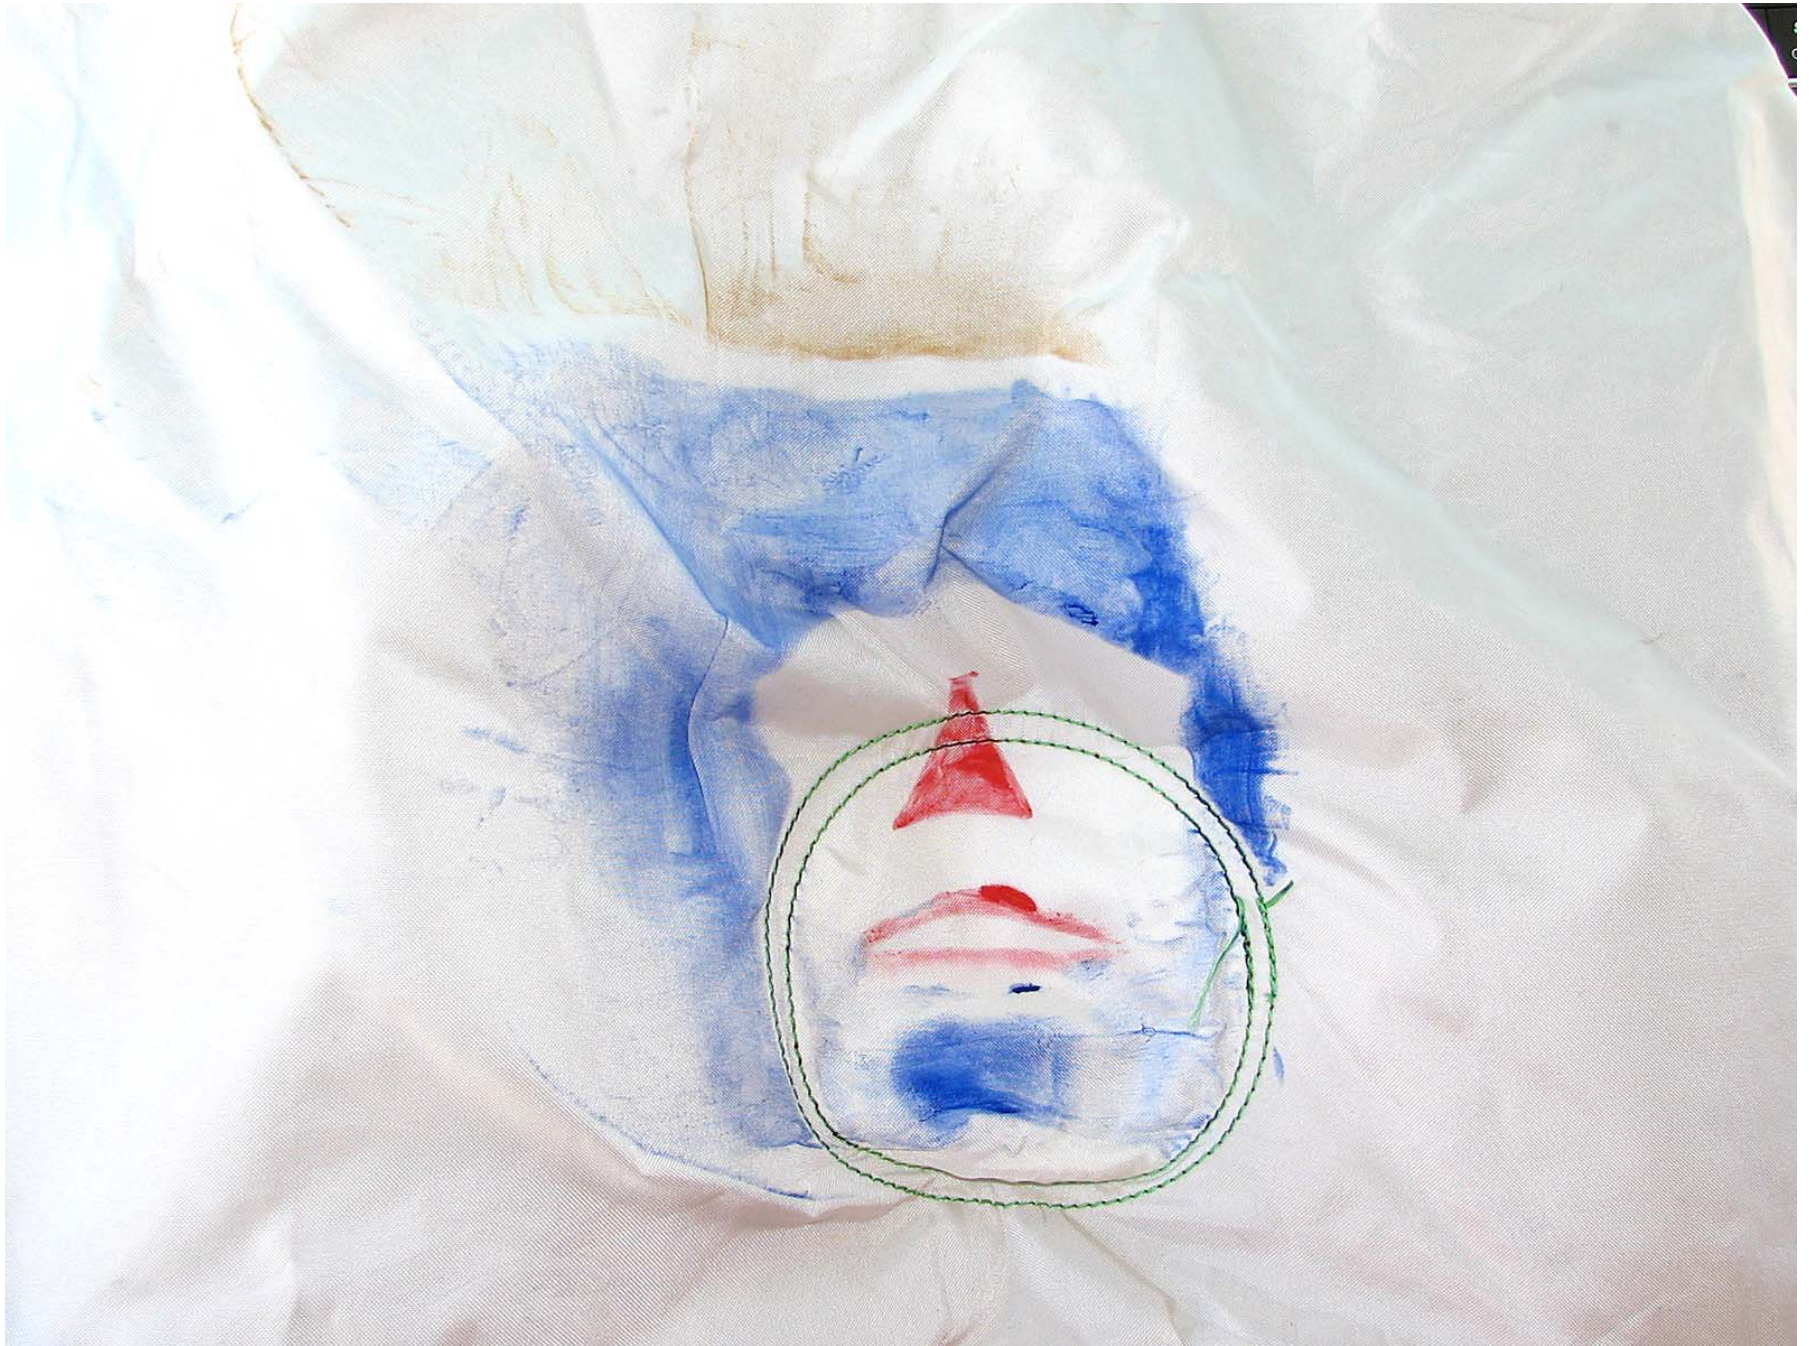
Figure A-48: Post-Test Driver Dummy Airbag Contact

The driver's visible contact points were as follows: The driver ATD's head and chest contacted the airbag. The head also contacted the headrest. Both knees contacted the Knee airbag.

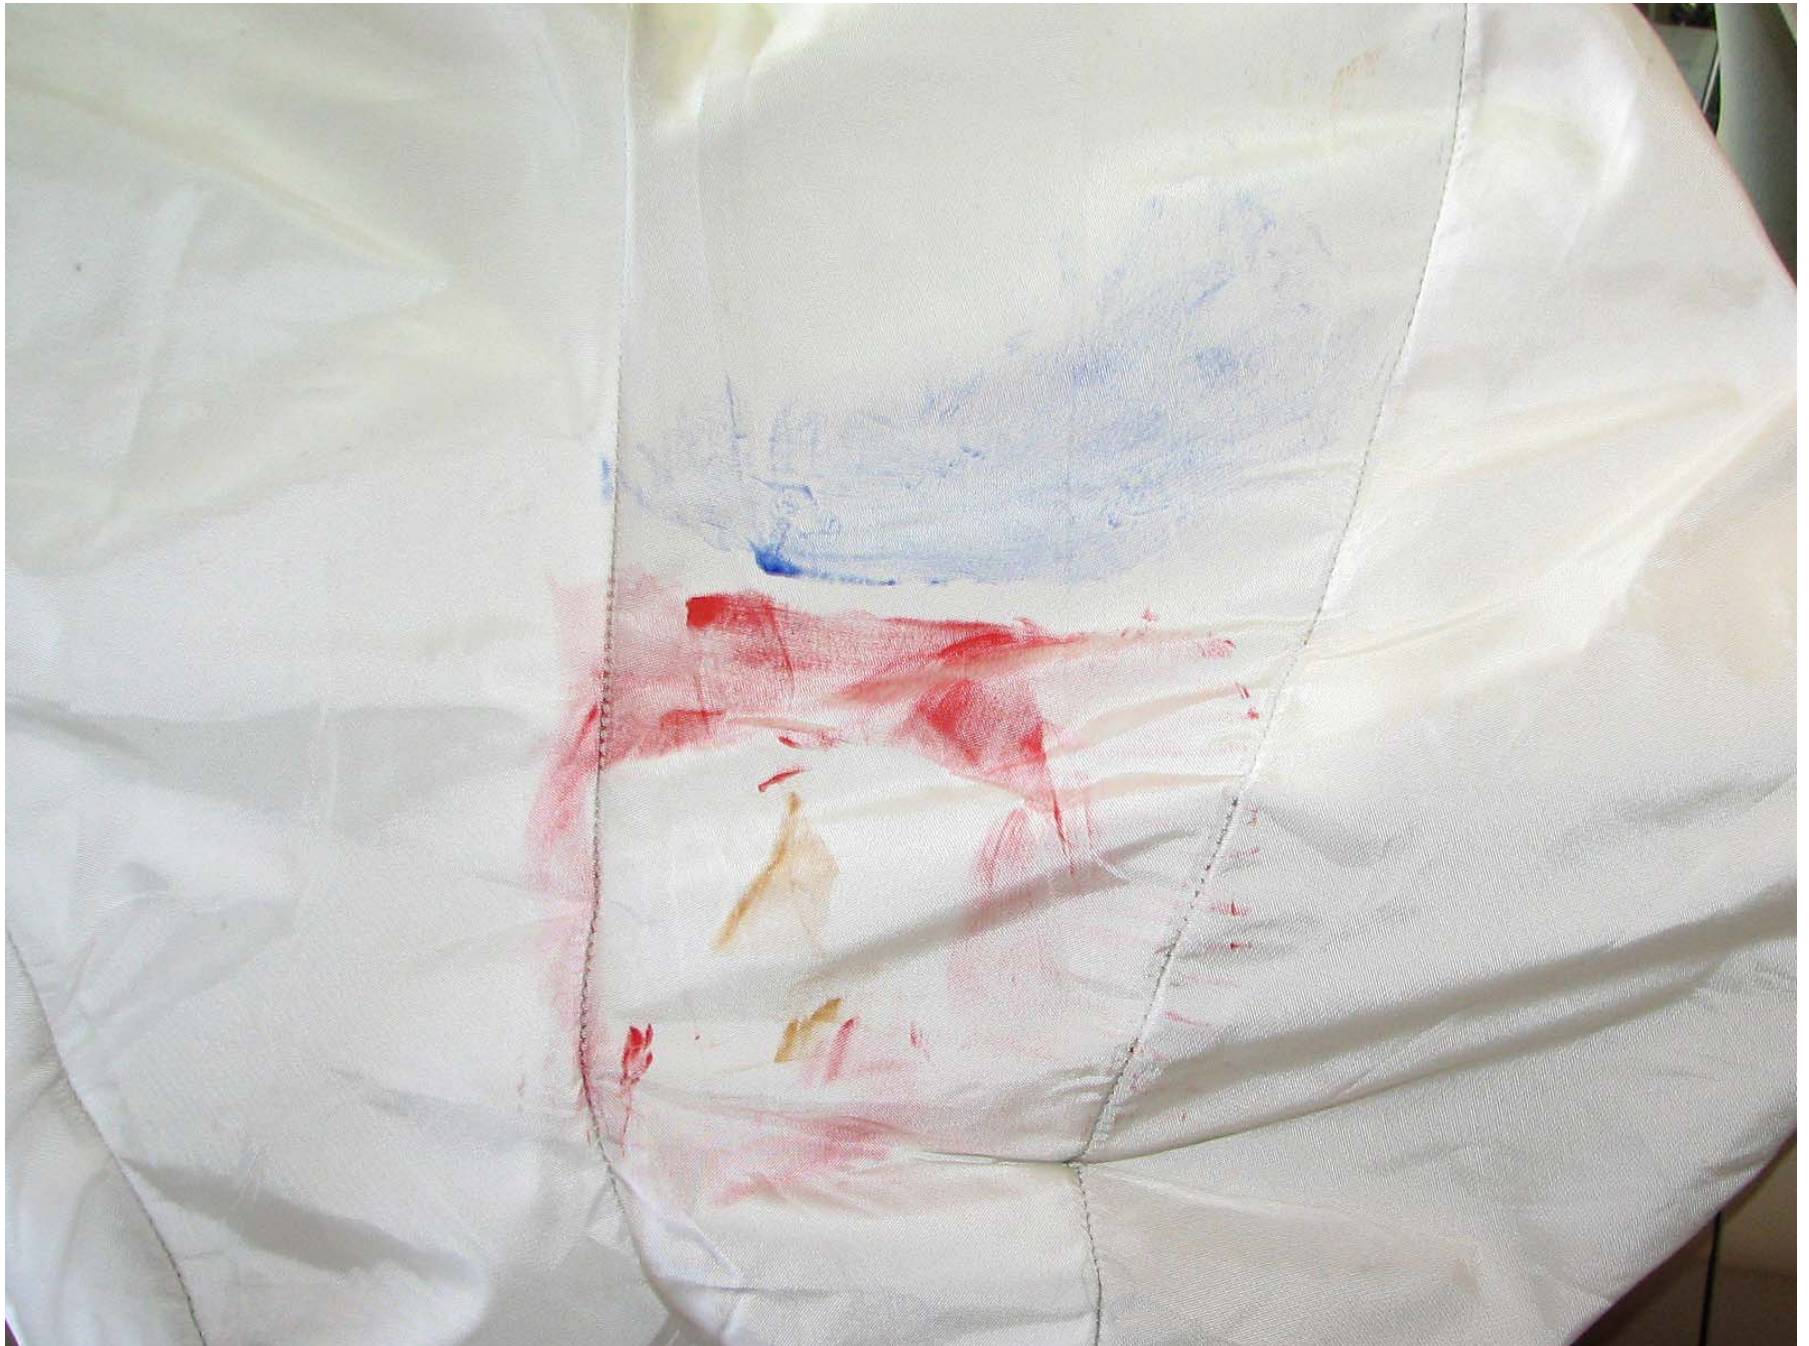
Figure A-62: Post-Test Passenger Dummy Airbag Contact

The passenger's visible contact points were as follows: The passenger ATD's head and chest contacted the airbag. The head also contacted the headrest. Both knees contacted the Knee airbag.

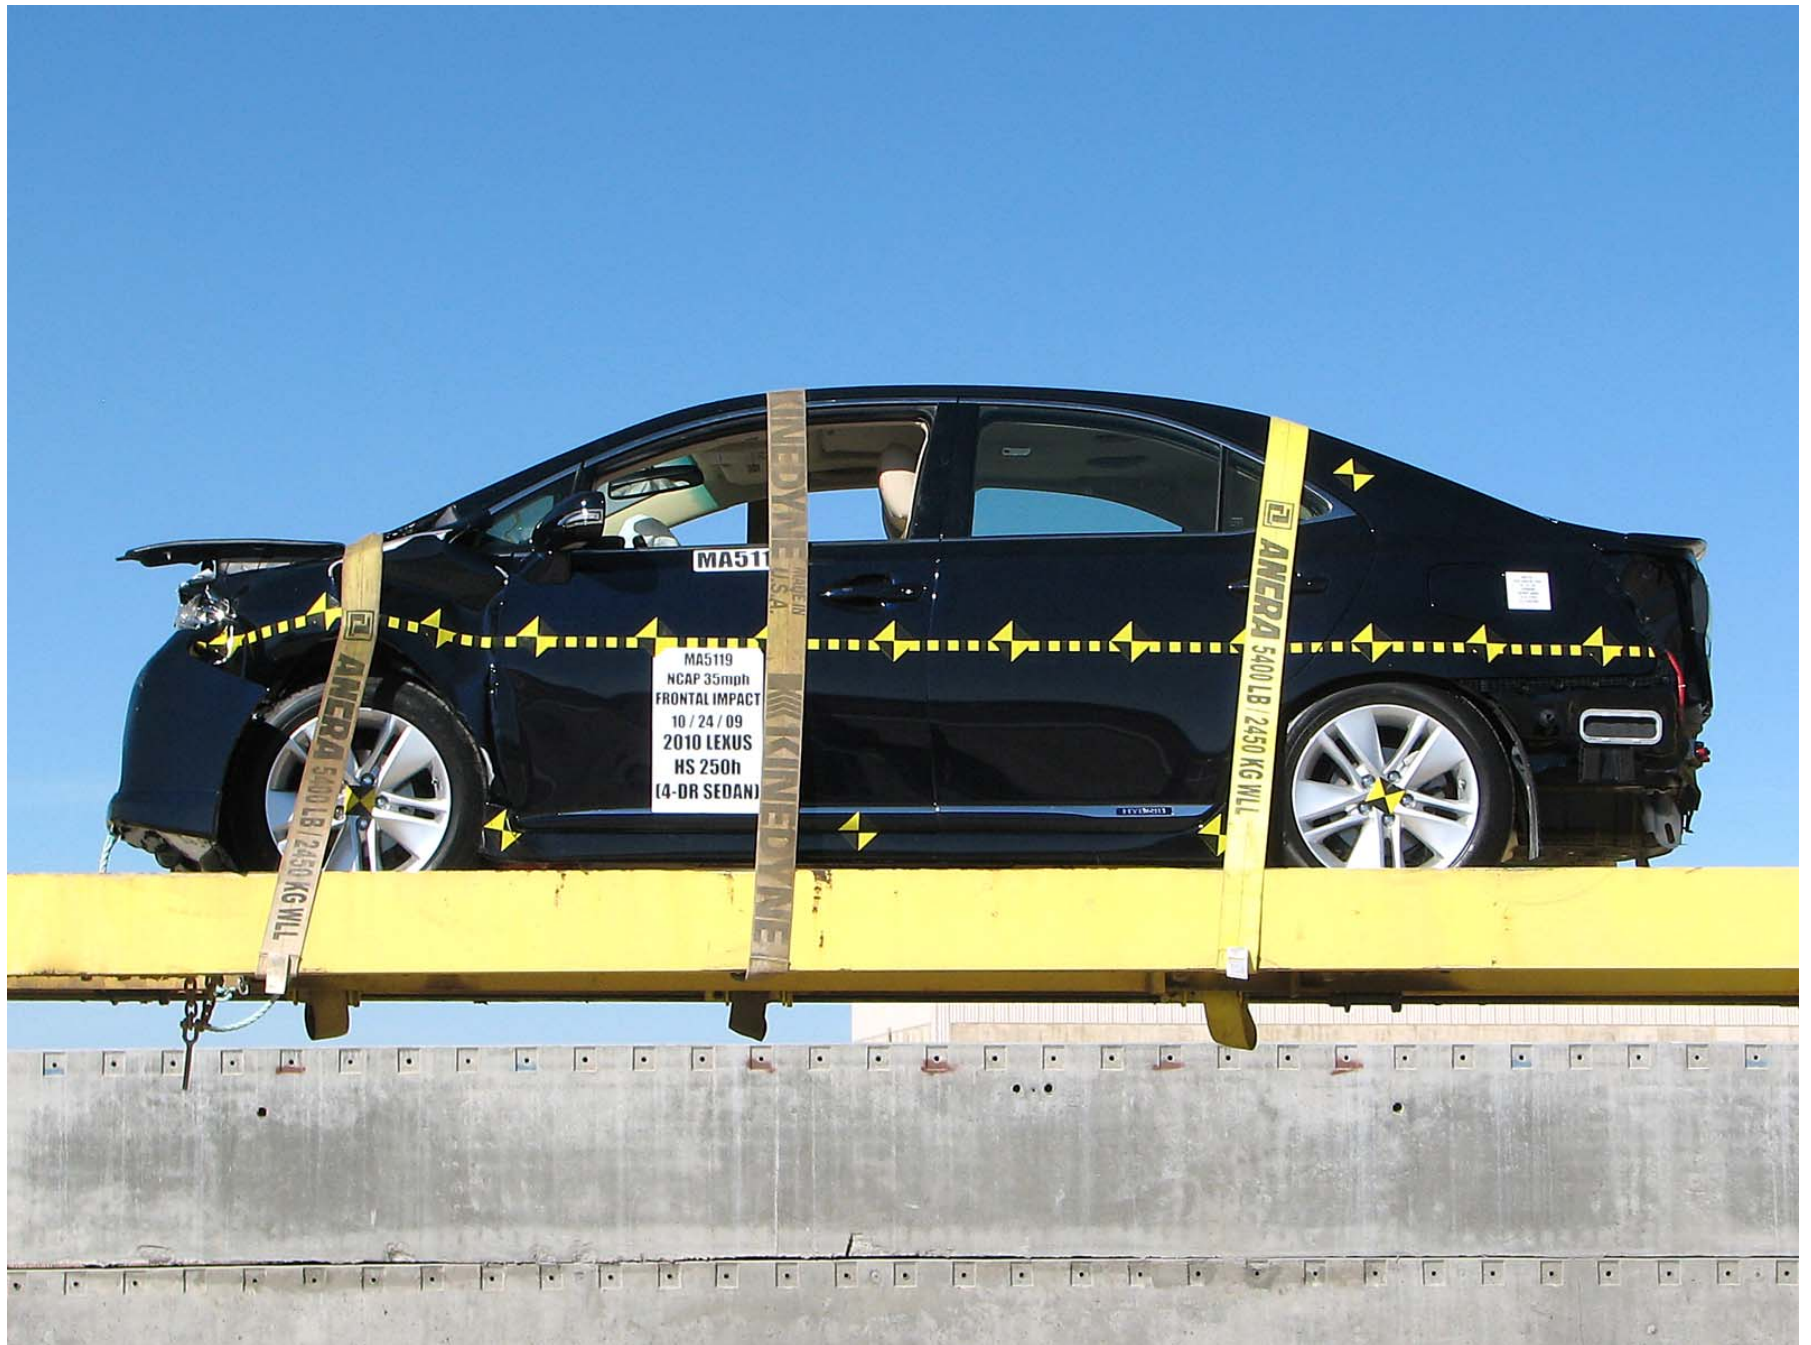
Figure A-71: Vehicle on Rollover Device (0°)
