**REPORT NUMBER TR-P29001-10-NC**

**NEW CAR ASSESMENT PROGRAM  
FRONTAL BARRIER IMPACT TEST**

**TOYOTA MOTOR CORPORATION  
2010 LEXUS HS 250H  
4-DOOR SEDAN**

**NHTSA NUMBER: MA5119**

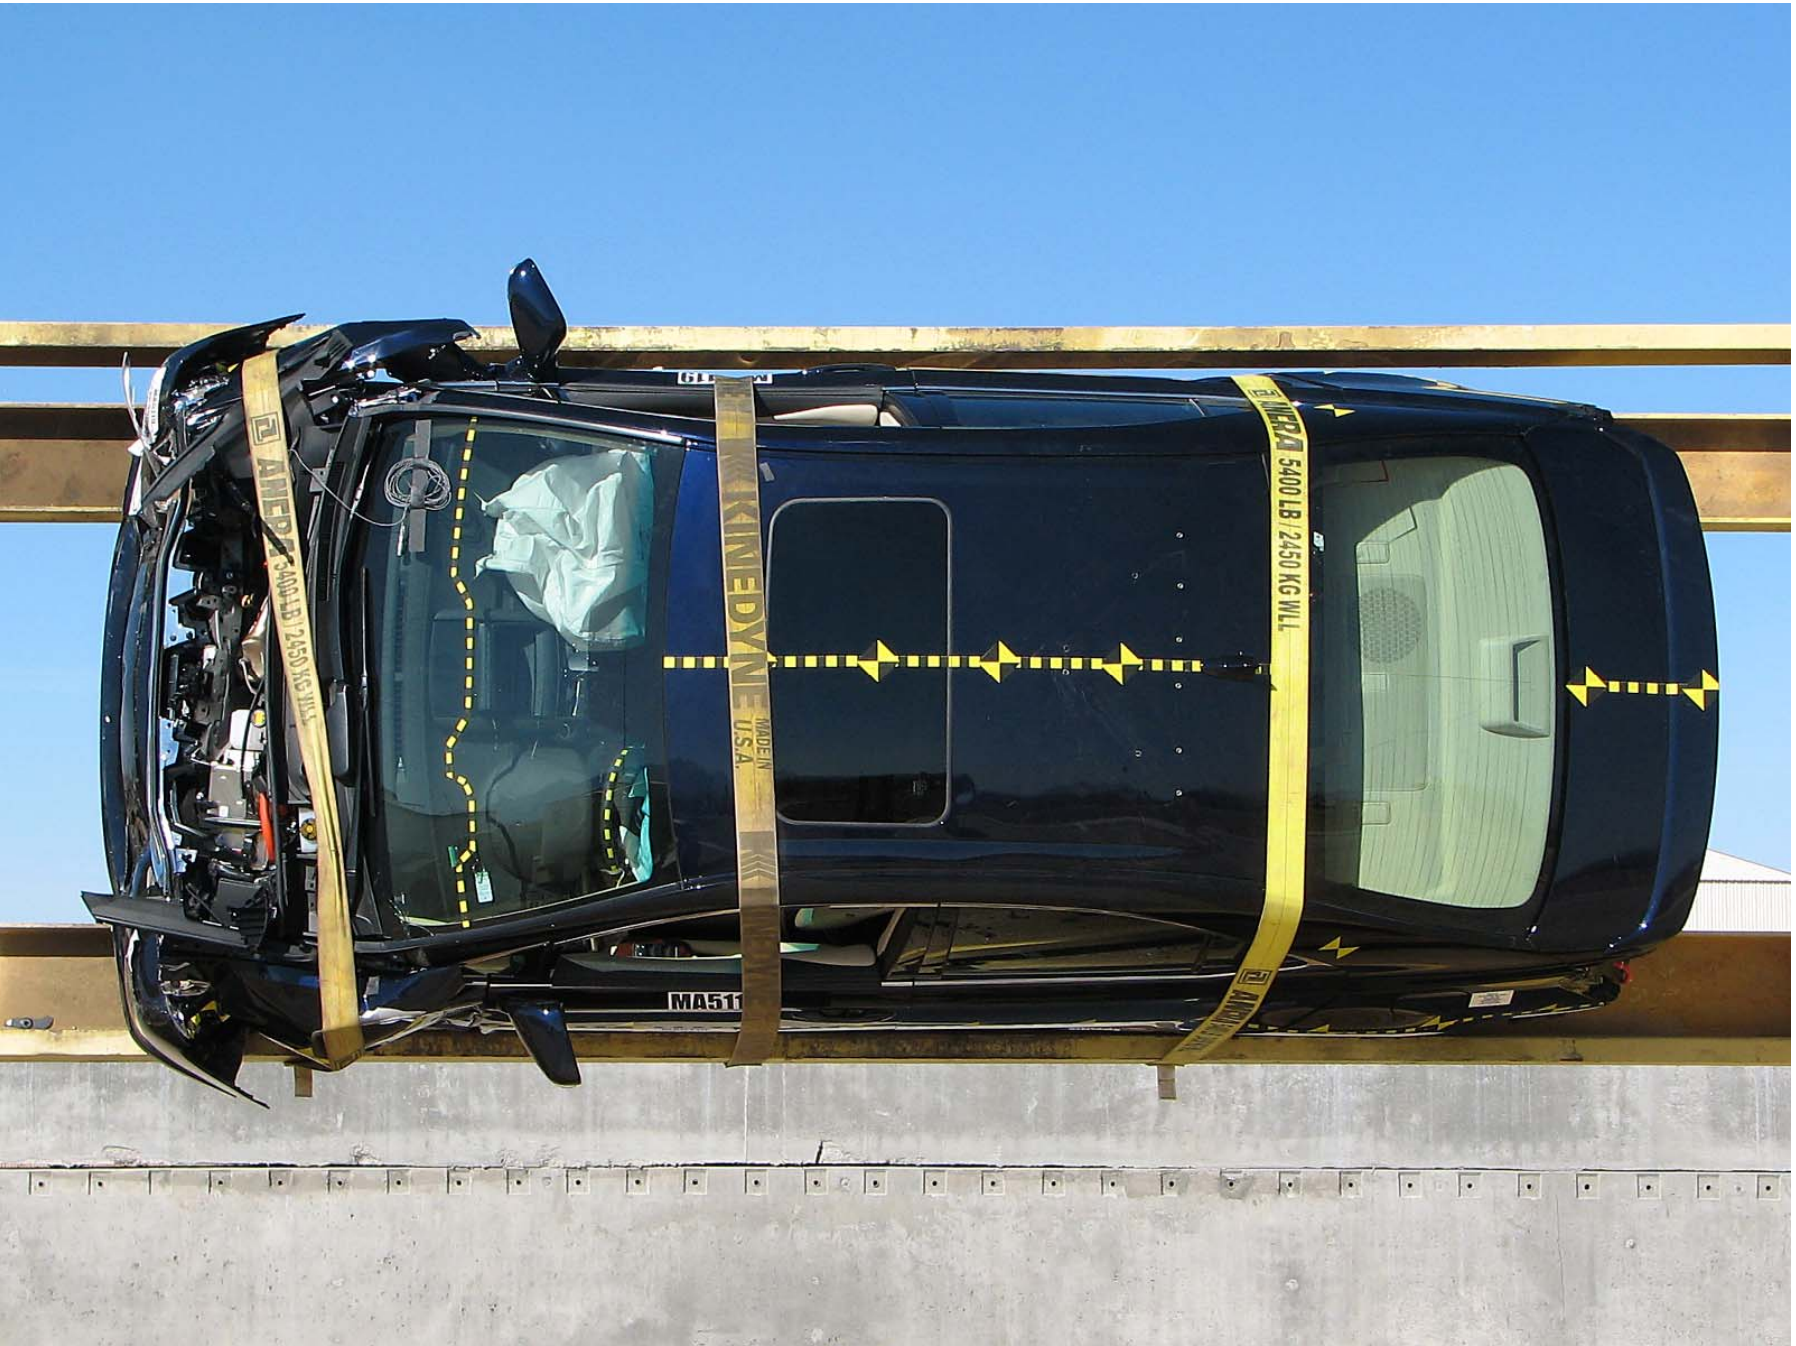
Figure A-72: Vehicle on Rollover Device (90°)

There was 100% windshield retention and no intrusion into the protected zone of the windshield during impact. There was no Stoddard solvent leakage after the event, or during any phase of the static rollover. There was also no electrolyte leakage or propulsion battery shorting to chassis after the event or at any phase of the static rollover.

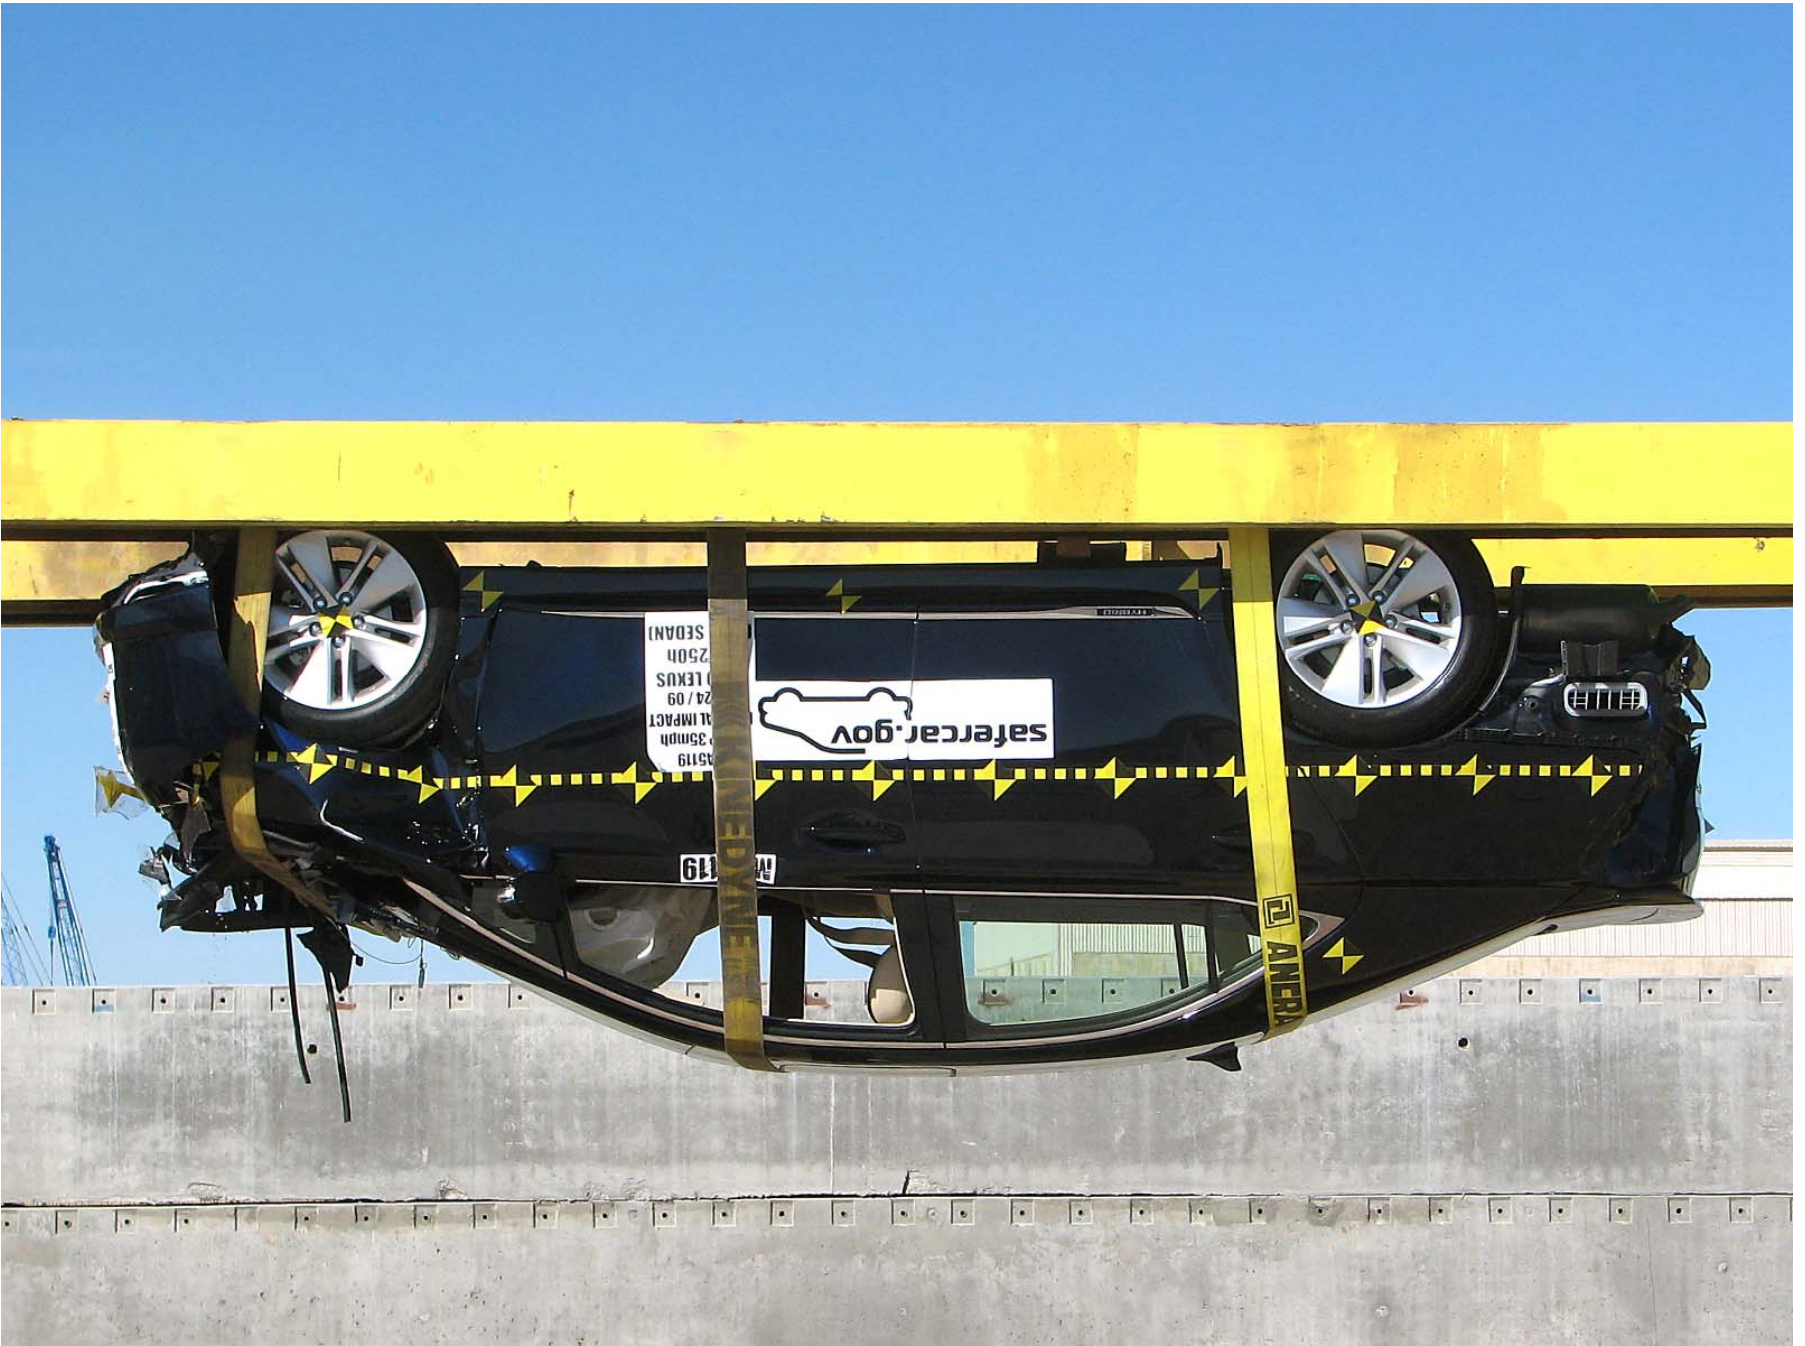
Figure A-73: Vehicle on Rollover Device (180°)

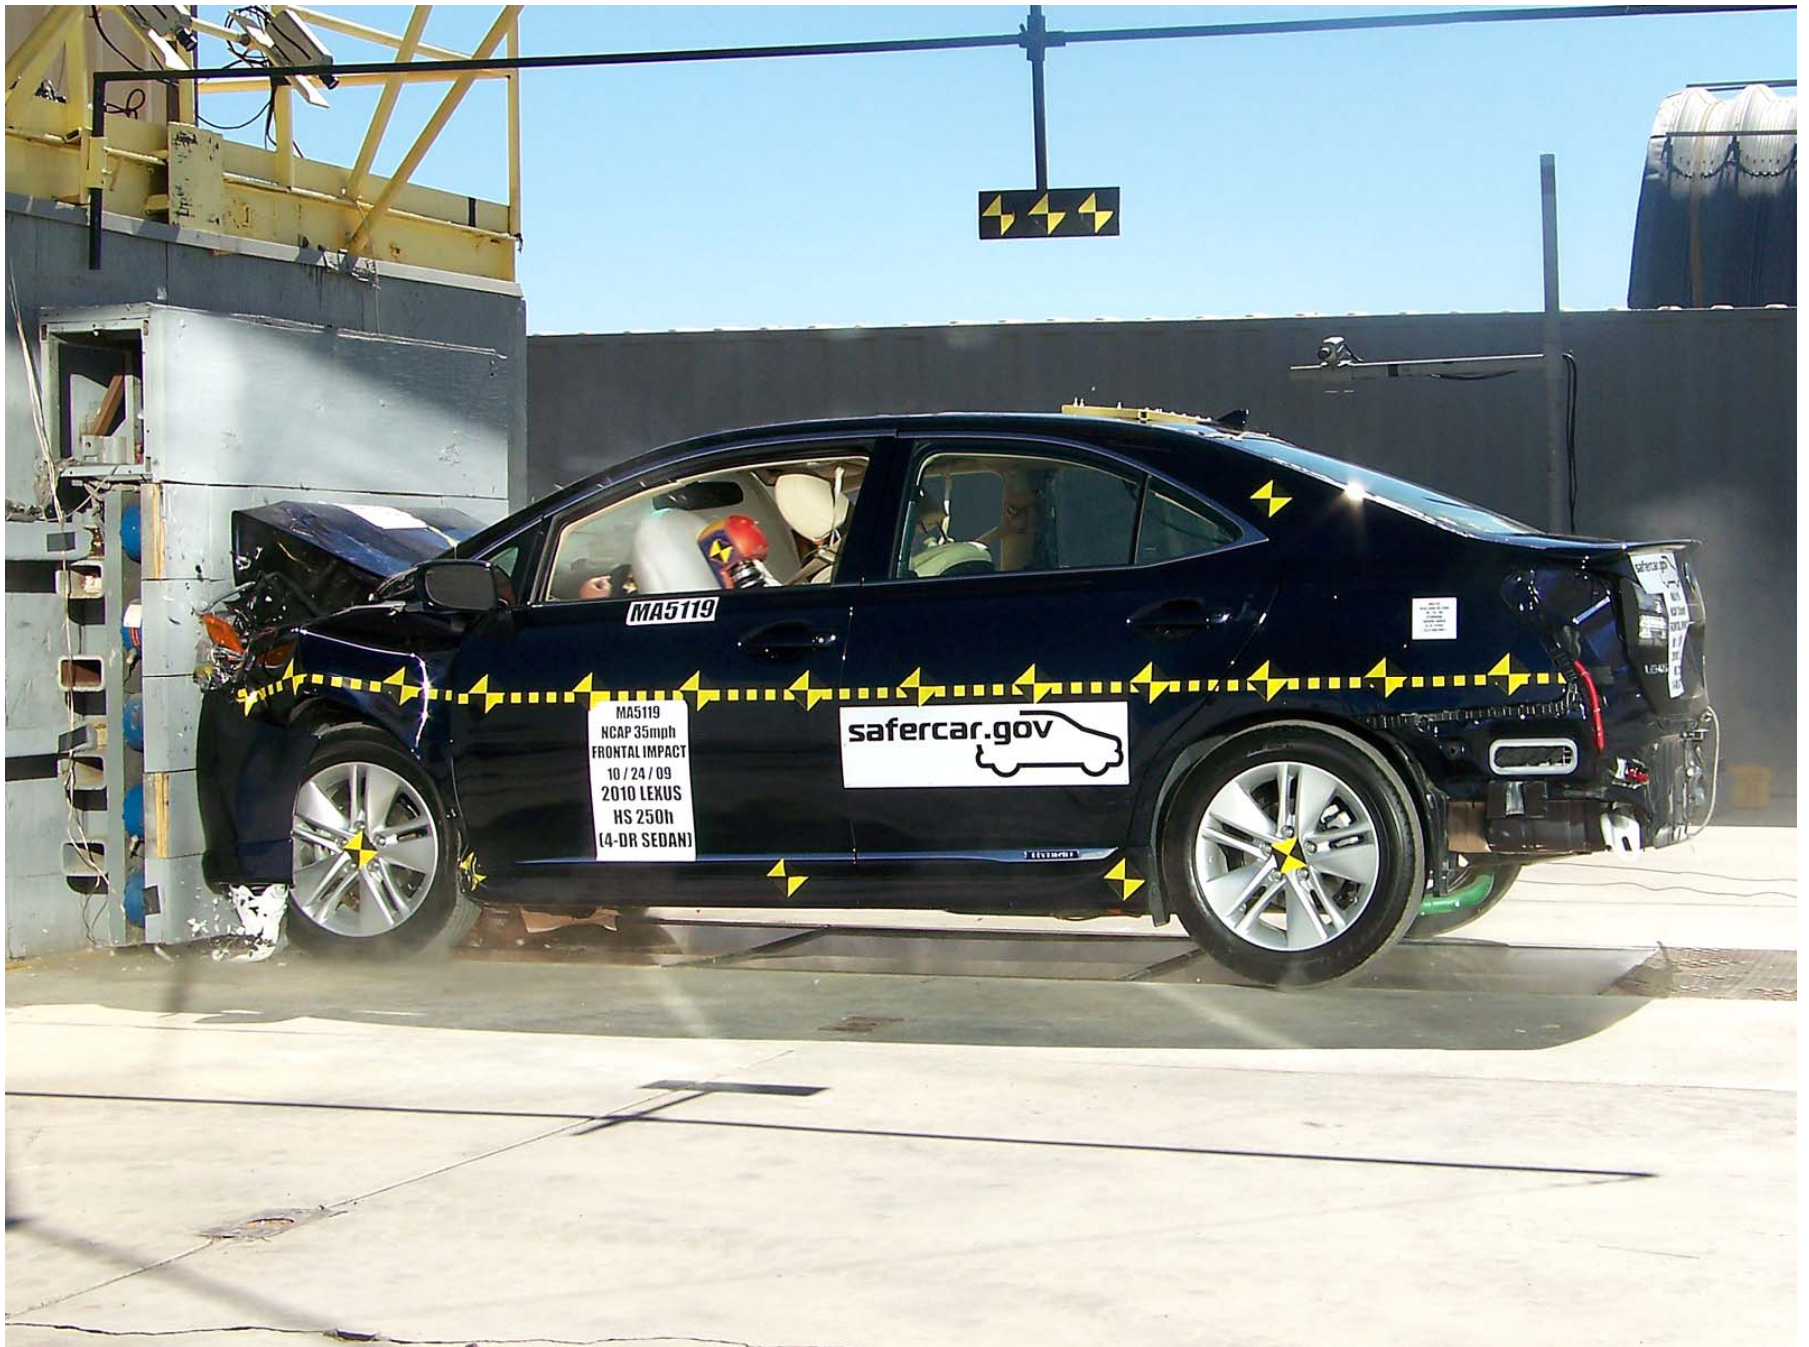
Figure A-77: Vehicle Impact

A load cell barrier consisting of 36 load cells was impacted by a 2010 Lexus HS 250h 4-Door Sedan at a velocity of 56.44 km/h. The test was performed at KARCO Engineering, LLC on October 24, 2009.
