**REPORT NUMBER: MCW-DOT-10SN02**

**NEW CAR ASSESSMENT PROGRAM  
SIDE IMPACT TEST**

**2010 DODGE AVENGER SXT 4-DOOR SEDAN**

**FINAL REPORT**

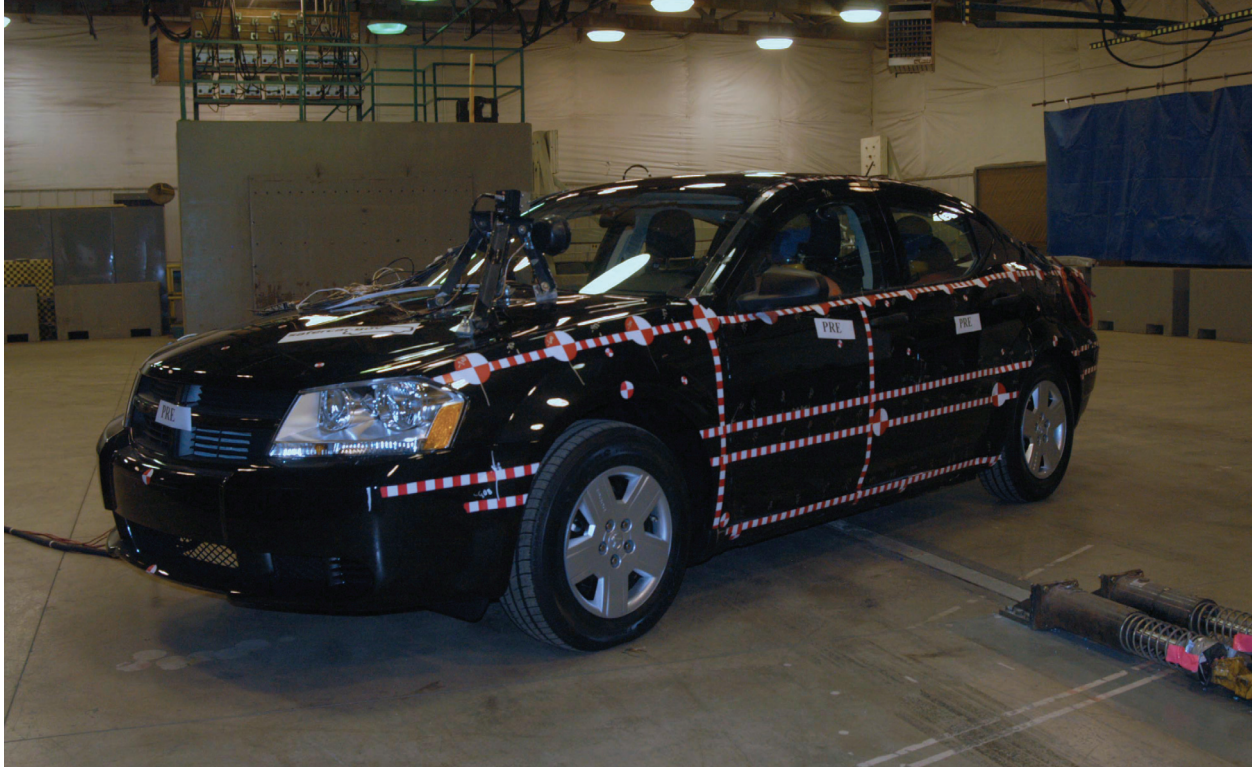
Figure A-6: Post test front view of test vehicle

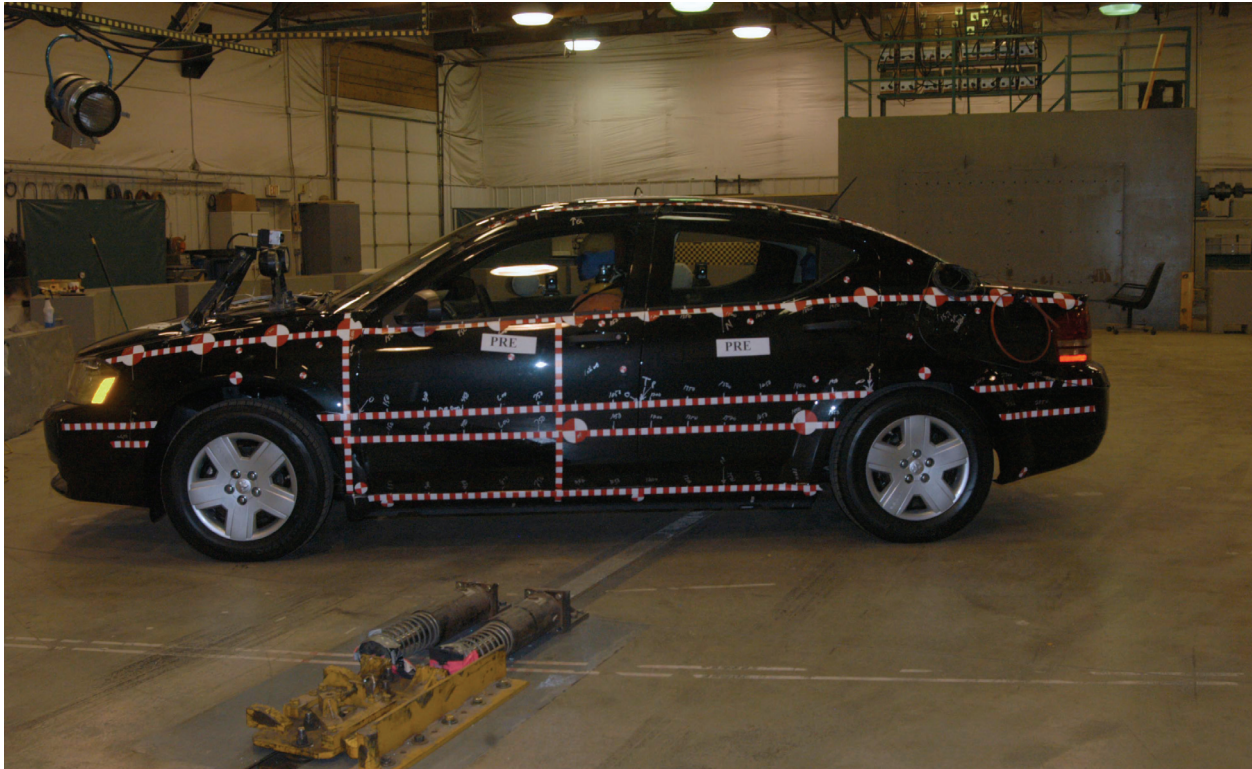
Figure A-8: Post test left front 3/4 view of test vehicle

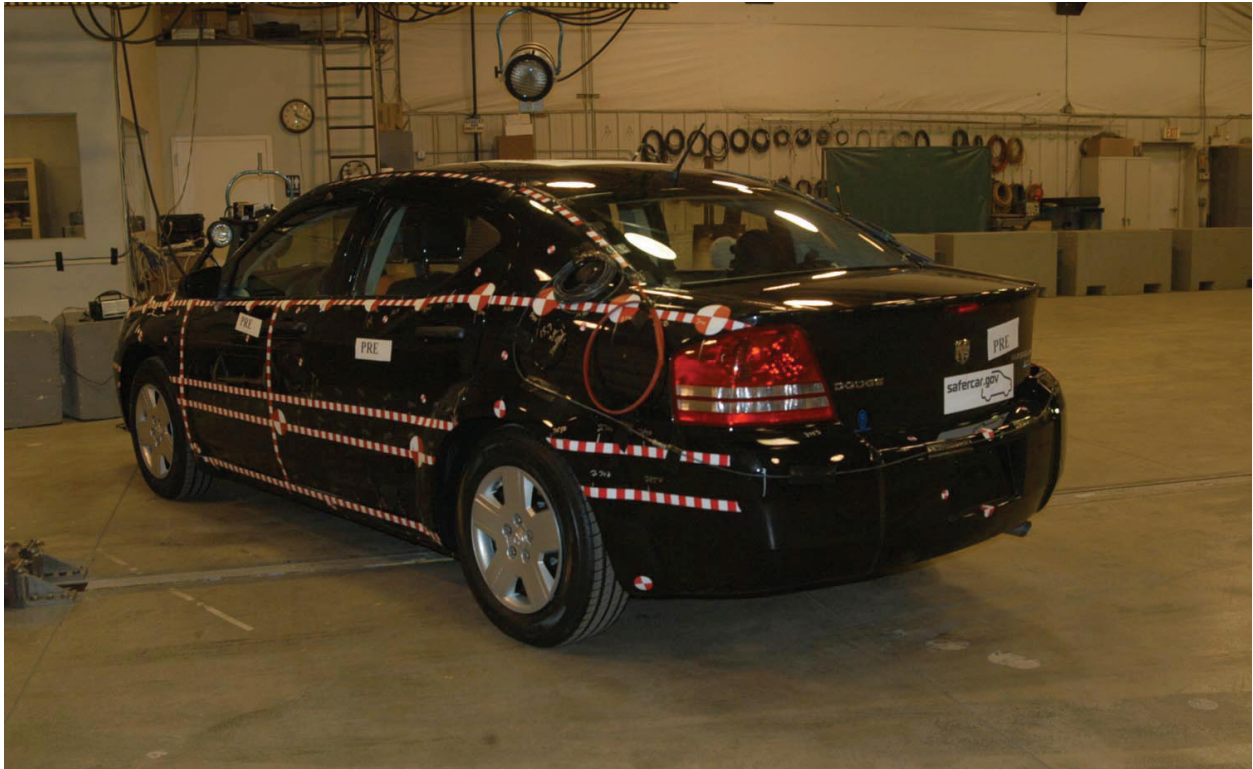
Figure A-10: Post test left side view of test vehicle

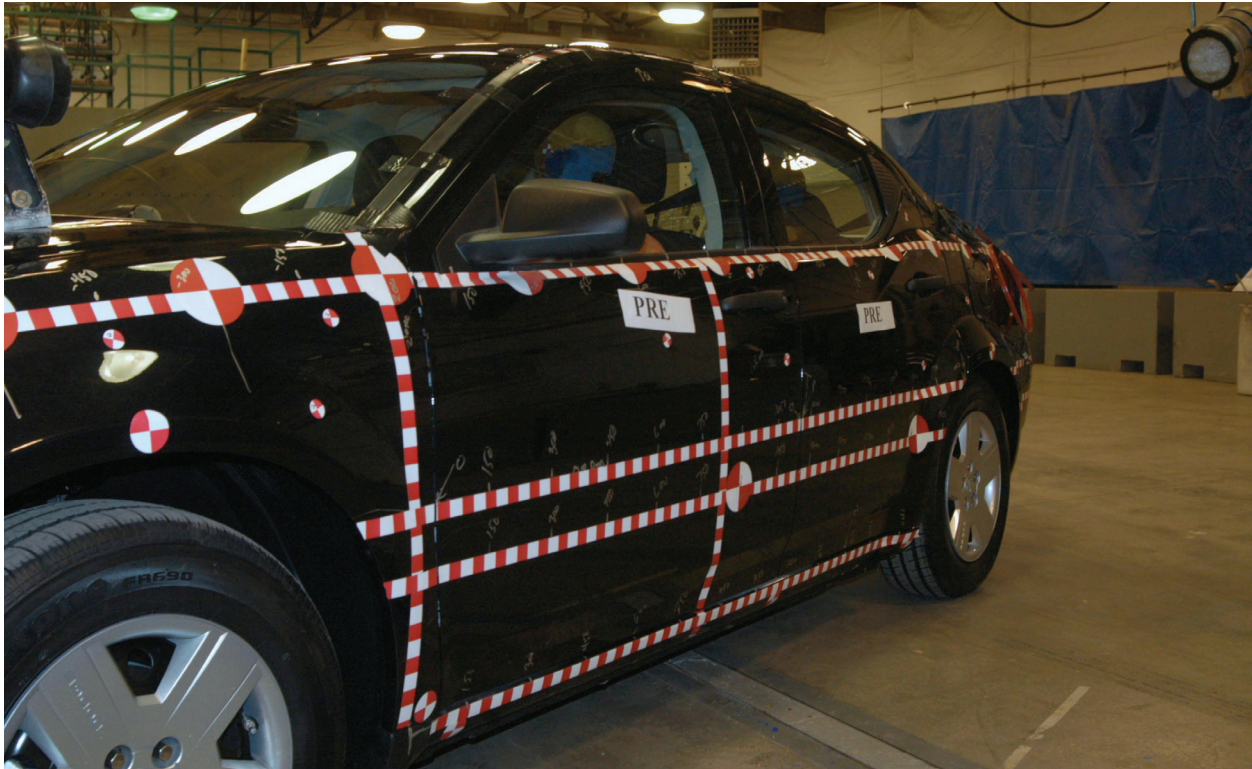
Figure A-26: Post test impact point

The test vehicle sustained a maximum static crush of 265 mm at level 3, 1650 mm rearward of the vertical impact line.

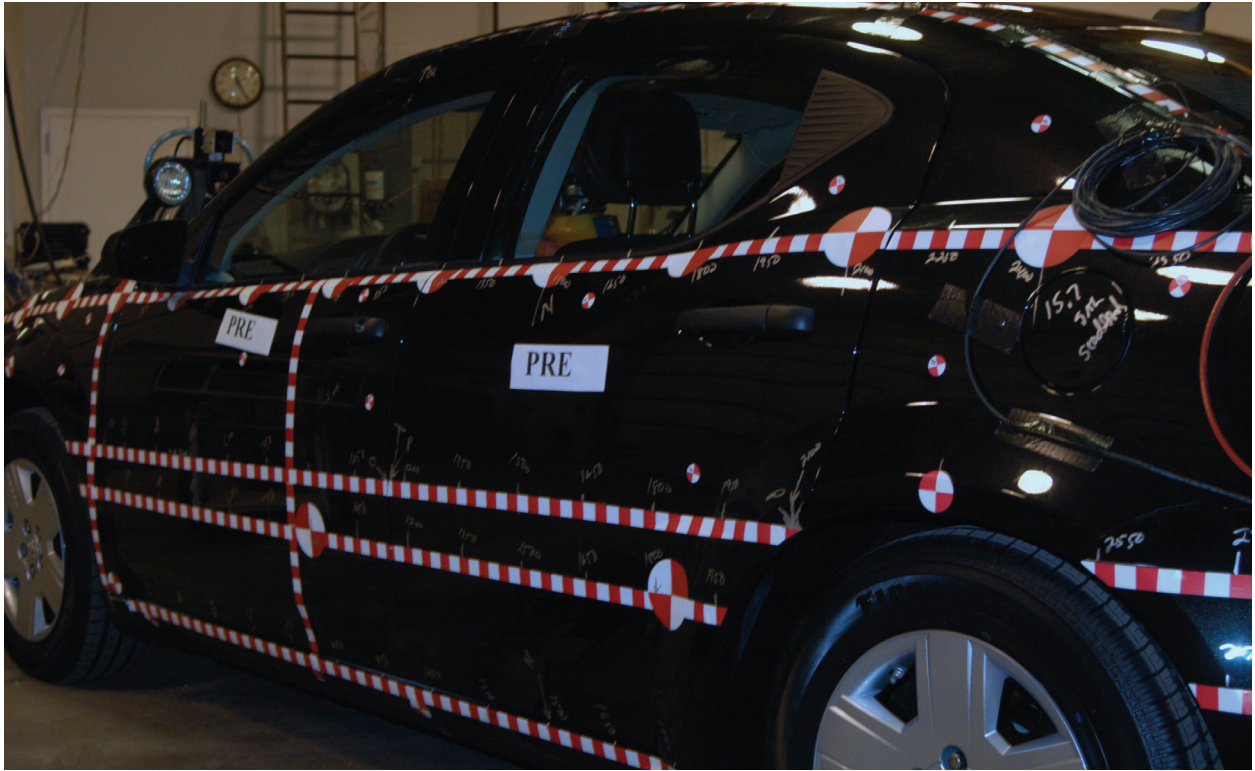
Figure A-28: Post test front 3/4 view of left side doors

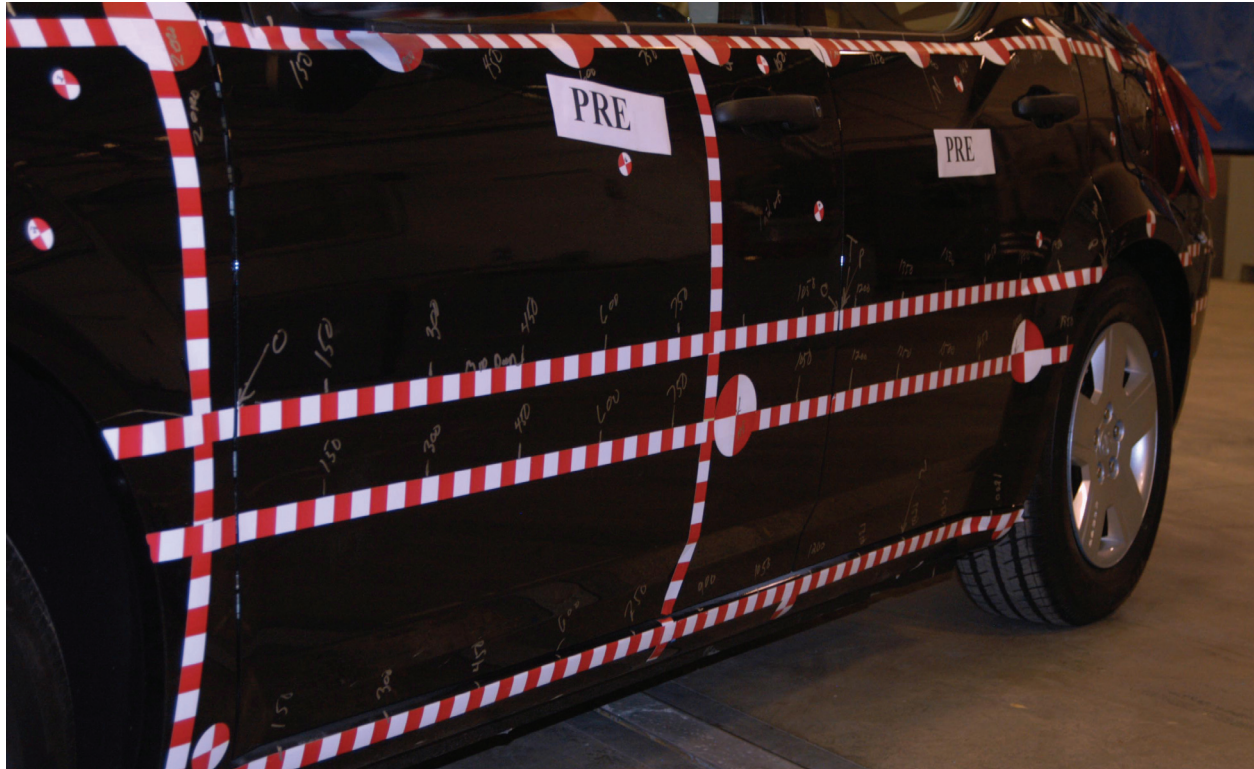
Figure A-30: Post test rear 3/4 view of left side doors

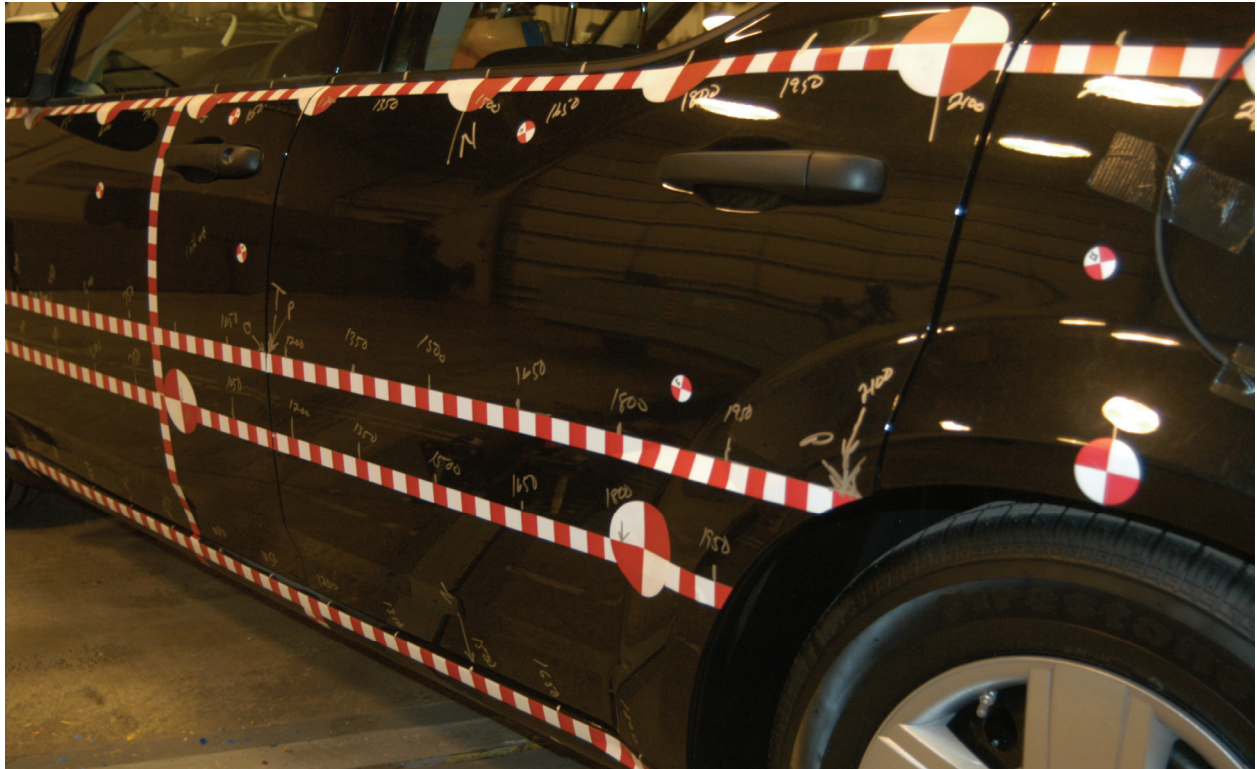
Figure A-32: Post test left front door

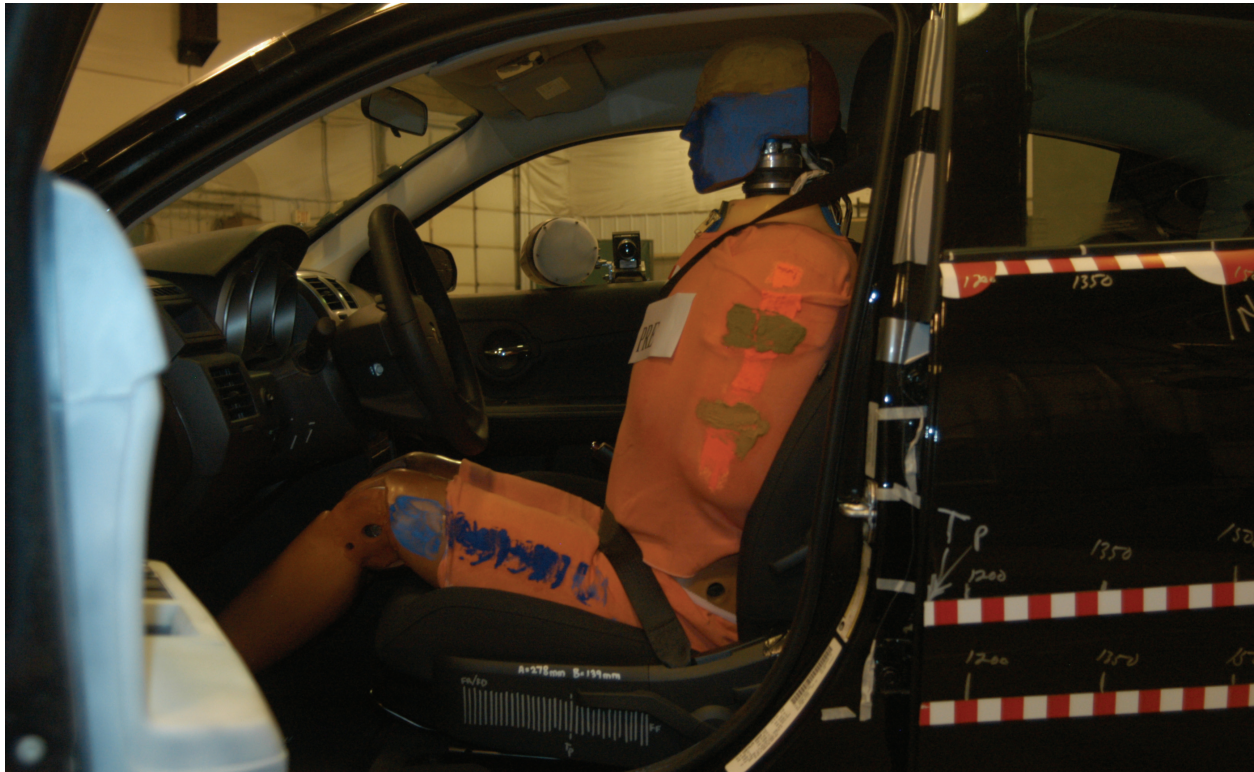
Figure A-34: Post test left rear door

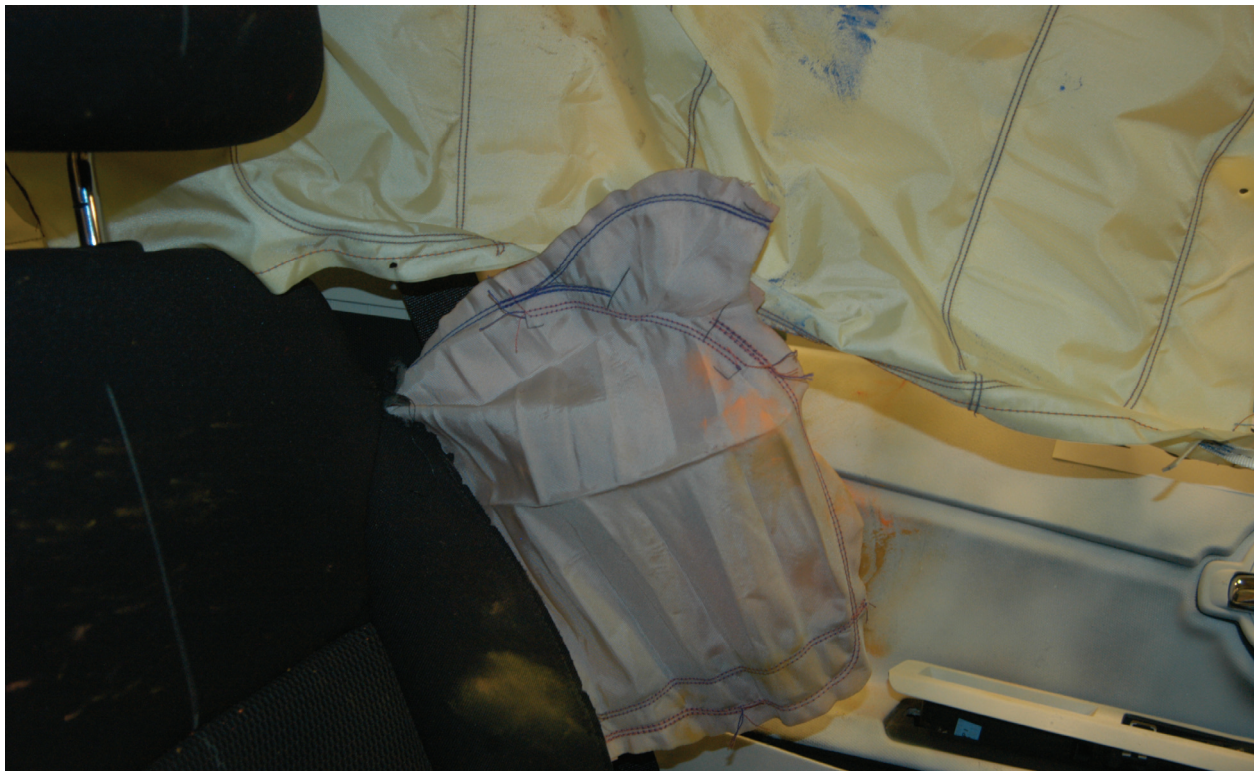
Figure A-41: Post test driver contact locations (1)

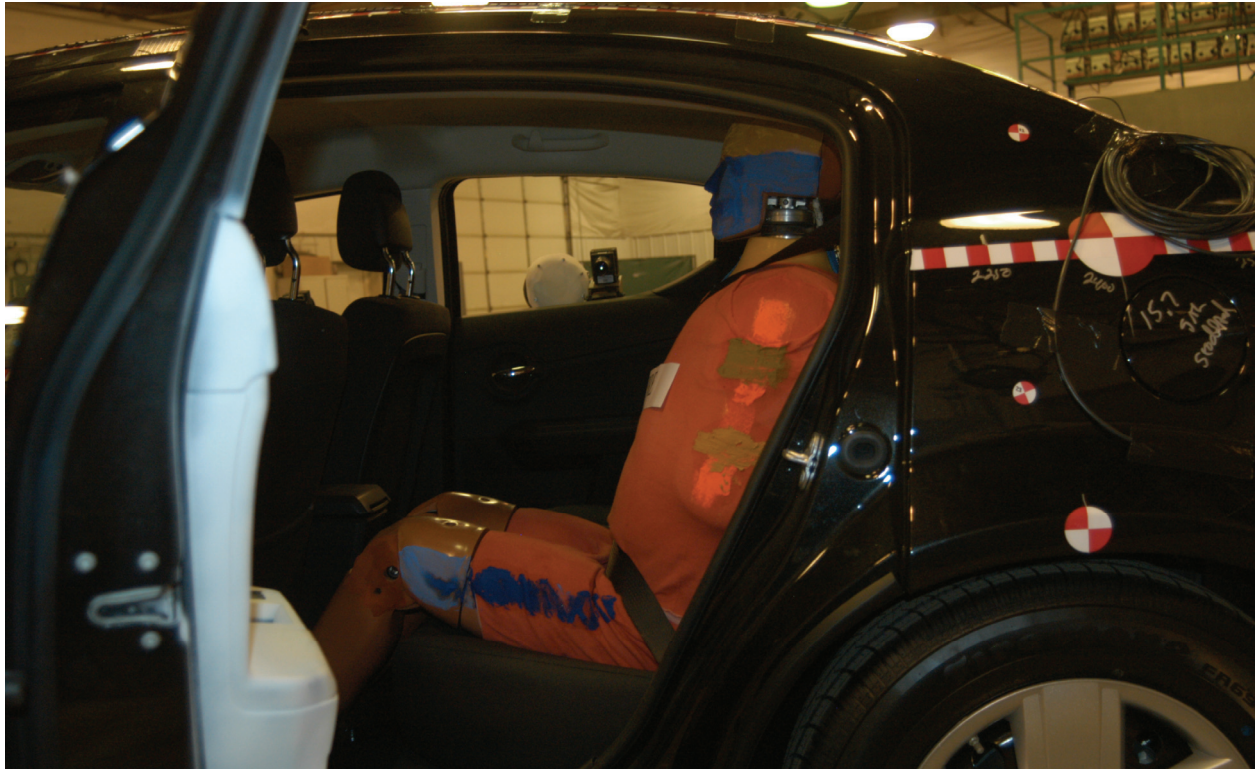
Figure A-42: Post test driver contact locations (2)

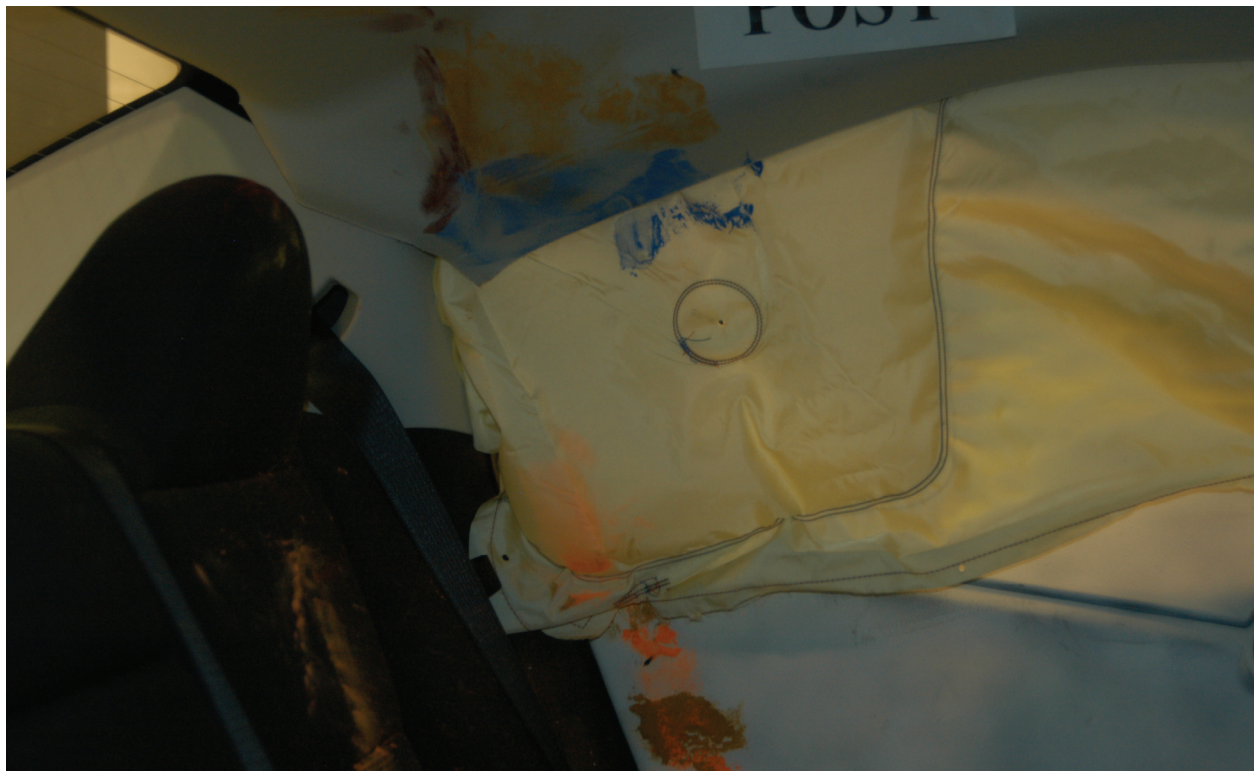
Figure A-49: Post test passenger contact locations (1)
