**REPORT NUMBER: SNCAP-TRC-2009-005**

**NEW CAR ASSESSMENT PROGRAM (NCAP)  
SIDE IMPACT TEST**

**NISSAN MOTOR COMPANY  
2010 NISSAN FRONTIER 4X2 SE CREW CAB 4-DOOR PICKUP  
NHTSA NUMBER: MA5201**

**PREPARED BY:  
TRANSPORTATION RESEARCH CENTER INC.  
10820 STATE ROUTE 347  
P. O. Box B-67  
EAST LIBERTY, OH 43319**

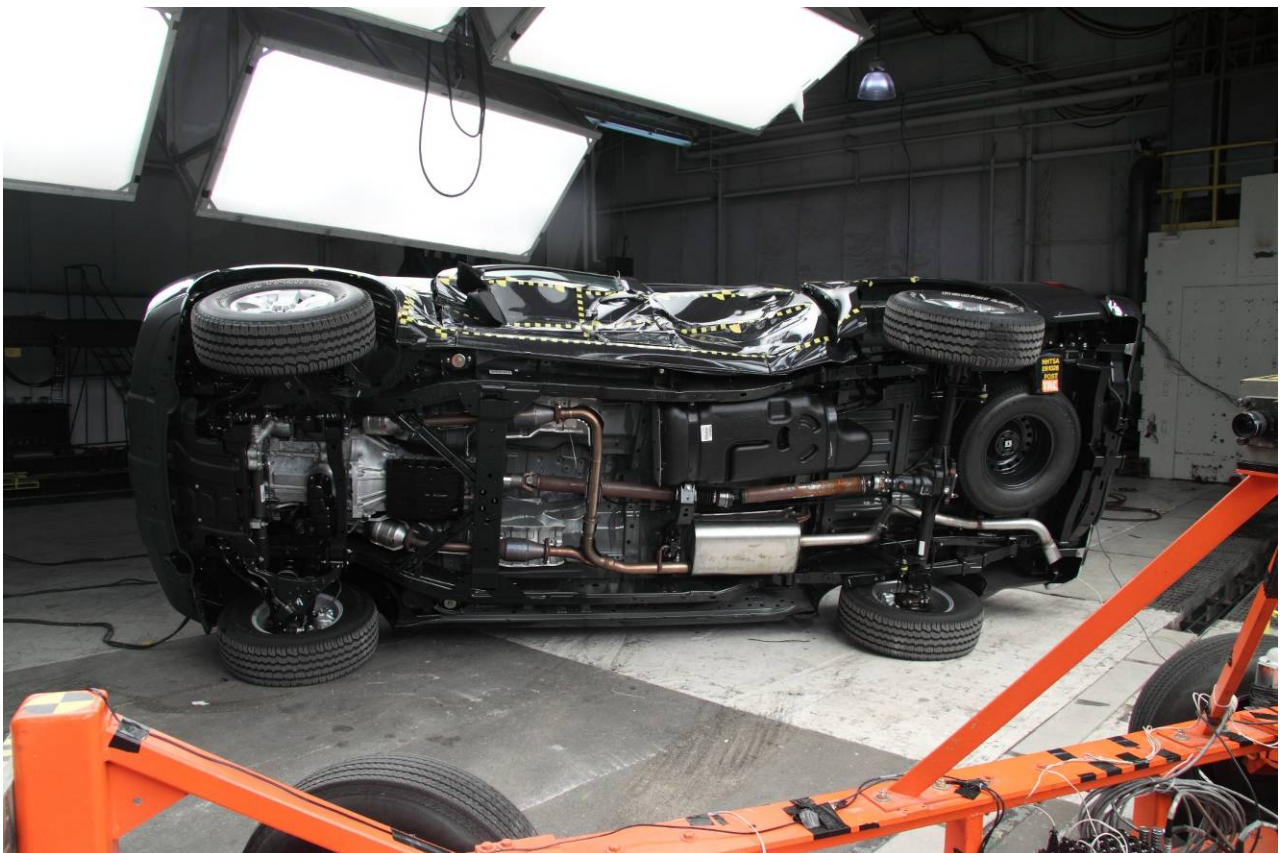
**Figure A-6 Post-Test Impacted Side View of Test Vehicle**

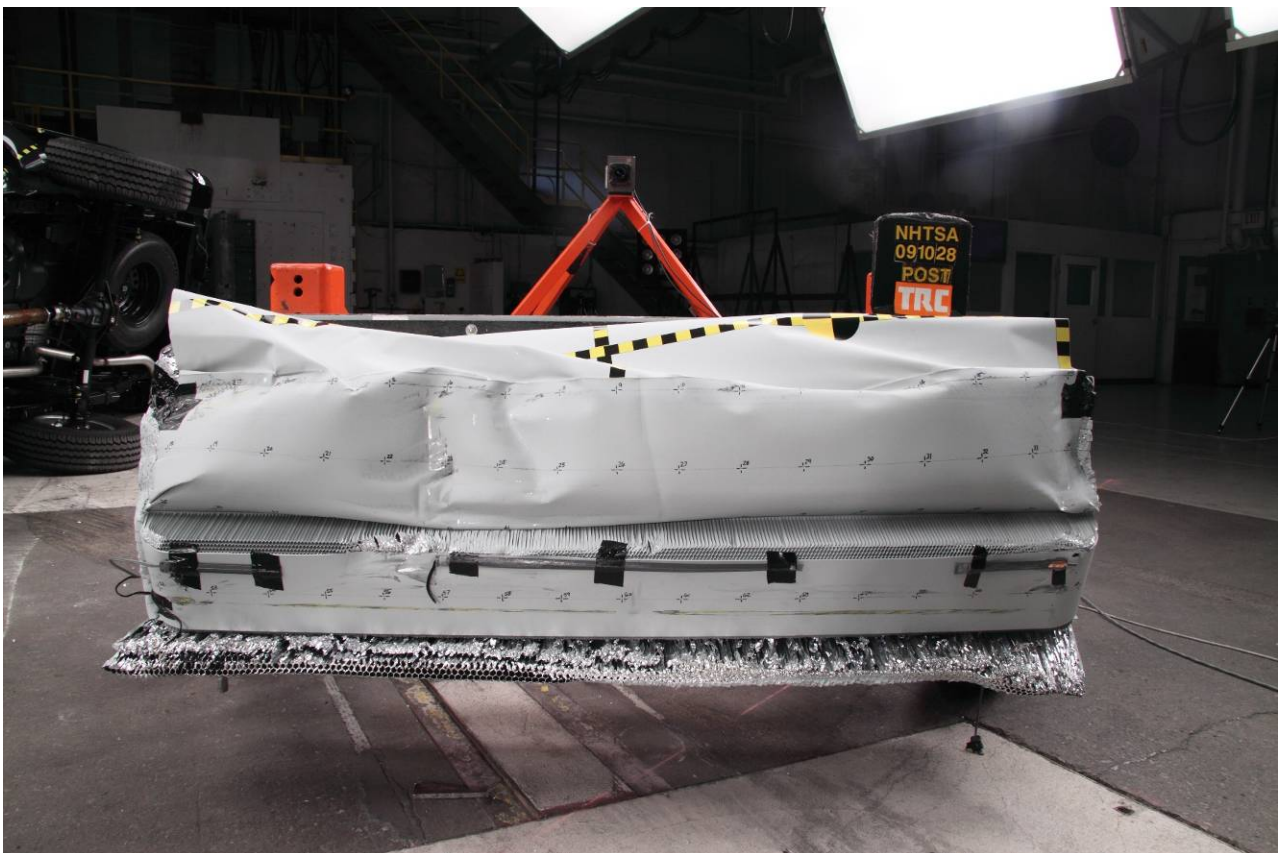
**Figure A-36 Post-Test View of MDB Showing Contact Switches in Place**

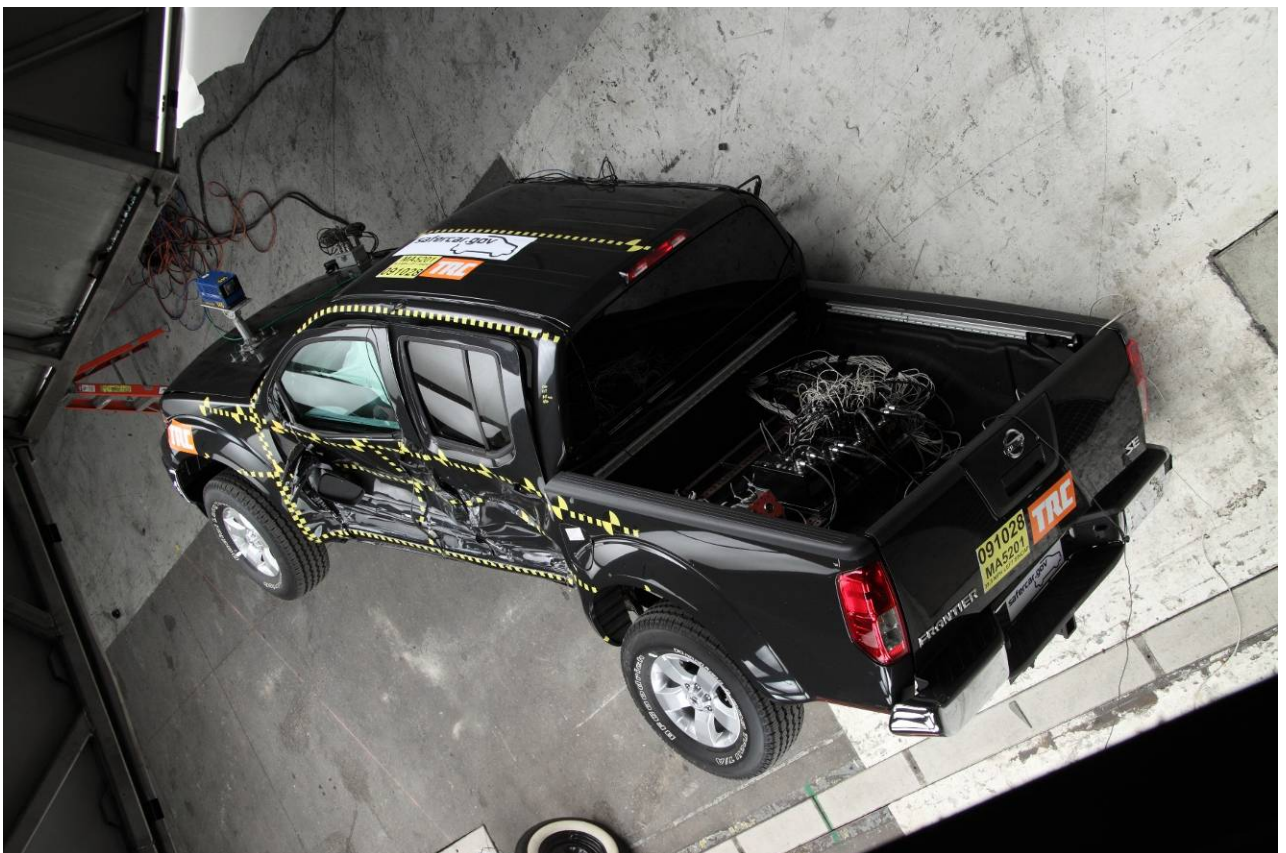
**Figure A-38 Post-Test Overhead View of MDB and Vehicle**

The subject vehicle landed on its right side after the impact with the Moving Deformable Barrier.

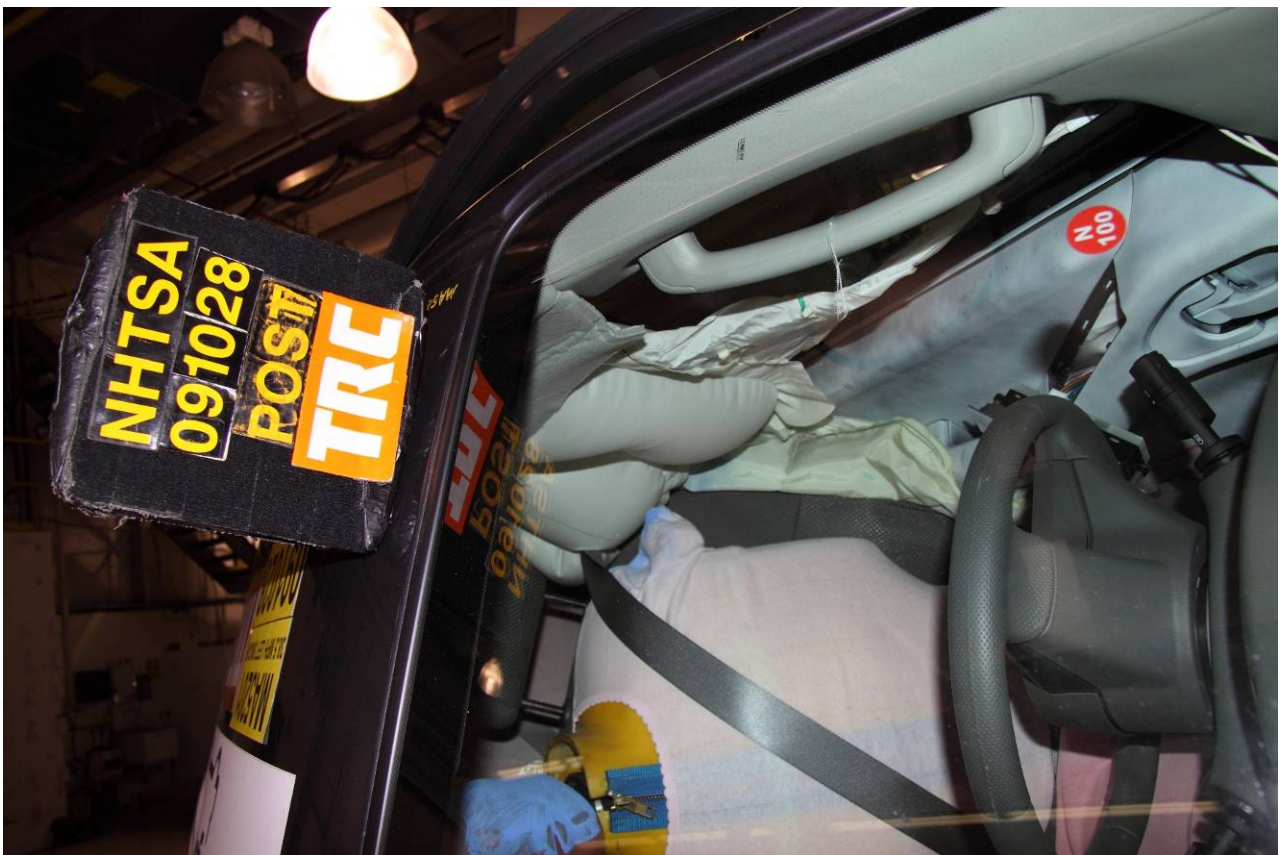
**Figure A-47 Post-Test Left View of Front SID HIII and Door Clearance**

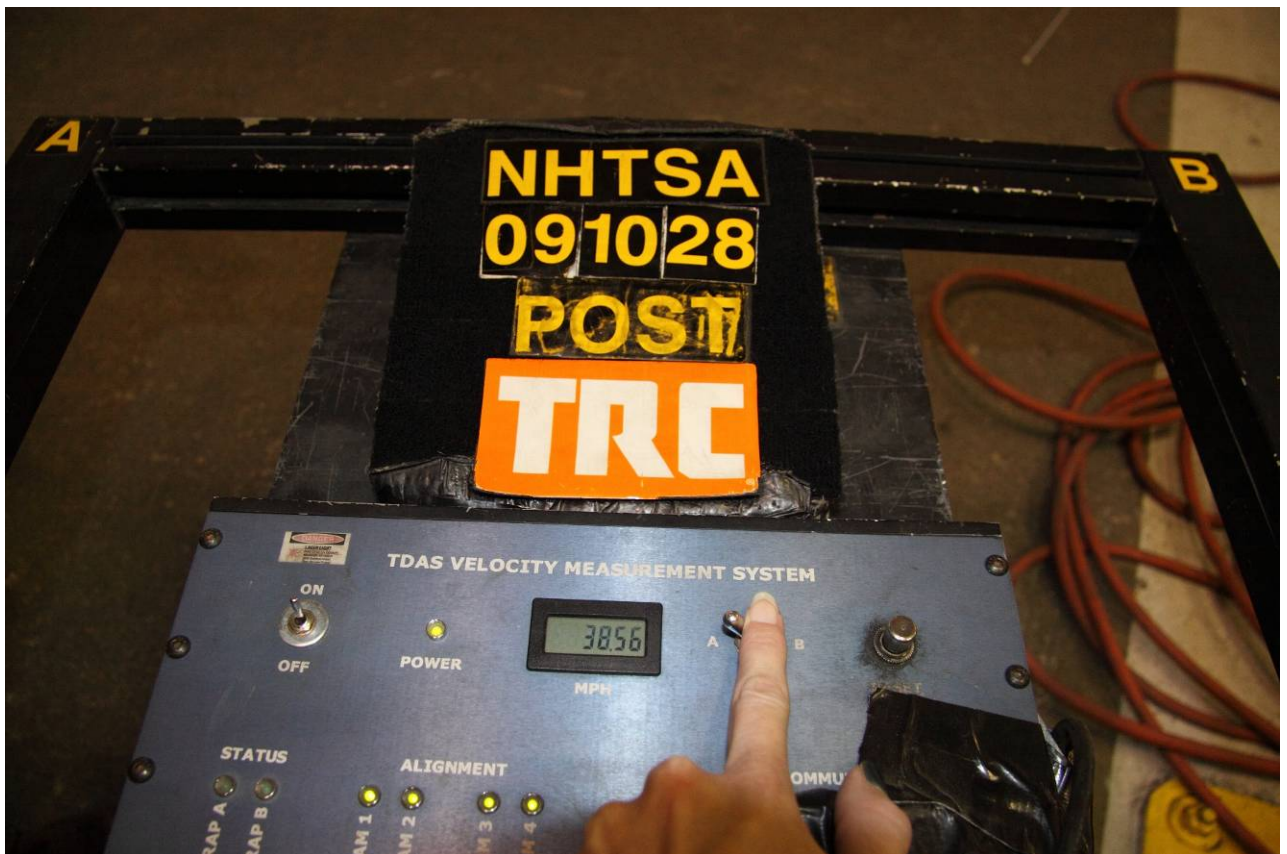
Figure A-75 Post-Test Primary Light Trap Digital Readout
