**REPORT NUMBER: MCW-DOT-10SN03**

**NEW CAR ASSESSMENT PROGRAM  
SIDE IMPACT TEST**

**2010 DODGE CHARGER 4-DOOR SEDAN**

**PREPARED BY:  
MEDICAL COLLEGE OF WISCONSIN  
5000 WEST NATIONAL AVENUE  
RESEARCH 151  
MILWAUKEE, WISCONSIN 53295**

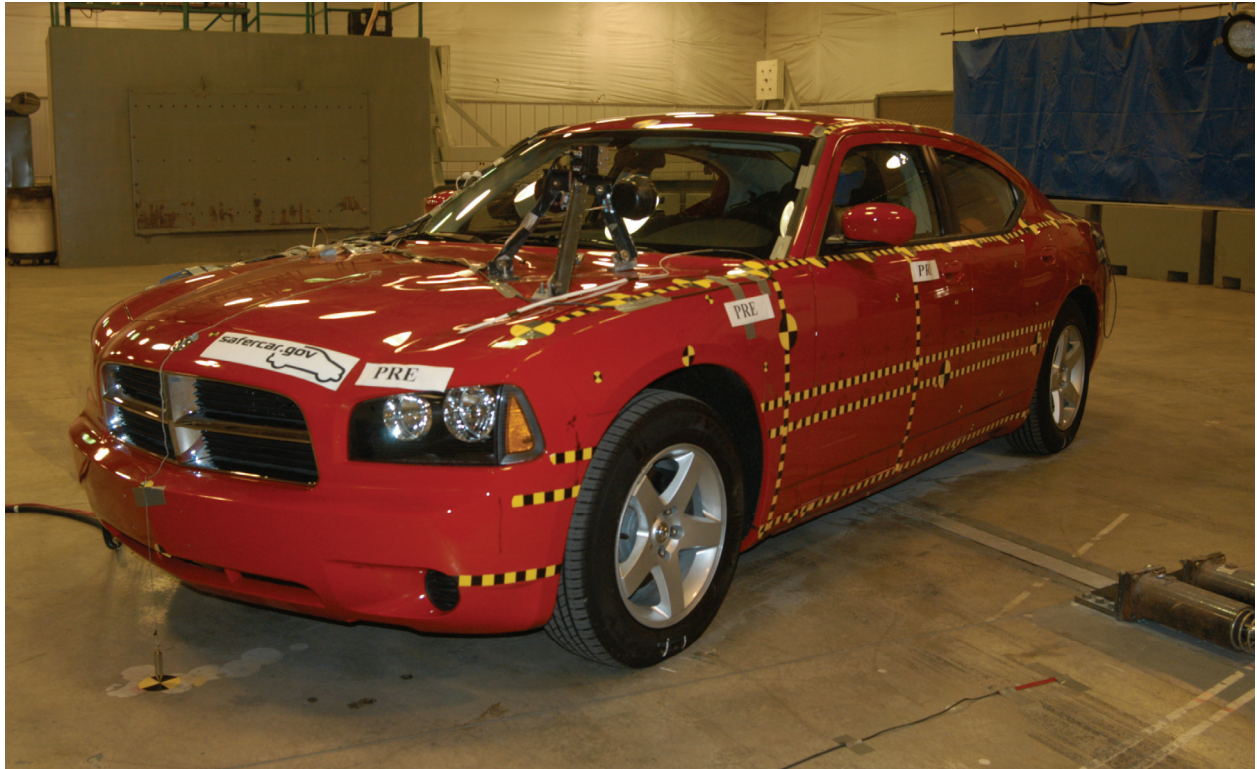
Figure A-6: Post test front view of test vehicle

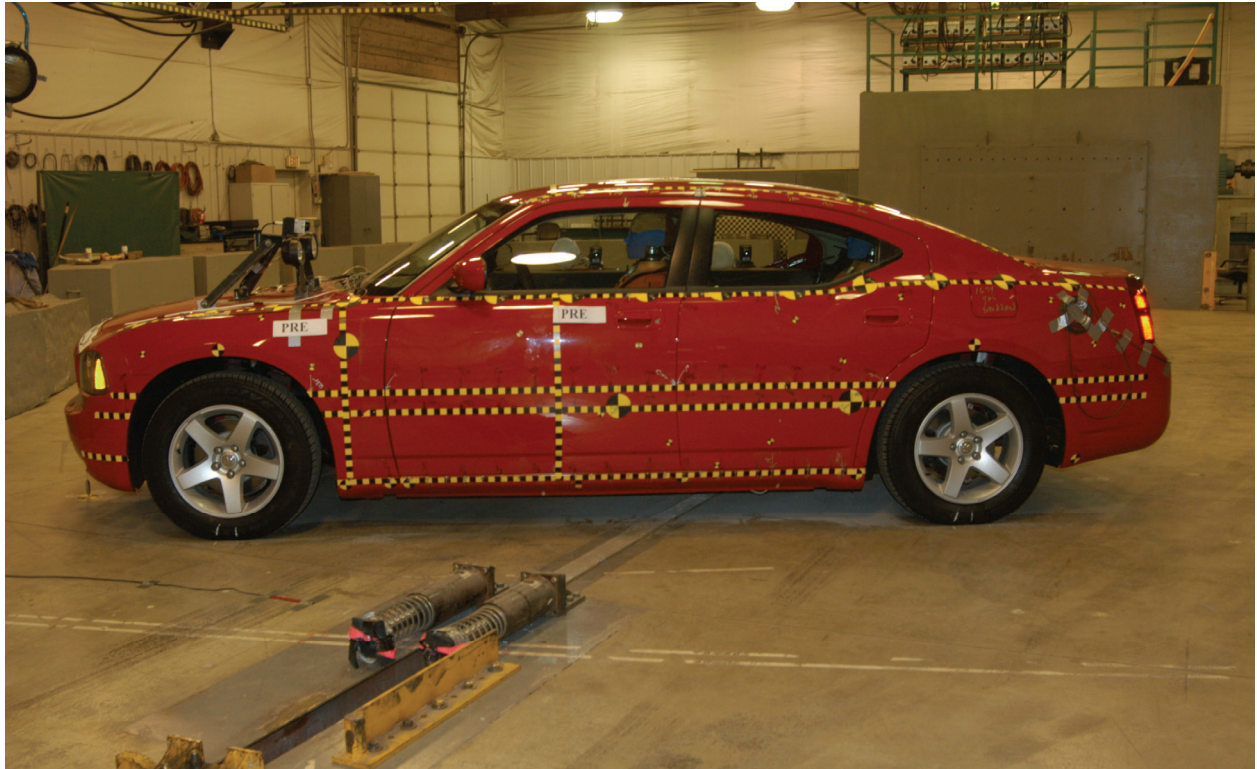
Figure A-8: Post test left front 3/4 view of test vehicle

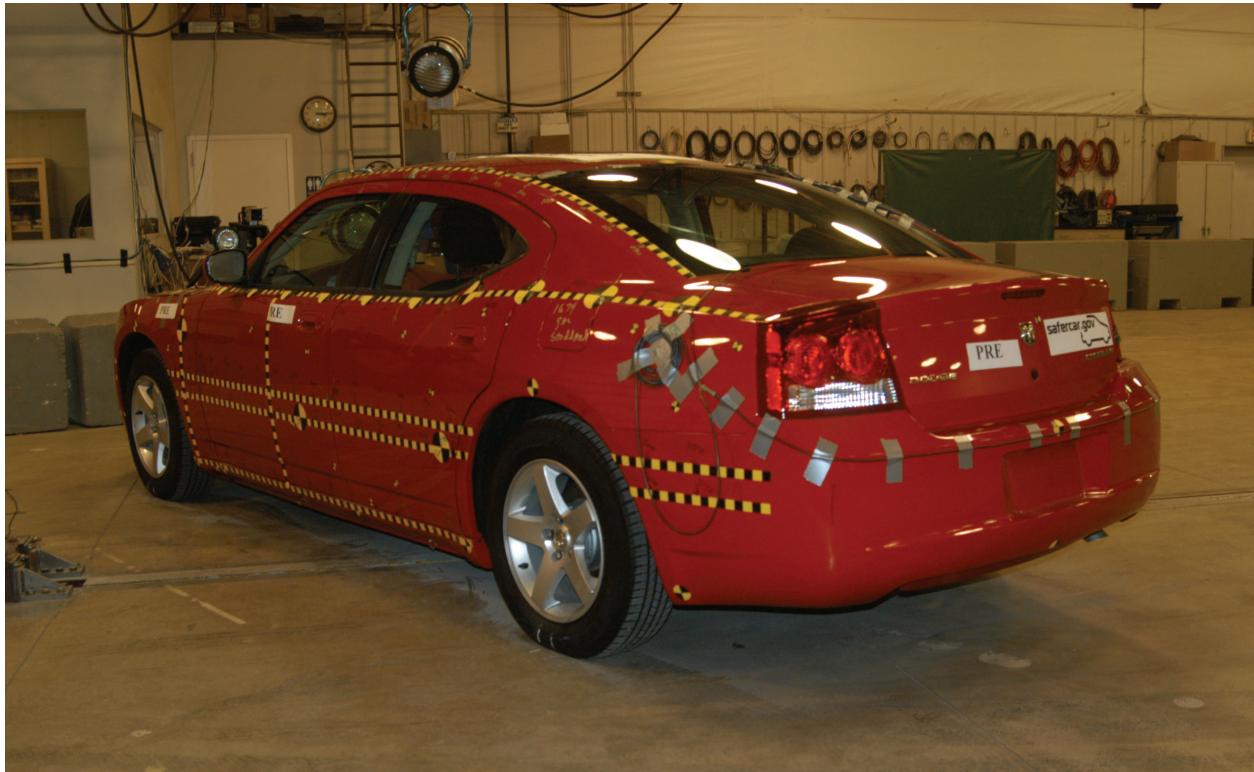
Figure A-10: Post test left side view of test vehicle

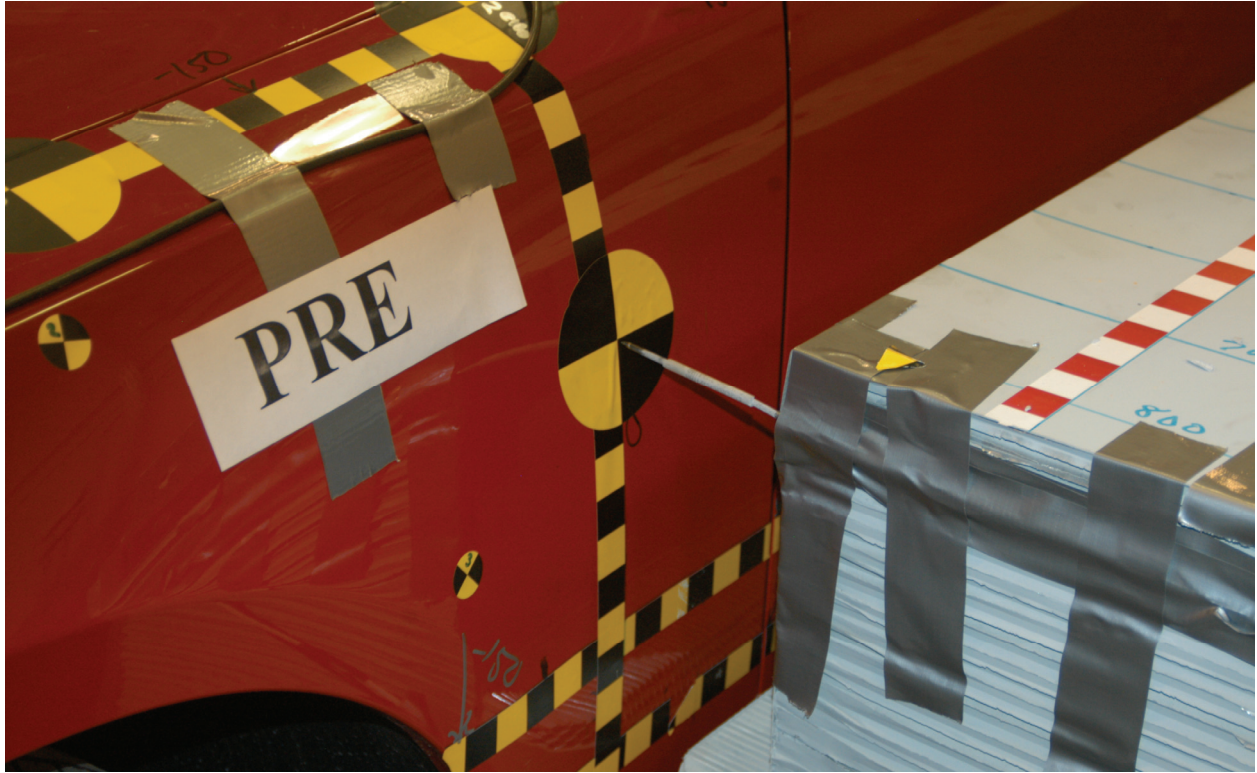
Figure A-24: Post test overhead close-up view

The test vehicle sustained a maximum static crush of 318 mm at level 3, 1500 mm rearward of the vertical impact line.

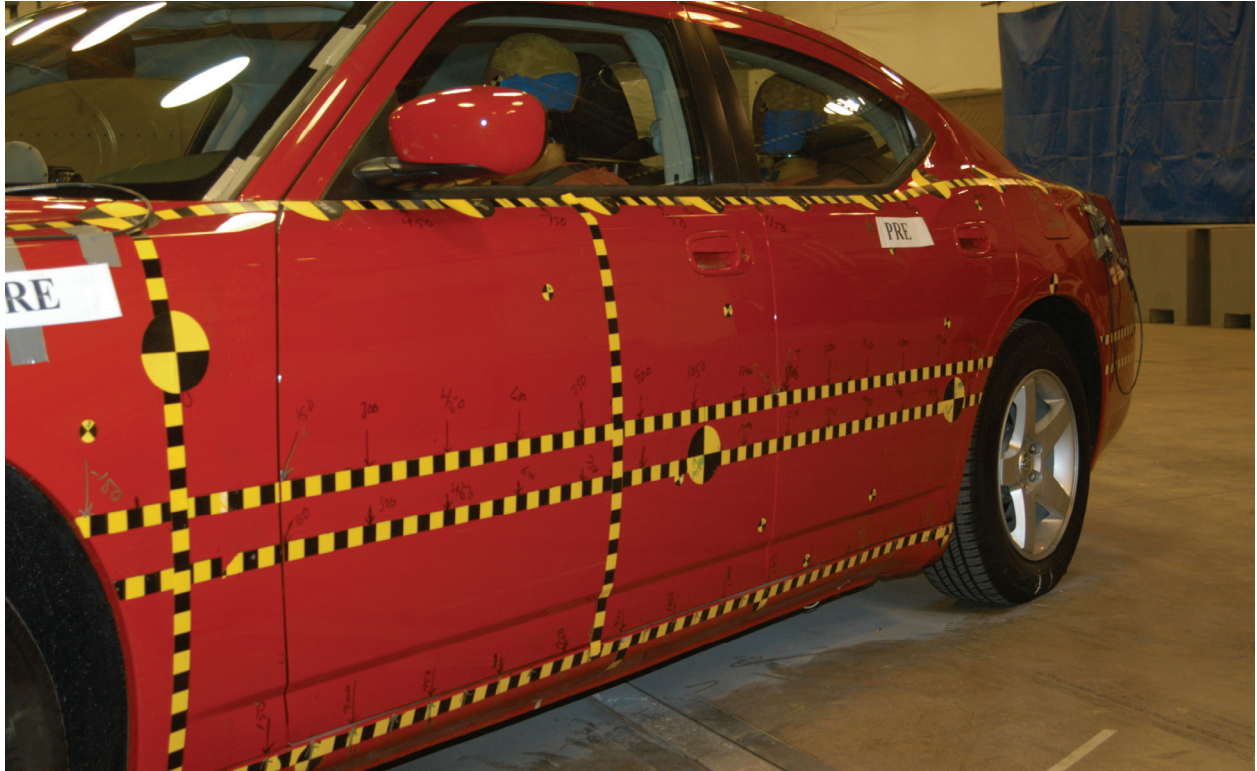
Figure A-26: Post test impact point

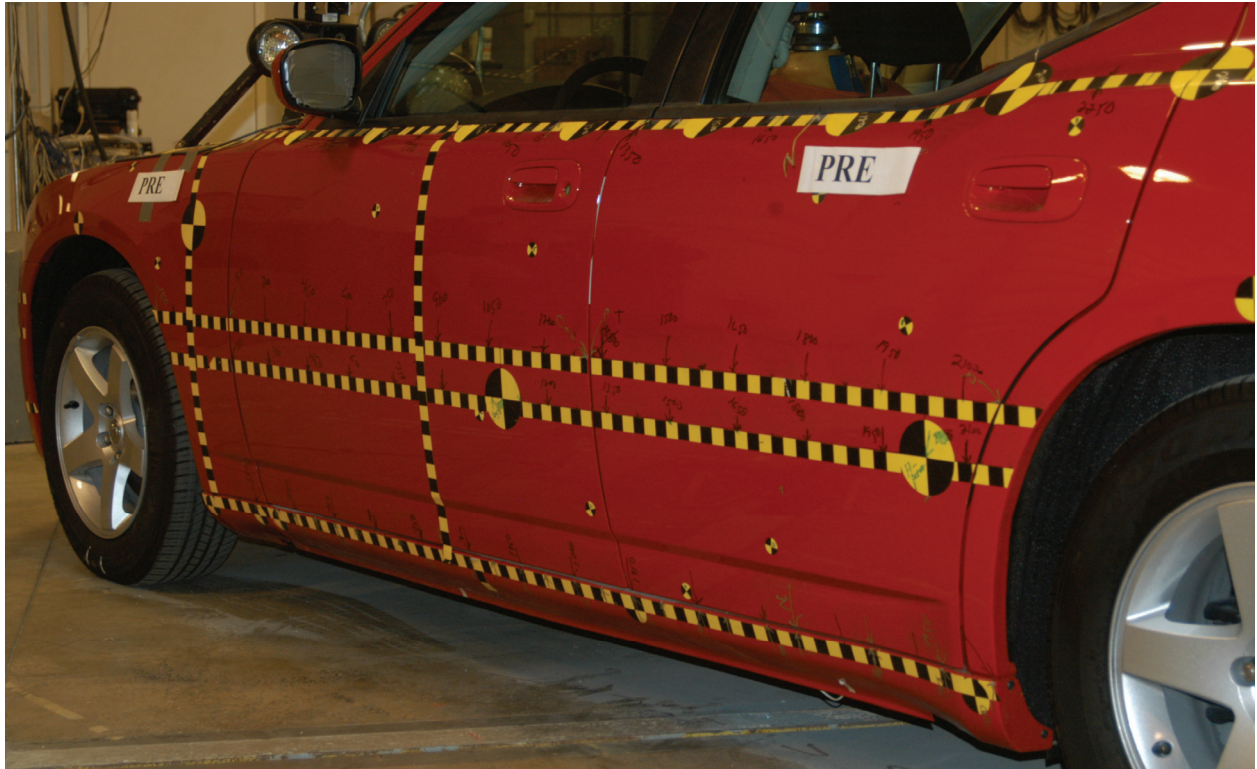
Figure A-28: Post test front 3/4 view of left side doors

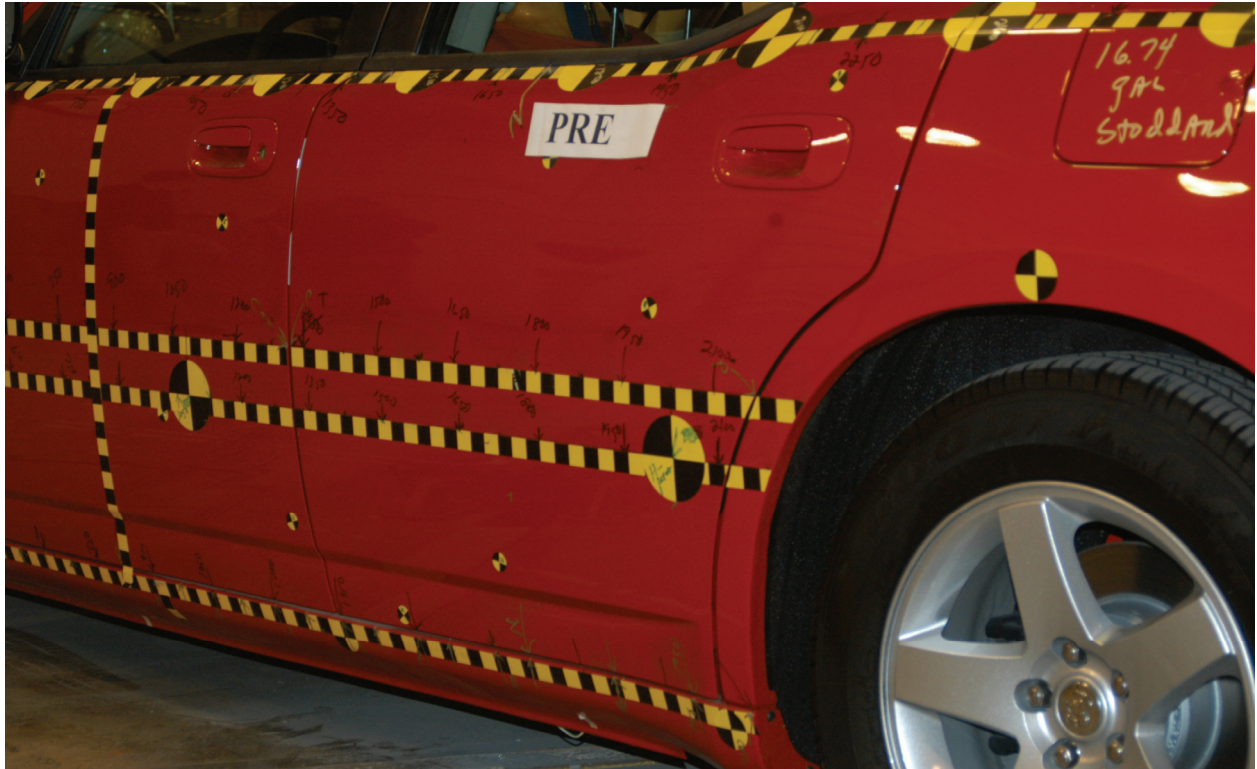
Figure A-32: Post test left front door

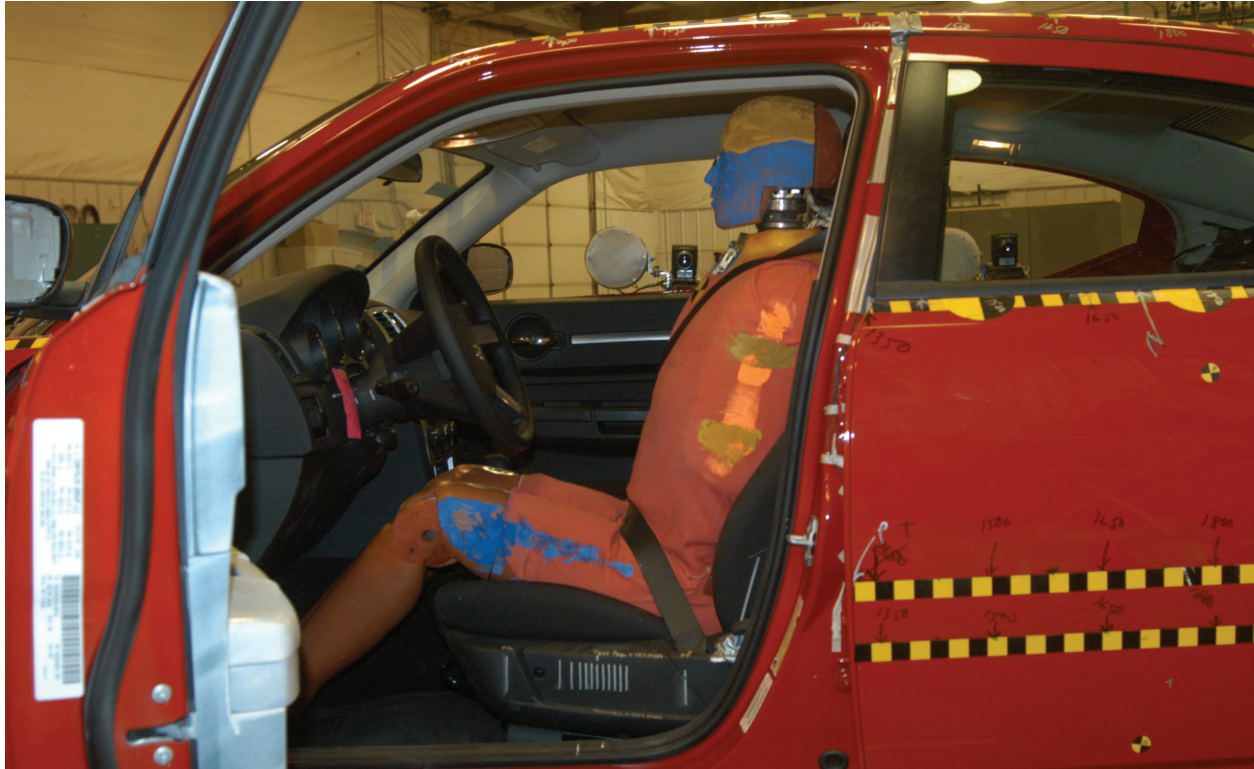
Figure A-34: Post test left rear door

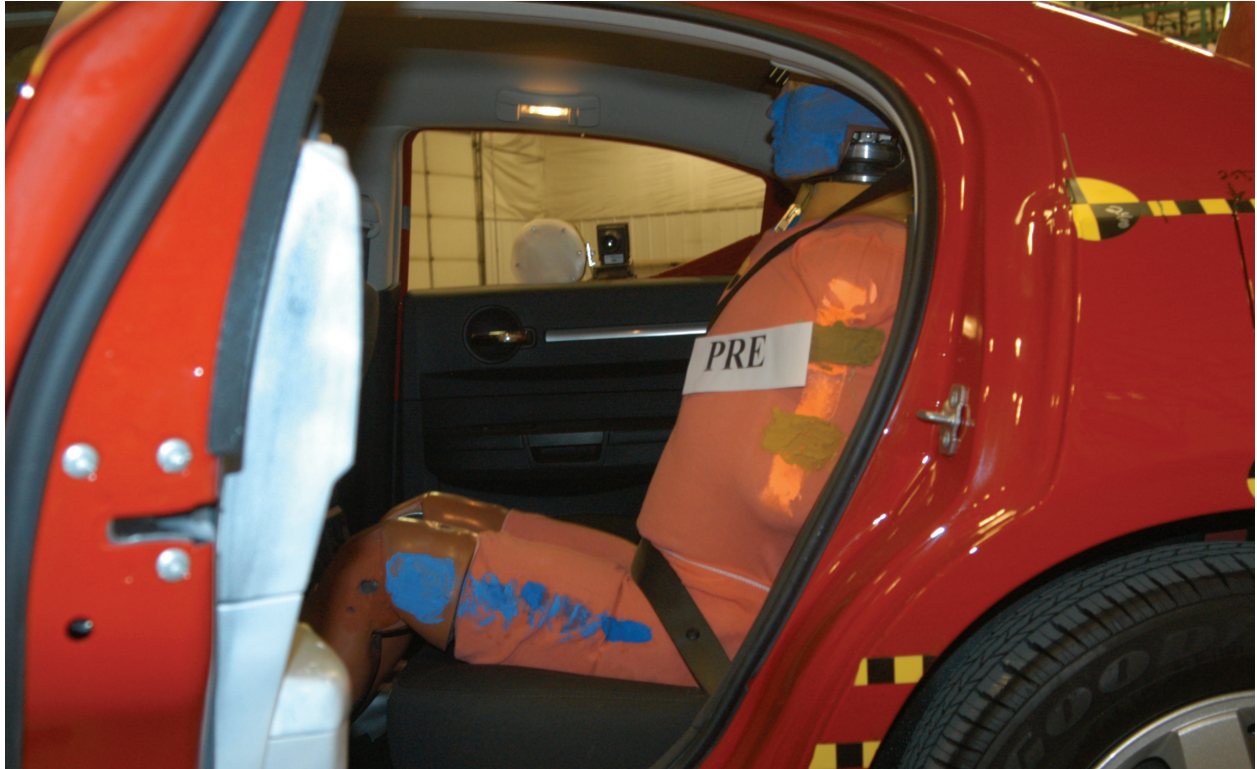
Figure A-42: Post test driver contact locations (2)

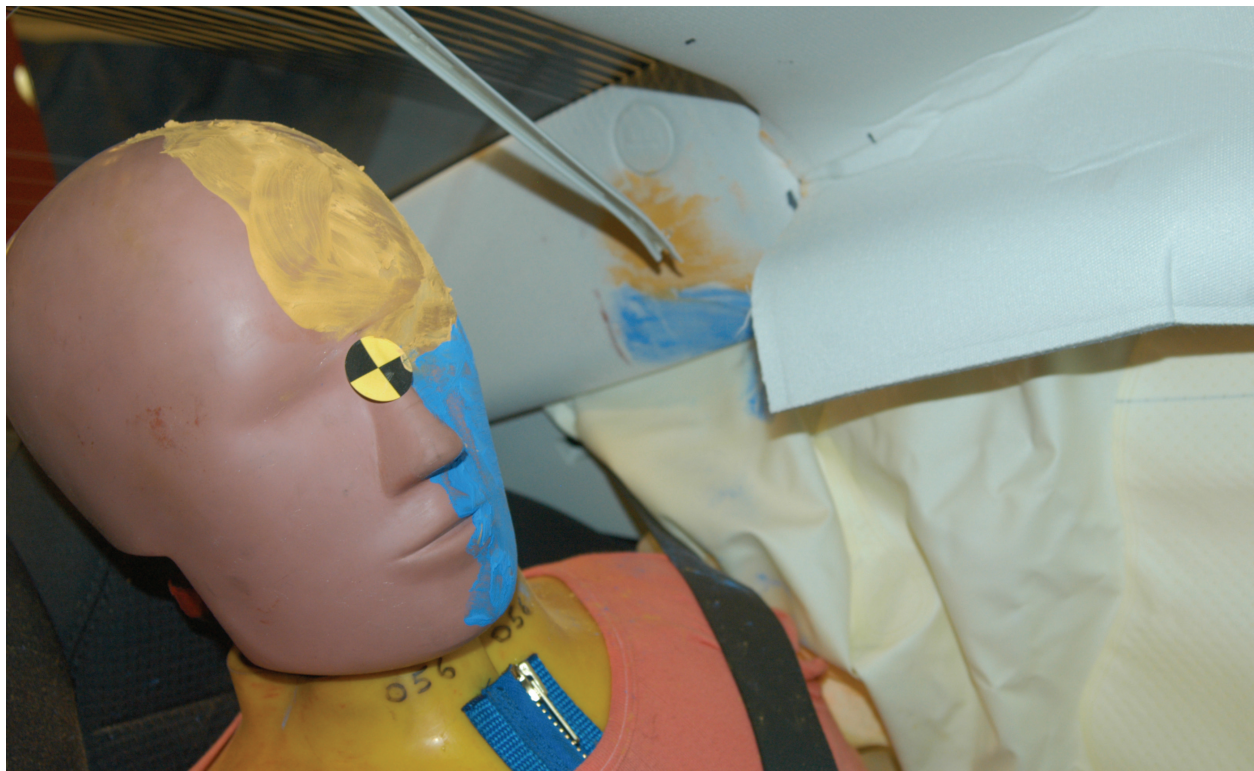
Figure A-49: Post test passenger contact locations (1)
