**REPORT NUMBER: NCAPSIDE-MGA-2010-007**

**NEW CAR ASSESSMENT PROGRAM  
SIDE IMPACT TEST**

**GENERAL MOTORS COMPANY  
2010 CHEVROLET COLORADO EXTENDED CAB  
NHTSA NUMBER: MA0122**

**PREPARED BY:  
MGA RESEARCH CORPORATION  
5000 WARREN ROAD  
BURLINGTON, WI 53105**

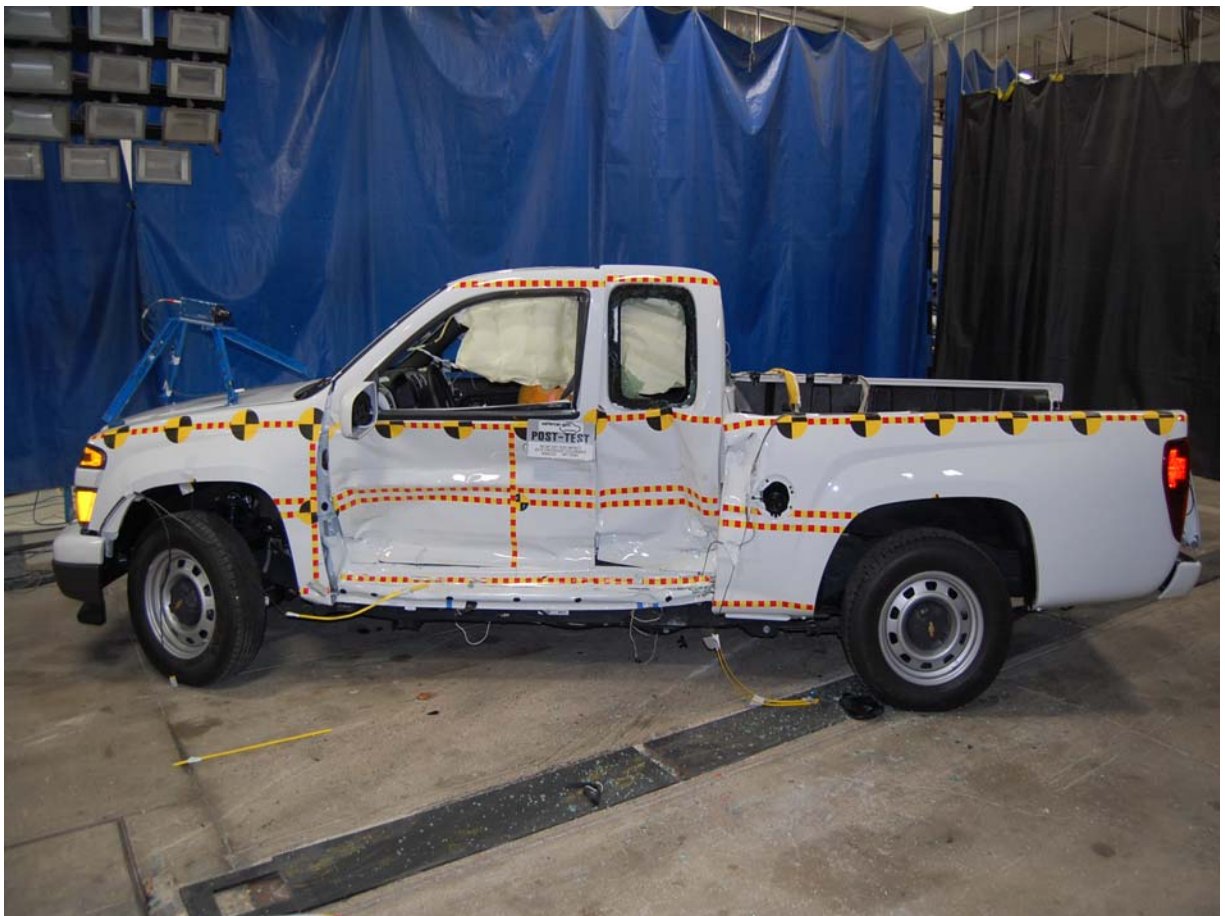
Post-Test Left Side View

The test vehicle sustained a maximum static crush of 398 mm at level 3, 1500 mm rearward of the vertical impact point. The driver SID/HIII, Serial No. 271 was calibrated just prior to this test.

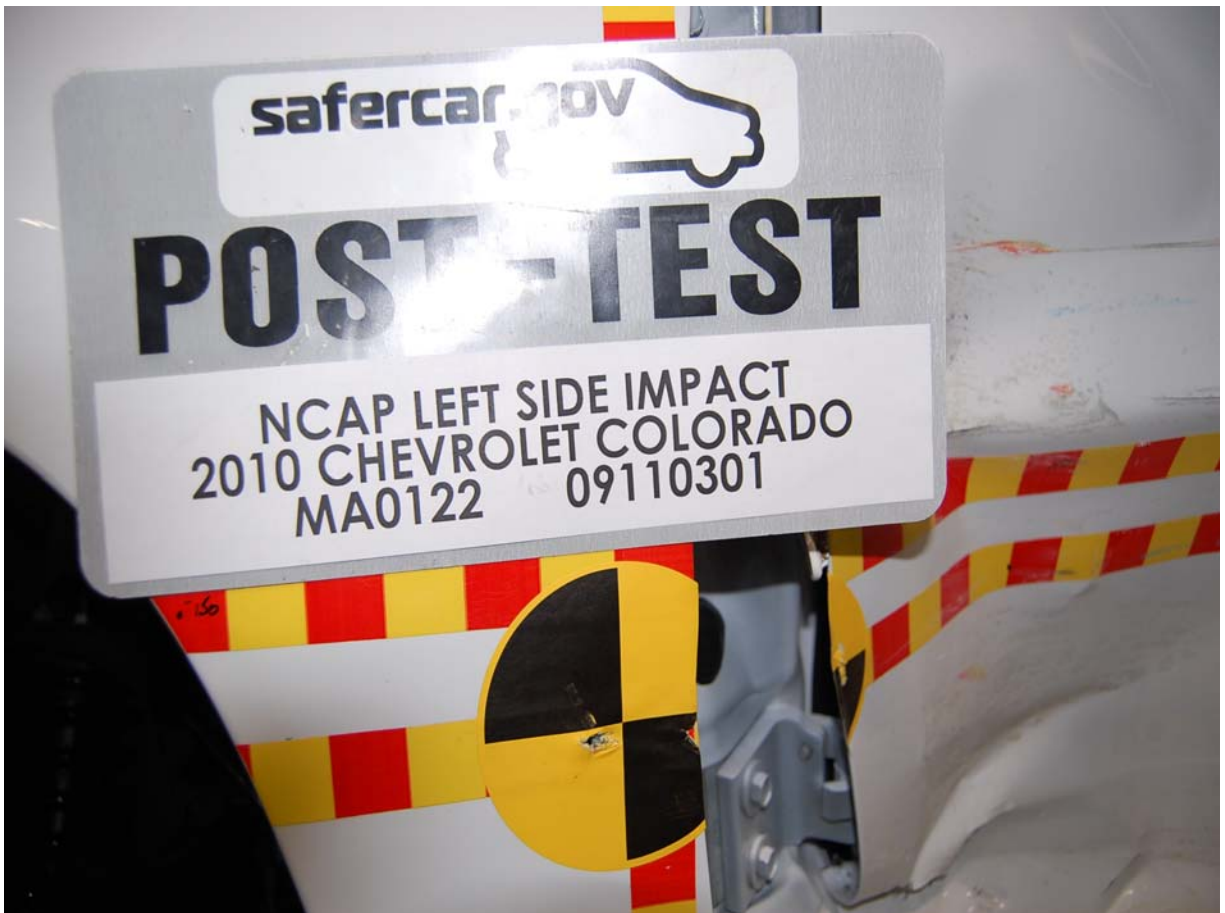
Post-Test Left Impact Point

| Measurement Description | Units | Value |
|---|---|---|
| Actual Impact Point Aft of Front Axle | mm | 497 |

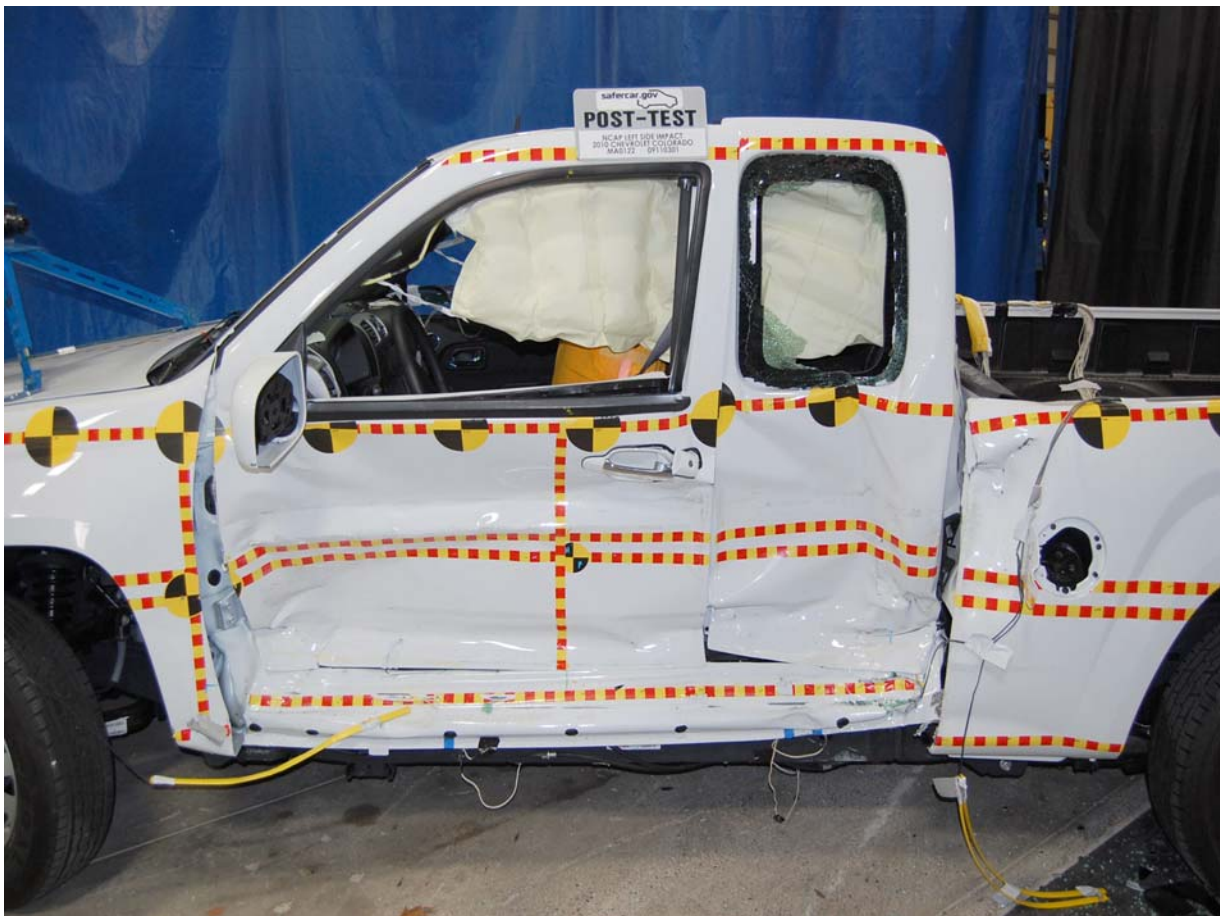
Post-Test Left Side Impact Close-up

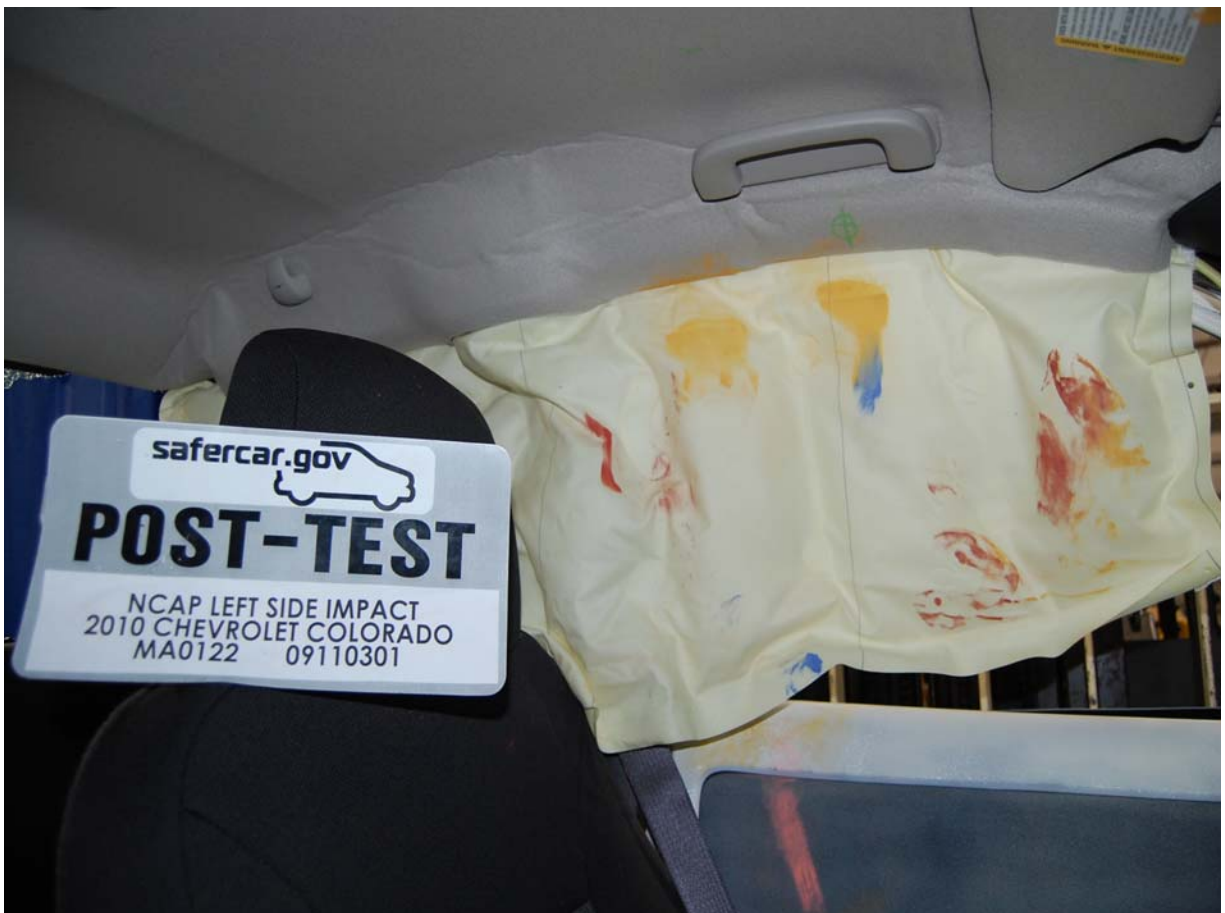
Post-Test Driver Dummy Head Contact View

| Description | Front Seat SID/HIII |
|---|---|
| Head Contact | Curtain Airbag |

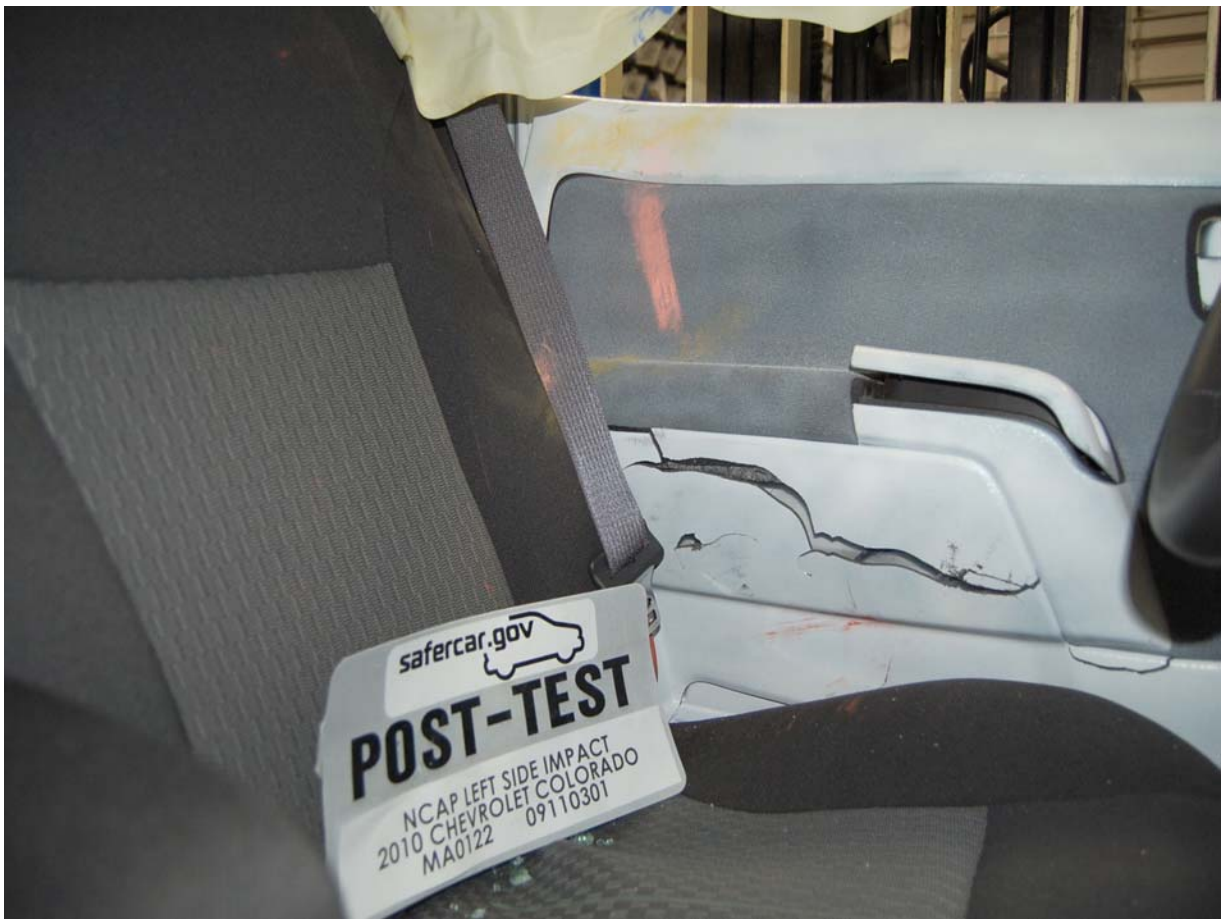
Post-Test Driver Dummy Torso Contact

| Description | Front Seat SID/HIII |
|---|---|
| Upper Torso Contact | Door Panel |
