**REPORT NUMBER: SNCAP-CAL-10-4**

**NEW CAR ASSESSMENT PROGRAM  
SIDE IMPACT TEST**

**MITSUBISHI MOTORS CORPORATION  
2010 MITSUBISHI LANCER ES  
4-DOOR SEDAN**

**FINAL REPORT**

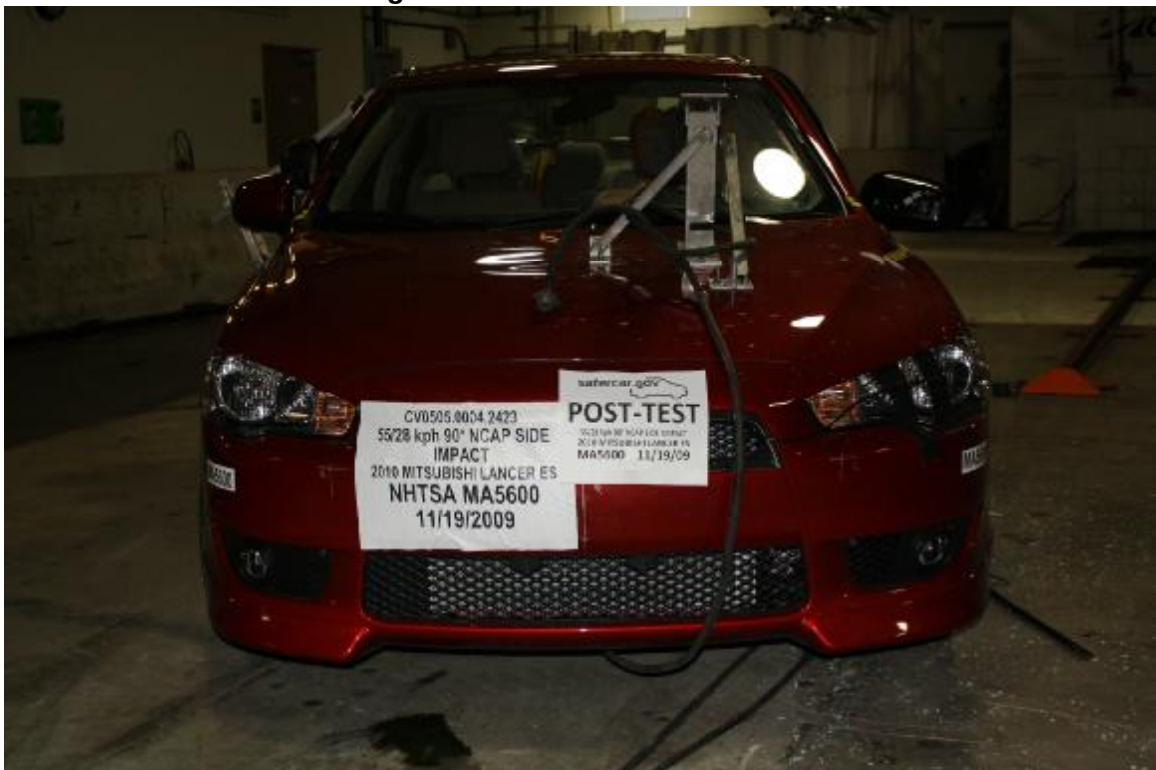
Figure A-6: Post-Test Front View

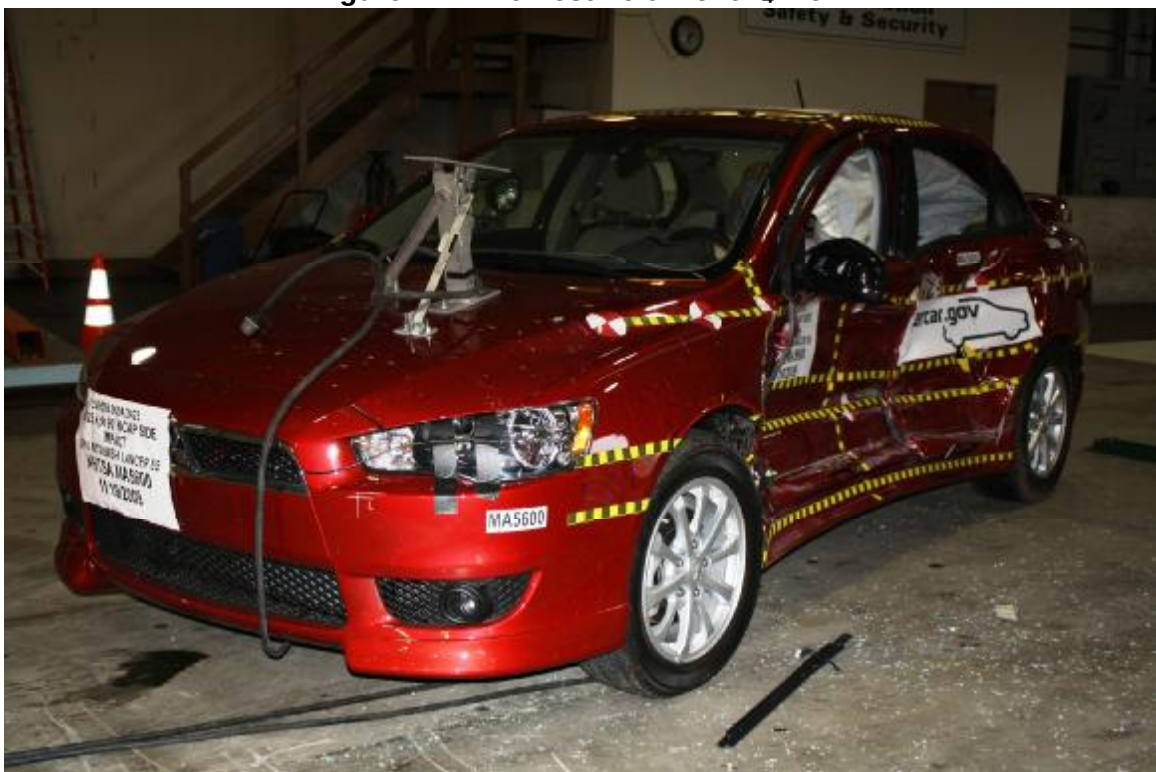
Figure A-8: Post-Test Left Front  $\frac{3}{4}$  View

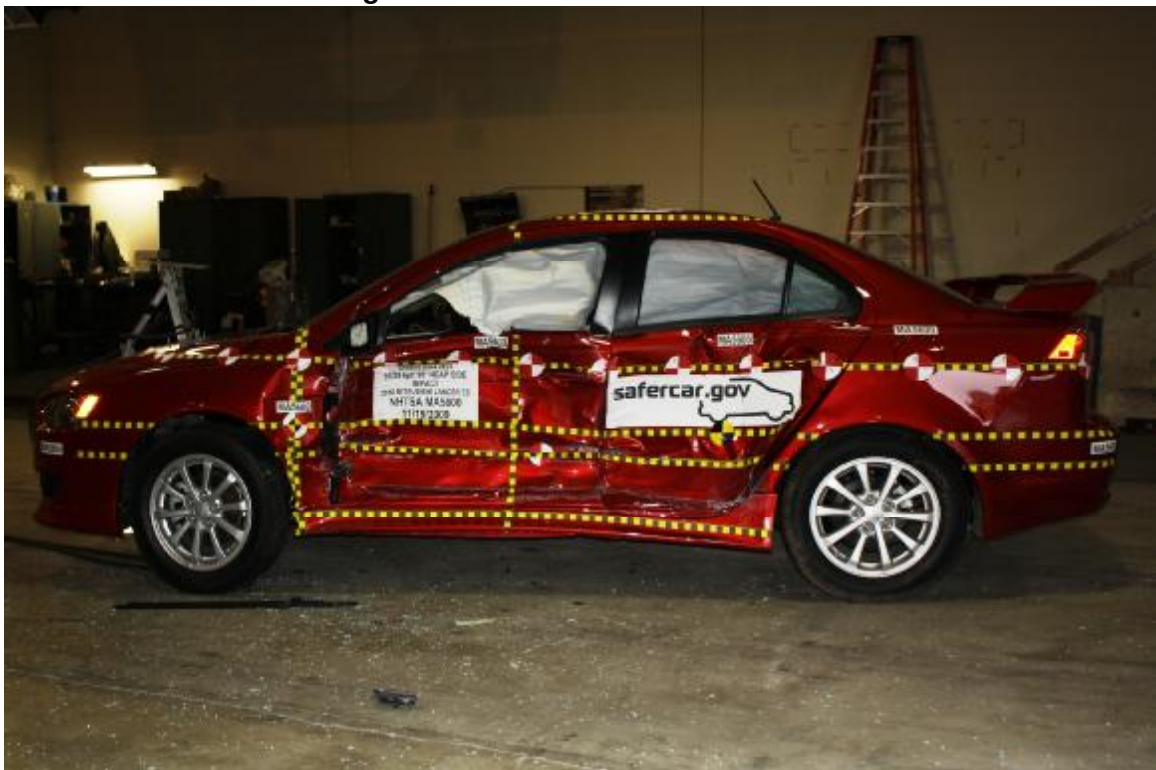
**Figure A-10: Post-Test Left Side View**

The test vehicle sustained a maximum static crush of 231 mm at level 3, 750 mm rearward of the left vertical impact point. The driver and passenger SID/HIII's, Serial Nos. 905 and 270 respectively, were calibrated just prior to this test.

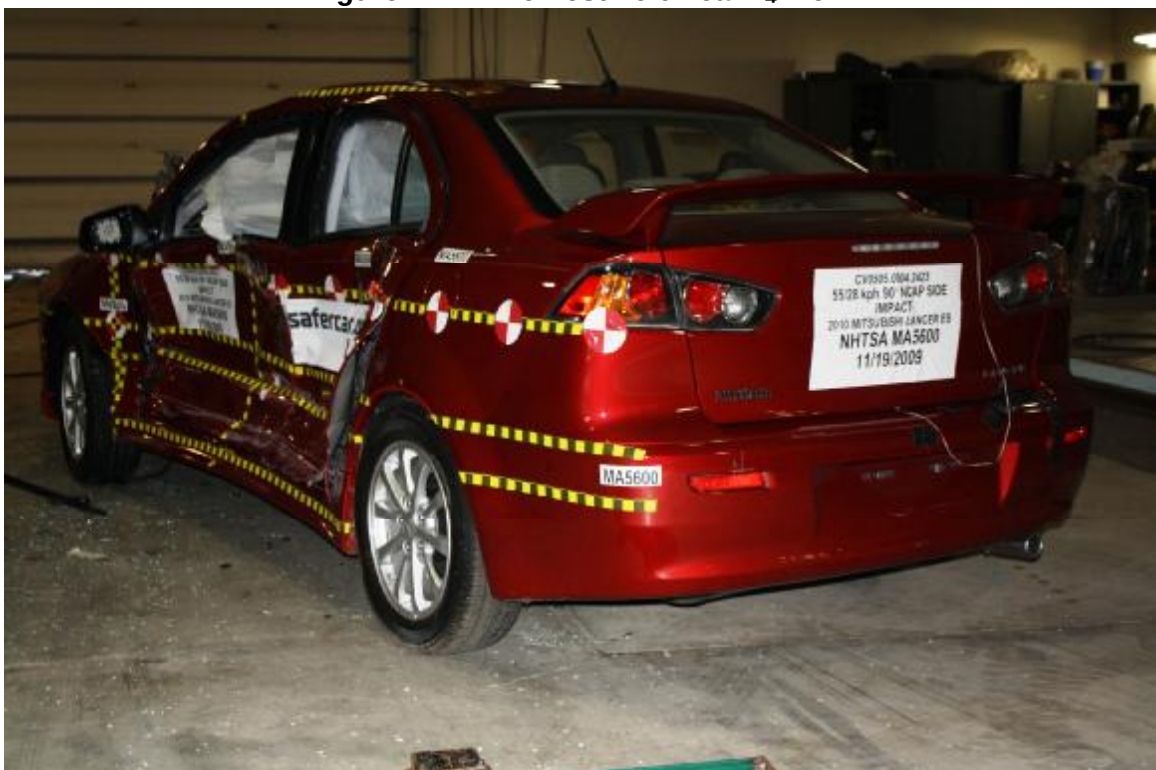
Figure A-12: Post-Test Left Rear  $\frac{3}{4}$  View

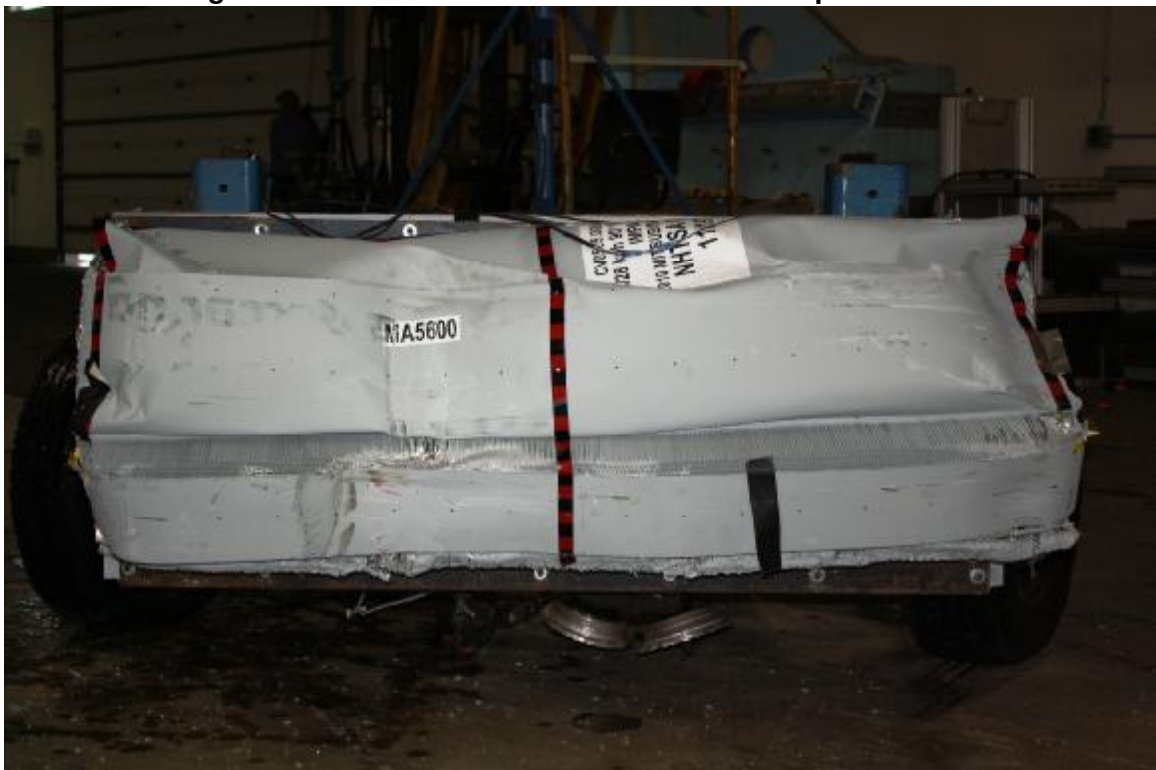
Figure A-22: Post-Test Frontal View of MDB Impactor Face

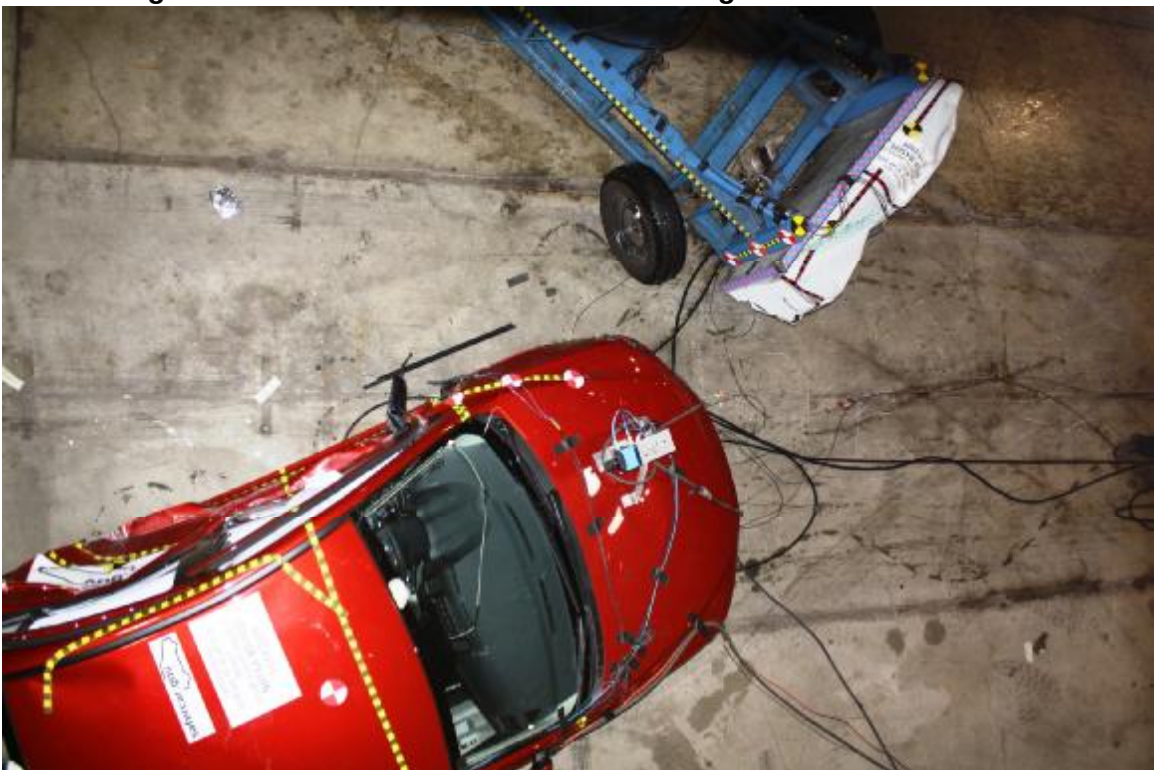
**Figure A-32: Post-Test Overhead View of MDB and Vehicle**

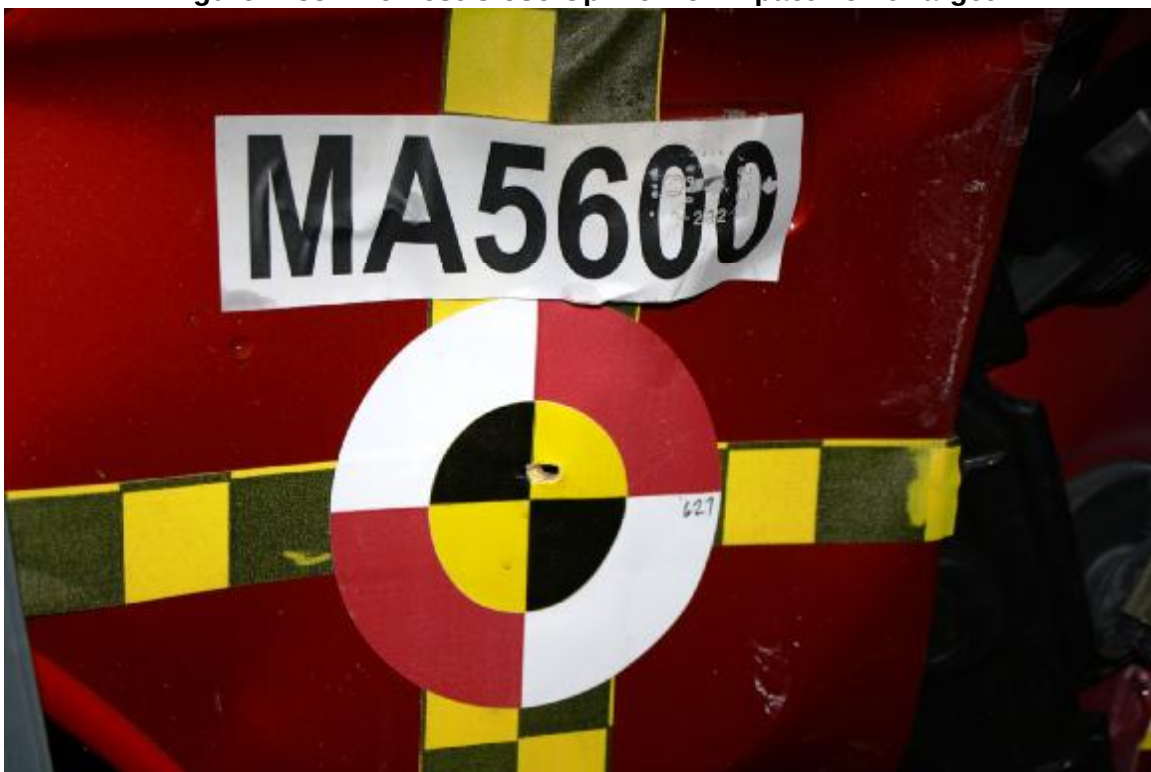
**Figure A-34: Post-Test Close-Up View of Impact Point Target**

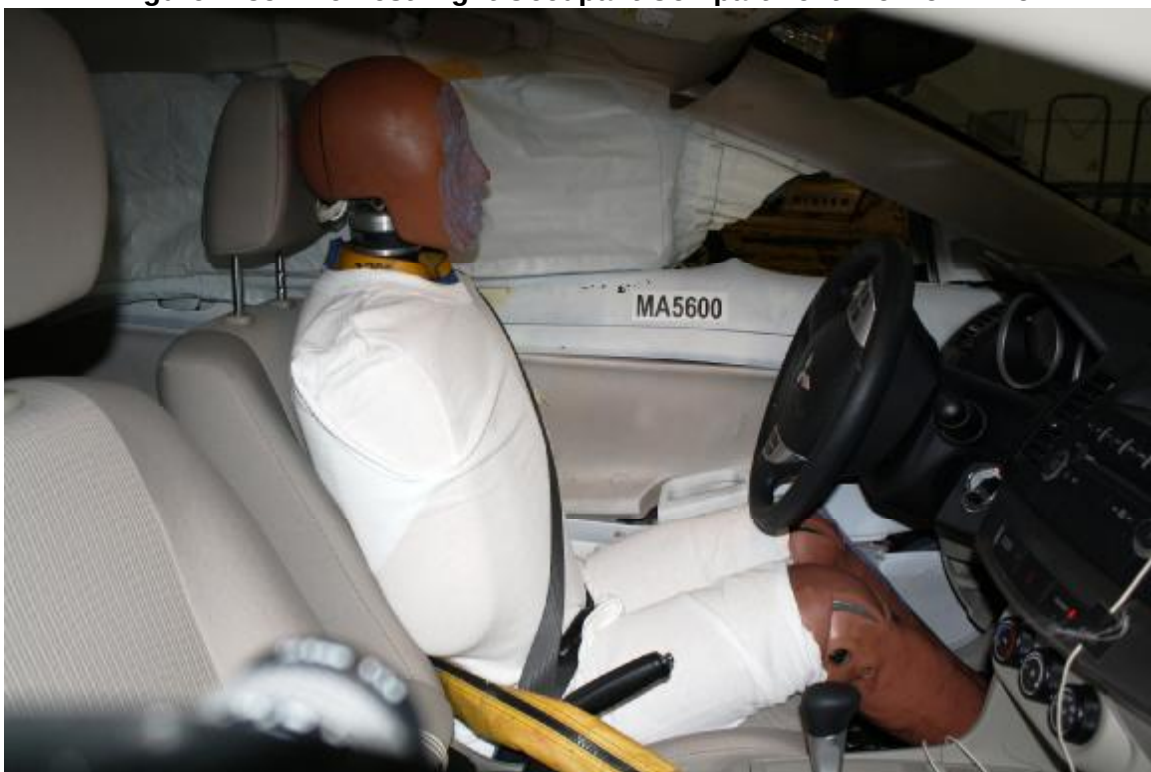
**Figure A-36: Post-Test Right Occupant Compartment View of Driver**

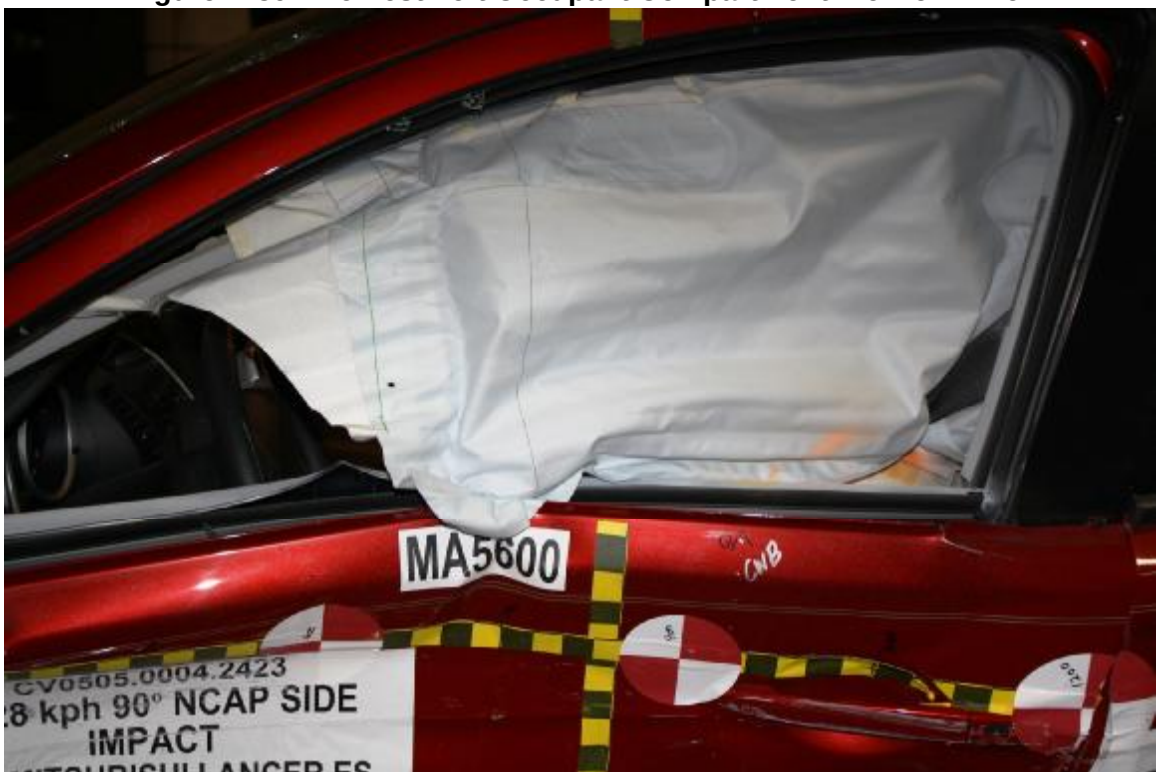
Figure A-40: Post-Test Left Occupant Compartment View of Driver

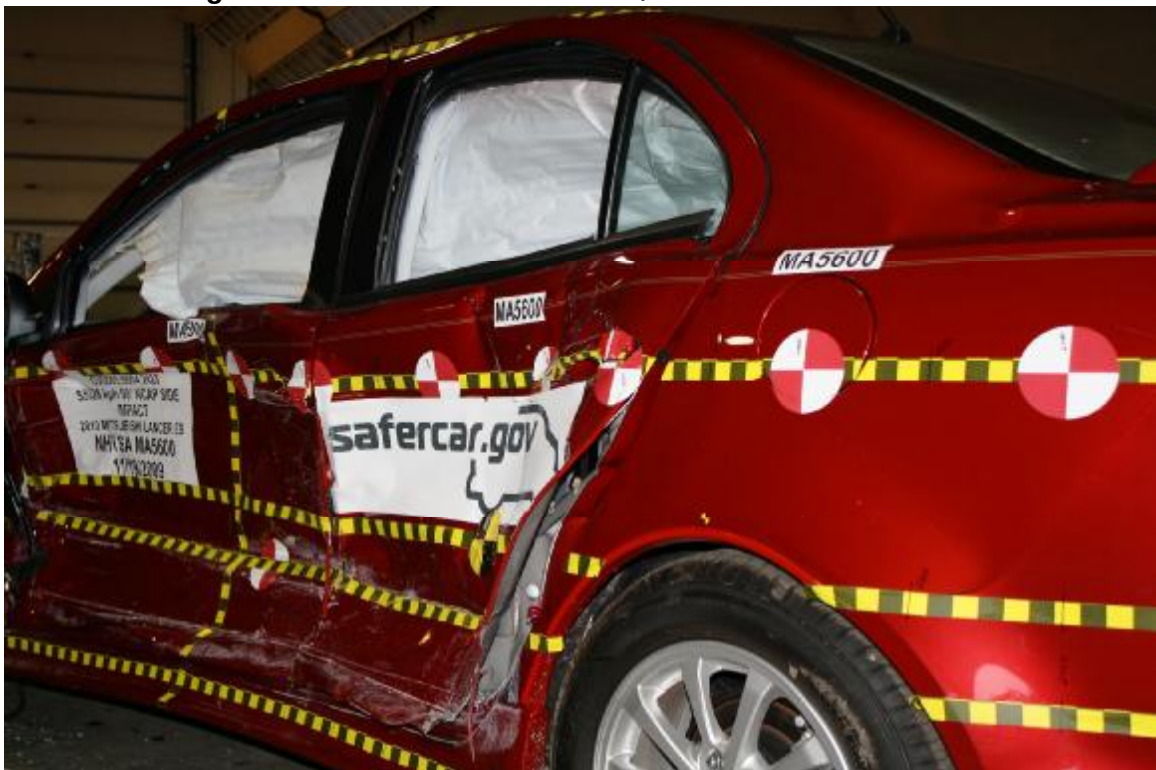
**Figure A-50: Post-Test Left Rear  $\frac{3}{4}$  View of Left Side Doors**
