**REPORT NUMBER: 214I-MGA-2010-001**

**SAFETY COMPLIANCE TESTING FOR  
FMVSS 214 INDICANT  
SIDE IMPACT PROTECTION**

**BAYERISCHE MOTORENWERKE  
2010 BMW 328i COUPE  
NHTSA NUMBER: MA0516**

**PREPARED BY:  
MGA RESEARCH CORPORATION  
5000 WARREN ROAD  
BURLINGTON, WI 53105**

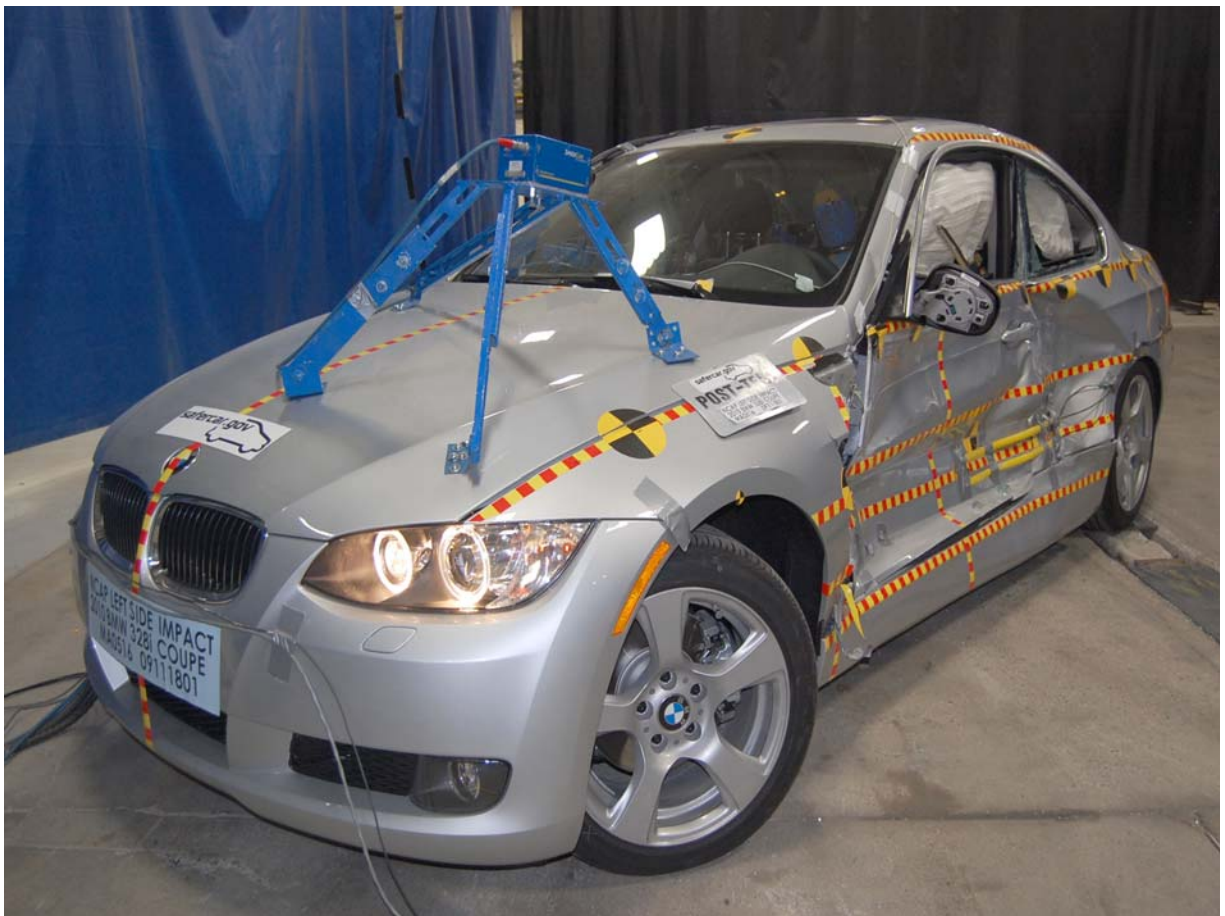
Post-Test Left Front  $\frac{3}{4}$  View

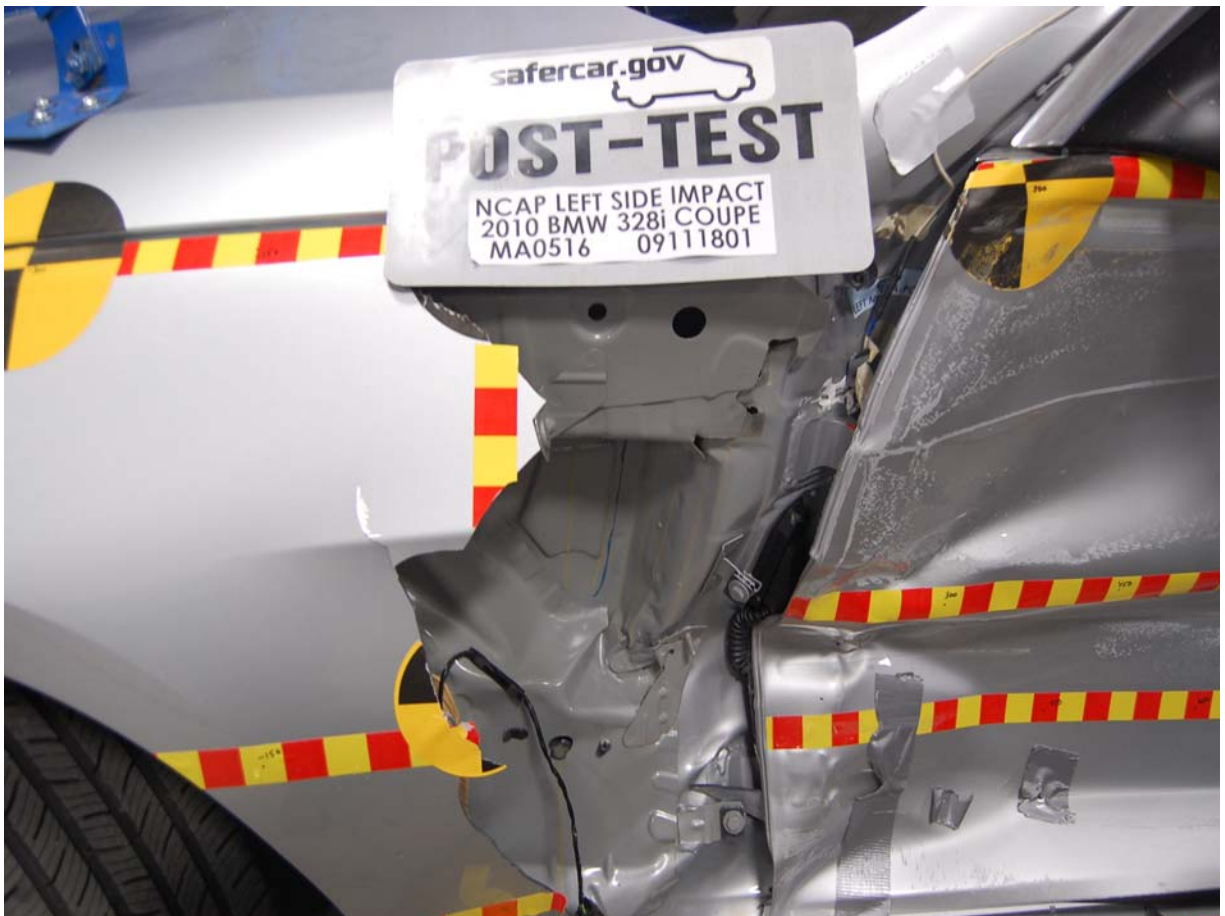
Post-Test Left Impact Point

The test vehicle sustained a maximum static crush of 210 mm at level 3, 1350 mm rearward of the vertical impact point. The driver and passenger SID/HIIIs, Serial Numbers 272 and 271 respectively, were calibrated just prior to this test.

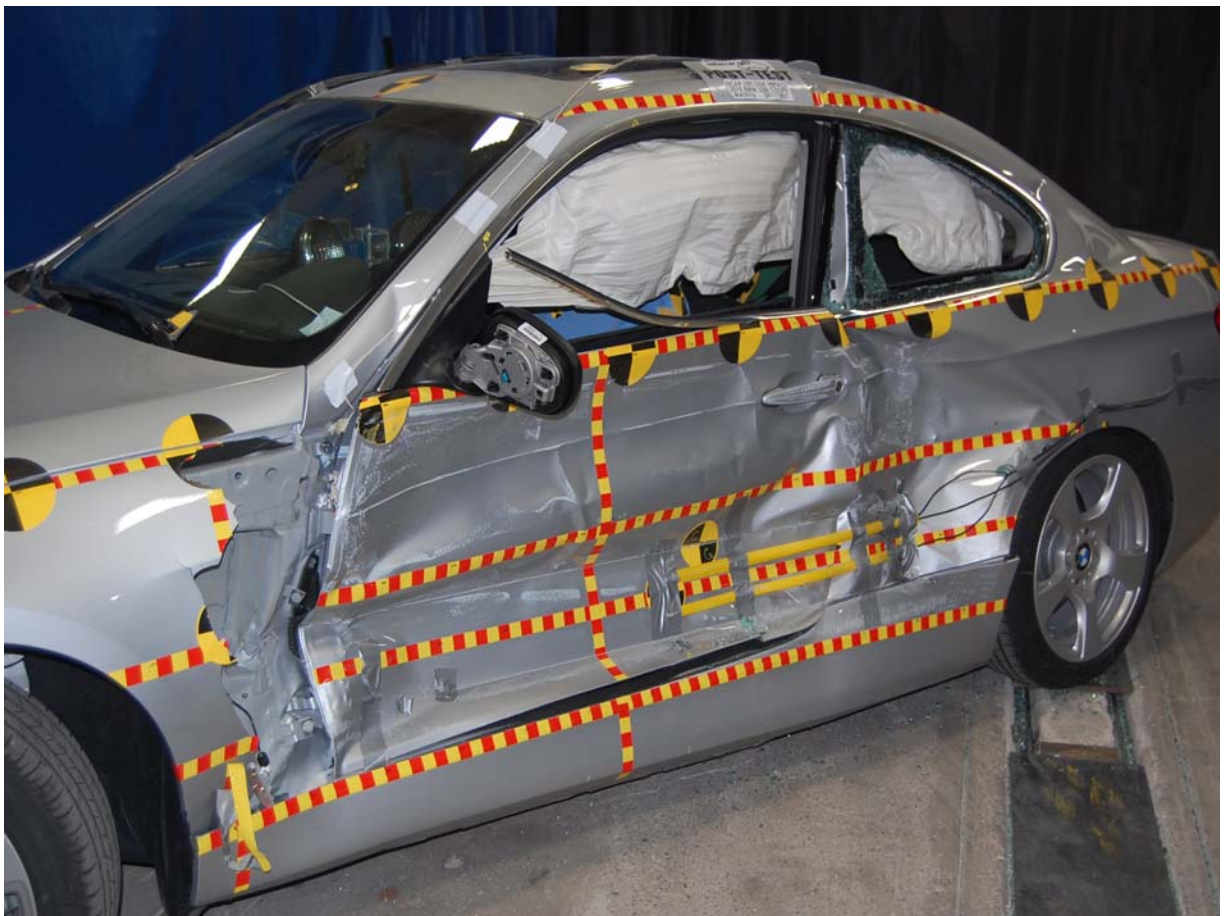
Post-Test Front  $\frac{3}{4}$  View of Left Side Doors

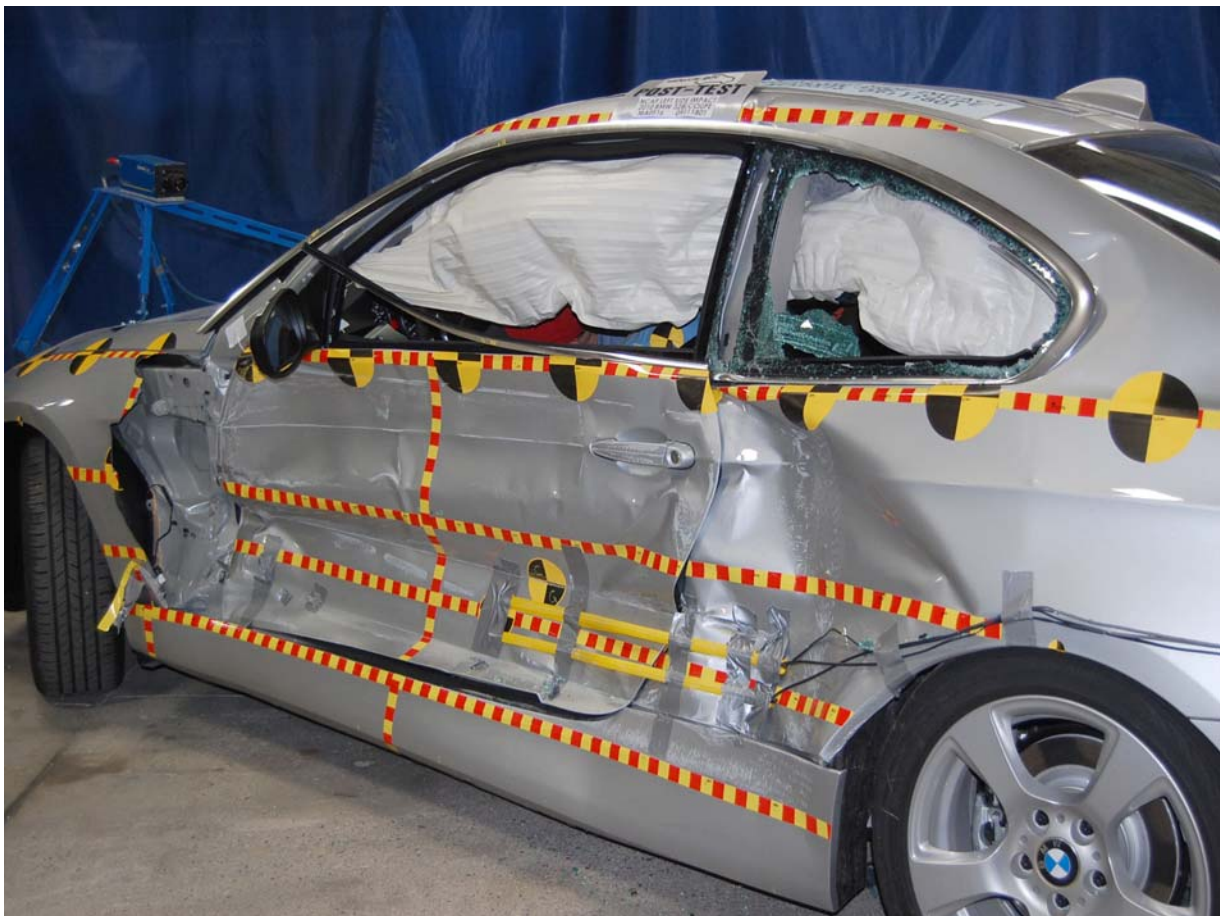
Post-Test Rear  $\frac{3}{4}$  View of Left Side Doors

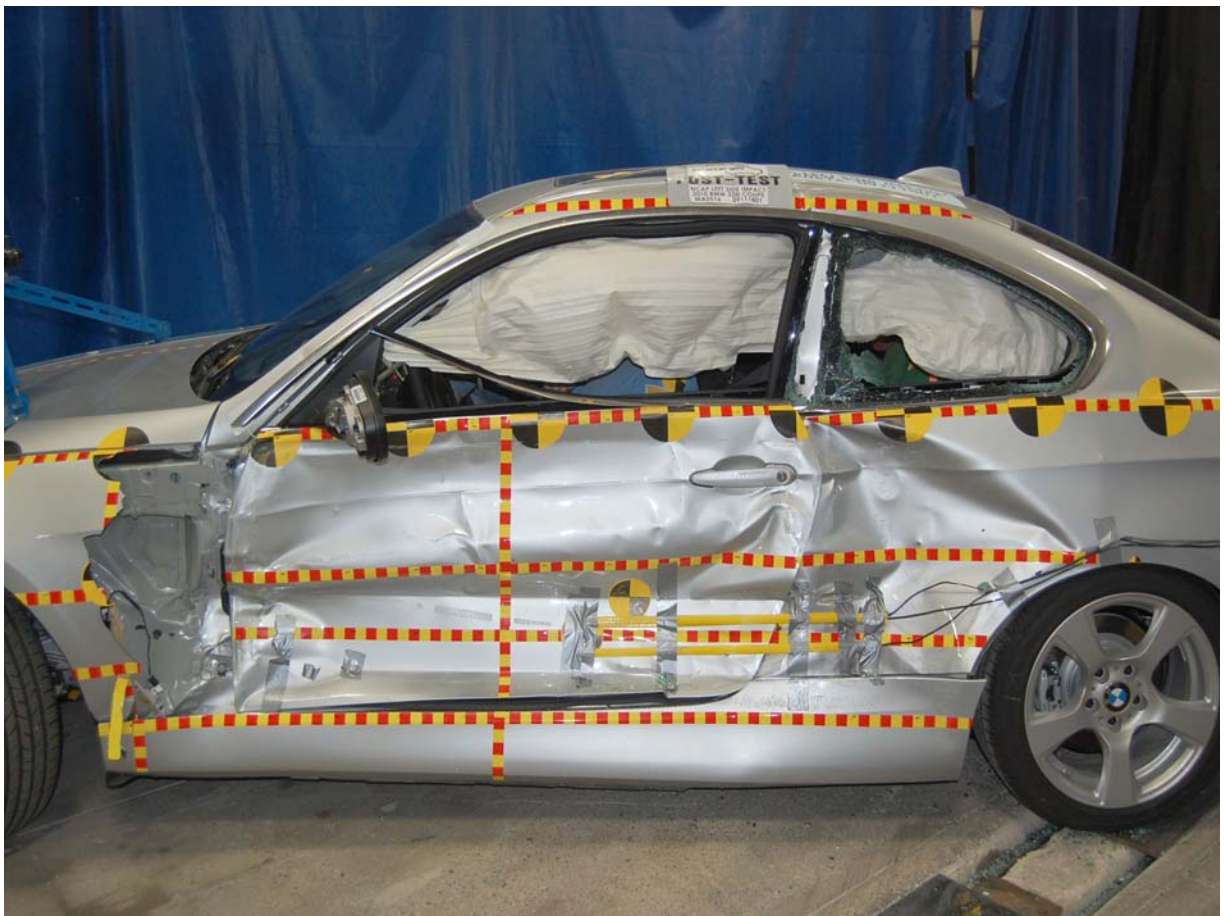
Post-Test Left Side Impact Close-up

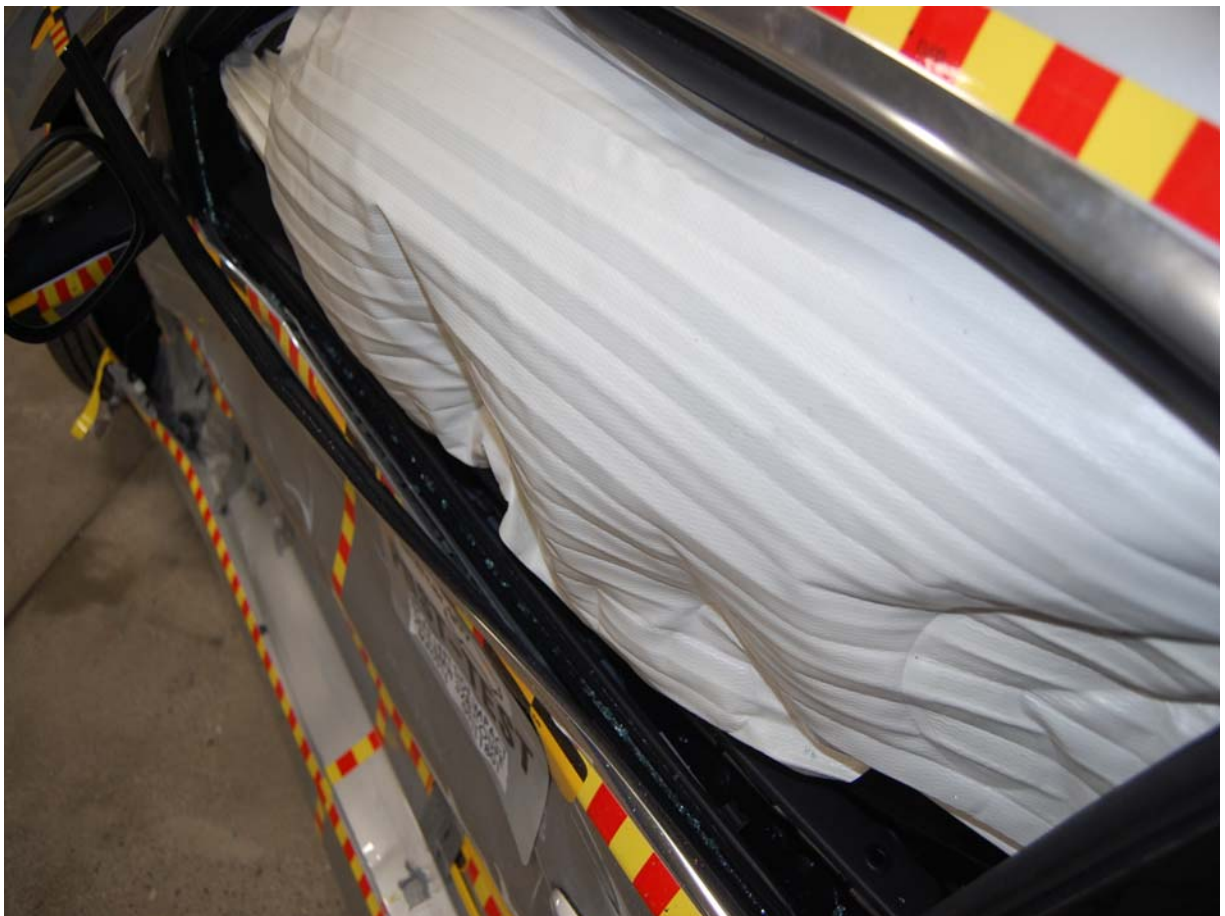
Post-Test Driver Dummy Clearance From Door

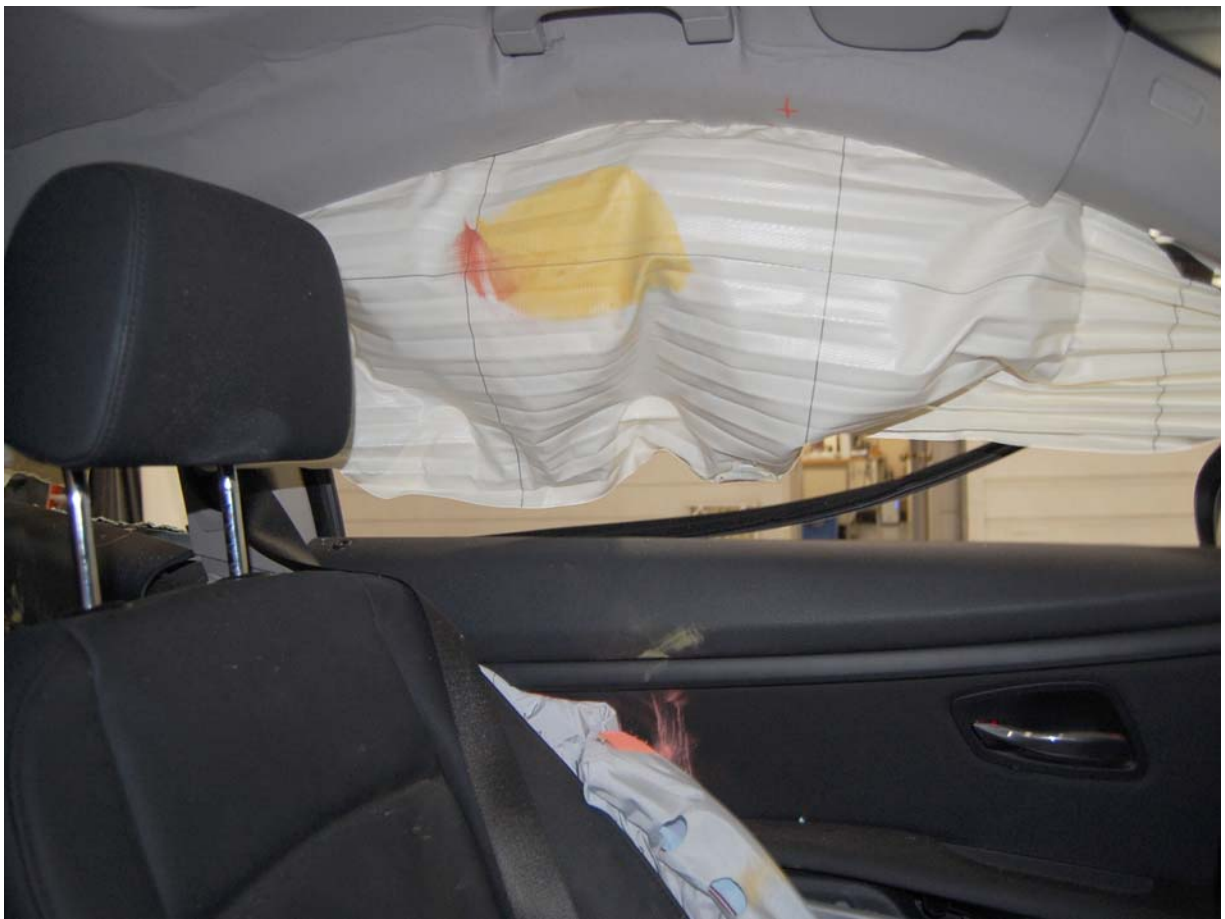
Post-Test Driver Dummy Head Contact View

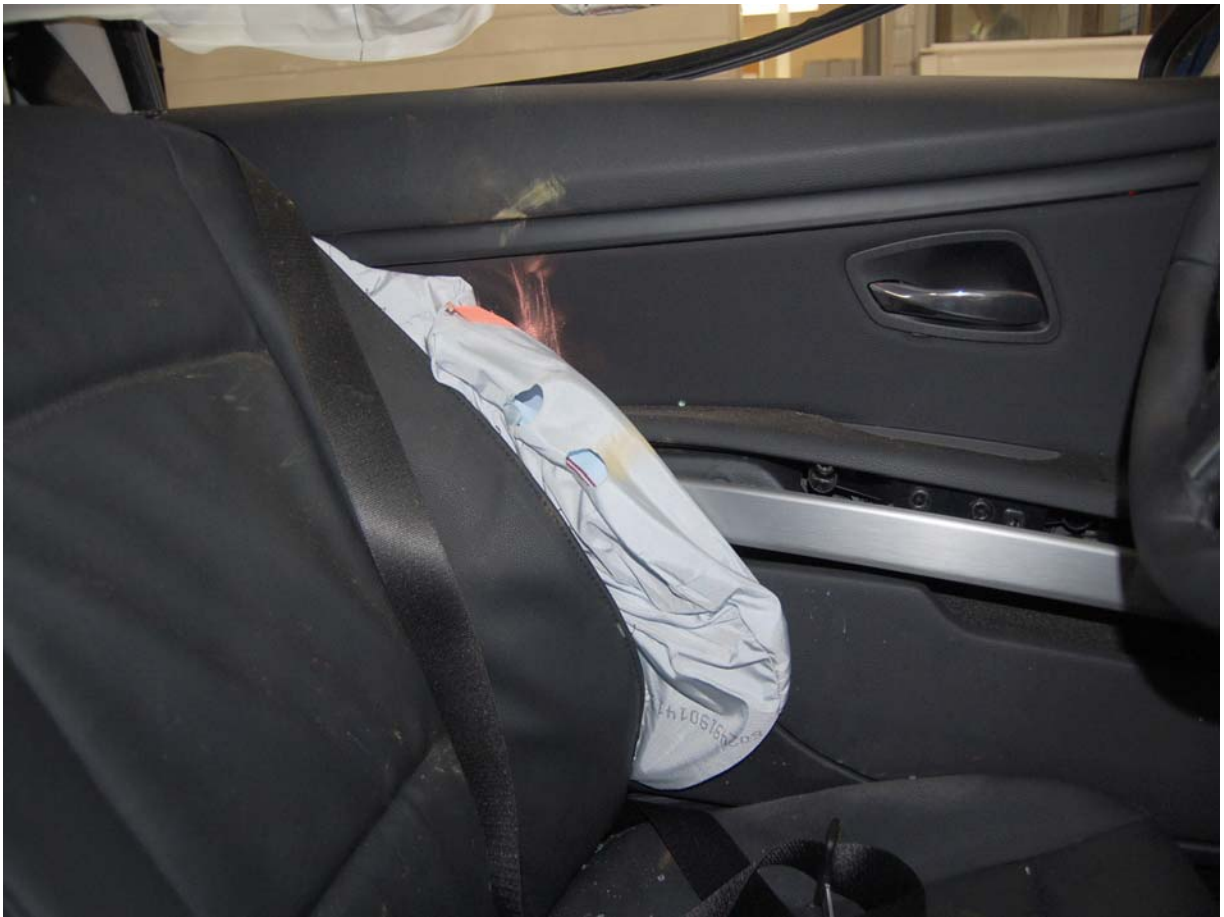
Post-Test Driver Dummy Torso Contact
