**REPORT NUMBER: NCAPSIDE-MGA-2010-008**

**NEW CAR ASSESSMENT PROGRAM  
SIDE IMPACT TEST**

**GENERAL MOTORS DE MEXICO, S. DE R.L. DE C.V.  
2010 CADILLAC SRX FWD  
NHTSA NUMBER: MA0121**

**PREPARED BY:  
MGA RESEARCH CORPORATION  
5000 WARREN ROAD  
BURLINGTON, WI 53105**

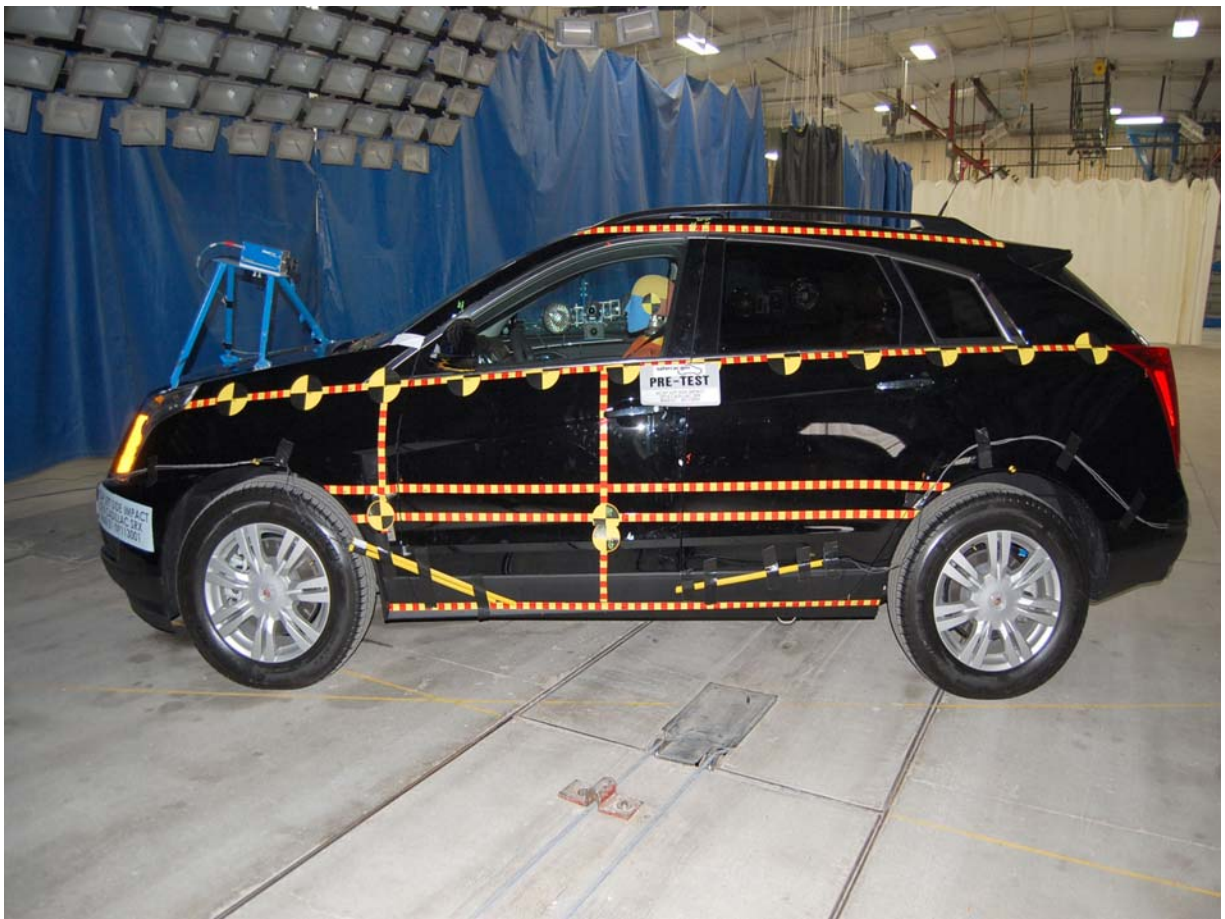
Pre-Test Left Side View

Post-Test Left Side View

The test vehicle sustained a maximum static crush of 238 mm at level 3, 1650 mm rearward of the vertical impact point. The driver and passenger SID/HIIIs, Serial Nos. 271 and 272 respectively, were calibrated just prior to this test.

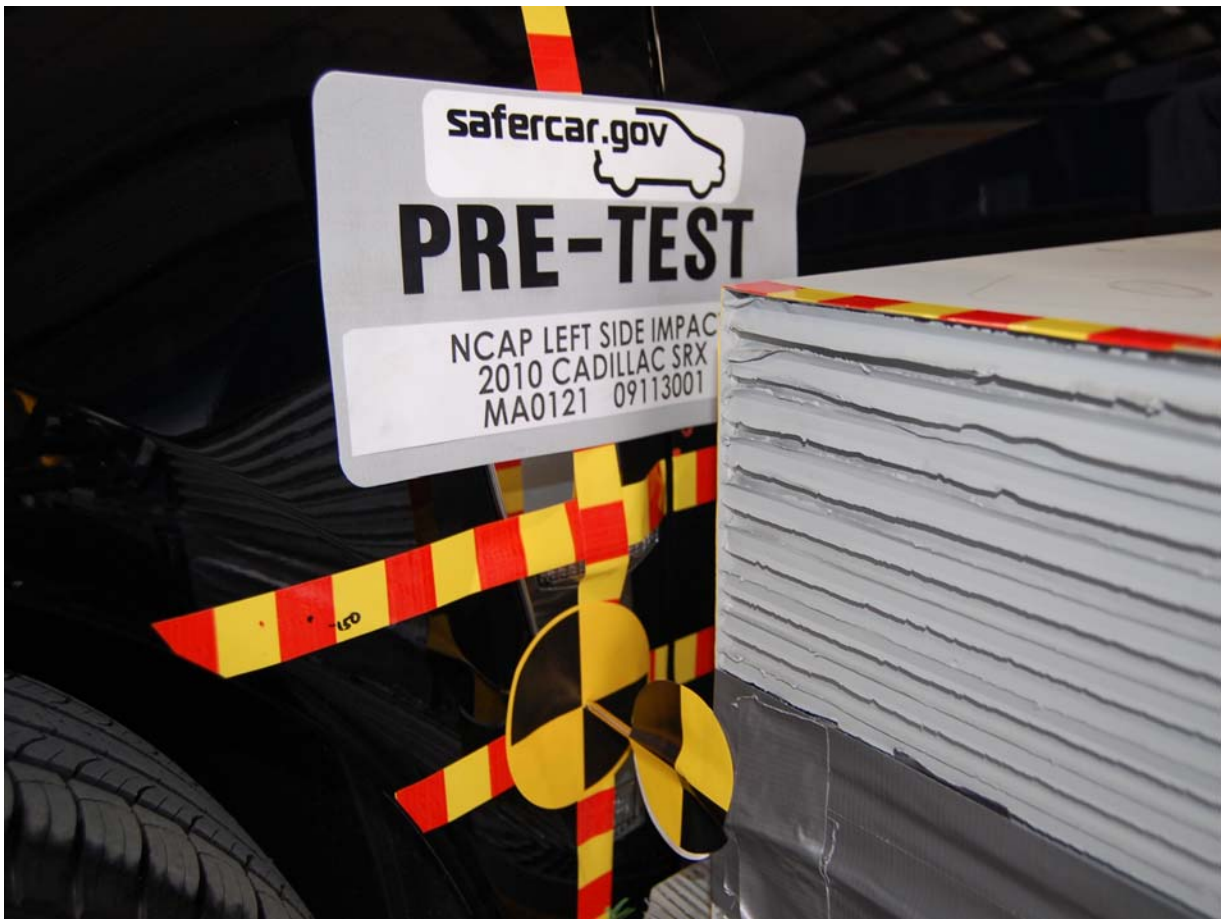
Pre-Test Left Impact Point

Post-Test Left Impact Point

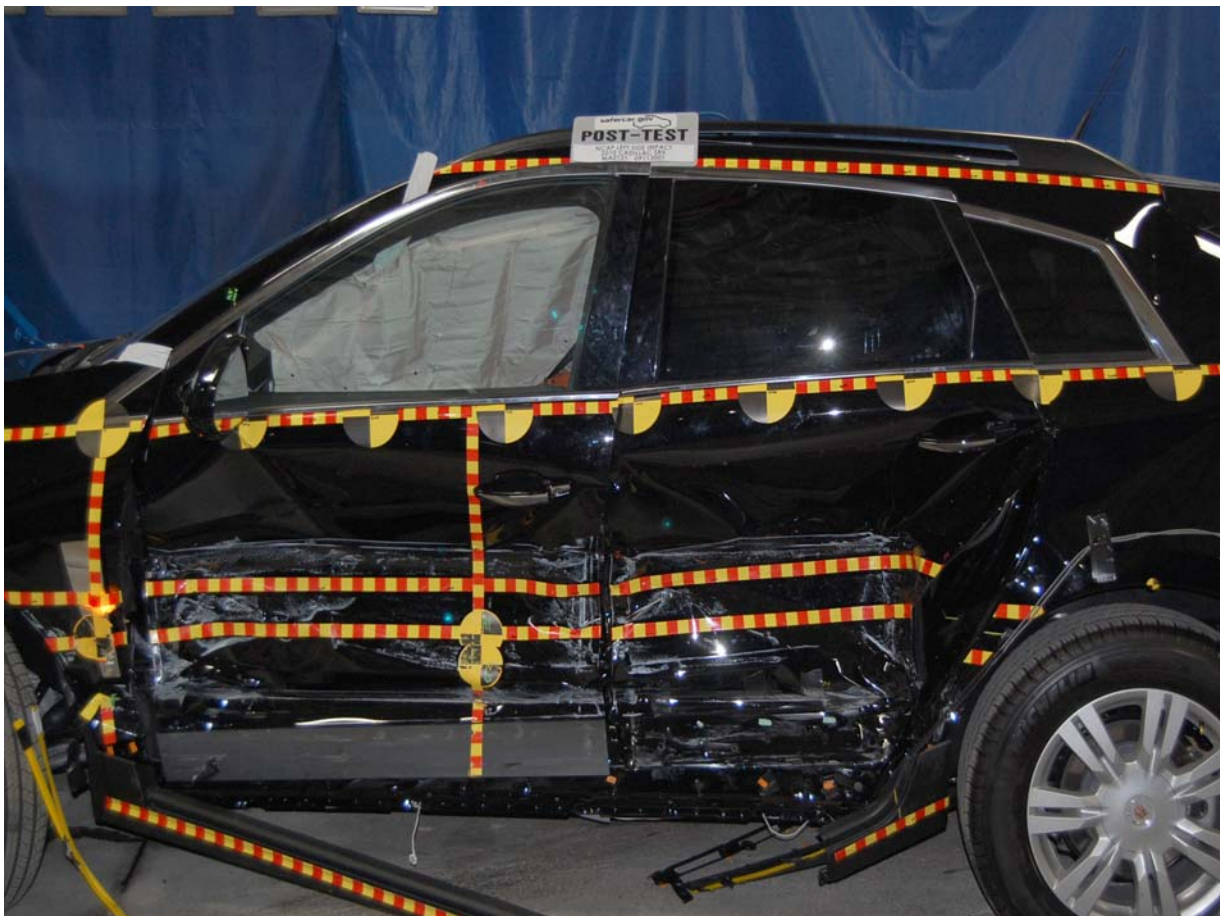
Post-Test Left Side Impact Close-up
