**REPORT NUMBER: NCAP-MGA-2010-011**

**NEW CAR ASSESSMENT PROGRAM  
FRONTAL BARRIER IMPACT TEST**

**GENERAL MOTORS DE MEXICO, S. DE R.L. DE C.V.  
2010 CADILLAC SRX AWD  
NHTSA NUMBER: MA0120**

**FINAL REPORT**

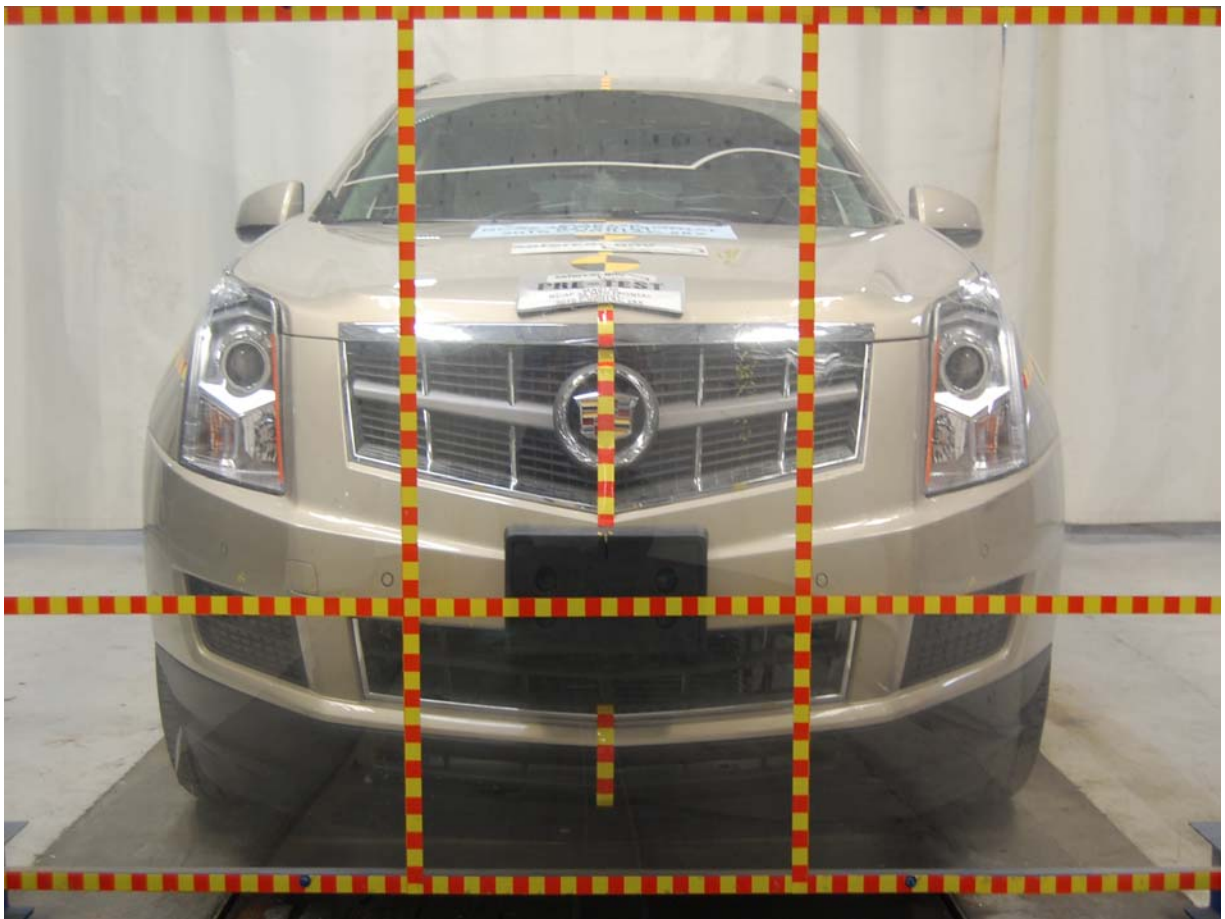
Load Cell Location

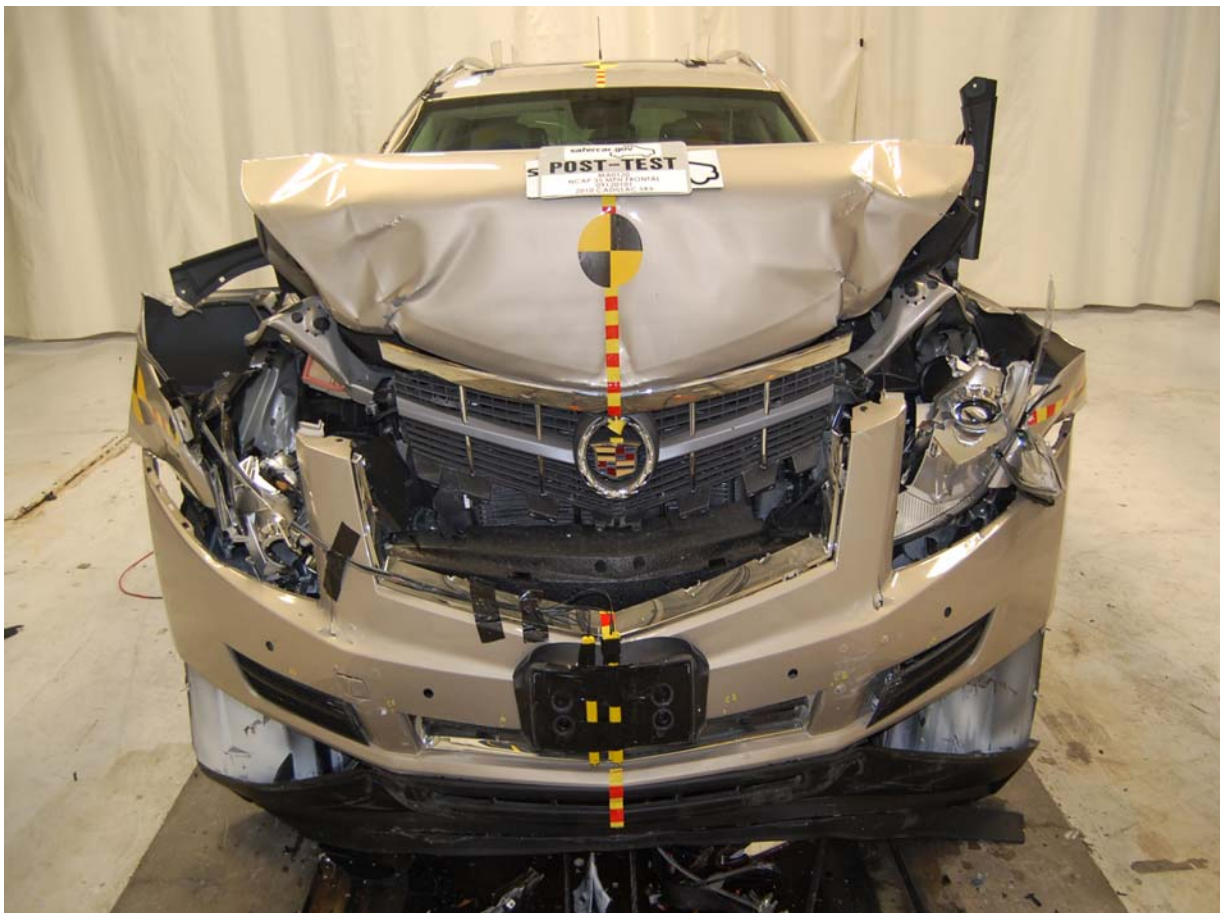
Post-Test Front View

The maximum static crush of the vehicle was 698 mm and both the driver and passenger side door remained closed and latched during the impact event and were operable after the impact.

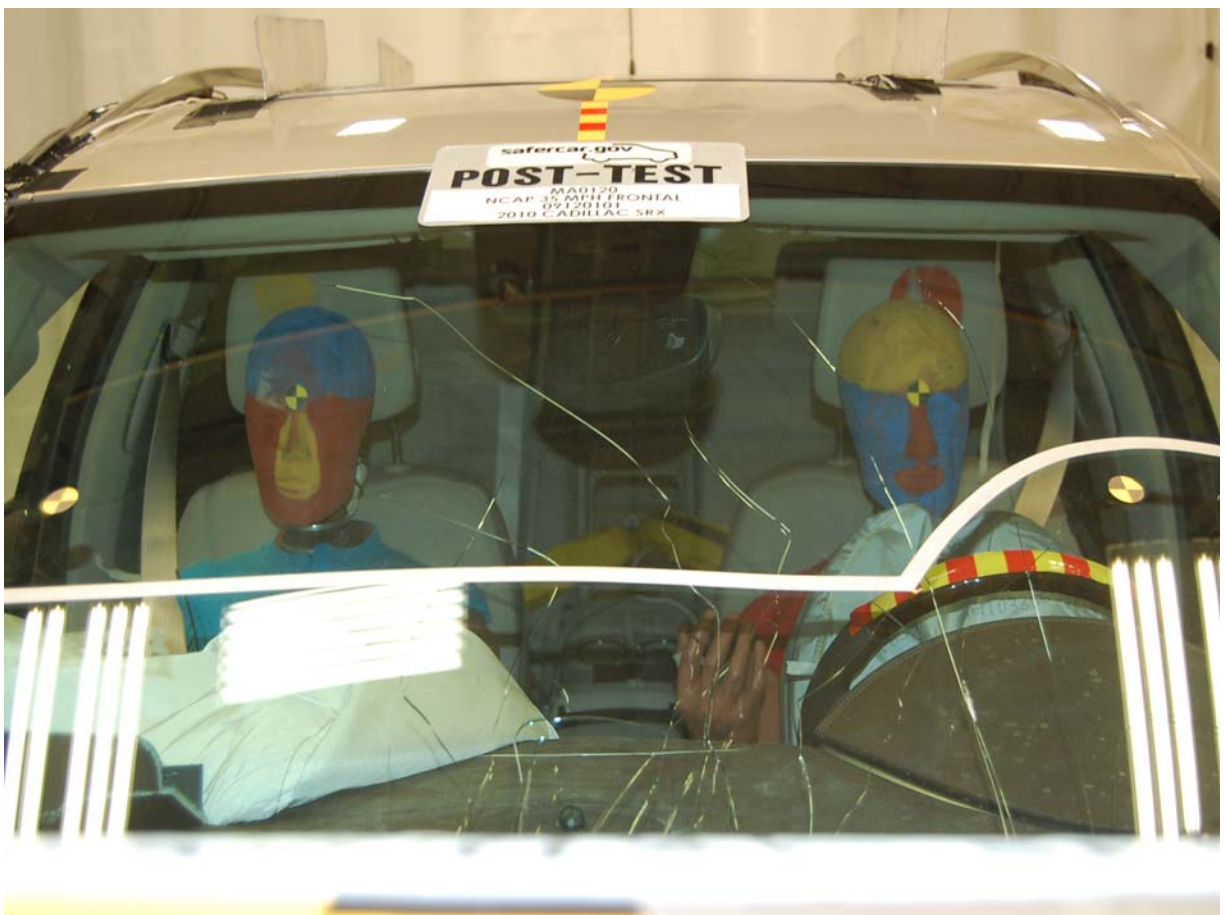
Post-Test Windshield View

There was 100 percent windshield retention and no intrusion into the protected zone of the windshield during the event. There was no Stoddard Solvent leakage after the event or during any phase of the static rollover.

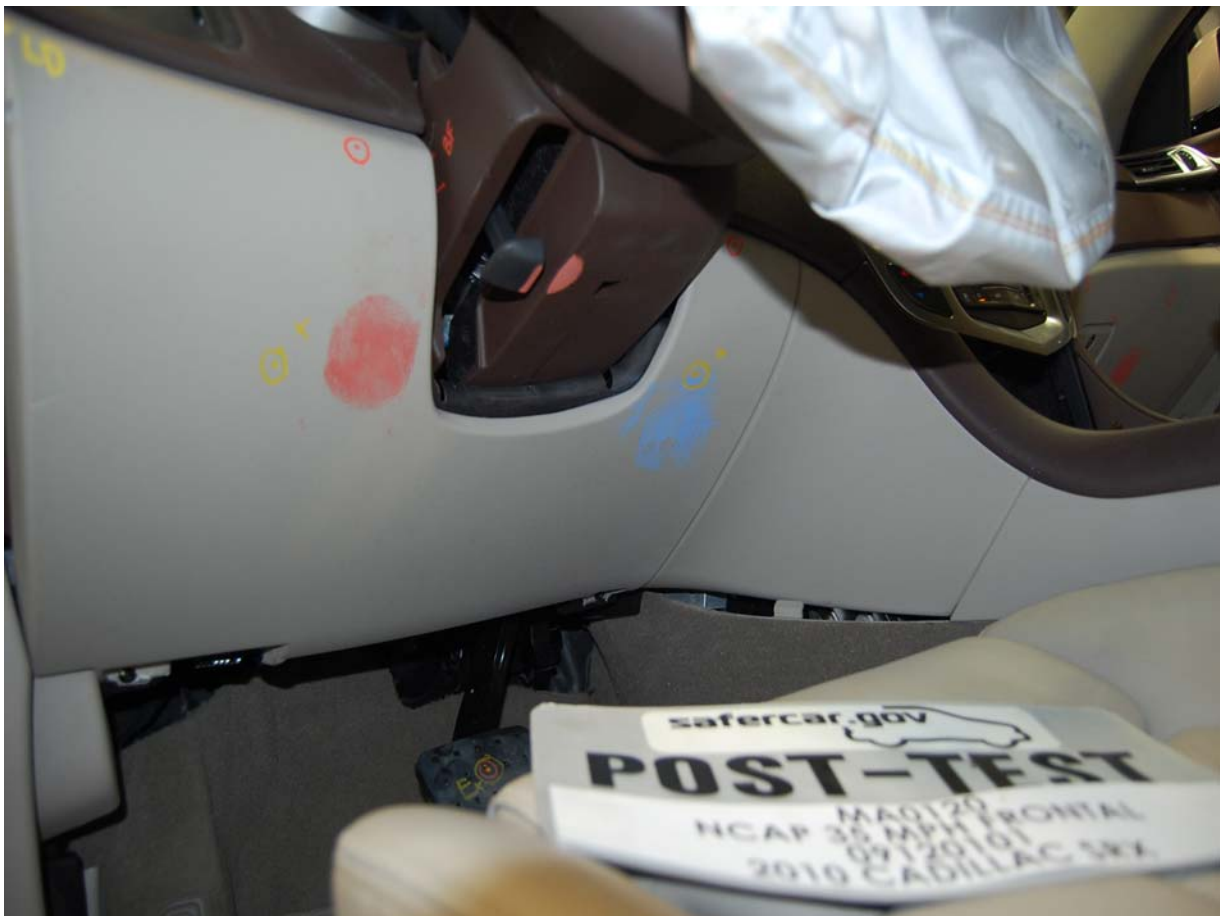
Post-Test Driver Dummy Knee Contact

The driver's head and chest contacted the airbag. The driver's head also contacted the headrest. The driver's knees contacted the knee bolster. The passenger's head and chest contacted the airbag. The passenger's head also contacted the headrest and headliner. The passenger's knees contacted the glove box.

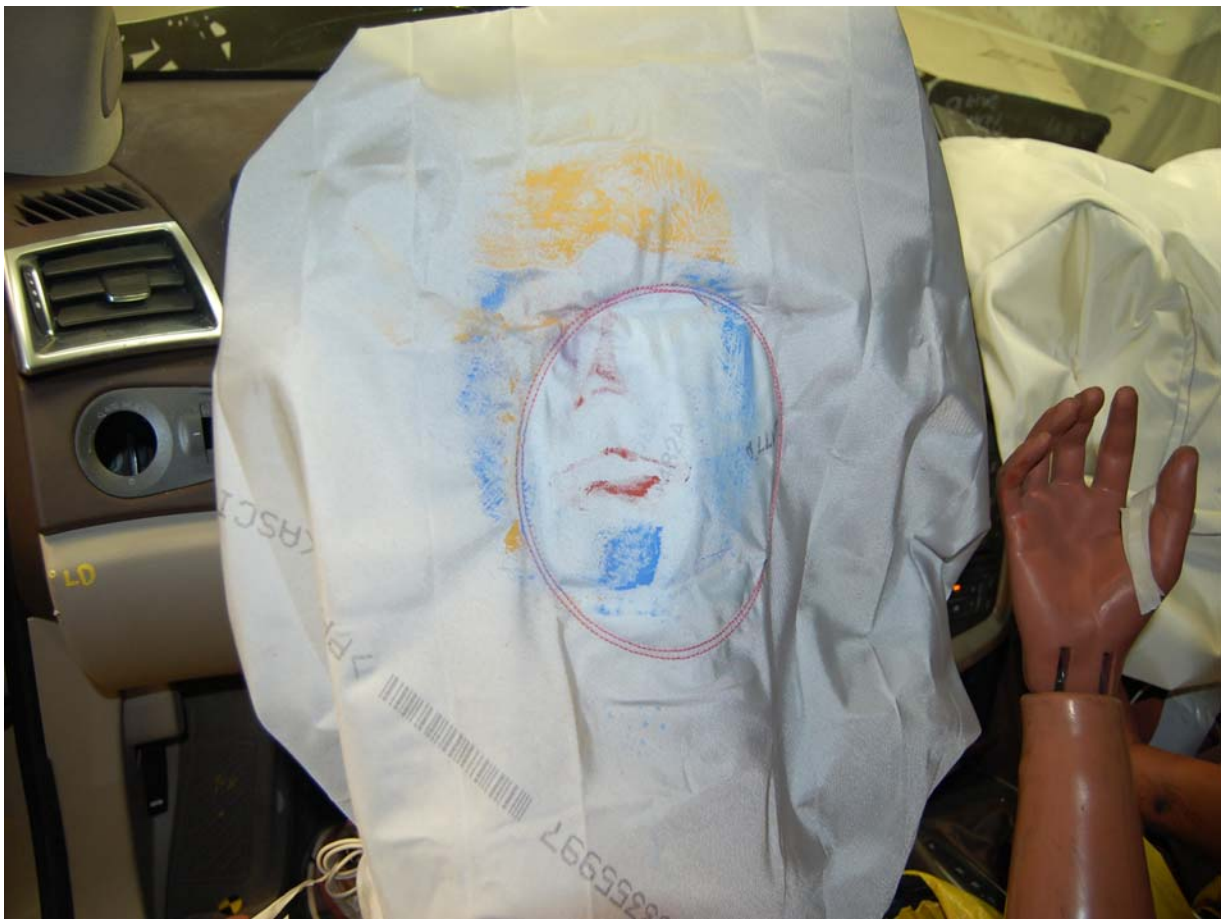
Post-Test Driver Dummy Airbag Contact

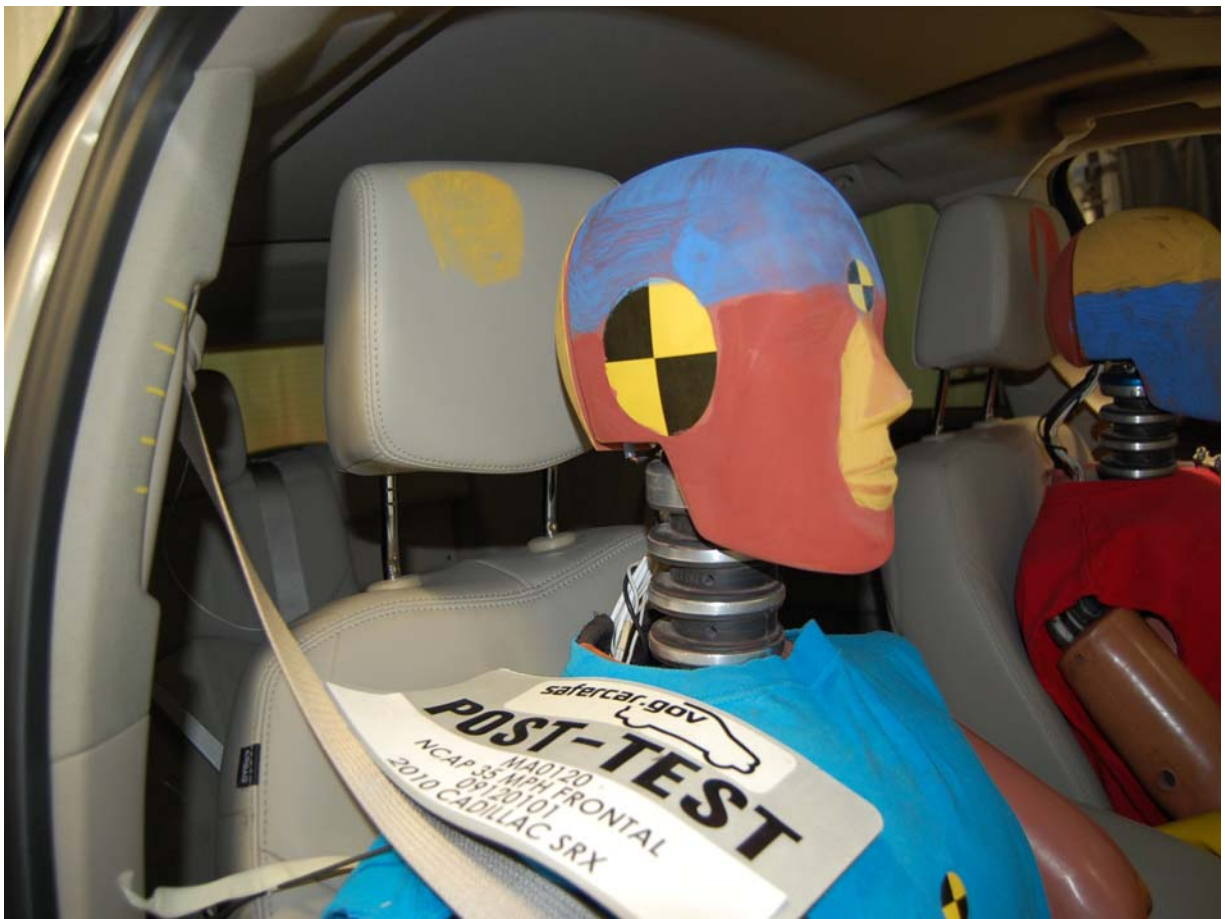
Post-Test Passenger Dummy Head Contact

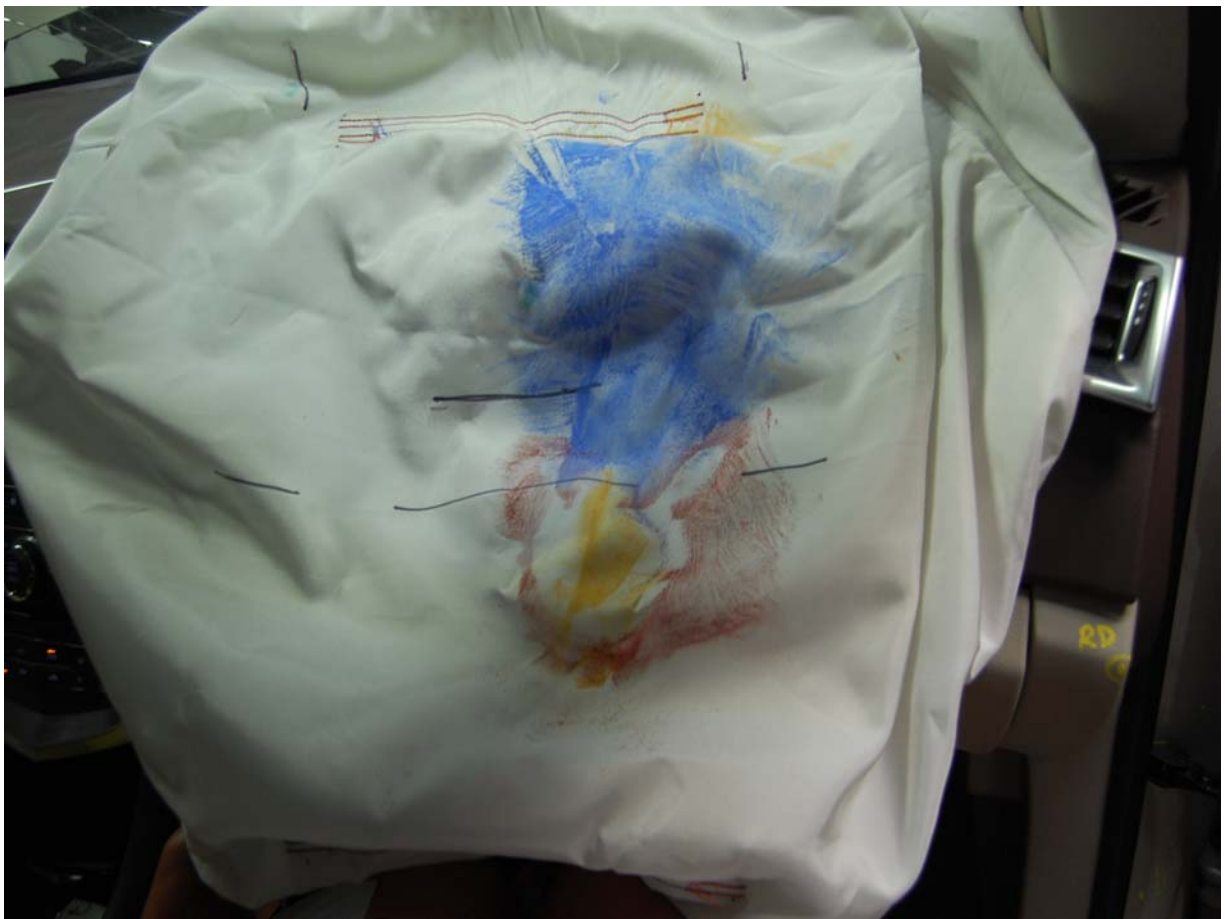
Post-Test Passenger Dummy Airbag Contact
