NEW CAR ASSESSMENT PROGRAM  
SIDE IMPACT TEST

HYUNDAI MOTOR COMPANY  
2010 HYUNDAI ACCENT  
3-DOOR HATCHBACK

NHTSA NUMBER: MA0518

FINAL REPORT

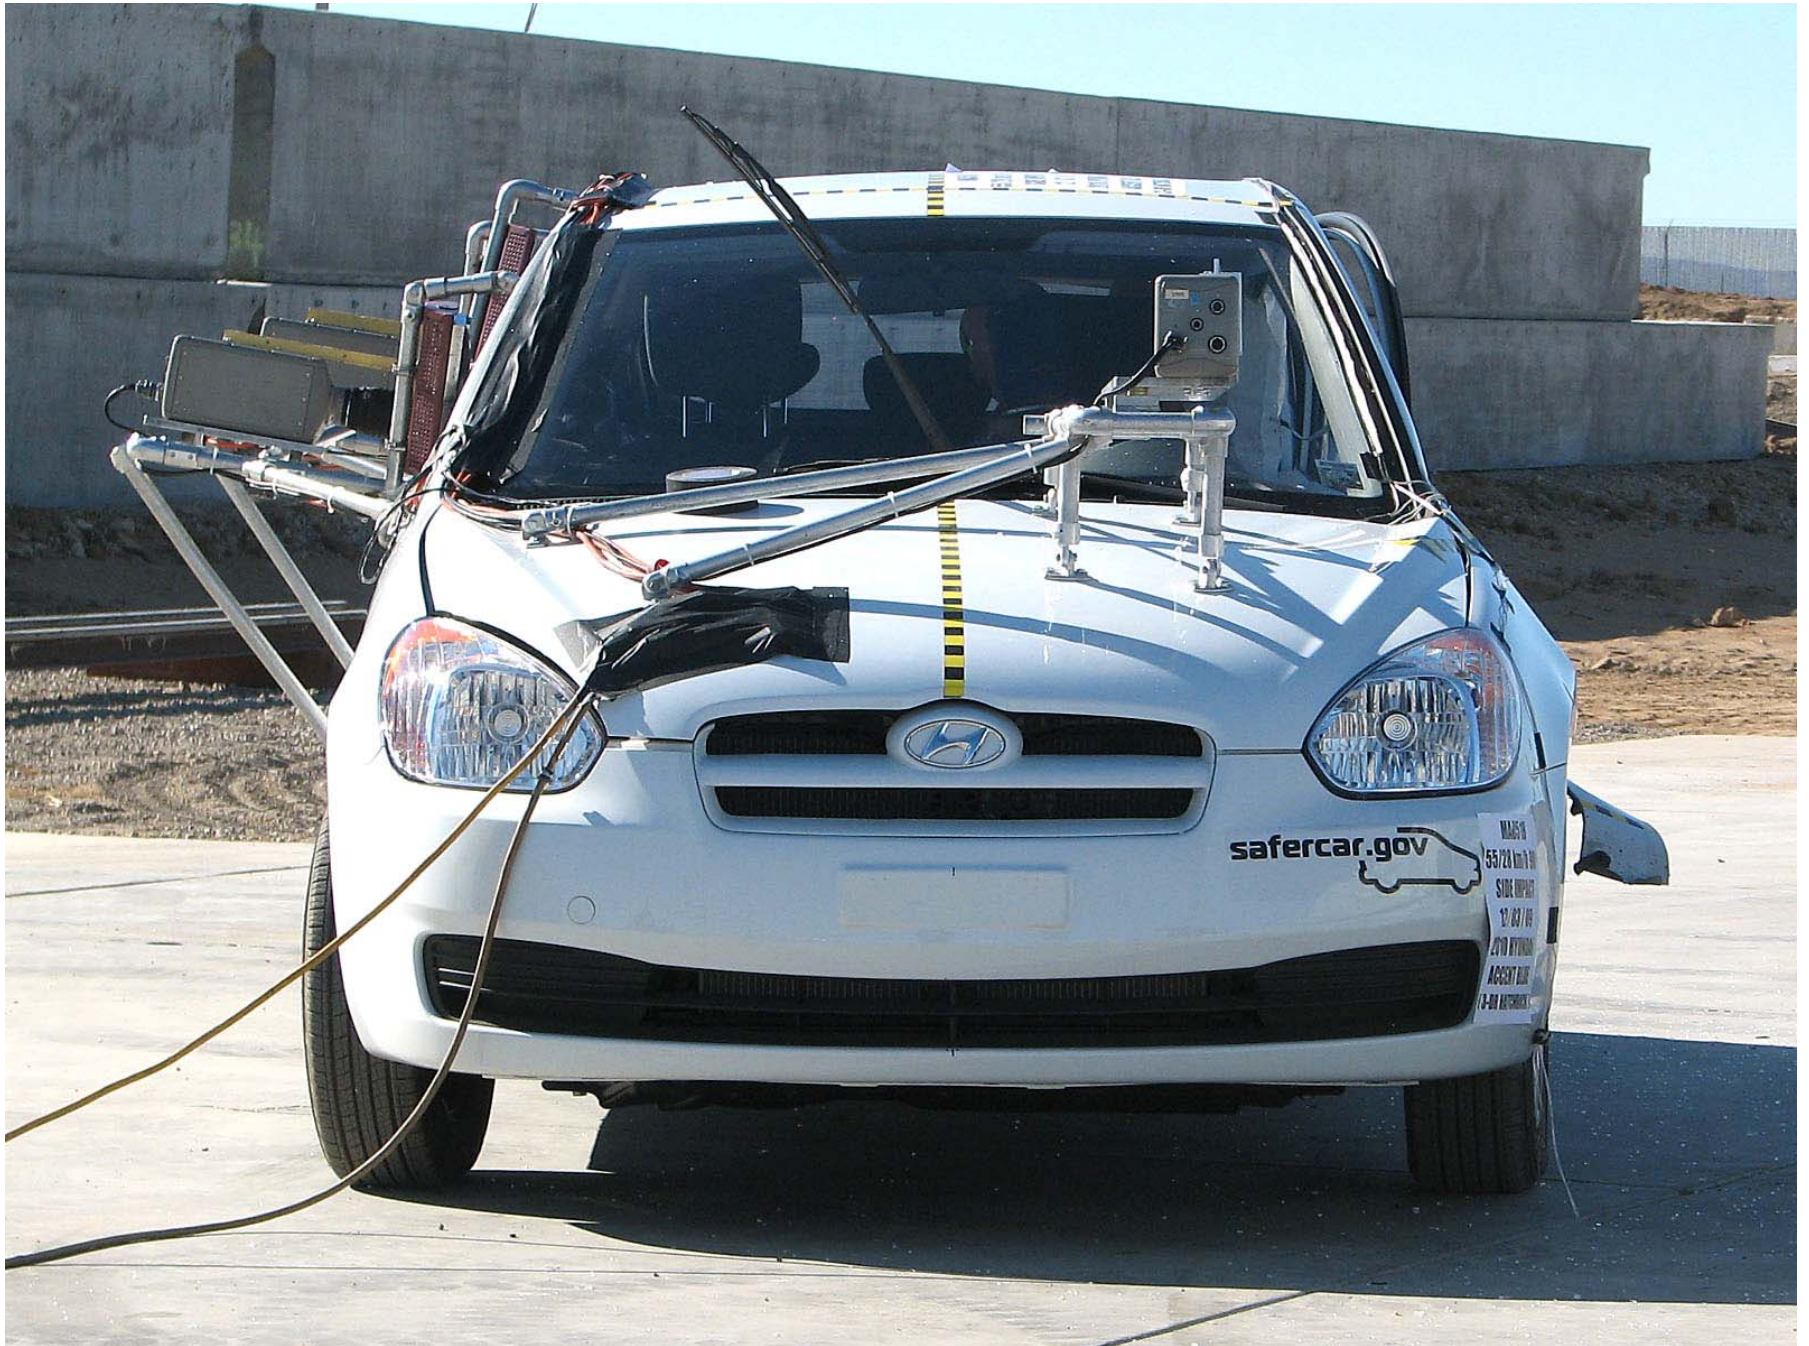
Figure A-6: Post-Test Front View

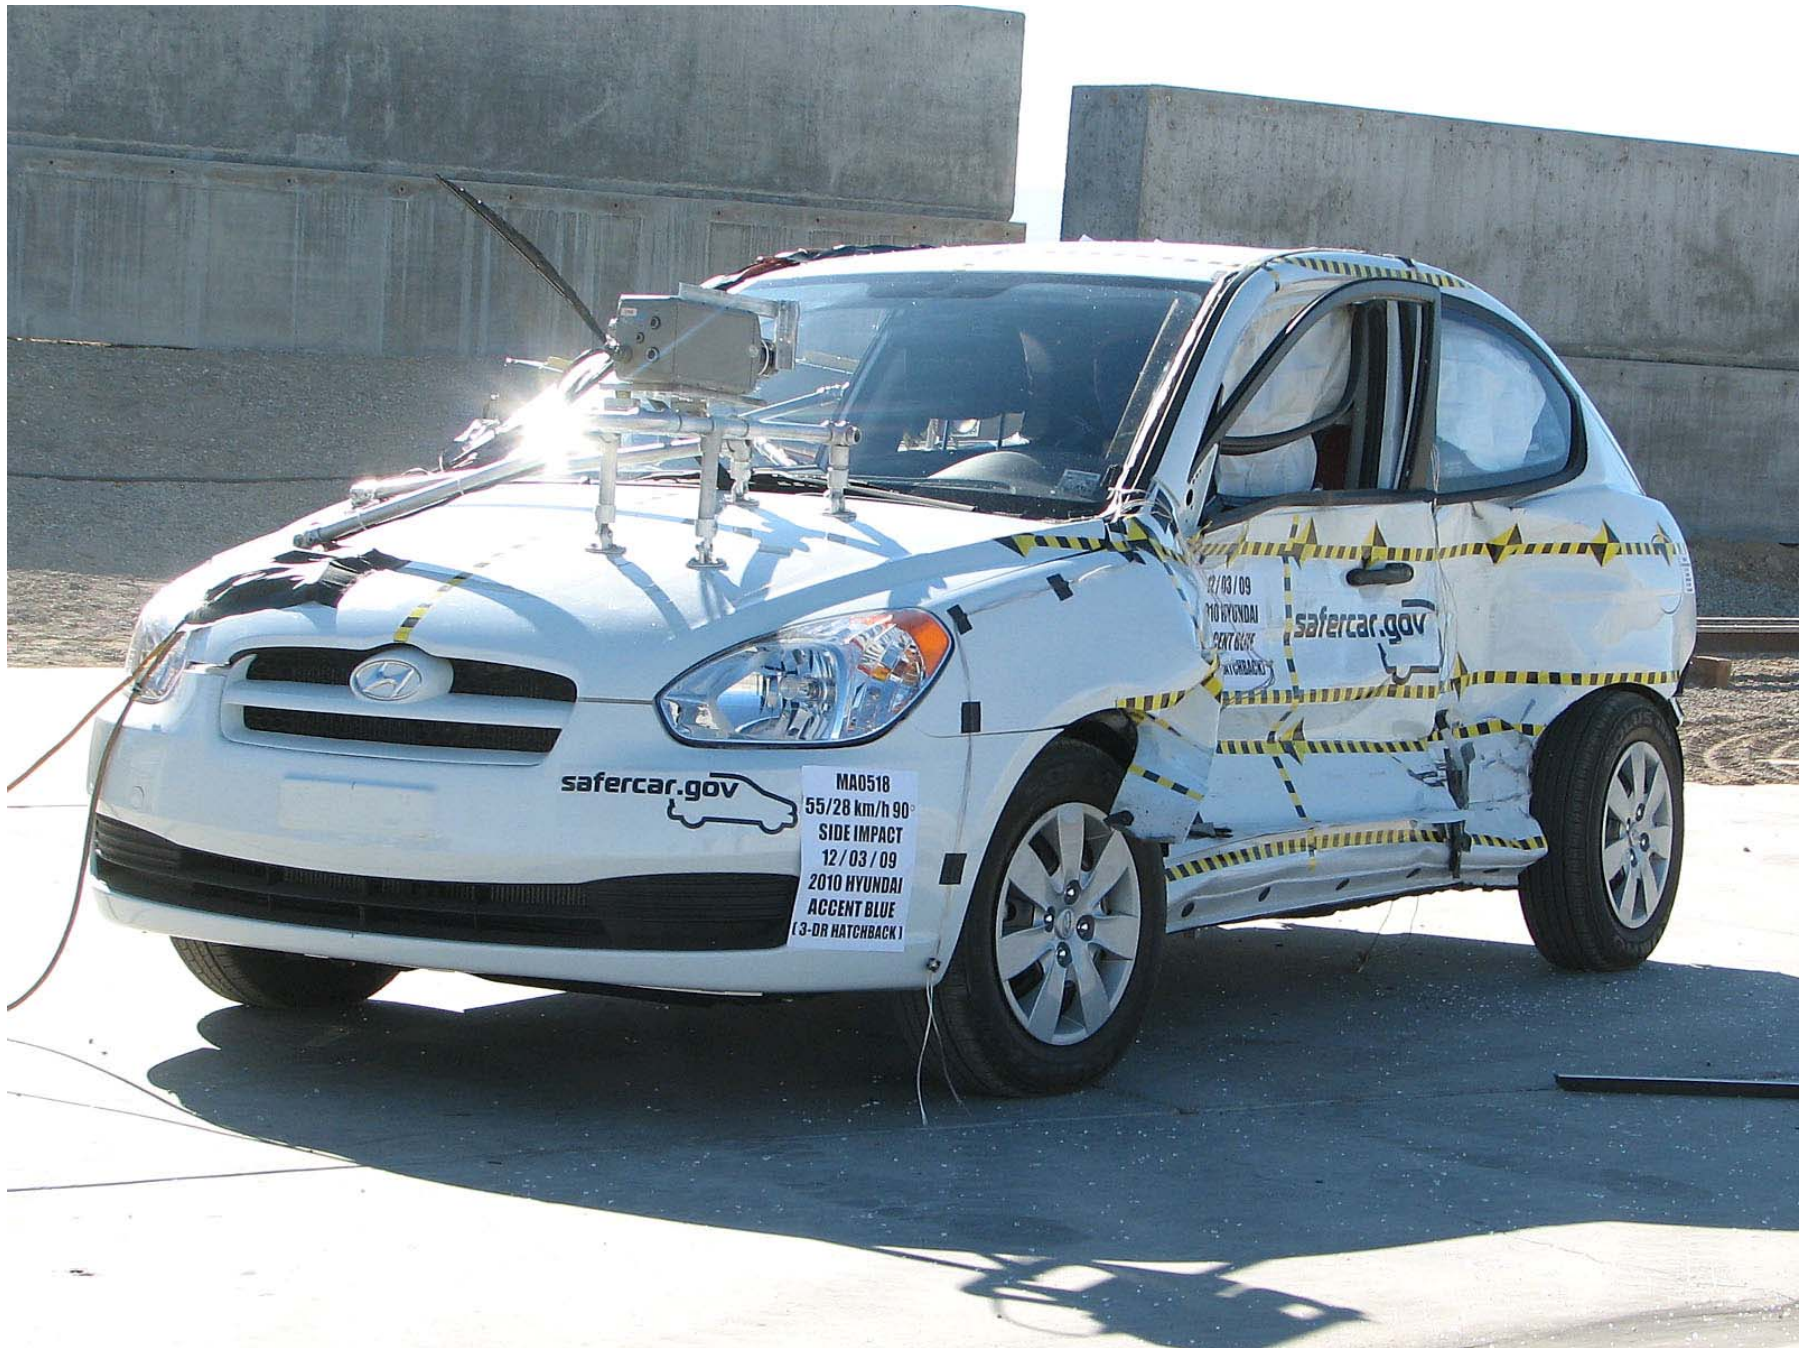
Figure A-8: Post-Test Left Front  $\frac{3}{4}$  View

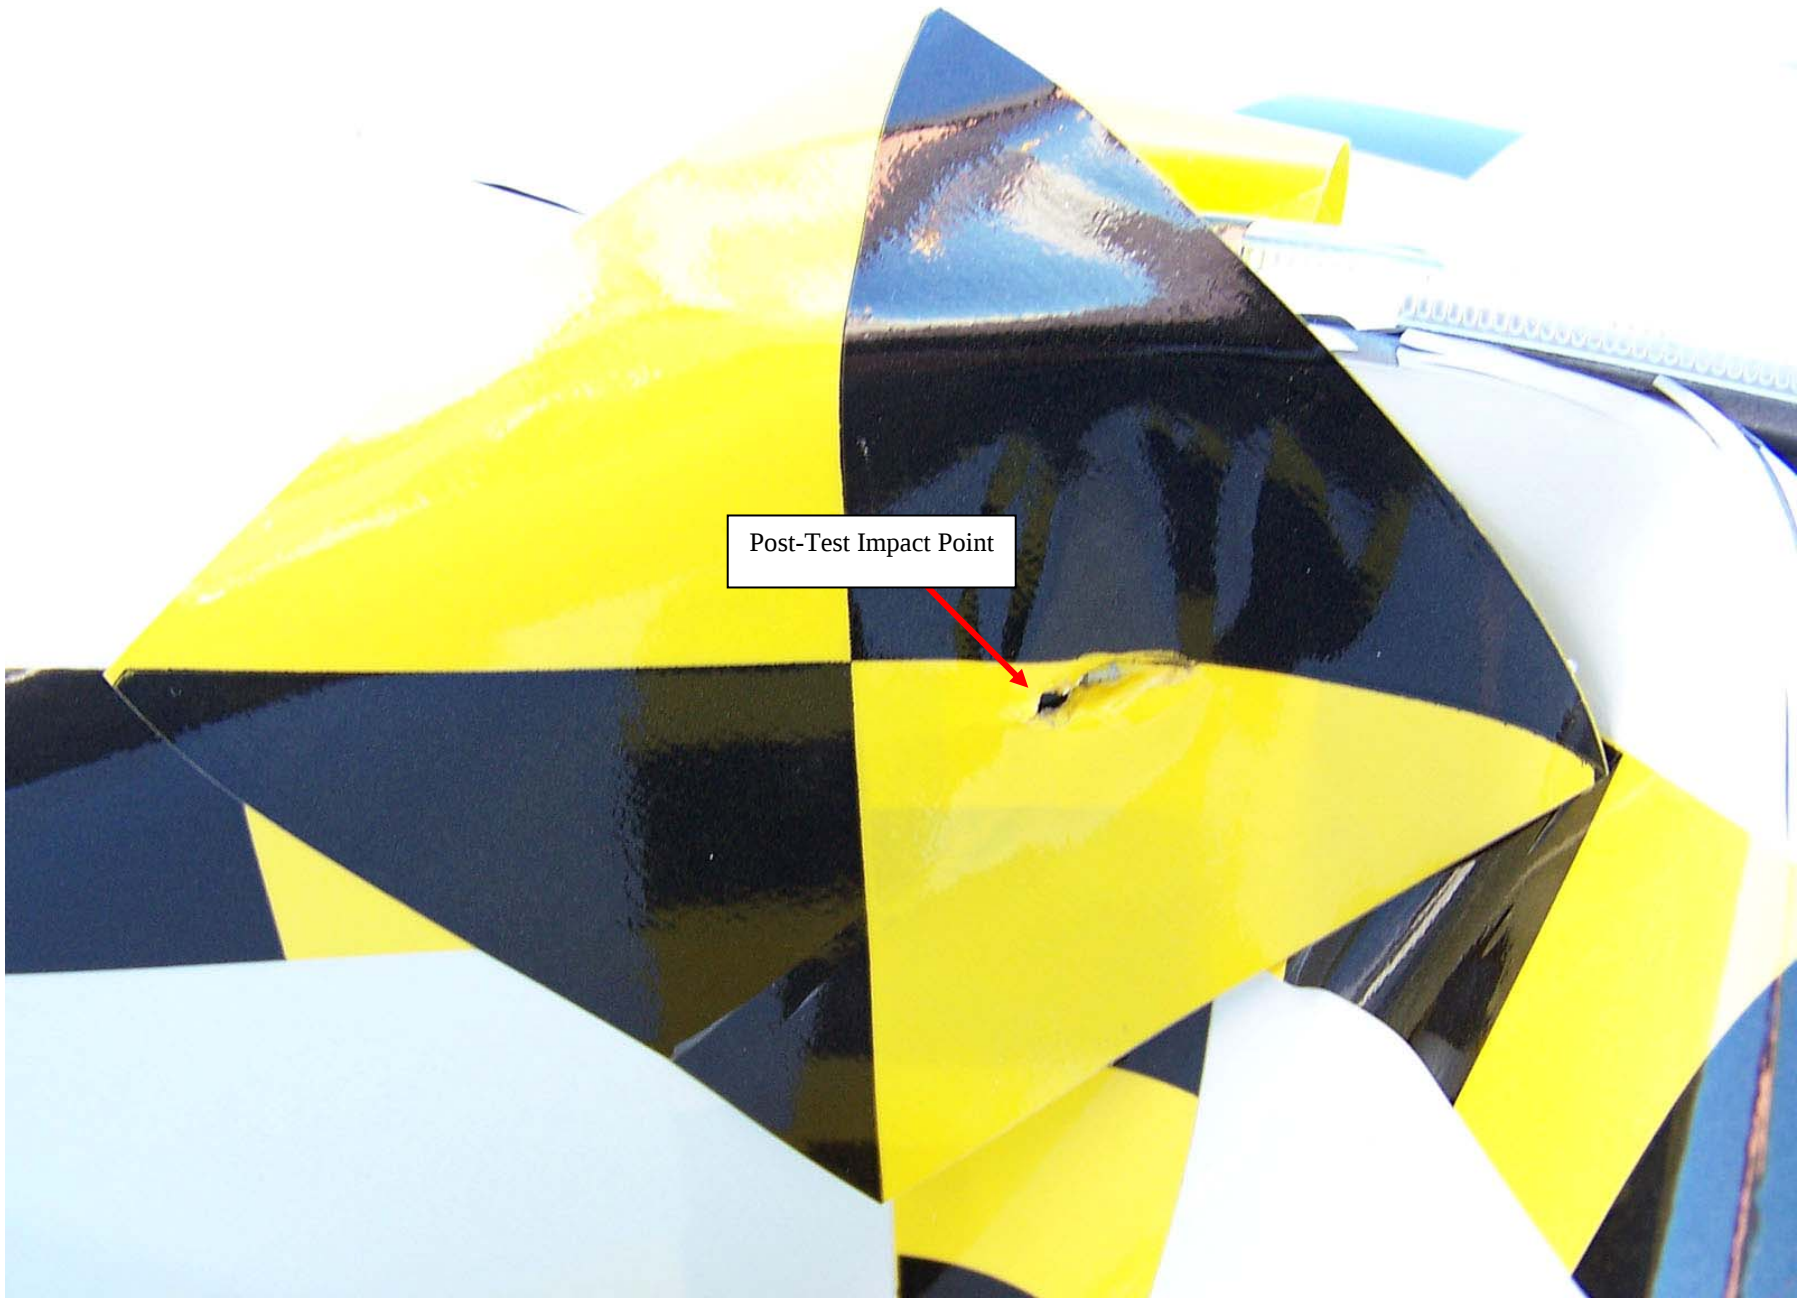
Figure A-26: Post-Test Left Impact Point

Both the driver and passenger doors remained closed during the impact. The test vehicle sustained a maximum static crush of 266 mm at level 2, 450 mm rearward of the left vertical impact point. The driver SID/Hybrid III, Serial No. 275 and the passenger SID/Hybrid III, Serial No. 274 were calibrated prior to this test. The SID/Hybrid III injury criteria are summarized as follows:

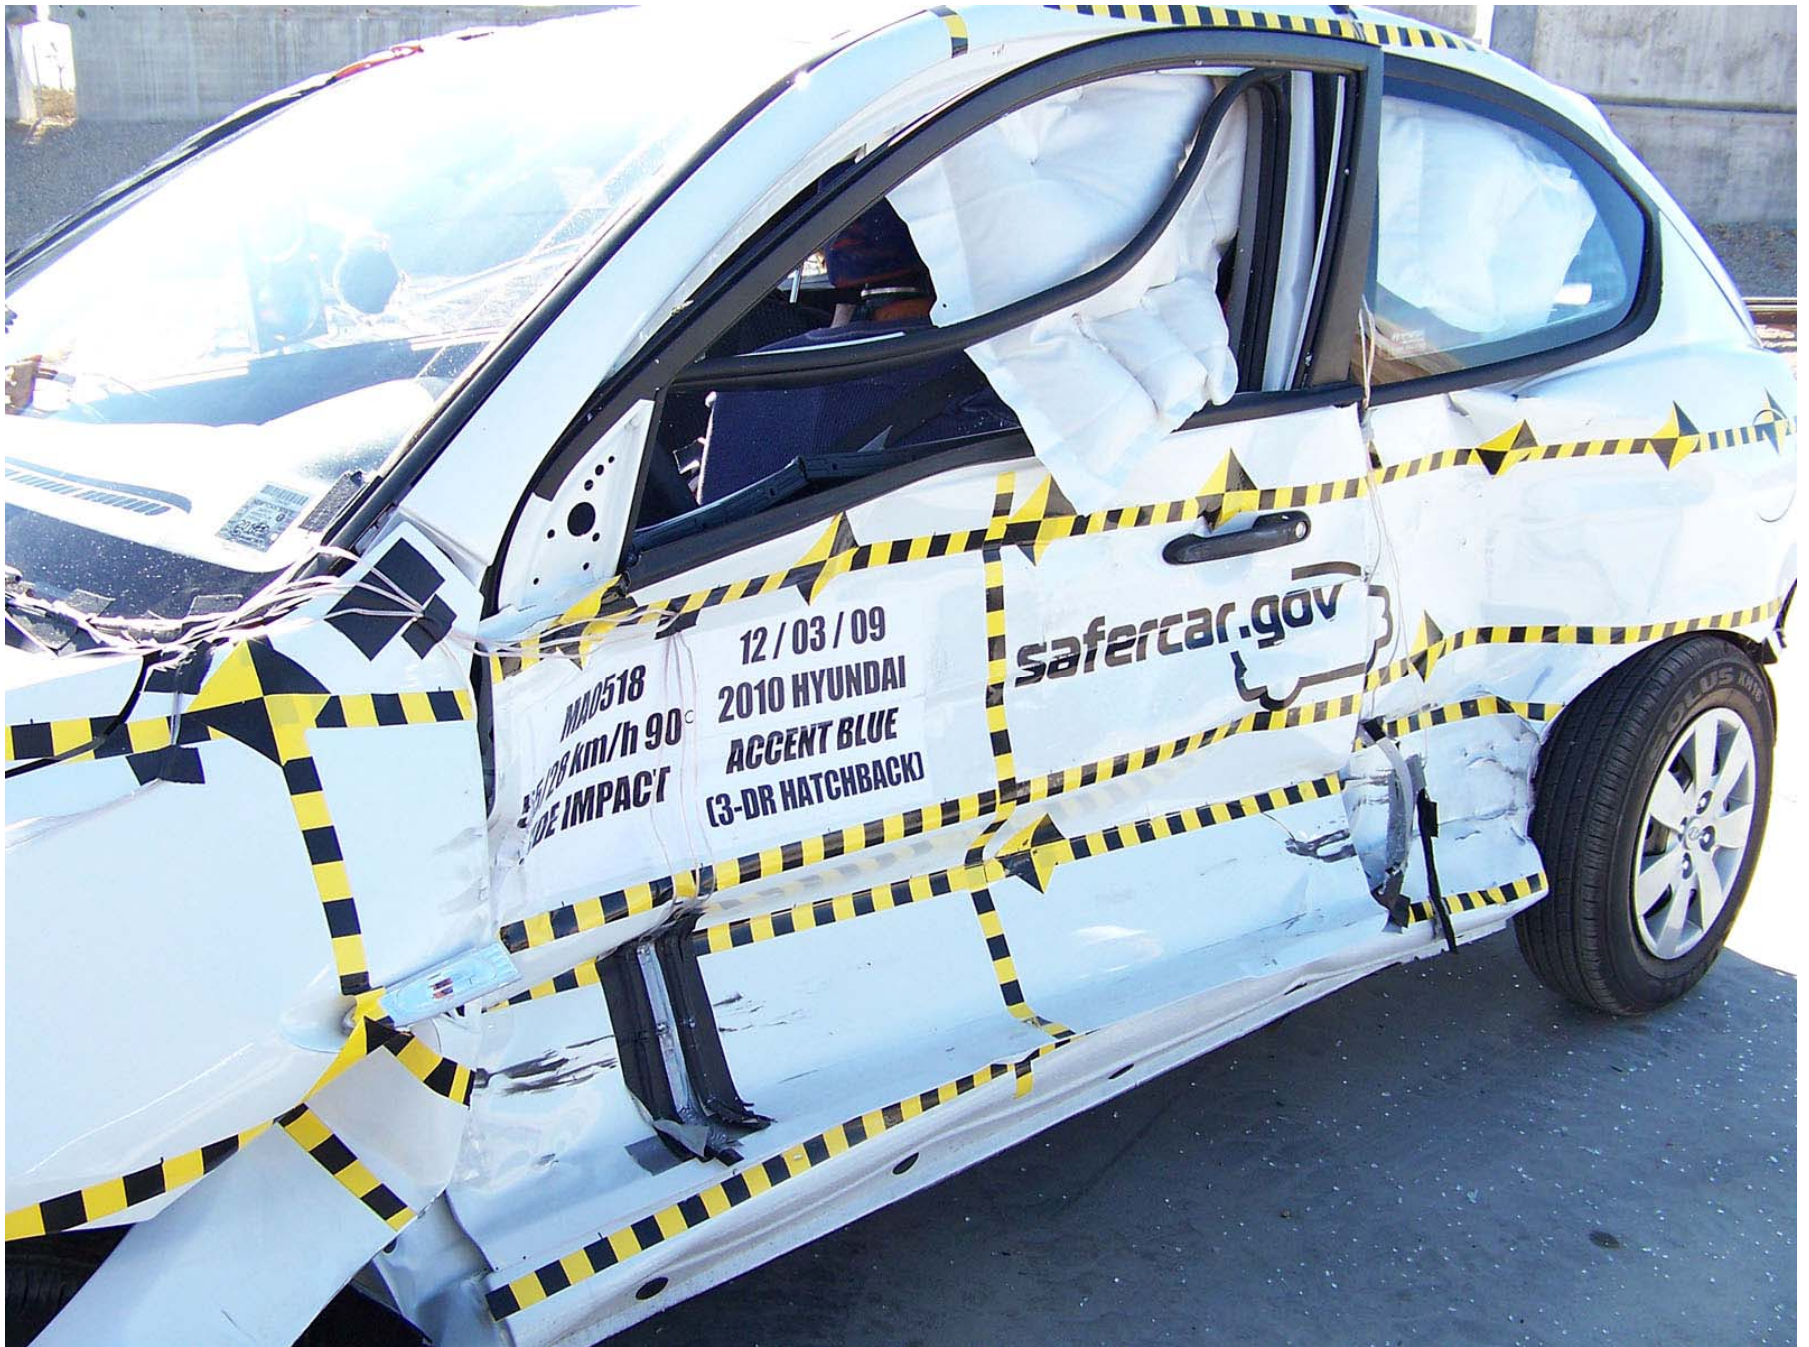
Figure A-28: Post-Test Front  $\frac{3}{4}$  View of Left Side Door

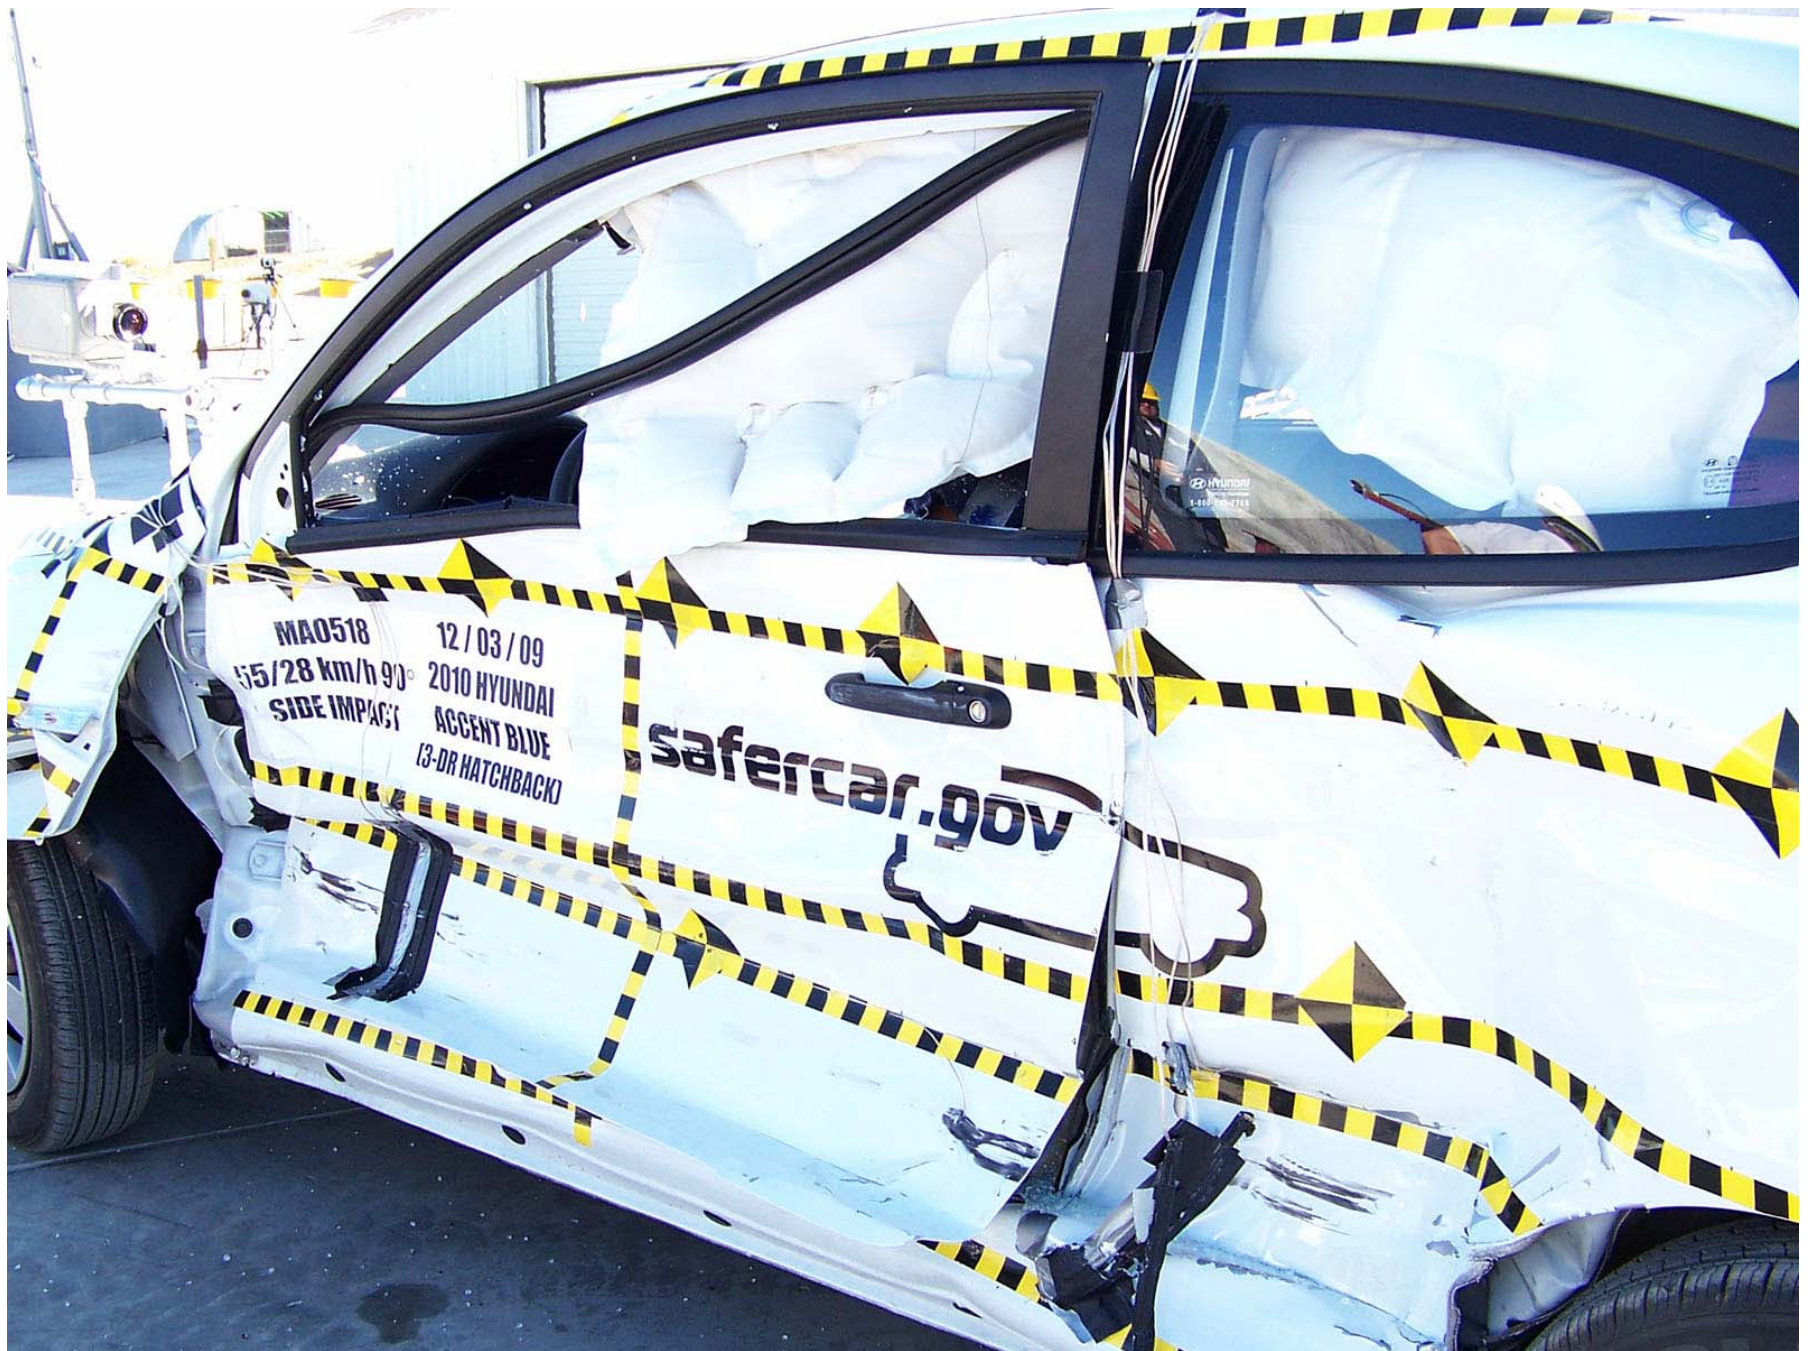
Figure A-30: Post-Test Rear ¾ View of Left Side Door

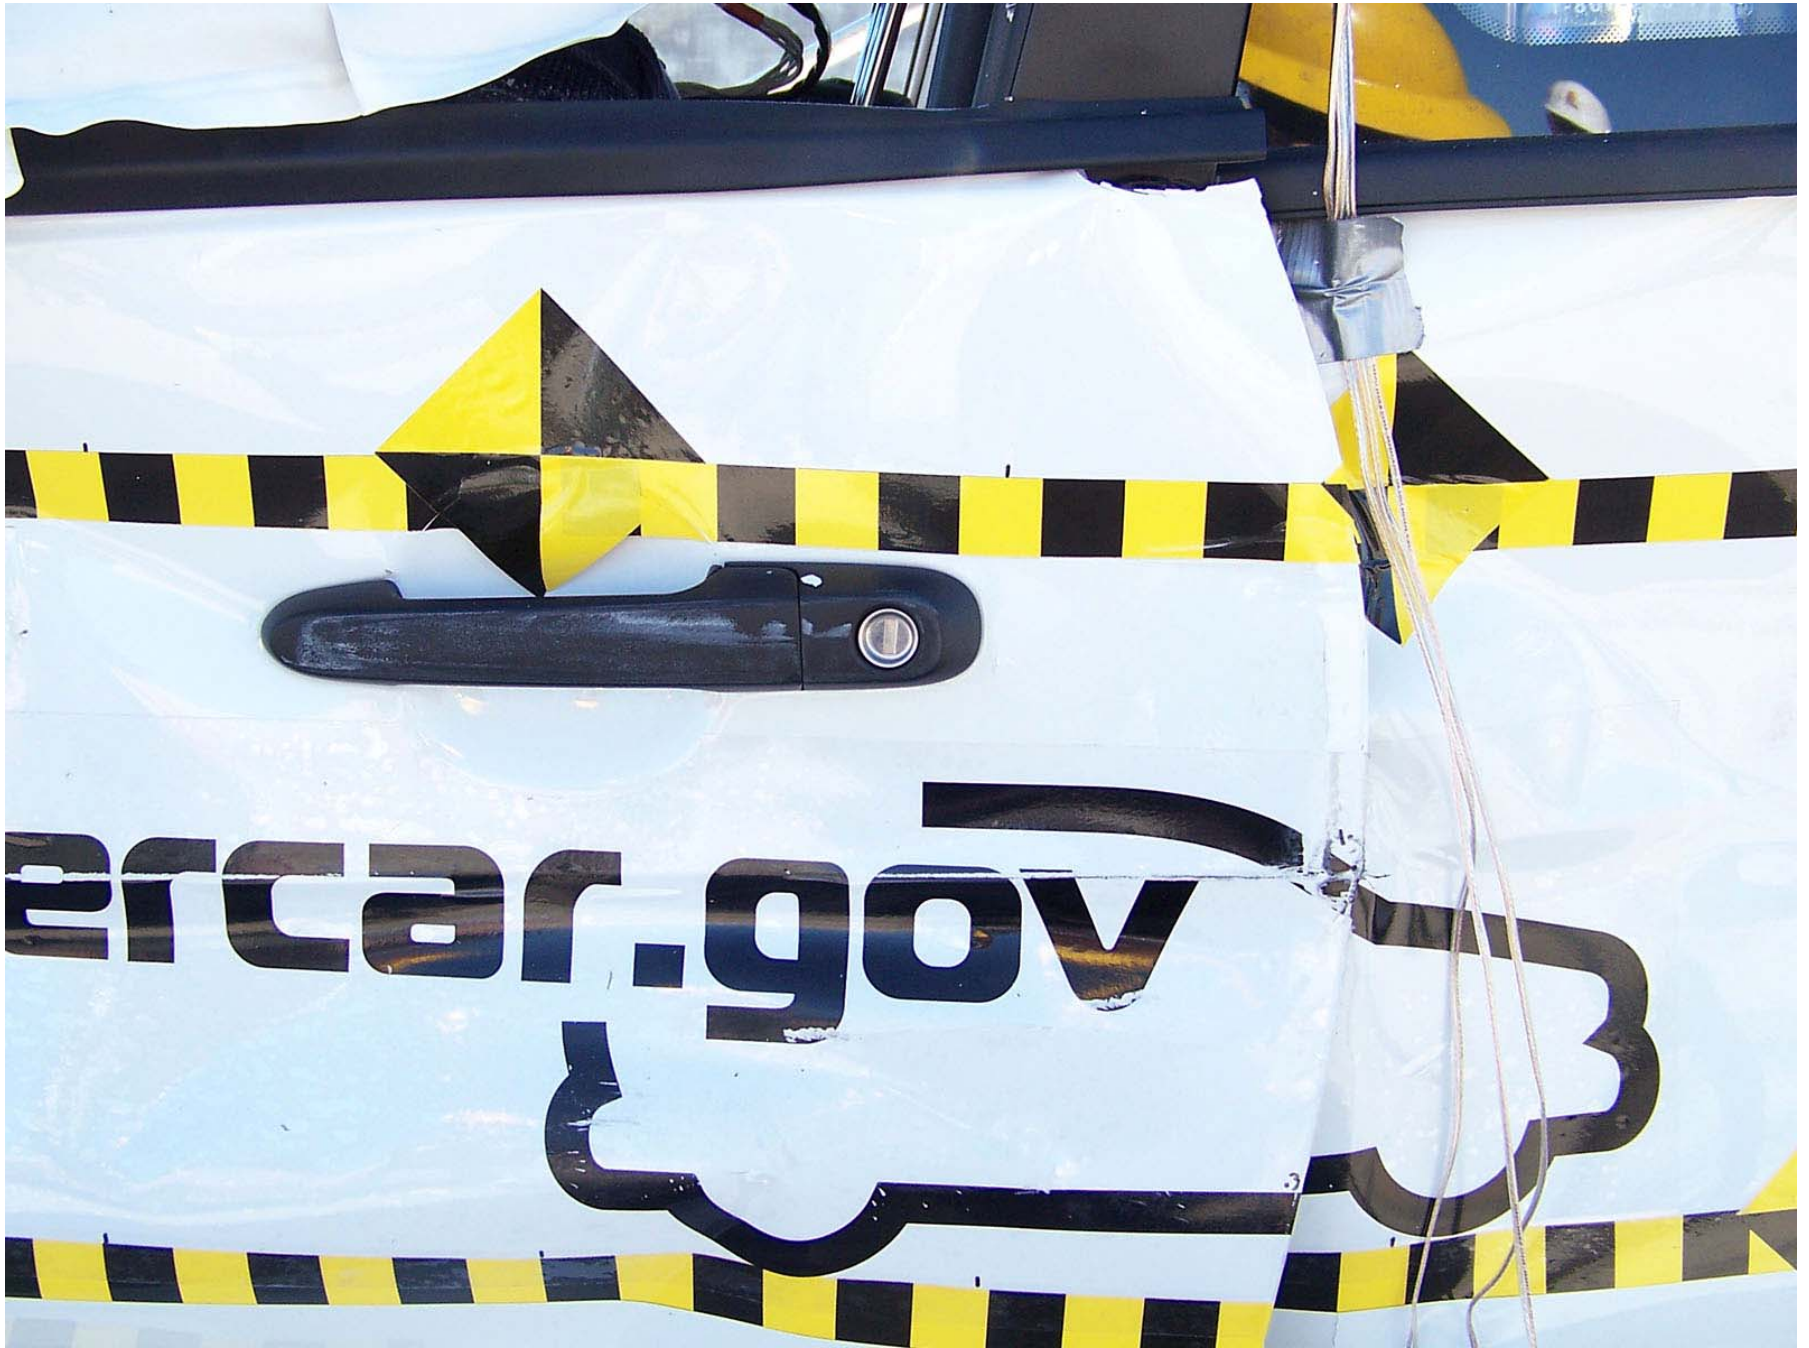
Figure A-32: Post-Test Left Front Door

| Critical Areas of Performance | Observations and Conclusions |
|---|---|
| Window Damage | Left front window broken |

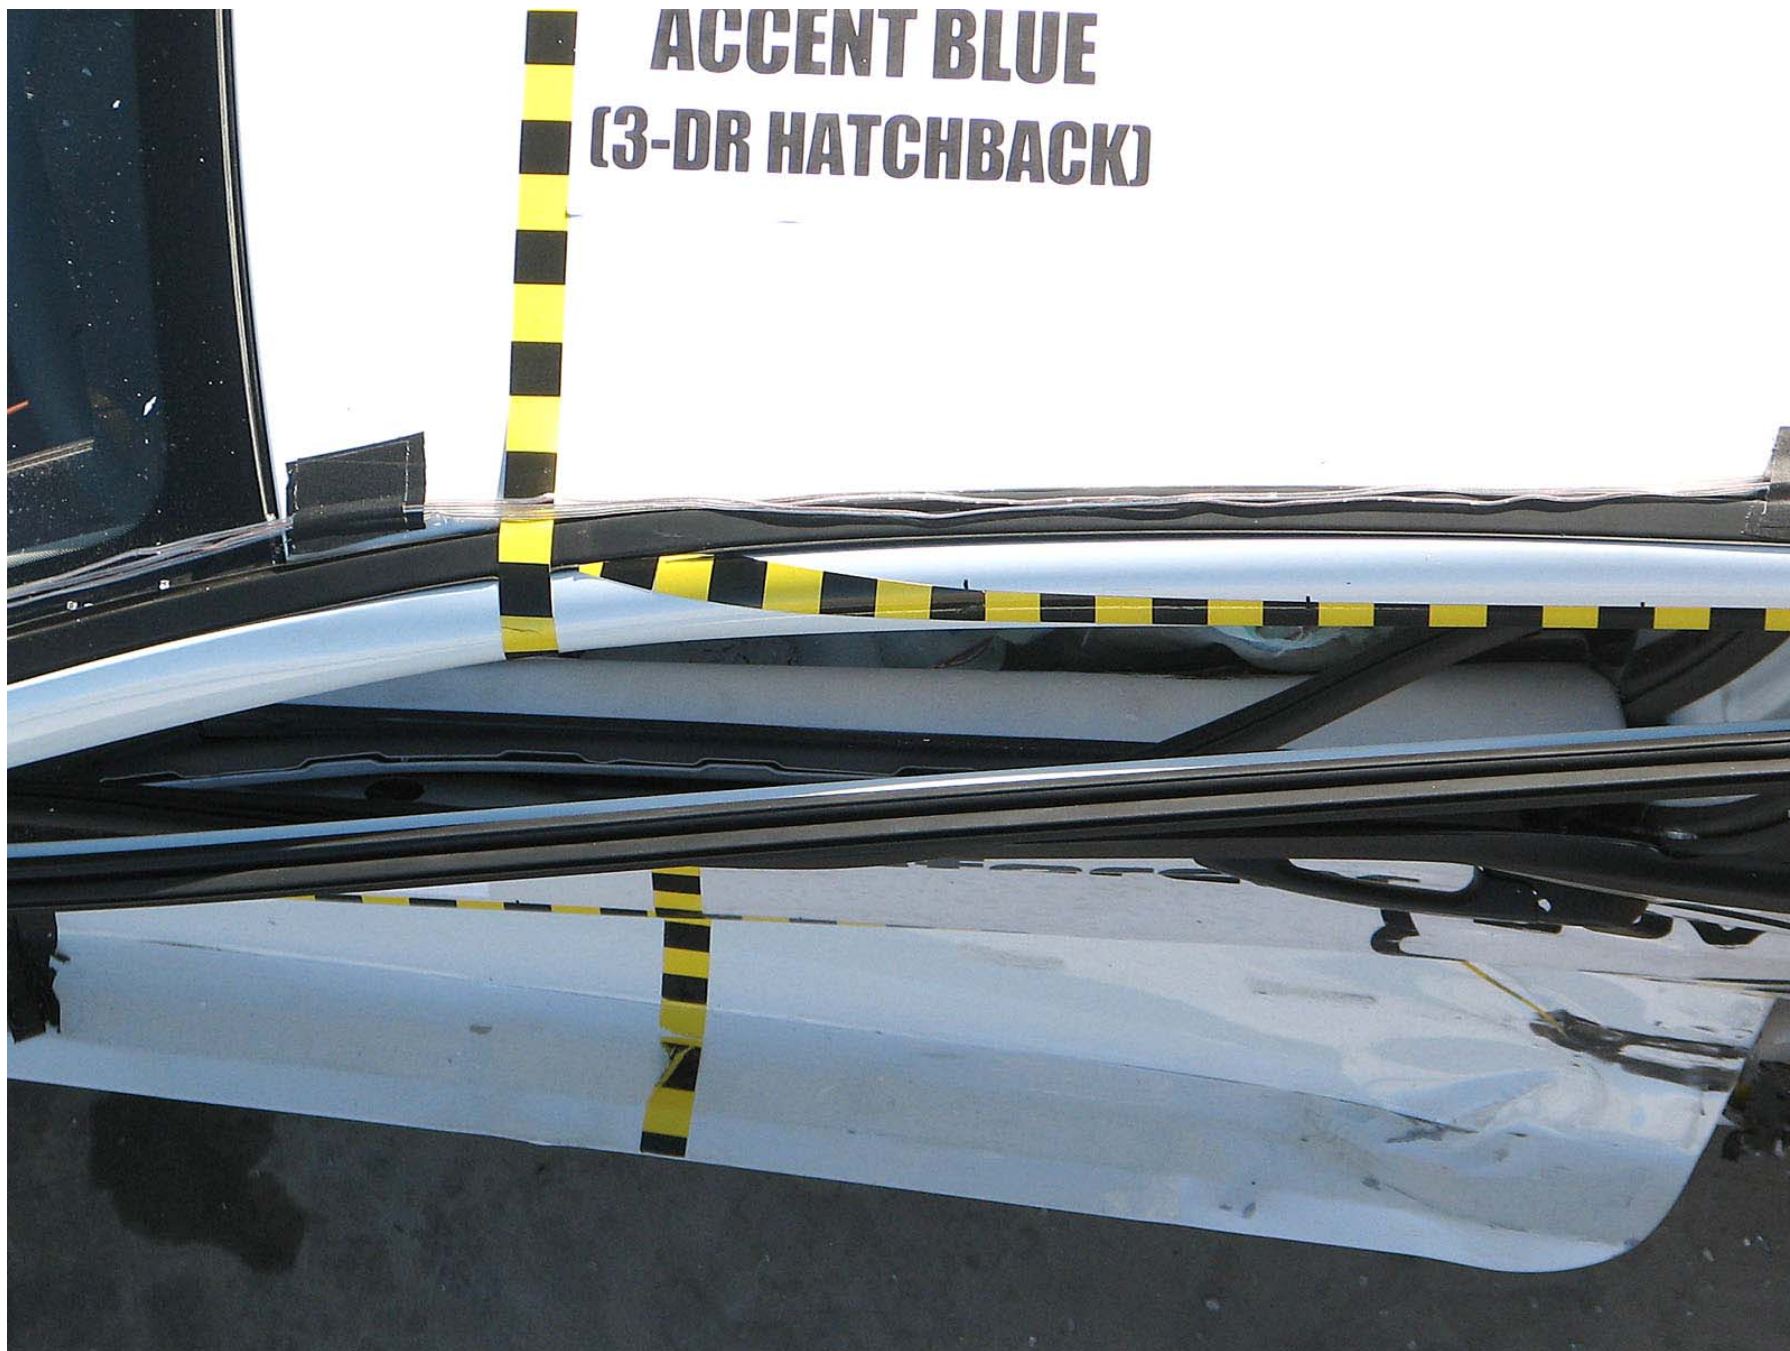
Figure A-37: Post-Test Driver Dummy Clearance From Door

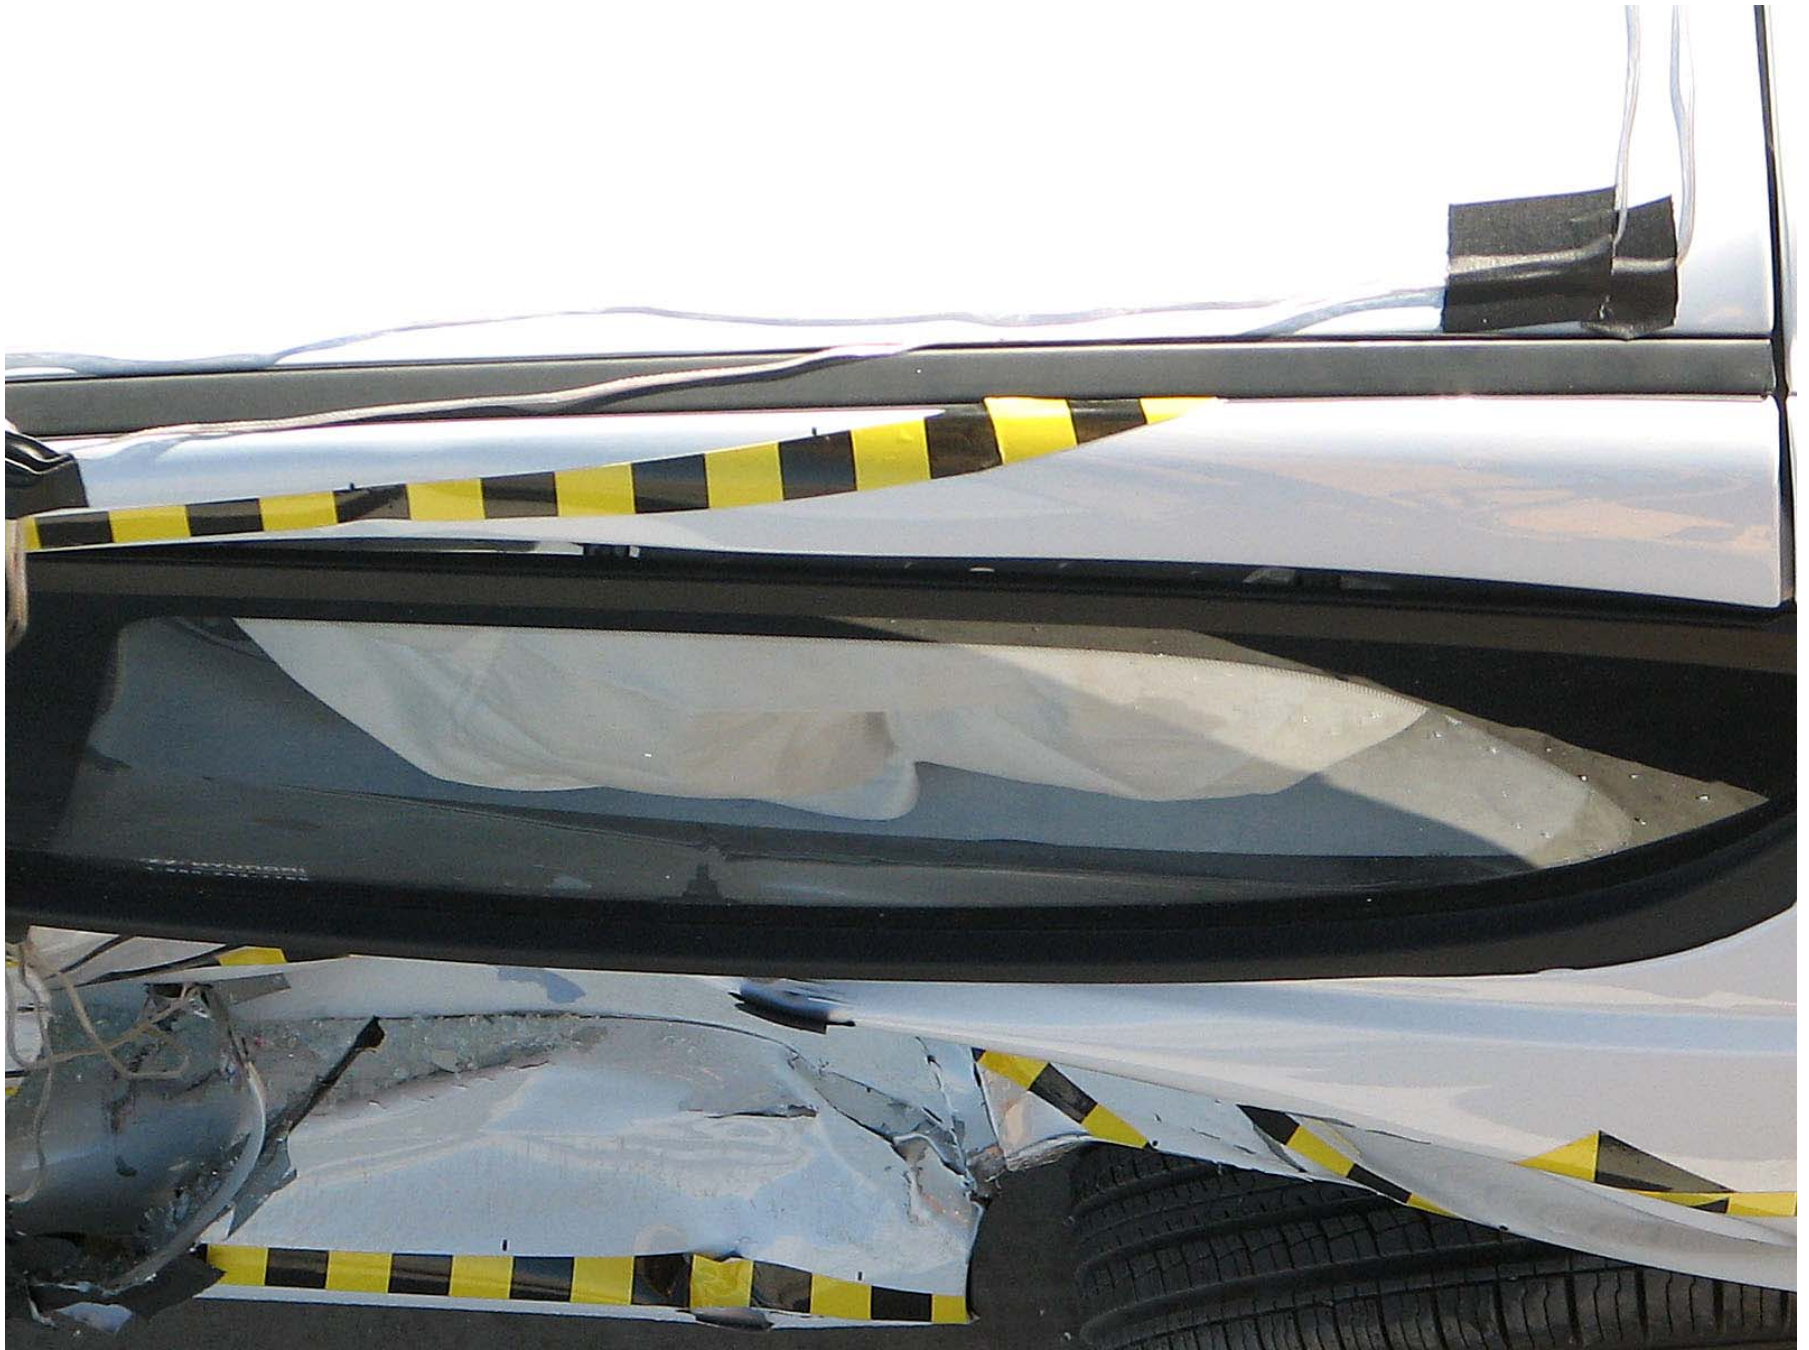
Figure A-46: Post-Test Passenger Dummy Clearance From Door

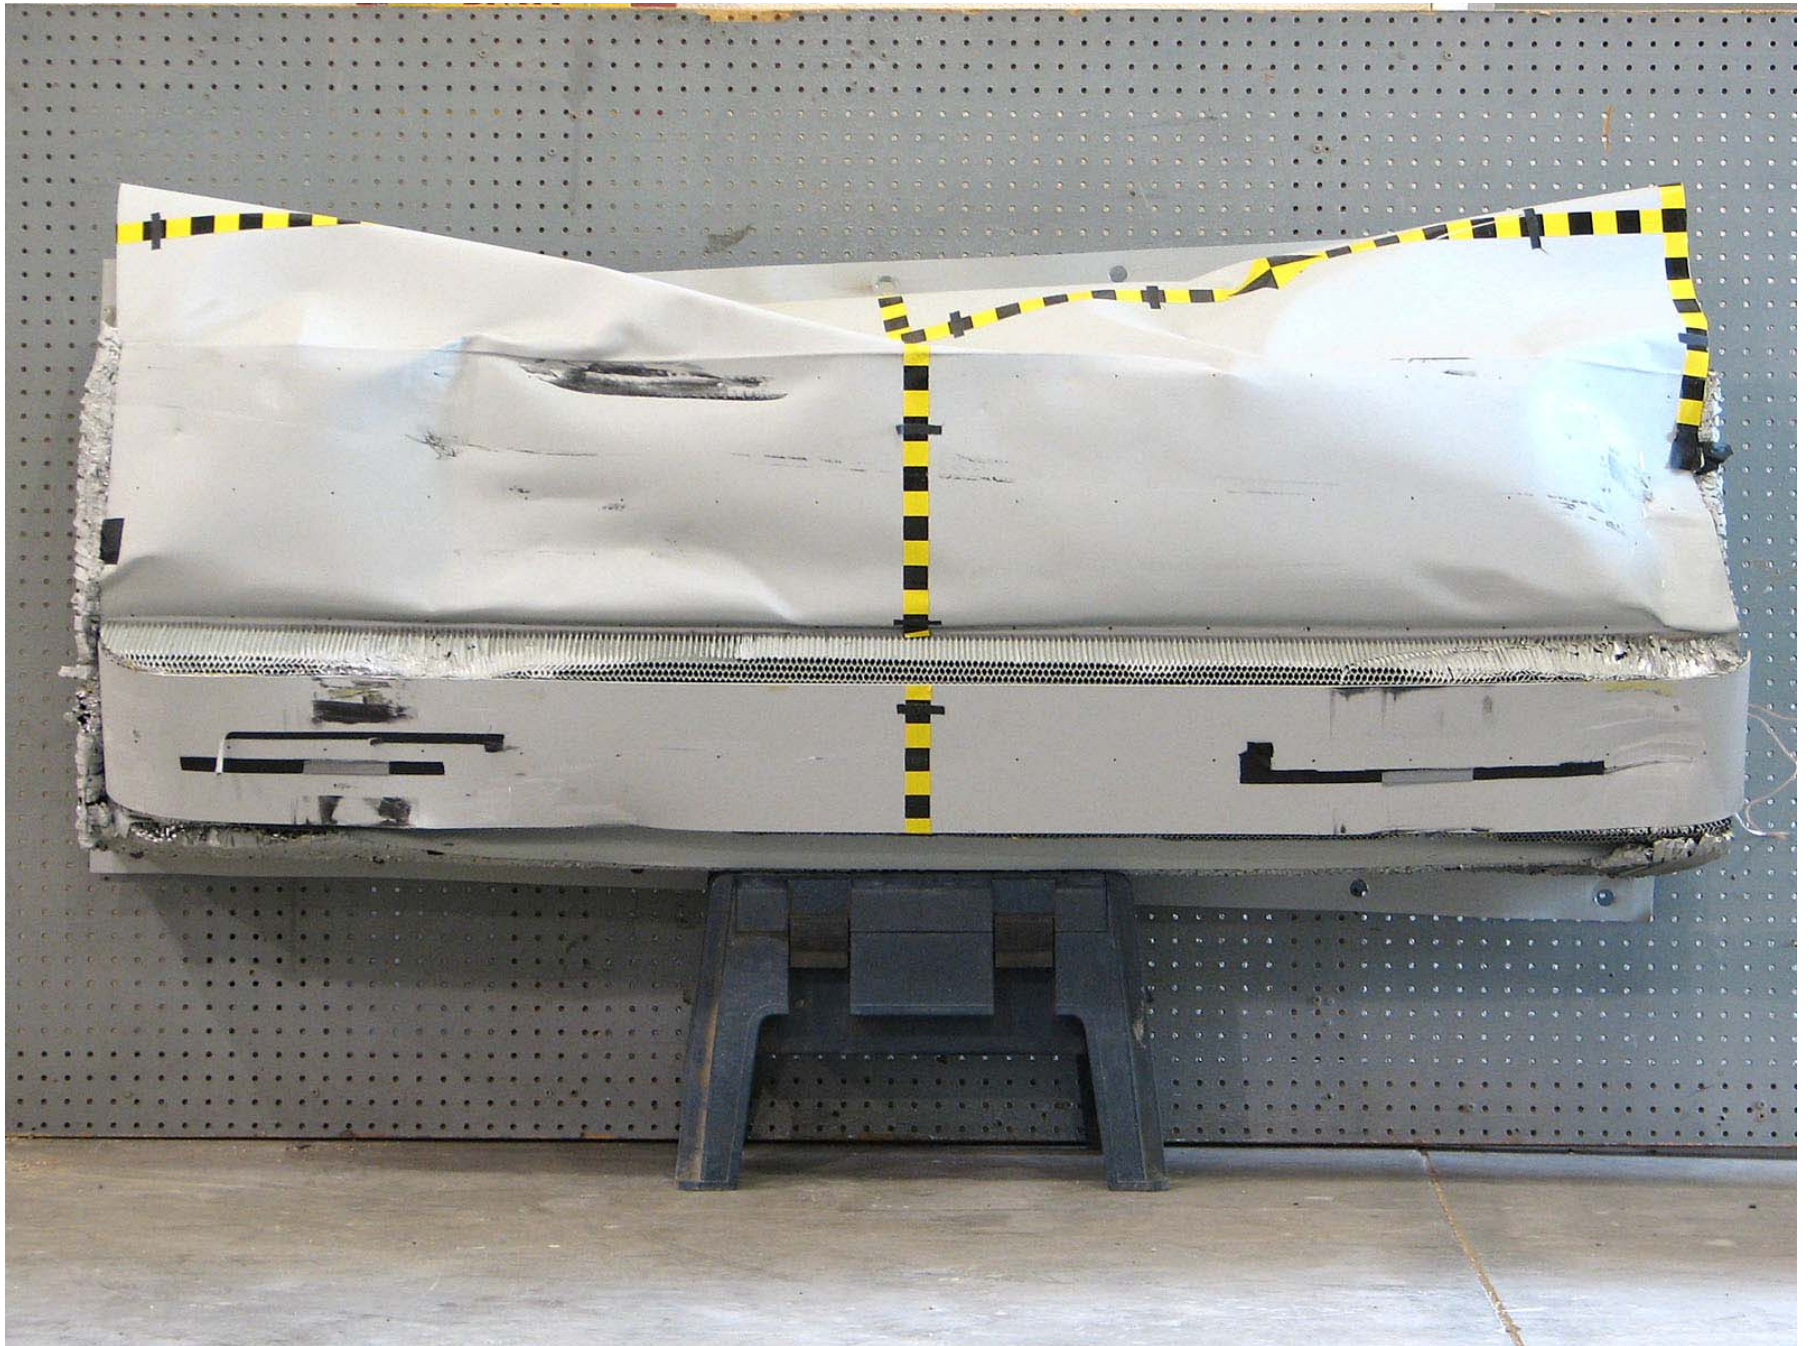
Figure A-52: Post-Test Front View of Deformable Barrier
