NEW CAR ASSESSMENT PROGRAM  
SIDE IMPACT TEST

HYUNDAI MOTOR COMPANY  
2010 HYUNDAI ACCENT  
3-DOOR HATCHBACK

NHTSA NUMBER: MA0518

FINAL REPORT

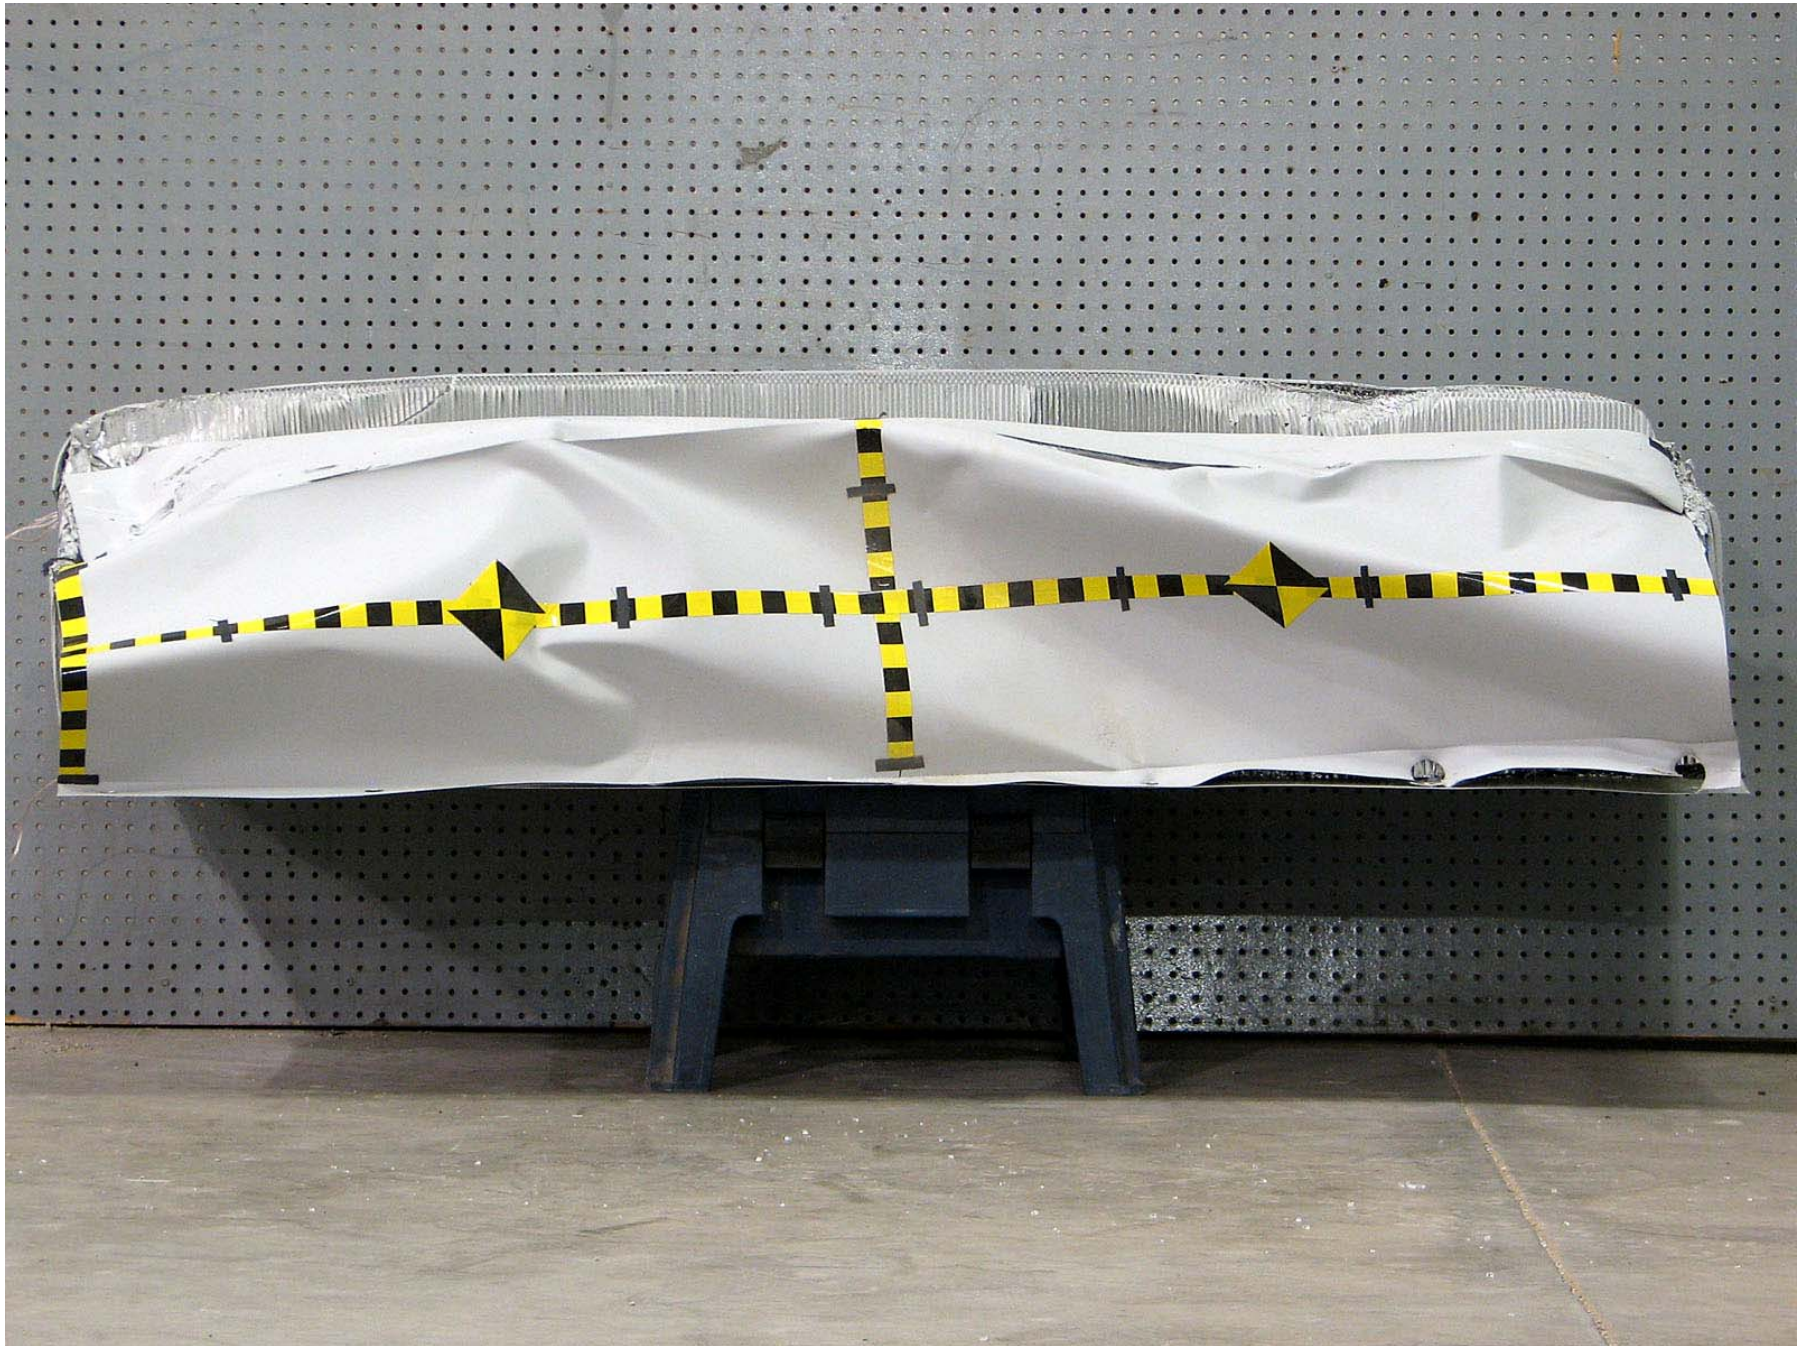
Figure A-54: Post-Test Top View of Deformable Barrier

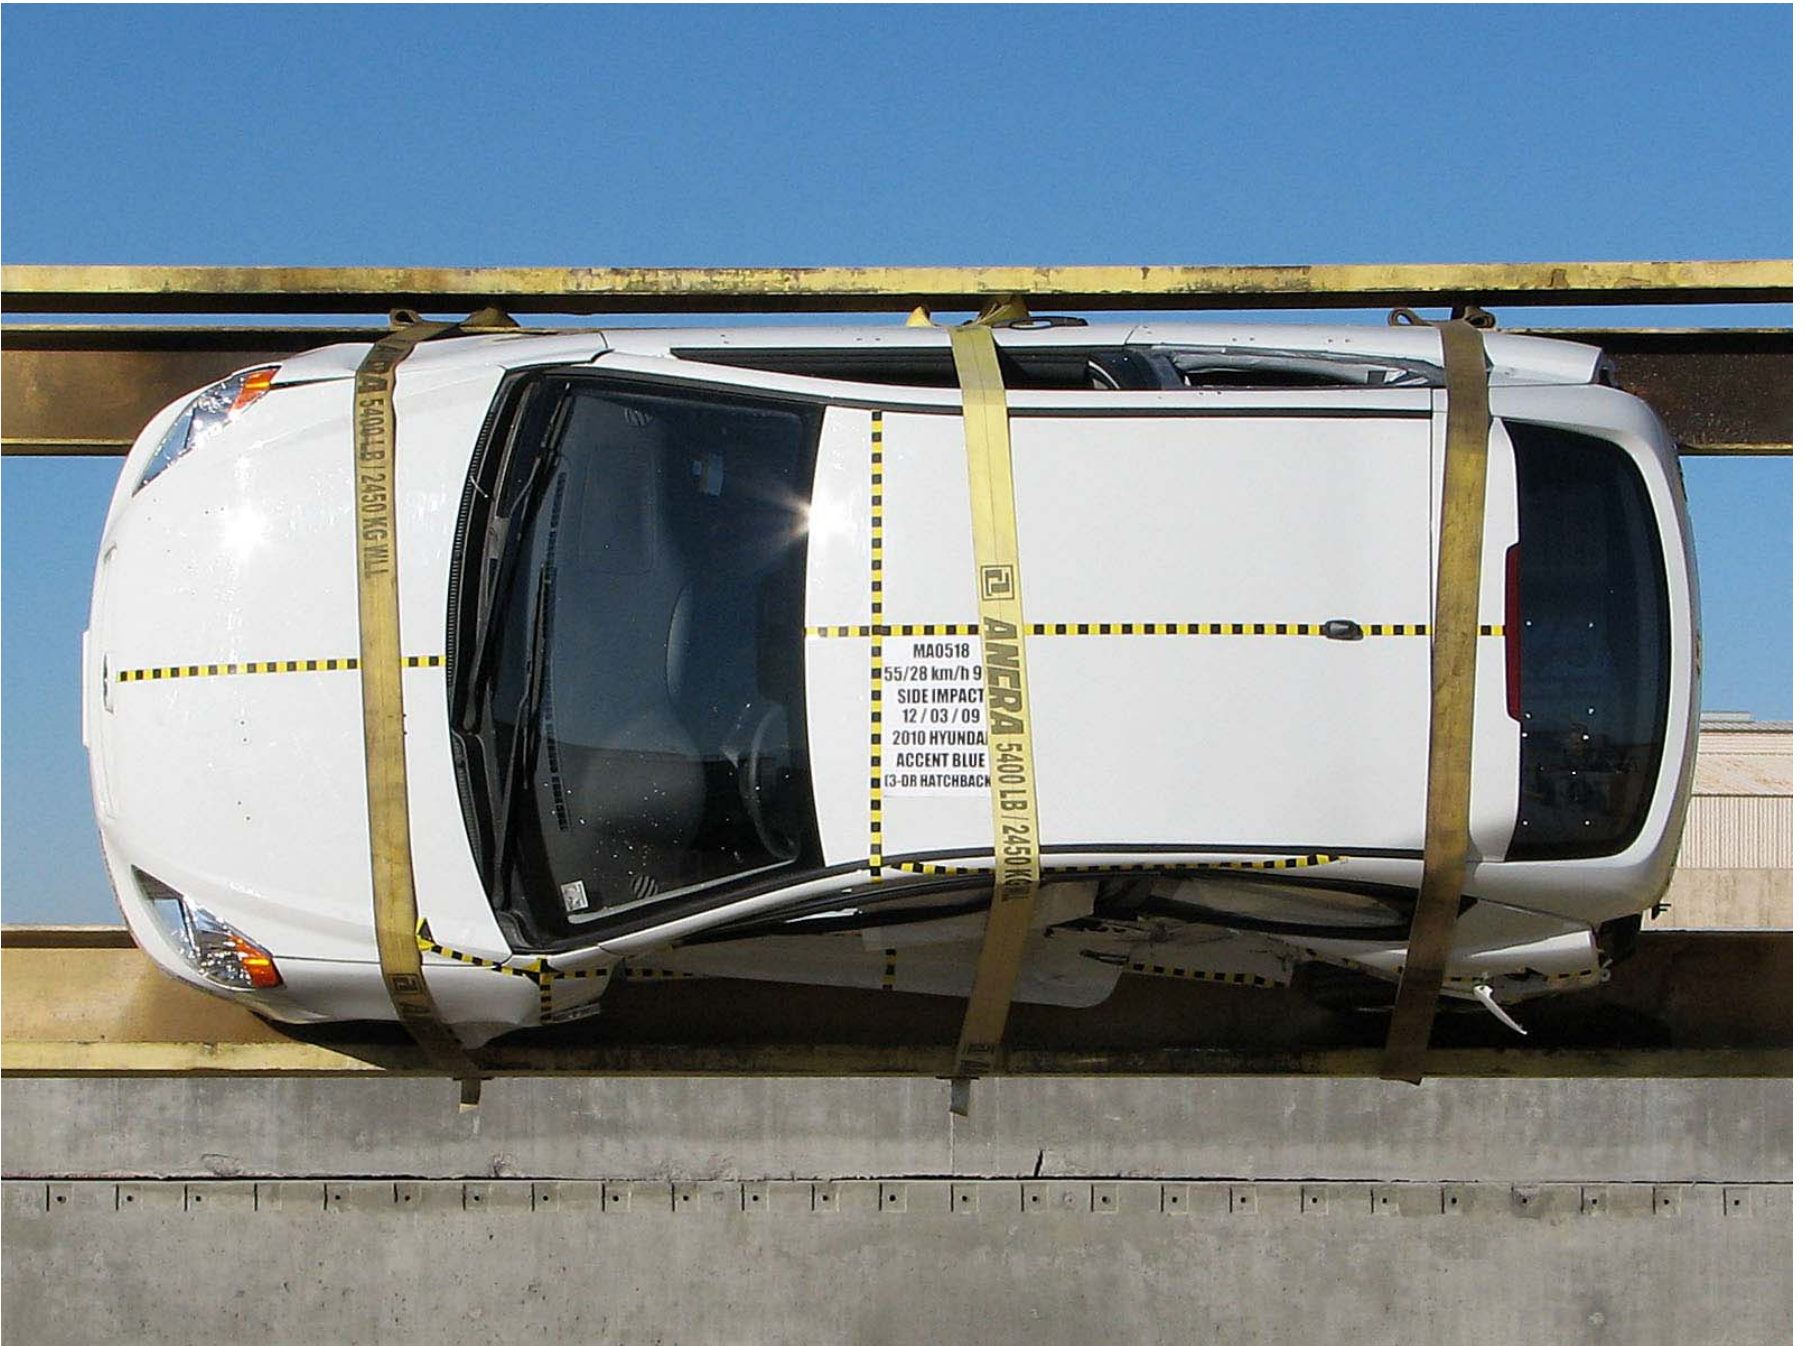
Figure A-59: Vehicle on Rollover Device (0°)

Figure A-60: Vehicle on Rollover Device (90°)

Figure A-61: Vehicle on Rollover Device (180°)

Figure A-62: Vehicle on Rollover Device (270°)

Figure A-63: Vehicle on Rollover Device (360°)

1. The specified fixture rollover rate for each 90° of rotation is 60 to 120 seconds.
2. The position hold time at each position is 300 seconds (minimum).
3. Details of Stoddard Solvent spillage locations.  
No solvent leakage occurred during static rollover testing.

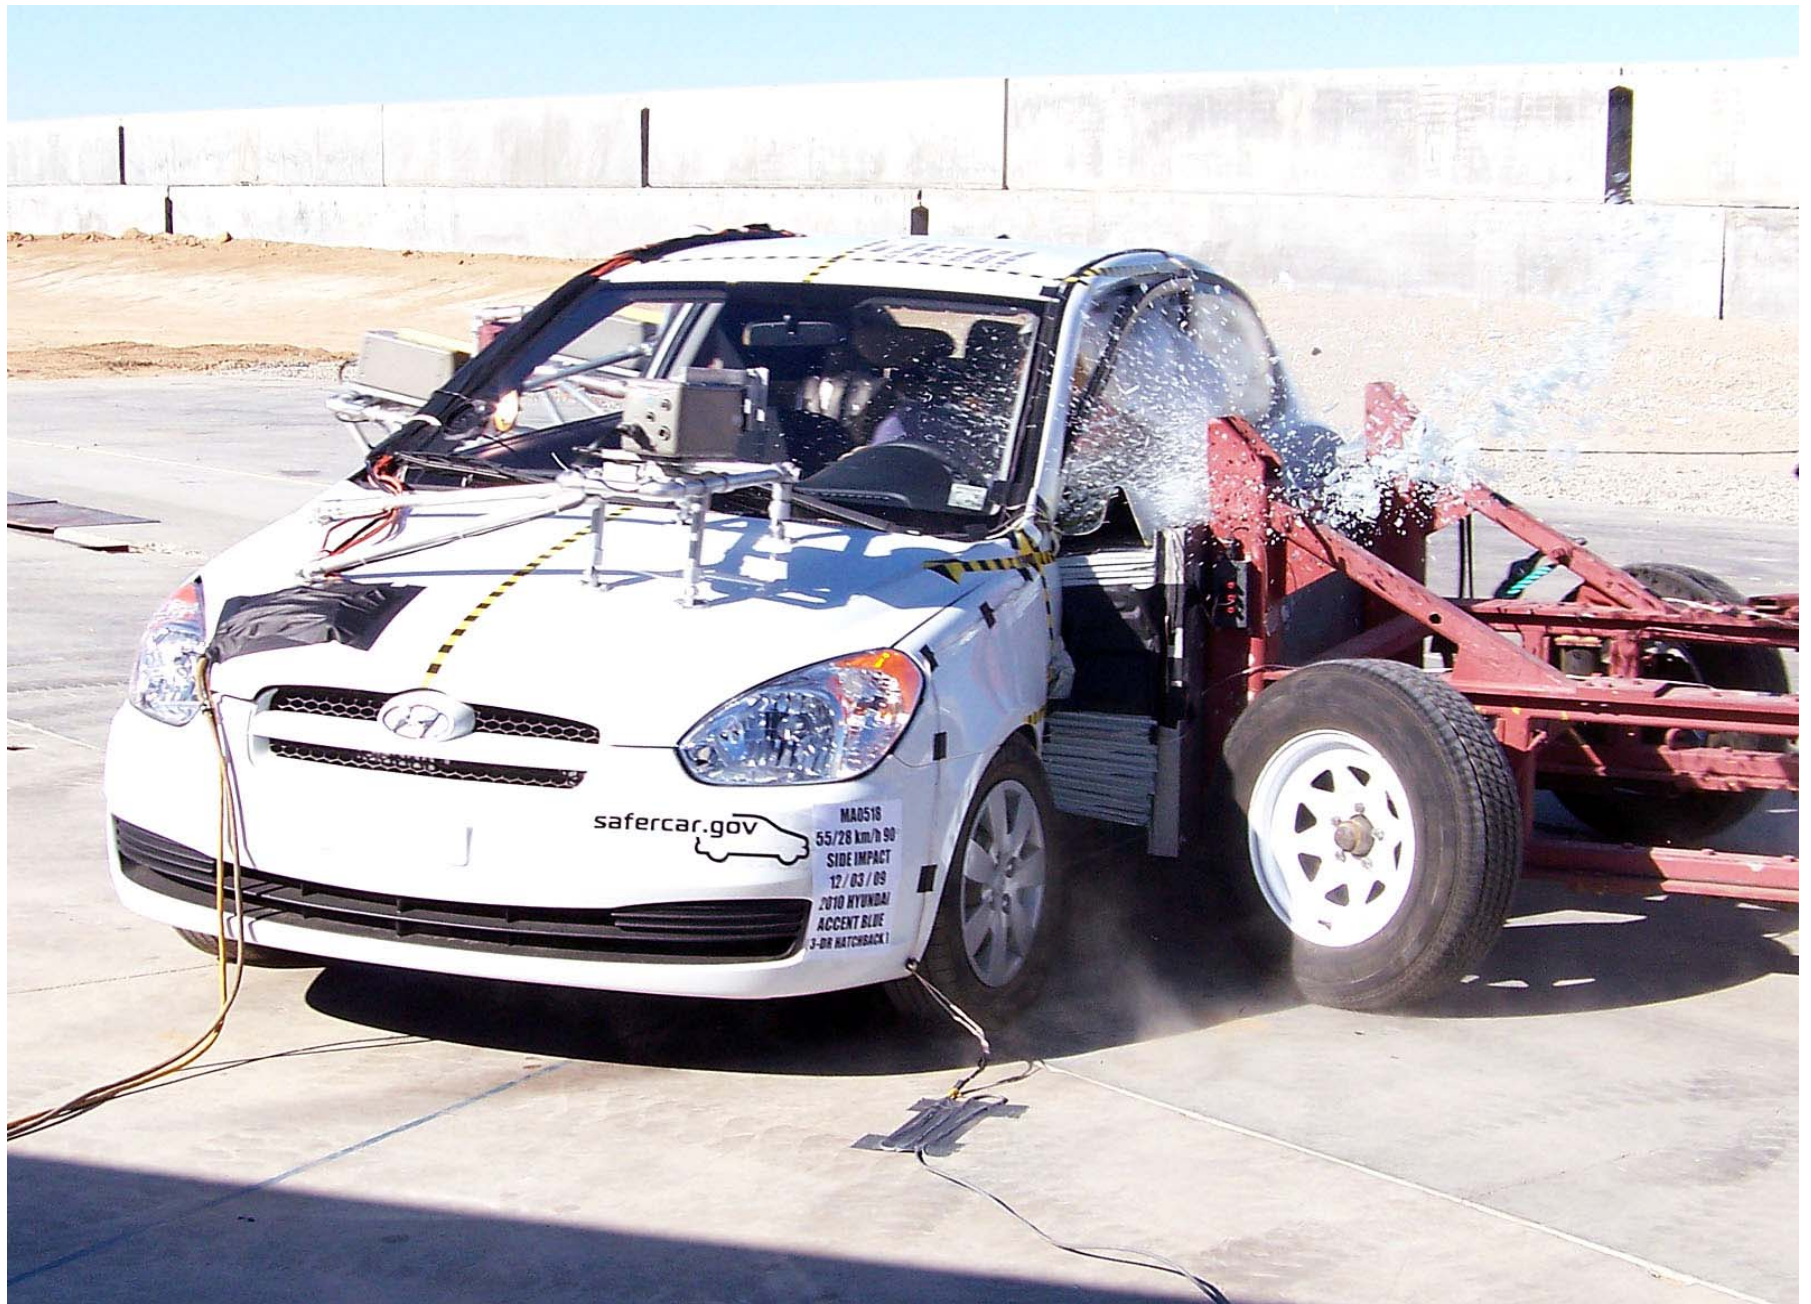
Figure A-65: Vehicle Impact

A model year 2010 Hyundai Accent 3-Door Hatchback was impacted on the left (driver's) side by a Moving Deformable Barrier (MDB) which was moving forward in a 27° crabbed position to the tow road guidance system at a velocity of 61.98 km/h. The specified impact velocity range is from 61.14 to 62.75 km/h. The test (target) vehicle was stationary and positioned 63° to the line of forward motion. The weight of the vehicle as tested was 1309.0 kg and the test weight of the MDB was 1361.0 kg. The test was conducted at KARCO Engineering, LLC in Adelanto, California, on December 3, 2009.
