**REPORT NUMBER: OPT-SNCAP-CAL-10-1**

**NEW CAR ASSESSMENT PROGRAM  
SIDE IMPACT TEST**

**FORD MOTOR COMPANY  
2010 LINCOLN MKT  
4-DOOR SUV**

**NHTSA NUMBER: FA0202**

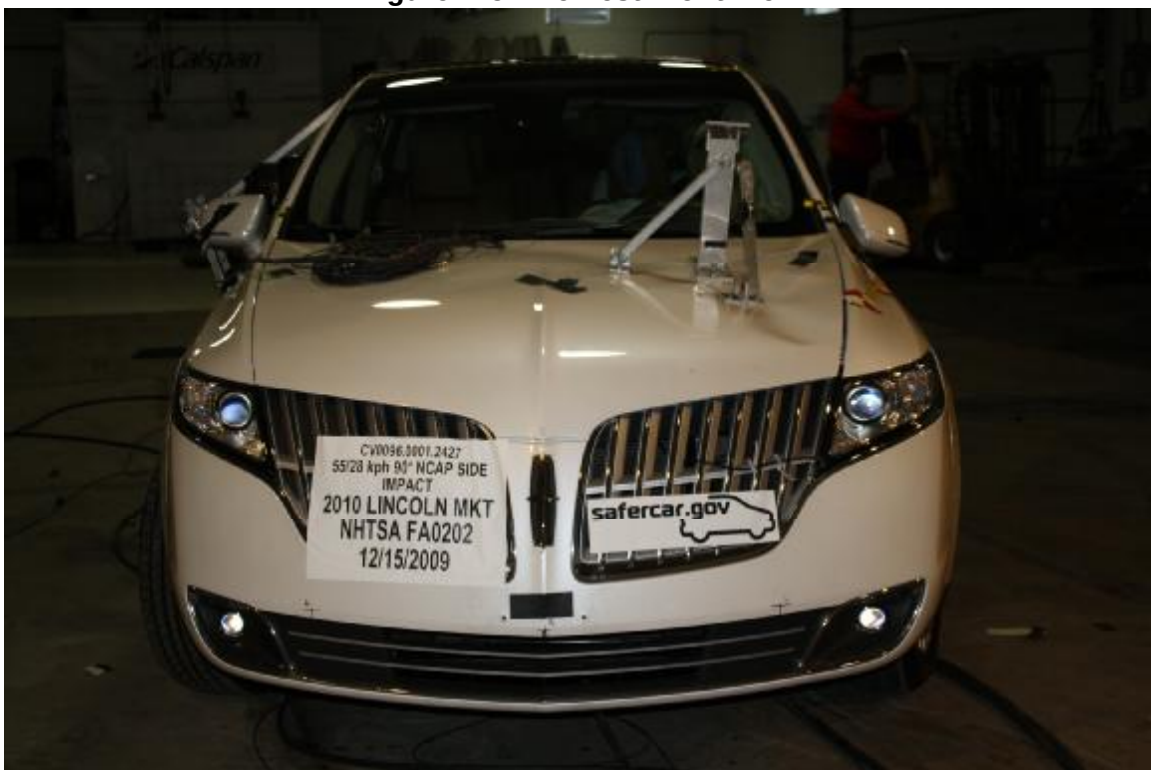
**Figure A-6: Post-Test Front View**

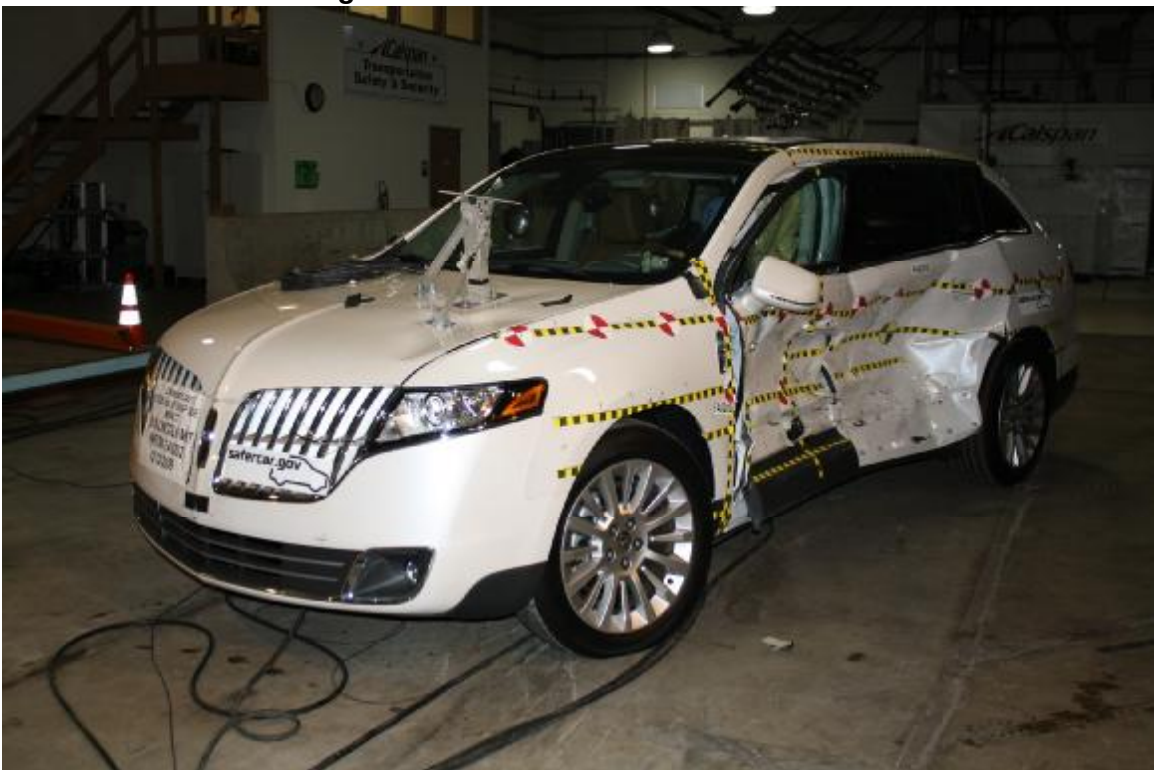
Figure A-8: Post-Test Left Front  $\frac{3}{4}$  View

| Critical Areas of Performance | Observations and Conclusions |
|---|---|
| Window Damage | Left Front Window had cracks but remained intact; Left Rear Window had no damage |

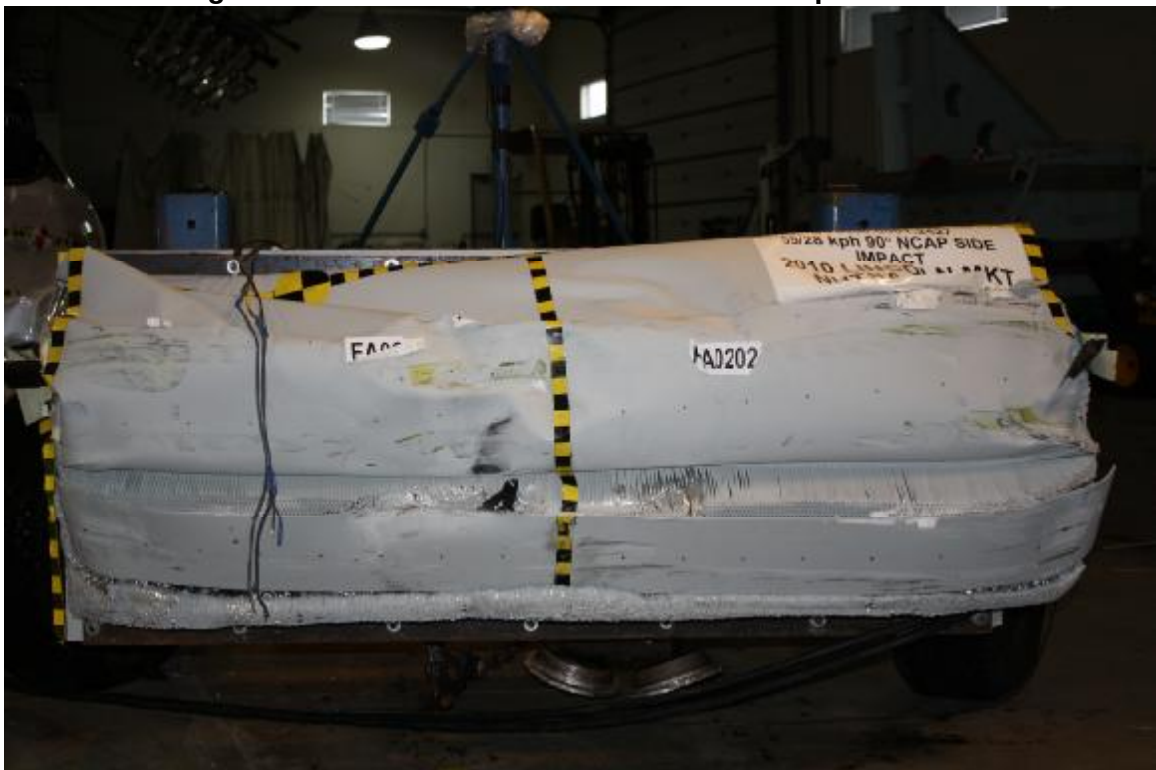
**Figure A-22: Post-Test Frontal View of MDB Impactor Face**

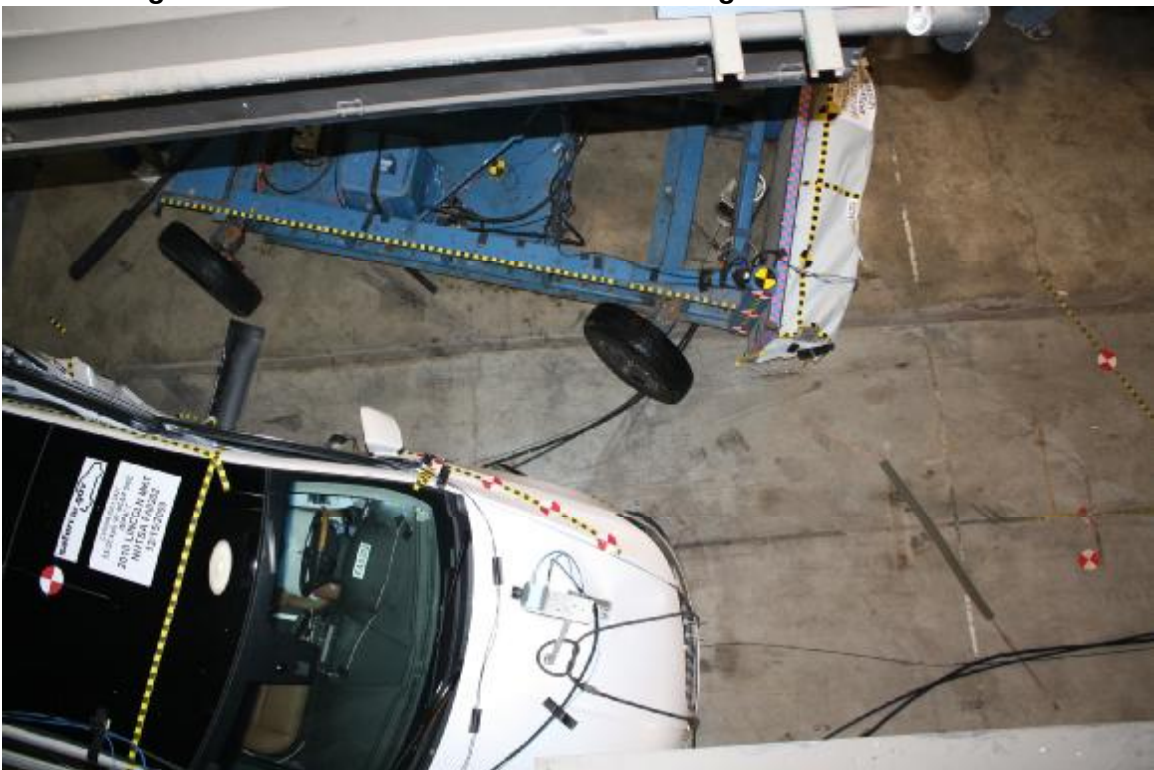
**Figure A-32: Post-Test Overhead View of MDB and Vehicle**

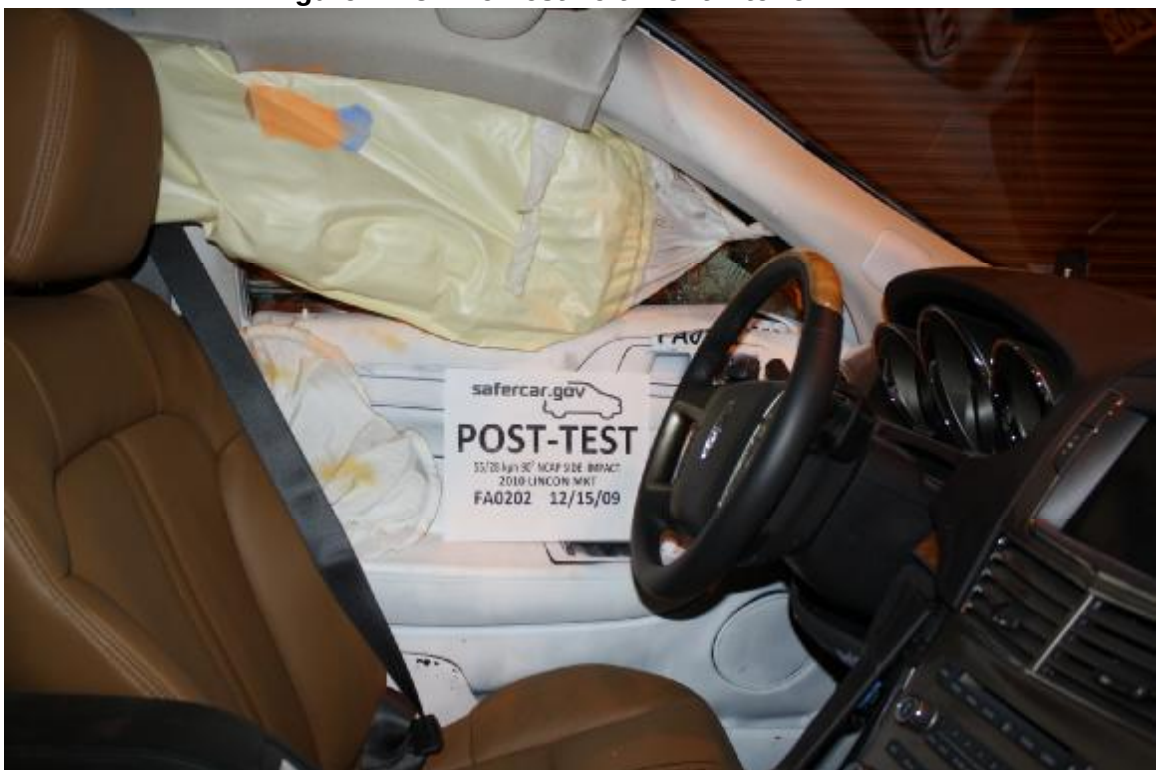
**Figure A-44: Post-Test Left Front Interior Trim**

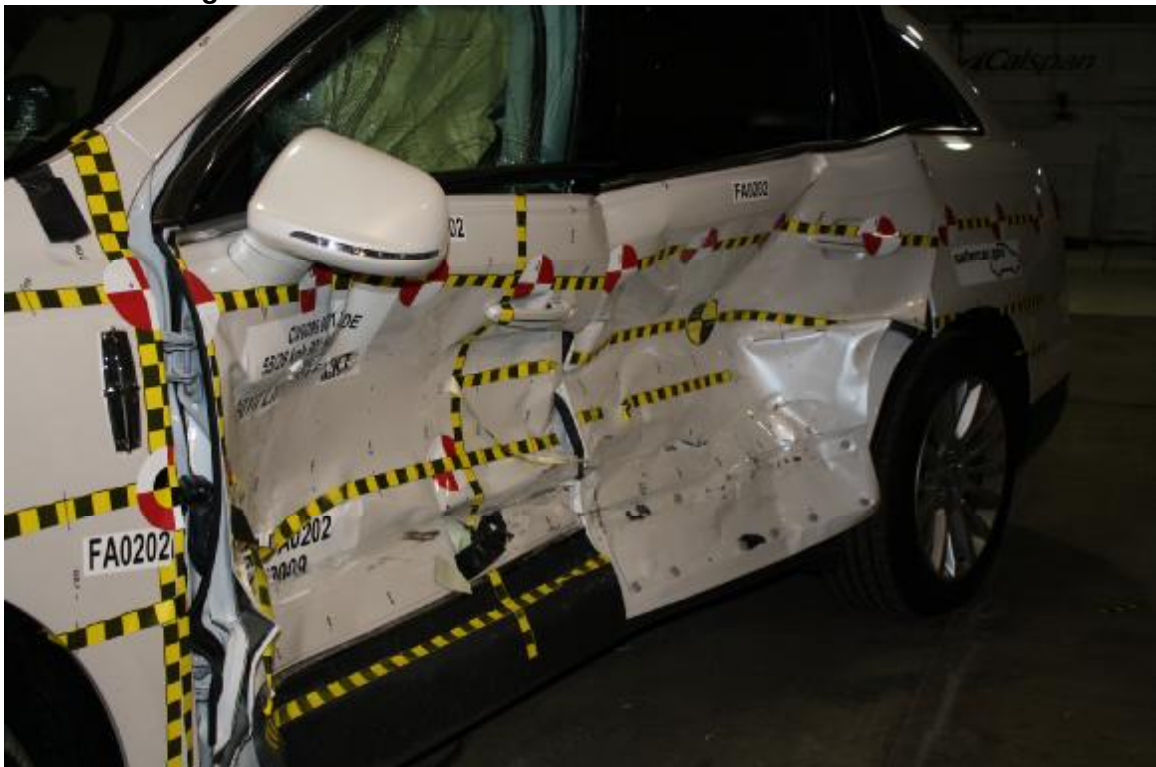
**Figure A-48: Post-Test Left Front ¾ View of Left Side Doors**

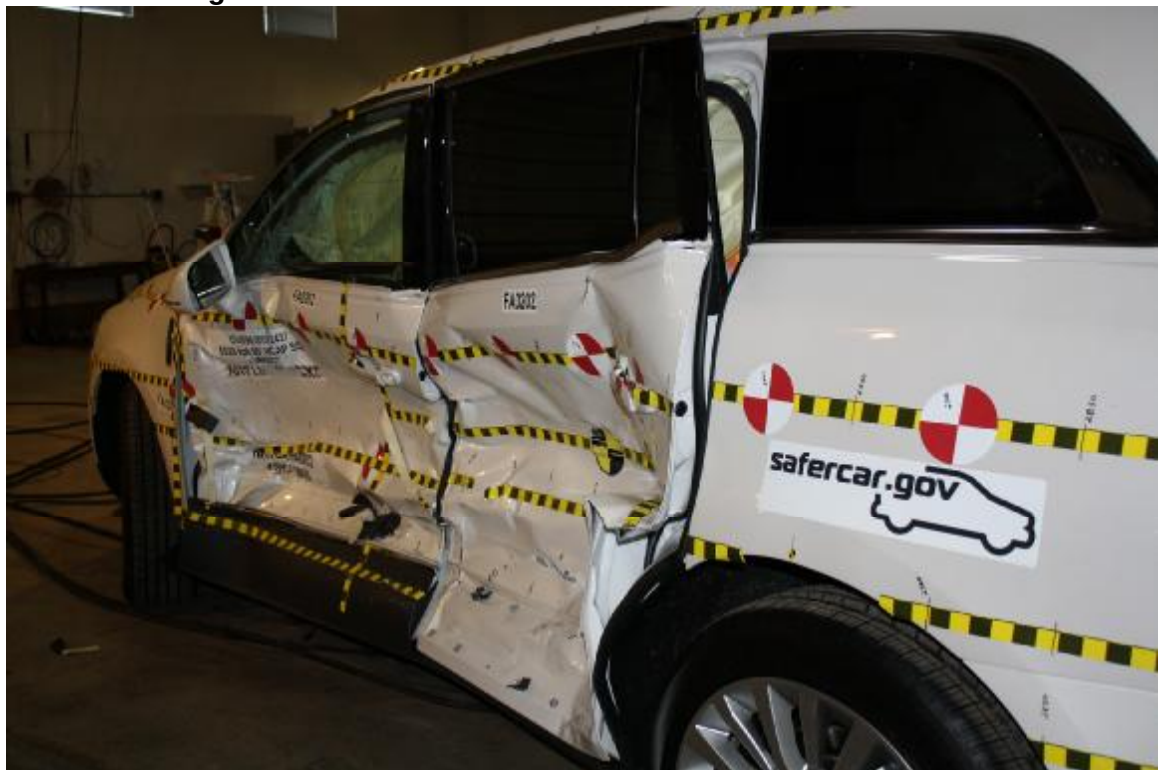
Figure A-50: Post-Test Left Rear  $\frac{3}{4}$  View of Left Side Doors
