REPORT NUMBER: CAL-10-01

**NEW CAR ASSESSMENT PROGRAM (NCAP)  
FRONTAL BARRIER IMPACT TEST**

FORD MOTOR COMPANY  
2010 LINCOLN MKT  
4-DOOR SUV

FINAL REPORT

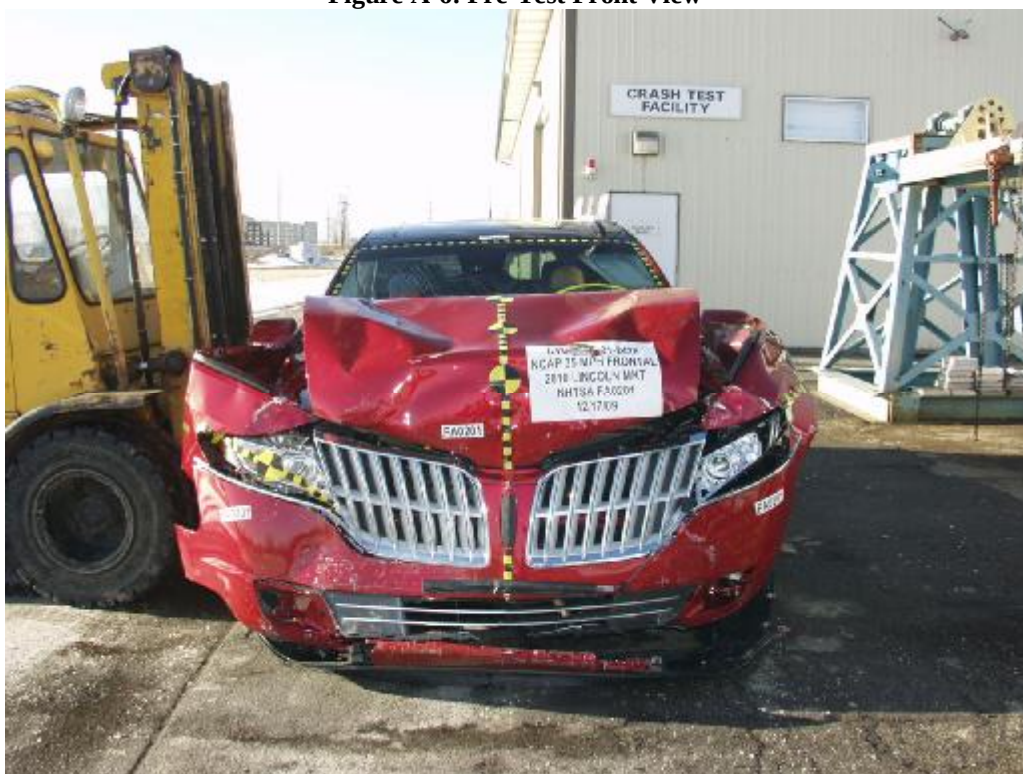
**Figure A-7: Post-Test Front View**

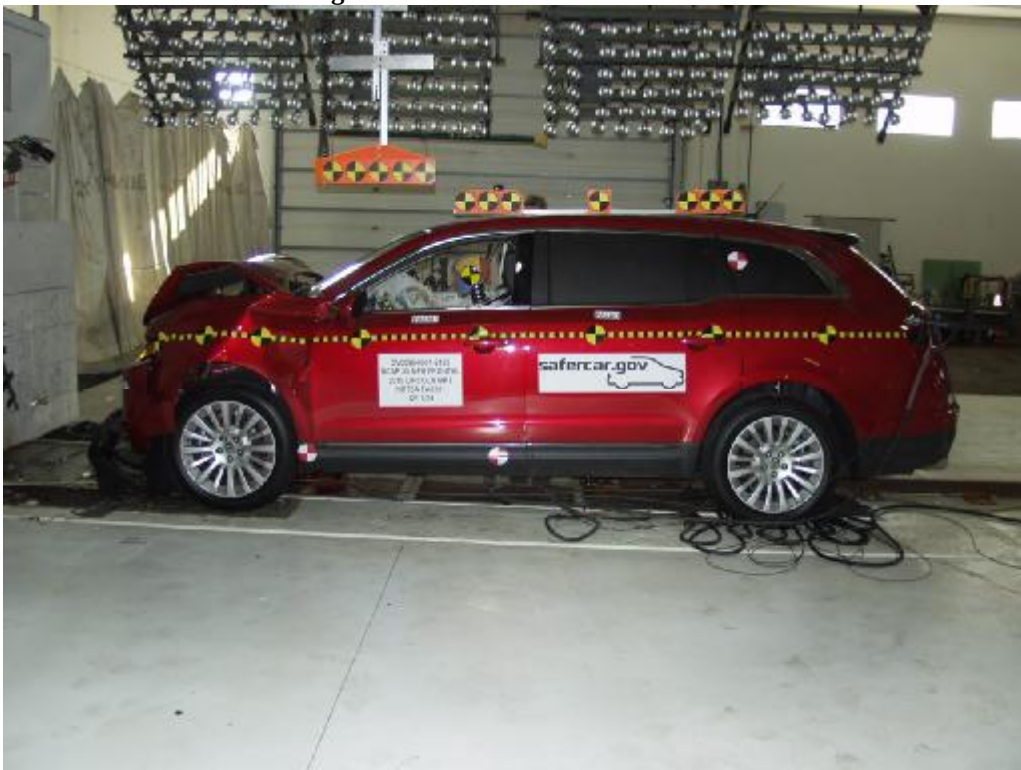
**Figure A-9: Post-Test Left Side View**

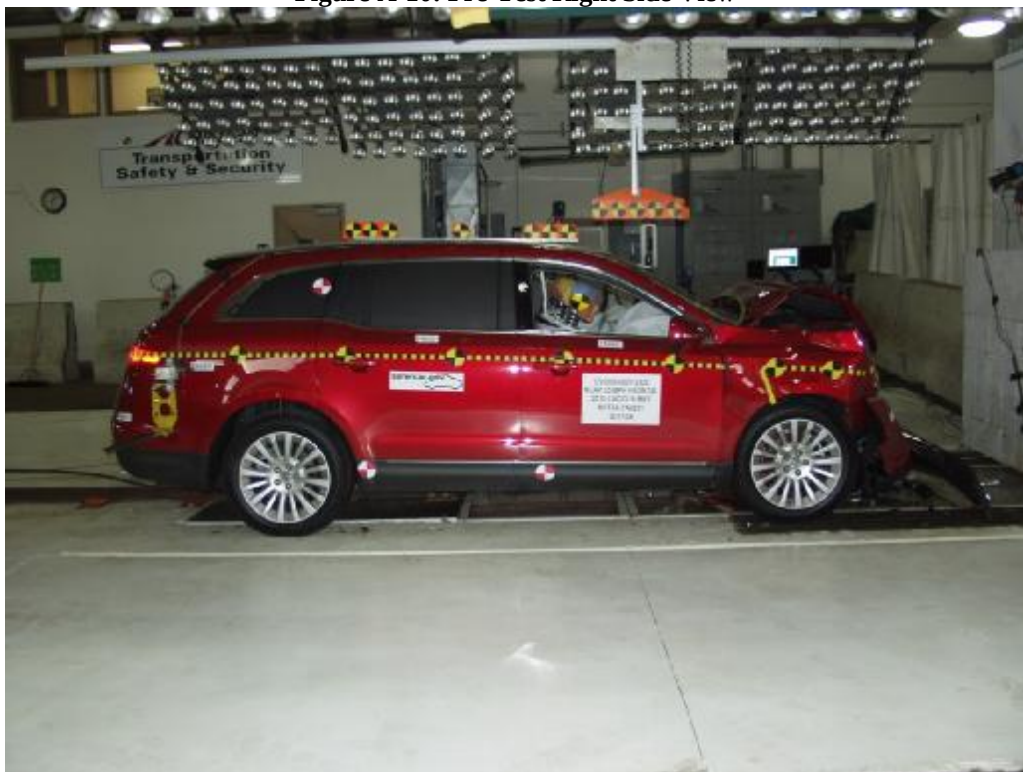
**Figure A-11: Post-Test Right Side View**

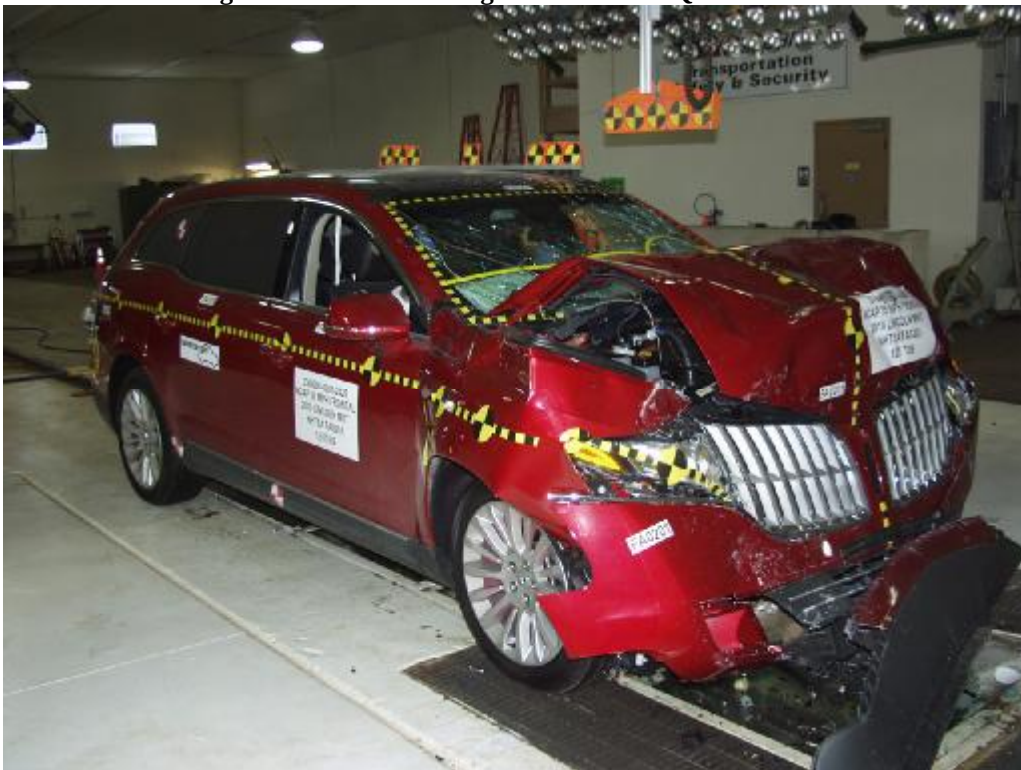
**Figure A-13: Post-Test Right Front Three-Quarter View**

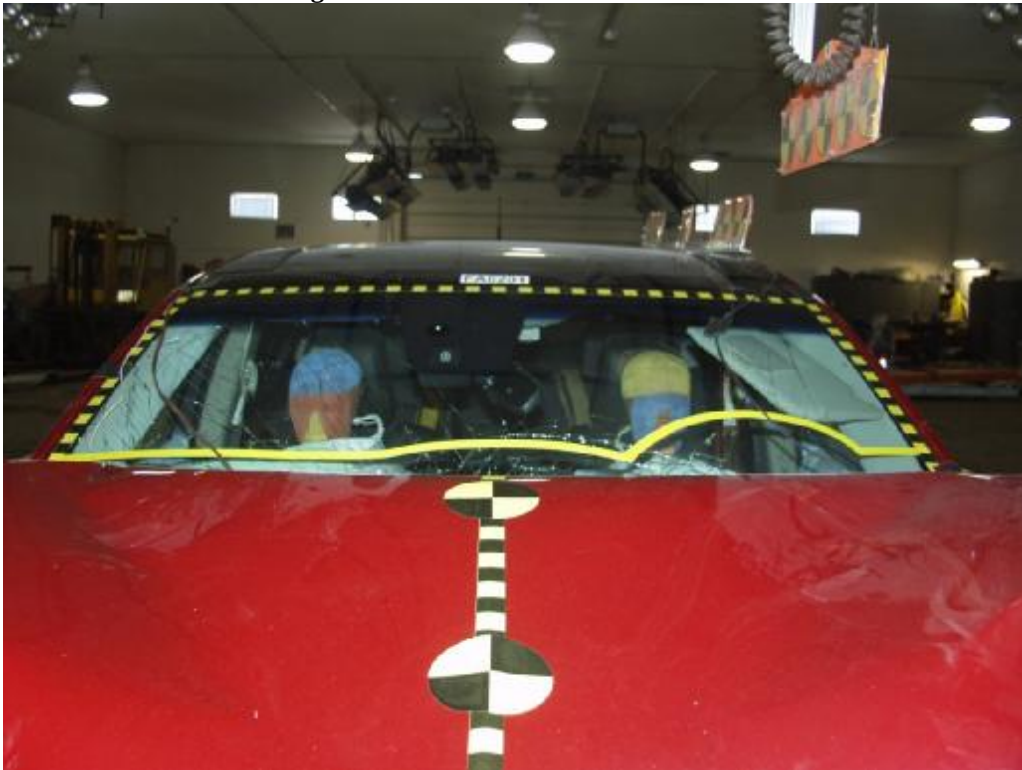
**Figure A-19: Post-Test Windshield View**

| Description | Driver Side | Passenger Side |
|---|---|---|
| Glazing Damage | Cracking on both of both sides of Windshield / No failures | |

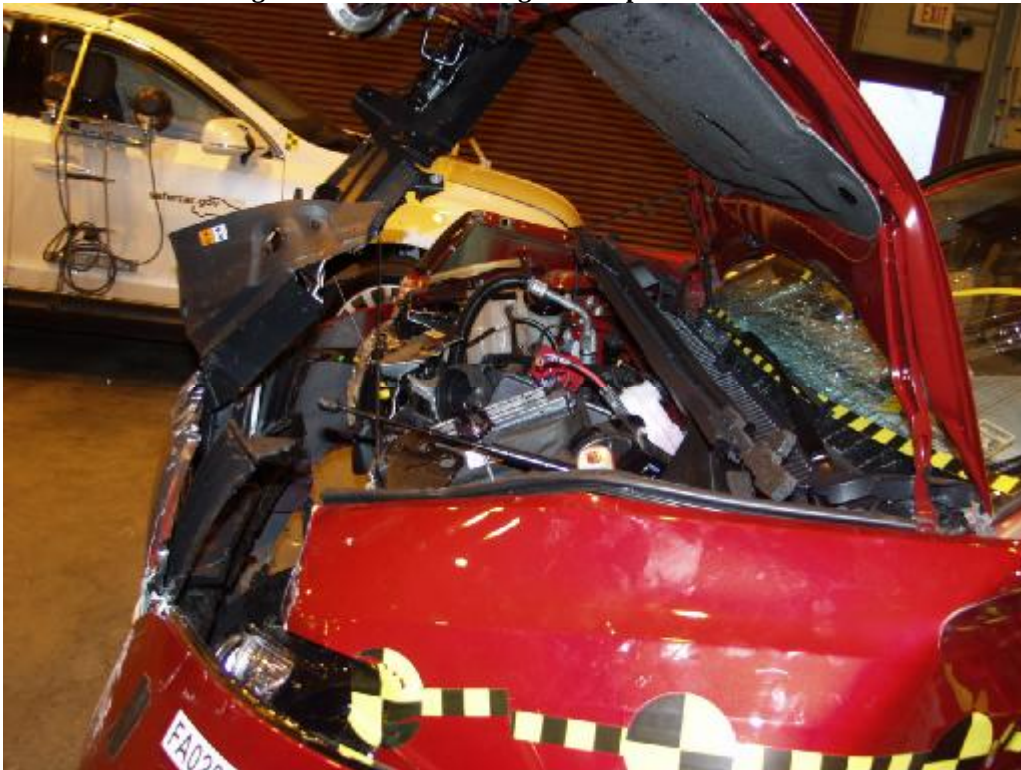
**Figure A-21: Post-Test Engine Compartment View**

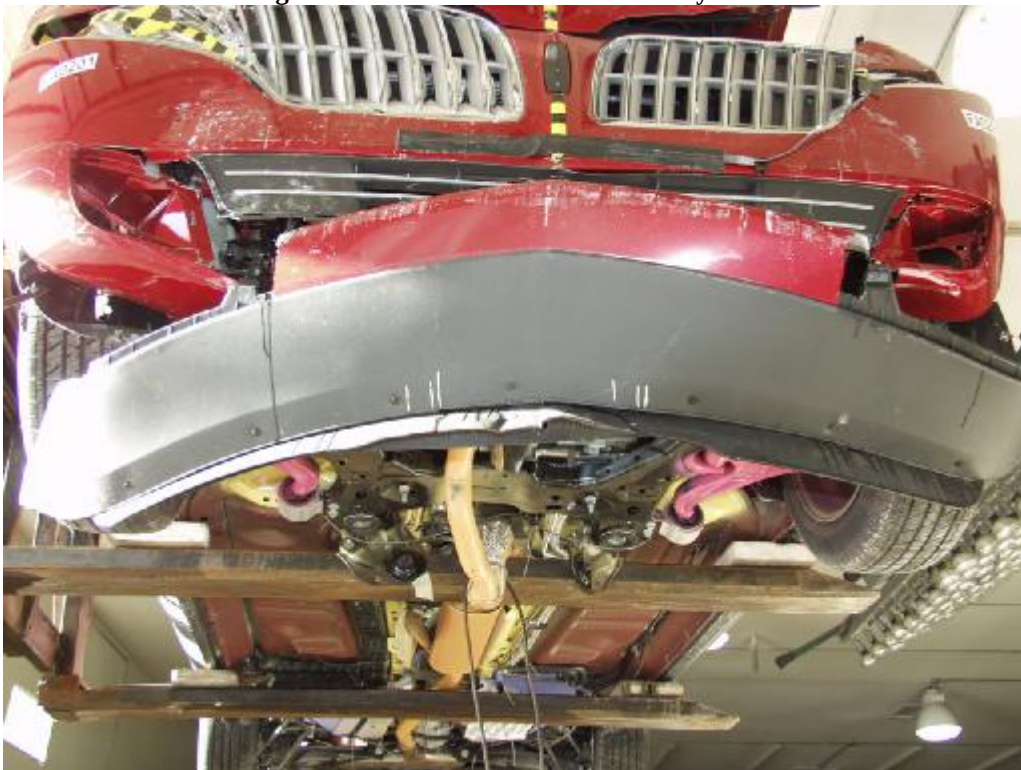
**Figure A-25: Post-Test Front Underbody View**

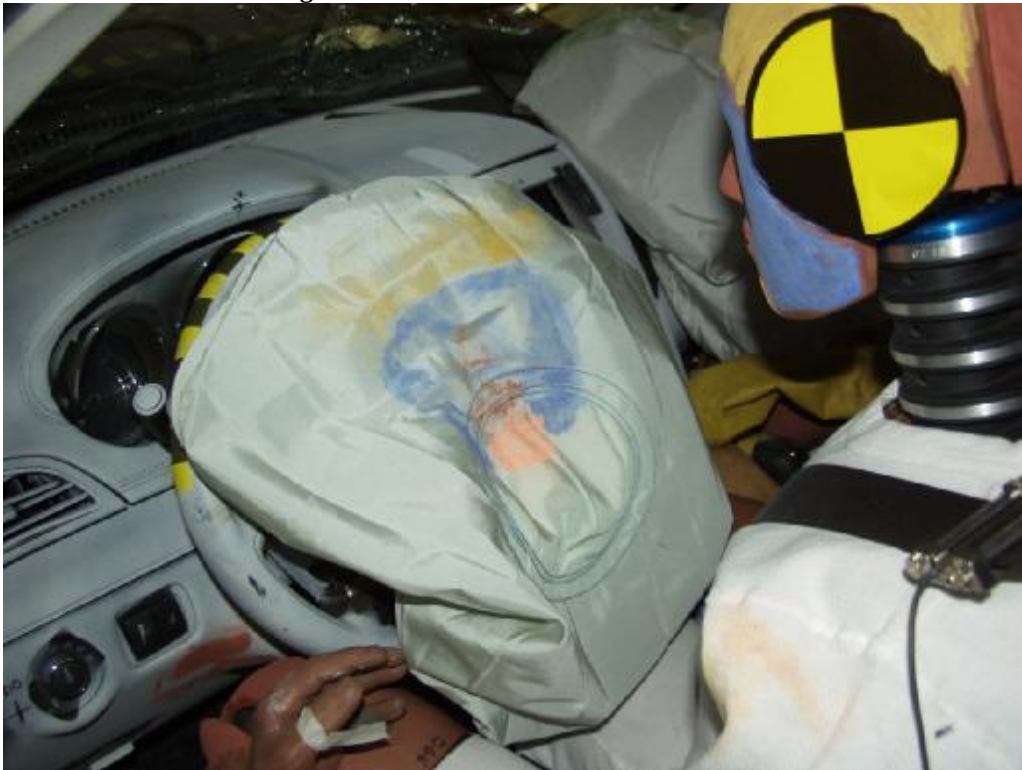
**Figure A-43: Post-Test Driver Contact to Airbag**

| | DRIVER | PASSENGER |
|---|---|---|
| Chest Contact: | Airbag | Airbag |

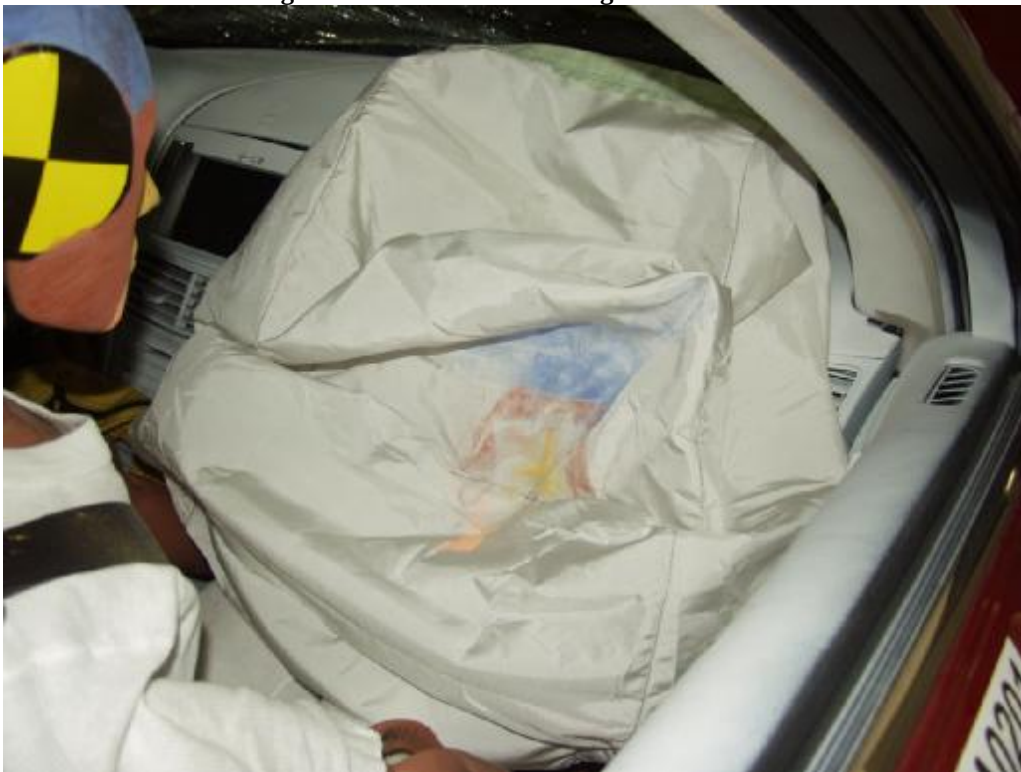
**Figure A-57: Post-Test Passenger Contact to Airbag**

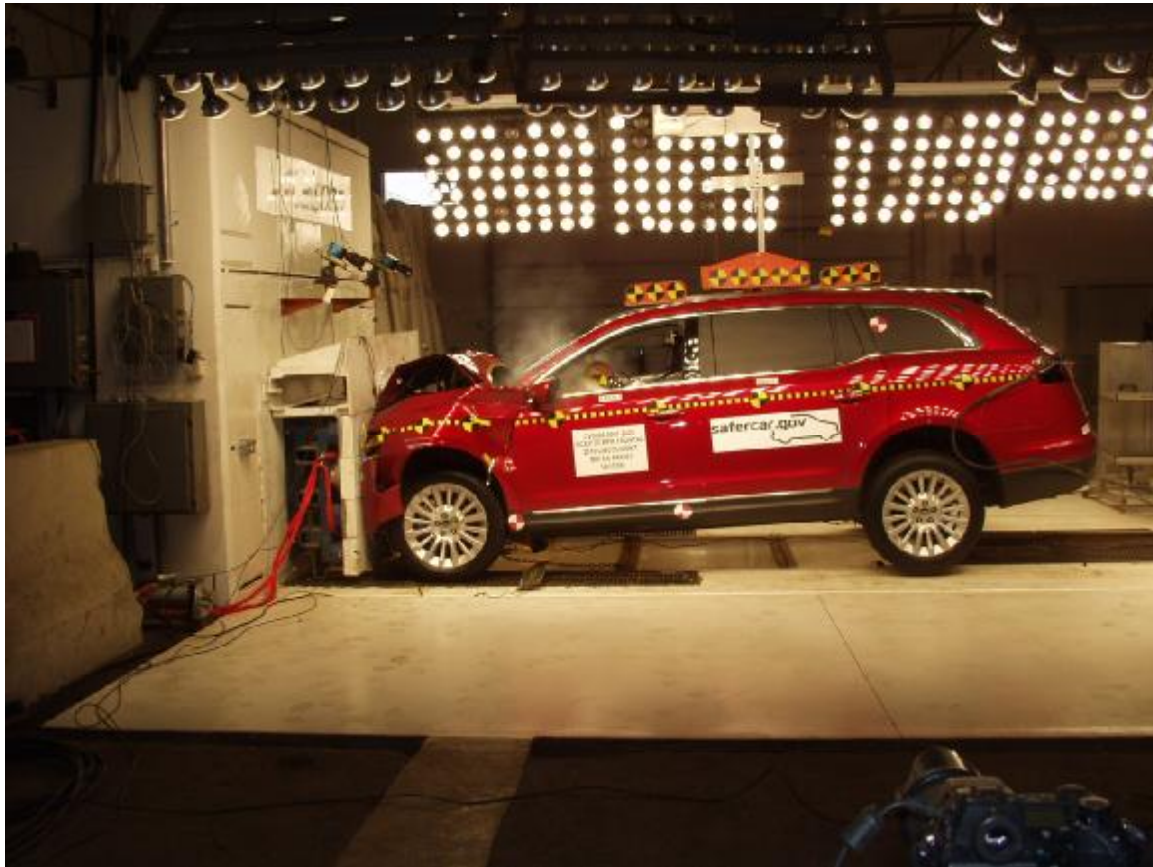
**Figure A-62: Impact View**

A load cell barrier consisting of 36 load cells was impacted by a 2010 Lincoln MKT 4-Door SUV at a velocity of 56.5 kph. The test was performed at Calspan on 12/17/09. Pre- and post-test photographs of the vehicle and dummies can be found in Appendix A.
