NEW CAR ASSESSMENT PROGRAM  
SIDE IMPACT TEST

TOYOTA MOTOR CORPORATION  
2010 TOYOTA 4RUNNER SR5 4X2  
5-DOOR MPV

NHTSA NUMBER: MA5124

FINAL REPORT

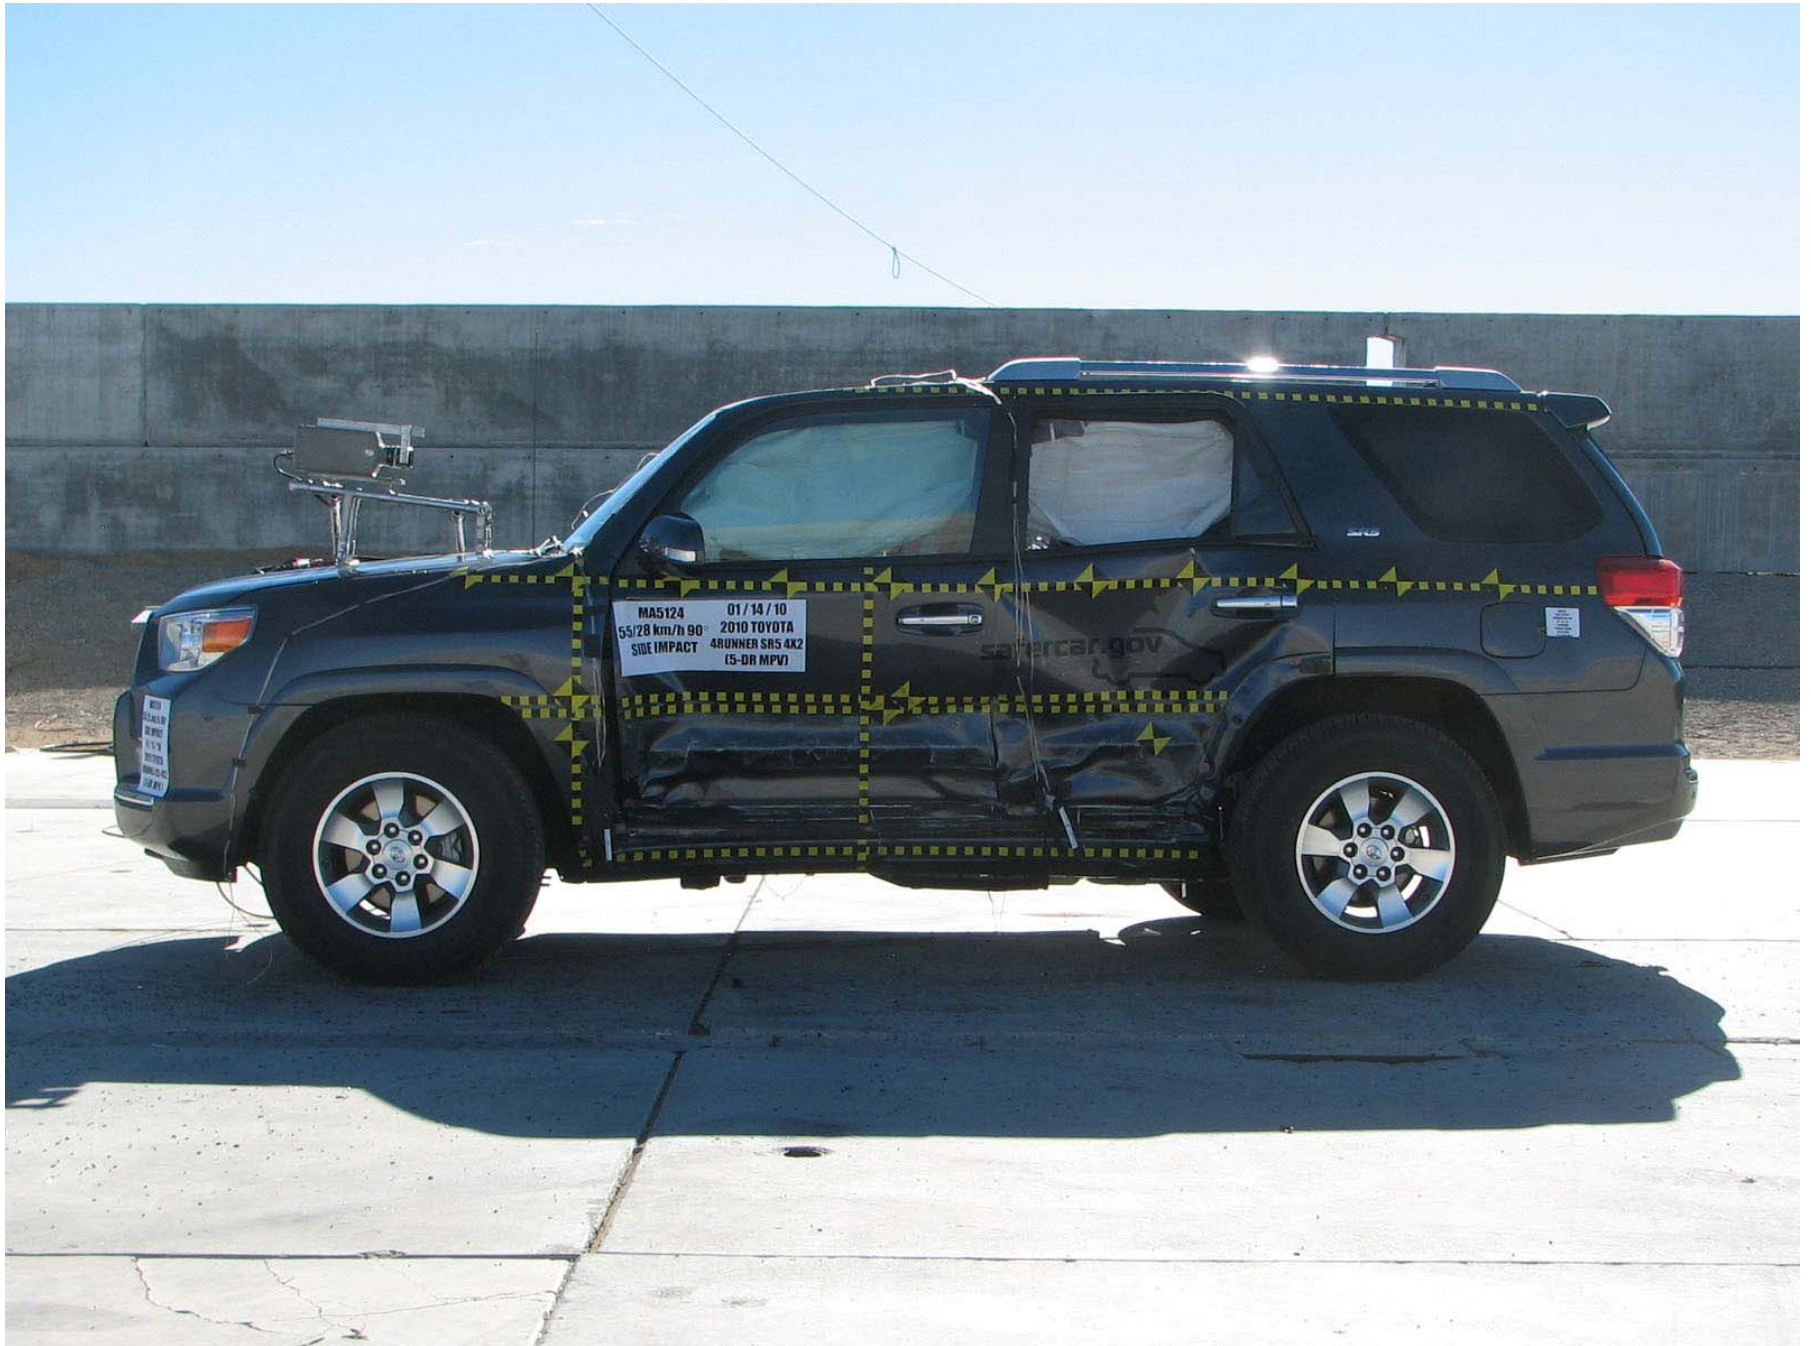
Figure A-10: Post-Test Left Side View (Vehicle Moved)

Both the driver and passenger doors remained closed during the impact. The test vehicle sustained a maximum static crush of 172 mm at level 1, 1050 mm rearward of the left vertical impact point. The driver SID/Hybrid III, Serial No. 274 and the passenger SID/Hybrid III, Serial No. 275 were calibrated prior to this test. The SID/Hybrid III injury criteria are summarized as follows:

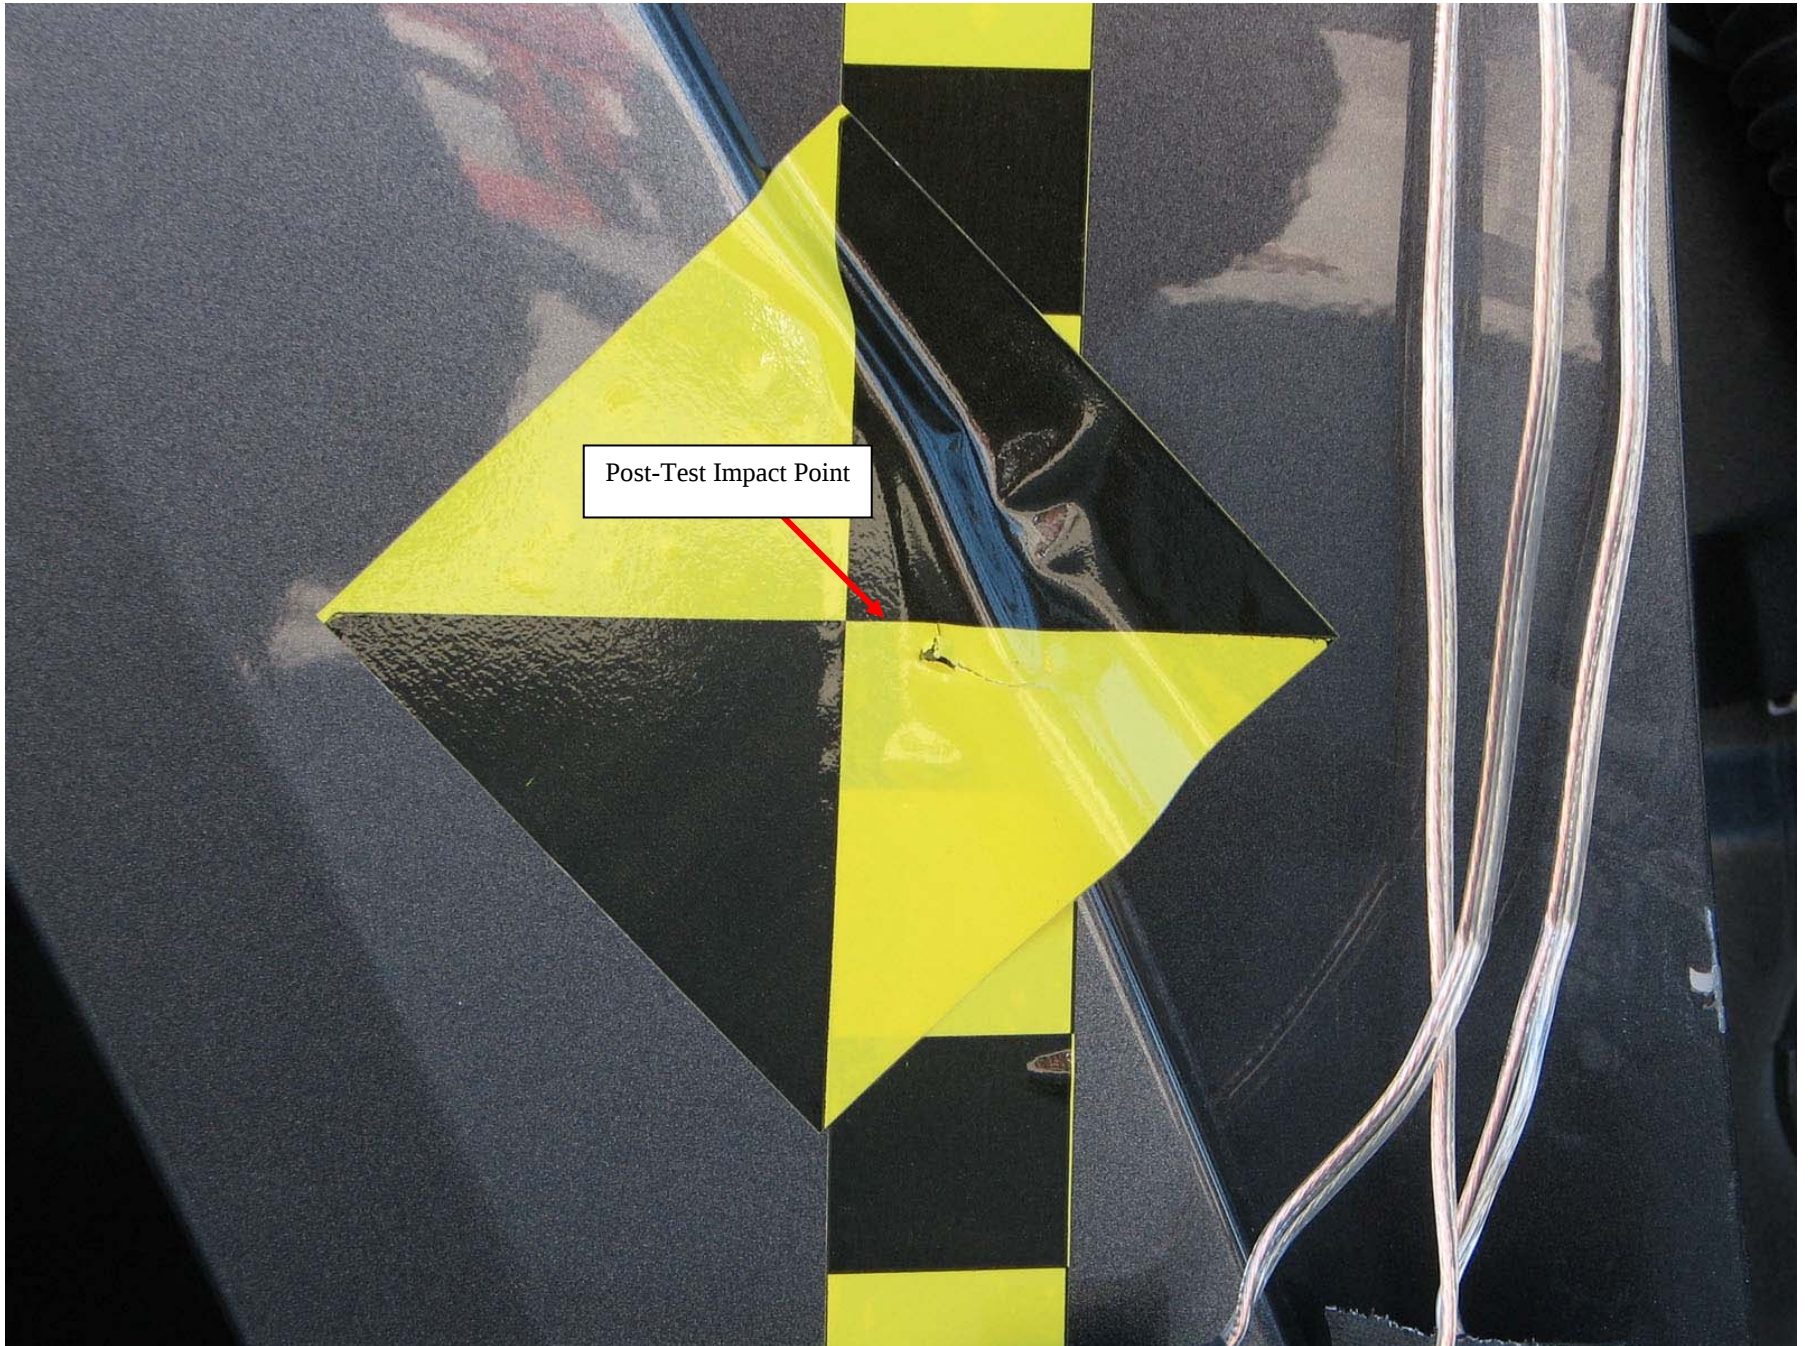
Figure A-26: Post-Test Left Impact Point

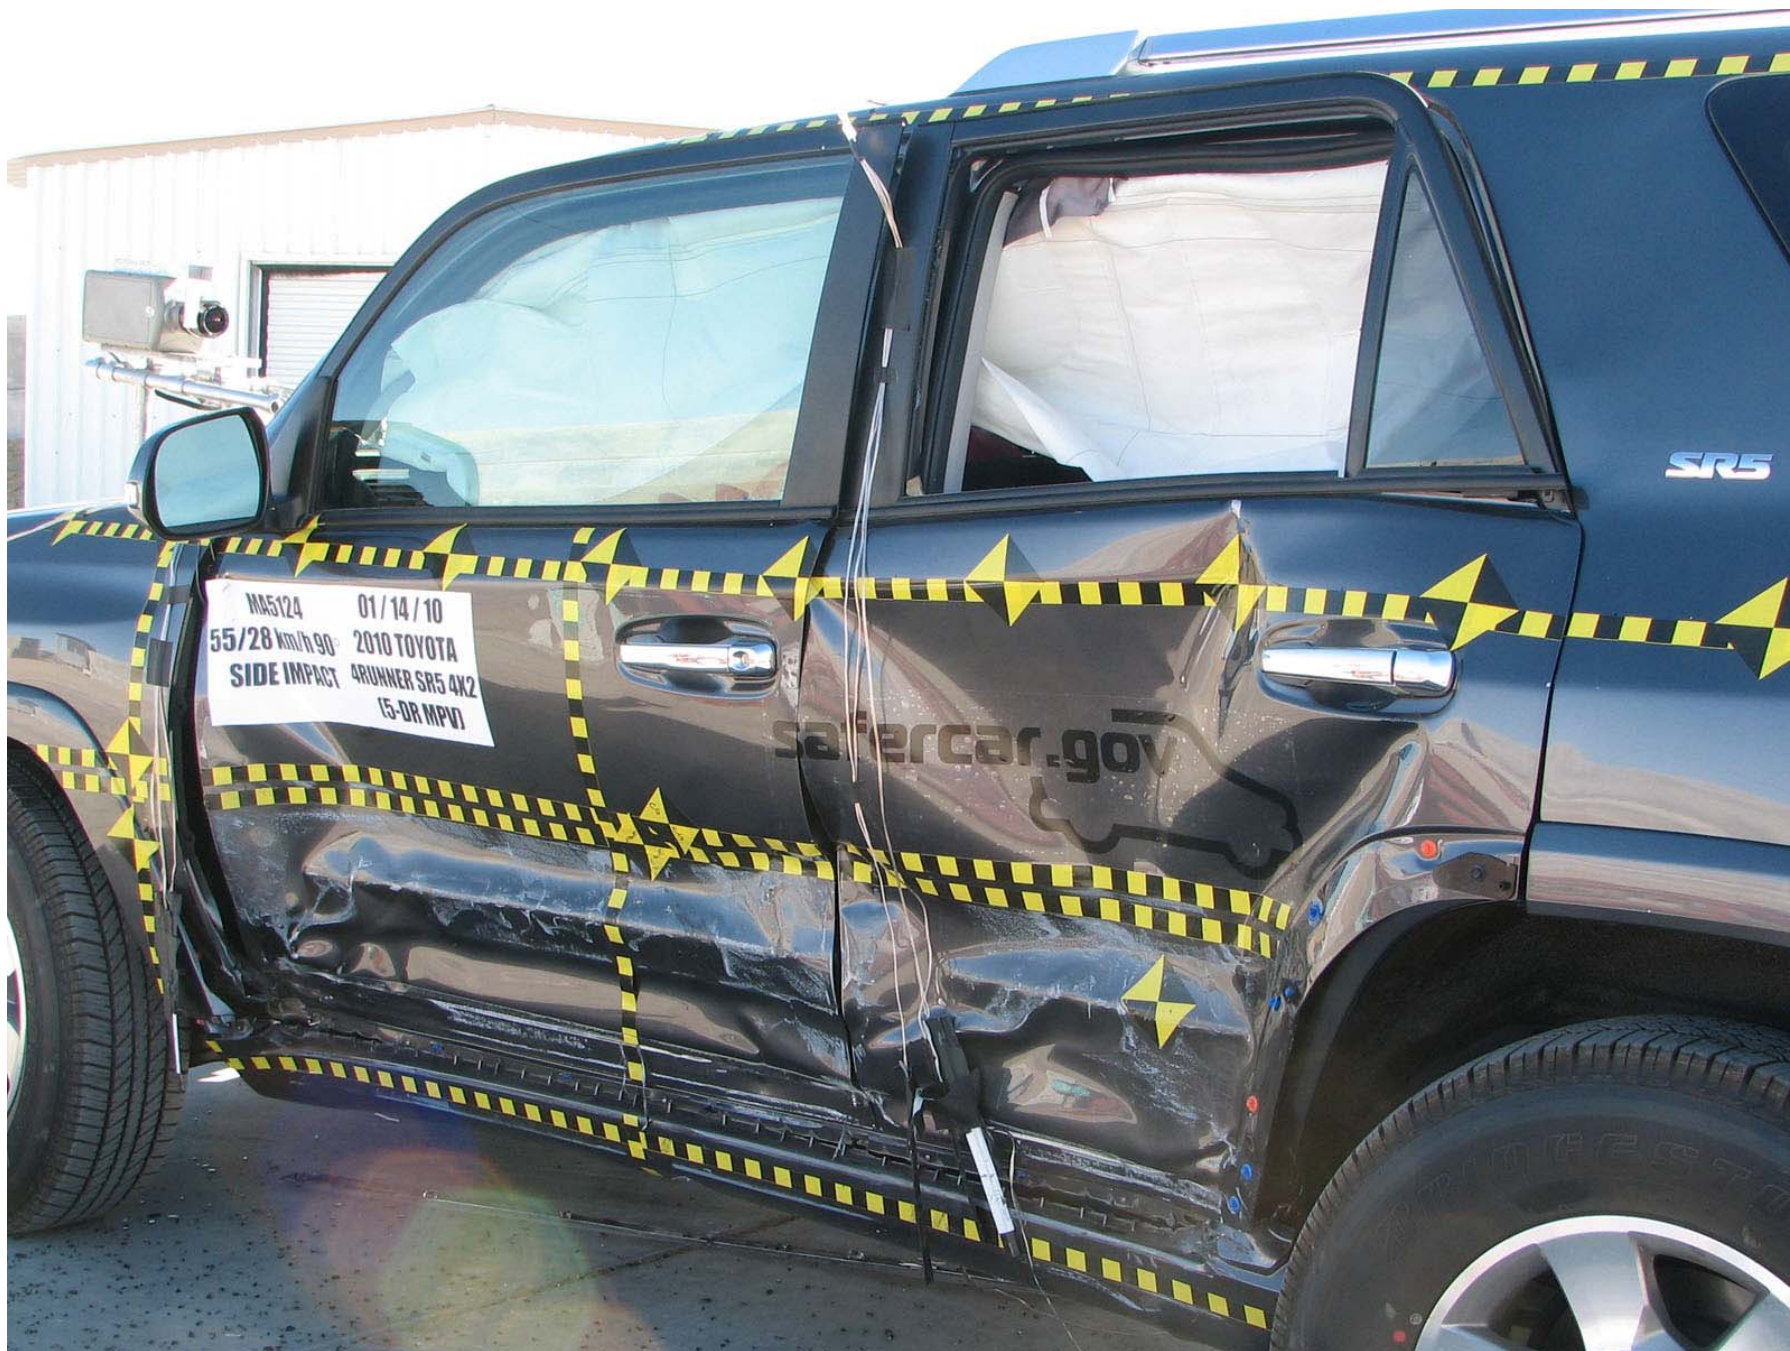
Figure A-30: Post-Test Rear  $\frac{3}{4}$  View of Left Side Door

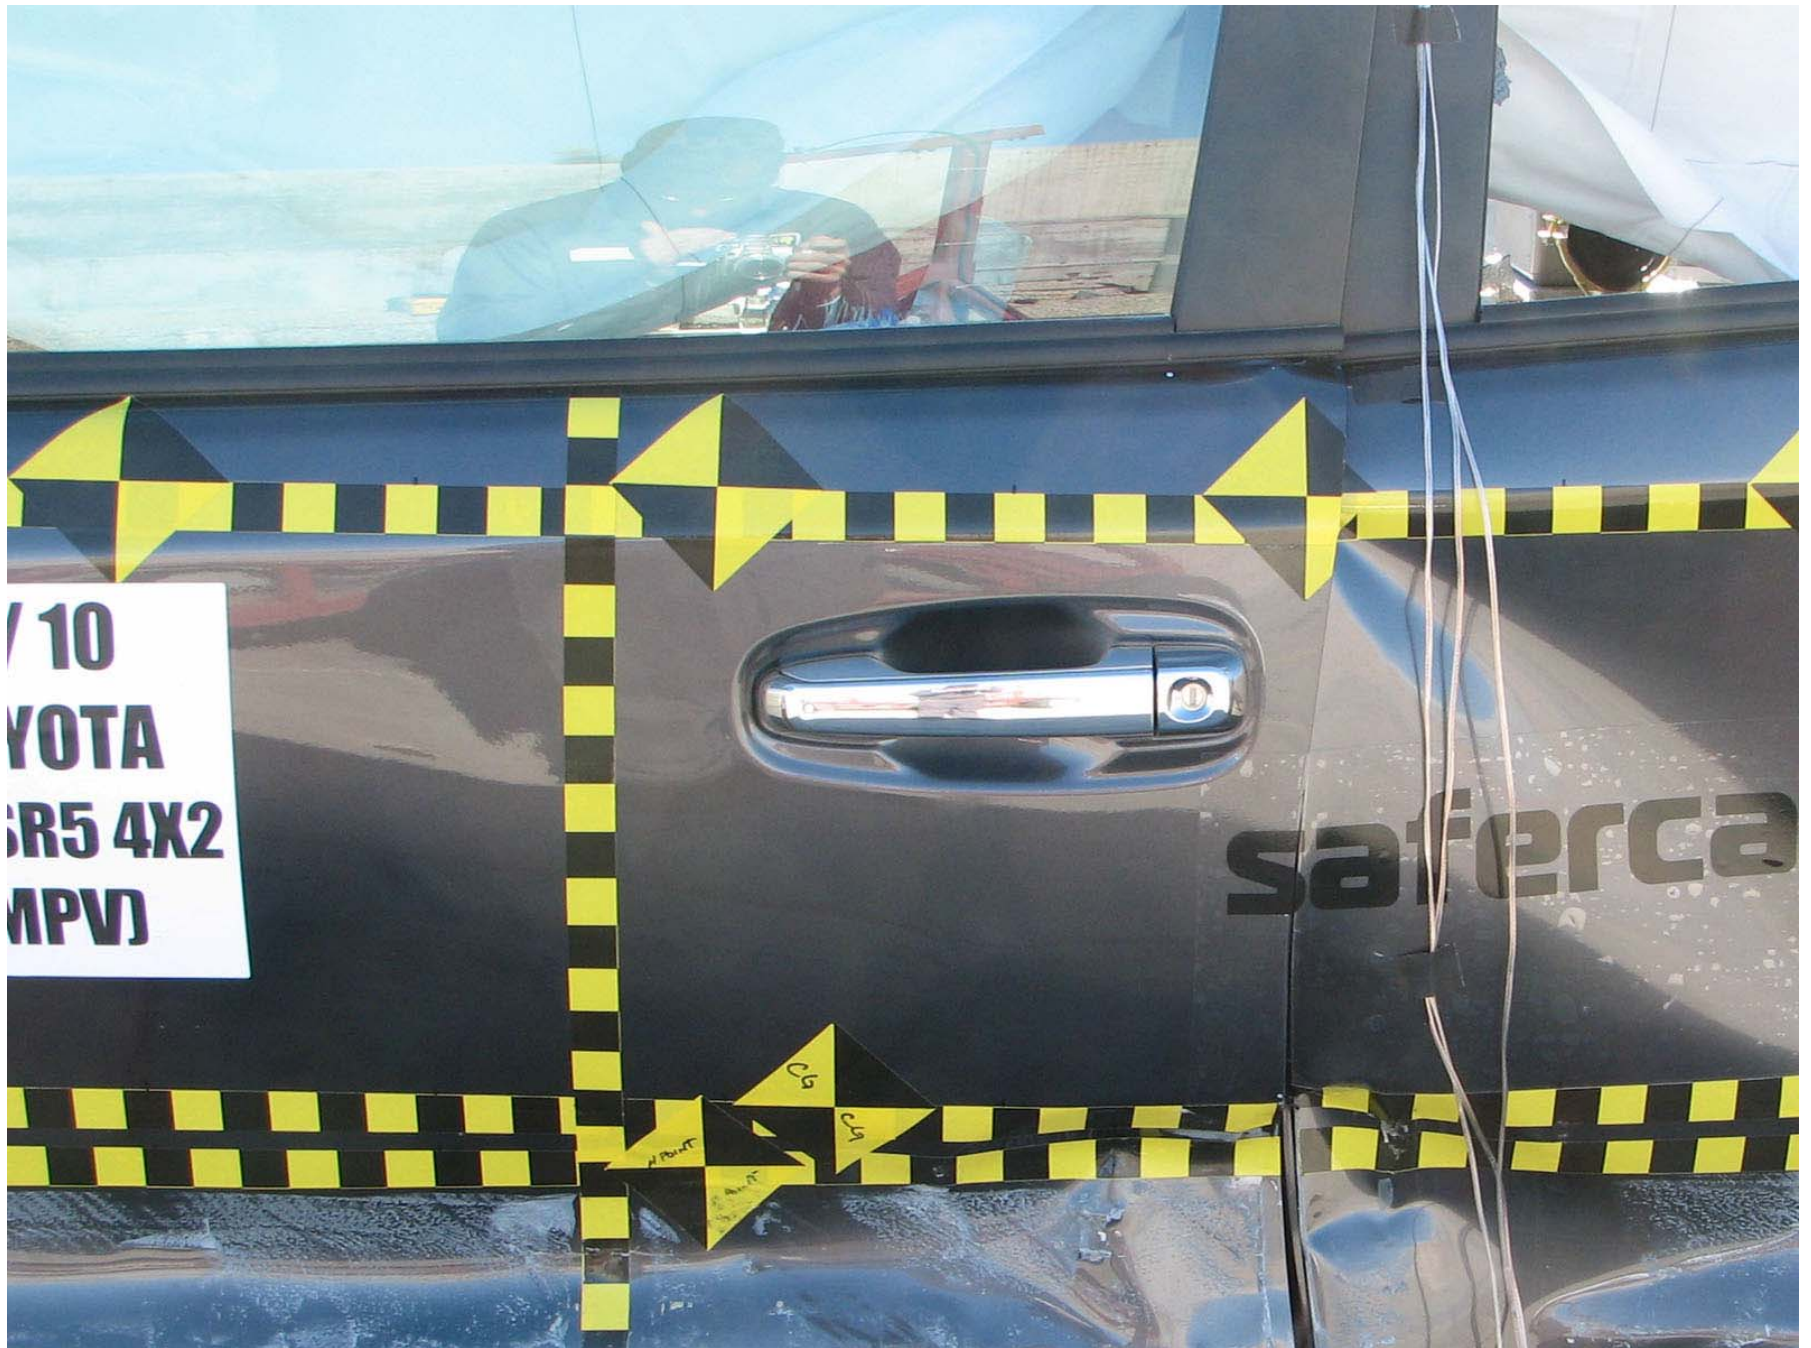
Figure A-32: Post-Test Left Front Door

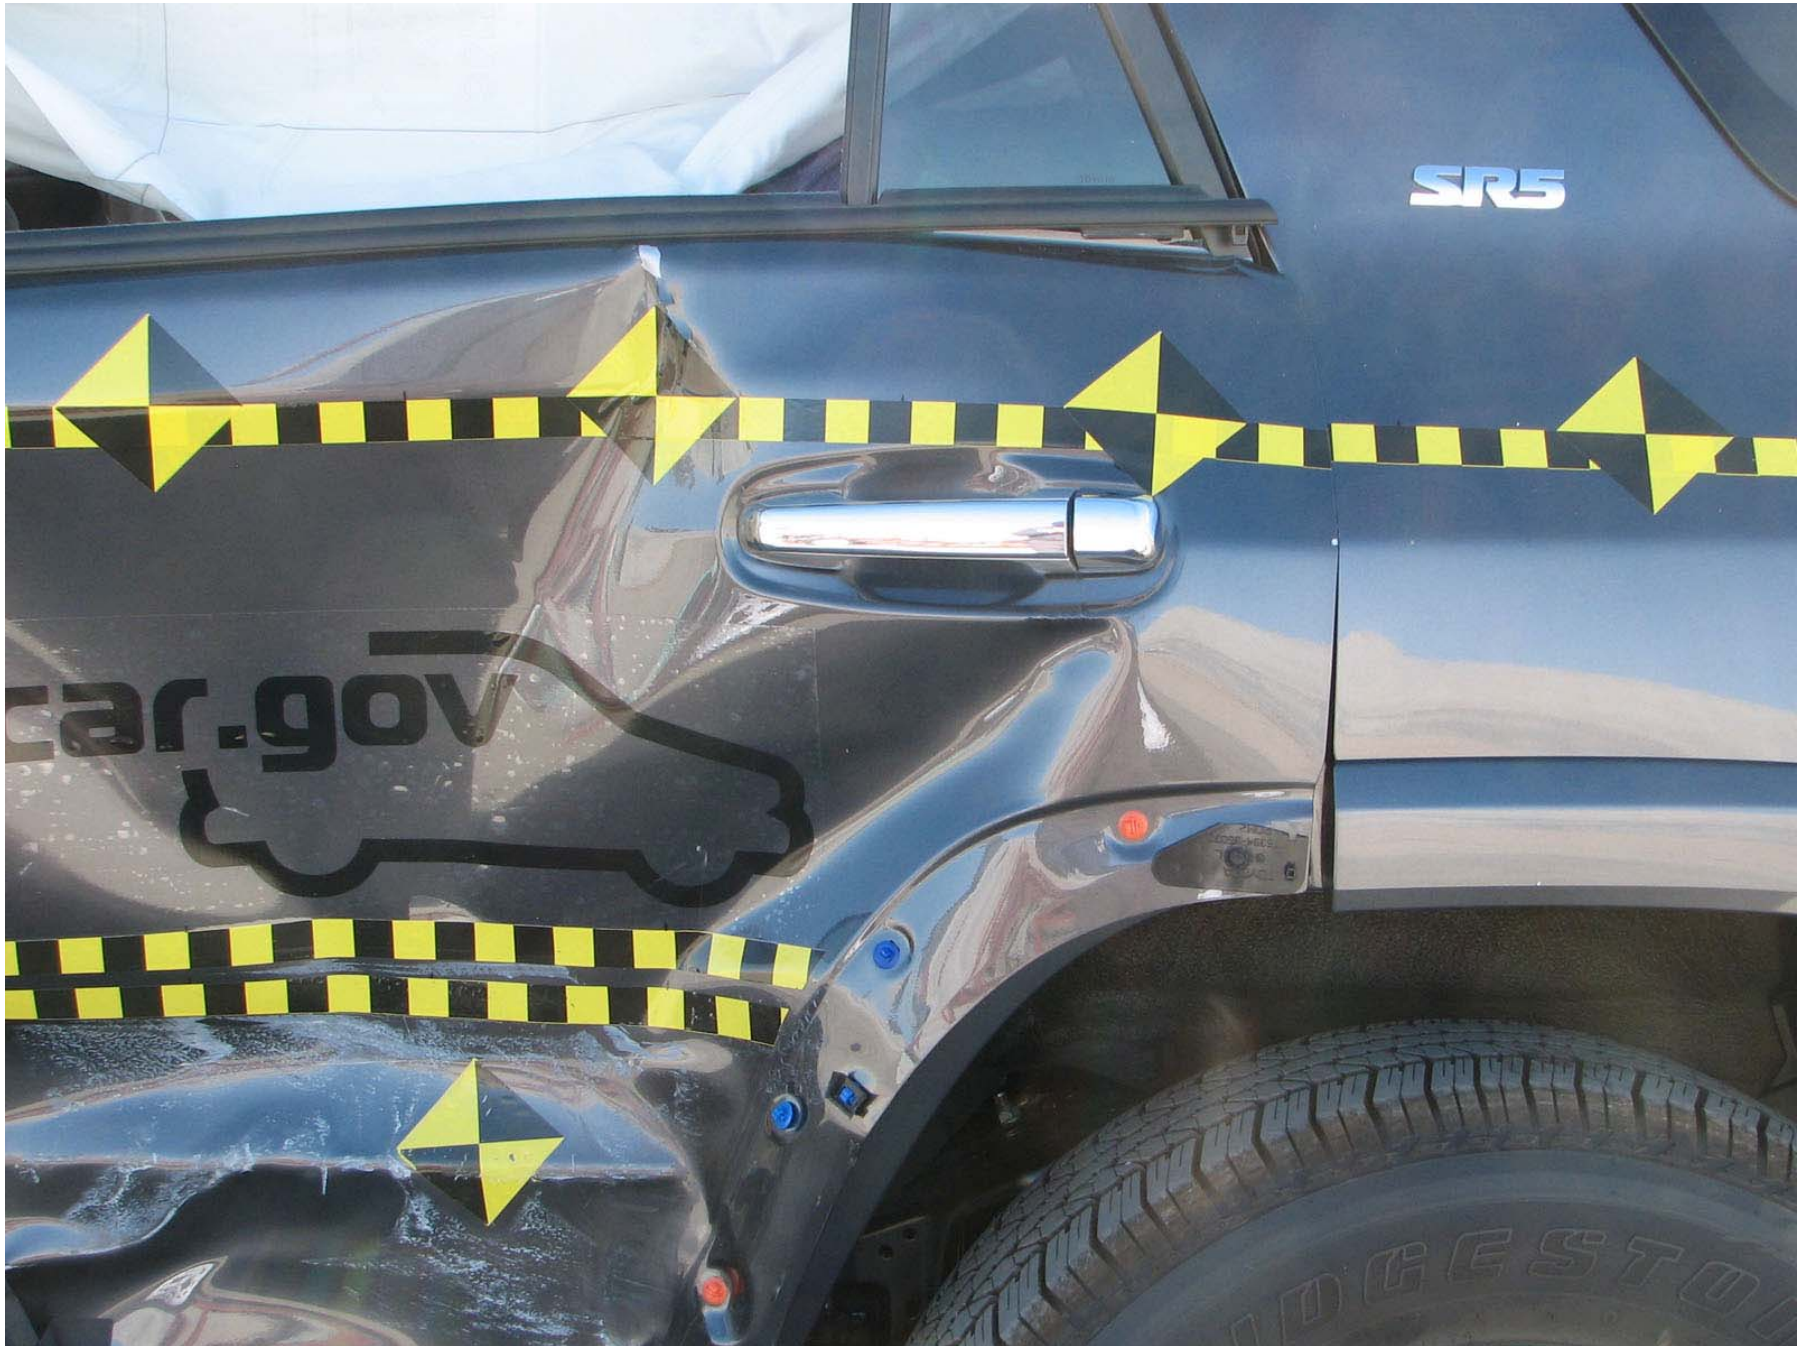
Figure A-34: Post-Test Left Rear Door

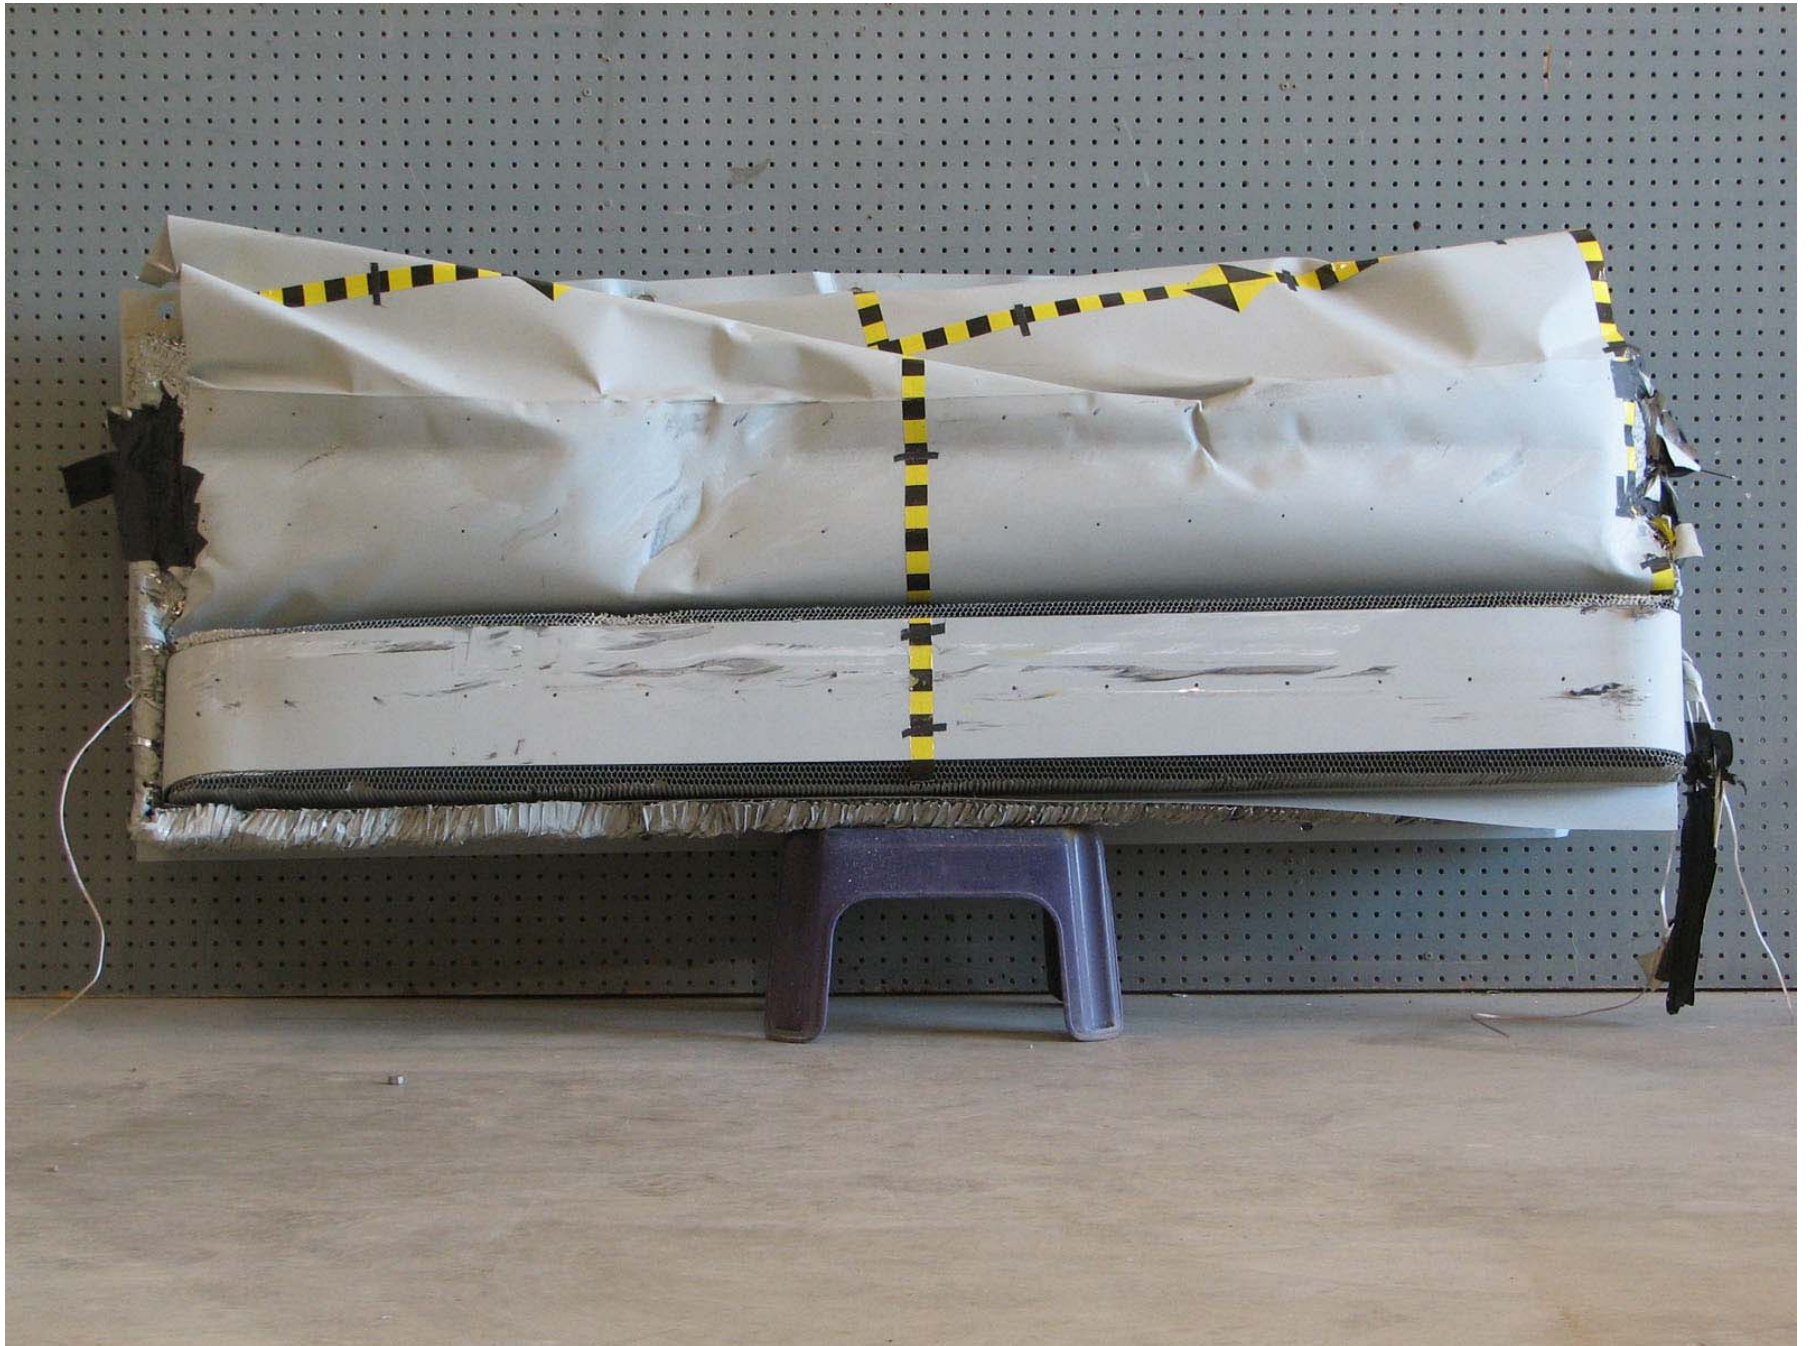
Figure A-54: Post-Test Front View of Deformable Barrier

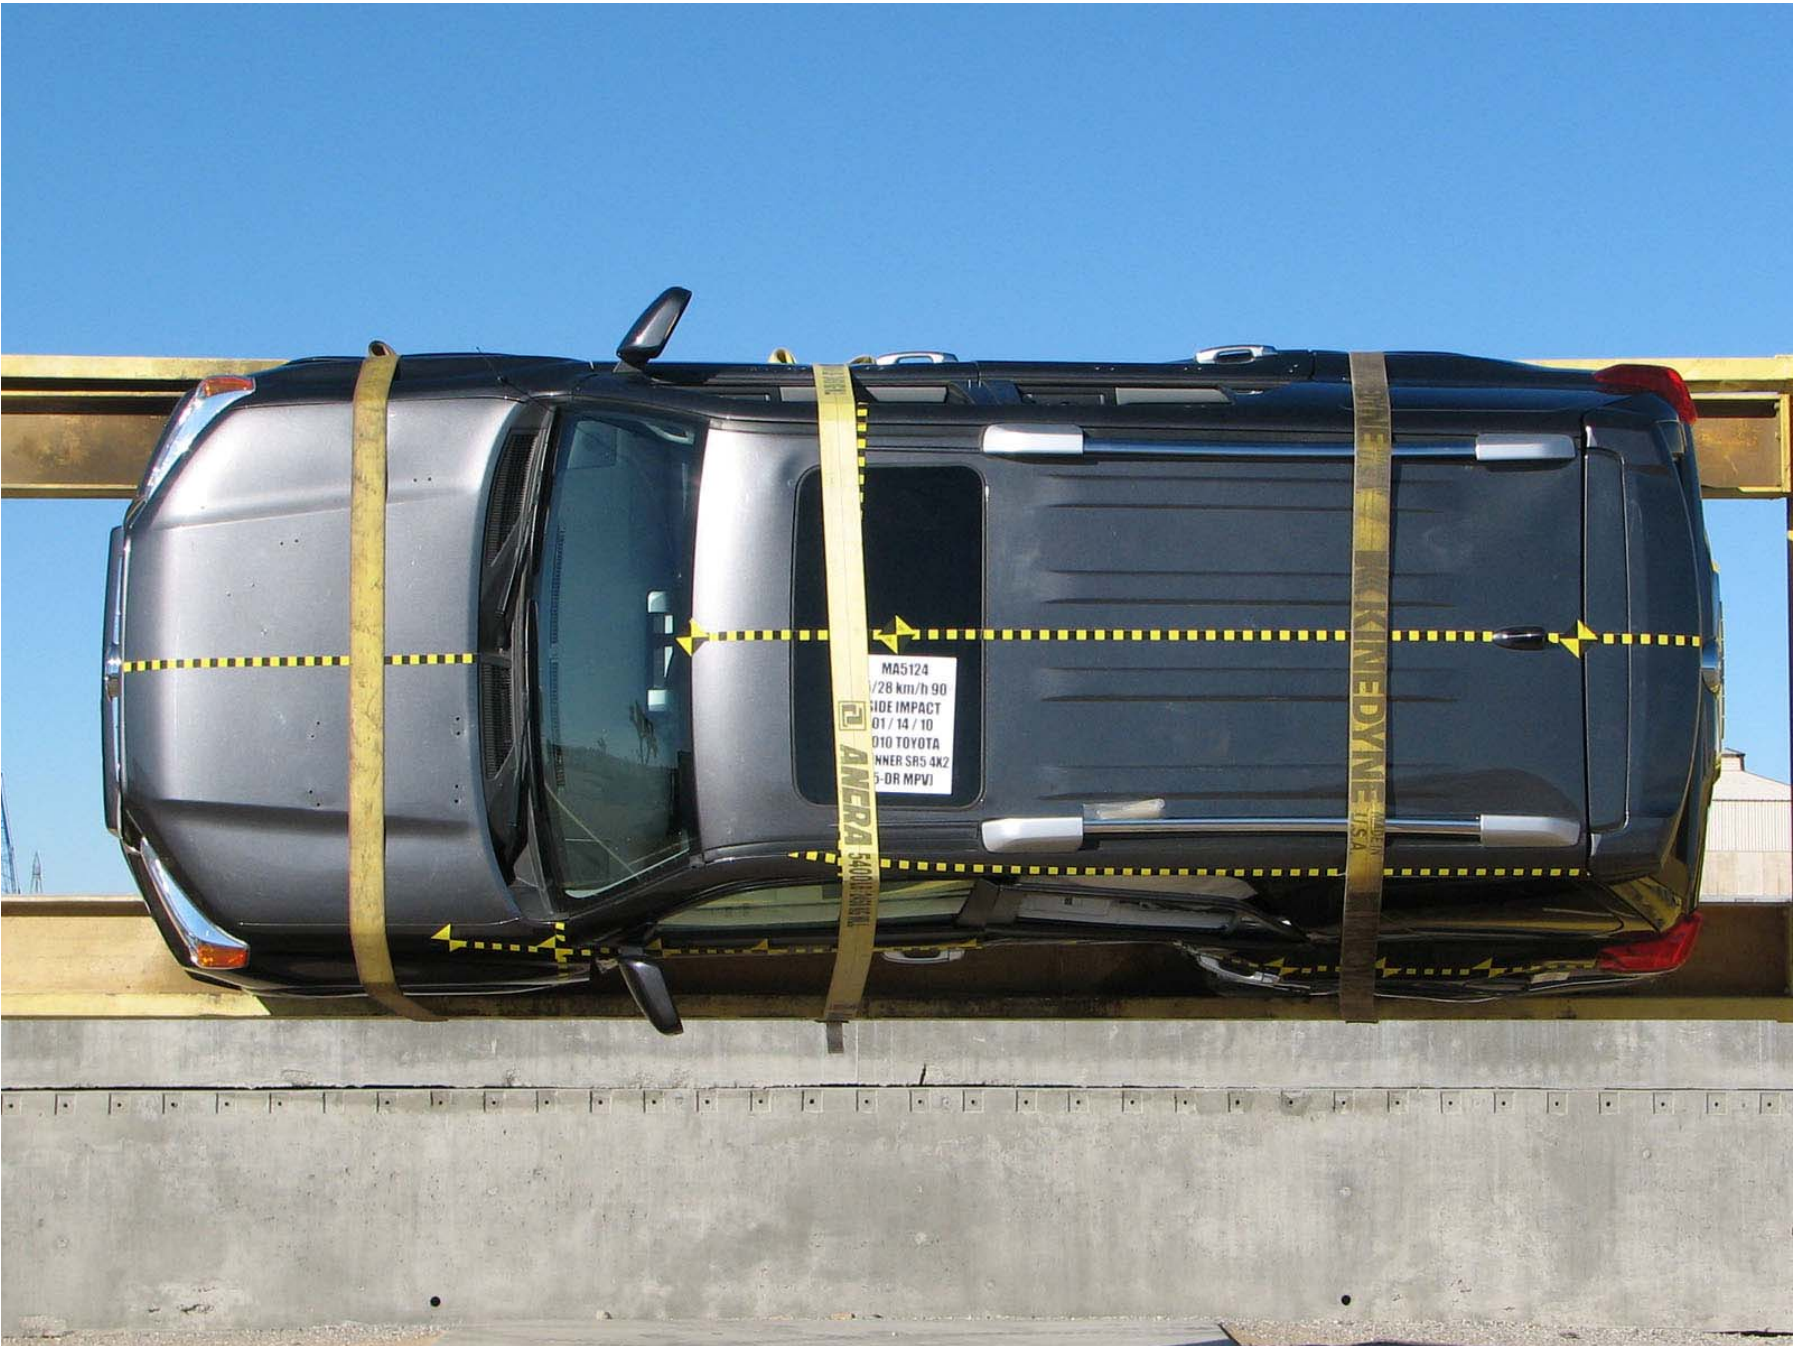
Figure A-62: Vehicle on Rollover Device (90°)

1. The specified fixture rollover rate for each 90° of rotation is 60 to 120 seconds.
  2. The position hold time at each position is 300 seconds (minimum).
  3. Details of Stoddard Solvent spillage locations.
- No solvent leakage occurred during static rollover testing.

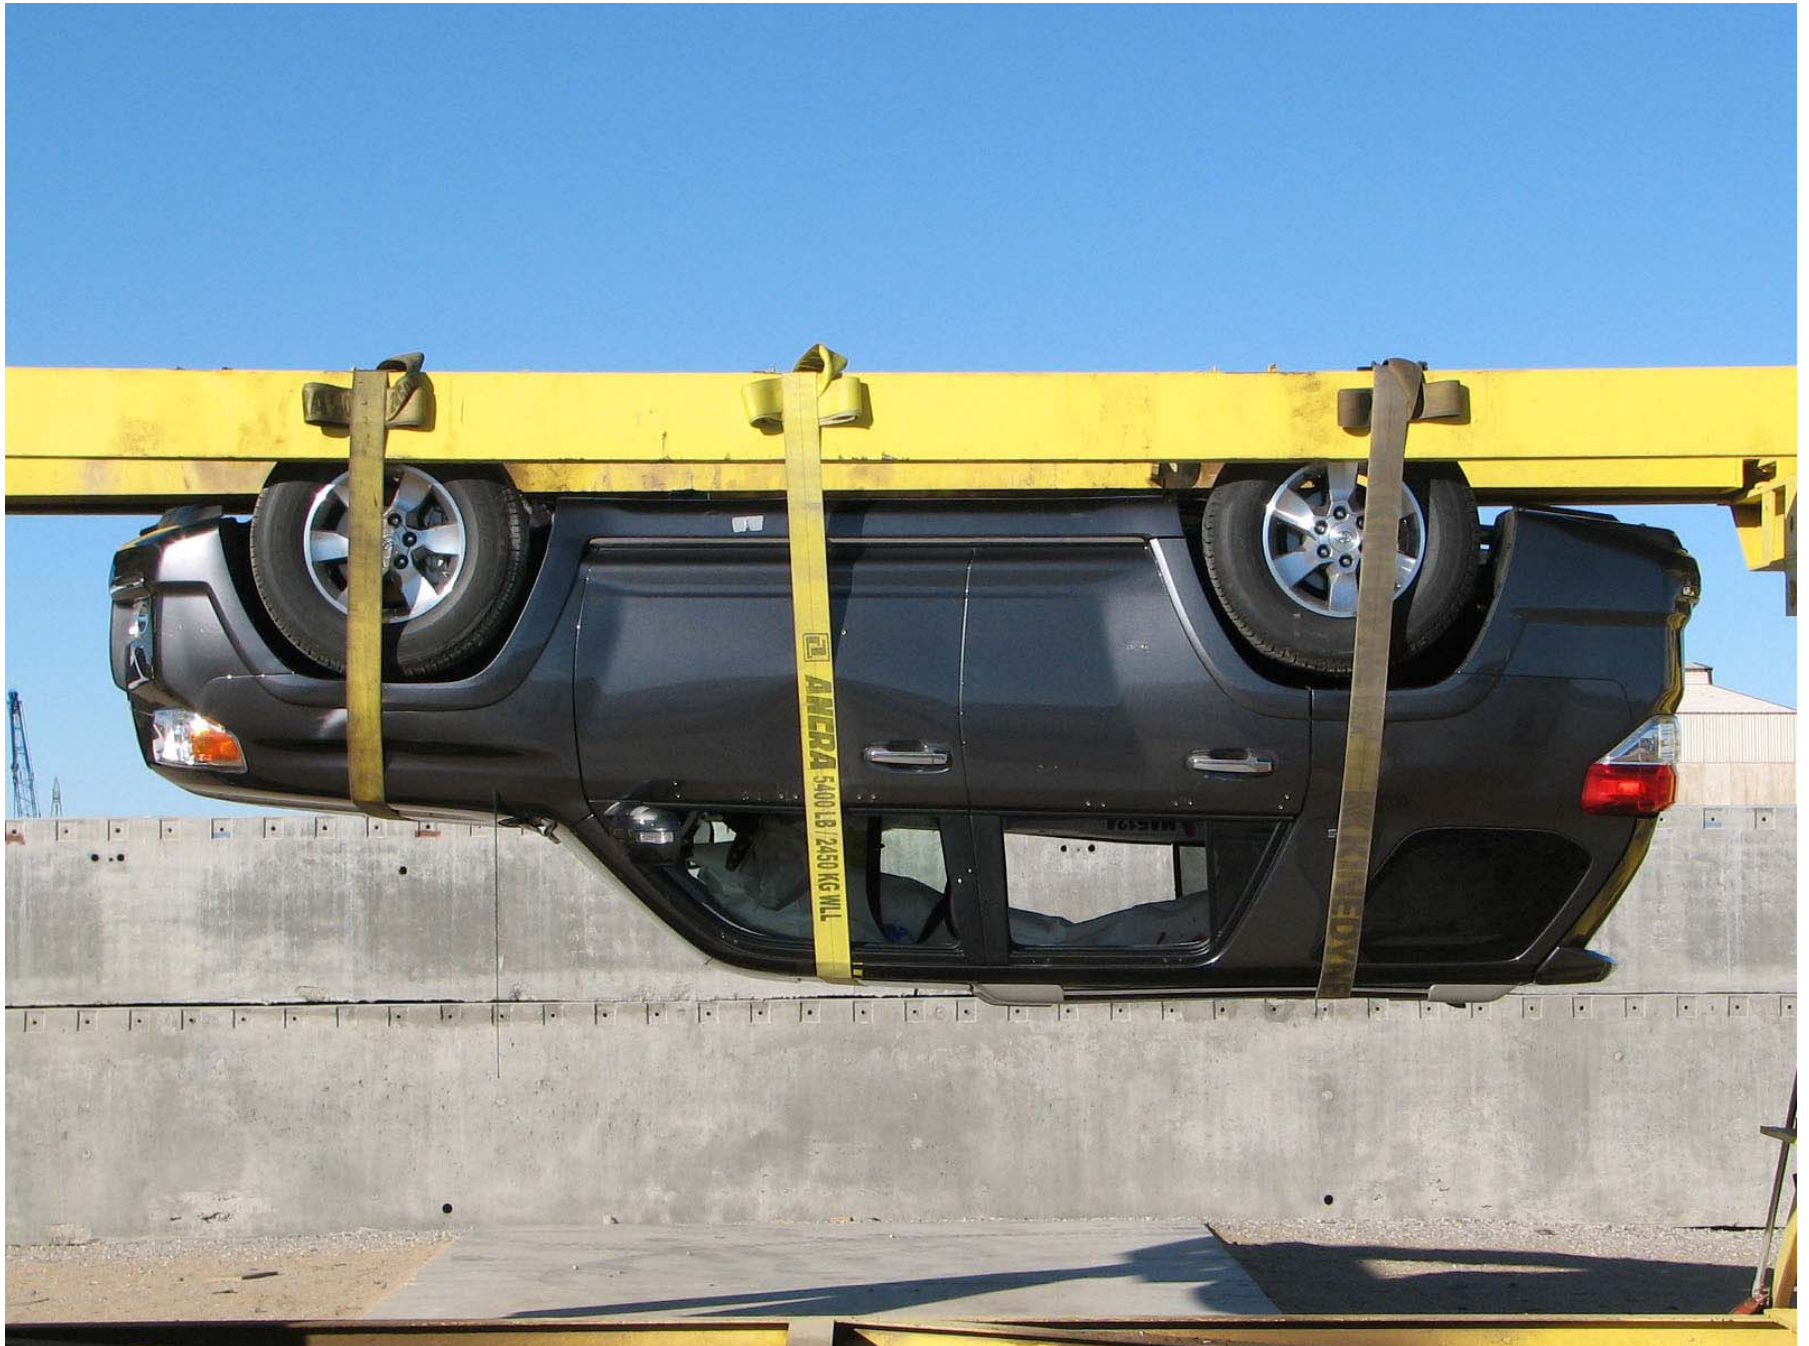
Figure A-63: Vehicle on Rollover Device (180°)
