**REPORT NUMBER: SNCAP-CAL-10-5**

**NEW CAR ASSESSMENT PROGRAM  
SIDE IMPACT TEST**

**MITSUBISHI MOTORS CORPORATION  
2010 MITSUBISHI OUTLANDER 2.4 ES  
4-DOOR SUV**

**NHTSA NUMBER: MA5601**

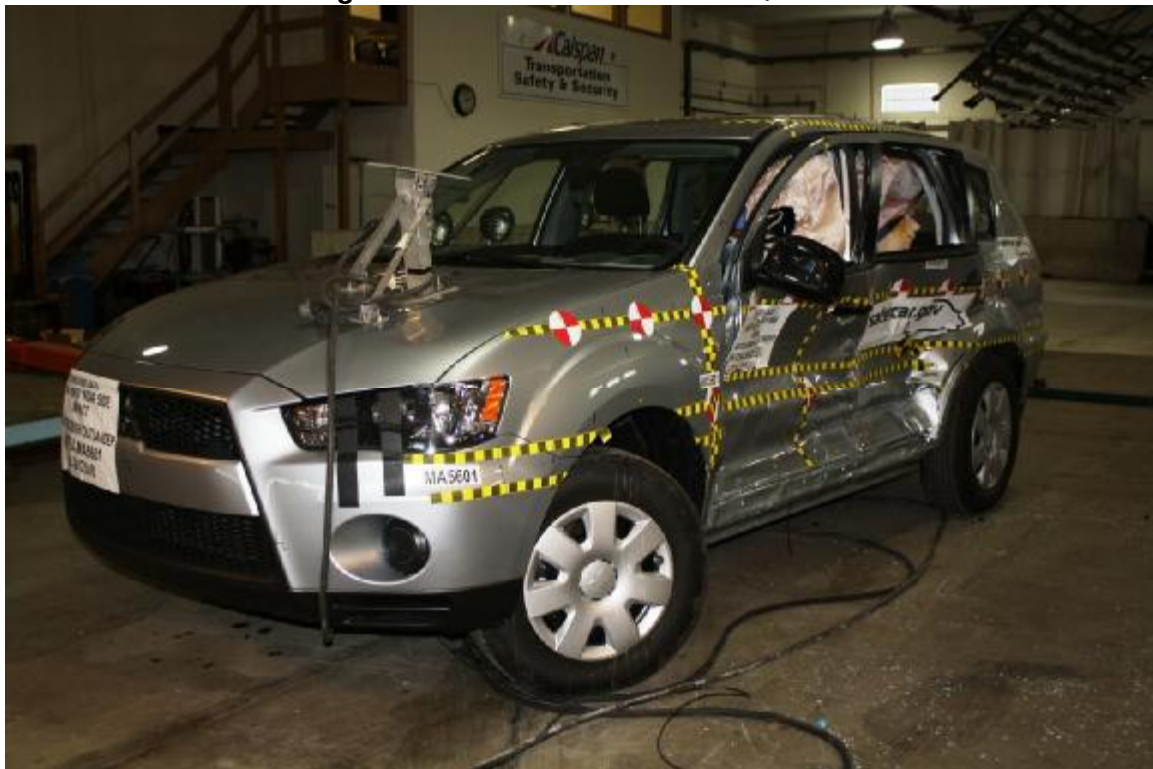
**Figure A-8: Post-Test Left Front  $\frac{3}{4}$  View**

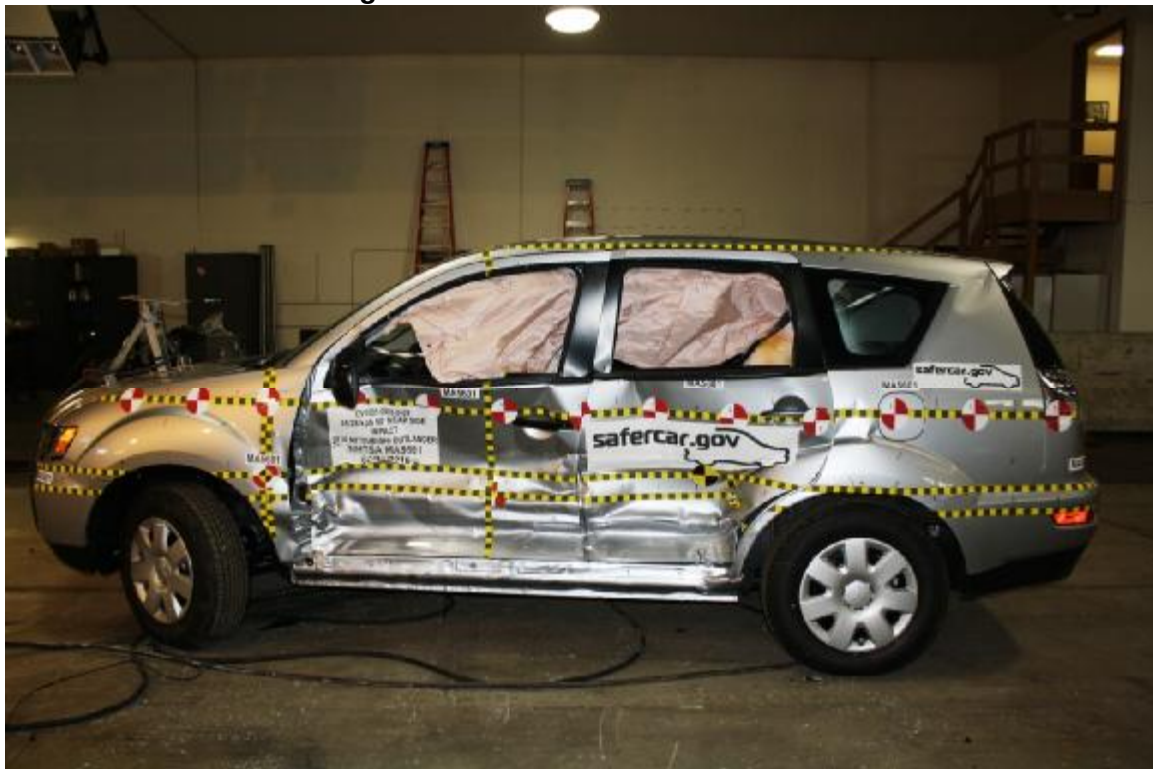
**Figure A-10: Post-Test Left Side View**

The test vehicle sustained a maximum static crush of 208 mm at level 3, 750 mm rearward of the left vertical impact point. The driver and passenger SID/HIII's, Serial Nos. 905 and 906 respectively, were calibrated just prior to this test.

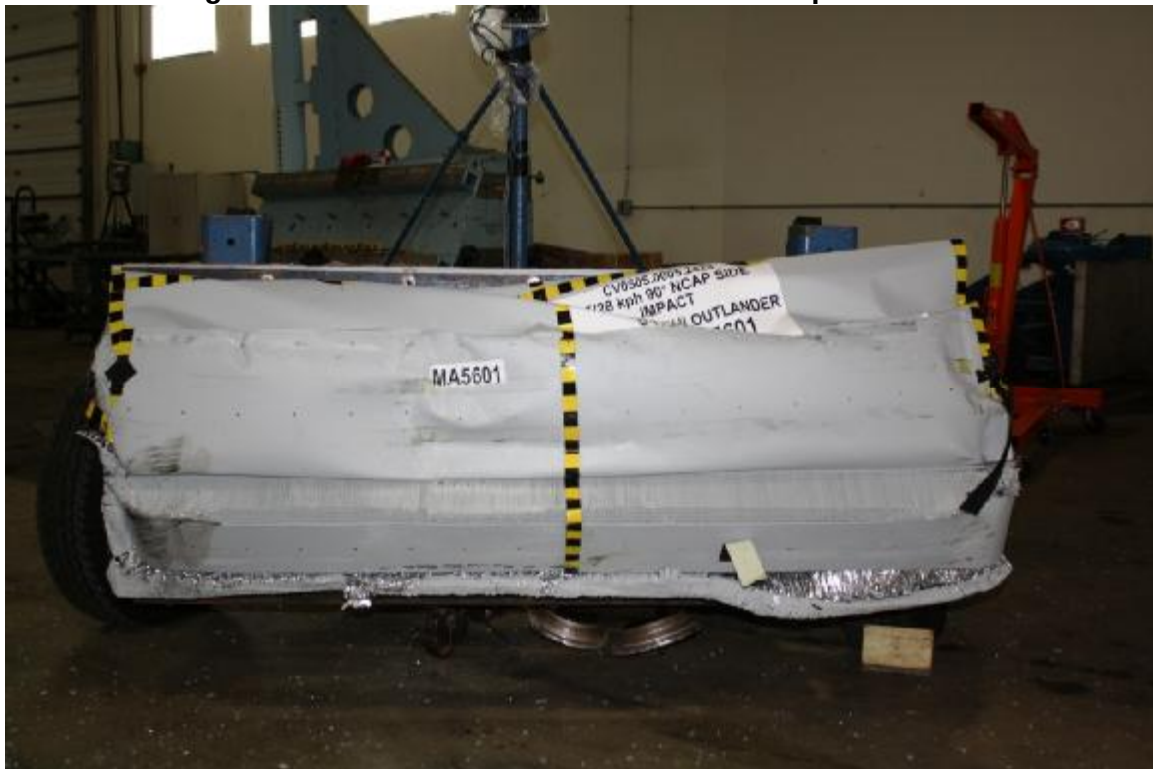
**Figure A-22: Post-Test Frontal View of MDB Impactor Face**

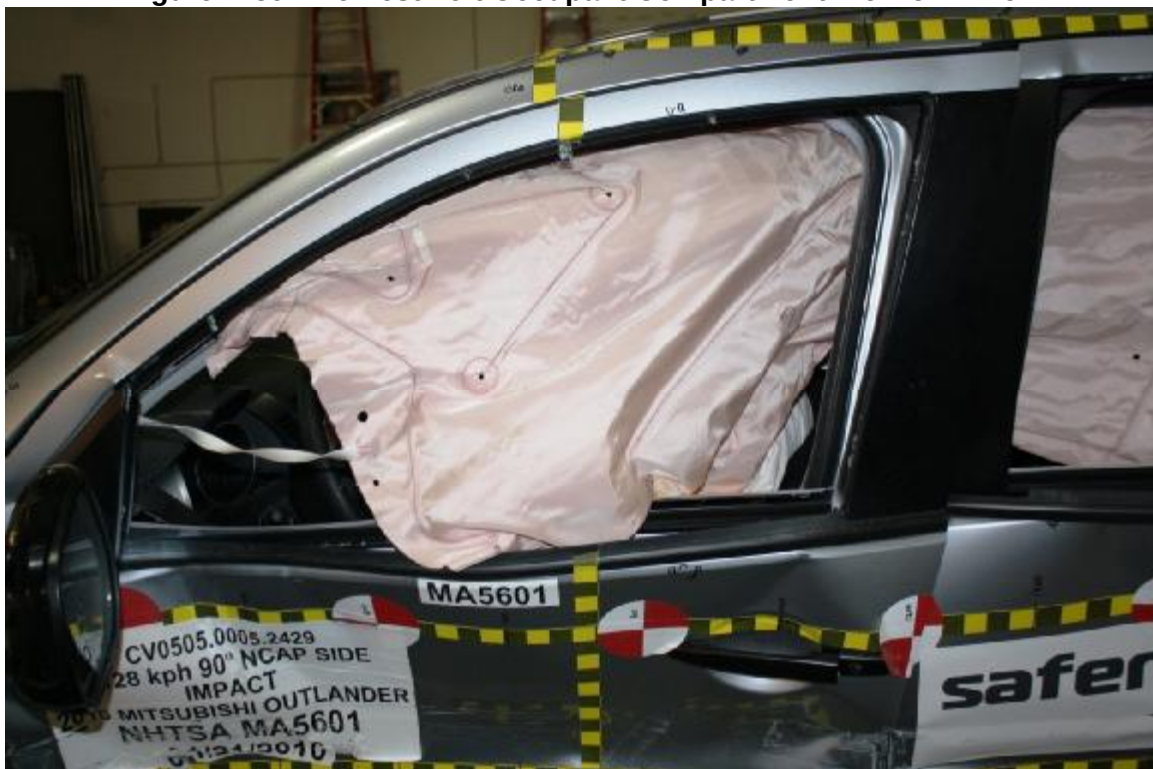
**Figure A-40: Post-Test Left Occupant Compartment View of Driver**

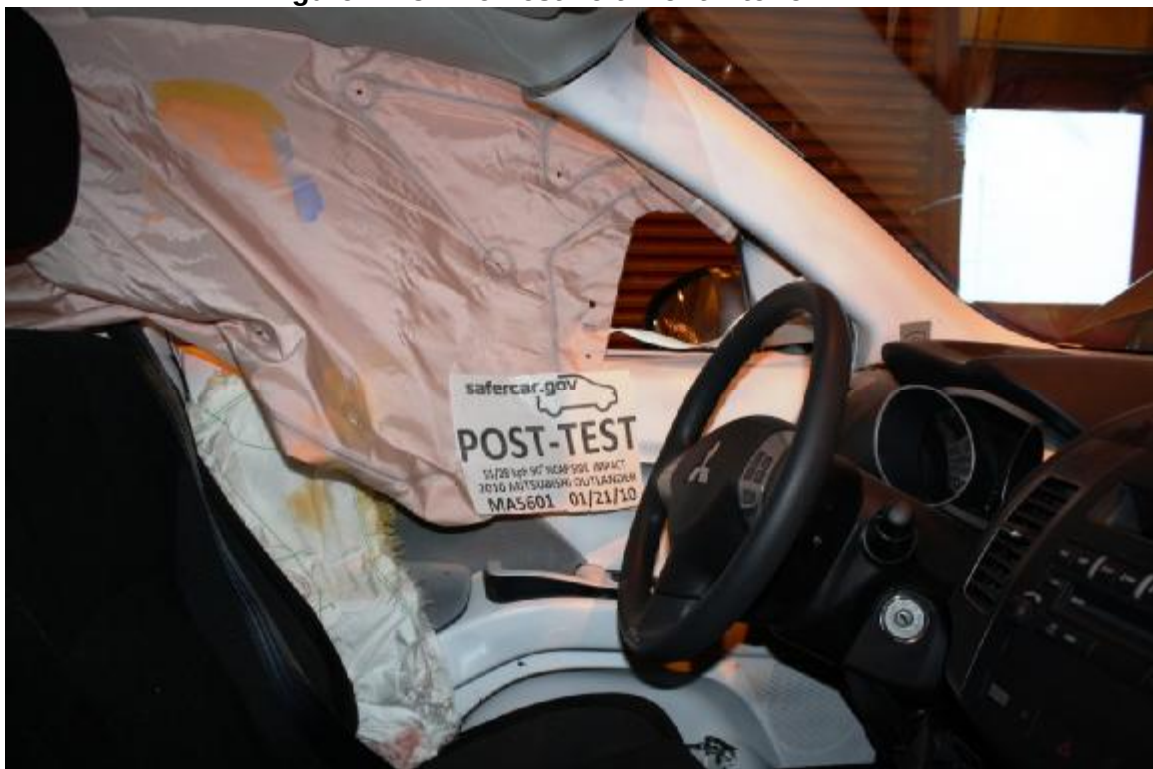
**Figure A-44: Post-Test Left Front Interior Trim**

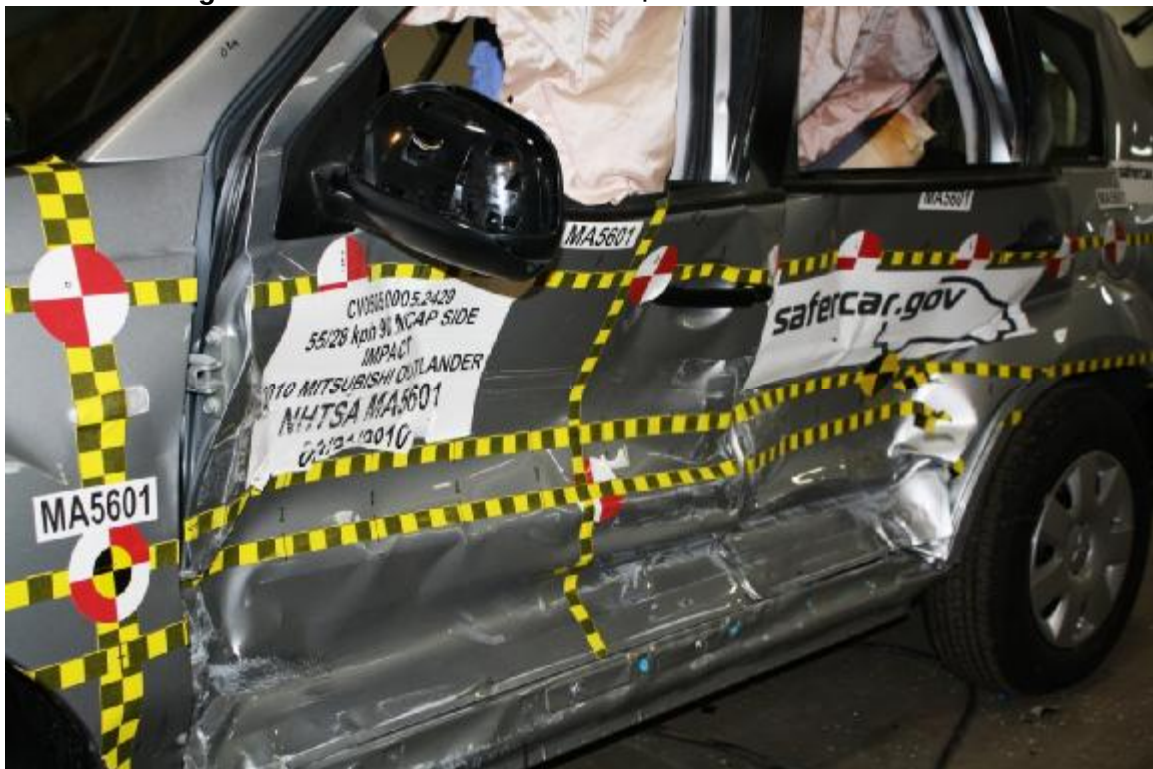
Figure A-48: Post-Test Left Front  $\frac{3}{4}$  View of Left Side Doors
